Maine Department of Transportation

Pavement Condition Report

PITTSFIELD MUNICIPAL AIRPORT (2B7)

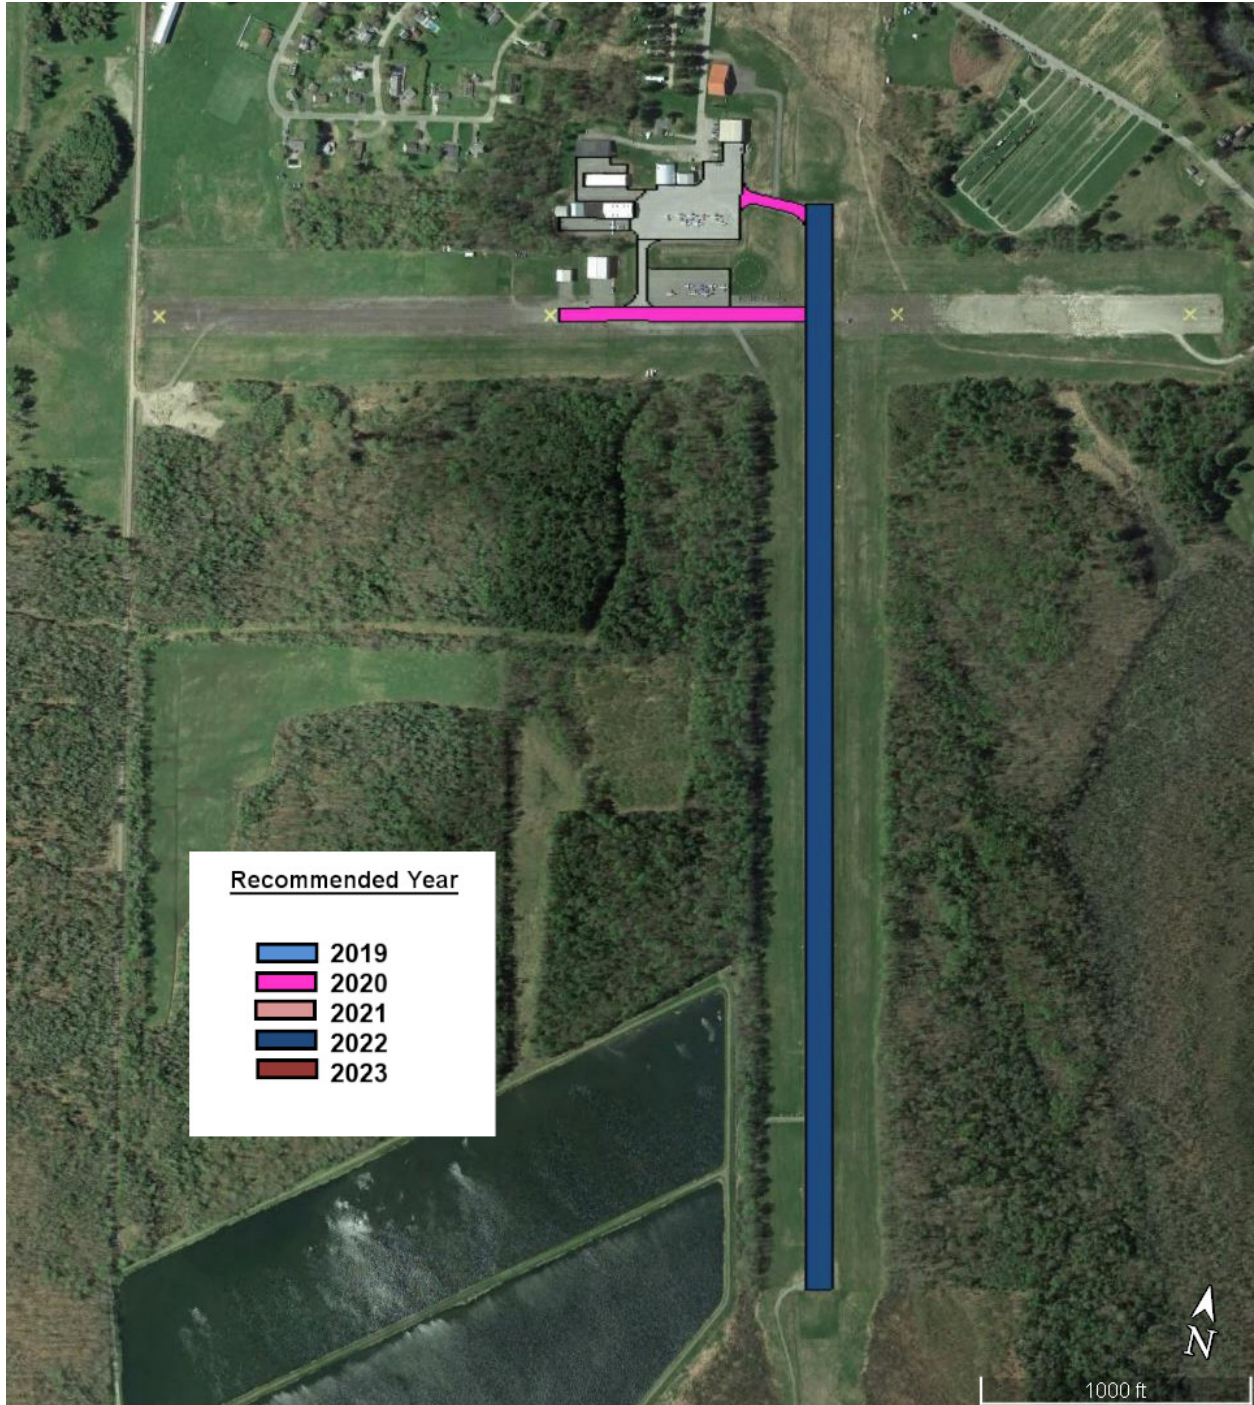
Figure 9. Major M&R

The pavement sections identified for major rehabilitation in Table 10 and shown in Figure 9 are at or are predicted to reach a condition level where major M&R should be considered. While the predicted rehabilitation timeline identifies specific sections and the general timing for the repair, more in-depth project-level studies will be needed to determine exactly how to fix each pavement (i.e. asphalt overlay, reconstruction, or some other repair alternative). Additionally, the airport may find it desirable to adjust the timing of projects to meet fiscal and operational constraints. For example, if the runway and several connector taxiways were forecast to reach the MSL in various years ranging from 2019-2023, it may be preferable to group these pavement sections into a single project.

Branch ID	Section ID	Year	Predicted PCI Before Rehab	Estimated Cost
CTB	001	2020	66	\$32,174
CTD	001	2020	65	\$128,972
RWY1836	001	2022	69	\$1,100,660
5-year Airport Total				\$1,261,805

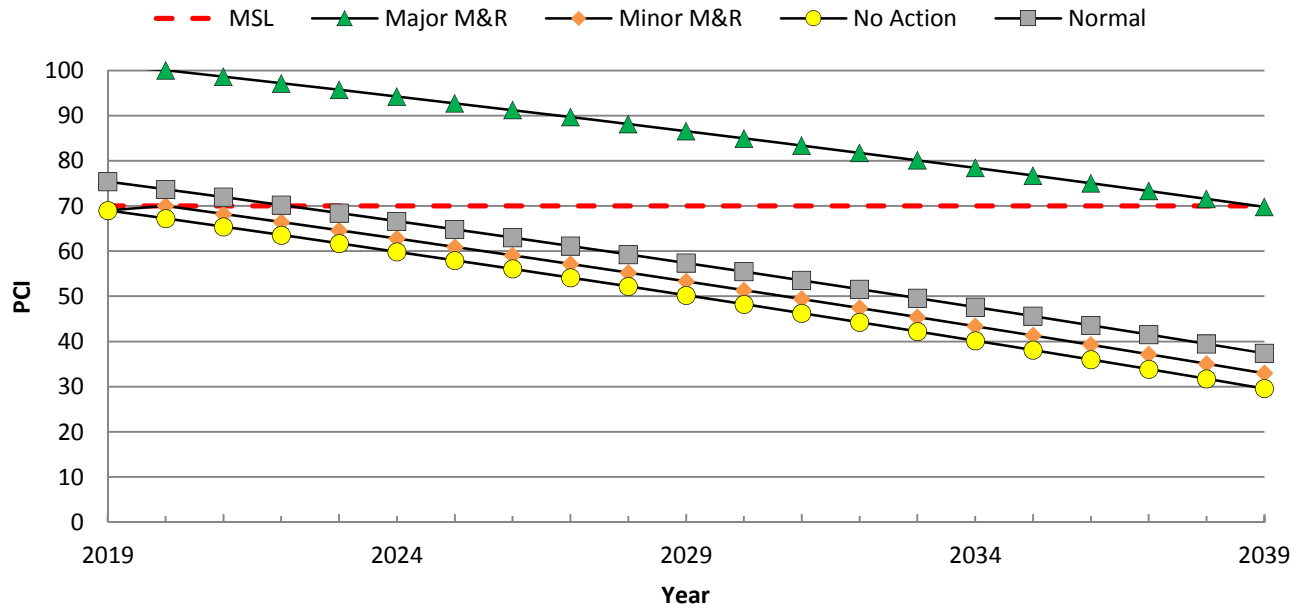
Section:	2B7::CTB::001
Description:	Connecting Taxiway B
PaveType:	AC
Area:	11,700
Built:	1/15/2003
Age:	16yr

M&R	Action	Year / Quantity	Cost (\$)	Ending PCI
Major	Major M&R	2020	32,174	100
Minor	All Minor	2020	128	70
1	Crack Sealing - AC	84 Ft	117	-
2	Surface Seal	19 SqFt	12	-
3	-	-	-	-
4	-	-	-	-
5	-	-	-	-
6	-	-	-	-
7	-	-	-	-

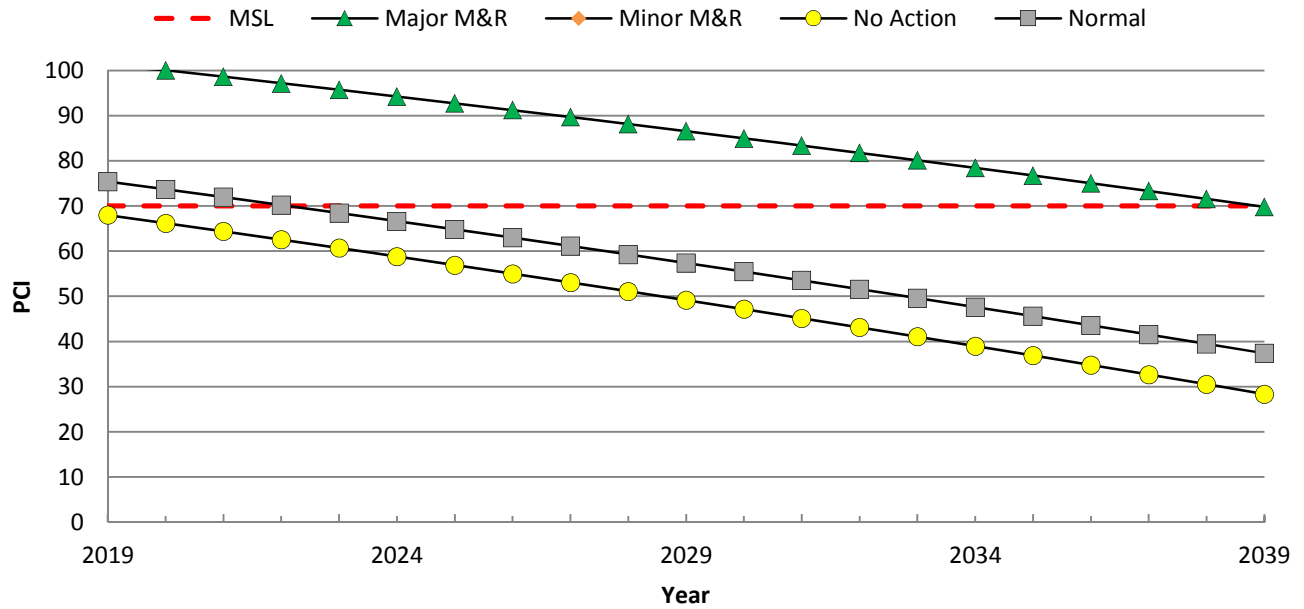
Section:	2B7::CTD::001
Description:	Connecting Taxiway D
PaveType:	AC
Area:	46,900
Built:	1/15/2003
Age:	16yr

M&R	Action	Year / Quantity	Cost (\$)	Ending PCI
Major	Major M&R	2020	128,972	100
Minor	-	-	-	-
1	-	-	-	-
2	-	-	-	-
3	-	-	-	-
4	-	-	-	-
5	-	-	-	-
6	-	-	-	-
7	-	-	-	-

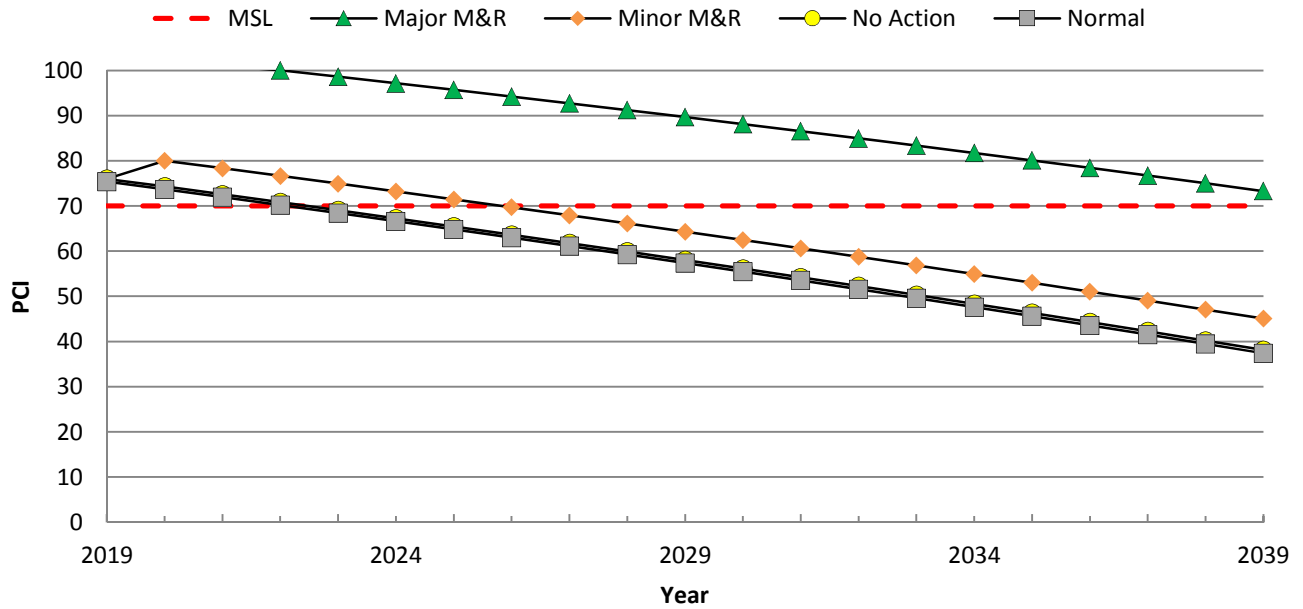
Section:	2B7::RWY1836::001
Description:	Runway 18-36
PaveType:	AC
Area:	400,250
Built:	1/15/2003
Age:	16yr

M&R	Action	Year / Quantity	Cost (\$)	Ending PCI
Major	Major M&R	2022	1,100,660	100
Minor	All Minor	2020	3,707	80
1	Crack Sealing - AC	2686 Ft	3,707	-
2	-	-	-	-
3	-	-	-	-
4	-	-	-	-
5	-	-	-	-
6	-	-	-	-
7	-	-	-	-
