Pavement Condition Report

STEPHEN A. BEAN MUNICIPAL AIRPORT (8B0)

STEPHEN A. BEAN
MUNICIPAL AIRFIELD

Submitted To:
Maine Department of Transportation
16 State House Station
Augusta, ME 04333

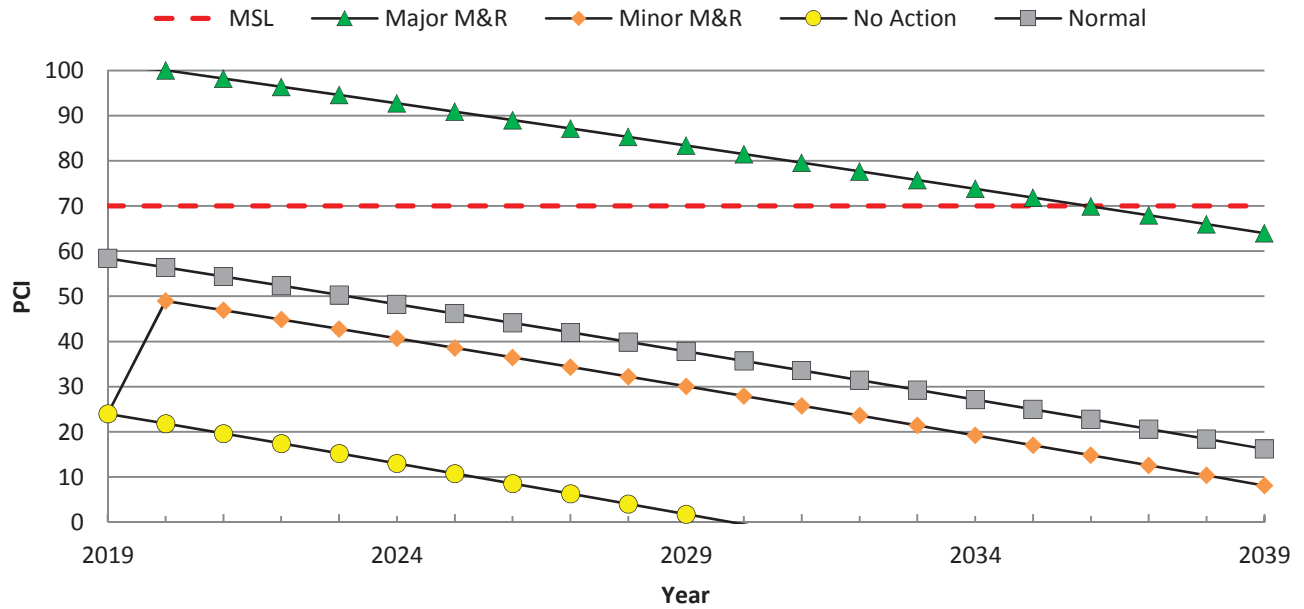
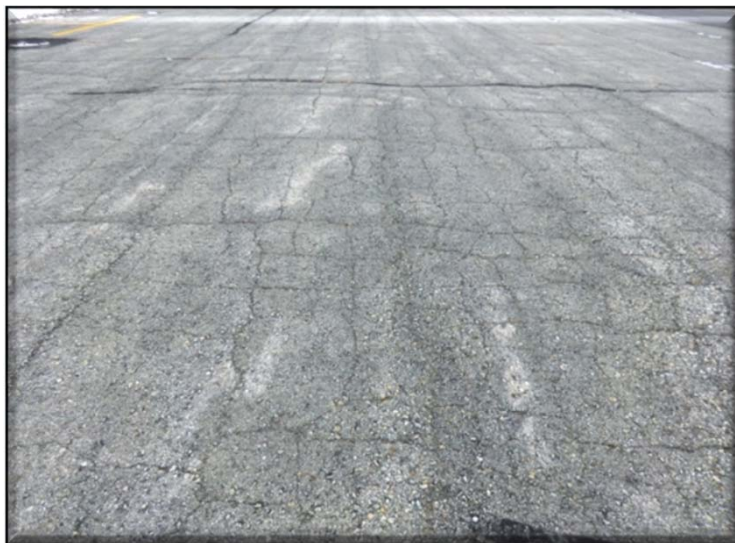
Apron A

M&R	Action	Year / Quantity	Cost (\$)	Ending PCI
Major	Major M&R	2020	332,514	100
Minor	All Minor	2020	6,856	49
1	Crack Sealing - AC	4968 Ft	6,856	-
2	-	-	-	-
3	-	-	-	-
4	-	-	-	-
5	-	-	-	-
6	-	-	-	-
7	-	-	-	-

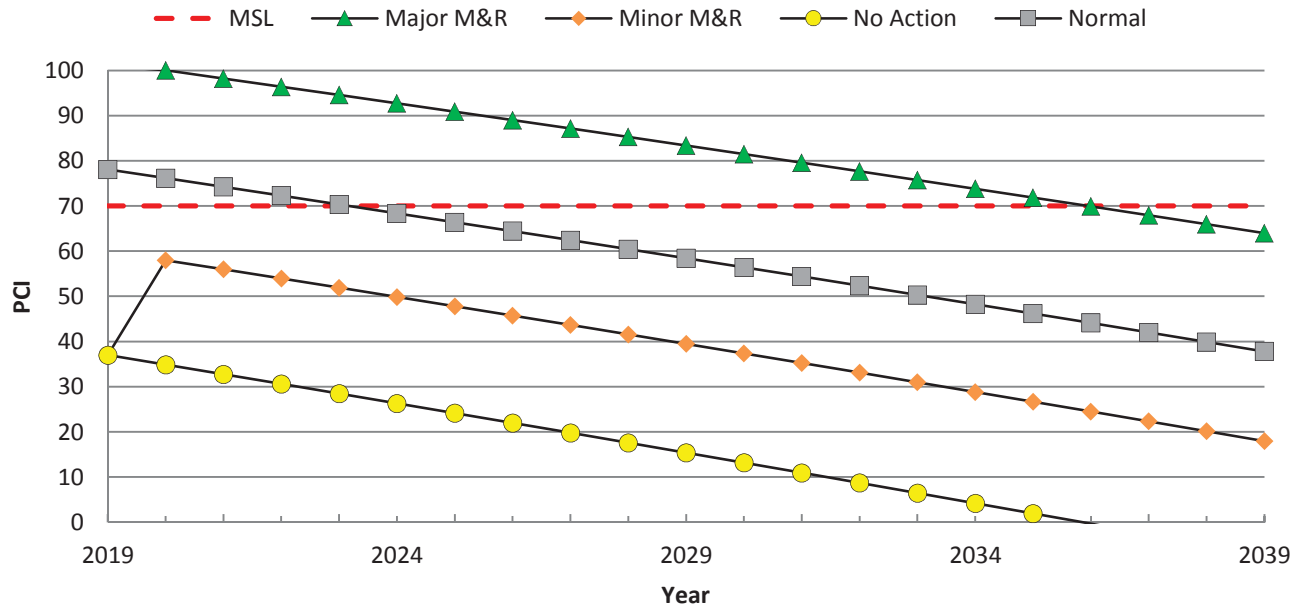
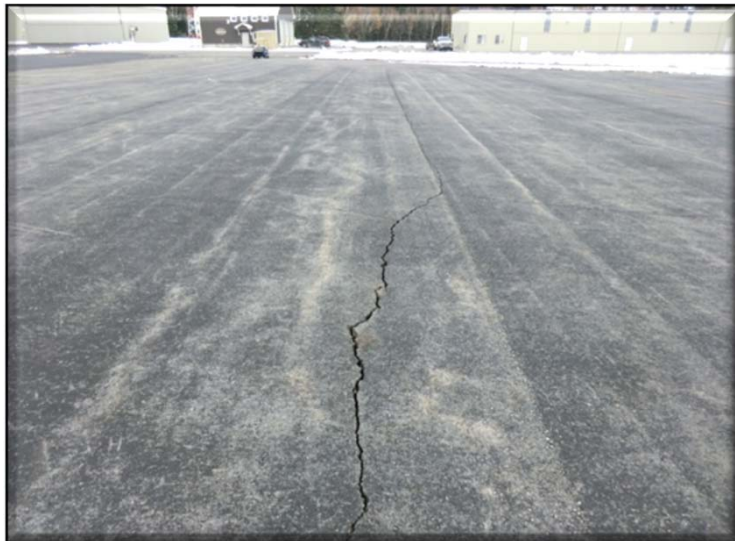
Apron A

⁴ The higher than average deterioration rate of 5.7 PCI/Yr for APA-002 is due to medium-and high-severity block cracking.

M&R	Action	Year / Quantity	Cost (\$)	Ending PCI
Major	Major M&R	2020	261,320	100
Minor	All Minor	2020	15,185	58
1	Crack Sealing - AC	11003 Ft	15,185	-
2	-	-	-	-
3	-	-	-	-
4	-	-	-	-
5	-	-	-	-
6	-	-	-	-
7	-	-	-	-

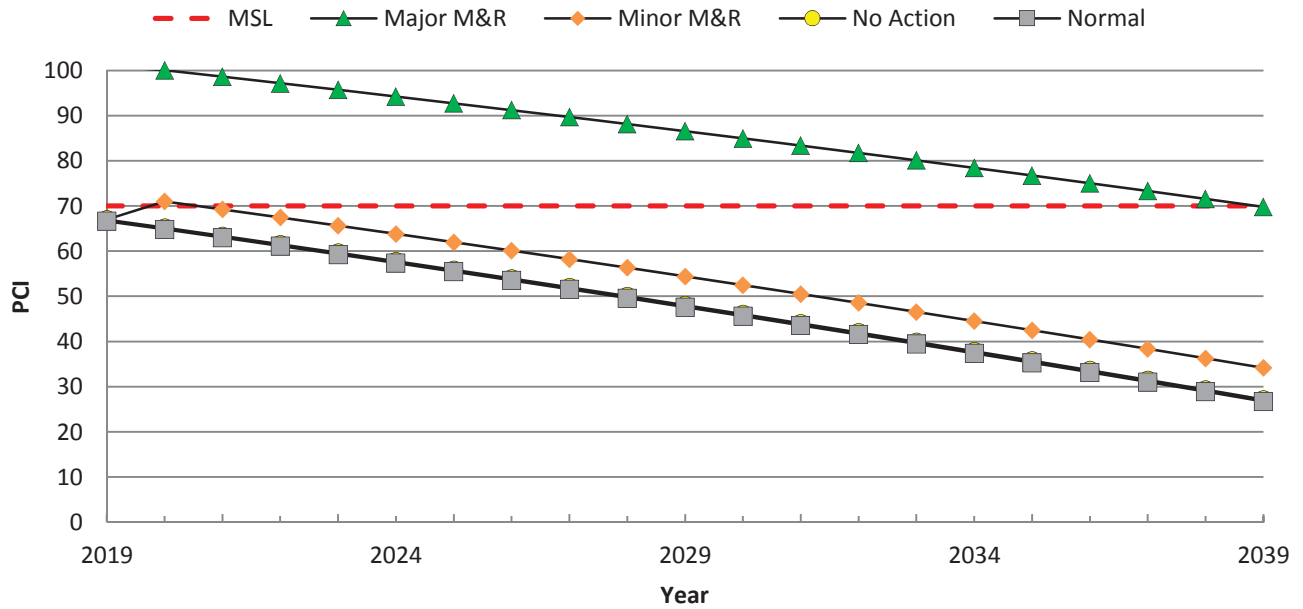
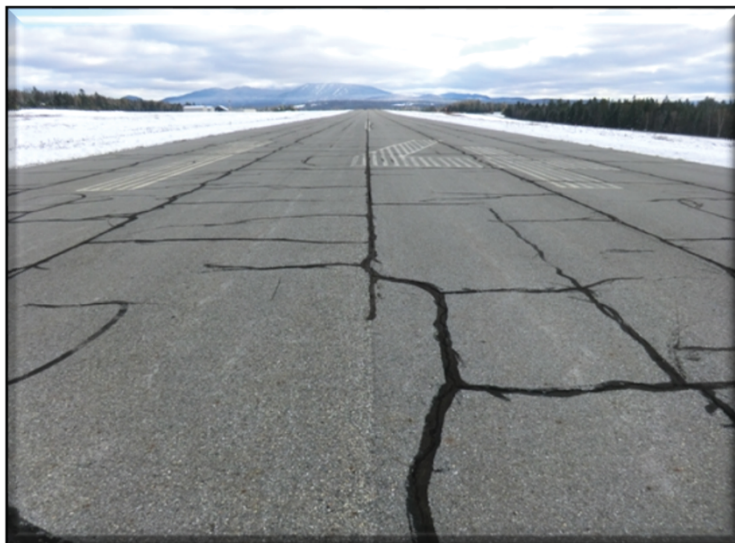
Runway 14-32

M&R	Action	Year / Quantity	Cost (\$)	Ending PCI
Major	Major M&R	2020	660,396	100
Minor	All Minor	2020	2,596	71
1	Crack Sealing - AC	1881 Ft	2,596	-
2	-	-	-	-
3	-	-	-	-
4	-	-	-	-
5	-	-	-	-
6	-	-	-	-
7	-	-	-	-
