# Maine Department of Transportation

## Pavement Condition Report

## NORTHERN AROOSTOOK REGIONAL AIRPORT (KFVE)

Submitted By:  
**DuBois & King & ARA**  
355 Husson Avenue - Suite 1  
Bangor, Maine 04401

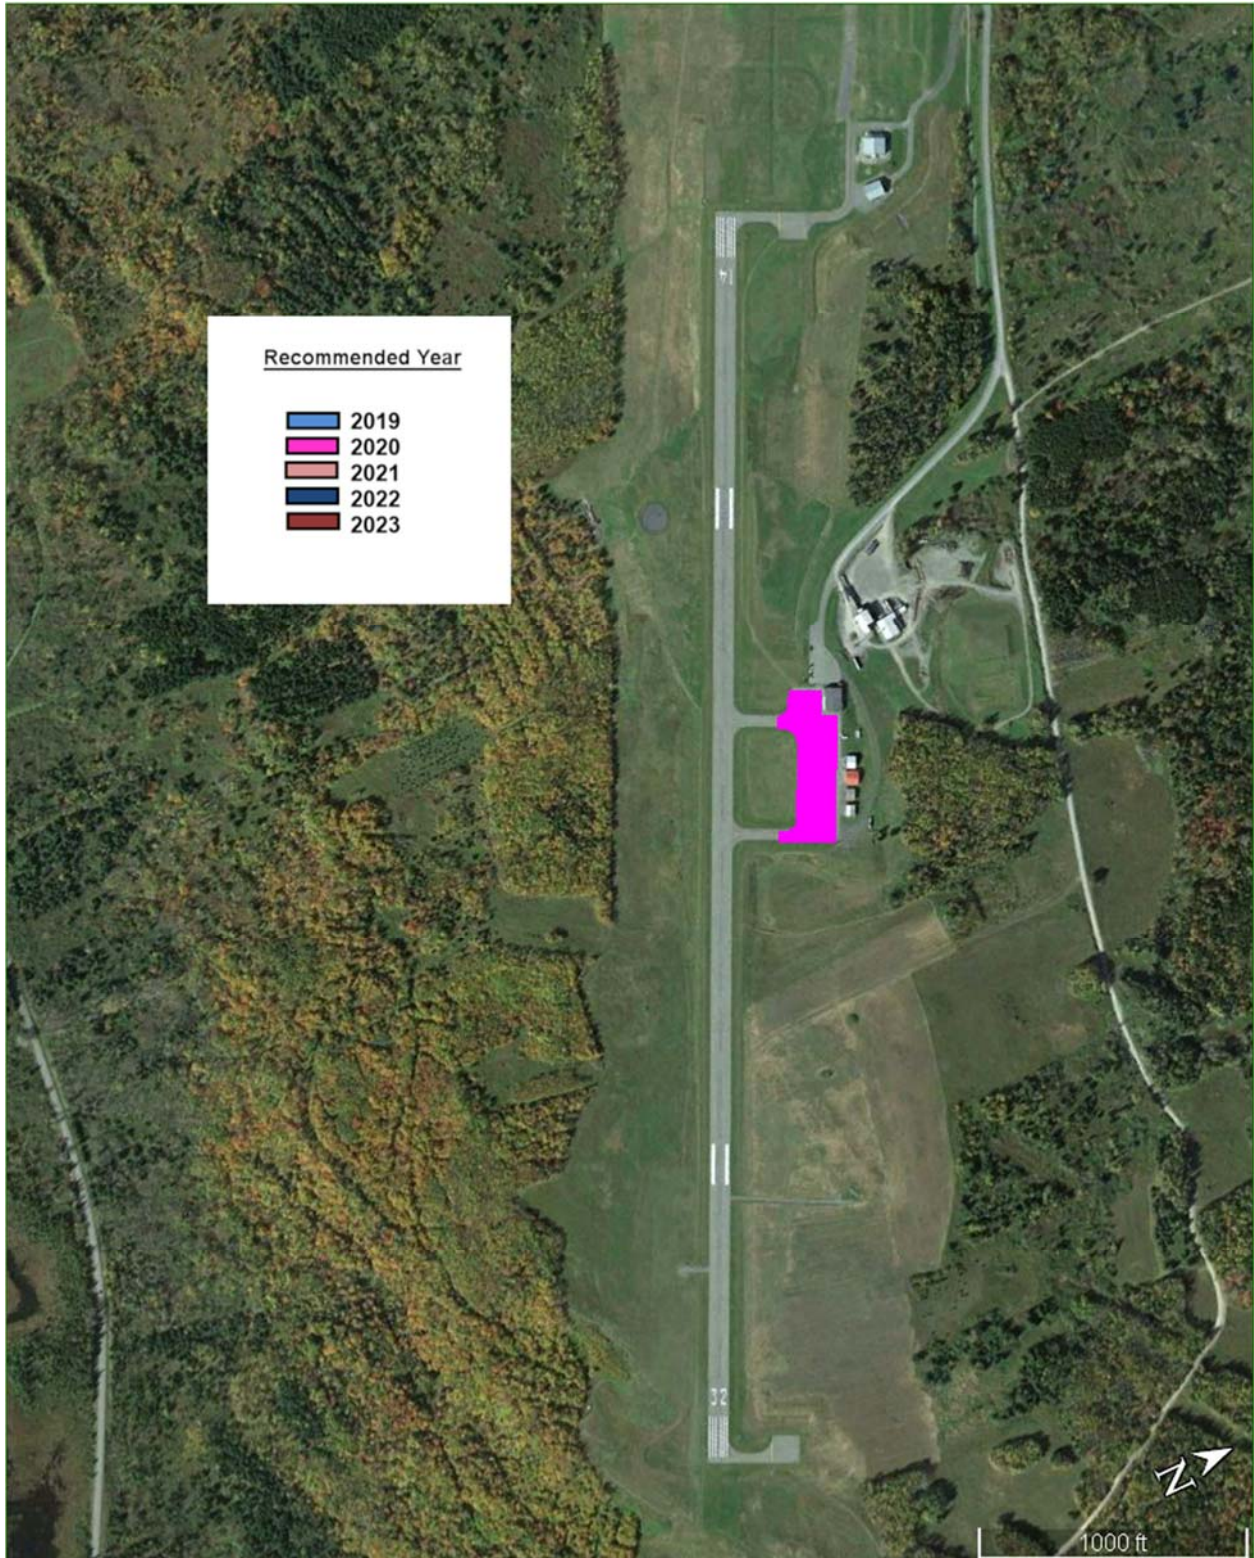
Figure 9. Major M&R

The pavement sections identified for major rehabilitation in Table 10 and shown in Figure 9 are at or are predicted to reach a condition level where major M&R should be considered. While the predicted rehabilitation timeline identifies specific sections and the general timing for the repair, more in-depth project-level studies will be needed to determine exactly how to fix each pavement (i.e. asphalt overlay, reconstruction, or some other repair alternative). Additionally, the airport may find it desirable to adjust the timing of projects to meet fiscal and operational constraints. For example, if the runway and several connector taxiways were forecast to reach the MSL in various years ranging from 2019-2023, it may be preferable to group these pavement sections into a single project.

Branch ID	Section ID	Year	Predicted PCI Before Rehab	Estimated Cost
APA	001	2020	62	\$243,369
<b>5-year Airport Total</b>				<b>\$243,369</b>

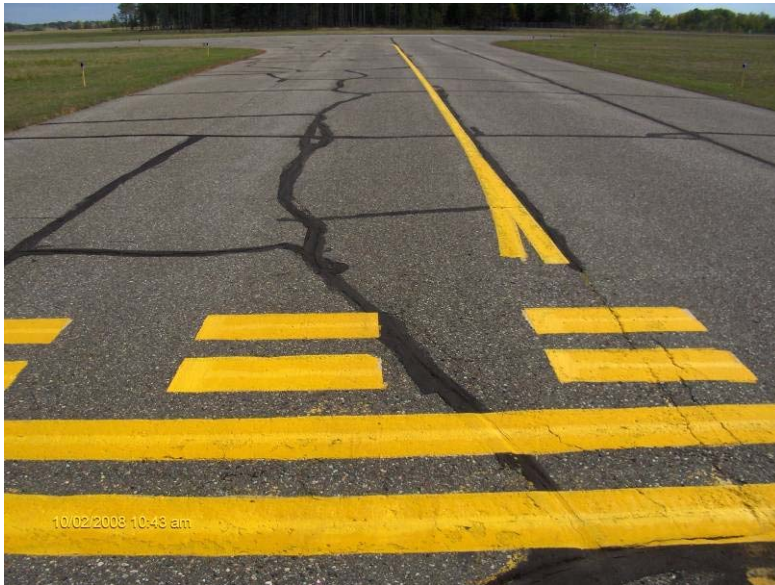
### *Example of Longitudinal and Transverse Cracking (L&T cracking)*

Longitudinal and transverse cracks are caused by pavement aging, by construction, and by subsurface movement. Aging occurs as pavement loses some of its components to the atmosphere and becomes more brittle. Consistent application of pavement sealcoats can help to prevent the occurrence of age related cracks. Cracks will also develop along poorly constructed paving lane joints. Ensuring that joints are made when both sides are still hot, and near the same temperature, is one of the best ways to mitigate this potential problem. Seasonal movement caused by changes in moisture content or temperature differences can also cause pavement cracks. Asphalt pavement placed over a PCC pavement or cement stabilized base course may evidence reflective cracking from the underlying material. Longitudinal and transverse cracks are not caused by wheel loads, although traffic may worsen their condition.

Low severity longitudinal and transverse cracks are less than  $\frac{1}{4}$  inch wide, or if sealed with suitable filler material in satisfactory condition can be any width, less than 3 inches, if they are not spalled. Maintenance usually is not indicated for low-severity cracking. Moderately spalled cracks and cracks wider than  $\frac{1}{4}$  inch which are not satisfactorily sealed are at medium severity. Medium-severity cracks should be sealed with a high-quality crack filling material. Severely spalled cracks and cracks wider than 3 inches are at high severity. High-severity L&T cracks normally require patching.

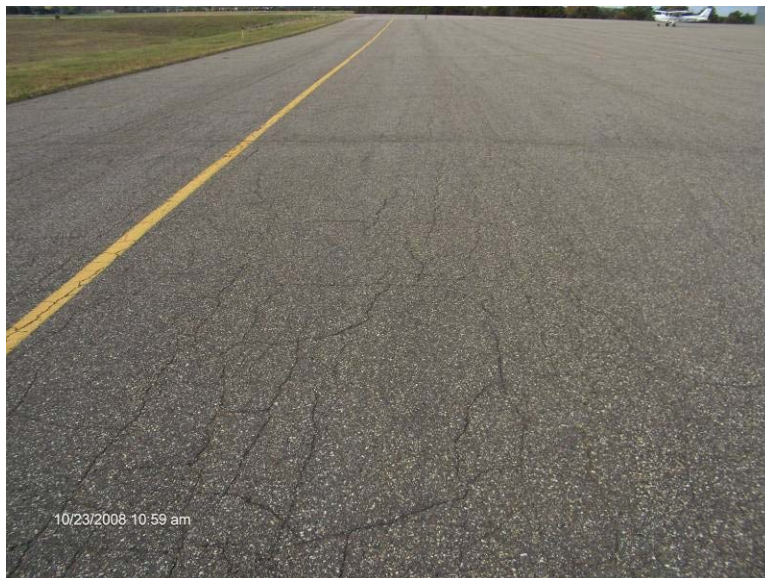
### *Example of Alligator Cracking*

Alligator (or fatigue) cracks are a series of interconnected load-related cracks caused by fatigue of the asphalt surface. Alligator cracking is a significant structural distress and develops only in places subject to traffic loads. These cracks typically initiate at the bottom of the asphalt layer (where tensile strains

are highest) and propagate upward - so once a fatigue crack is visible, significant damage has already occurred.

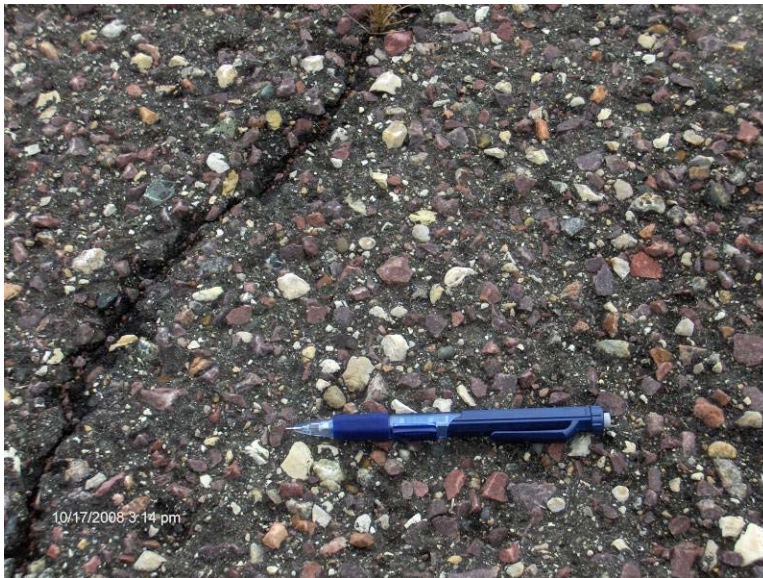
**Example of Raveling/Weathering**

Raveling and weathering are the wearing away of the pavement surface. Raveling is the condition where the mid- to large size aggregates are becoming dislodged; weathering is when the fine aggregate wears away exposing the edges of the larger aggregate. These distresses are usually evident over large areas and may occur together (pictured above) or separately. Raveling and weathering may indicate that the asphalt binder has hardened significantly.

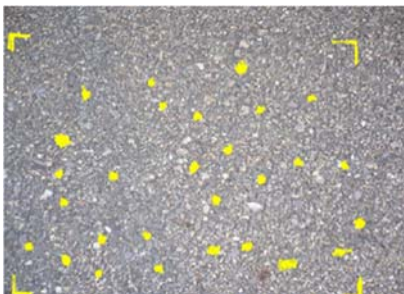
Raveling – At low severity, the number of missing coarse aggregates (> 3/8 inch) is between 5-20 missing/yd<sup>2</sup>, medium severity (pictured below where the missing coarse aggregates have been dotted with yellow paint) is 21-40 missing/yd<sup>2</sup>, and high severity is > 40 missing/yd<sup>2</sup>.

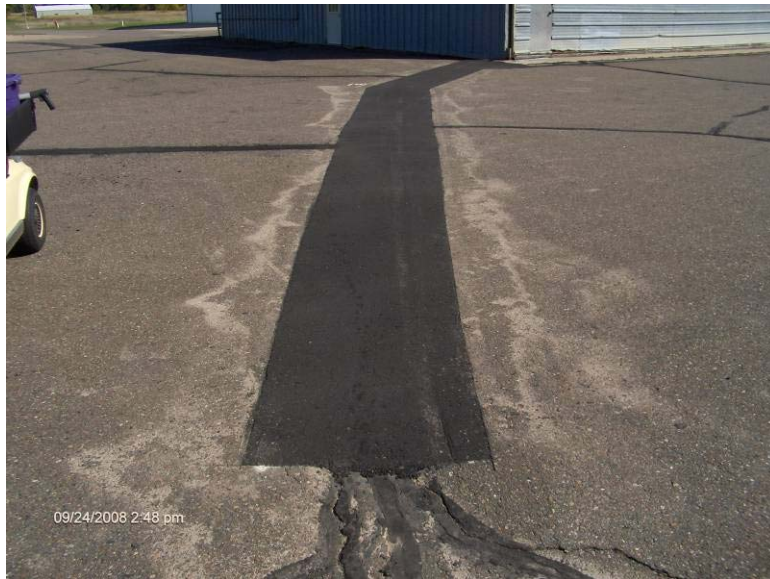
### Example of Patching

Patched areas are defined when a portion of the original pavement is replaced with a material intended as a semi-permanent repair. A patch is documented as a defect because it is considered a break in the integrity of the pavement structure. Patches are constructed for a variety of reasons including utility repairs, correcting grade issues, and addressing a defect in the original pavement. The severity level of patches is determined by the amount of distress (i.e. cracking, depression, weathering/raveling, etc.) occurring within the limits of the patched area.

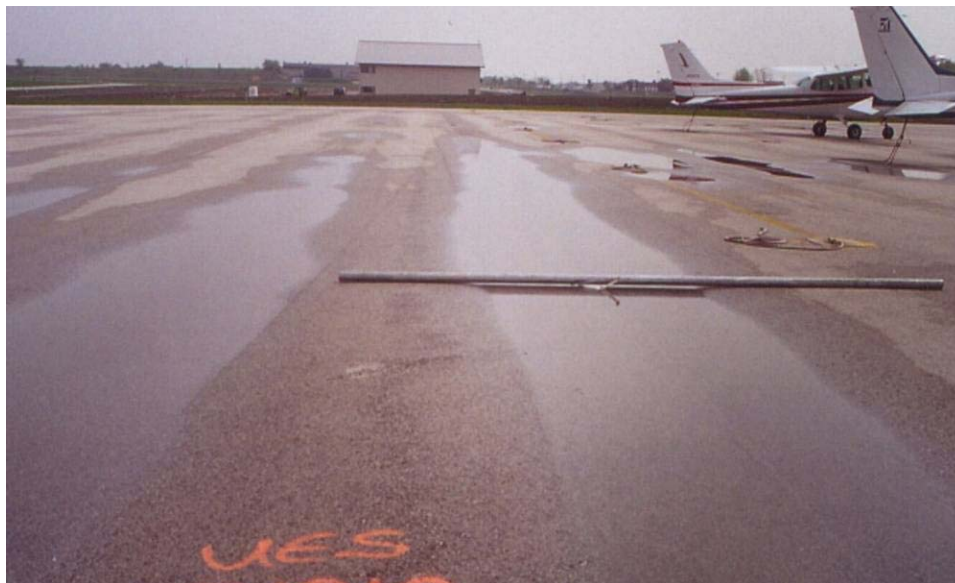
### Example of Rutting

Ruts are localized, load related, areas of pavement having elevations lower than the surrounding sections. Rutting is due to base and subgrade consolidation, caused by excessive wheel loads or poor compaction. Ruts indicate structural failure, and can cause hydroplaning. At low severity, ruts have an

average depth of  $\frac{1}{4}$  to  $\frac{1}{2}$  inches. At medium severity, ruts have an average depth of  $\frac{1}{2}$  to 1 inch. High severity, ruts have an average depth greater than 1 inch. Full-depth patching is the appropriate repair for ruts.
