Summary of ET-Plus Guardrail End Treatment Inspections

12/16/2015

Maine Department of Transportation

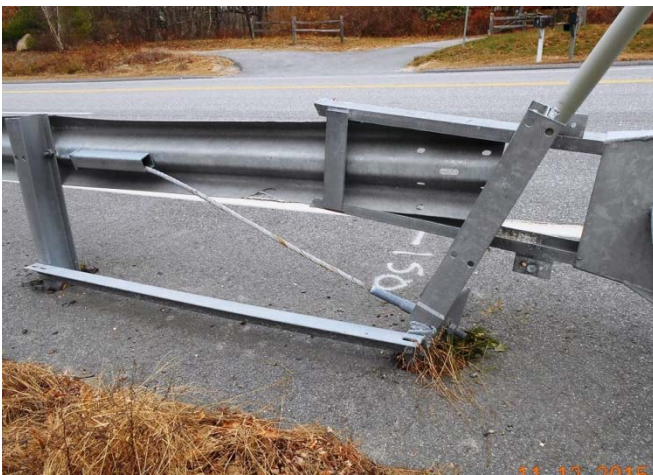
Photo 1
Location 892718

Twelve (12) of the 86 units inspected (14%) were deemed nonfunctional. Of these 12 units, six (6) had the w-beam disengaged from the extruder head [Photo 1]. One (1) was damaged such that the extruder head was completely off the assembly [Photo 2]. Most of these were damaged on the trailing end of a guardrail run. The damage appeared to be caused by impact in the opposite direction from the impacts these systems were designed to handle. Three (3) units were hit from the head on direction, sustaining damage and requiring replacement [Photo 3]. Two (2) nonfunctional units were not part of the random sample but were noted in the same area as the unit being inspected [Photo 4].

NOTE: The Regions and applicable urban compact municipalities have been notified of these nonfunctional units and actions to repair or replace are underway.

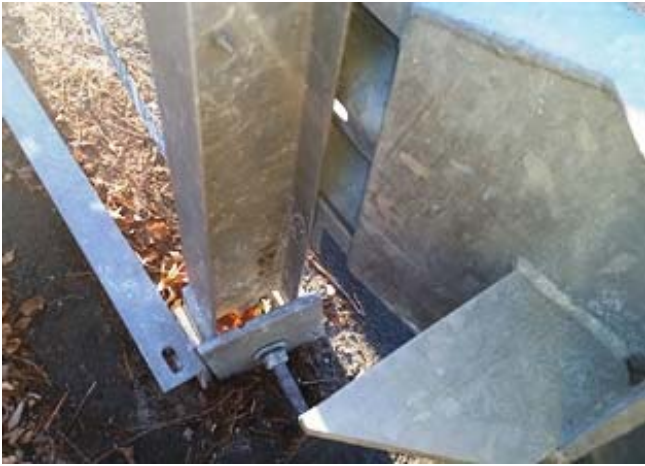
Photo 5
Location 282554

In addition, twenty-one (21) units or 24% had some deficiencies: Installation and maintenance issues including inadequate height, hinge posts installed backwards [Photo 5], cable/bearing plate not installed correctly [Photo 6 & 7], and missing/incorrect/ bolts or hardware incorrectly bolted together [Photo 8].
