Pavement Condition Report

## **NEWTON FIELD AIRPORT (59B)**

## Executive Summary

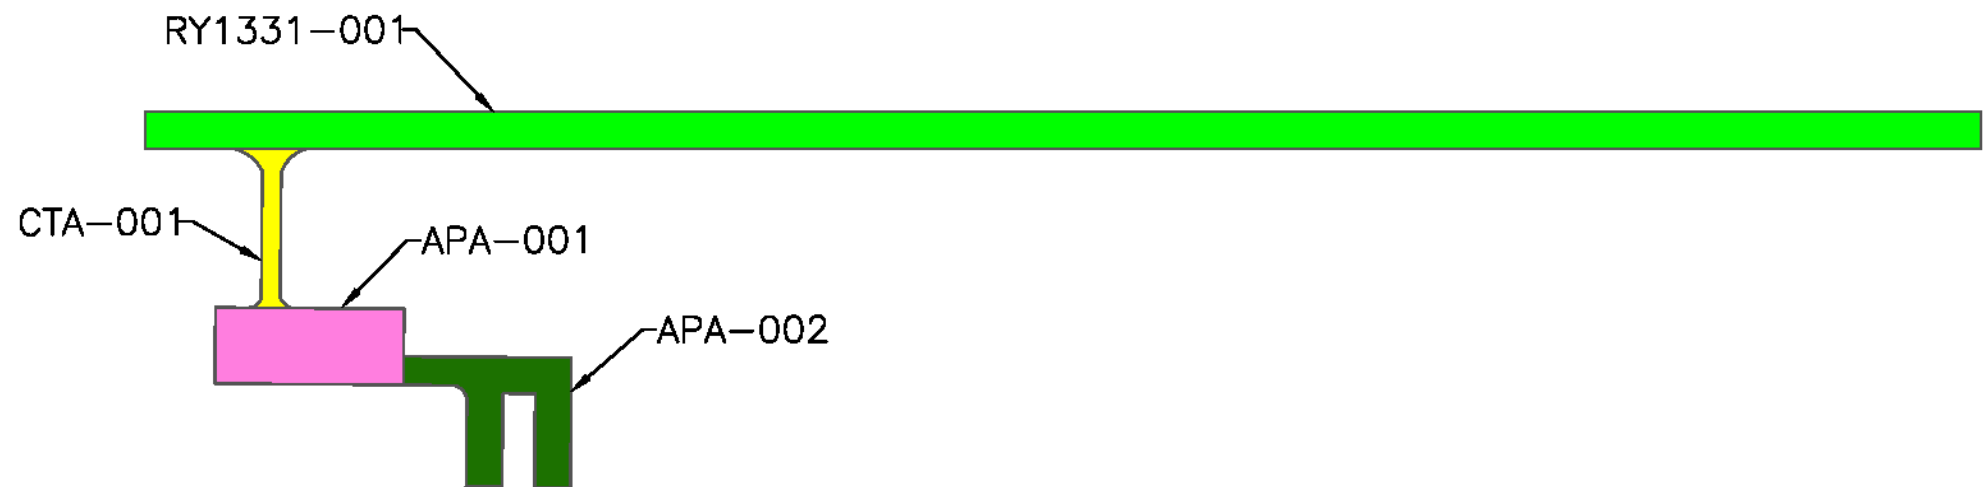
2018 Pavement Condition Map Newton Field Airport - Jackman (59B)			
ENGINEER: BDA	DRAWN BY: MJP	DATE: Jul 2019	CTAF 122.9

The average inspected Pavement Condition Index (PCI) for all the airfield pavements at 59B was 76. Runway 13-31 had an average inspected PCI of 78, which is above the MSL of 70. Taxiways had an average inspected PCI of 65, and aprons had an average inspected PCI of 71. A comparison of the average PCI values at 59B to the statewide average PCI values, by branch use, is shown in the figure below.

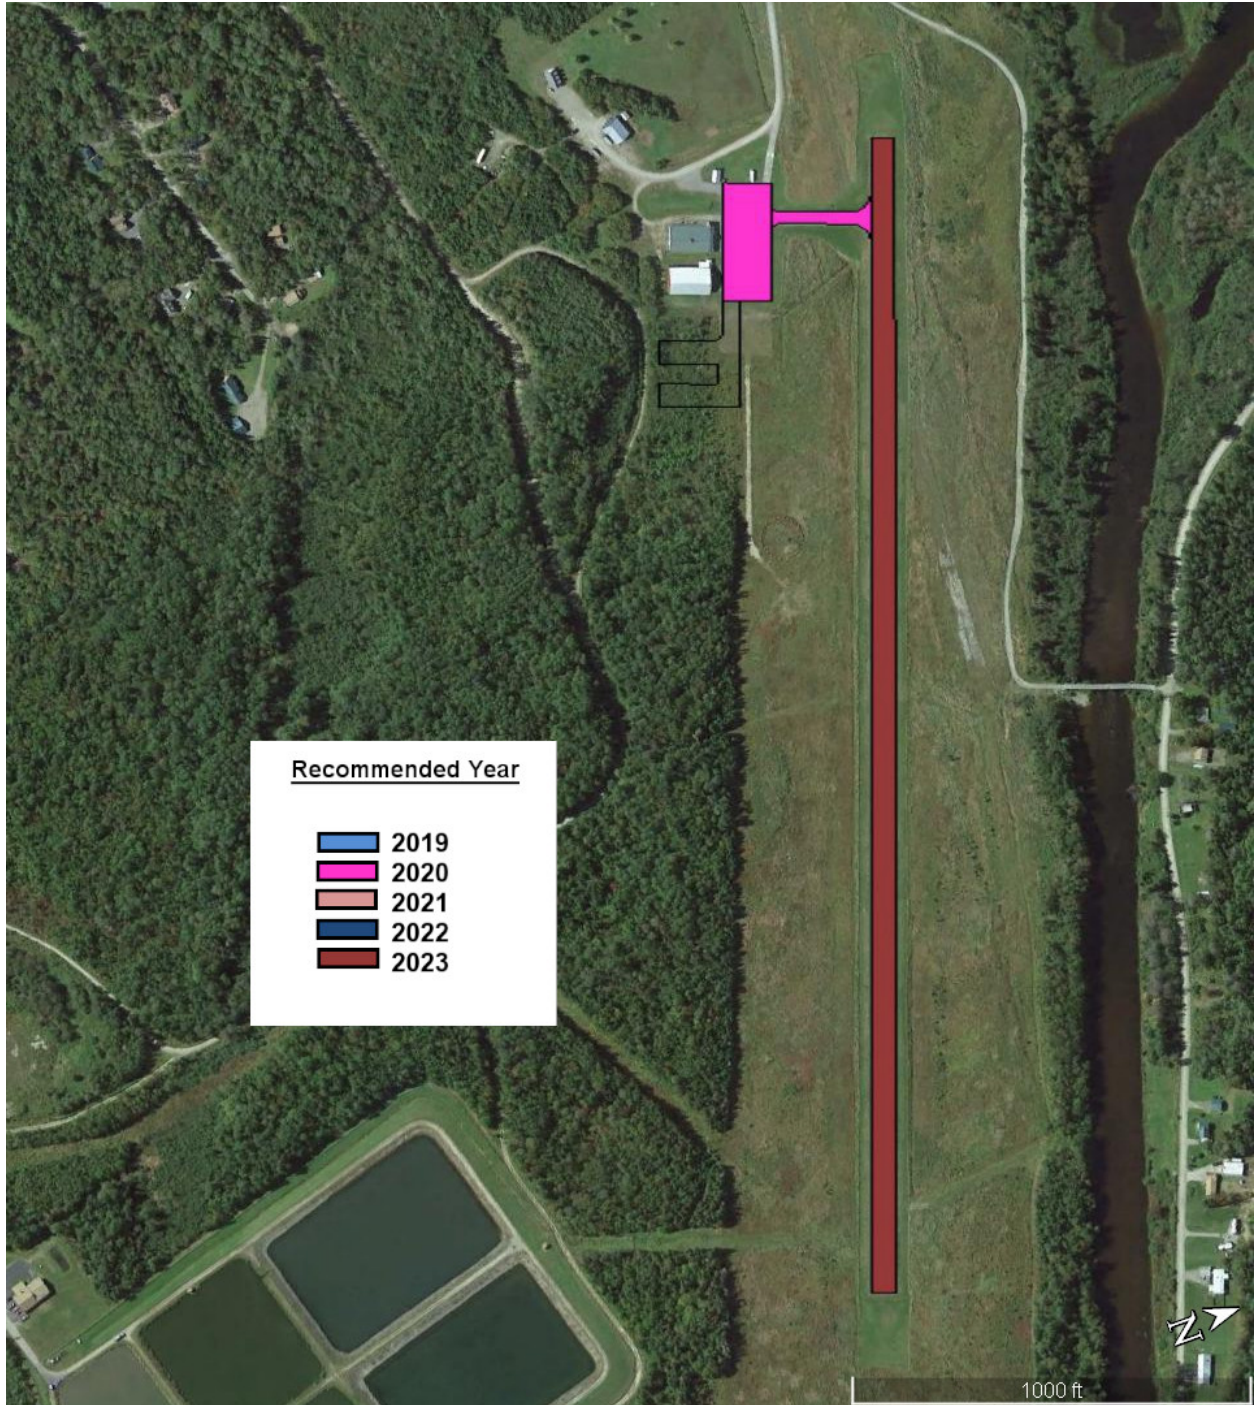
Figure 9. Major M&R

The pavement sections identified for major rehabilitation in Table 10 and shown in Figure 9 are at or are predicted to reach a condition level where major M&R should be considered. While the predicted rehabilitation timeline identifies specific sections and the general timing for the repair, more in-depth project-level studies will be needed to determine exactly how to fix each pavement (i.e. asphalt overlay, reconstruction, or some other repair alternative). Additionally, the airport may find it desirable to adjust the timing of projects to meet fiscal and operational constraints. For example, if the runway and several connector taxiways were forecast to reach the MSL in various years ranging from 2019-2023, it may be preferable to group these pavement sections into a single project.

Branch ID	Section ID	Year	Predicted PCI Before Rehab	Estimated Cost
APA	001	2020	43	\$729,288
CTA	001	2020	61	\$23,924
RY1331	001	2023	69	\$478,075
<b>5-year Airport Total</b>				<b>\$1,231,287</b>
