Maine Department of Transportation

Pavement Condition Report

AUGUSTA STATE AIRPORT (KAUG)

Executive Summary

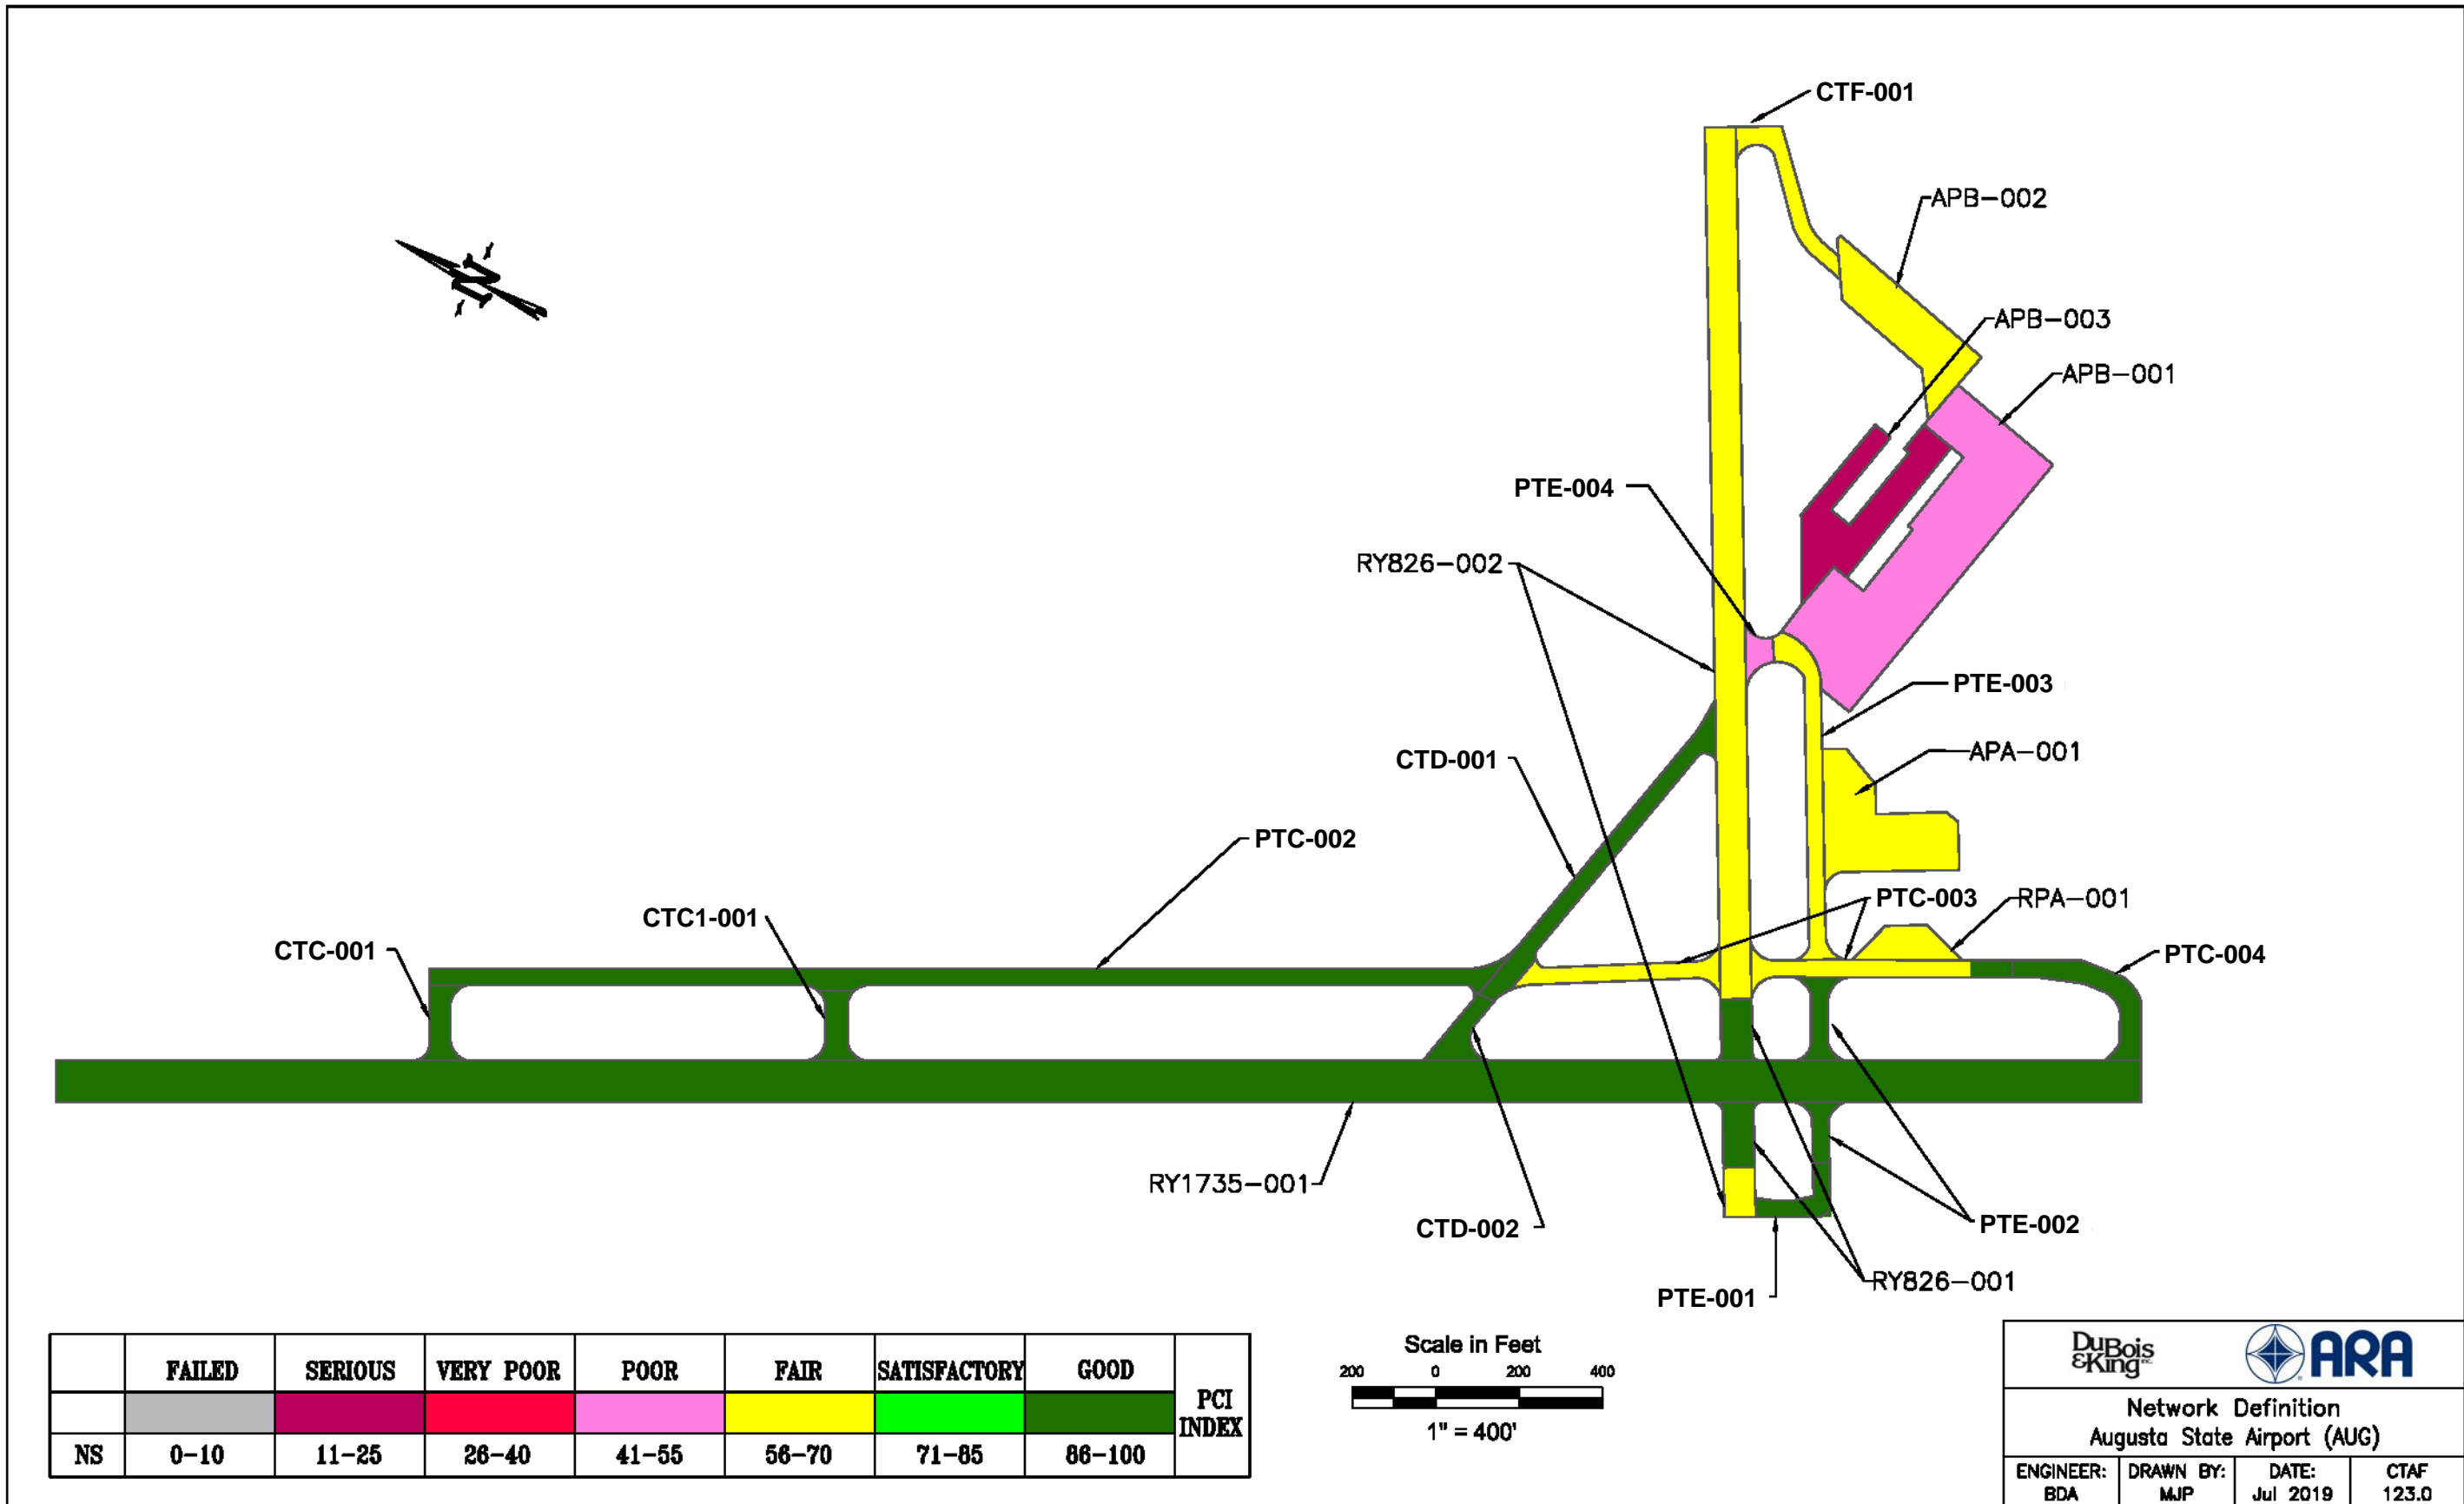
Figure 7. 2018 PCI Map at Augusta State Airport (AUG)

The average inspected Pavement Condition Index (PCI) for all the airfield pavements at AUG was 77. Runways had an average inspected PCI of 89, which is above the MSL of 70. Taxiways had an average inspected PCI of 82, and aprons had an average inspected PCI of 49. A comparison of the average PCI values at AUG to the statewide average PCI values, by branch use, is shown in the figure below.

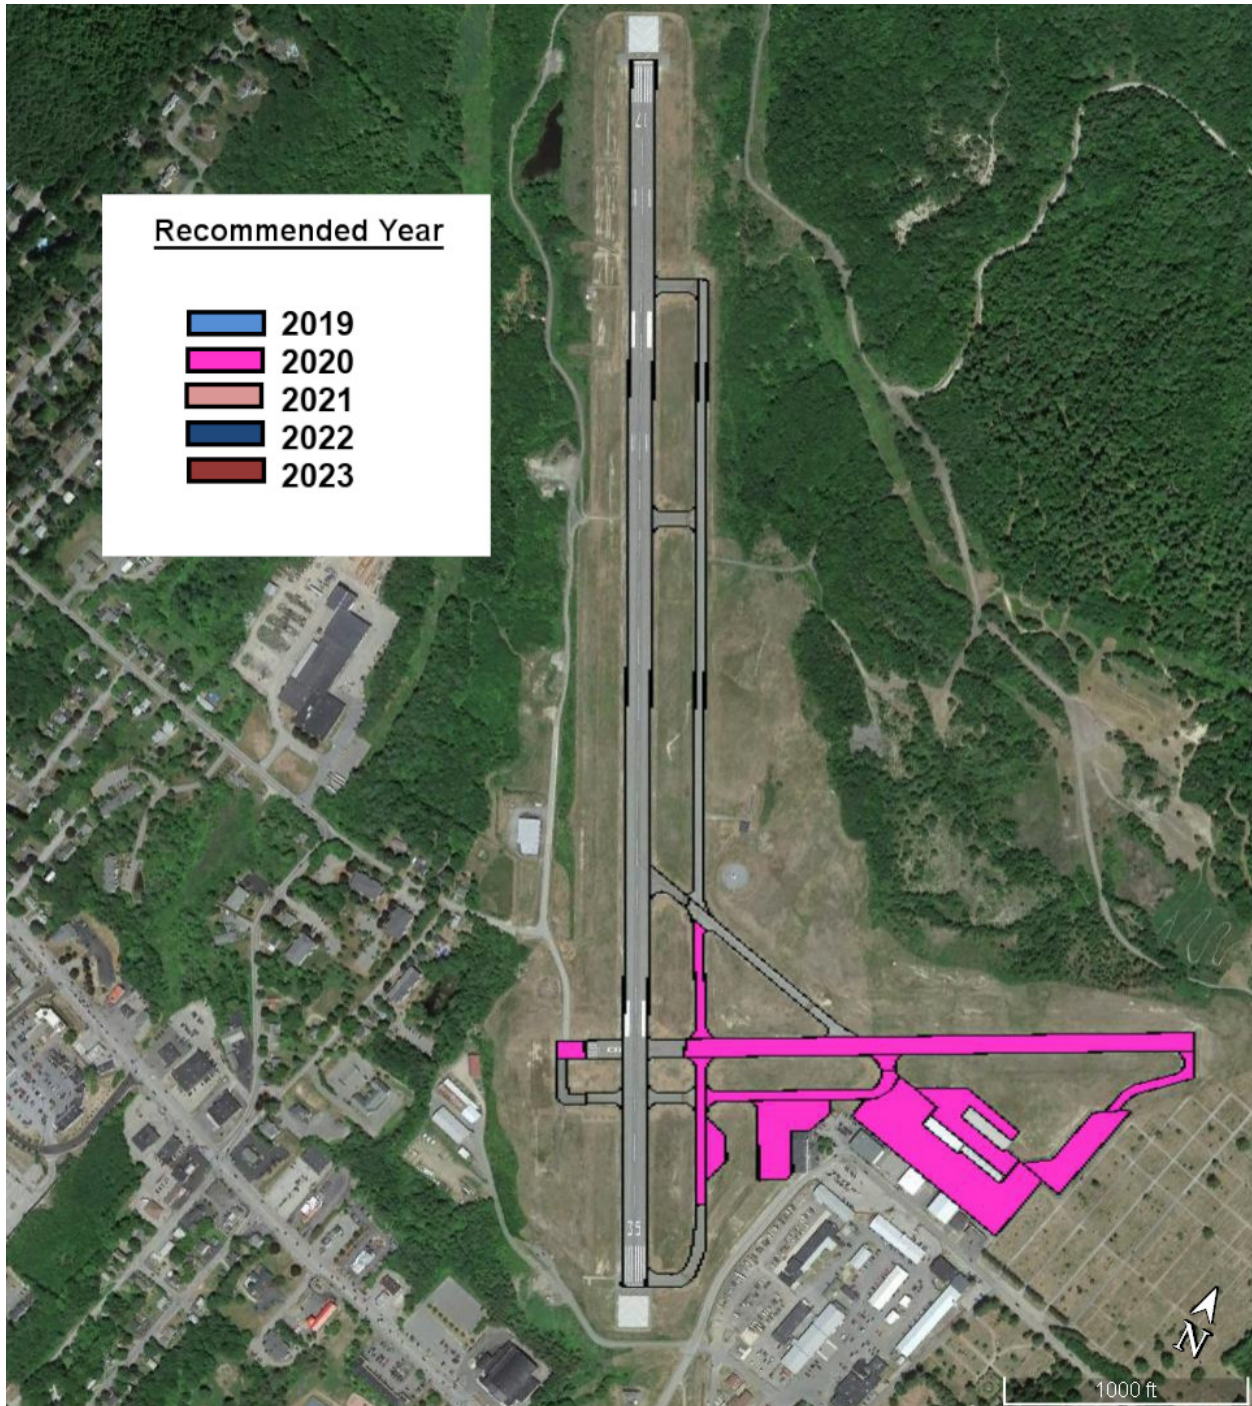
Figure 9. Major M&R

The pavement sections identified for major rehabilitation in Table 10 and shown in Figure 9 are at or are predicted to reach a condition level where major M&R should be considered. While the predicted rehabilitation timeline identifies specific sections and the general timing for the repair, more in-depth project-level studies will be needed to determine exactly how to fix each pavement (i.e. asphalt overlay, reconstruction, or some other repair alternative). Additionally, the airport may find it desirable to adjust the timing of projects to meet fiscal and operational constraints. For example, if the runway and several connector taxiways were forecast to reach the MSL in various years ranging from 2019-2023, it may be preferable to group these pavement sections into a single project.

Branch ID	Section ID	Year	Predicted PCI Before Rehab	Estimated Cost
APA	001	2020	54	\$1,260,698
APB	001	2020	50	\$3,248,644
APB	002	2020	59	\$1,014,883
APB	003	2020	8	\$1,159,720
CTF	001	2020	62	\$52,111
PTC	002	2020	55	\$555,890
PTE	003	2020	52	\$725,208
PTE	004	2020	49	\$109,138
RPA	001	2020	53	\$310,075
RY826	002	2020	62	\$454,838
5-year Airport Total				\$8,891,205
