Pavement Condition Report

BELFAST MUNICIPAL AIRPORT (KBST)

Submitted To:
Maine Department of Transportation
16 State House Station
Augusta, ME 04333

Submitted By:
DuBois & King & ARA
355 Husson Avenue - Suite 1
Bangor, Maine 04401

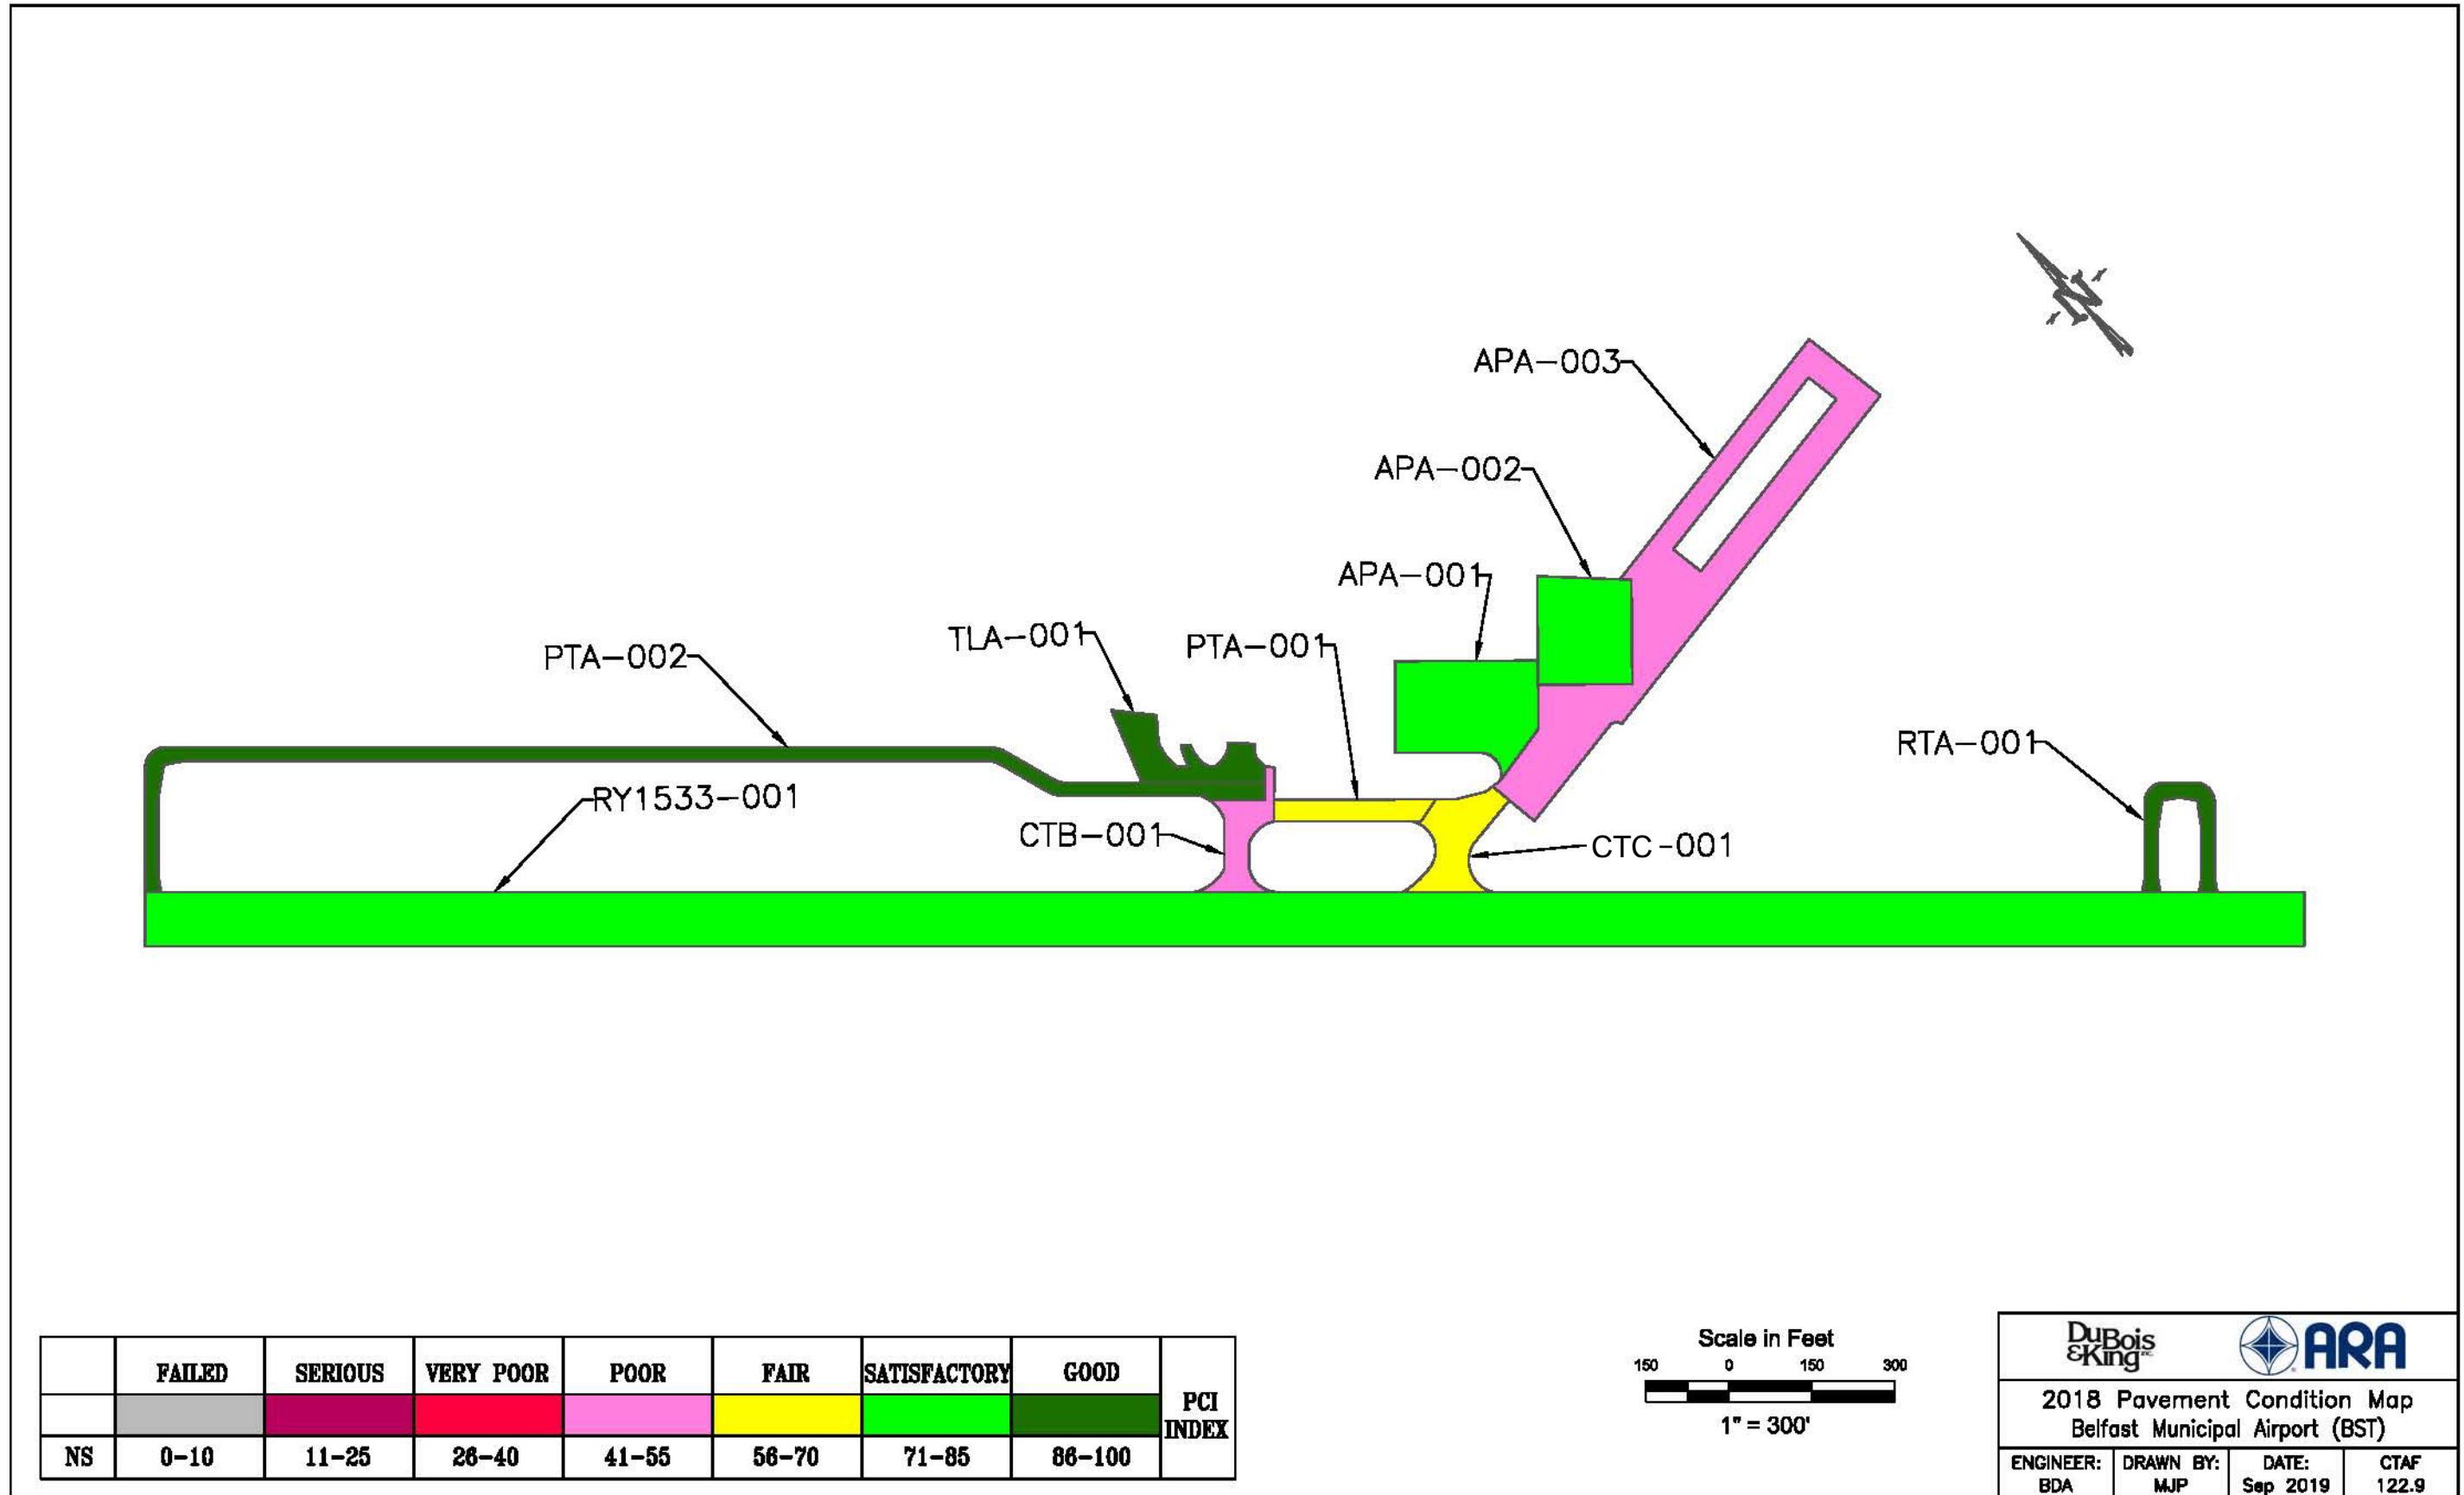
Figure 7. 2018 PCI Map at Belfast Municipal Airport (BST)

The average inspected Pavement Condition Index (PCI) for all the airfield pavements at BST was 74. Runway 15-33 had an average inspected PCI of 75, which is above the MSL of 70. Taxiways had an average inspected PCI of 84, taxilanes had an average inspected PCI of 100, and aprons had an average inspected PCI of 65. A comparison of the average PCI values at BST to the statewide average PCI values, by branch use, is shown in the figure below.

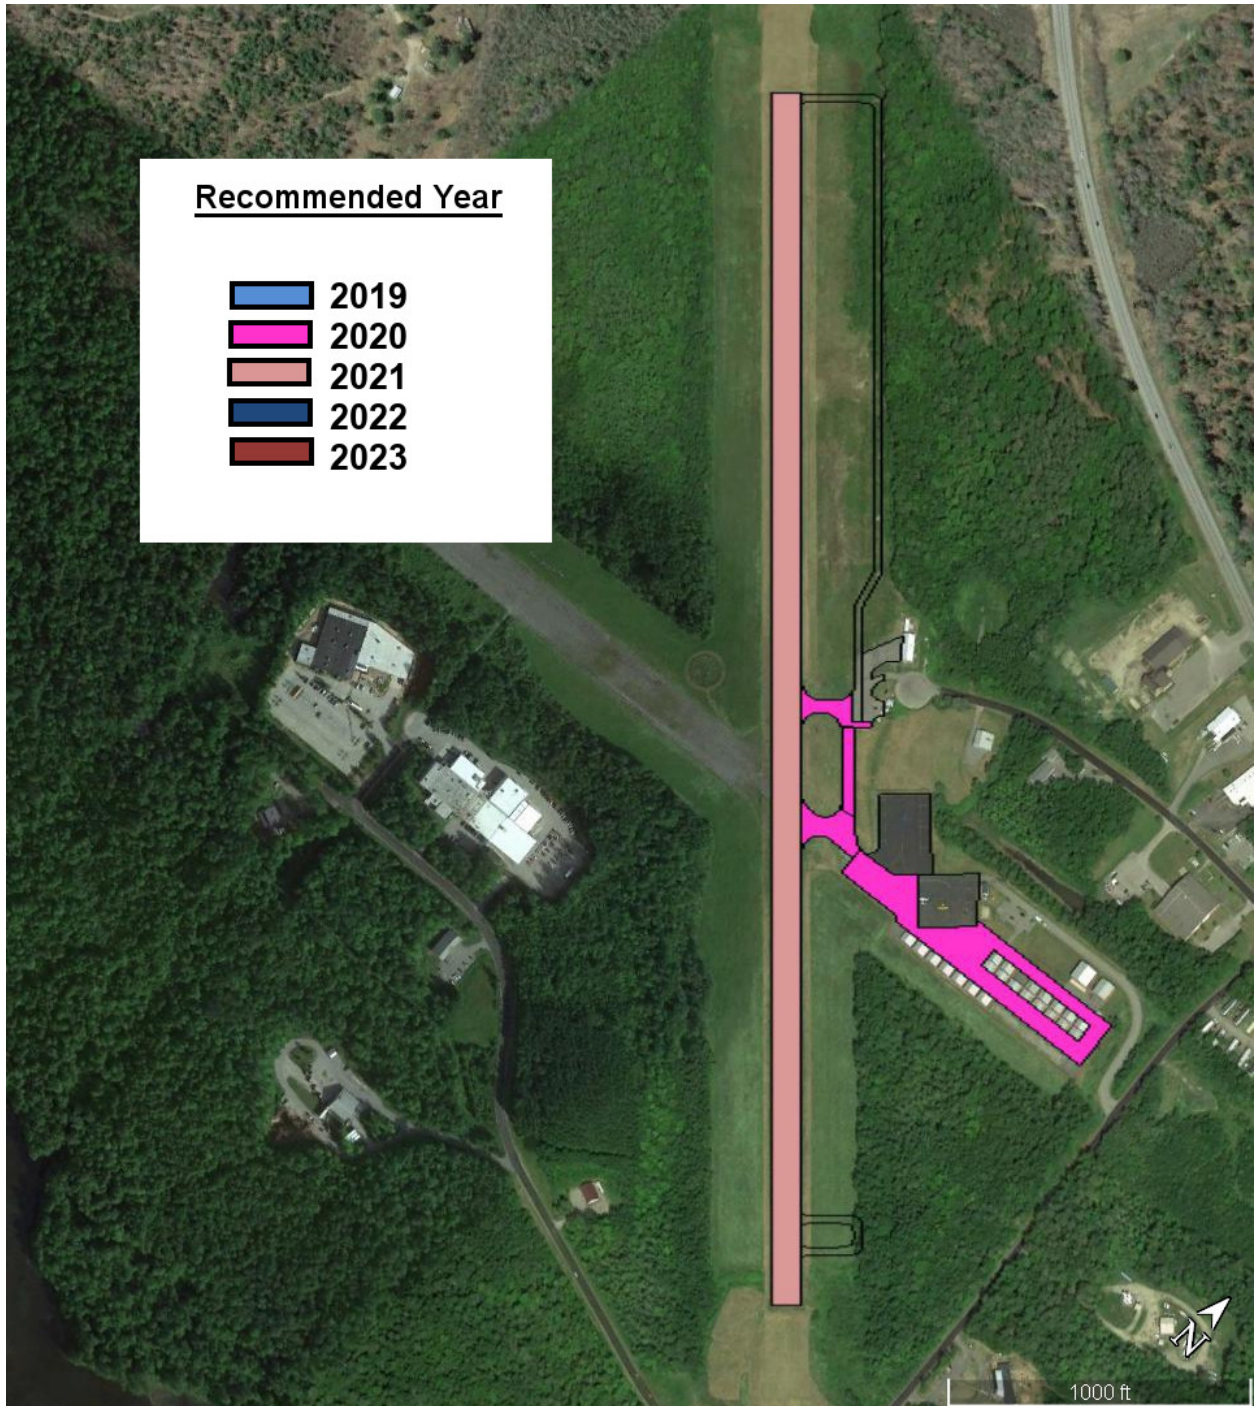
Figure 9. Major M&R

The pavement sections identified for major rehabilitation in Table 10 and shown in Figure 9 are at or are predicted to reach a condition level where major M&R should be considered. While the predicted rehabilitation timeline identifies specific sections and the general timing for the repair, more in-depth project-level studies will be needed to determine exactly how to fix each pavement (i.e. asphalt overlay, reconstruction, or some other repair alternative). Additionally, the airport may find it desirable to adjust the timing of projects to meet fiscal and operational constraints. For example, if the runway and several connector taxiways were forecast to reach the MSL in various years ranging from 2019-2023, it may be preferable to group these pavement sections into a single project.

Branch ID	Section ID	Year	Predicted PCI Before Rehab	Estimated Cost
APA	003	2020	48	\$2,278,641
CTC	001	2020	60	\$307,990
CTB	001	2020	39	\$266,215
PTA	001	2020	65	\$42,624
RY1533	001	2021	70	\$1,096,947
5-year Airport Total				\$3,992,417

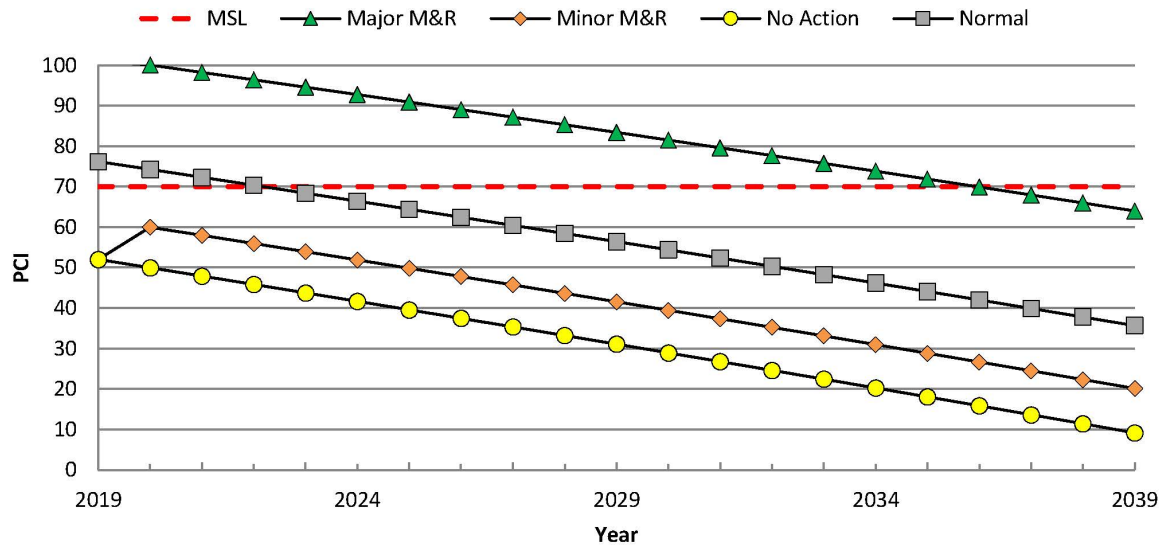
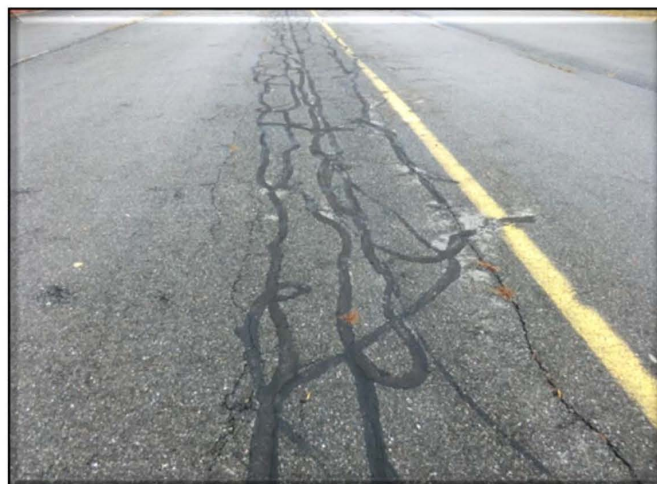
Section: **BST::APA::003** Description: Apron A

⁴ The higher than average deterioration rate of 4.0 PCI/Yr for APA-003 is due primarily to low-and medium-severity alligator cracking.

M&R	Action	Year / Quantity	Cost (\$)	Ending PCI
Major	Major M&R	2020	2,278,641	100
Minor	All Minor	2020	12,045	60
1	Patching - AC Deep	574 SqFt	10,666	-
2	Patching - AC Shallow	43 SqFt	729	-
3	Crack Sealing - AC	471 Ft	650	-
4	-	-	-	-
5	-	-	-	-
6	-	-	-	-
7	-	-	-	-
