Maine Department of Transportation

Pavement Condition Report

AUBURN/LEWISTON MUNICIPAL AIRPORT (KLEW)

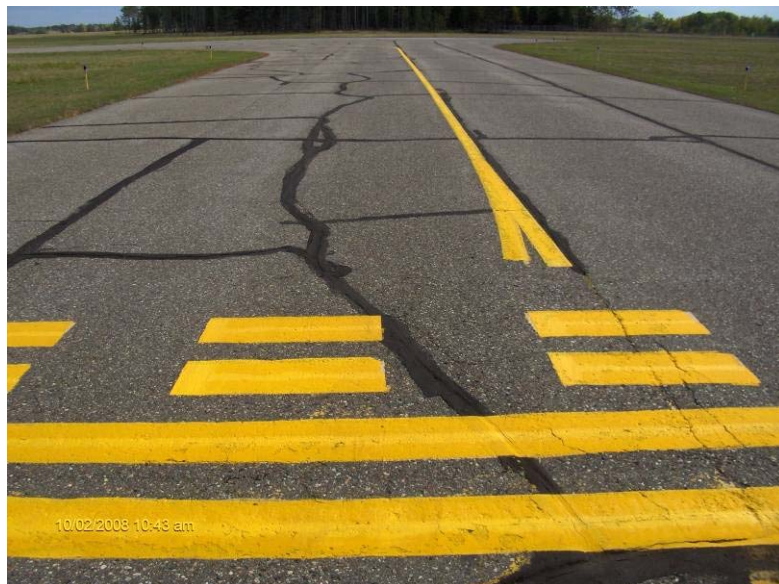
Example of Longitudinal and Transverse Cracking (L&T cracking)

Longitudinal and transverse cracks are caused by pavement aging, by construction, and by subsurface movement. Aging occurs as pavement loses some of its components to the atmosphere and becomes more brittle. Consistent application of pavement sealcoats can help to prevent the occurrence of age related cracks. Cracks will also develop along poorly constructed paving lane joints. Ensuring that joints are made when both sides are still hot, and near the same temperature, is one of the best ways to mitigate this potential problem. Seasonal movement caused by changes in moisture content or temperature differences can also cause pavement cracks. Asphalt pavement placed over a PCC pavement or cement stabilized base course may evidence reflective cracking from the underlying material. Longitudinal and transverse cracks are not caused by wheel loads, although traffic may worsen their condition.

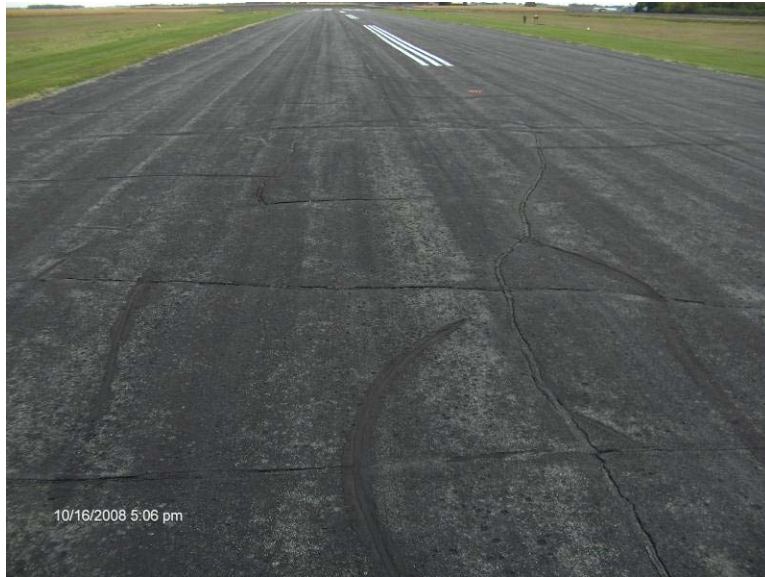
Example of Block Cracking

Block cracking is longitudinal and transverse cracking that has established a pattern of blocks ranging in size from 1ft x 1ft to 10ft x 10ft. This distress typically happens in older asphalt pavements and is an indication that the bituminous binder has lost most of its flexibility. The severity determination is basically determined by the crack width criteria defined for longitudinal and transverse cracking. Crack sealing typically is used to repair block cracking; however, the amount of required sealant can be extensive due to the high density of cracks.

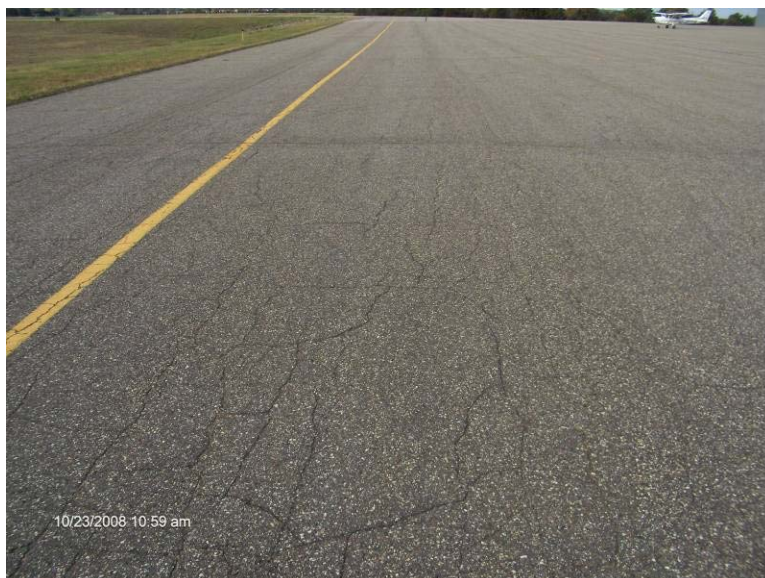
Example of Alligator Cracking

Alligator (or fatigue) cracks are a series of interconnected load-related cracks caused by fatigue of the asphalt surface. Alligator cracking is a significant structural distress and develops only in places subject to traffic loads. These cracks typically initiate at the bottom of the asphalt layer (where tensile strains

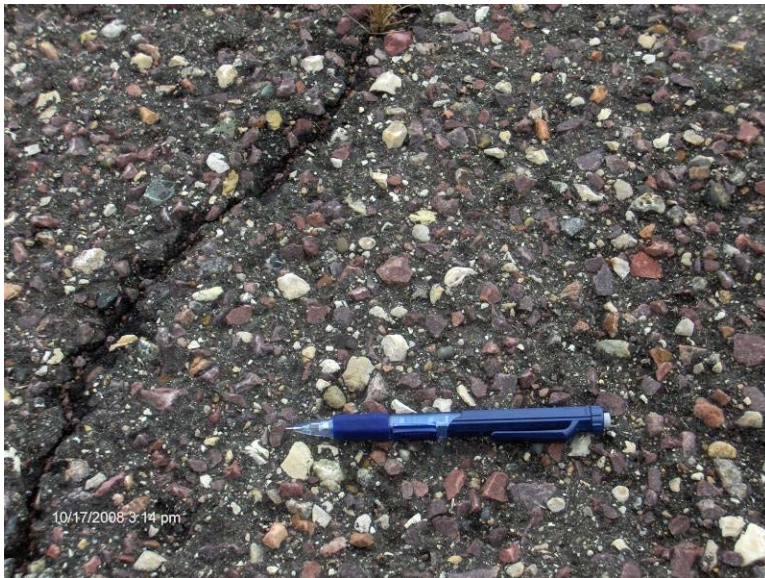
Example of Raveling/Weathering

Raveling and weathering are the wearing away of the pavement surface. Raveling is the condition where the mid- to large size aggregates are becoming dislodged; weathering is when the fine aggregate wears away exposing the edges of the larger aggregate. These distresses are usually evident over large areas and may occur together (pictured above) or separately. Raveling and weathering may indicate that the asphalt binder has hardened significantly.

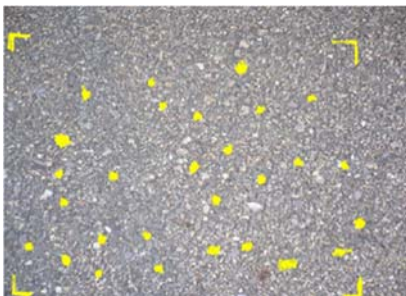
Raveling – At low severity, the number of missing coarse aggregates (> 3/8 inch) is between 5-20 missing/yd², medium severity (pictured below where the missing coarse aggregates have been dotted with yellow paint) is 21-40 missing/yd², and high severity is > 40 missing/yd².

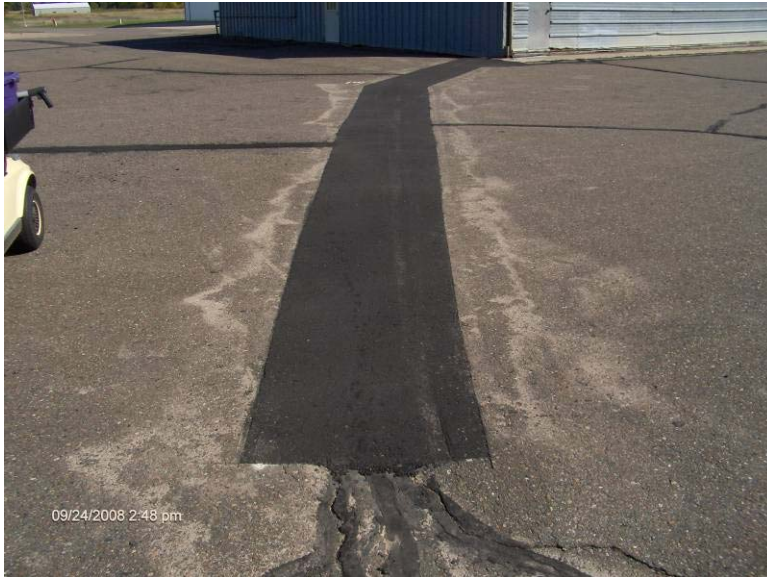
Example of Patching

Patched areas are defined when a portion of the original pavement is replaced with a material intended as a semi-permanent repair. A patch is documented as a defect because it is considered a break in the integrity of the pavement structure. Patches are constructed for a variety of reasons including utility repairs, correcting grade issues, and addressing a defect in the original pavement. The severity level of patches is determined by the amount of distress (i.e. cracking, depression, weathering/raveling, etc.) occurring within the limits of the patched area.

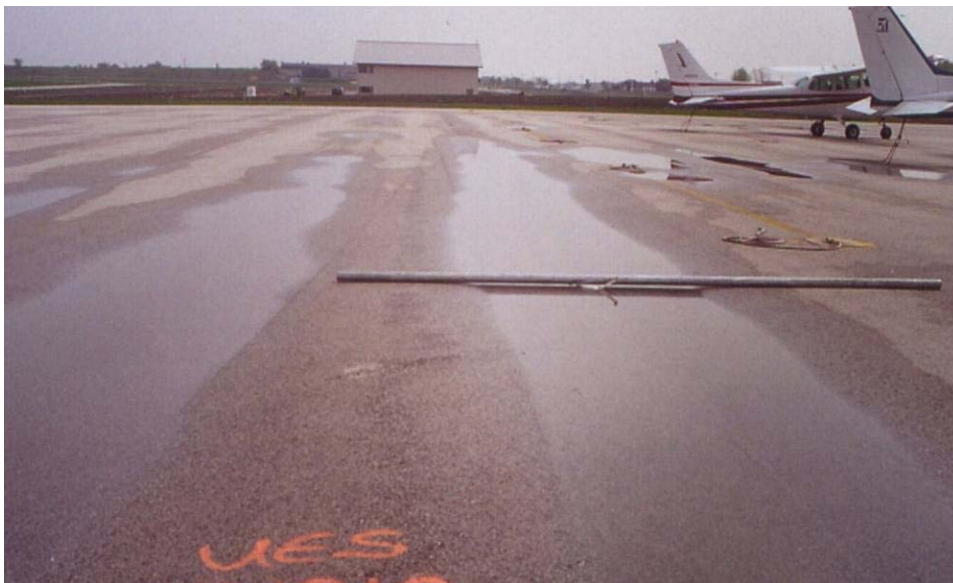
Example of Rutting

Ruts are localized, load related, areas of pavement having elevations lower than the surrounding sections. Rutting is due to base and subgrade consolidation, caused by excessive wheel loads or poor compaction. Ruts indicate structural failure, and can cause hydroplaning. At low severity, ruts have an

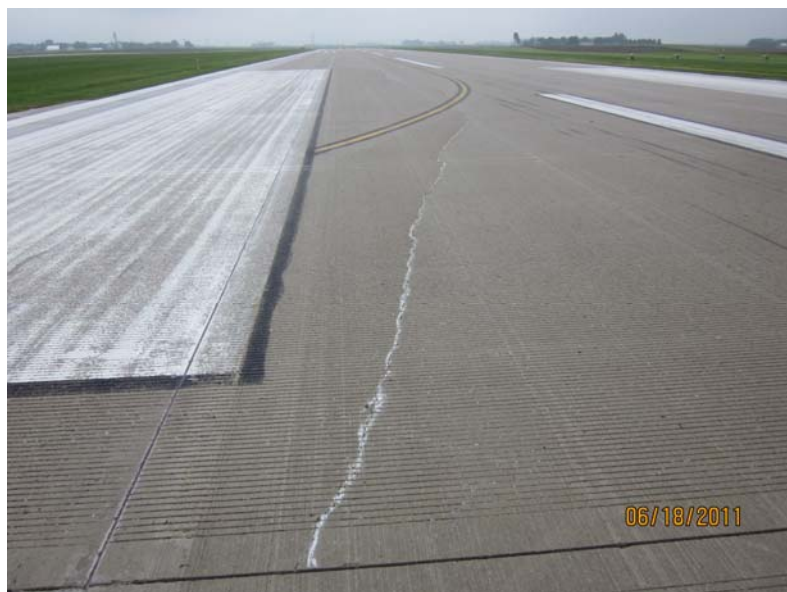
Example of Longitudinal, Transverse, and Diagonal Cracking

LTD cracking is most often a result of externally applied loads and/or constrained temperature deformations. External loads cause LTD cracking through flexure. Temperature changes on restrained slabs will result in stresses due to friction or curling. When any of these stresses exceed the strength of the slab, cracking will occur. LTD cracking is recorded at low, medium, or high severity, depending on the width of crack opening and degree of deterioration. At low severity, the crack is less than 1/8th inch wide with little spalling and no corrective action is indicated. At medium severity, LTD cracks can be up to 1 inch wide with moderate spalling, and should be repaired and sealed using procedures similar to joint sealing. At high severity, cracks exceed 1 inch in width and may be severely spalled. High-severity LTD cracking is evidence of serious load failure of the slab, and correction may require patching or slab replacement. If the distress occurs in several adjacent slabs at medium or high severity, major rehabilitation of that pavement area is indicated.

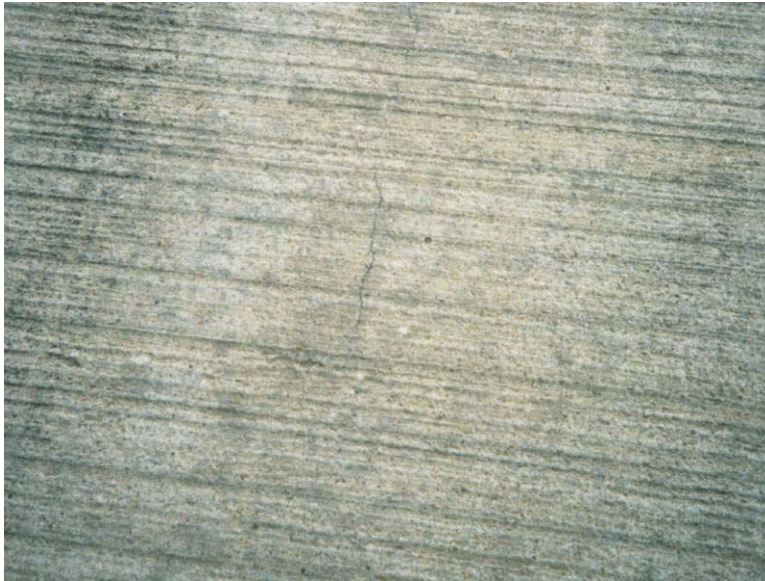
Example of Shrinkage Cracking

Shrinkage cracks are small, nonworking (no spalling along edge) cracks that are visible at the surface but do not penetrate through the full depth of concrete. Shrinkage cracks most commonly occur shortly after construction due to concrete shrinkage during the curing process. Shrinkage cracks are usually so small that they are not visible until staining or material loss at crack edges begins to take place. Shrinkage cracks do not represent a structural weakness, and no corrective action is prescribed.

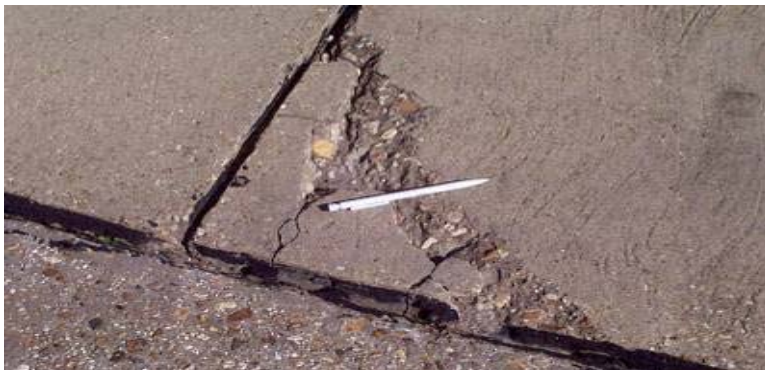
Example of Joint and Corner Spalling

Spalls at slab joints and corners are caused by excessive internal stress in the pavement. Spalls occur when these stresses exceed the shear strength of the concrete. Spalling usually results from thermal expansion during warm or hot weather. As slabs expand, they push against one another at joints. If the joints are filled with incompressibles, such as sand, or if adjacent slabs offset slightly, stresses can become severe, causing spalls. Spalling can be reduced significantly by conscientious maintenance of joint sealant.

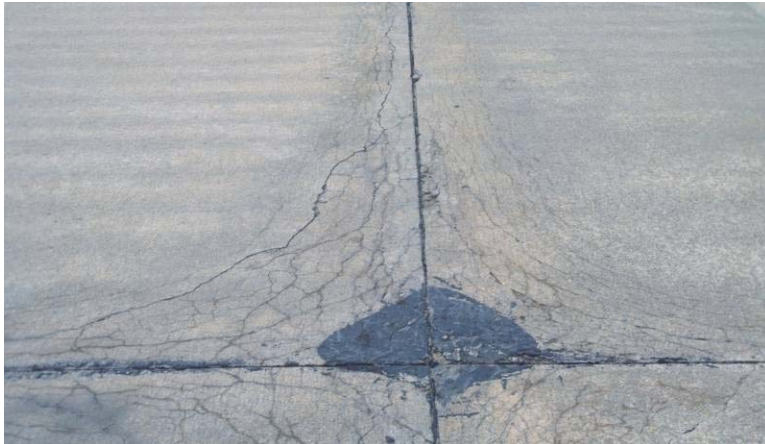
Example of Durability Cracking

Durability cracking (D-cracking) is caused by environmental factors, the most common of which is freezing/thawing. It usually appears as a pattern of hairline cracks running parallel to a joint or crack, or in a corner, where water tends to collect. This type of cracking eventually leads to disintegration of the pavement, creating FOD potential. At low severity, D-cracking is evident, but no disintegration has occurred. As the distress advances to medium severity, the distress pattern is evident over a significant area of the slab, and some disintegration and FOD potential exists. High severity durability cracking is evidenced by extensive cracking with loose and missing pieces and significant FOD potential.

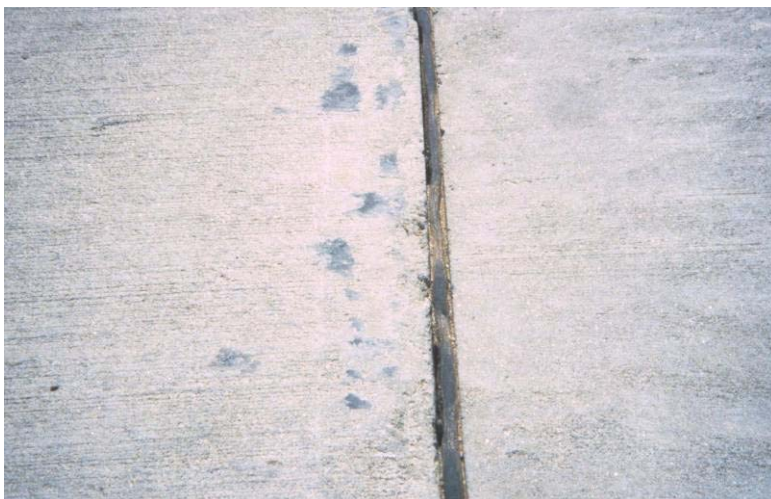
Example of Joint Seal Damage

Joint seal damage is recorded at three severities: low, medium, and high. When joint sealant is in perfect condition (no damage), it is not a distress. At low severity, at least 10 percent of the sealant is debonded but still in contact with the joint edges (i.e., joint sealant is in serviceable condition but should

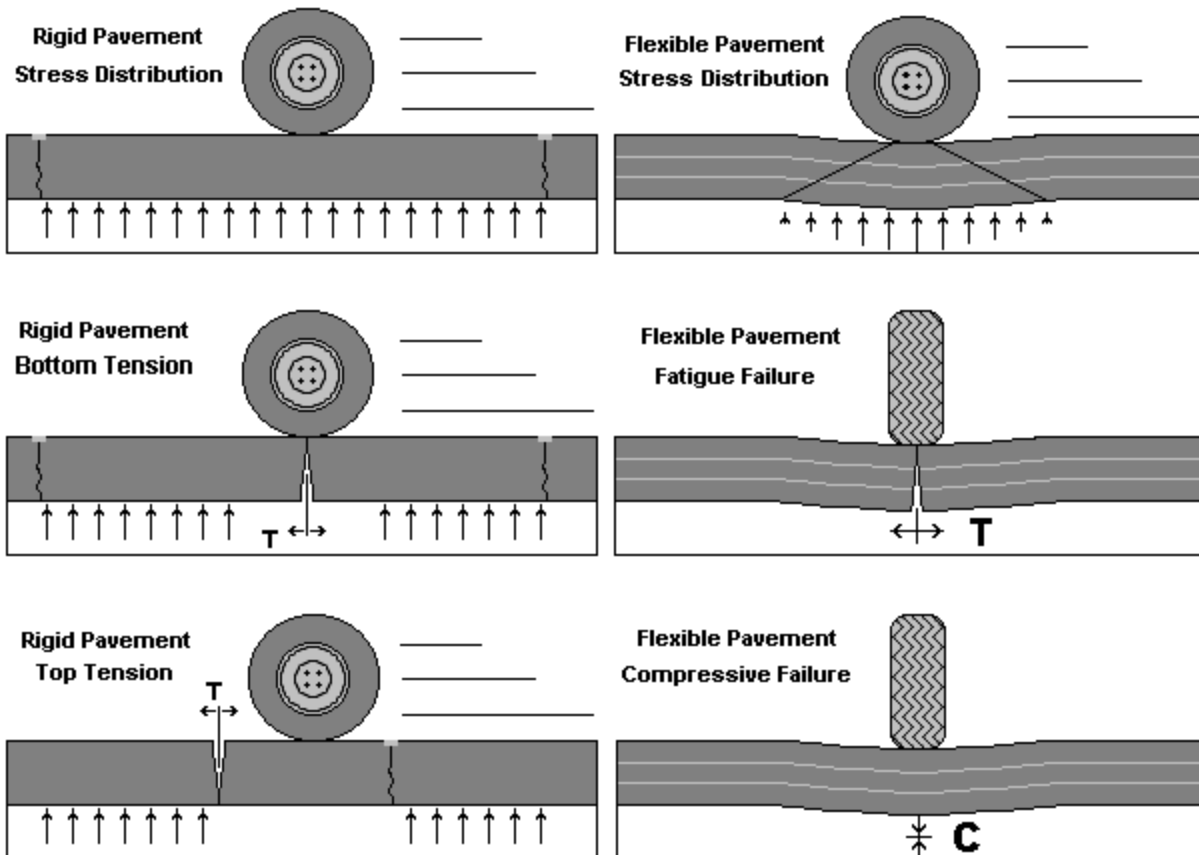
Figure 10. Pavement failure.

Spalls can be caused by either wheel loads or environmental factors, anytime there is movement between adjacent slabs. If a small rock is allowed into a joint, a differential movement between adjacent slabs can cause a spall. Spalling can be minimized by keeping joint and crack sealant intact.
