Maine Department of Transportation

Pavement Condition Report

MACHIAS VALLEY AIRPORT (KMVM)

To assist individual airports to effectively maintain their pavement infrastructure and help improve airport pavement conditions statewide, the Maine Department of Transportation (MaineDOT) contracted with DuBois & King, Inc. (D&K) to provide pavement evaluation surveys at local airports. Assisting D&K on this effort was Applied Research Associates, Inc. (ARA). This report documents the pavement condition at Machias Valley Airport (MVM) in October 2018.

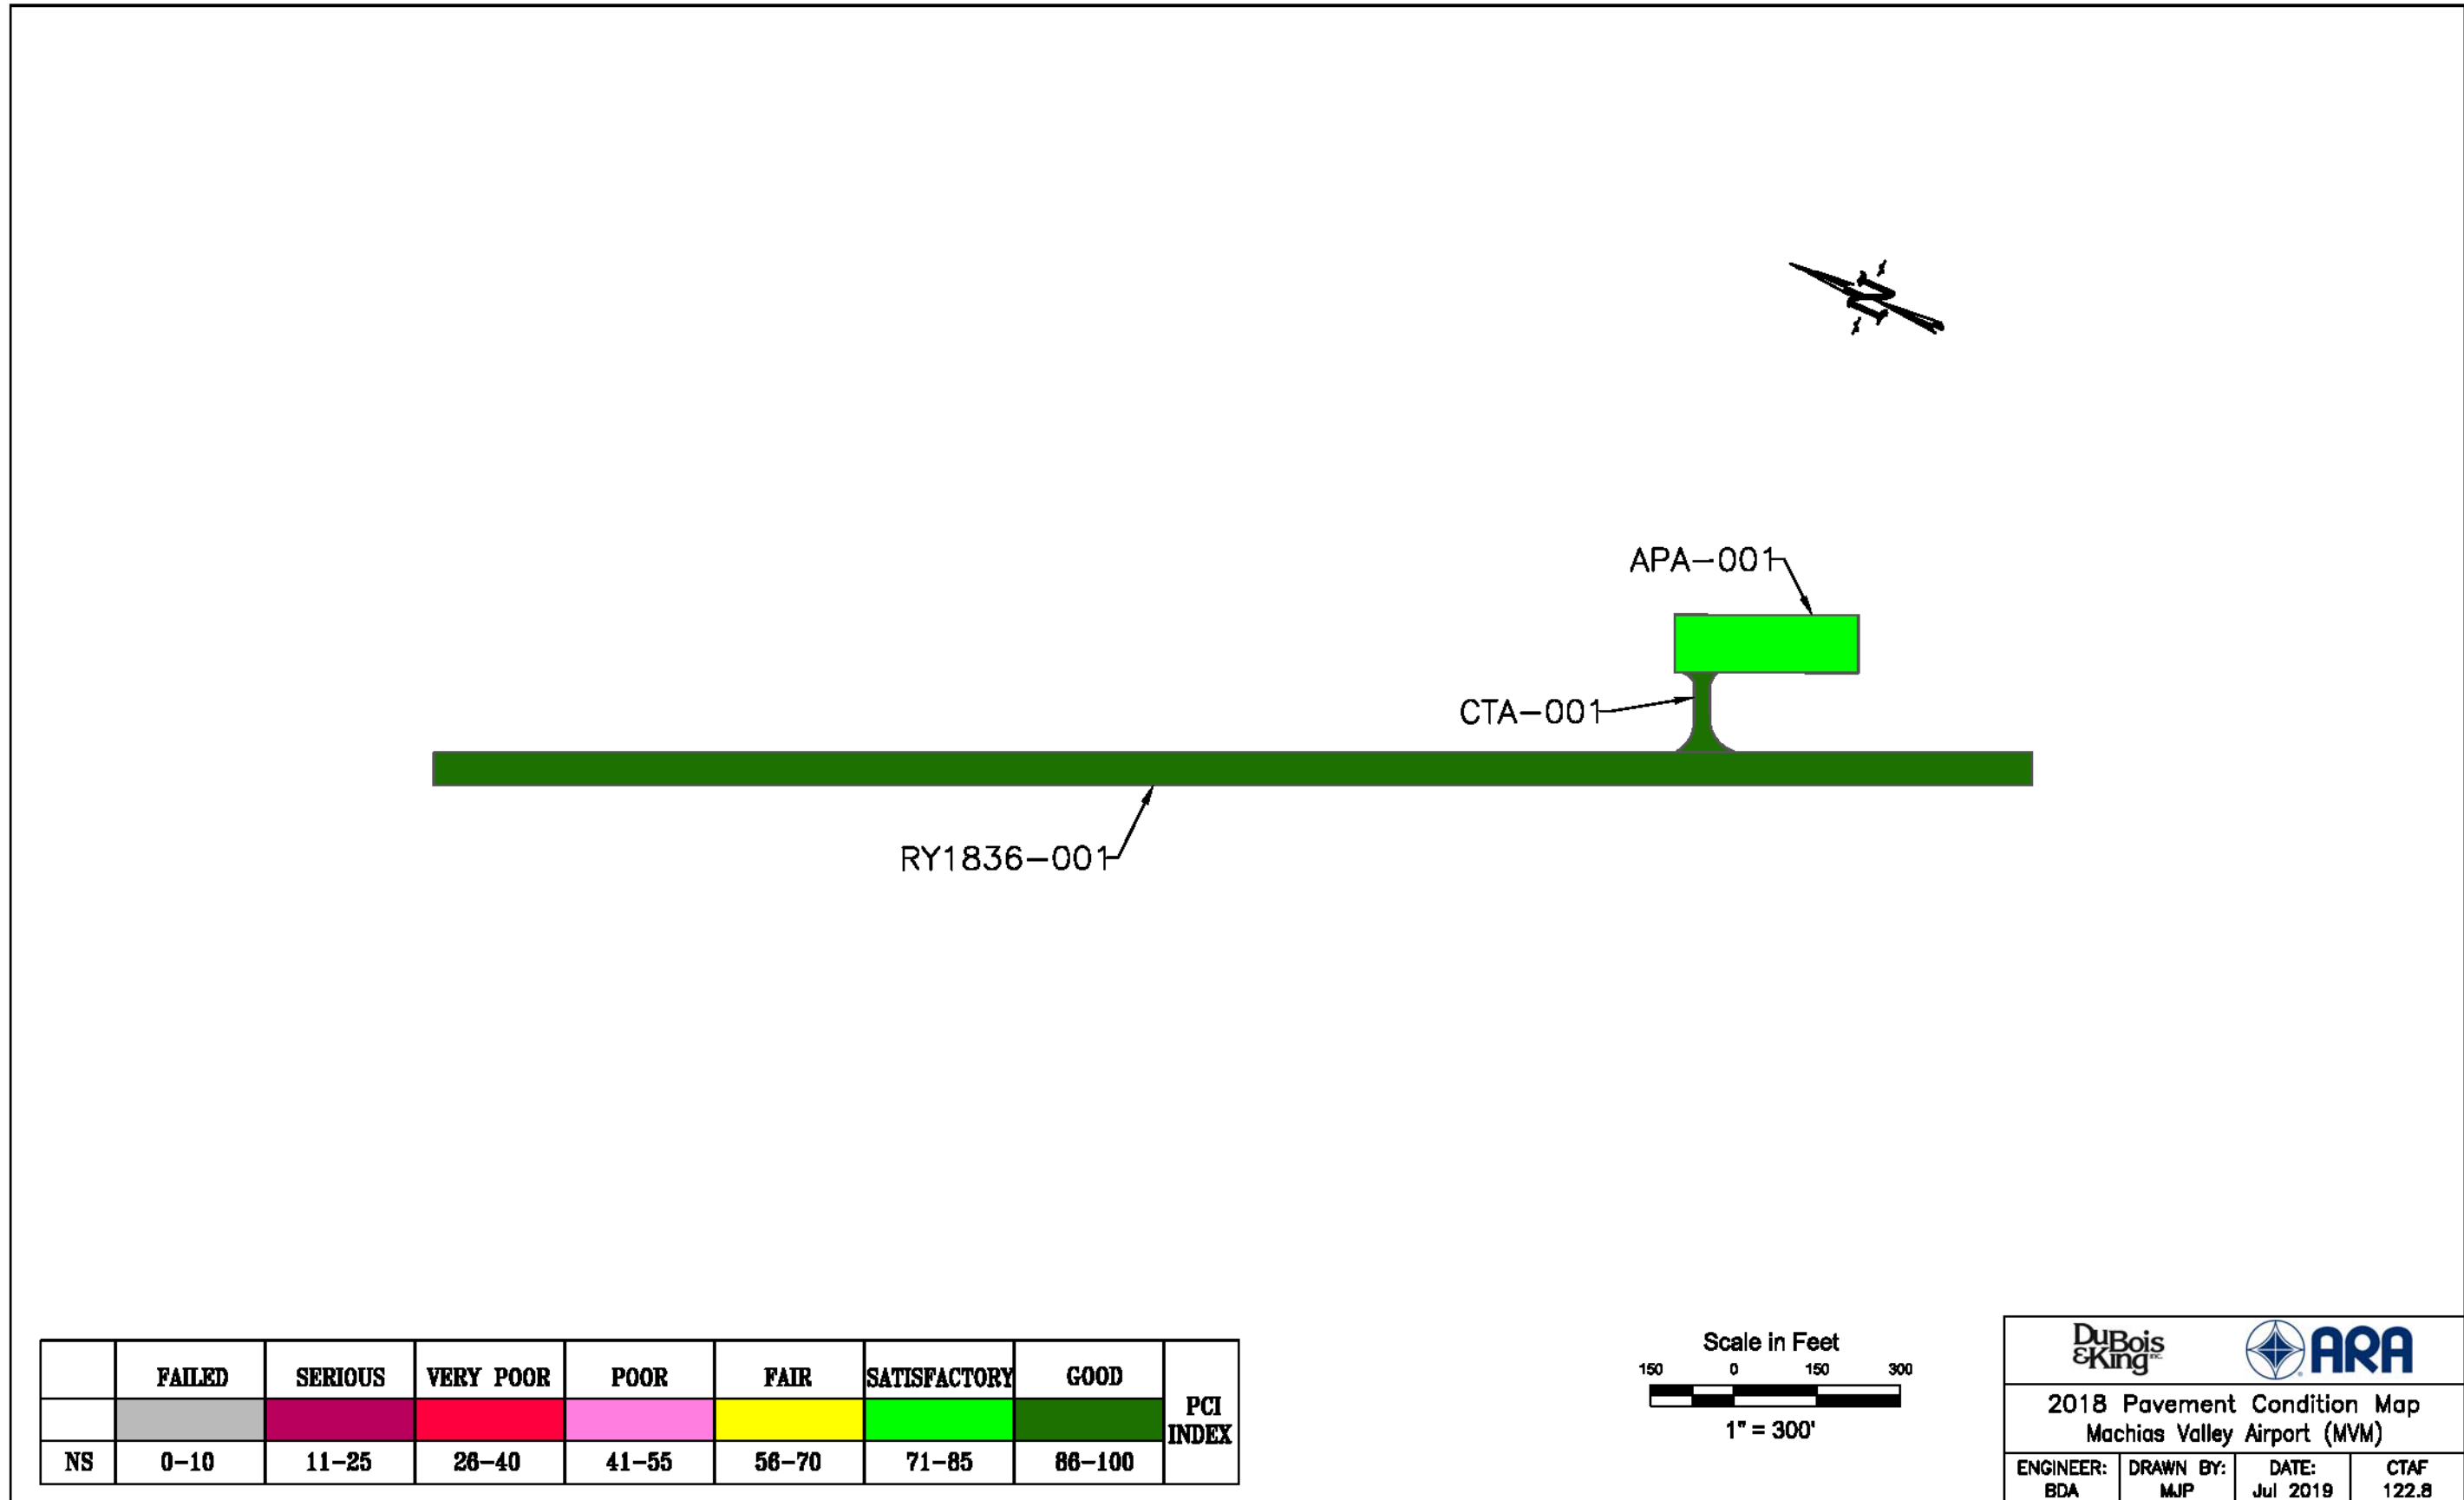
Figure 7. 2018 PCI Map at Machias Valley Airport (MVM)

The average inspected Pavement Condition Index (PCI) for all the airfield pavements at MVM was 96. Runway 18-36 had an average inspected PCI of 100, which is above the MSL of 70. Taxiways had an average inspected PCI of 100, and the apron had an average inspected PCI of 77. A comparison of the average PCI values at MVM to the statewide average PCI values, by branch use, is shown in the figure below.

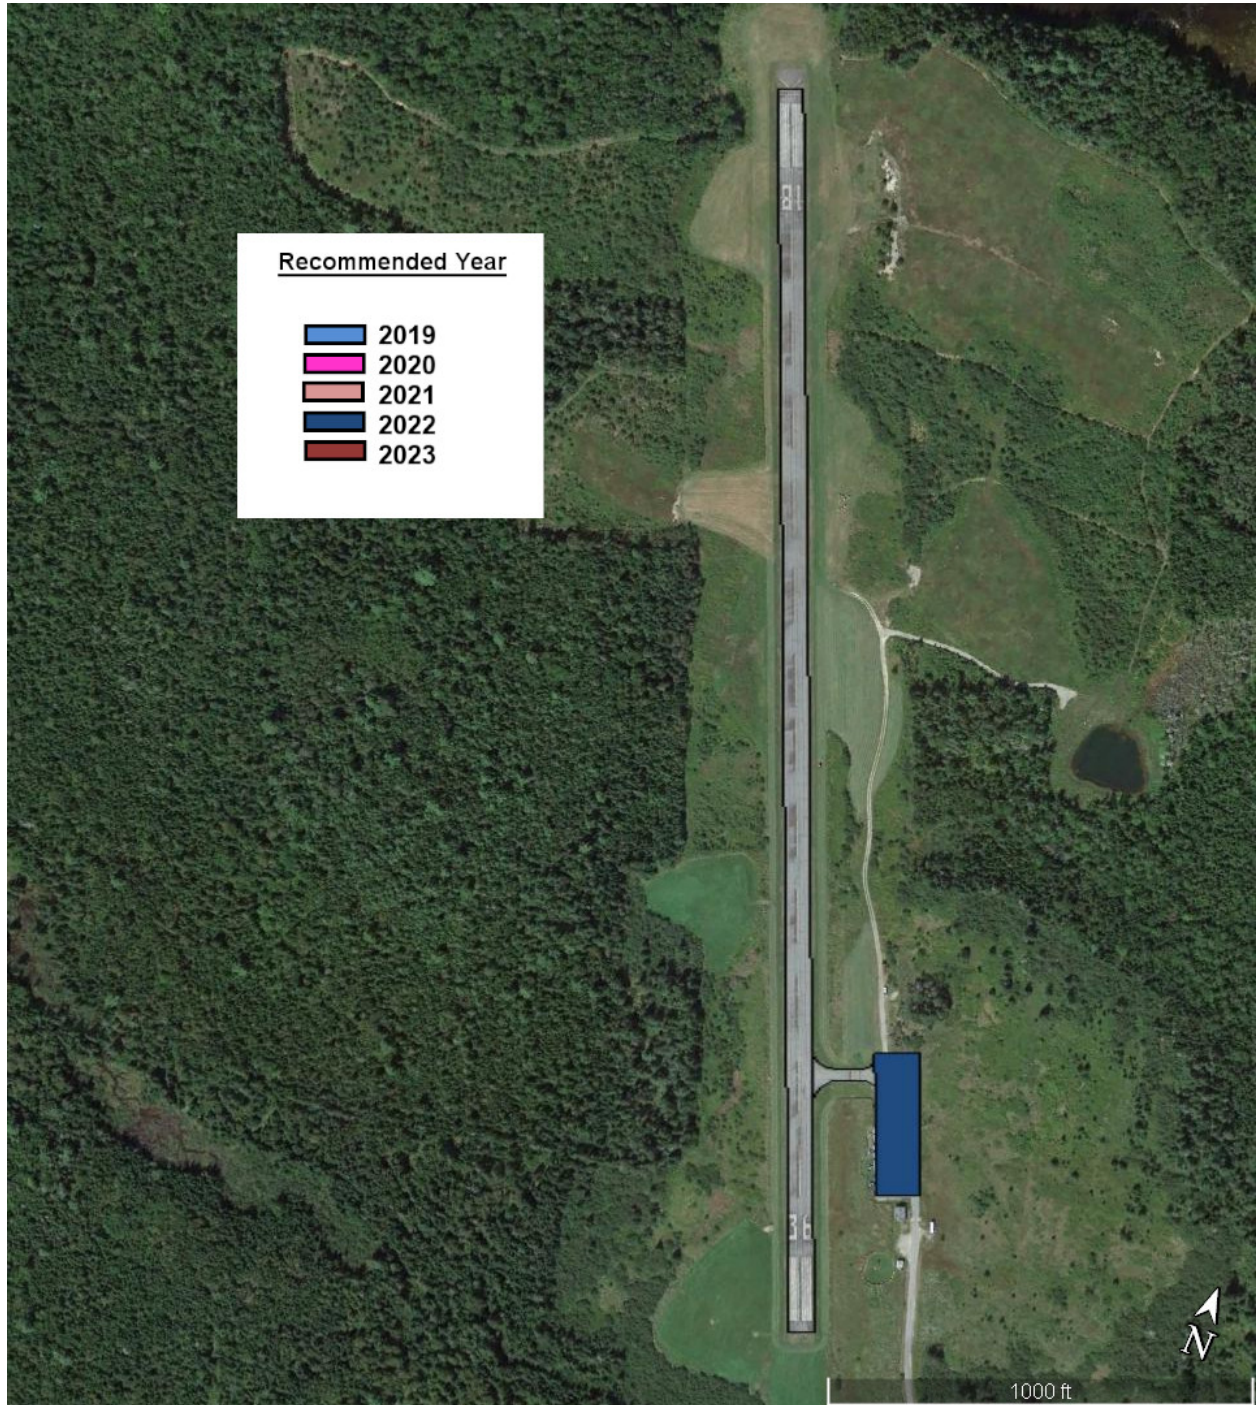
Figure 9. Major M&R

The pavement sections identified for major rehabilitation in Table 10 and shown in Figure 9 are at or are predicted to reach a condition level where major M&R should be considered. While the predicted rehabilitation timeline identifies specific sections and the general timing for the repair, more in-depth project-level studies will be needed to determine exactly how to fix each pavement (i.e. asphalt overlay, reconstruction, or some other repair alternative). Additionally, the airport may find it desirable to adjust the timing of projects to meet fiscal and operational constraints. For example, if the runway and several connector taxiways were forecast to reach the MSL in various years ranging from 2019-2023, it may be preferable to group these pavement sections into a single project.

| Branch ID | Section ID | Year | Predicted PCI Before Rehab | Estimated Cost |
|---|---|---|---|---|
| APA | 001 | 2022 | 69 | \$96,523 |
