Preliminary Design Report

Frank J. Wood #2016

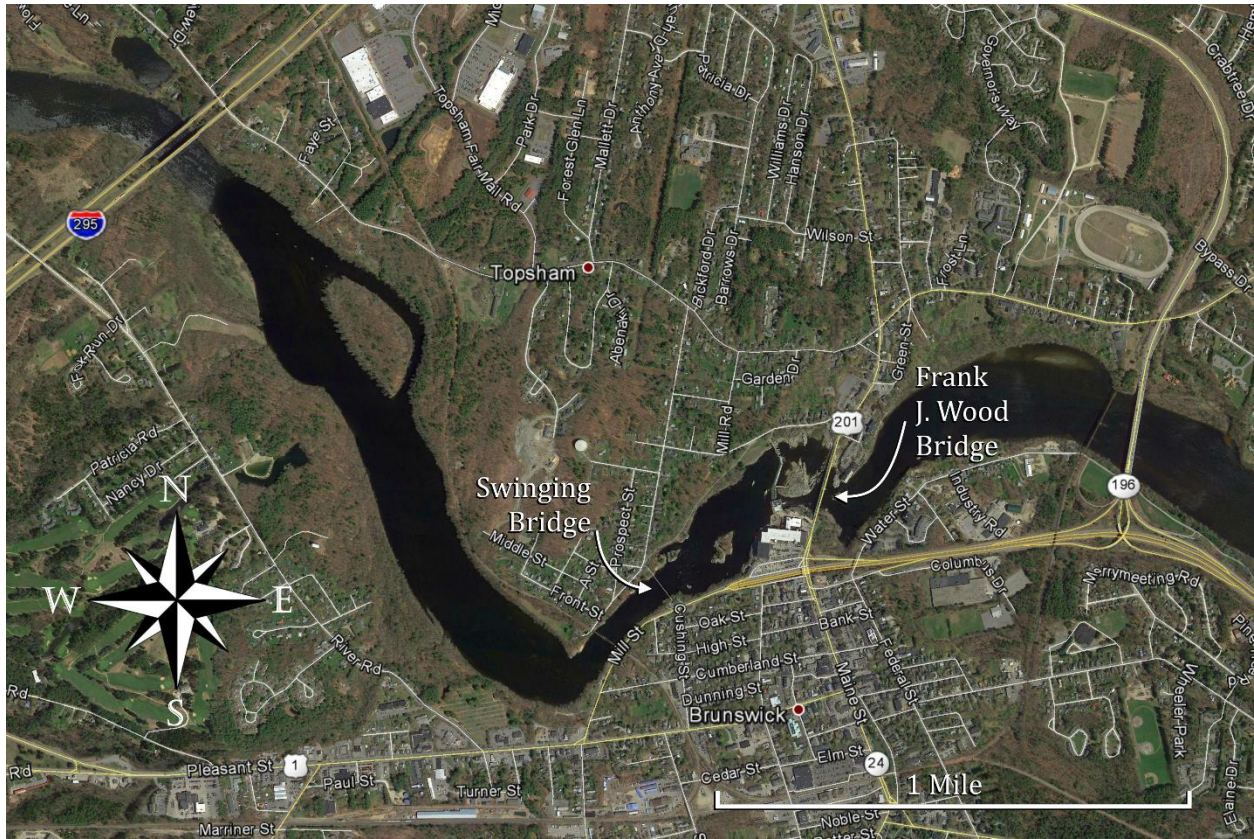
Figure 2: Androscoggin River crossings between Brunswick and Topsham

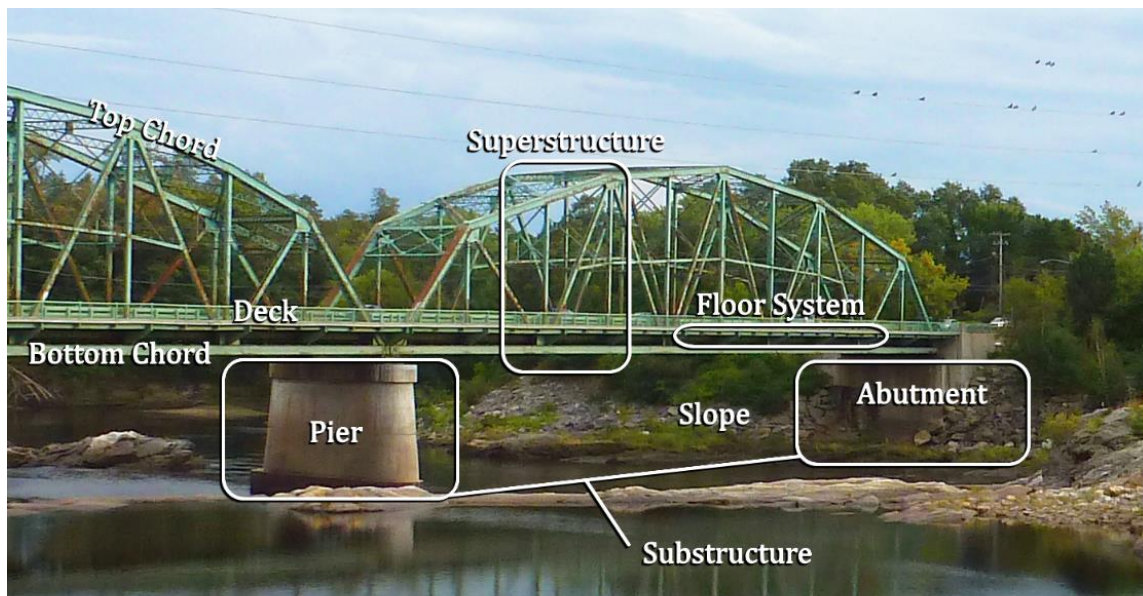
Figure 3: This report uses technical terms to describe various parts of the bridge. The superstructure is what many think of as a “bridge”, including the steel floor system or girders below the deck, while the substructure is what supports the superstructure. The deck (what cars drive on) rests on the floor system, which is made up of floor beams, stringers, and sometimes crossbeams. The floor system carries load from the deck to the truss bottom chord.

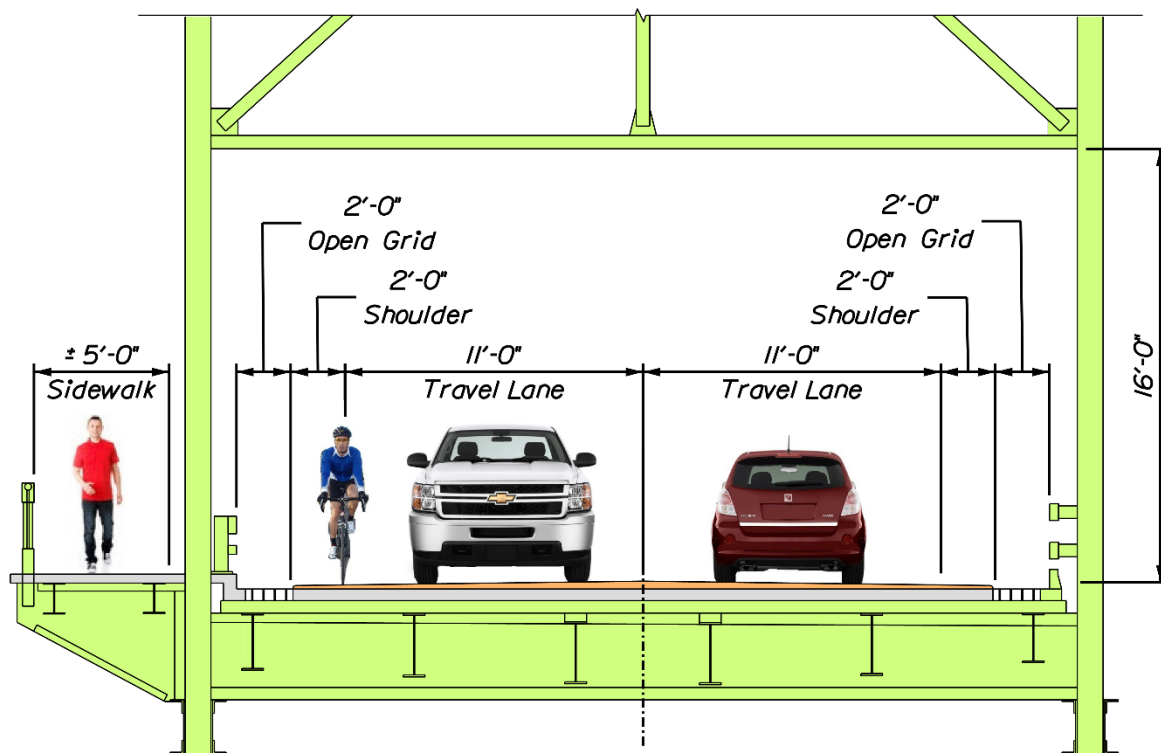
EXISTING BRIDGE SECTION

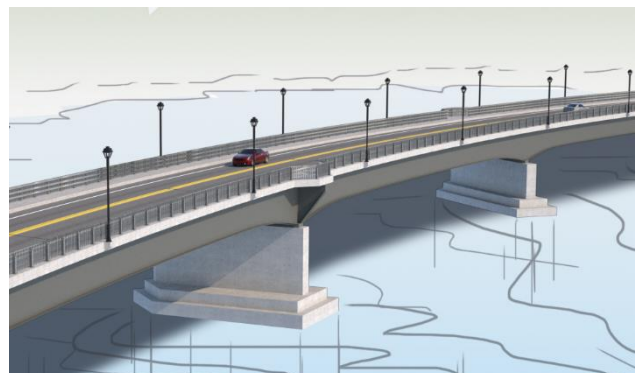
Figure 5: Artist's rendering of a steel girder bridge

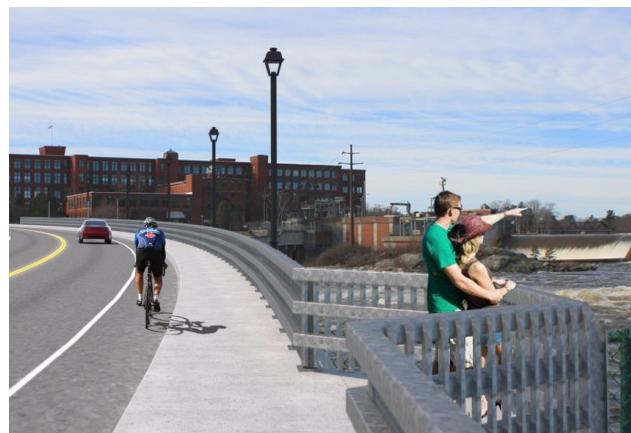
Figure 6: Rendering of a Possible New Bridge

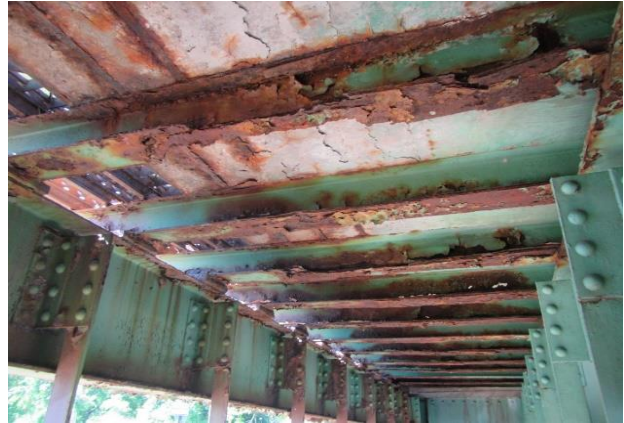
Figure 8: Deteriorated crossbeams & deck

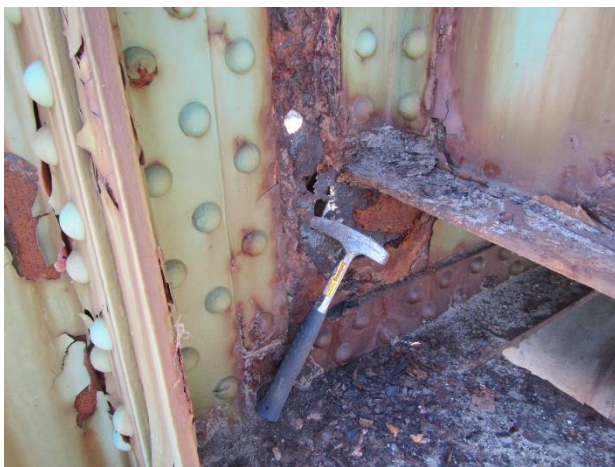
Figure 9: Hole in floor beam

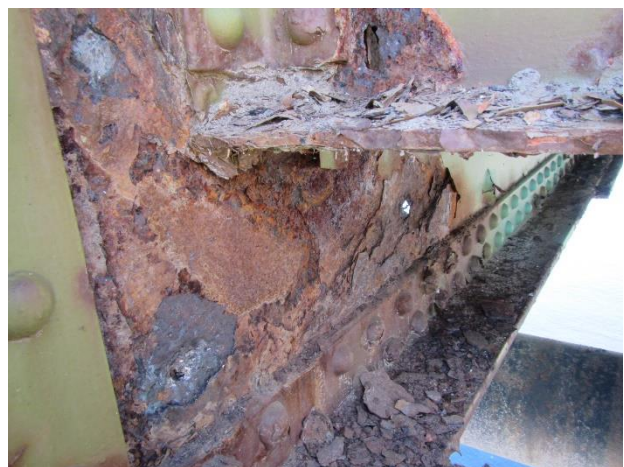
Figure 10: Deteriorated floor beam

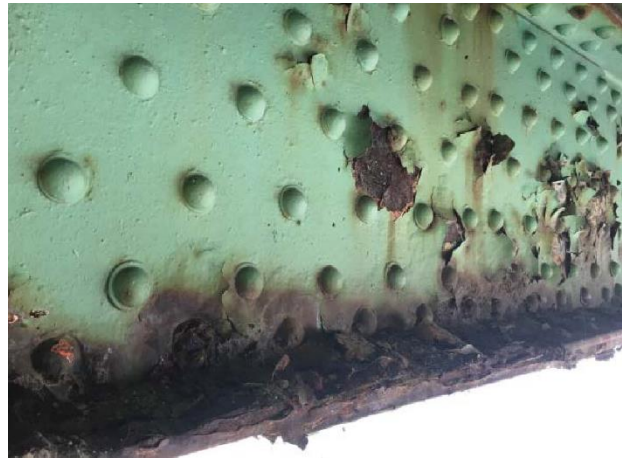
Figure 11: Bottom chord bottom flange corrosion

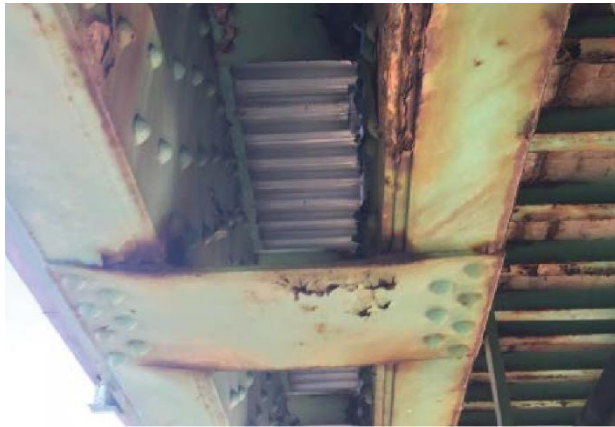
Figure 13: Bottom chord lattice plate bowing

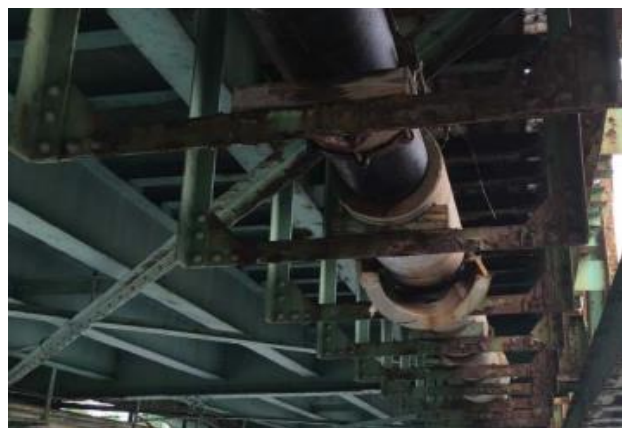
Figure 14: Utility brackets

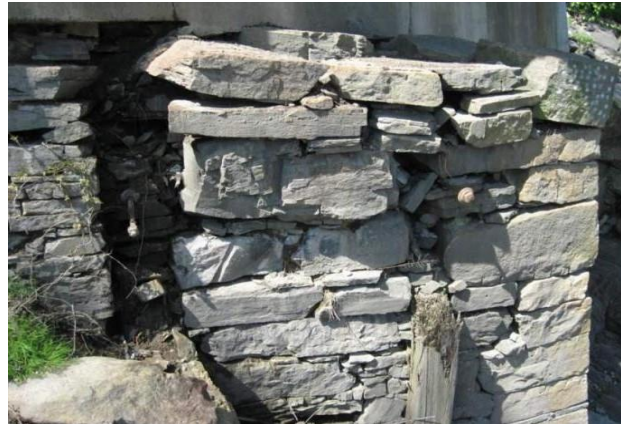
Figure 15: Abutment masonry

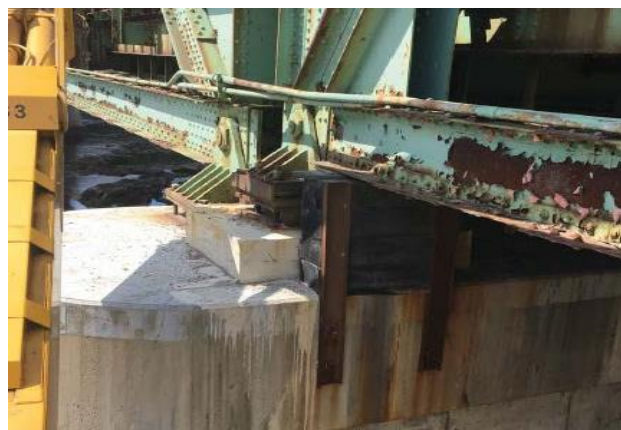
Figure 16: Damaged concrete pedestals

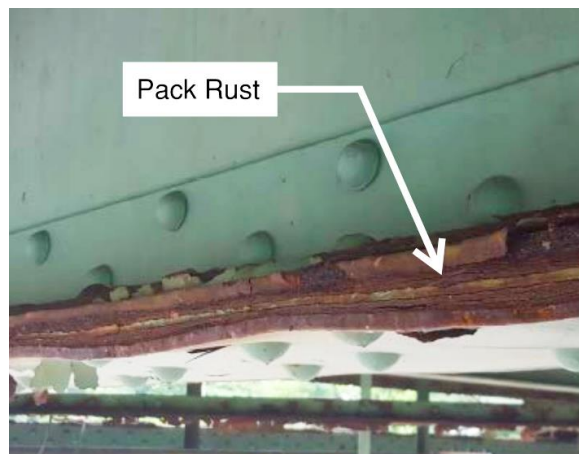
Figure 17: Pack rust is corrosion in the crevice between two plates of steel that are bolted or riveted together. As the rust progresses, it gradually pushes the pieces of steel apart, bending them and sometimes breaking bolts or rivets. To truly fix pack rust, the members need to be taken apart and thoroughly cleaned, which is a complex and expensive effort.

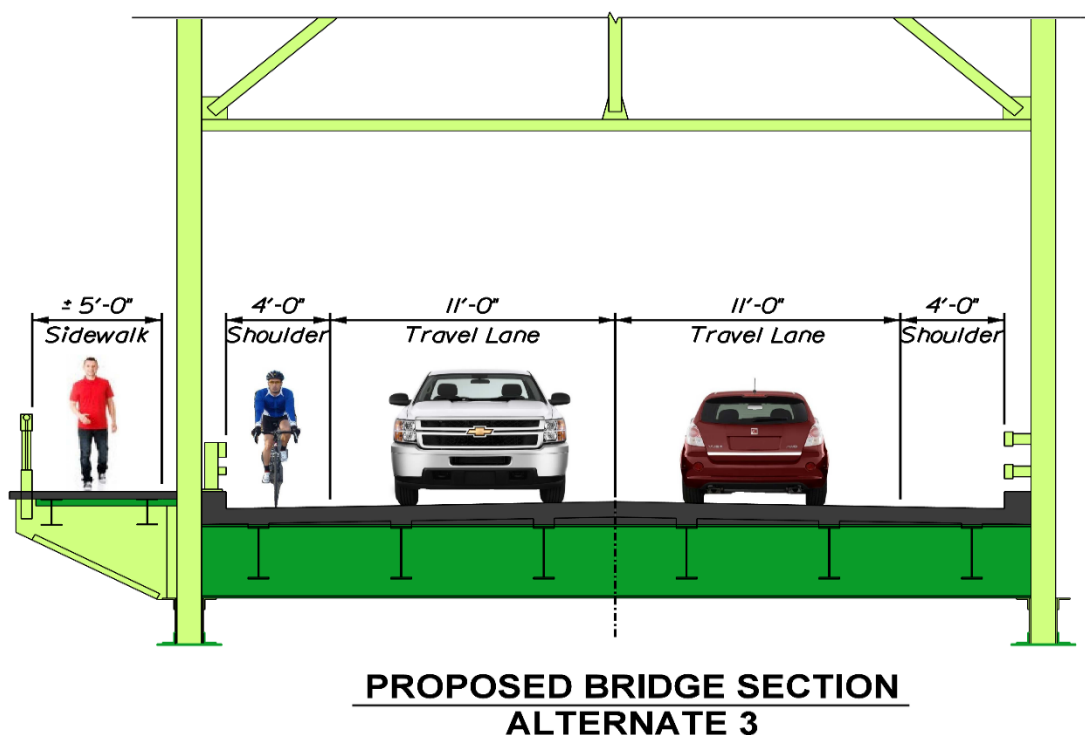
Figure 18: Alternative 3 cross section

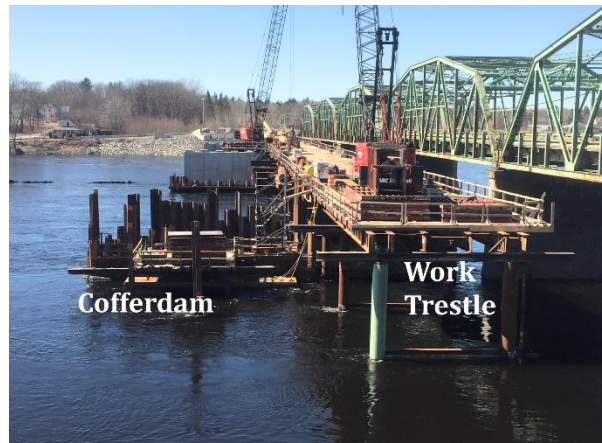
Figure 21: Two types of temporary impacts

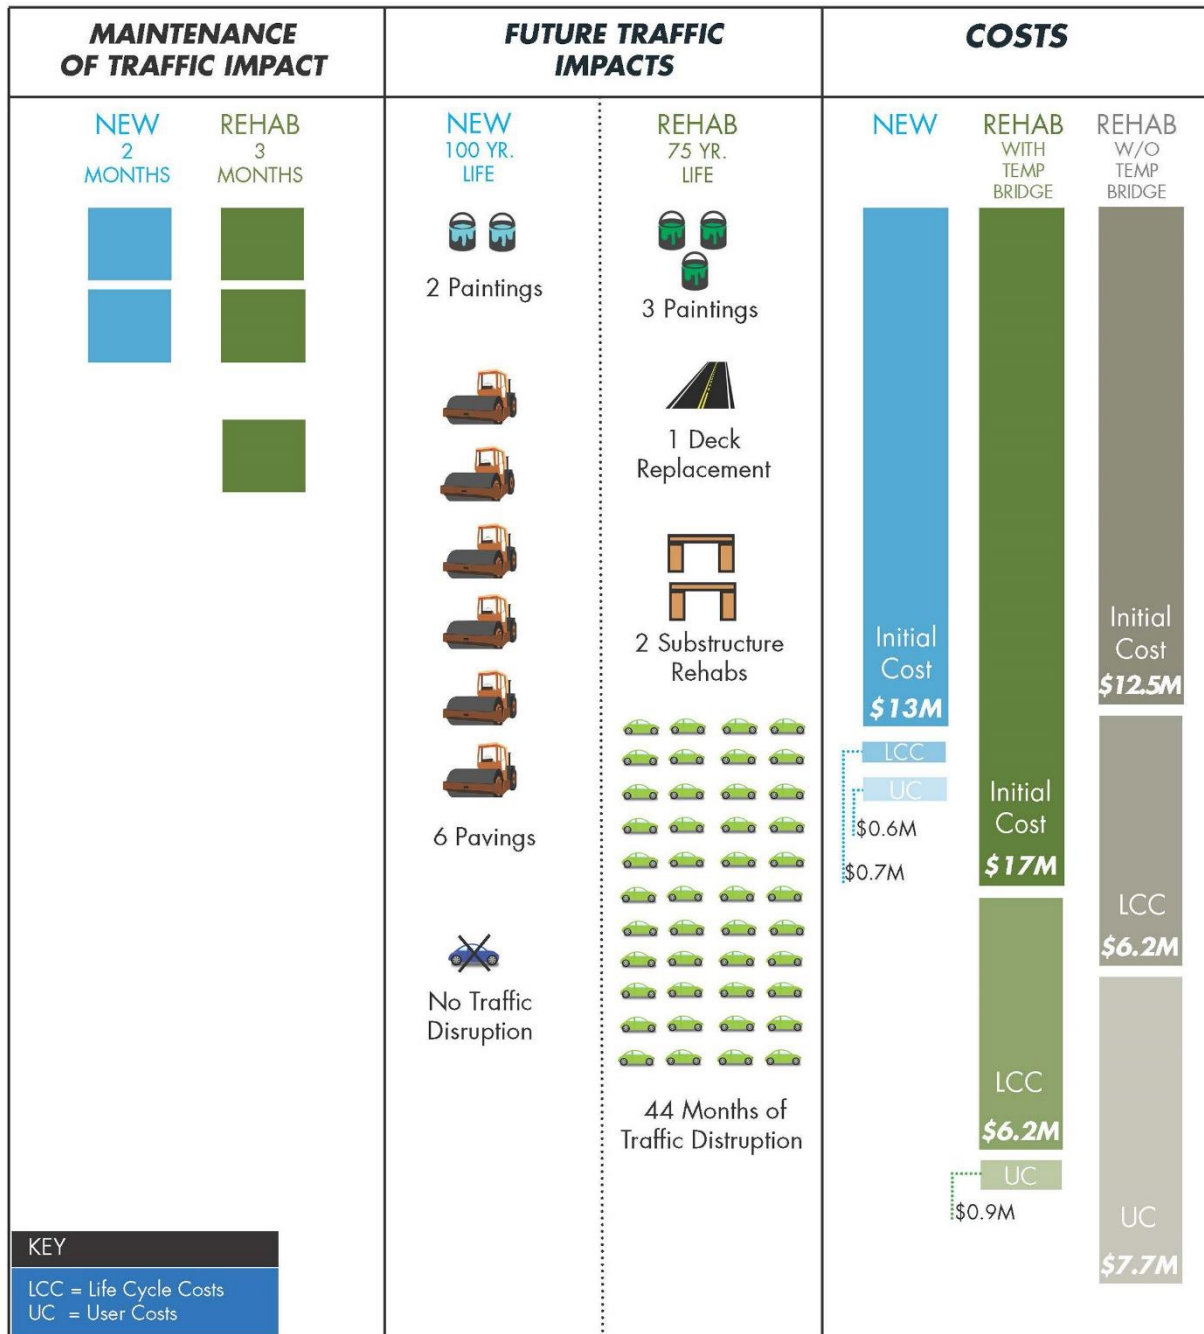
PROPOSED ALTERNATIVE

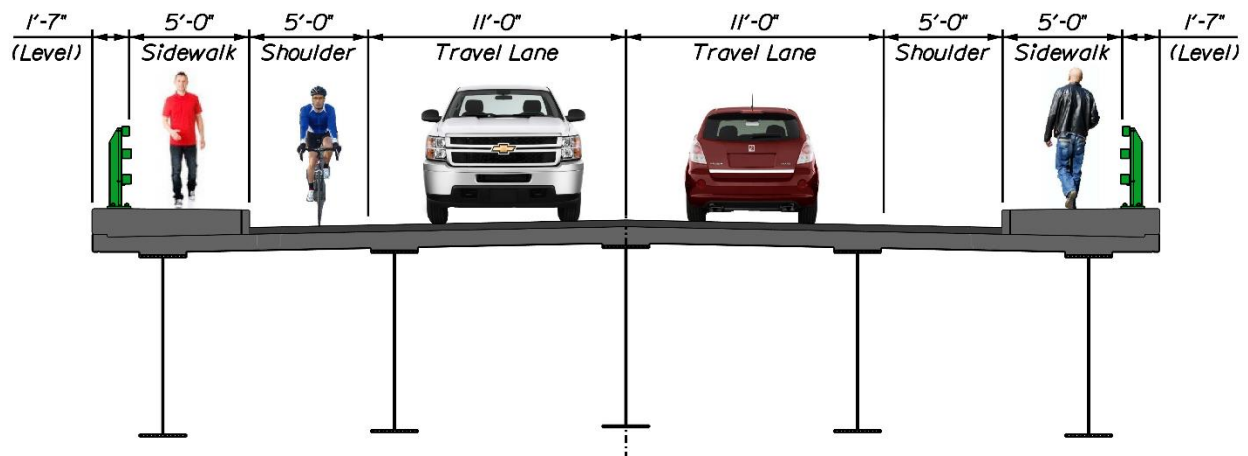
PROPOSED BRIDGE SECTION

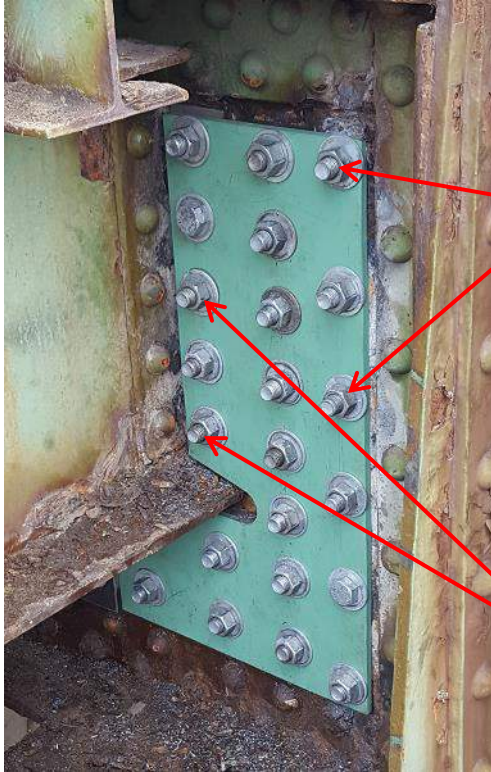
Floorbeam 2 (5 & 7 identical repair).

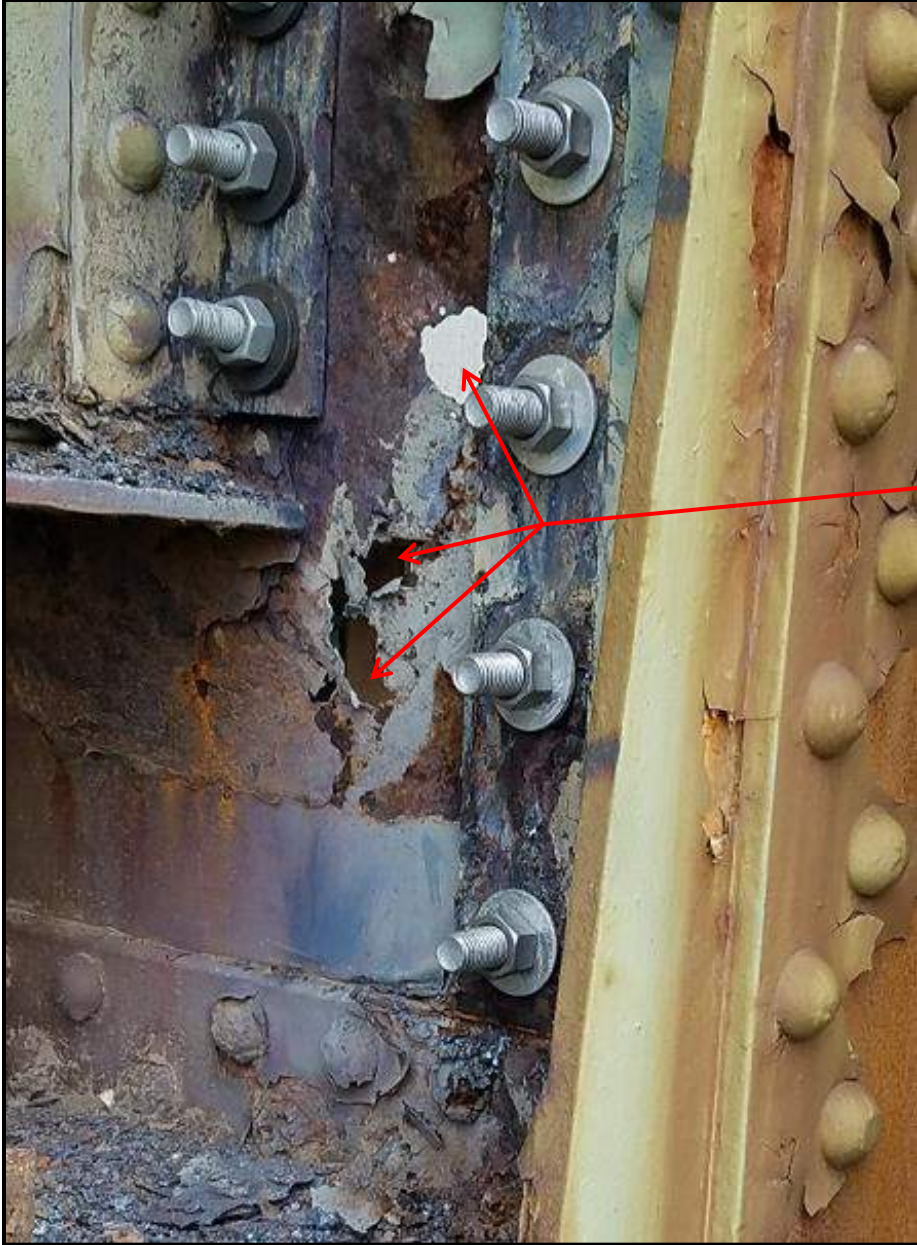
Floorbeam 7 was in the worst condition.

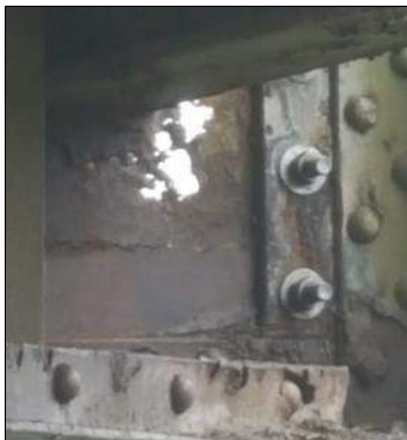
Another view of Floorbeam 7 deterioration prior to repair.

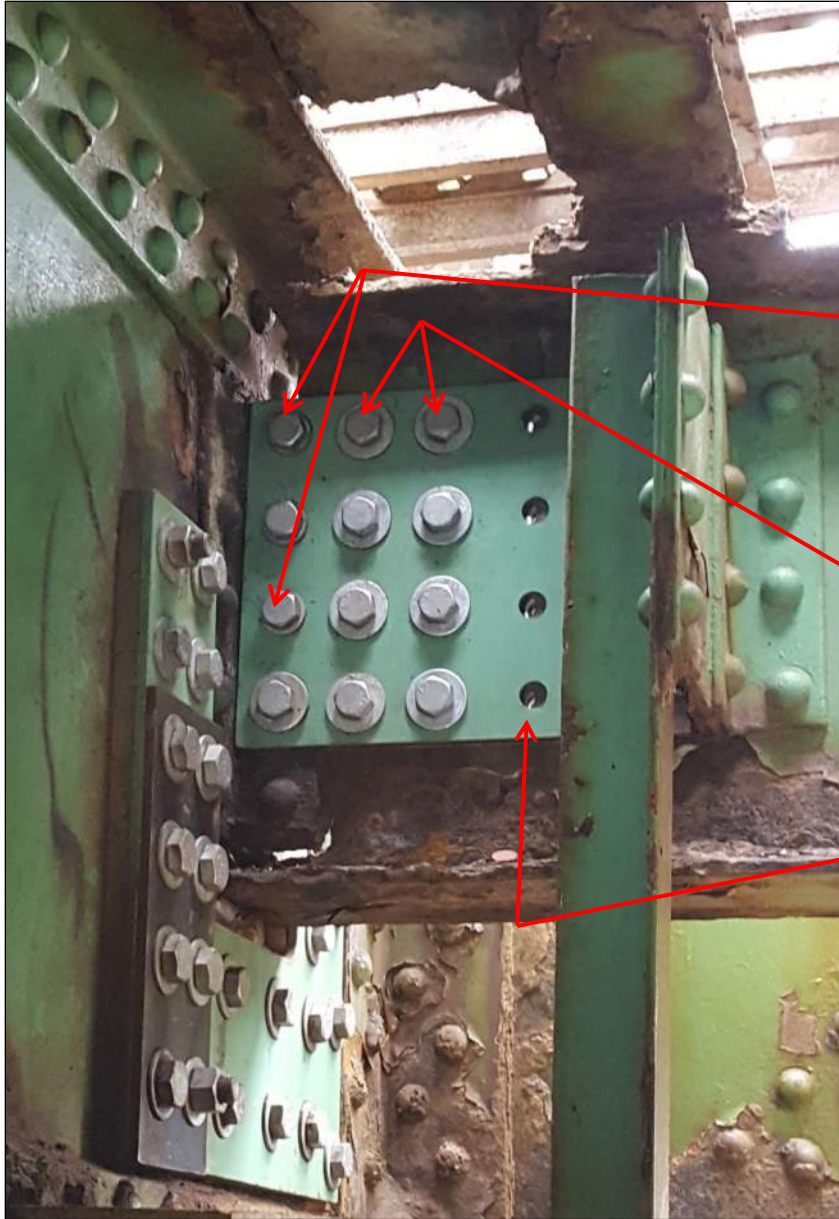
**Repair of Stringer 8 to Floorbeam 2
(Brunswick side).**

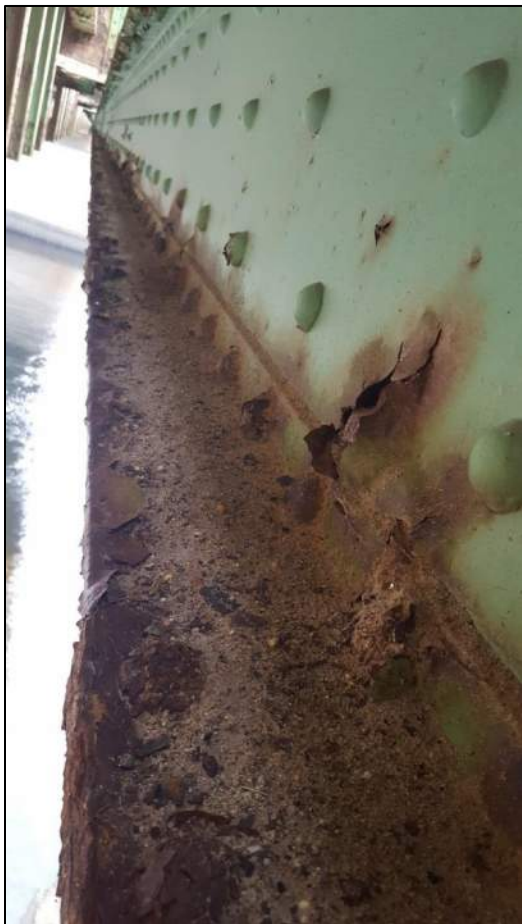
During August of 2016 Special Inspection it was noted a significant buildup of sand/dirt made visual clues more difficult.

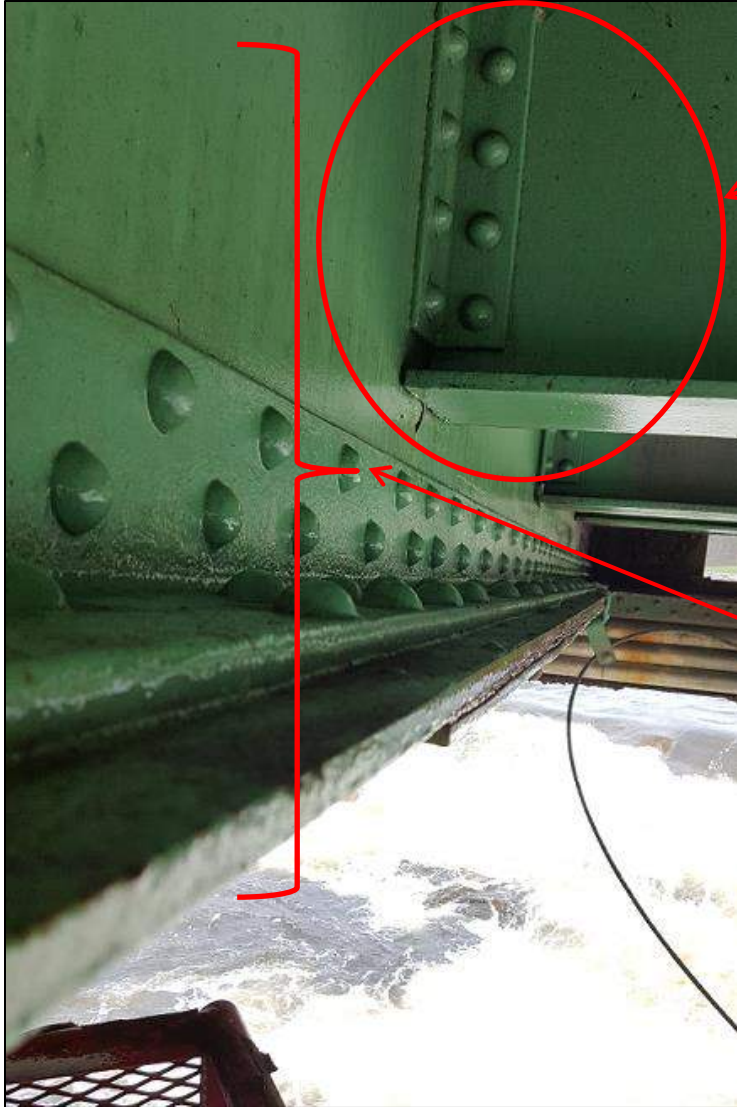
Although the contract indicated to apply fluid film to the connection of Stringers 3 & 8 (exterior stringers), the contract was modified to include the interior stringers as well. Blown and fluid film applied 3 foot min along their lengths.

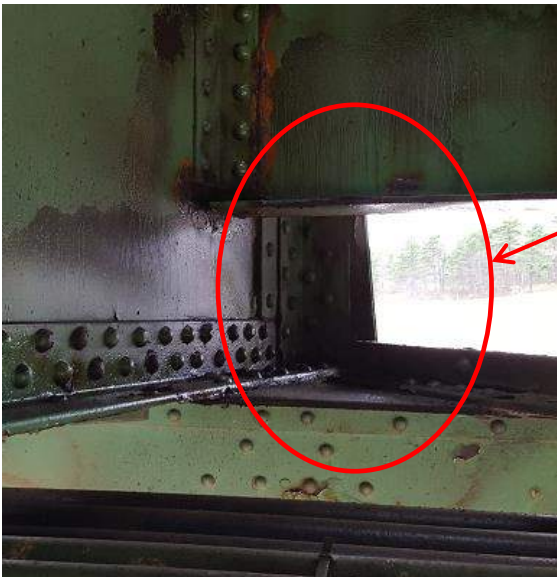
The apparent most susceptible area of the Floorbeam to deterioration were blown clean and coated with fluid film where reasonably accessible with a UBIT.

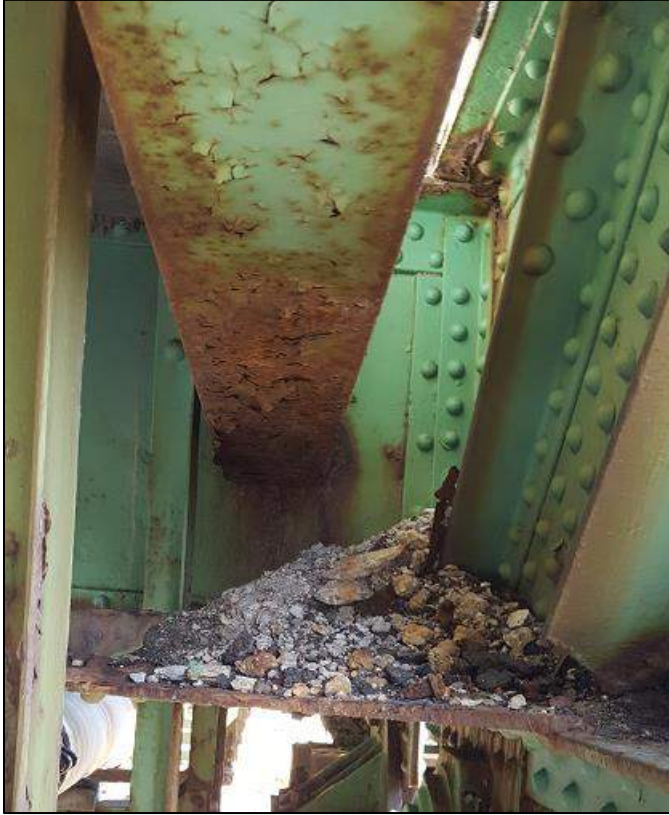
Noted last August was significant build-up of sand, dirt & debris on horizontal members including gusset plates.

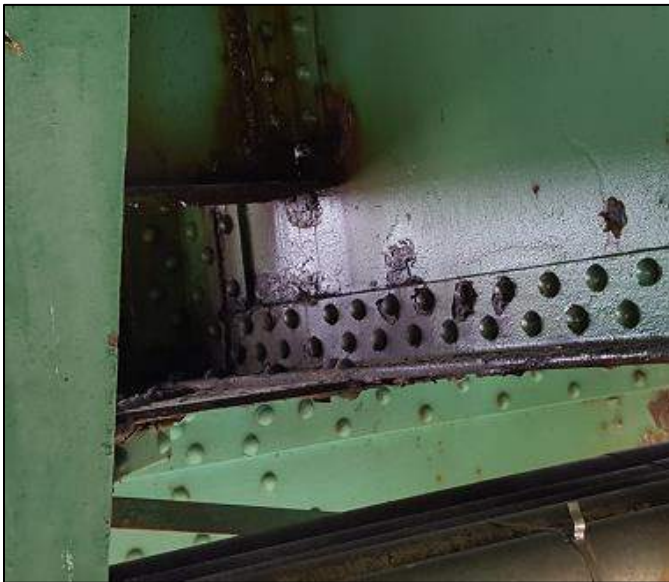
The modification of this contract resulted in most of these areas successfully blown clean with 145 psi of air.

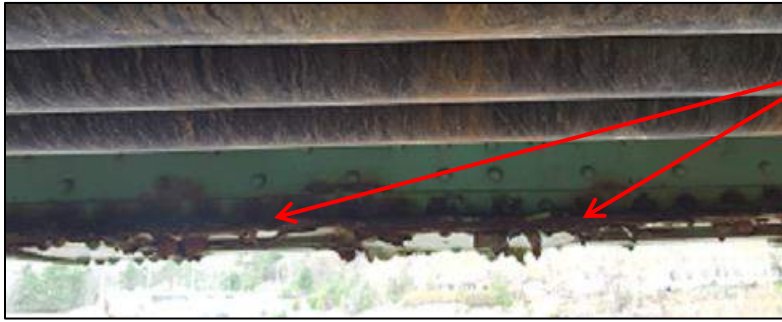
These rivets should be more exposed after blowing sand and dirt off.

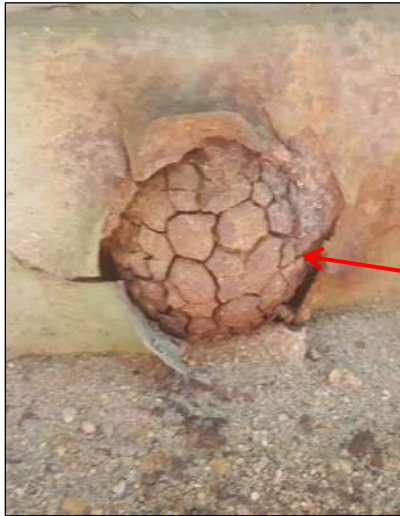
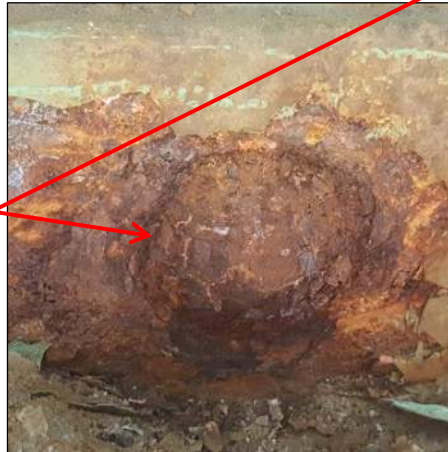
In August of 2016 a typical rivet was located in the sand/debris was struck until rusted portion was removed. A smaller head resulted.

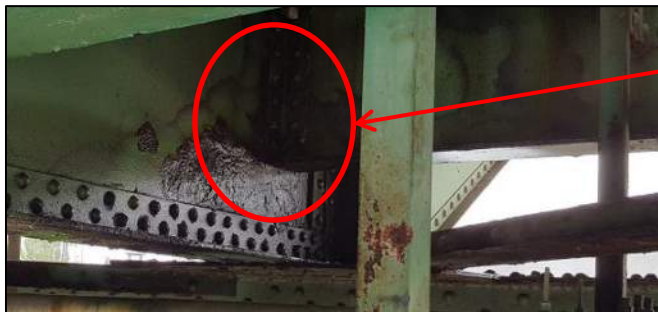
This area in particular.

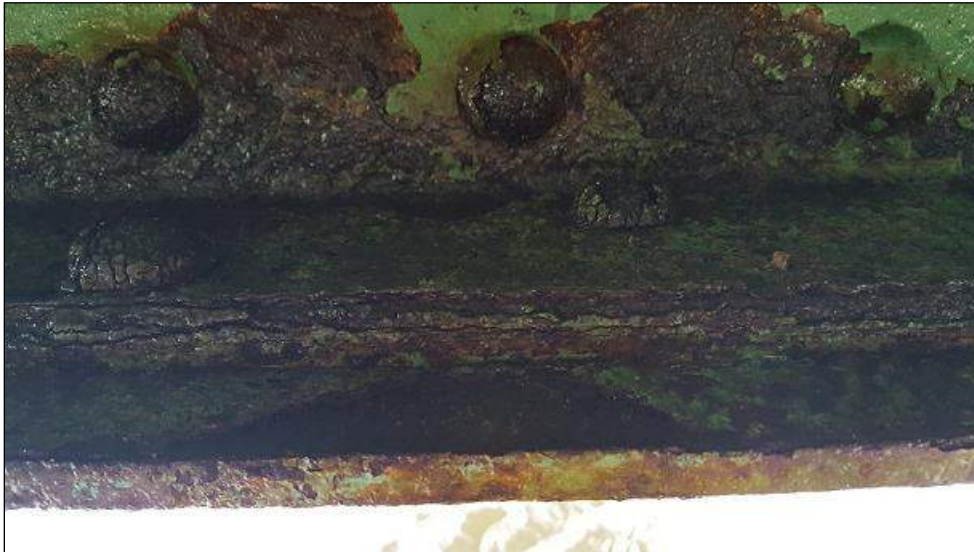
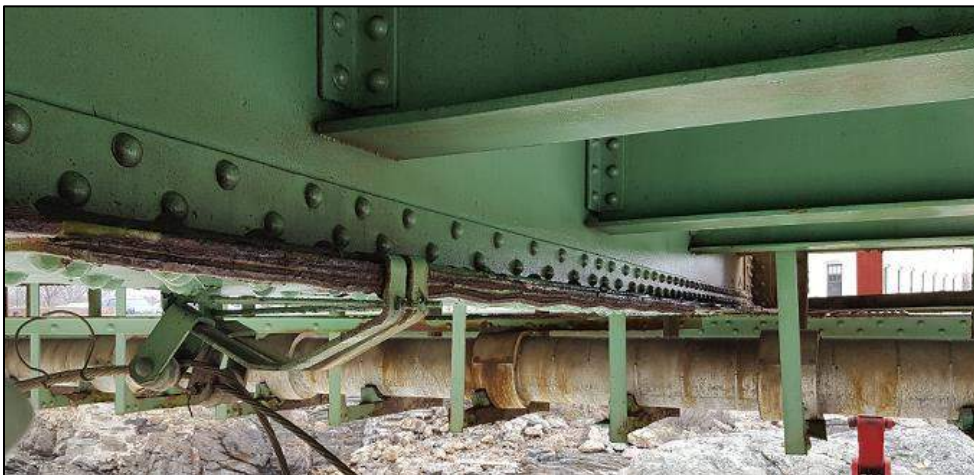
4. **Inspect the web area above and below pin hole in the Floorbeam web shown below.**
This would be a good spot check for a series of D-meter readings. This spot check will serve as good general information for the Department.

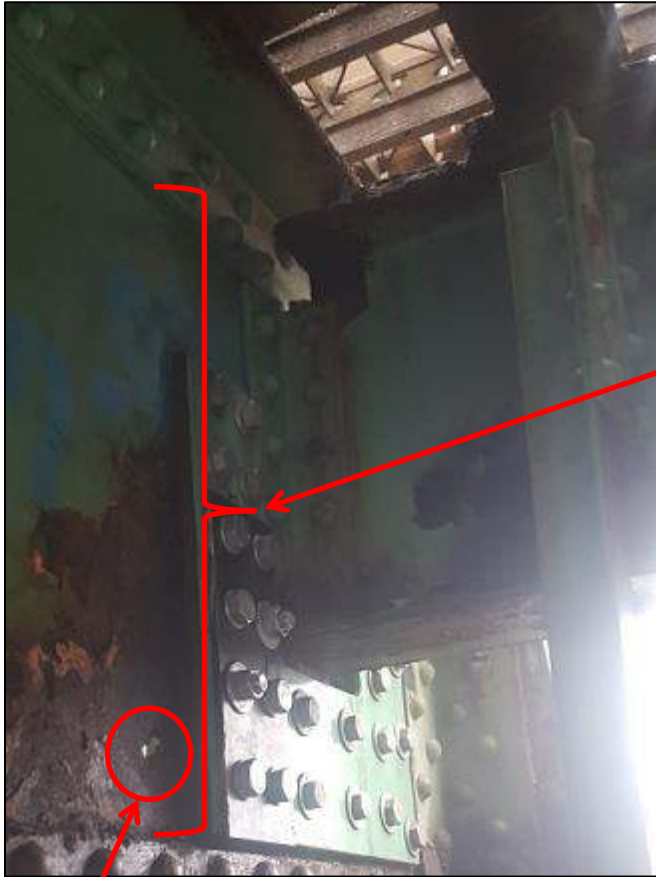
Repair Location at Floorbeam 5, Roadside Truss – Stringer 8, note hole through web to the left of cover plate.

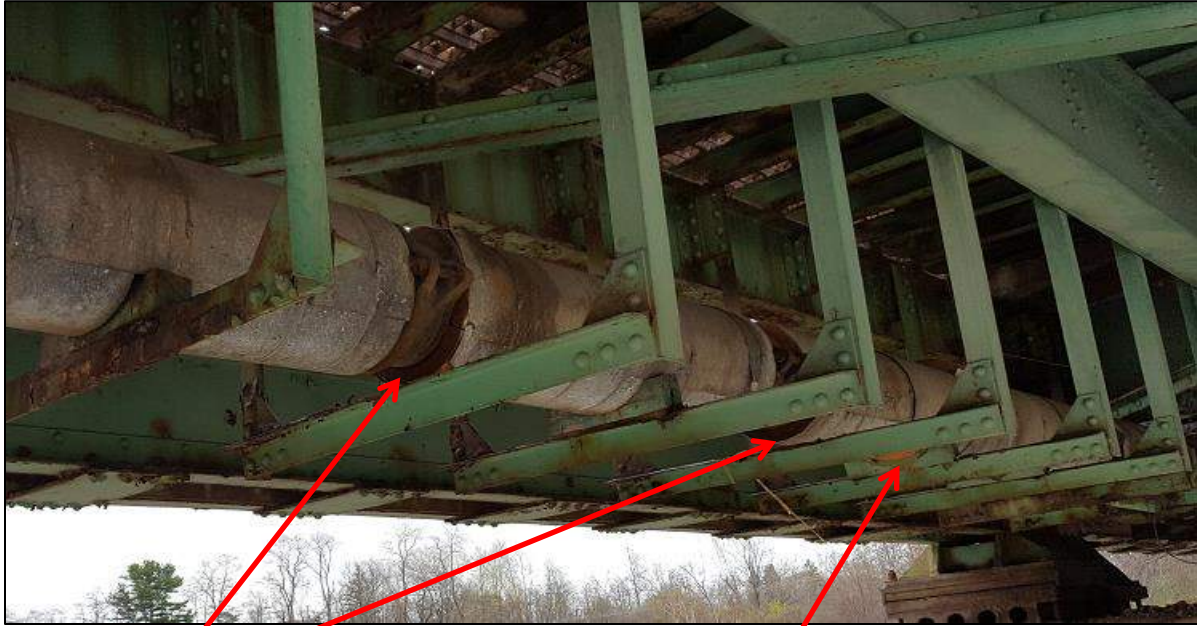
Custom blocks of wood missing.

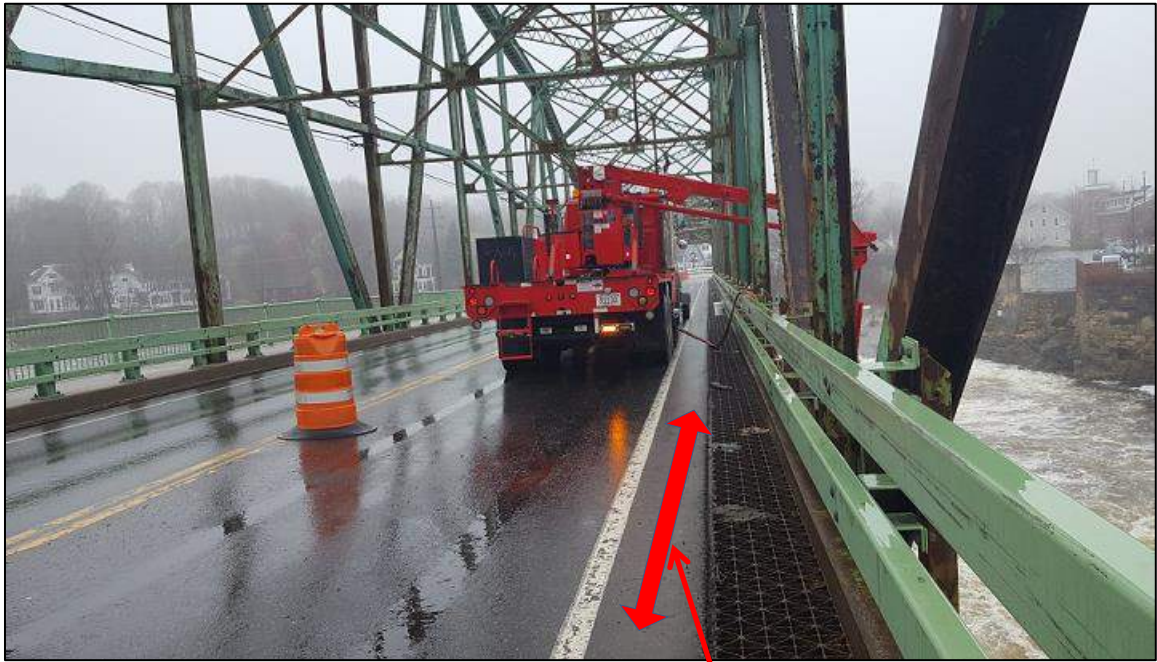
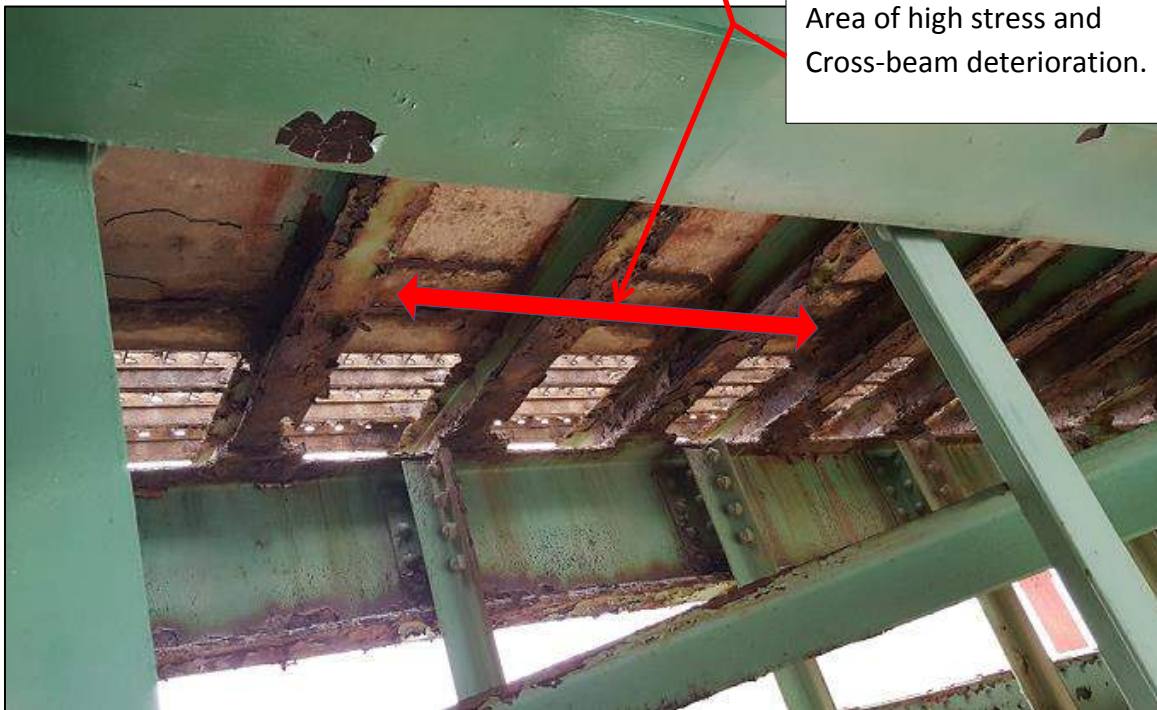
7. Continue to review/inspect Stringer ends. Significant numbers in Spans 1 and 3 are deteriorating. If any rivets become suspect, identify which one(s).

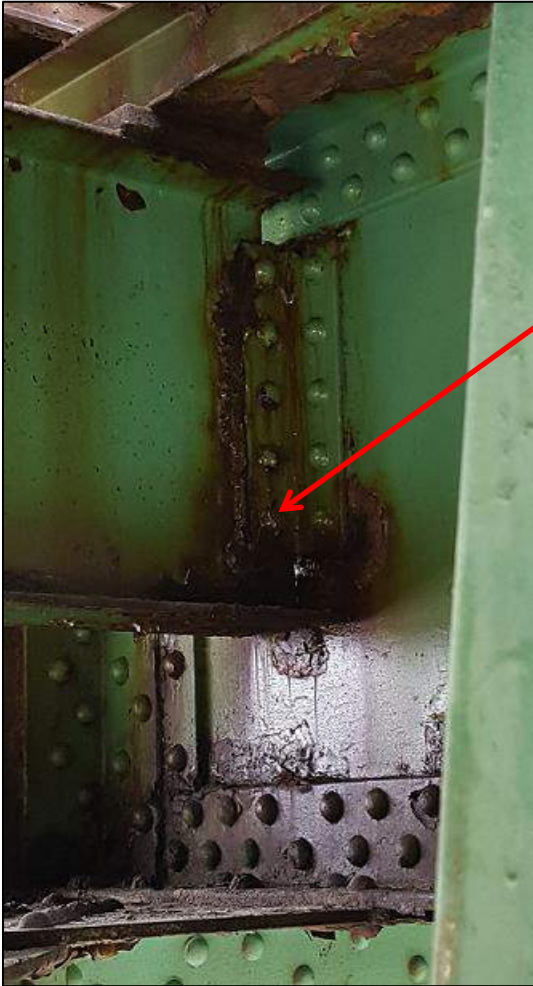
The Department has a standard uniform fix for stringer end connection. The bottom rivet remains to keep the stringer in place while plating is added.

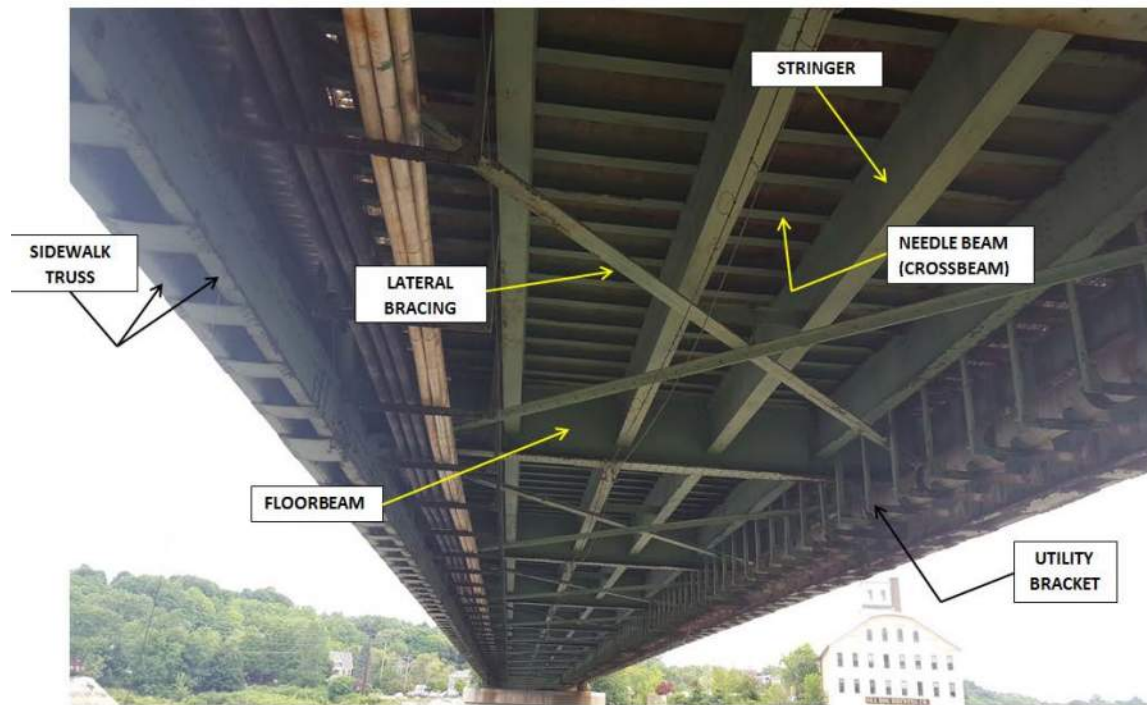
Typ. nomenclature of Frank J Wood Bridge – looking north from Abut. 1 to Pier 1, in Span 1.

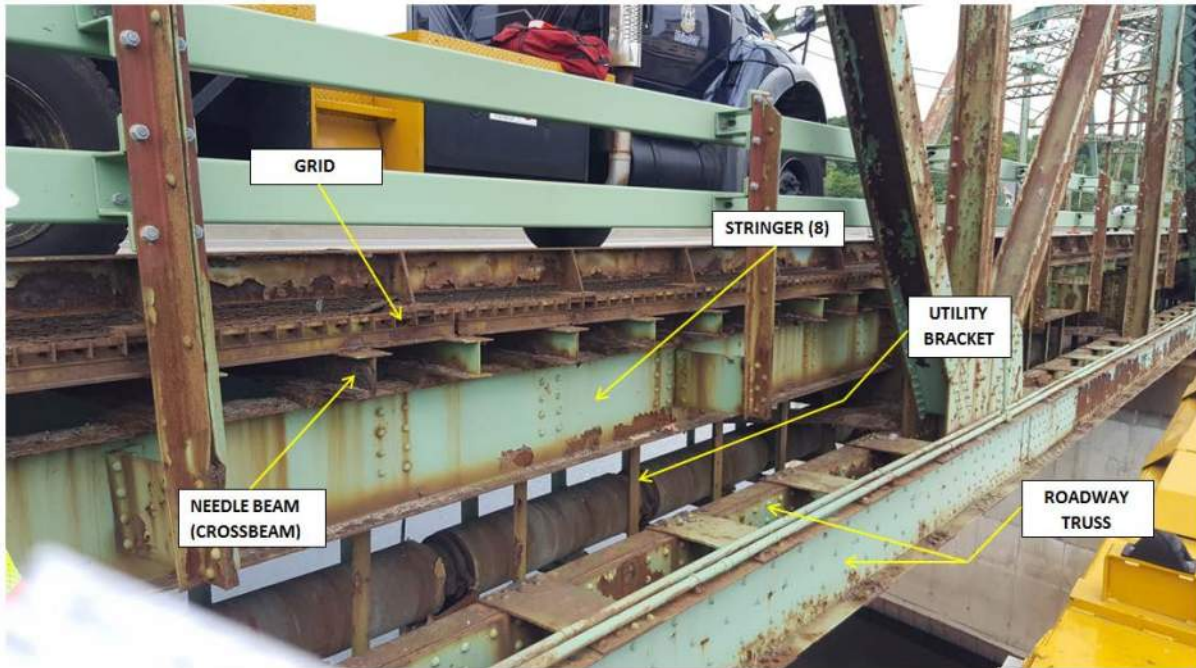
Typical Nomenclature of Frank J Wood Bridge – Looking Northwest midspan of Span 2.

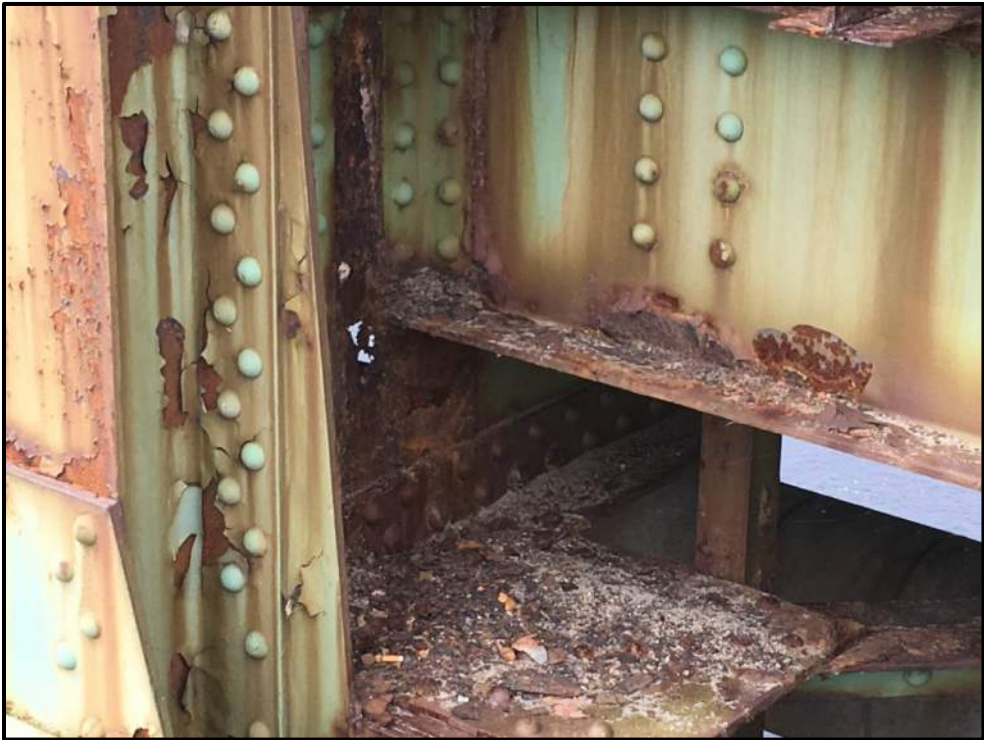
Photo A1 – Floorbeam 7, Roadway Truss @ Stringer 8 (Exterior)
