Preliminary Design Report

Frank J. Wood #2016

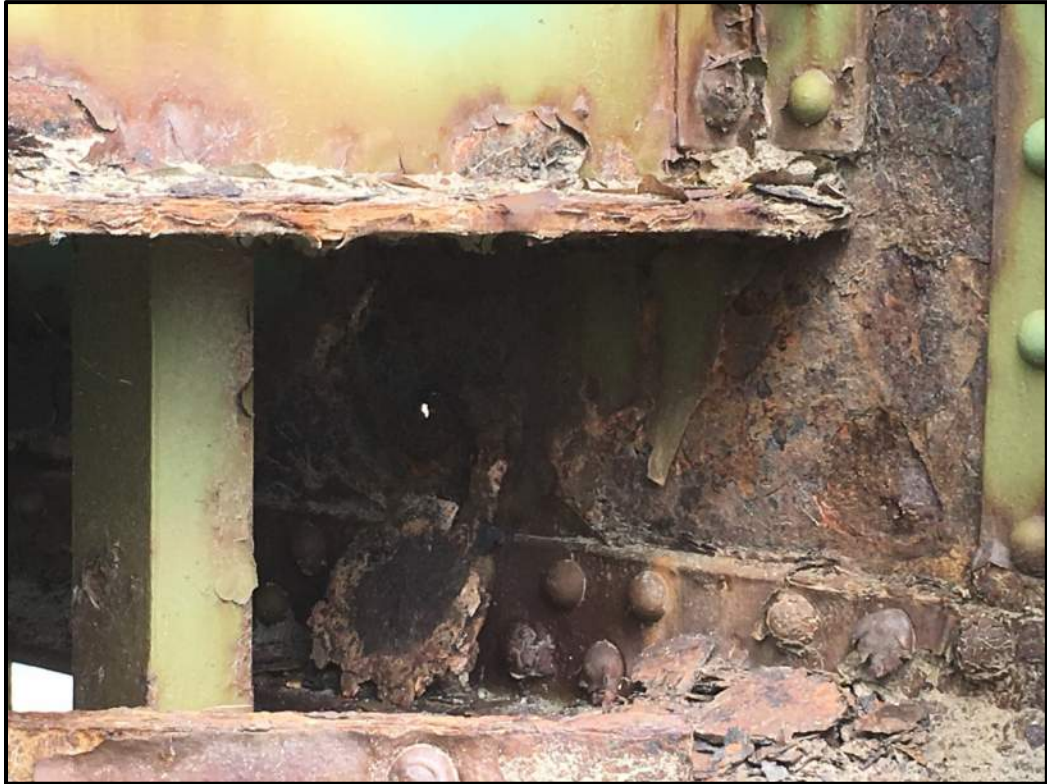
Photo A3 – Floorbeam 2, Roadway Truss @ Stringer 8 (Exterior)

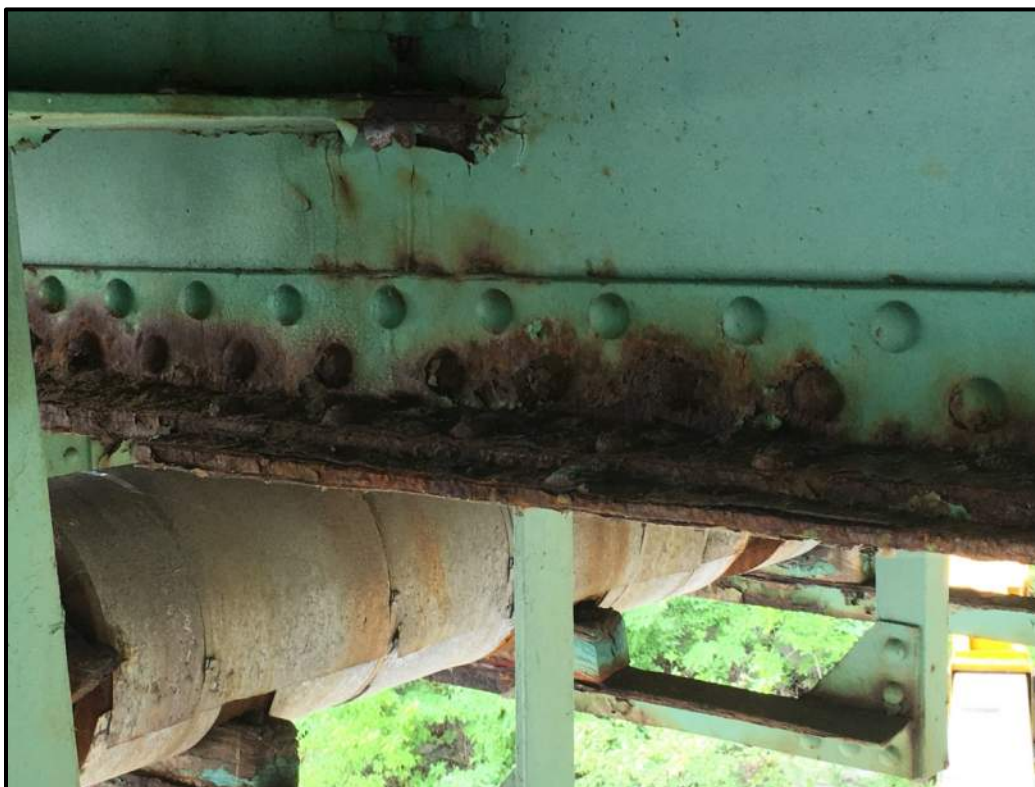
Photo A4 – Floorbeam 2 coverplate particularly between Stringer 7 & 6 is an area of concern which will be closely monitored.

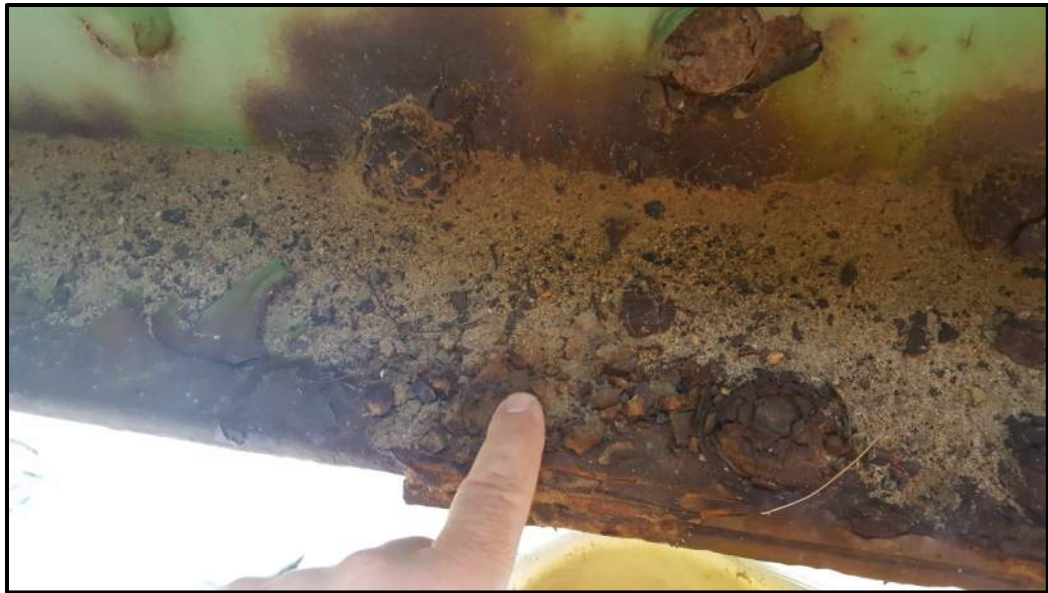
Photo A5 – Floorbeam 5 coverplate has enough deterioration issues to expect a repair within 5 years.

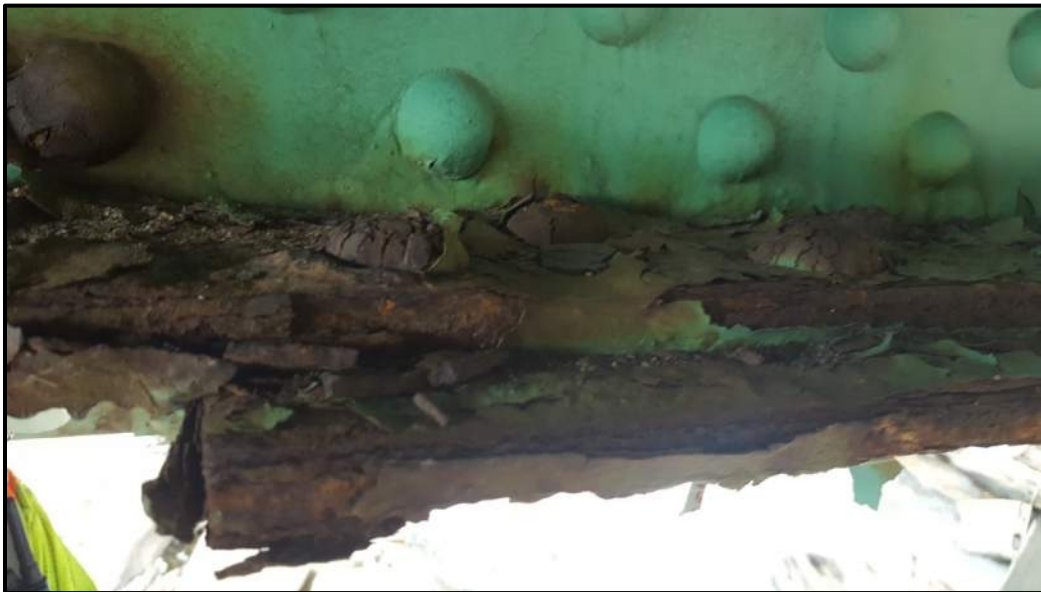
Photo A6 – Floorbeam 6 exhibiting excessive pack rust and rivet deterioration.

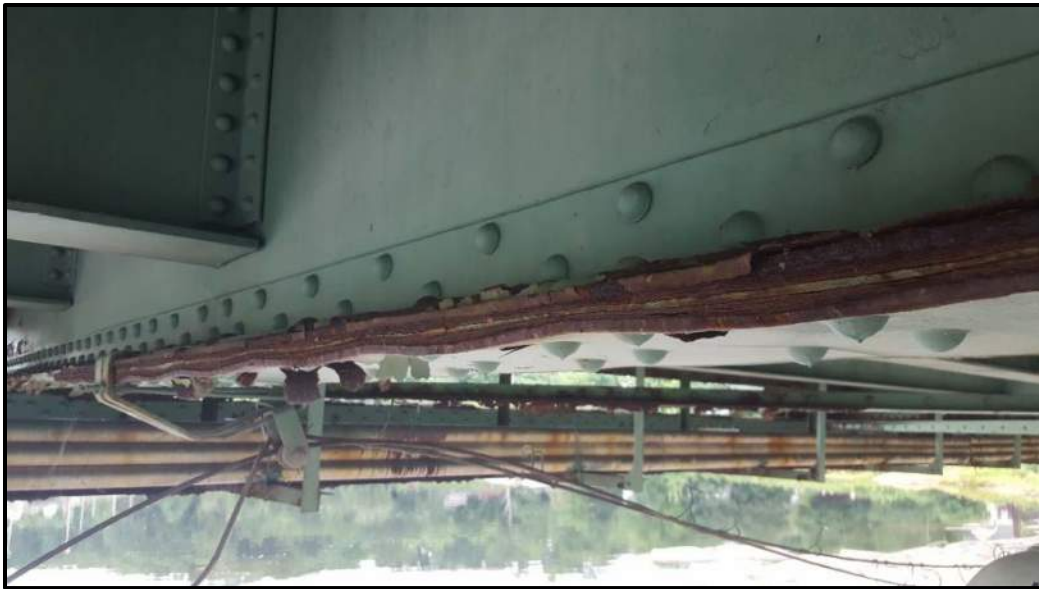
Photo A7 – Floorbeam 8 bottom flange midspan plies showing pack rust and deformation which may lead to repair activity within the next 5 years.

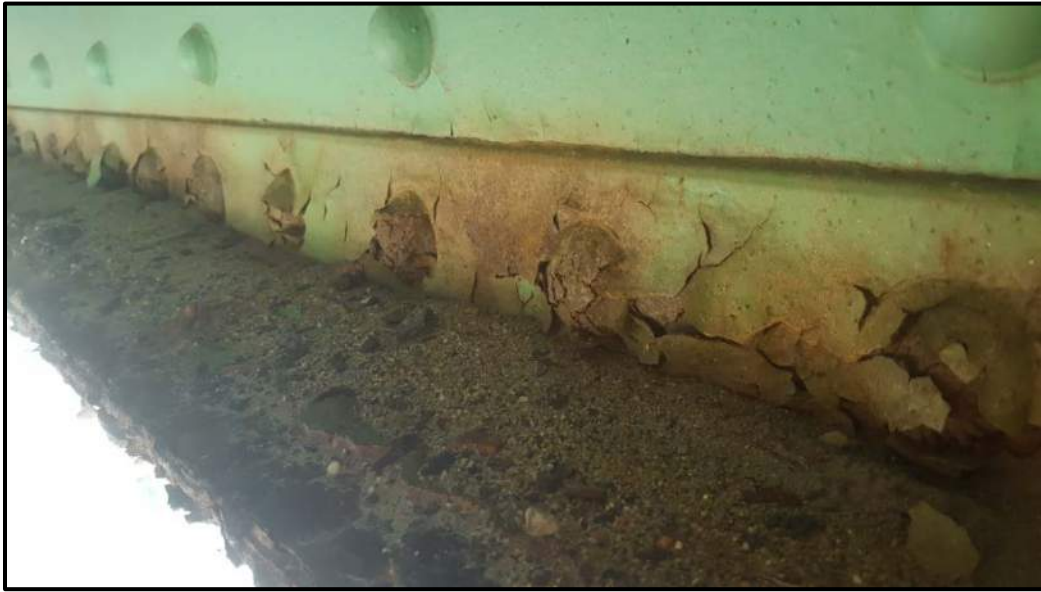
Photo A8 - View of the inside of Sidewalk Truss's lower angle depicts continuous corroding rivet heads and sand, salts and debris occupying the angle flange.

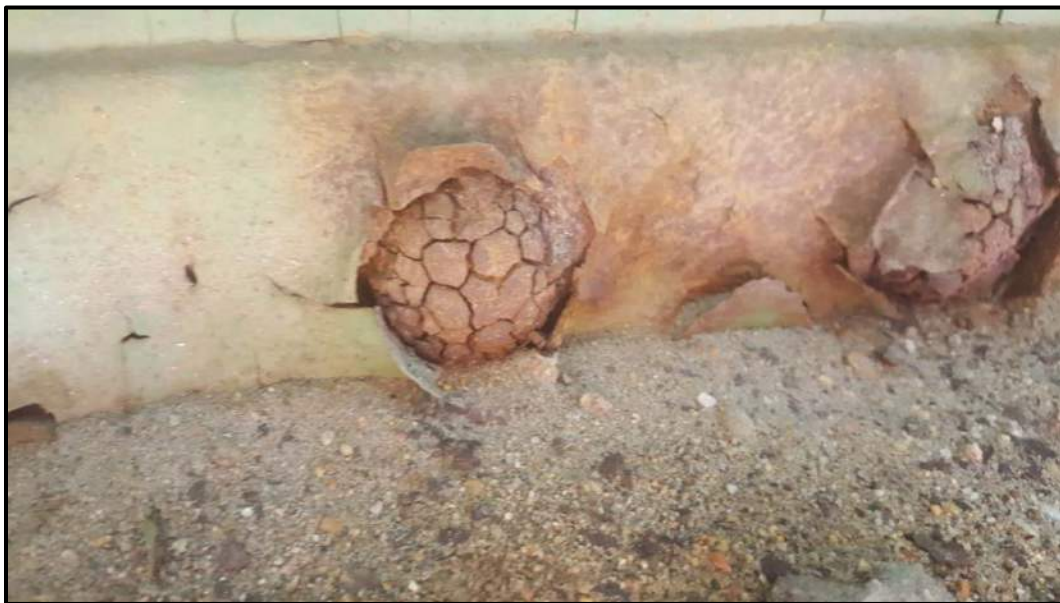
Photo A9 - Typical rivet head condition along Sidewalk Truss Lower Chord of Span 3 for at least 100 ' length of angle to plate connection.

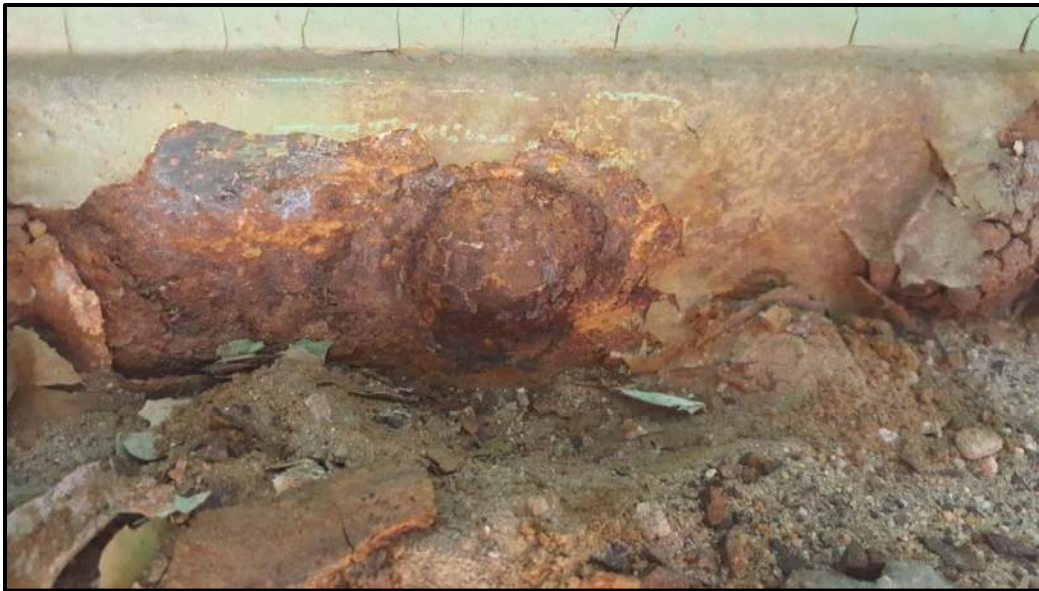
Photo A10 – This is the same rivet as above after briefly pounding loose corrosion away. The rivet head size is significantly smaller than the diameter and height of a new rivet head.

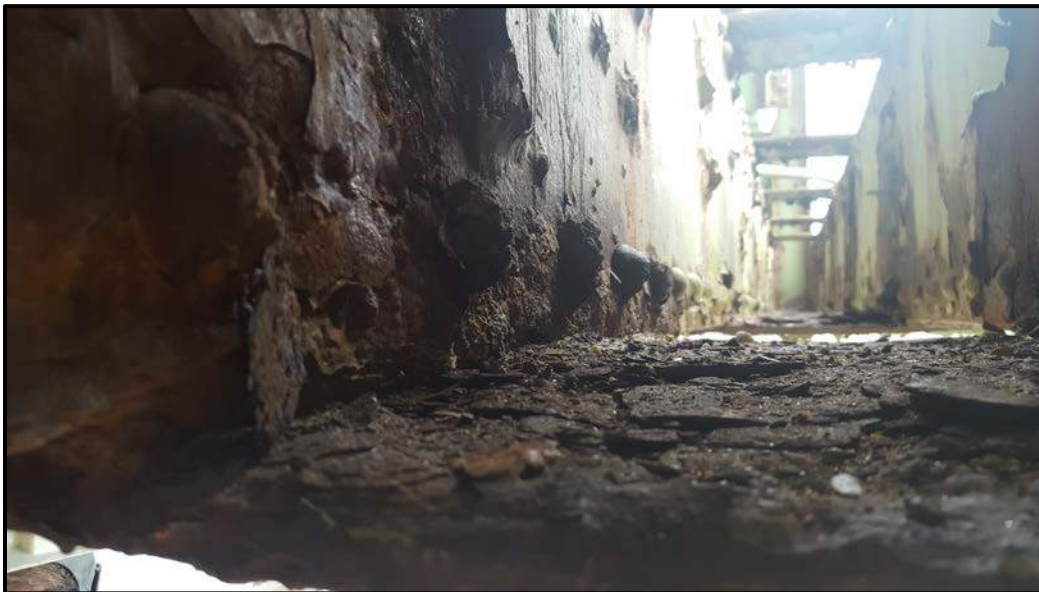
Photo A11 – This is the general condition view of the inside lower chord truss member collecting rust and debris on the lacing bars.

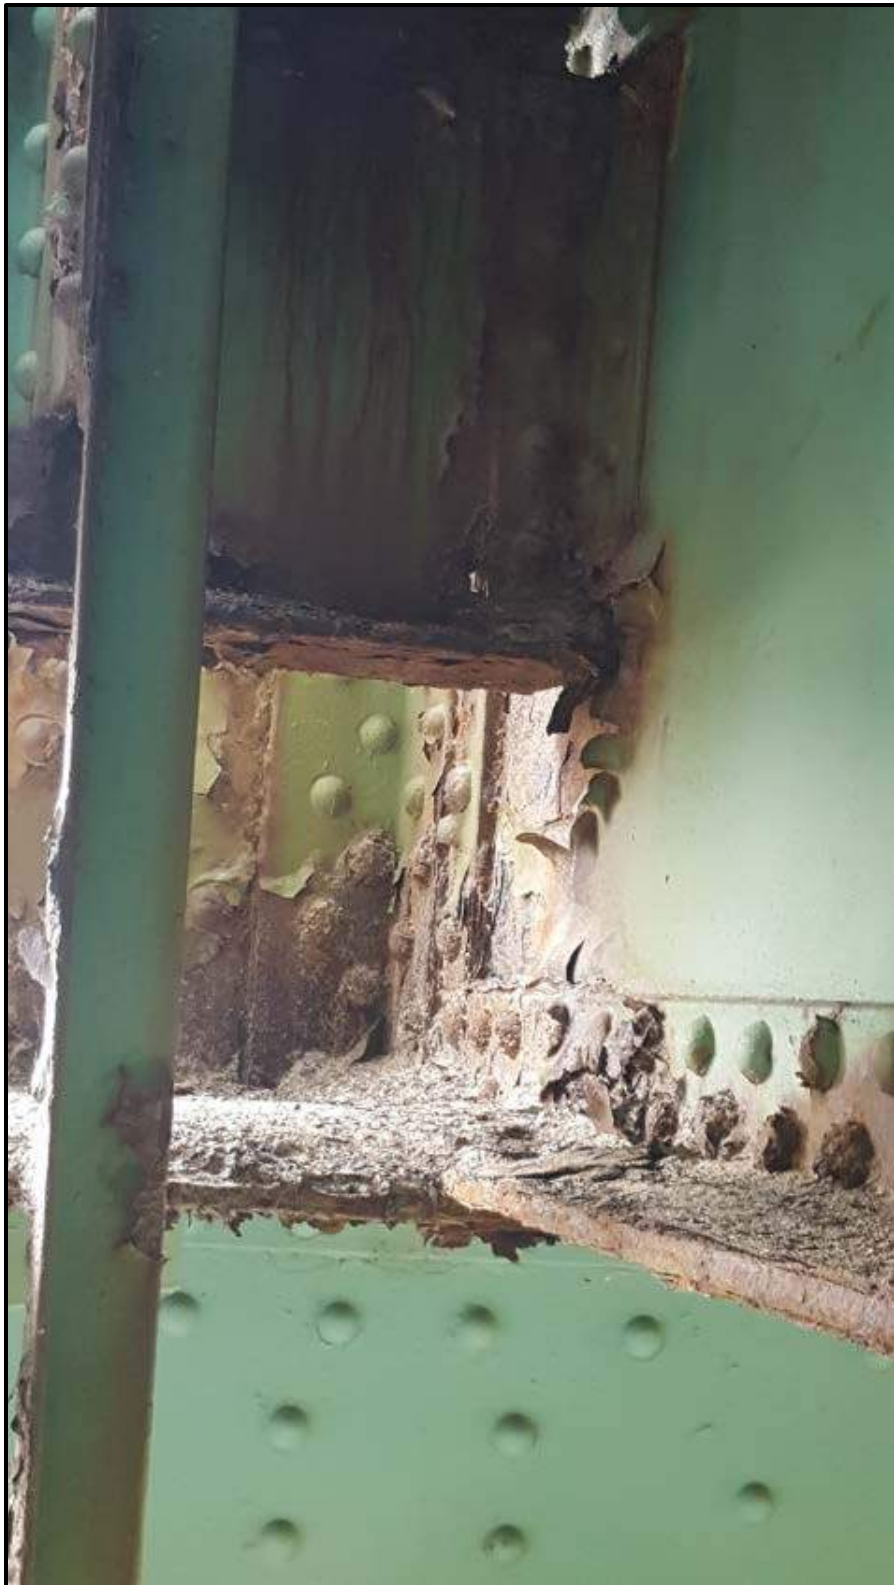
Photo A12 – Stringer 8, Roadway Truss @ Floorbeam 2 has section loss revealing a web hole.

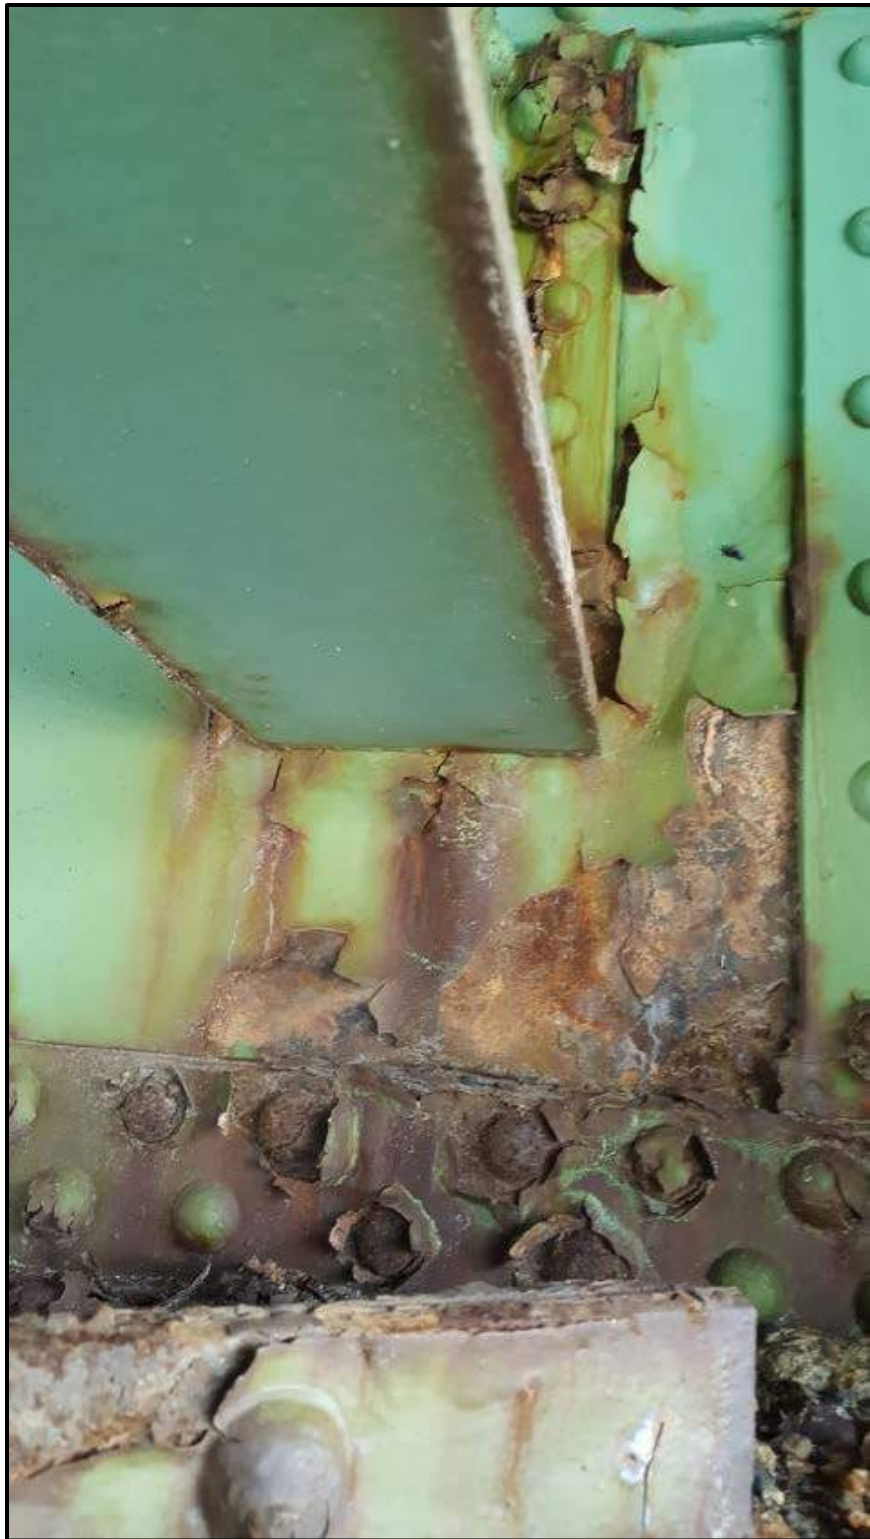
Photo A13 – Looking at the condition of north end of Stringer 8 attached to Floorbeam 3.

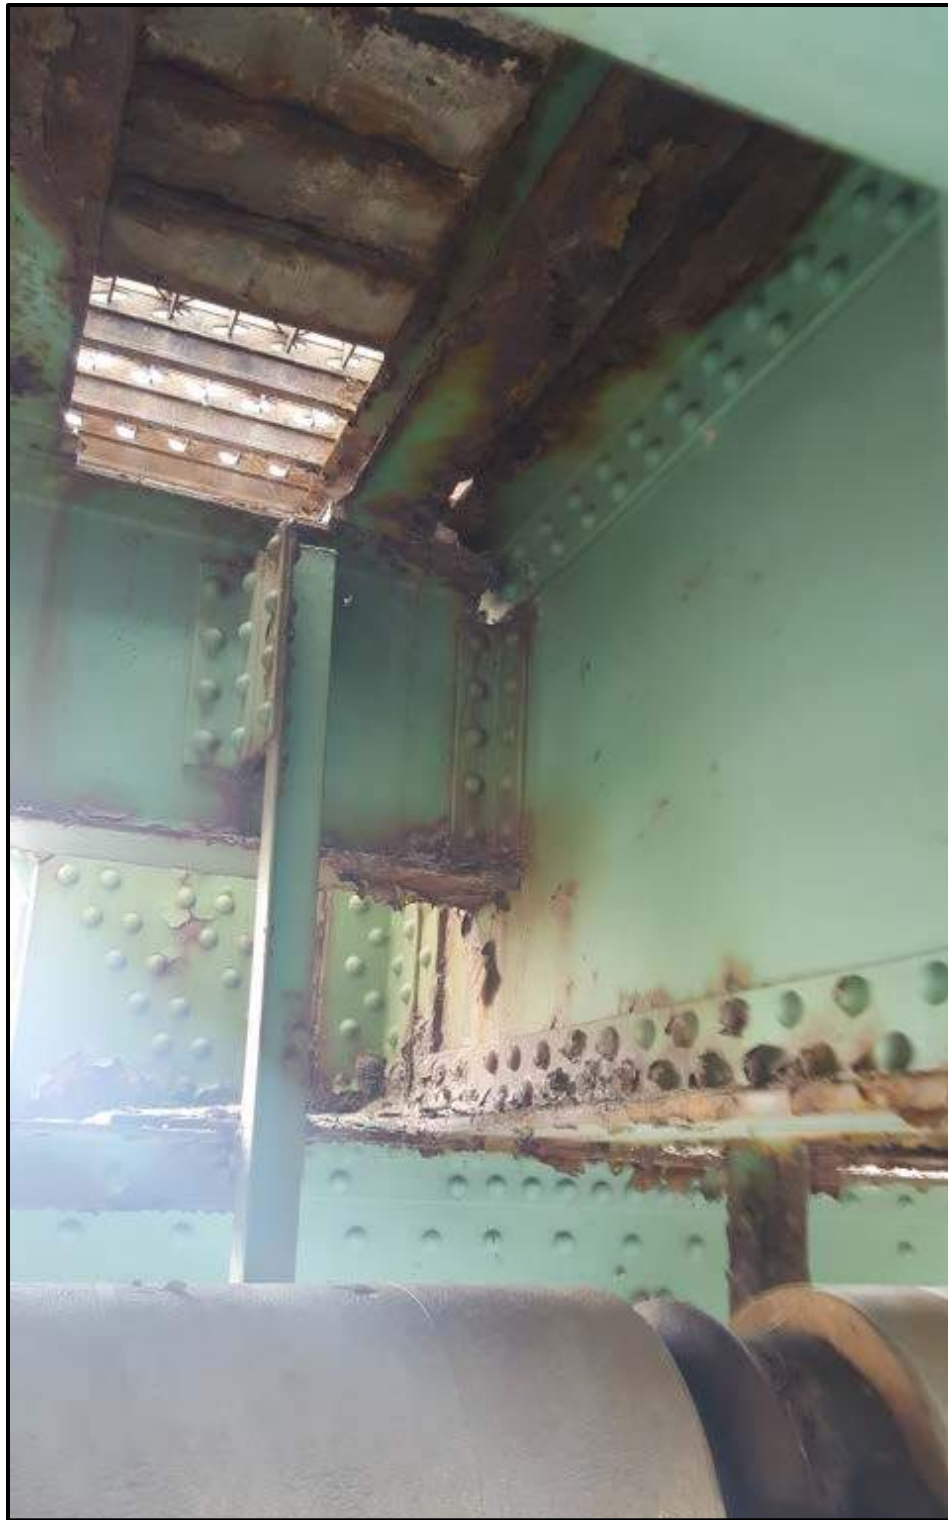
Photo A14 – Stringer 8 connection to Floorbeam 6, Roadside Truss, may warrant a reattachment repair within 5 years. Similar connection conditions @ Stringer 3 to Floorbeams 6 and 7.

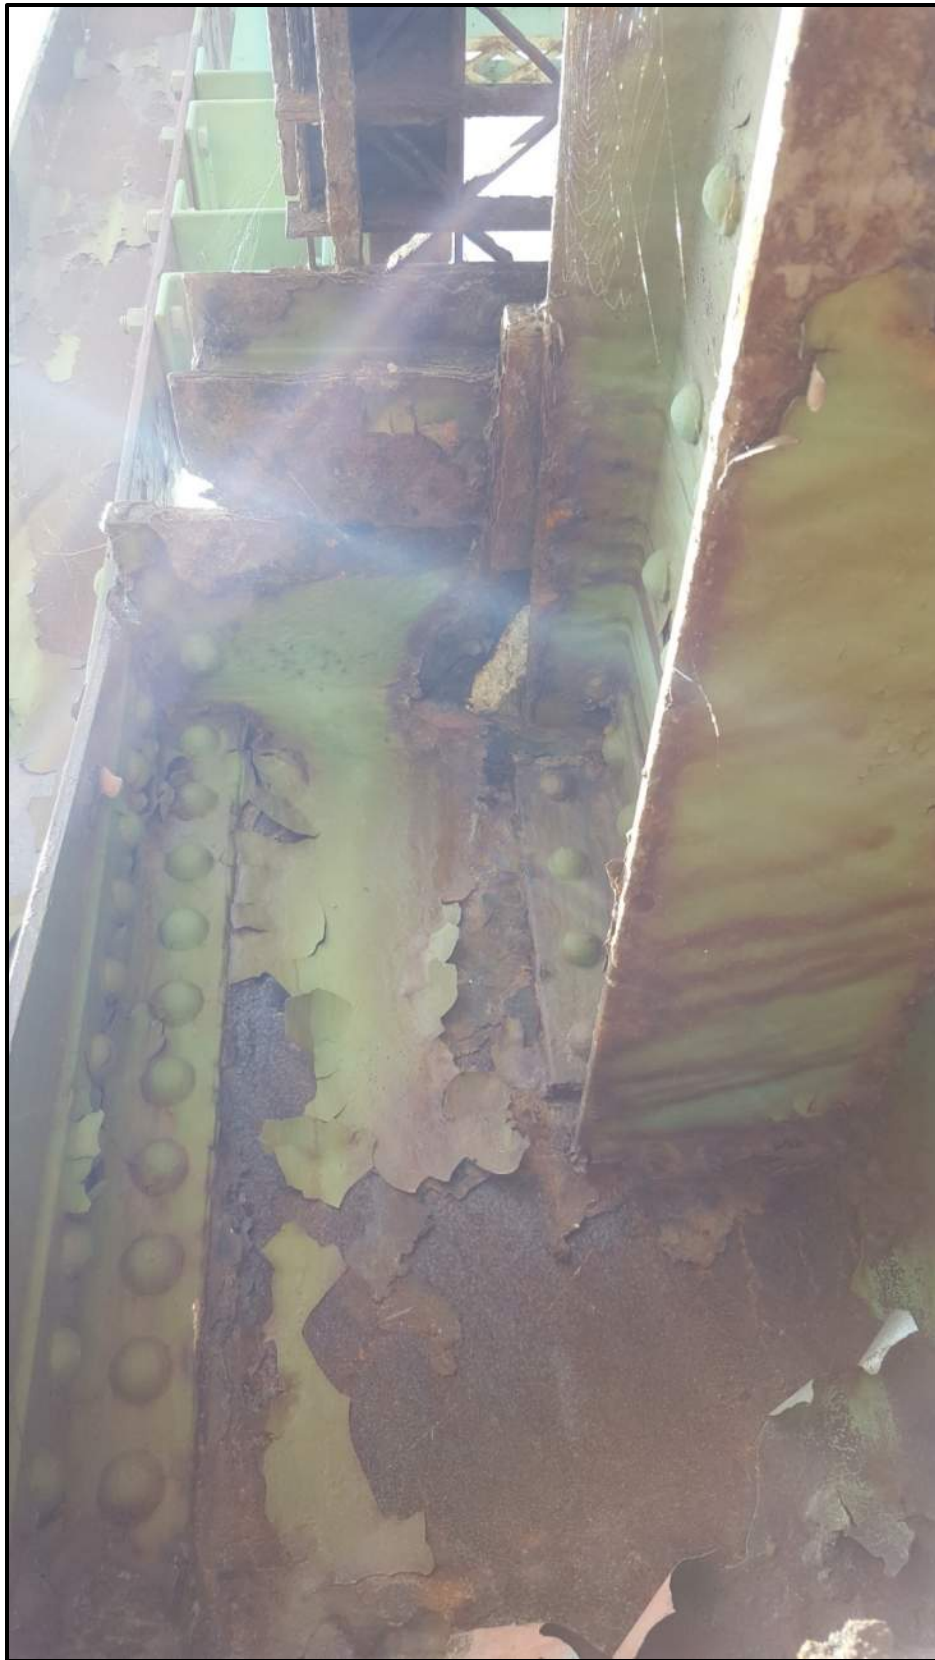
Photo A15 – Stringer 8 connection to Floorbeam 1 showing active corrosion.

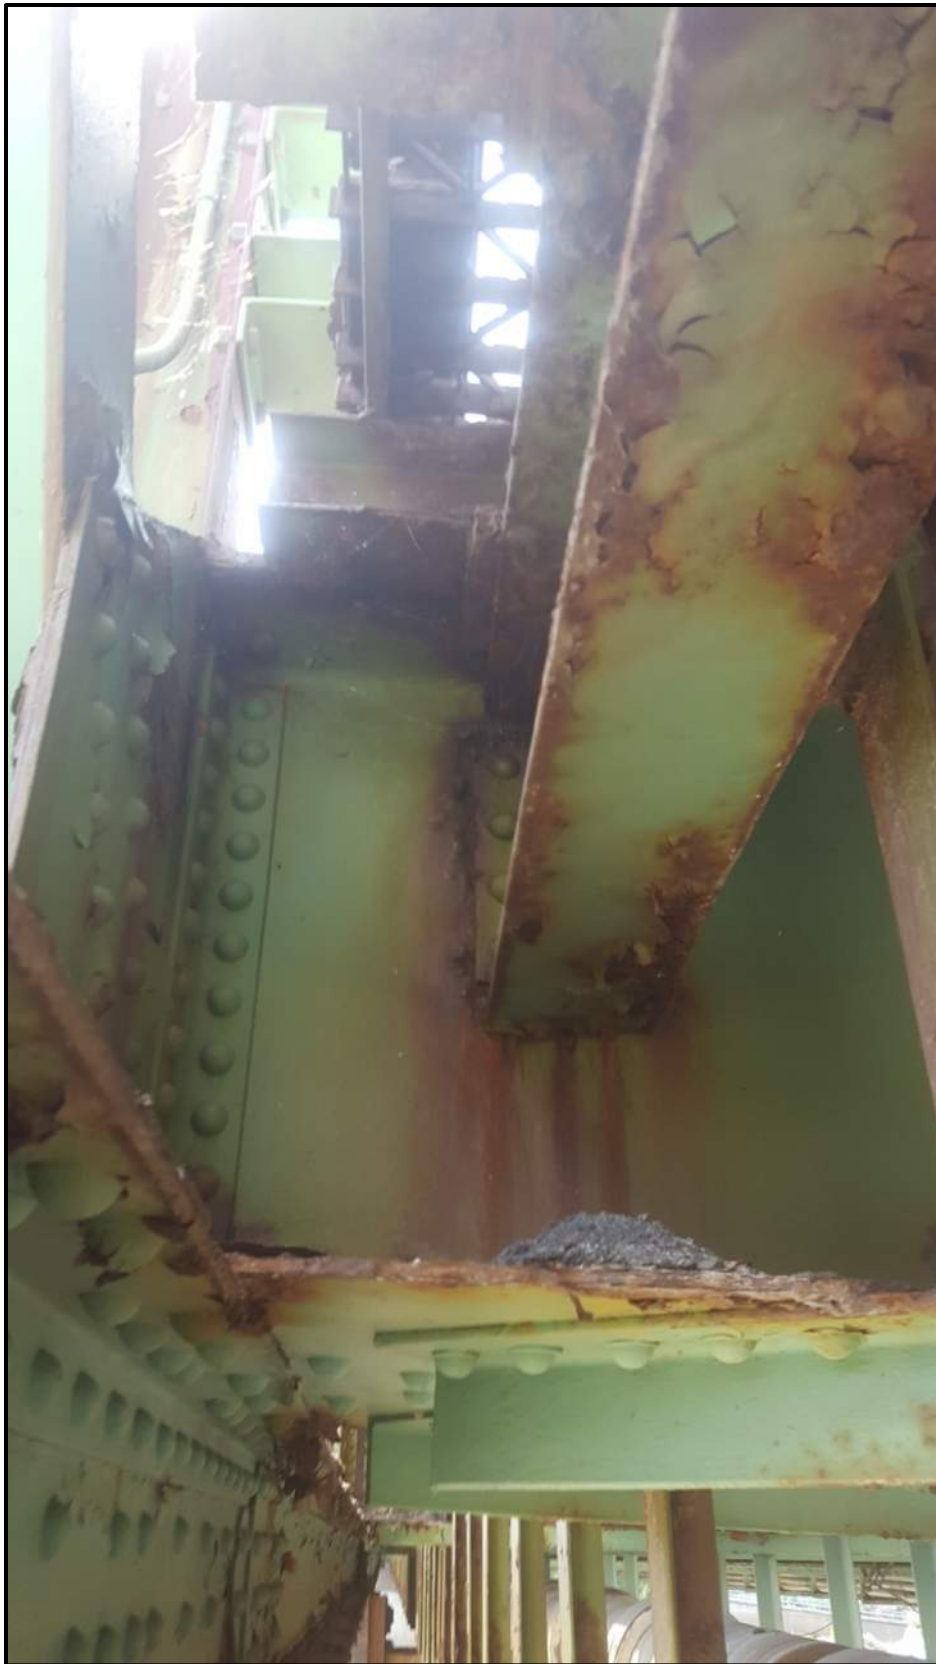
Photo A16 – Stringer 8 connection to Floorbeam 2 will likely need repair within 5 years.

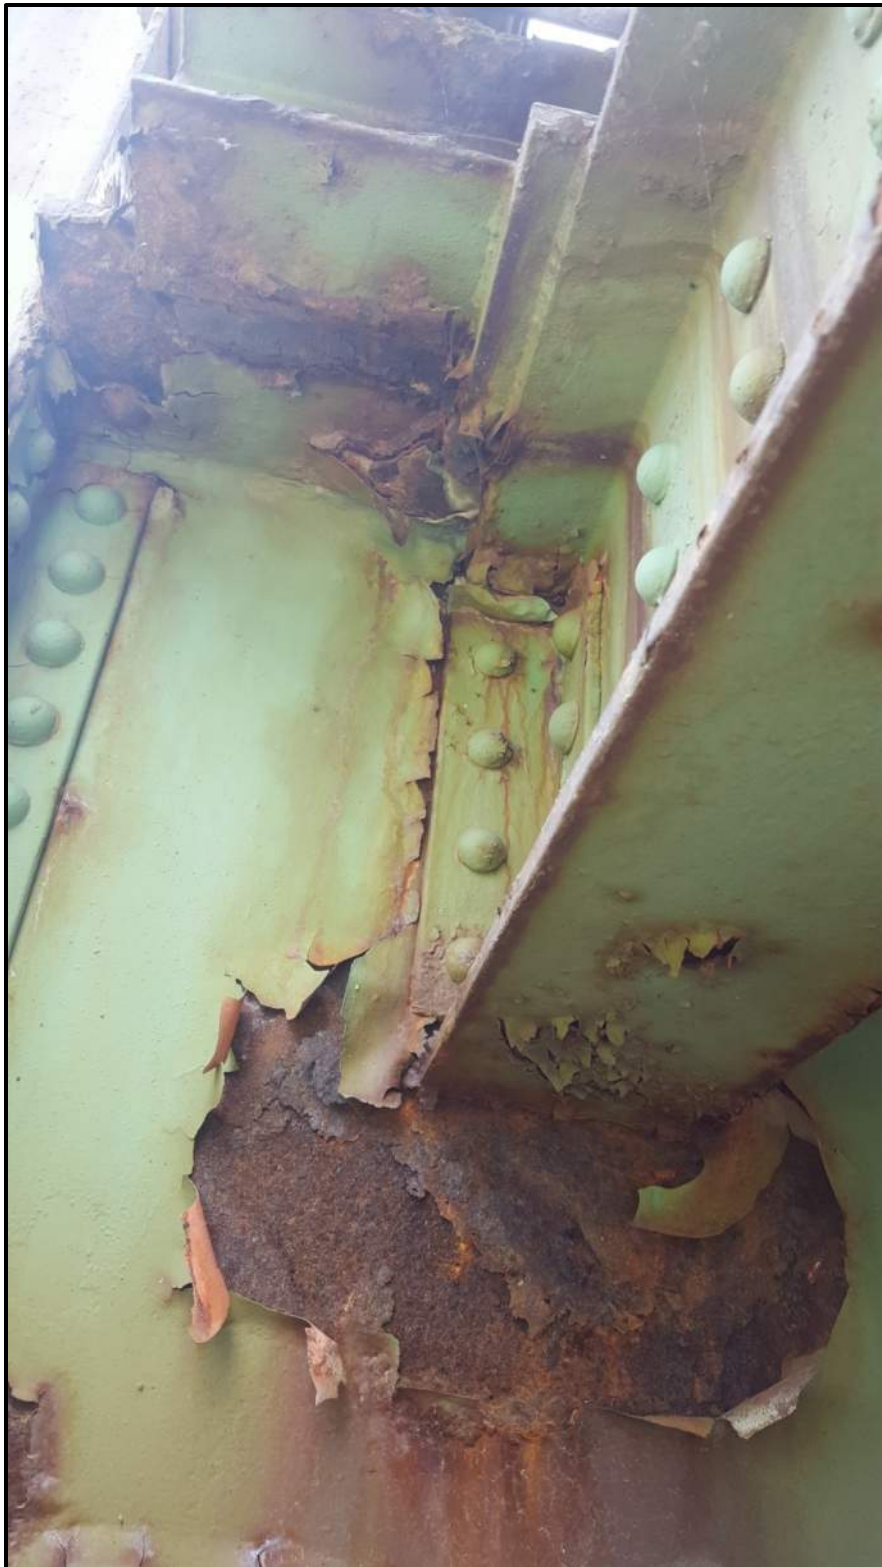
Photo A17 – Stringer 8 connection to Floorbeam 5 shows active corrosion.

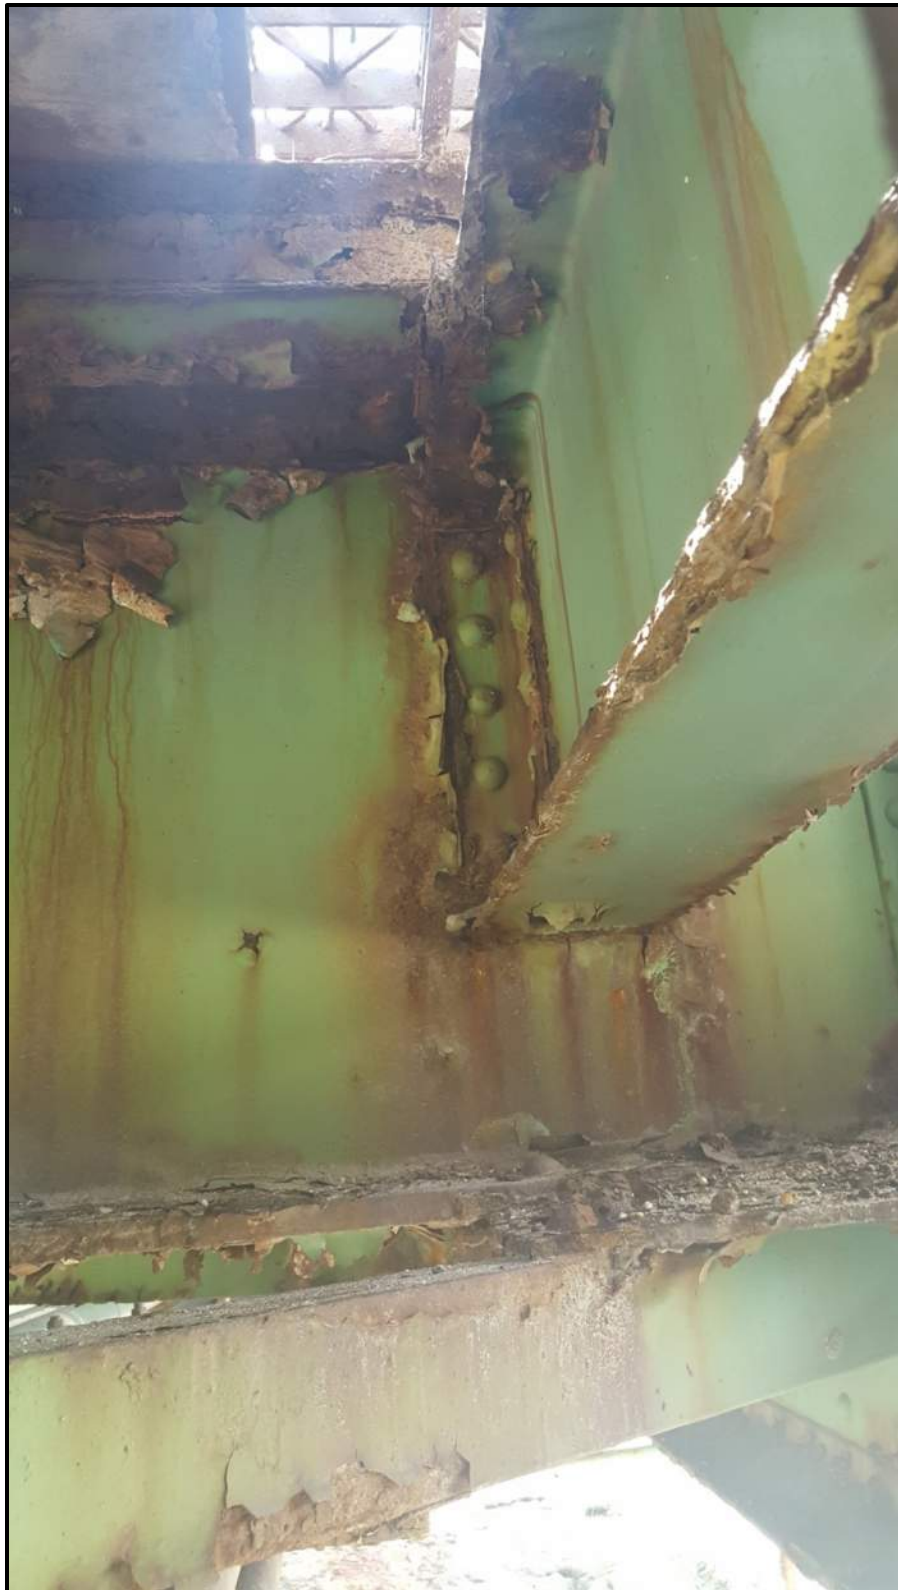
Photo A18 - Stringer 8 connection to Floorbeam 6. Stringer 3 connection similar condition.

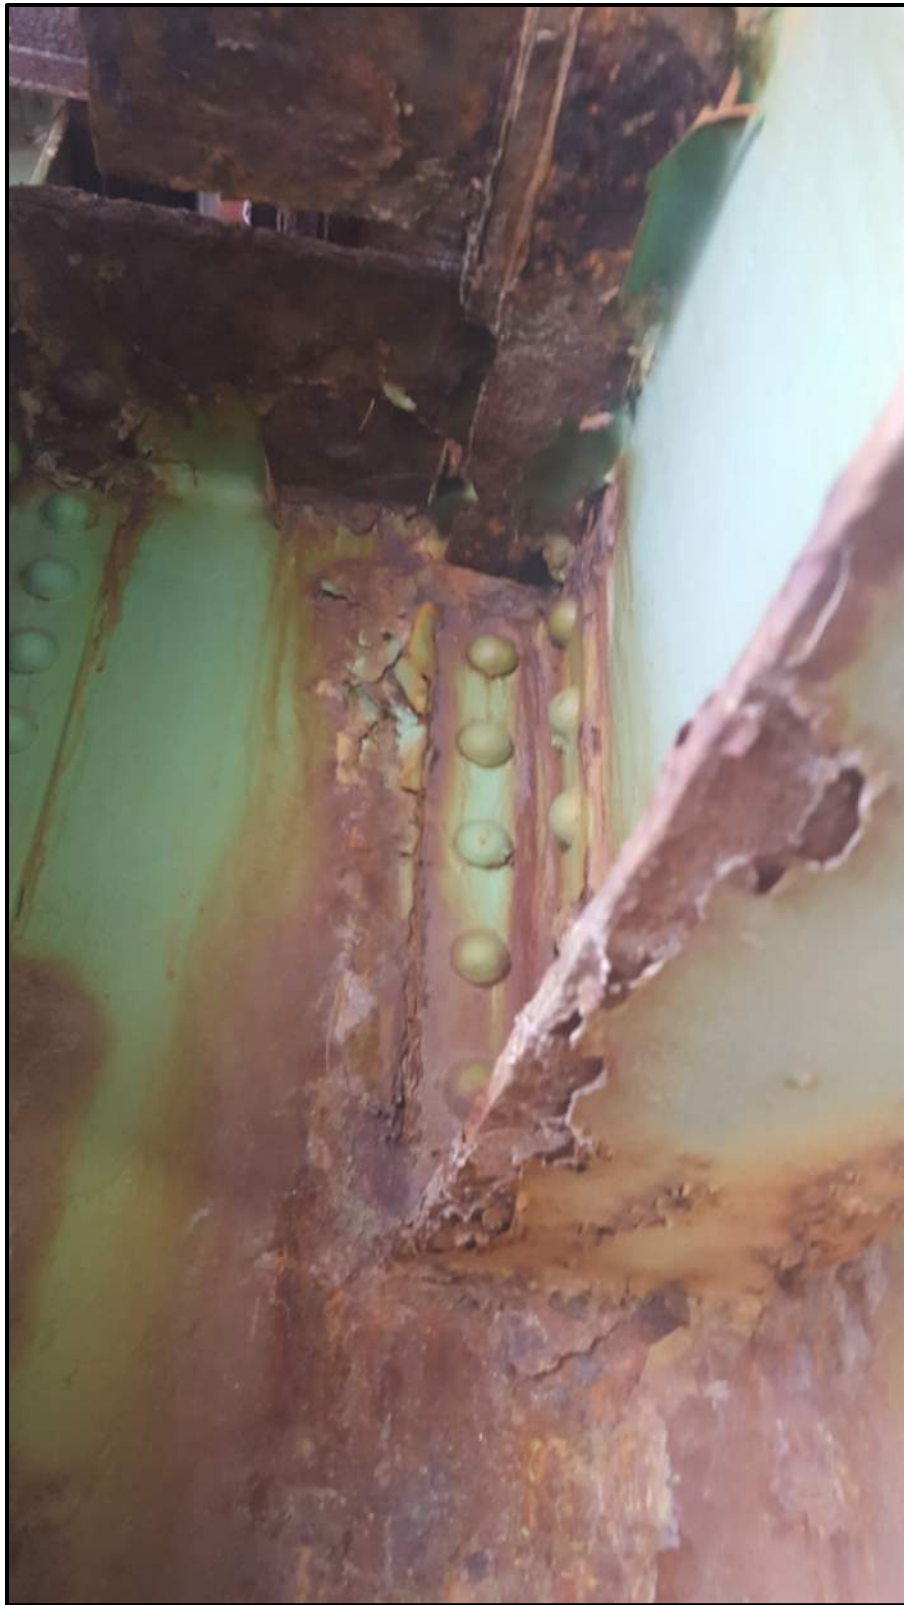
Photo A19 – Stringer 8 connection to Floorbeam 6 will likely require repairs within 5 years.

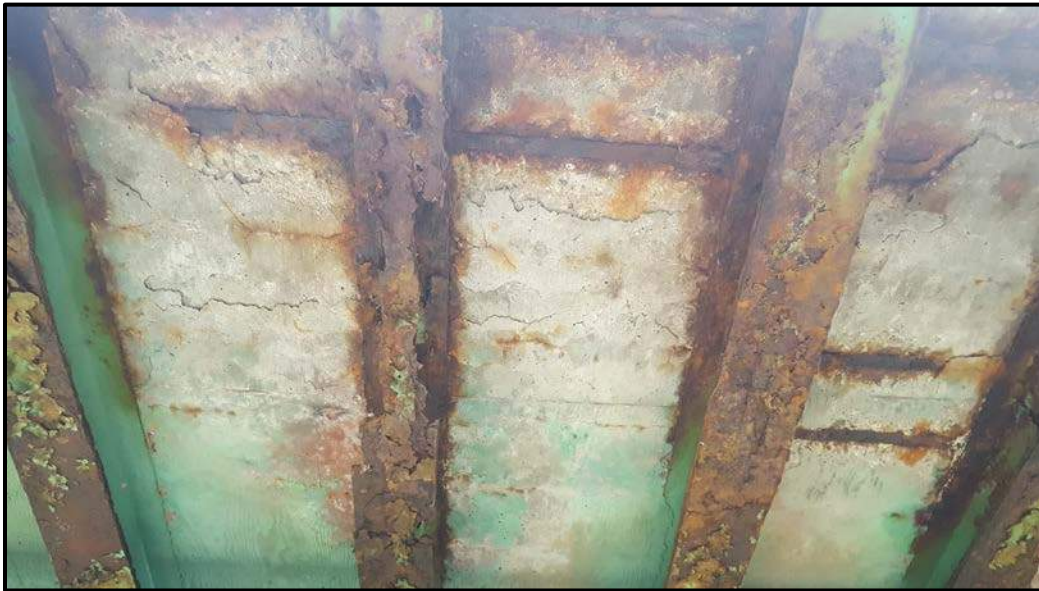
Photo A20 – Deteriorated Needle Beams shown here in Span1, Floorbeam 0 to 1, are evident throughout all 3 spans. These beams are 2'-0" on center supporting a grid deck mostly filled with concrete supporting an 1 ½ " to 2" asphalt wearing surface.

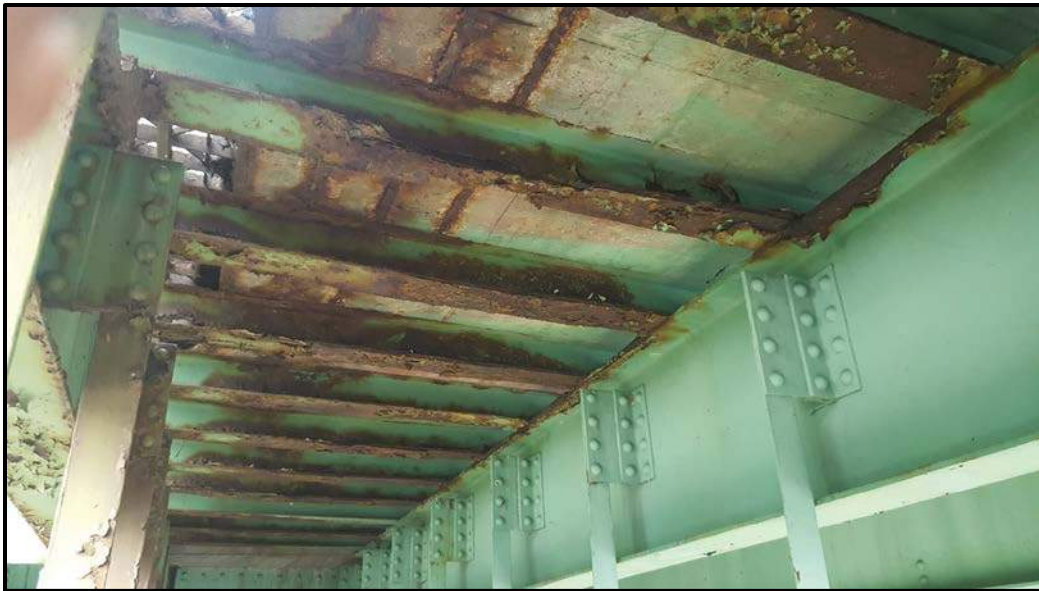
Photo A21 – View showing Needle Beams between Stringers 7 and 8. Area between stringers 3 and 4 are similar.

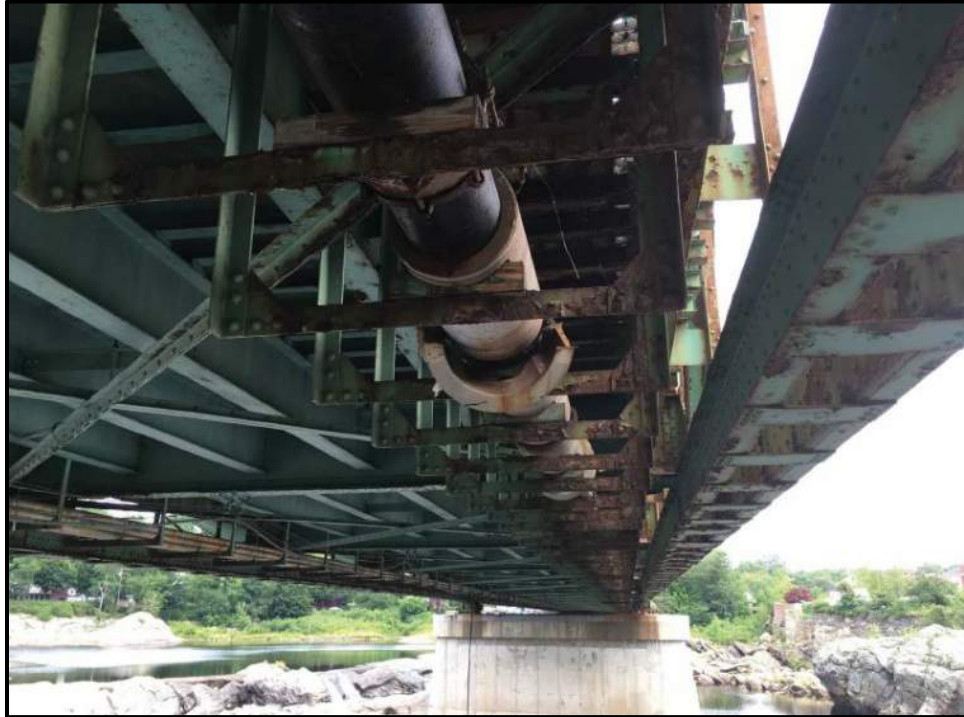
Photo A23 – View of steel insulated utility pipe extending across the bridge on the Roadside Truss side.

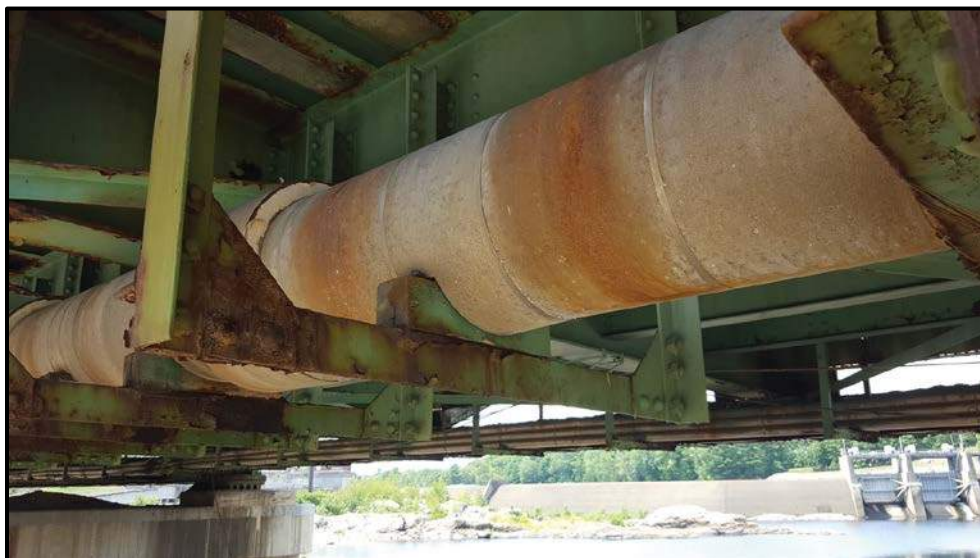
Photo A24 – The Utility Brackets are in poor condition with extensive active corrosion.

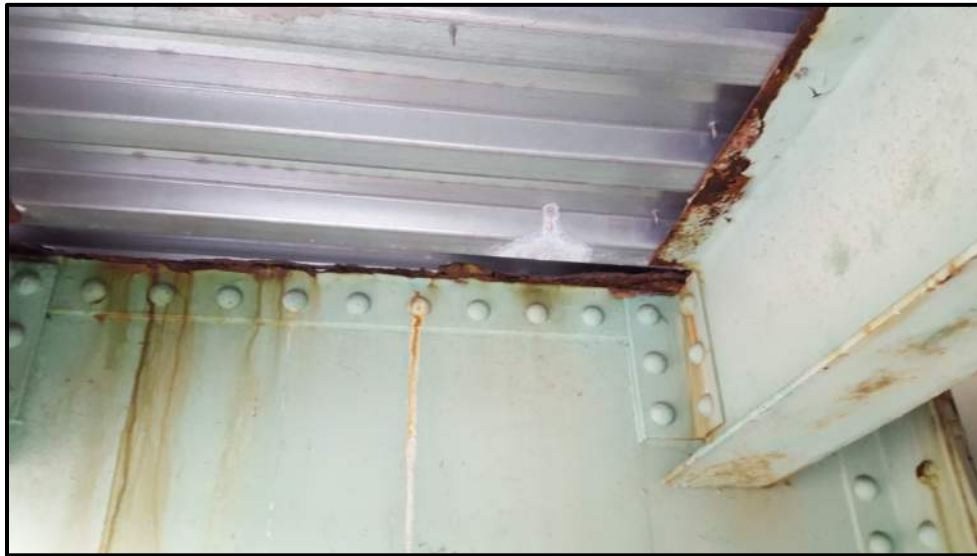
Photo A25 – View of the top half of cantilevered brackets that support the sidewalk.

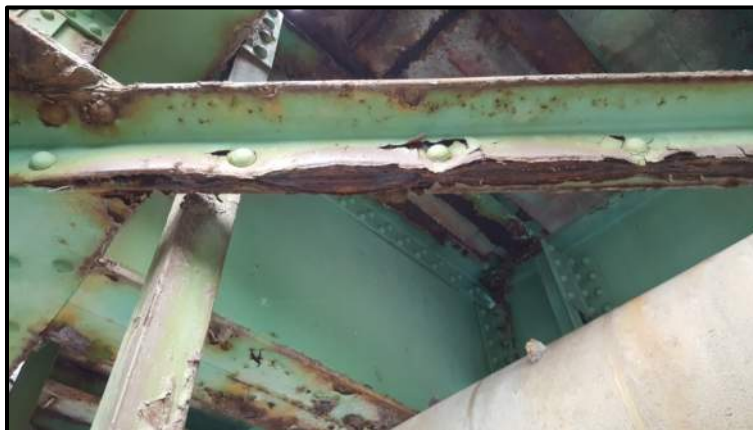
Photo A26 – In general, a good amount of deterioration exists in the lateral bracing system.

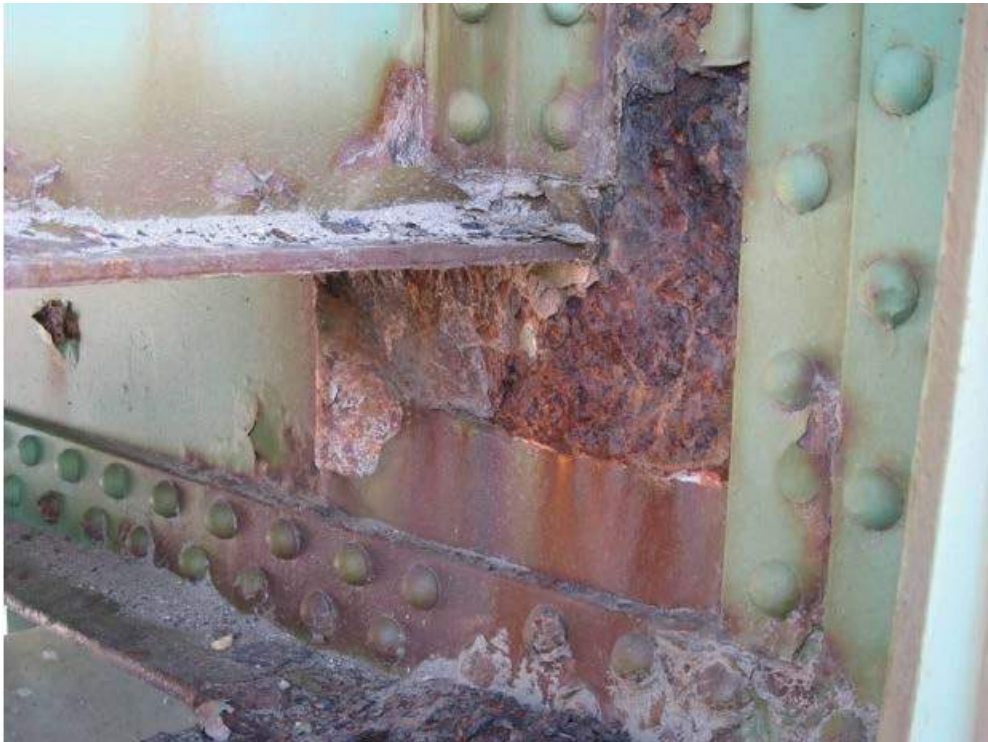
Photo 44 – At Span 1 FB7 below S8 both faces of the web exhibit active corrosion with section loss of 1/8 inch depth over a height of 8 inches and length of 12 inches.

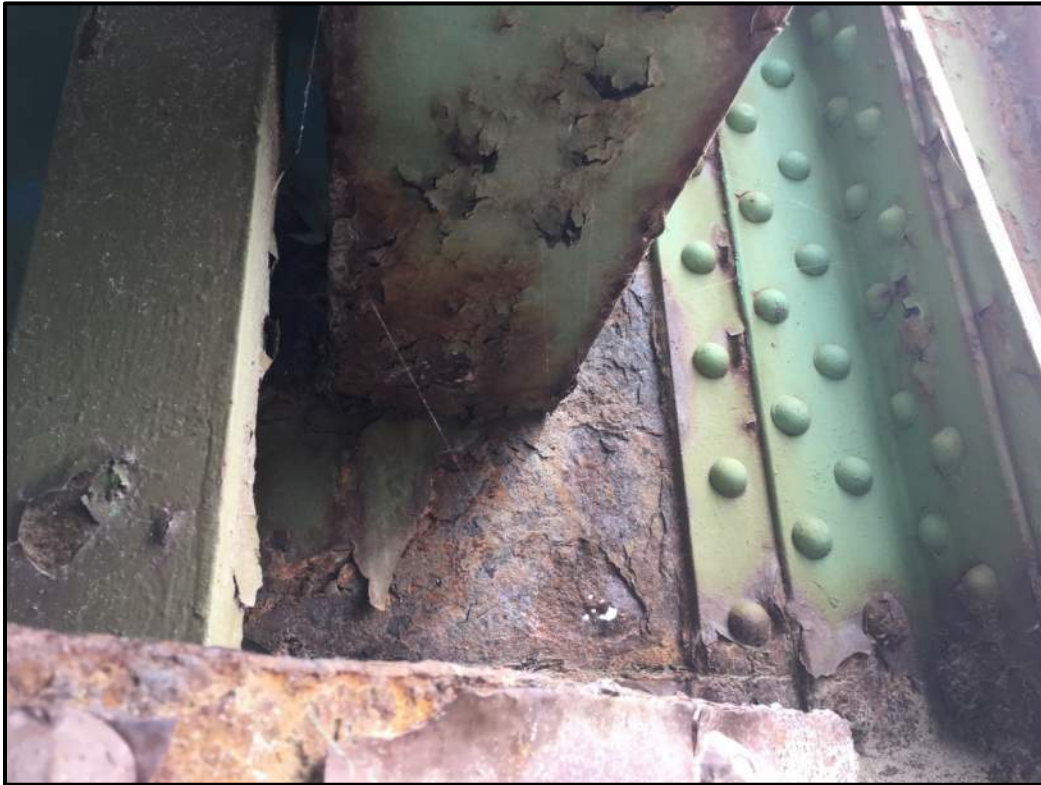
Photo A2 – Floorbeam 5, Roadway Truss @ Stringer 8 (Exterior)
