Preliminary Design Report

Frank J. Wood #2016

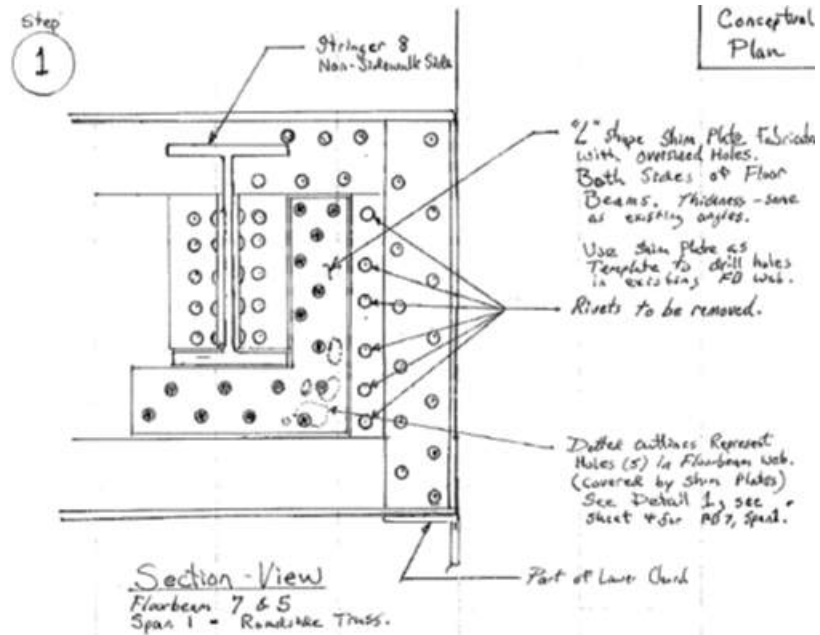
Sketch 2 – Step 1 of Floorbeam Repair.

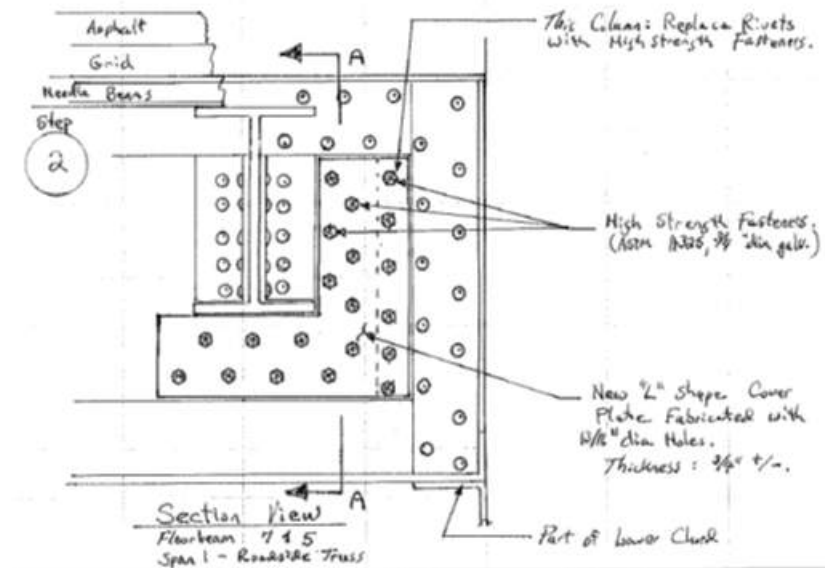
Sketch 3 – Step 2 of Floorbeam Repair.

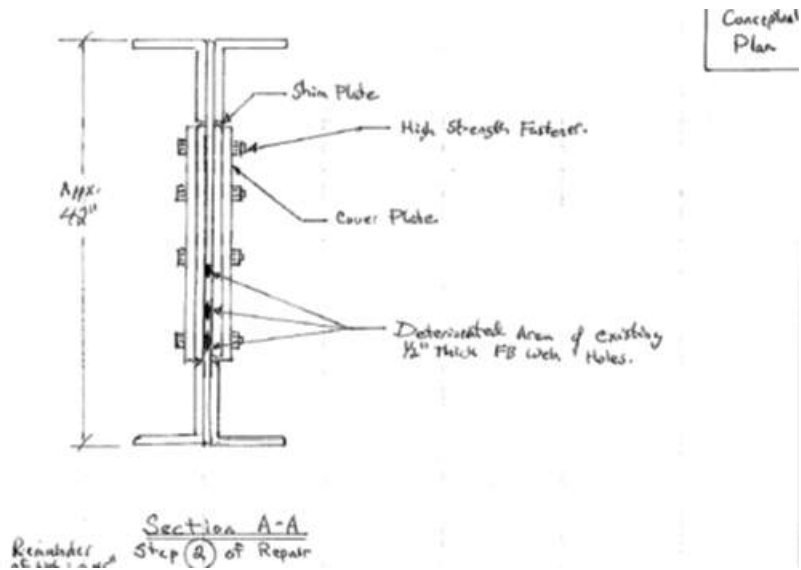
Sketch 4 – Step 2, Section View of Floorbeam Repair.

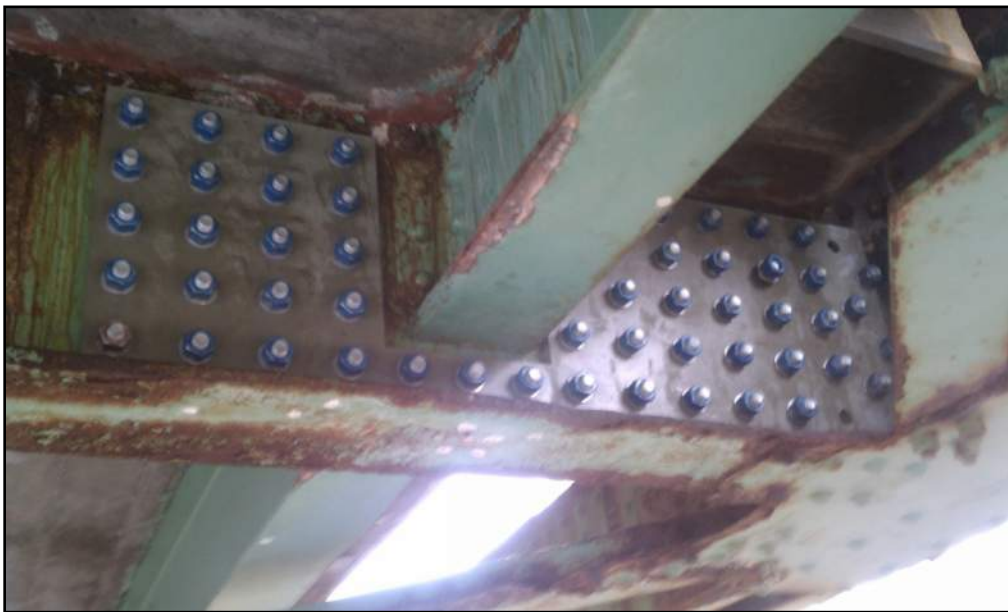
Photo A26 – End result of similar repair to Floorbeam.

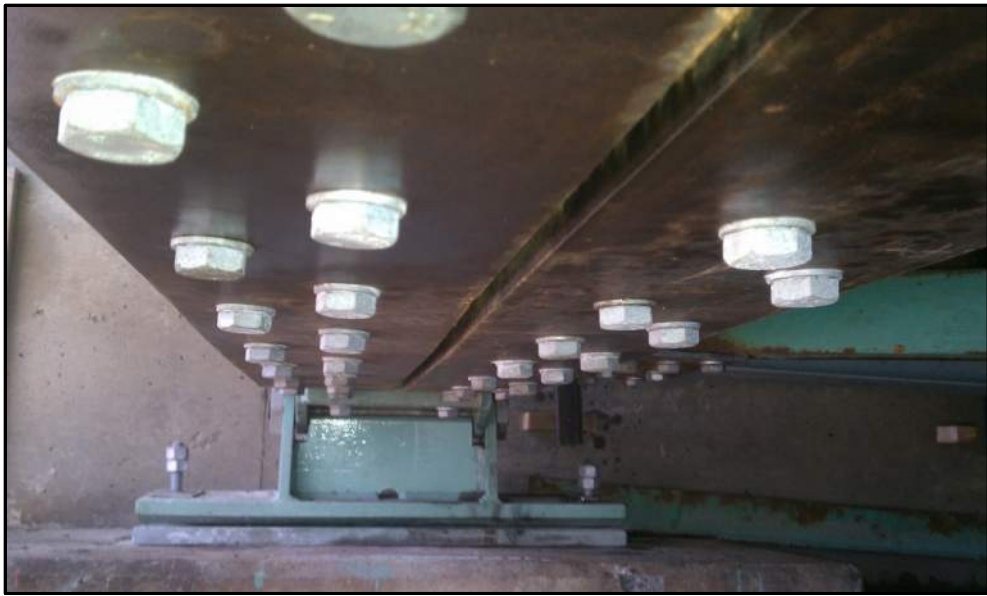
Photo A27 – End result of repair to built-up Floorbeam bottom flange.

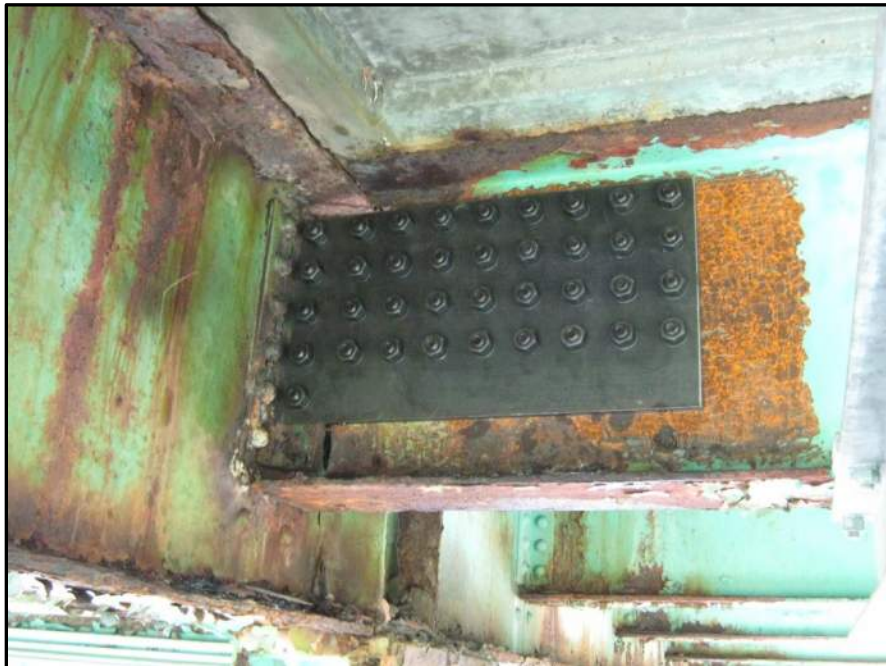
Photo A28 – End result of a typical Stringer to Floorbeam connection.

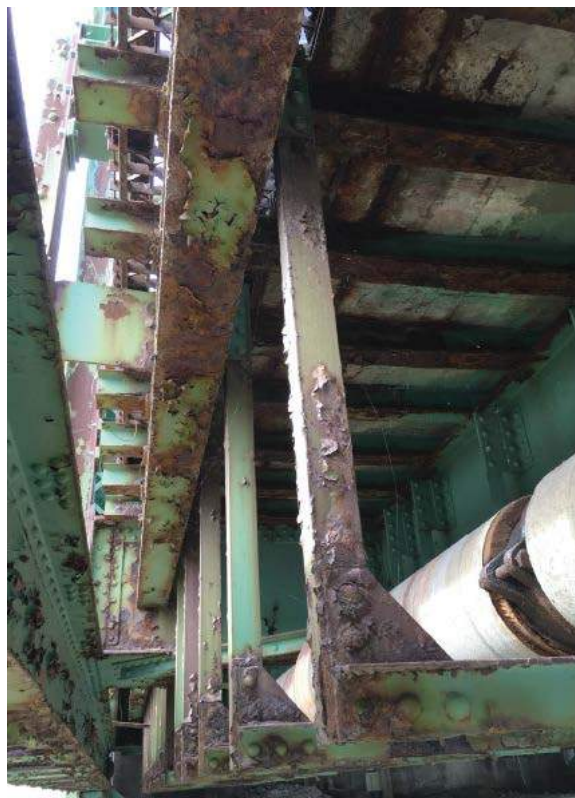
Photo # 8: General view of paint loss and corrosion to bays below the open grid decking in the travel way shoulders on the non-sidewalk side (eastern) of the bridge (8/1/16)

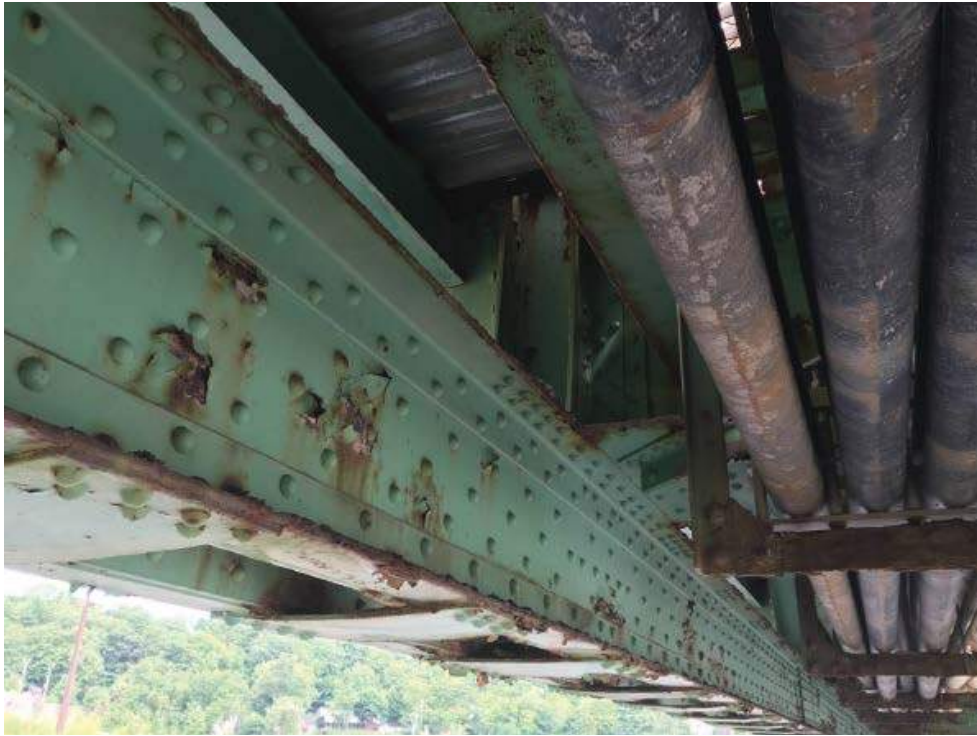
Photo # 9: General view of paint loss and corrosion to bays below the open grid decking in the travel way shoulders on the sidewalk side (western) of the bridge (8/1/16)

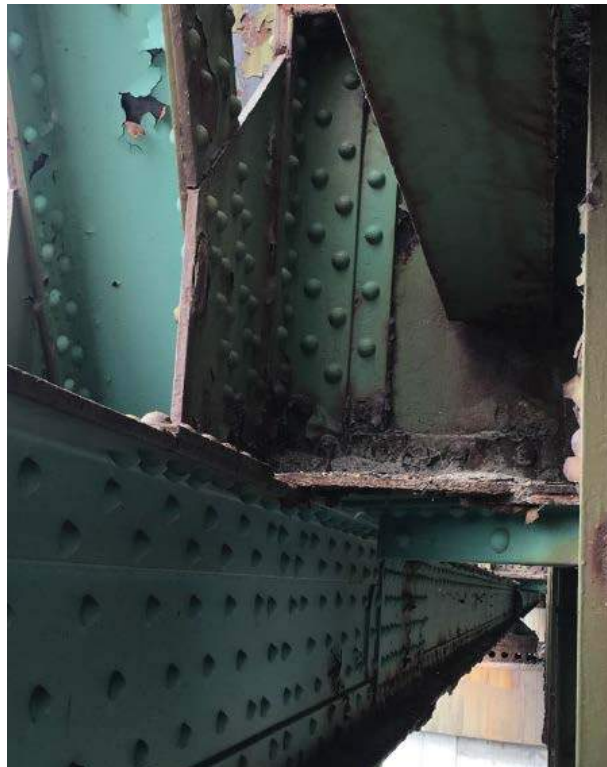
Photo # 10: General view of floor beam to truss gusset plate connection (8/1/16)

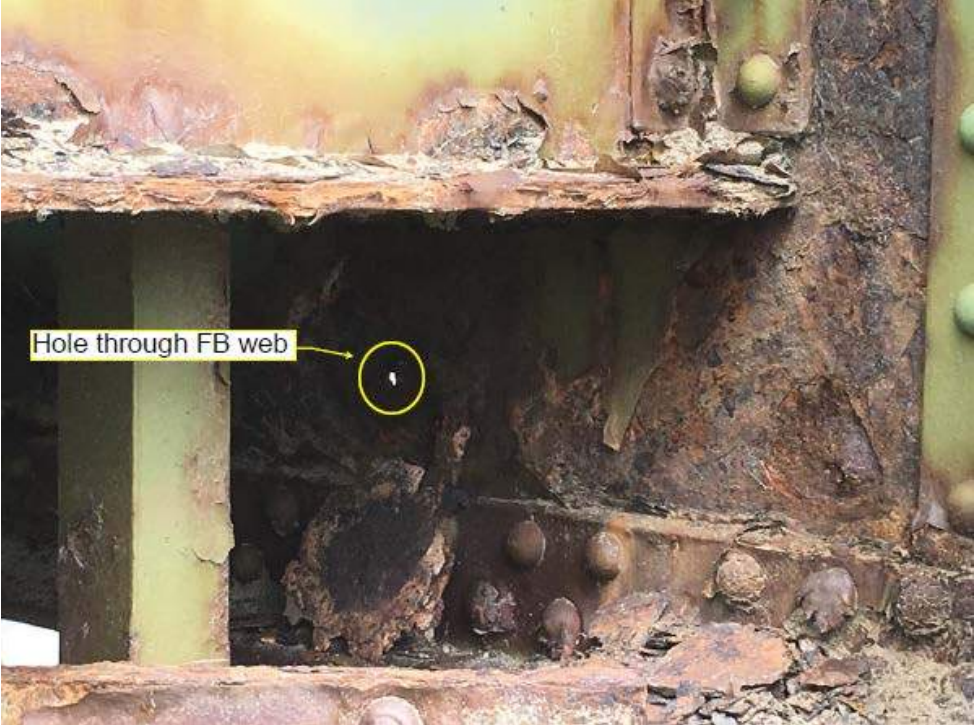
Photo # 12: General view of corrosion & hole through the web on the non-sidewalk (eastern) end of FB2 in span 1 (8/1/16)

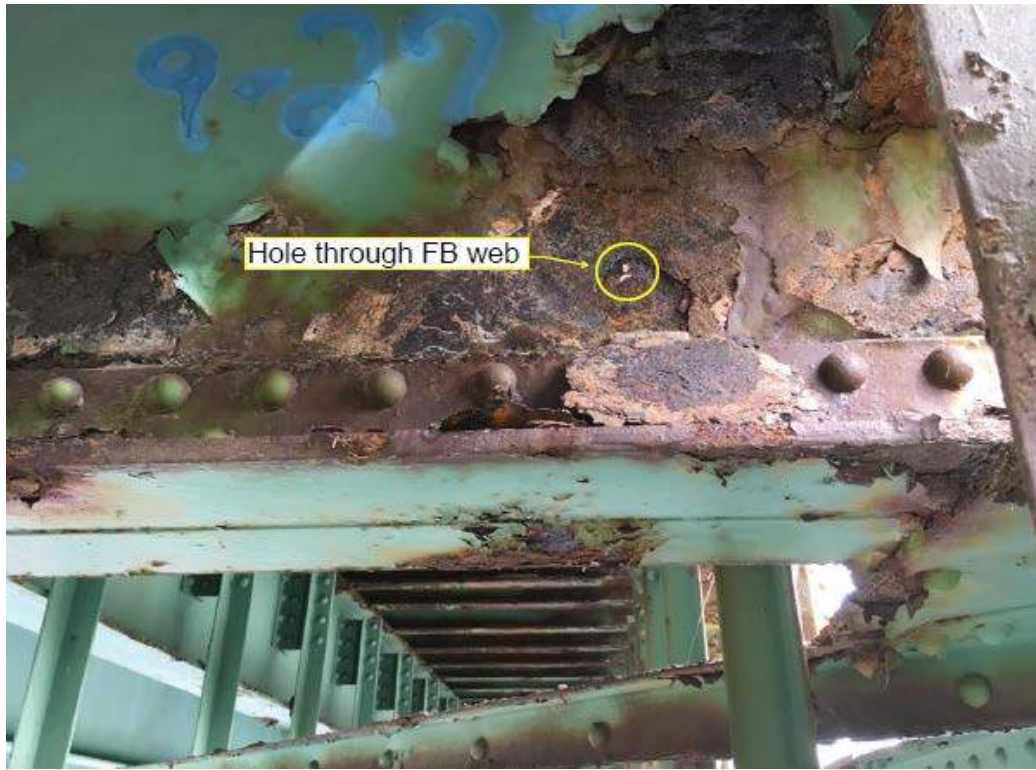
Photo # 13: Closer image of hole through the web of FB2 in span 1 (8/1/16)

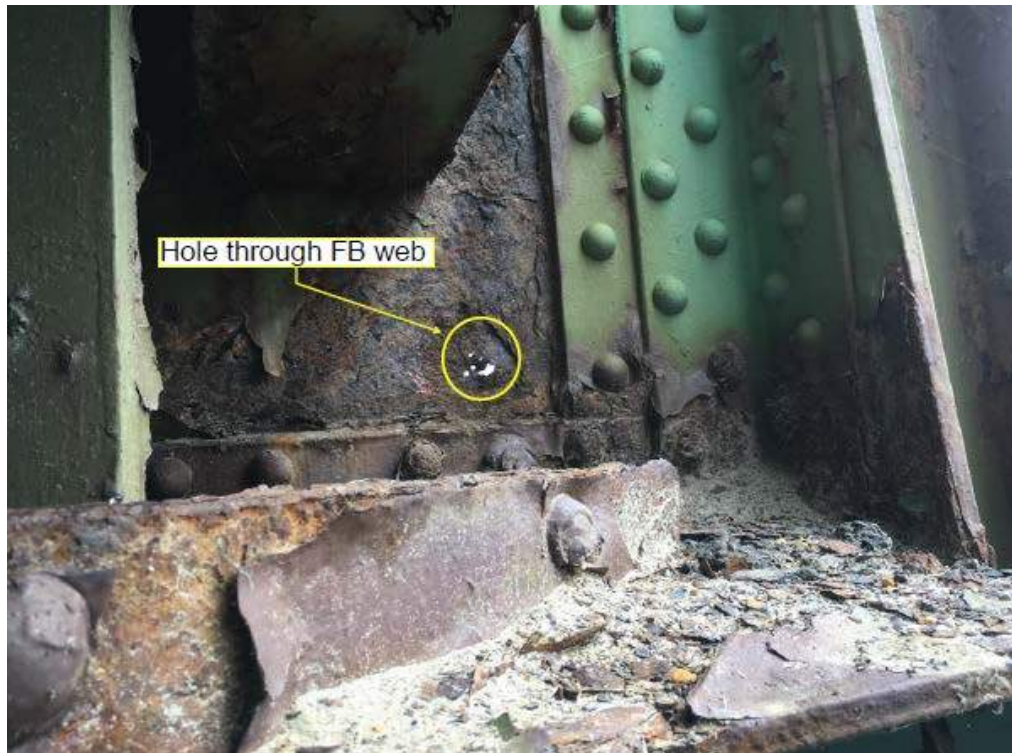
Photo # 14: General view of corrosion and hole through the web of the non-sidewalk (eastern) end of FB5 in span 1 (8/1/16)

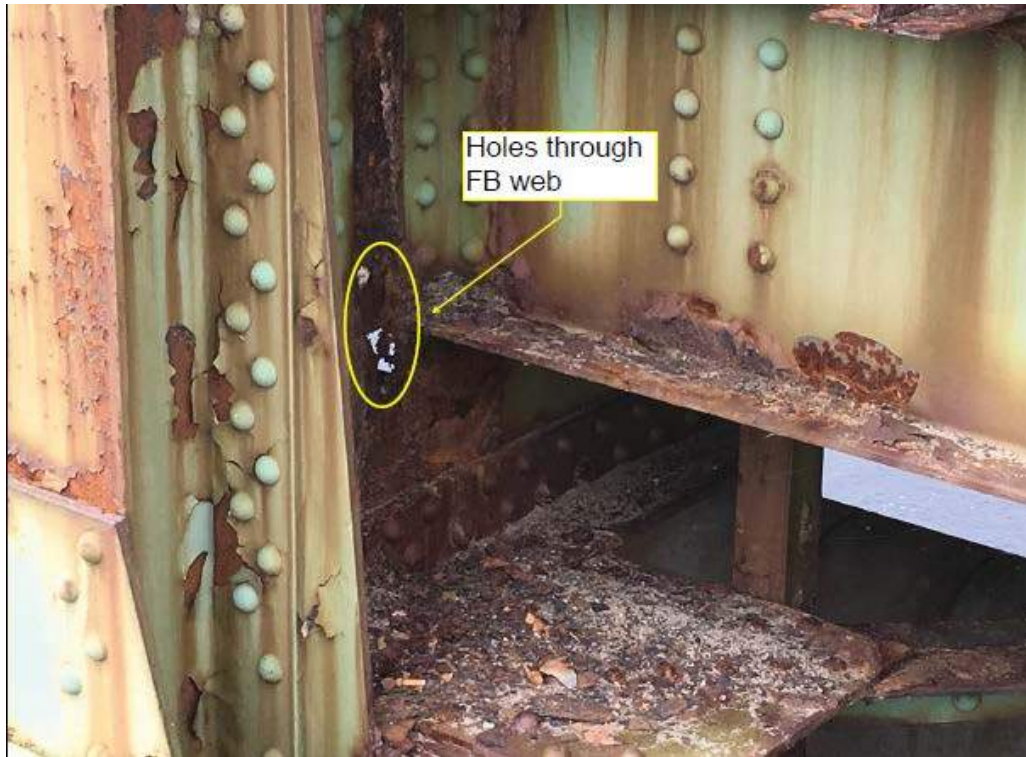
Photo # 15: General view of corrosion and holes through the web of non-sidewalk (eastern) end of FB7 in span 1 (8/1/16)

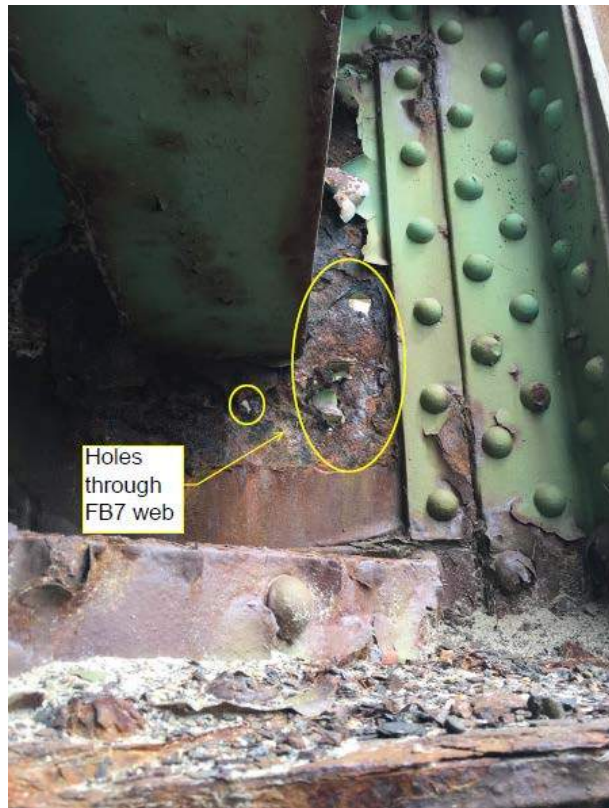
Photo # 16: Closer view of holes through the web of FB7 (8/1/16)

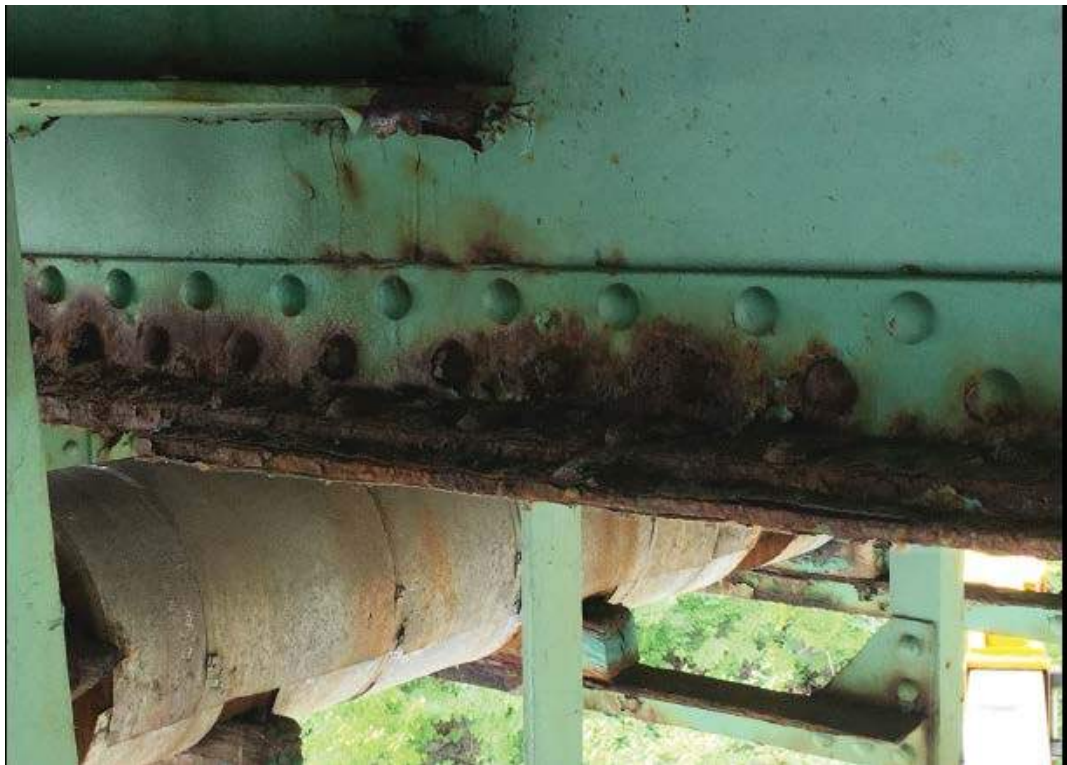
Photo # 18: Severe corrosion & pack rust between the bottom flange of the floor beam and the cover plate near midspan of FB5 in span 2, (span 2 FB4, FB6 & FB7 similar) (8/2/16)

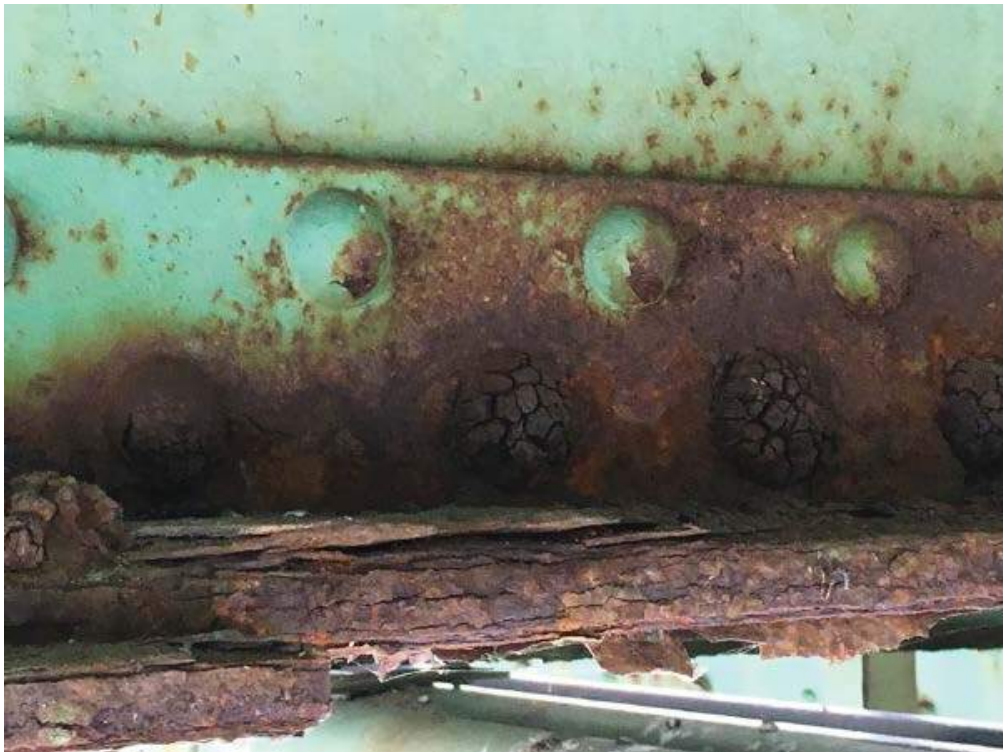
Photo # 19: Severe corrosion to the rivets as well as corrosion & pack rust between the bottom flange of the floor beam and the cover plate near midspan of FB5 in span 2 (span 2 FB4, FB6 & FB7 similar) (8/2/16)

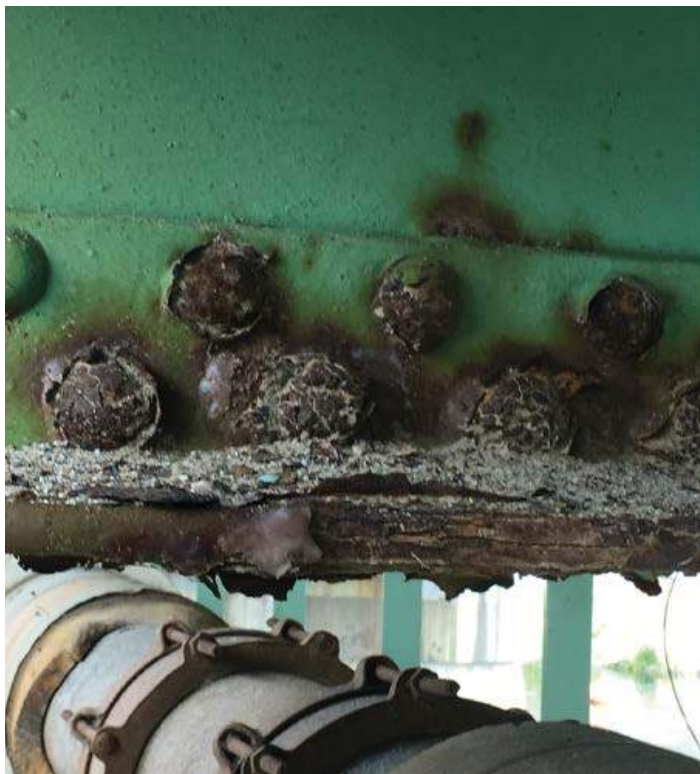
Photo # 20: Advanced deterioration of rivets near midspan of FB7 in span 2 (8/2/16)

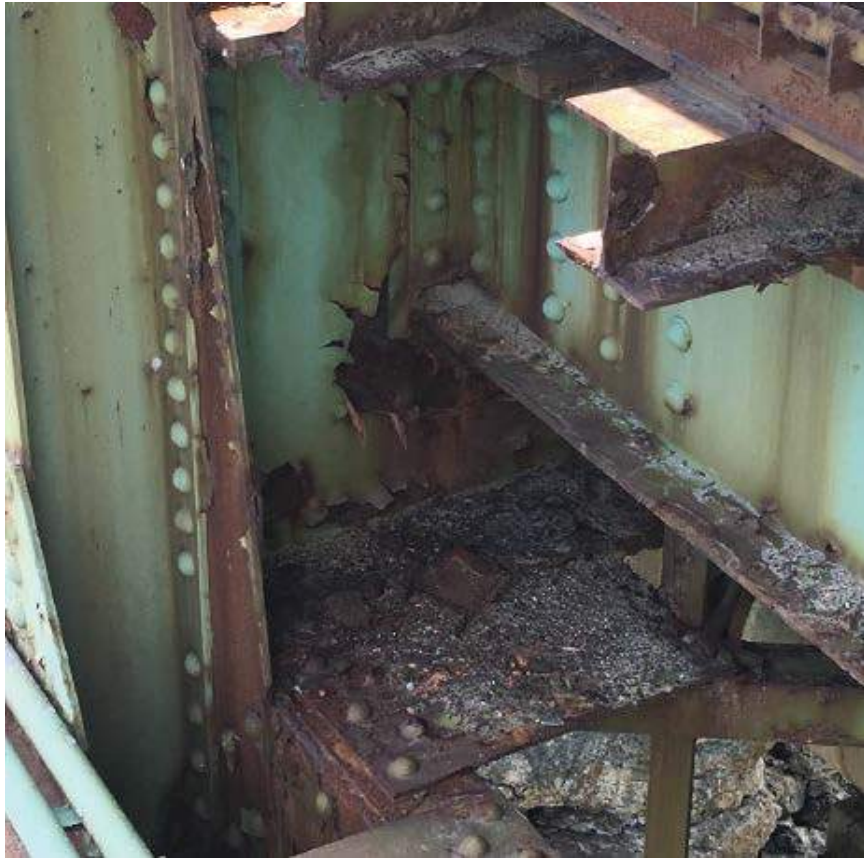
Photo # 21: General view of floor beam end in span 3 (8/2/16)

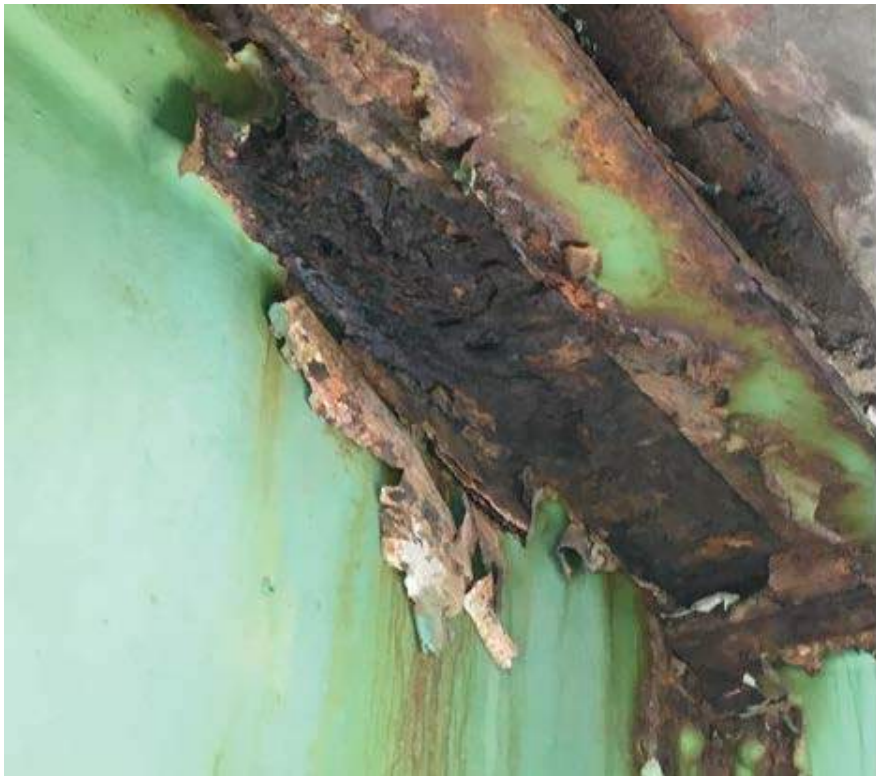
Photo # 22: Top flange corrosion & section loss of FB 5 in span 3 (8/2/16)

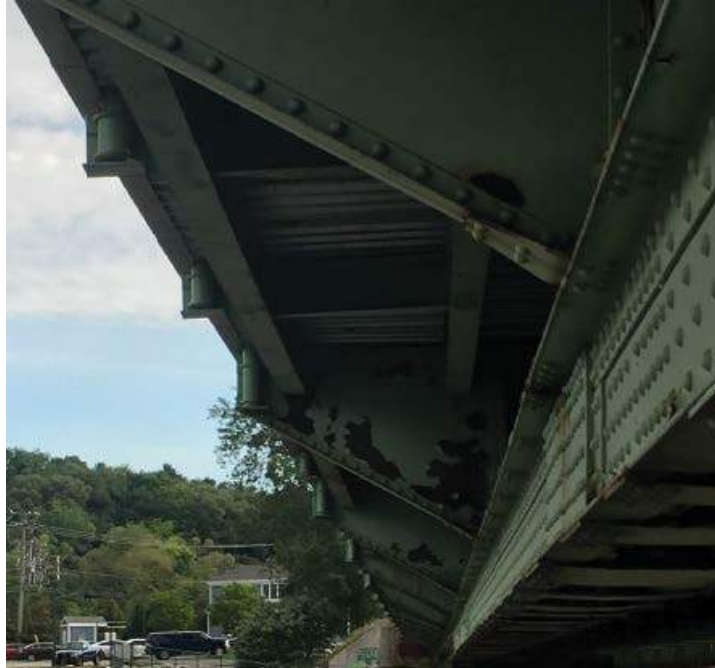
Photo #23: Typical view of the sidewalk stringers (S1 & S2) on the upstream side of the bridge (western side, looking north) (8/1/16)

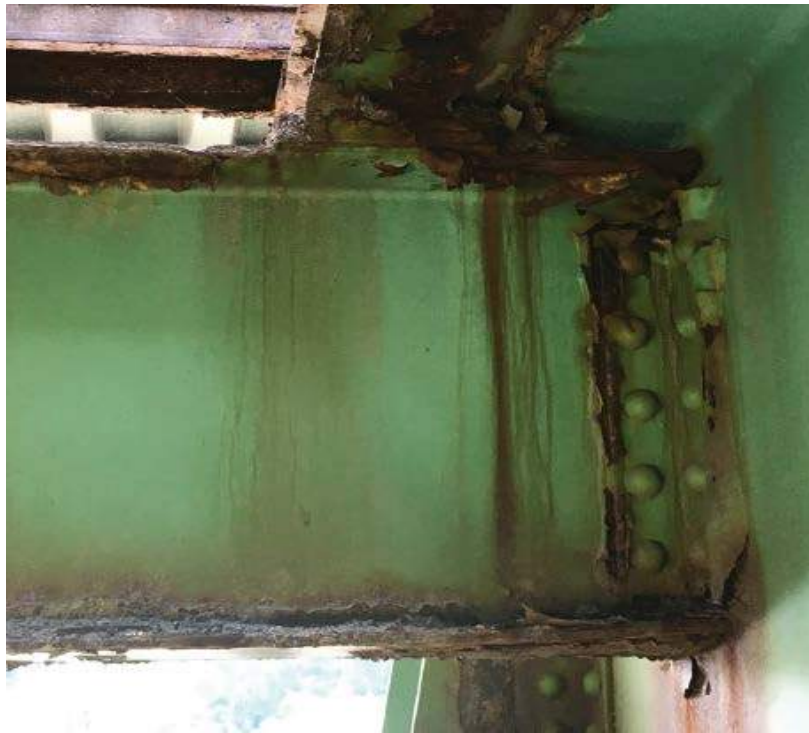
Photo #27: Moderate corrosion to S3 in span 3 near FB4 (8/2/16)

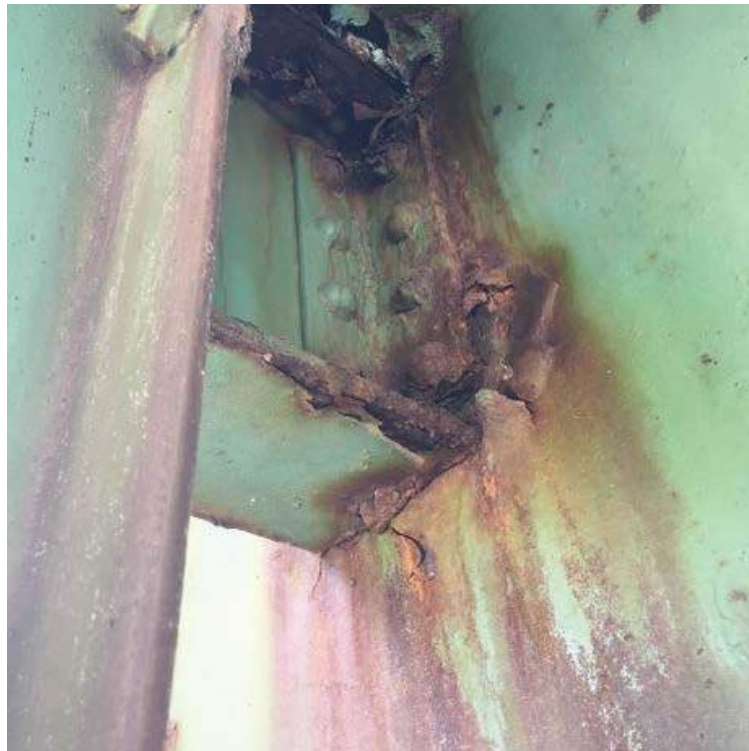
Photo #28: Moderate corrosion with pack rust between the connection angles and floor beam, at S8 in span 3 near FB5 (8/2/16)

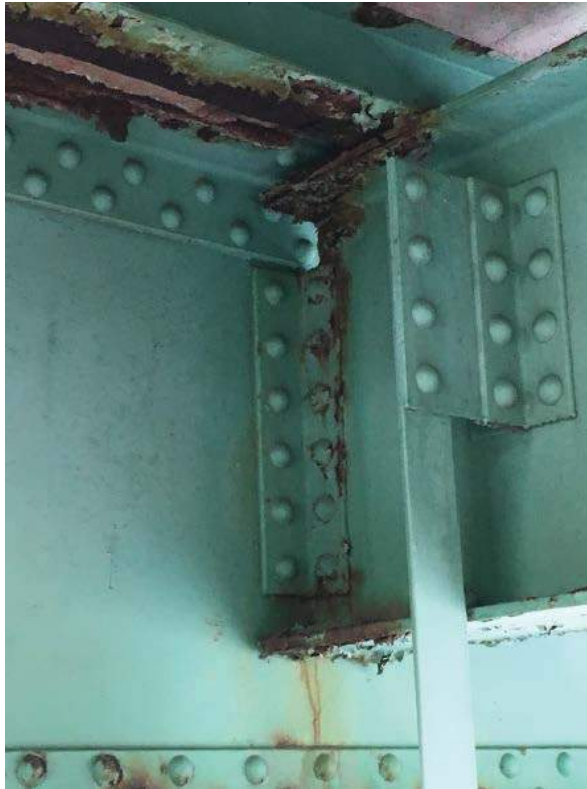
Photo #29: Typical interior stringer (S4 through S7) to floor beam connection (Typ. all spans) (8/1/16)

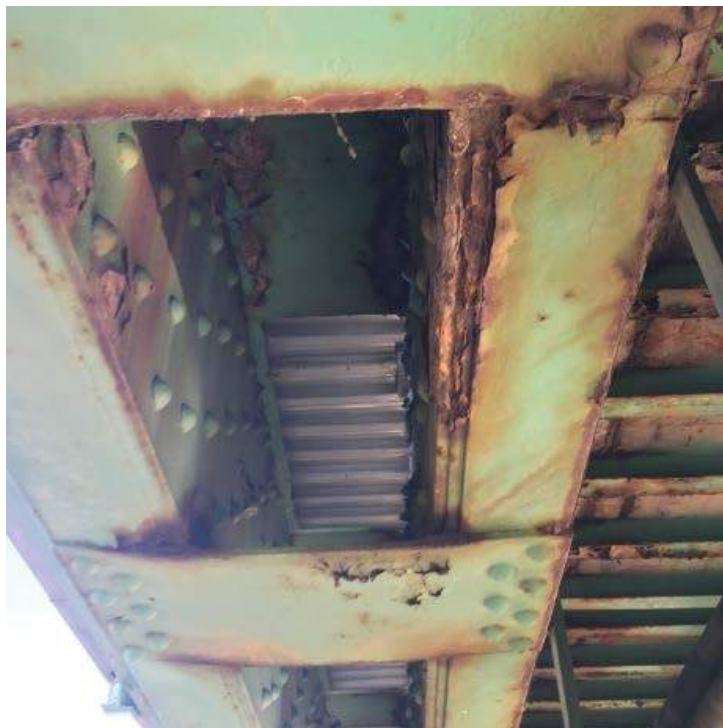
Photo #30: Typical corrosion of the bottom chord of the truss members, showing “bowing” of the Lattice plates due to pack rust (8/2/12)

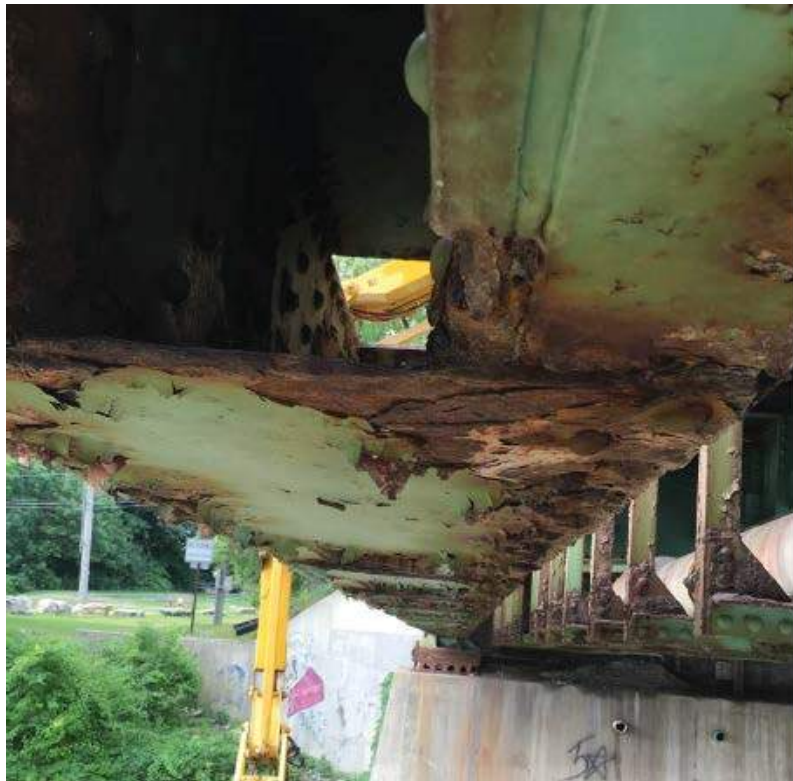
Photo #31: Corrosion of lattice plate on bottom chord of non-sidewalk truss in span 1 (8/1/16)

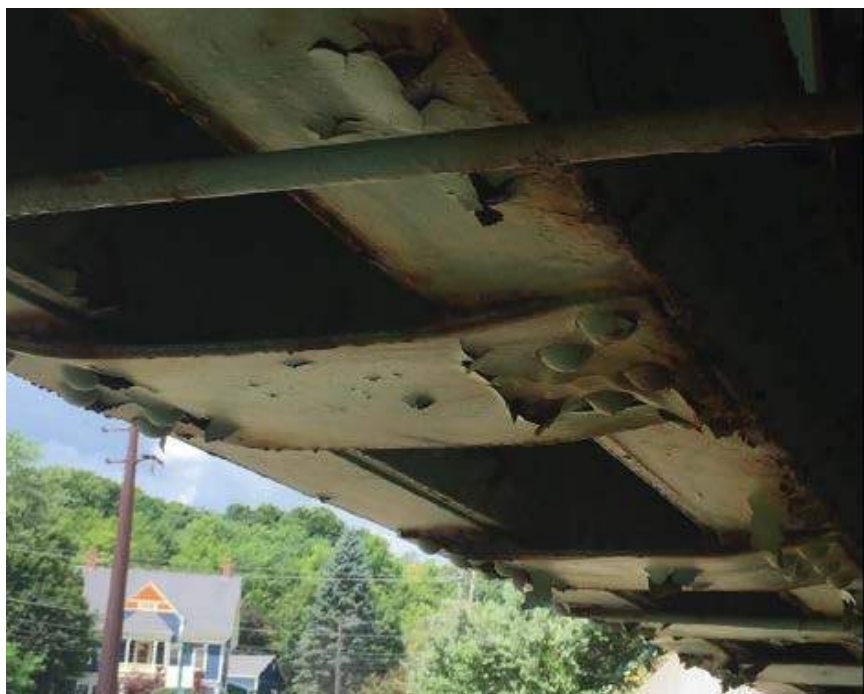
Photo #32: "Bowing" of lattice plates on the bottom chord of the sidewalk truss in span 3 (8/2/16)

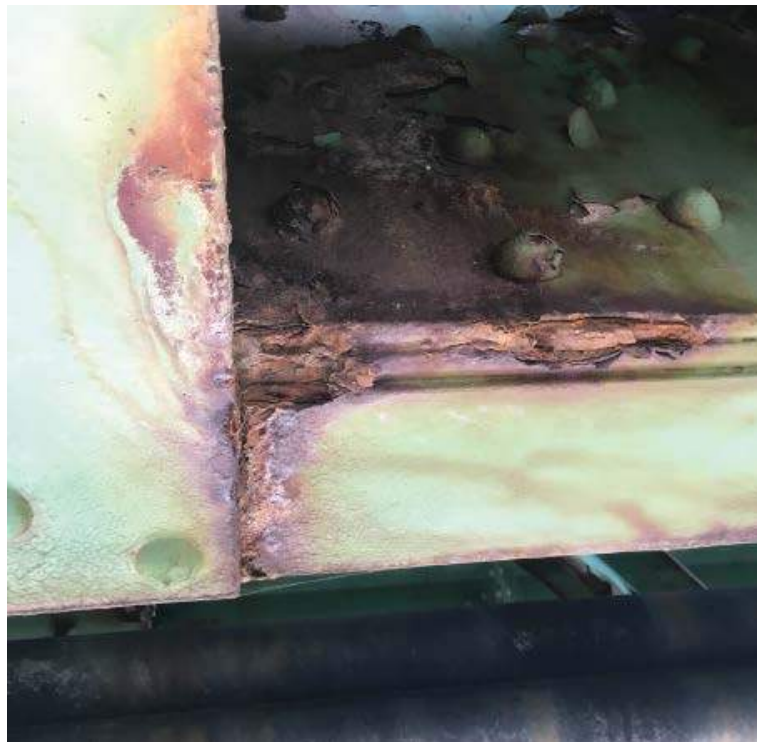
Photo #34: Pack rust between lattice plate and bottom angle on the the bottom chord of the sidewalk truss in span 3 (8//16)

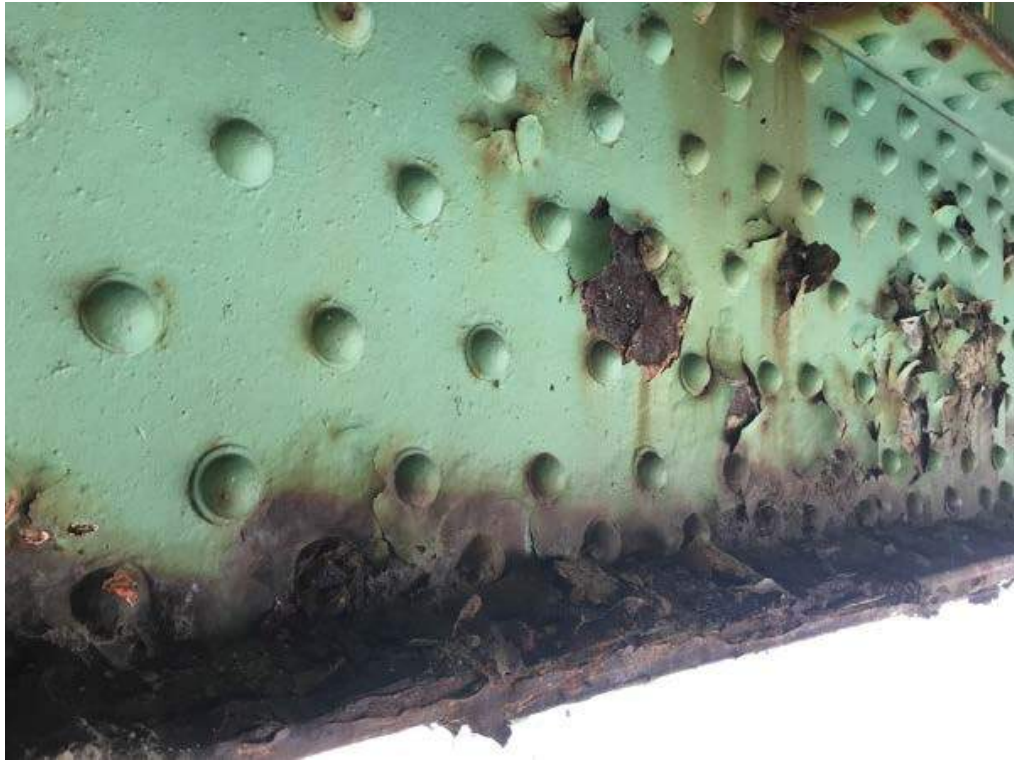
Photo #35: Bottom chord of non-sidewalk (eastern) truss, in span 1 near FB 2 (8/1/16)

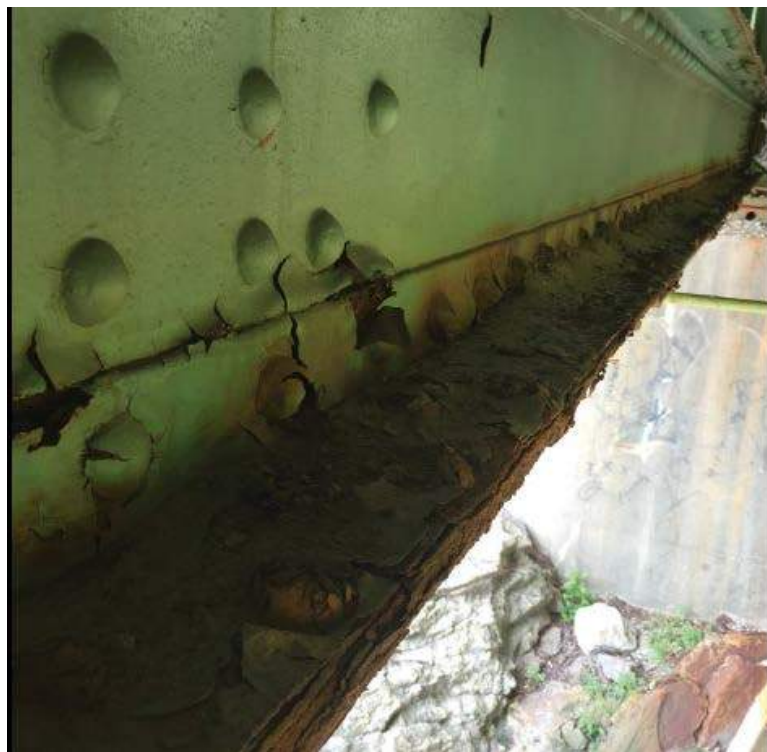
Photo #36: Corrosion to the bottom flange of the bottom chord of the sidewalk side truss in span 3 (western side of the bridge looking north) (8/2/16)

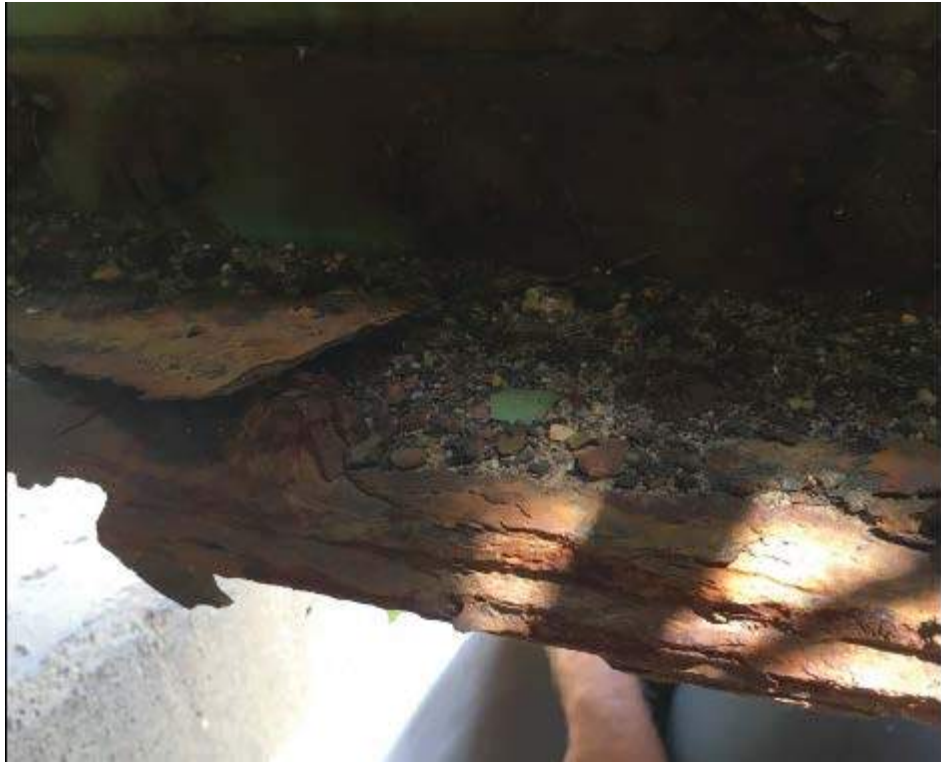
Photo #37: Pack rust between plates on the bottom chord of the non-sidewalk truss in span 3 (eastern side of the bridge) (8/2/16)

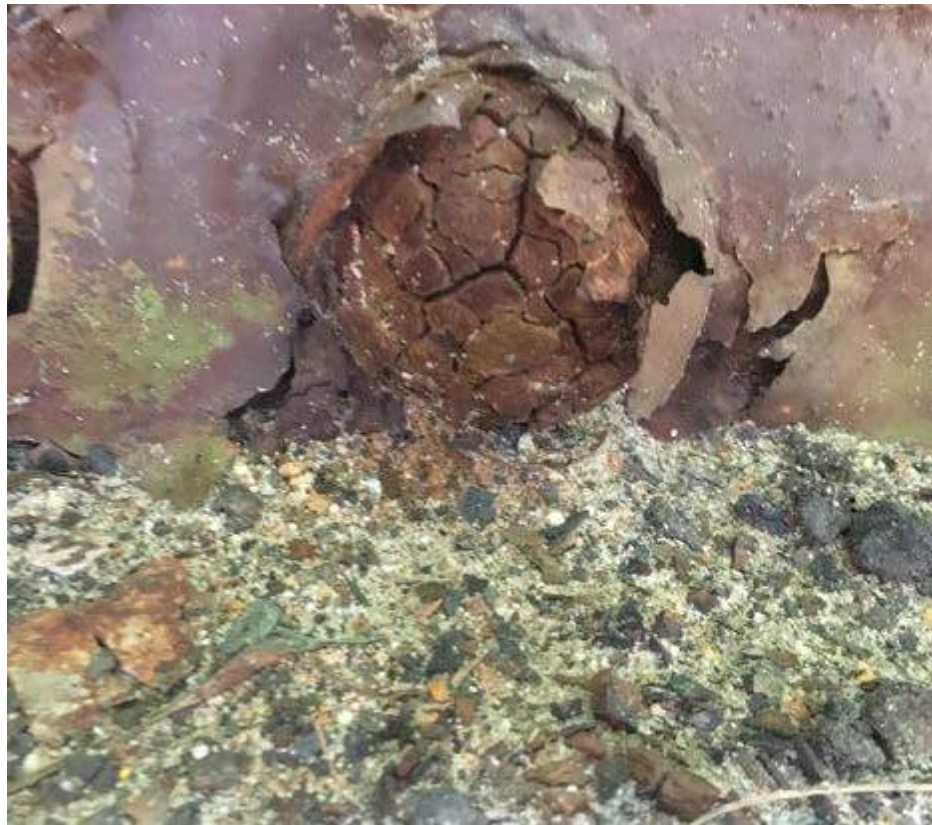
Photo #38: Severely deteriorated rivet heads on the bottom chord of the sidewalk side truss, span 3 (8/2/16)

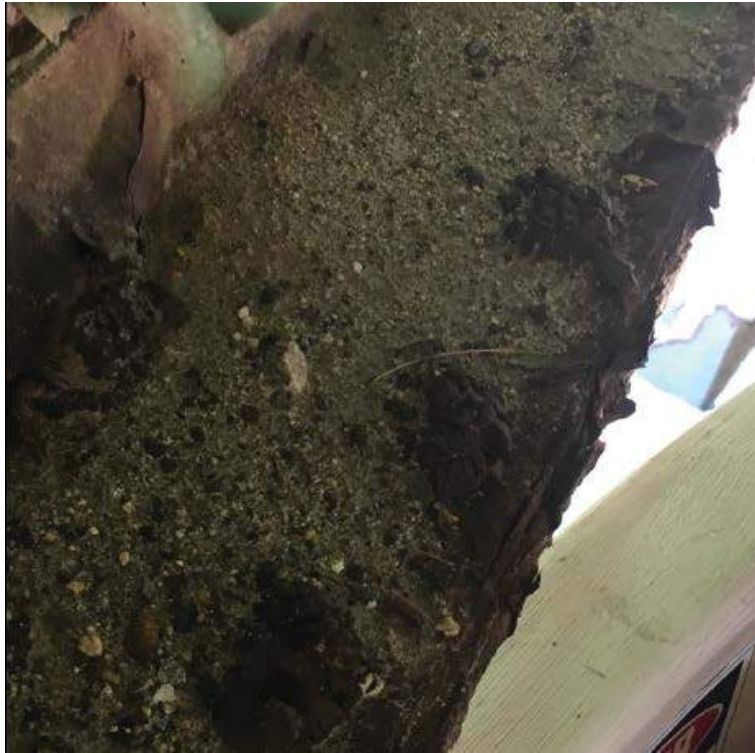
Photo #39: Remnants of rivet heads along the top of the bottom flange of the bottom chord of the sidewalk truss (western) in span 3 (8/2/16)

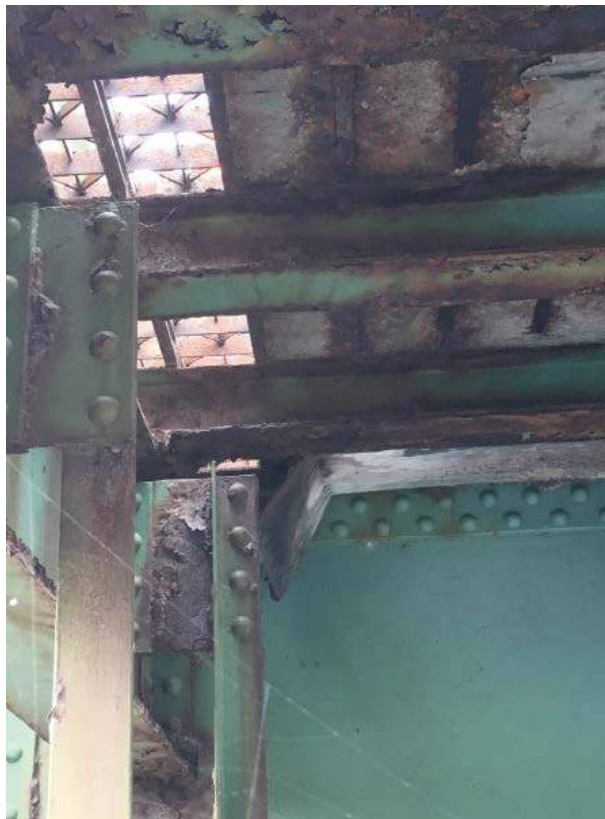
Photo #44: Moderate corrosion to cross beams (needle beam) (Typ.) (8/1/16)

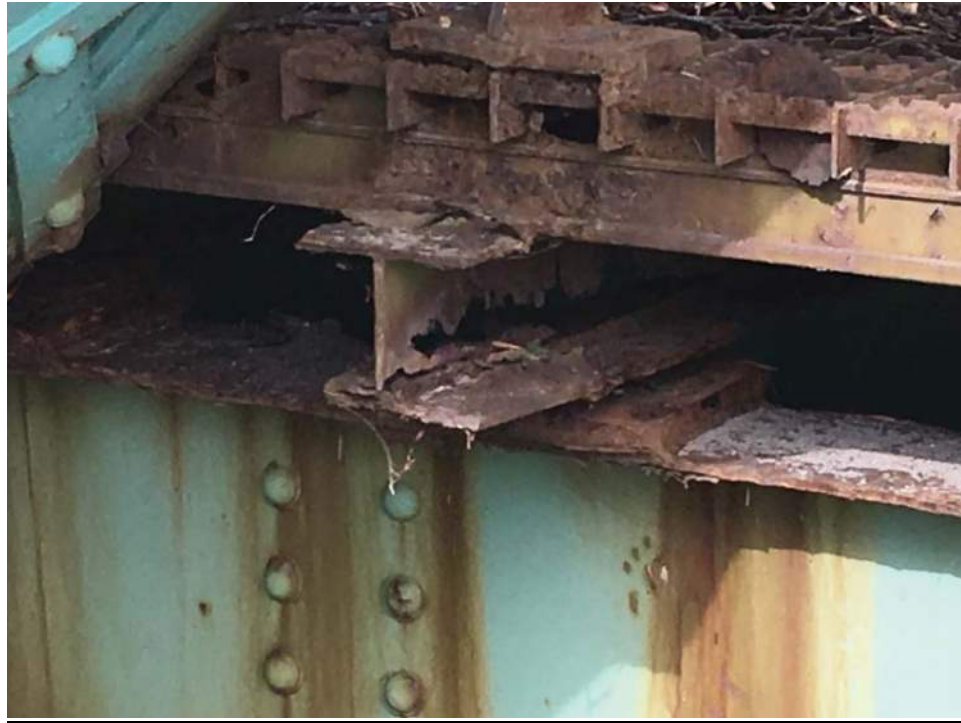
Photo #45: Severe corrosion to a cross beam (needle beam) near FB 1 in span 1 of non-sidewalk (eastern) truss (8/1/16)

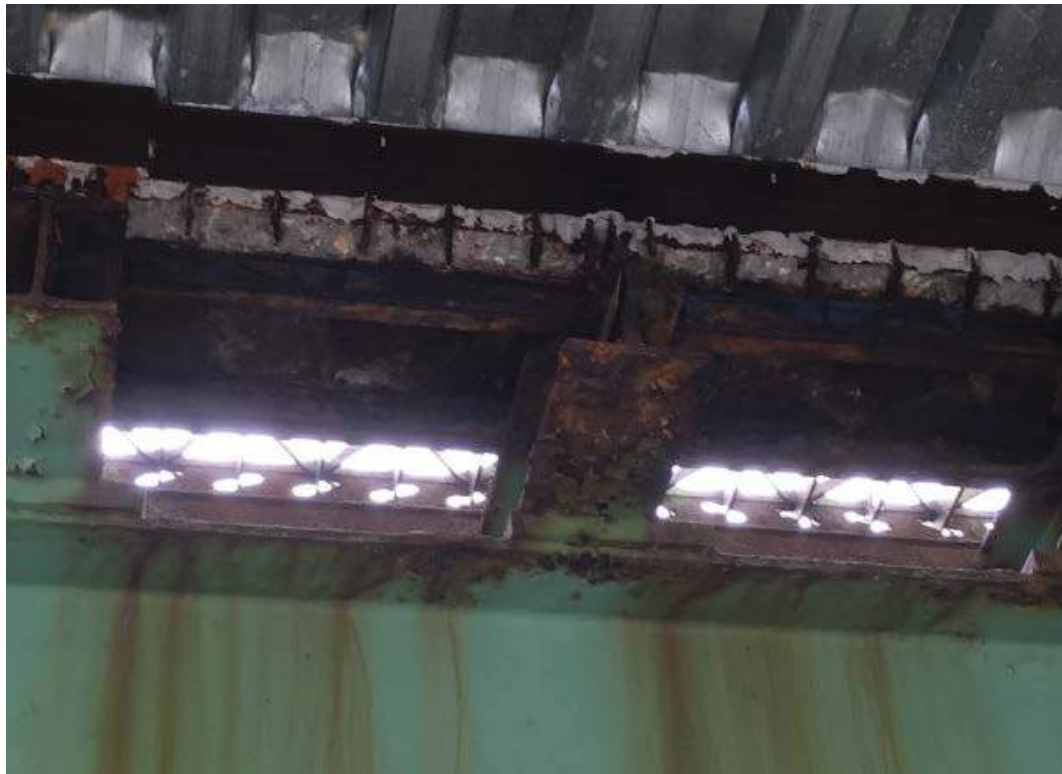
Photo #46: Severe corrosion to a cross beam (needle beam) on the sidewalk (western) truss (8/1/16)
