Preliminary Design Report

Frank J. Wood #2016

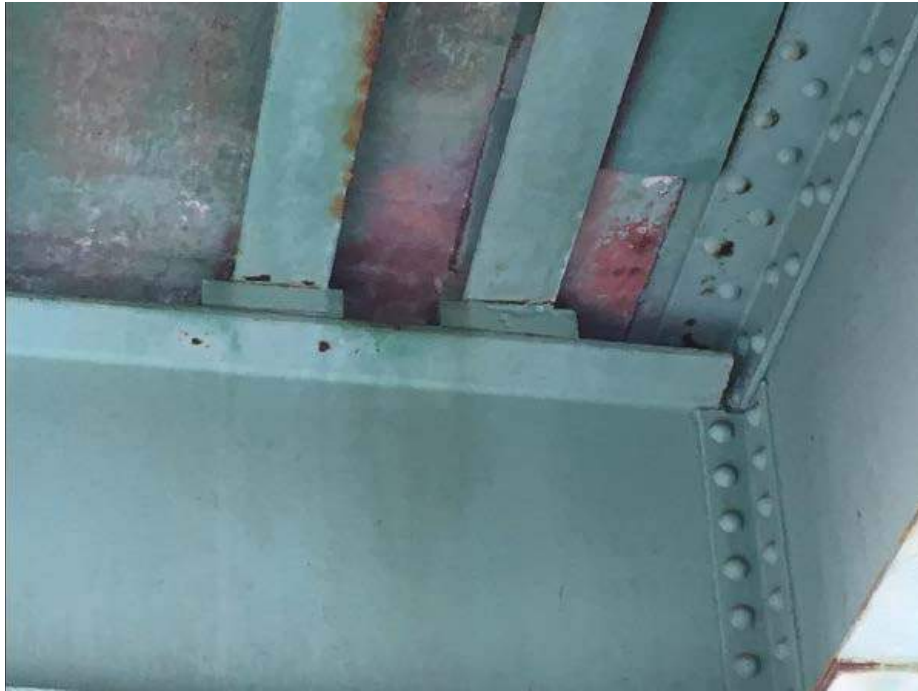
Photo #47: Failed weld between needle beam and an interior stringer in span 1 (8/1/16)

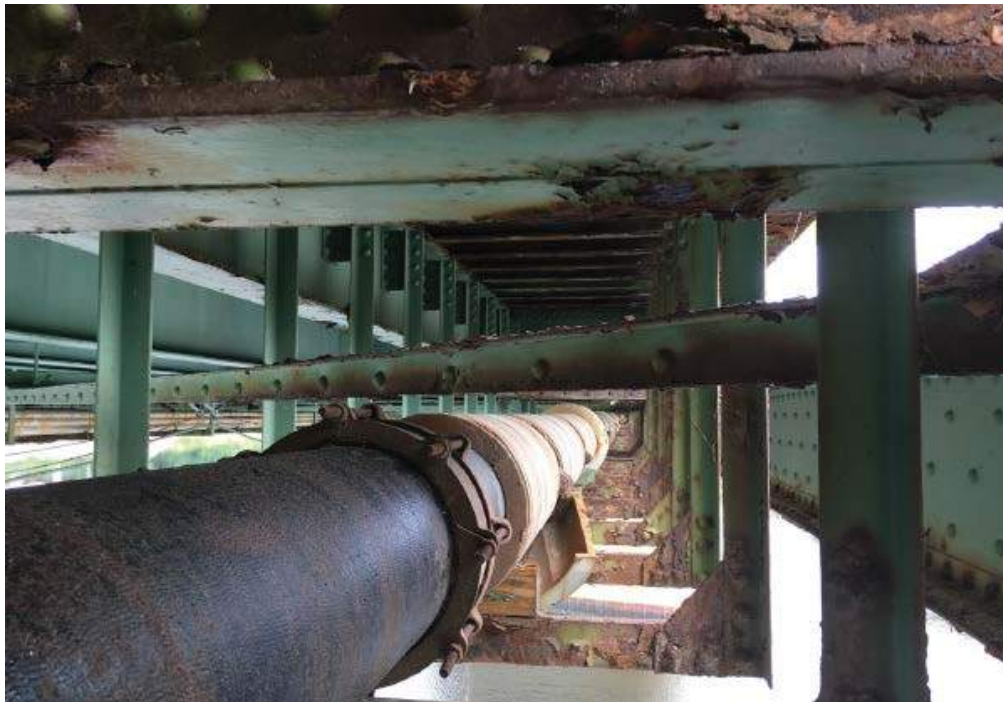
Photo #48: General view of lateral bracing spanning between utility supports in span 1 & 2 (8/1/16)

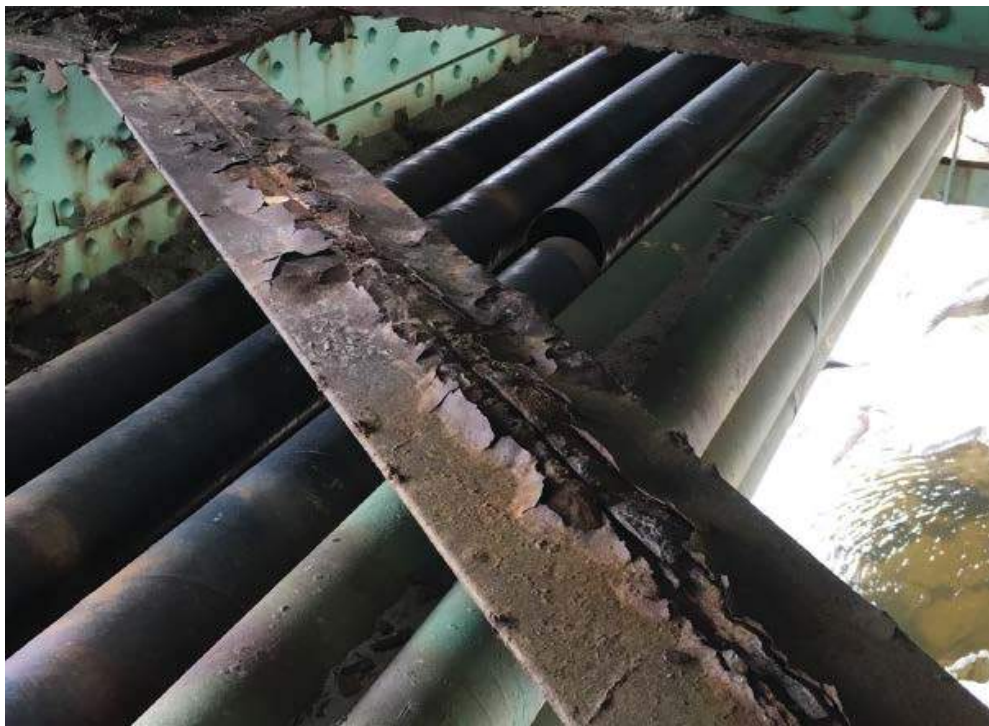
Photo #50: Severely corroded lateral bracing member view from top of double angle in spans 1 & 2 (8/1/12)

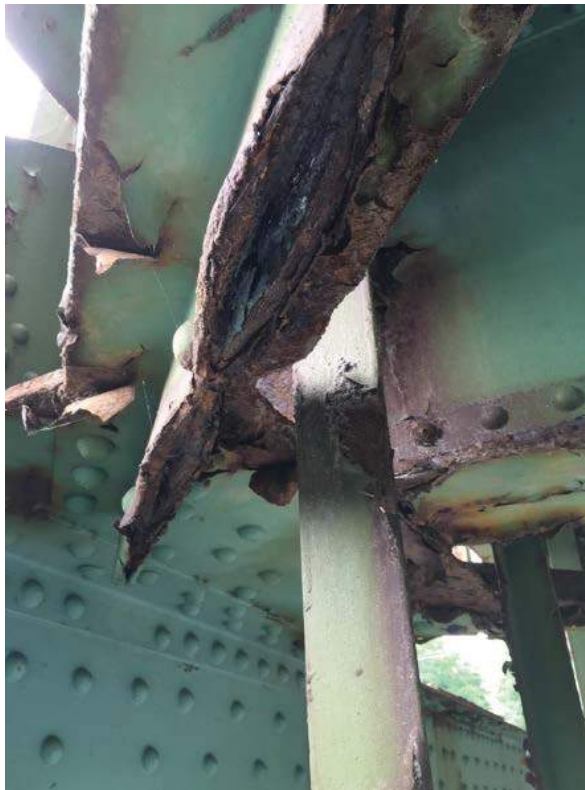
Photo #51: Severely corroded lateral bracing member, view from the bottom of the double angle connections in Spans 1 & 2 (8/1/12)

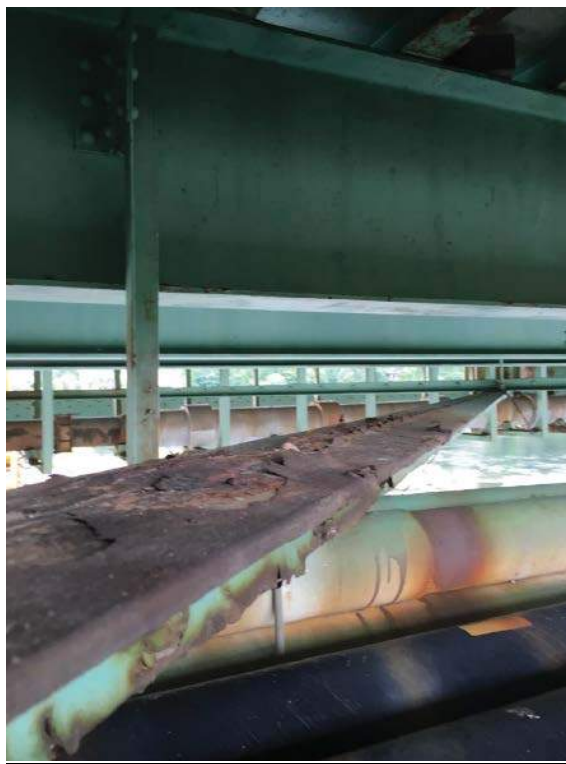
Photo #52: General top view of lateral bracing span (inverted) from non-sidewalk truss to sidewalk truss in spans 1 & 2 (8/2/16)

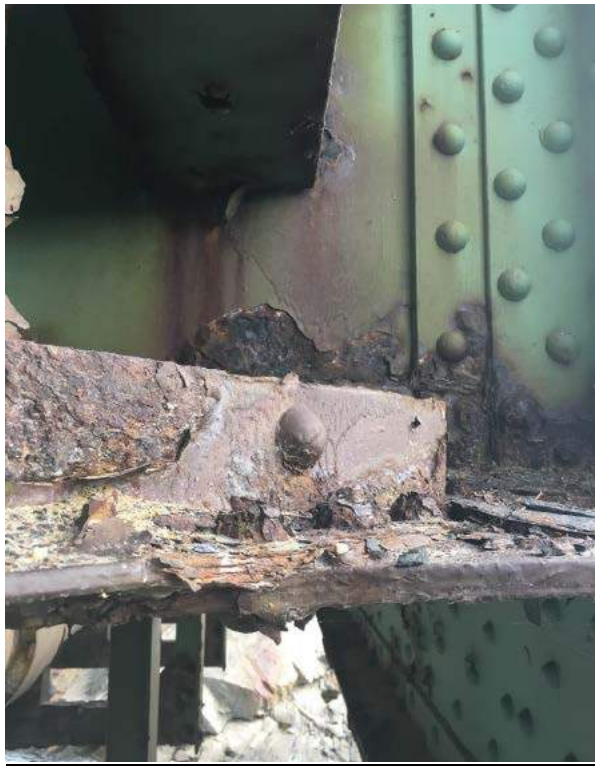
Photo #54: Corroded lateral bracing end at its connection to the horizontal plate at FB8 span 2 (8/2/16)

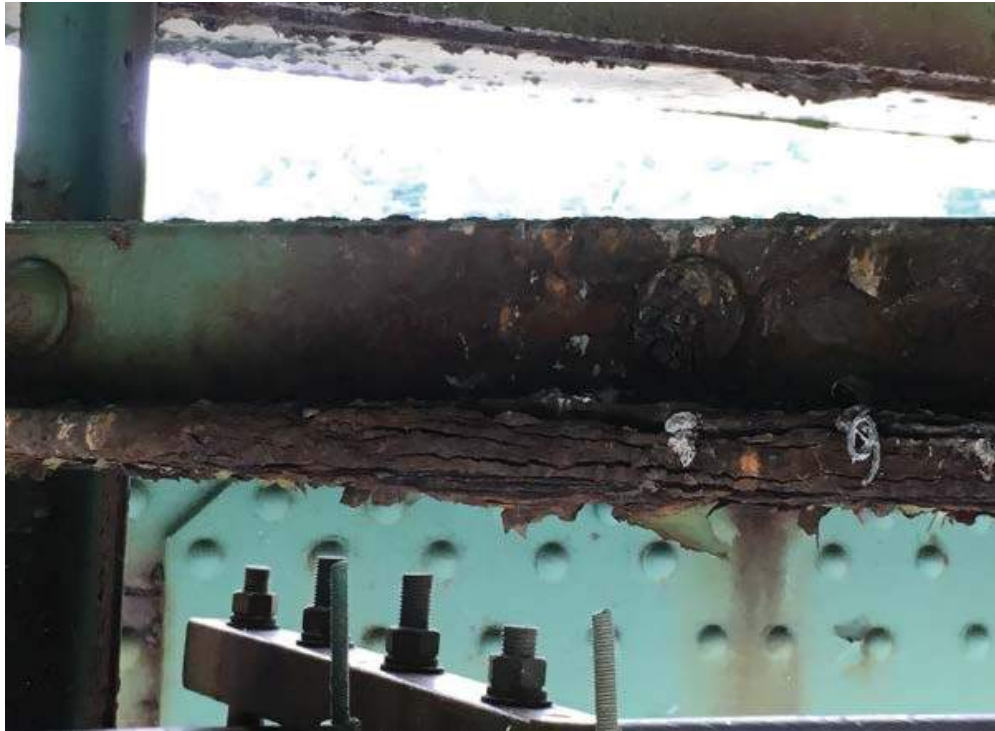
Photo #55: Pack rust and section loss to the lateral bracing near FB6 in span 1 (8/1/16)

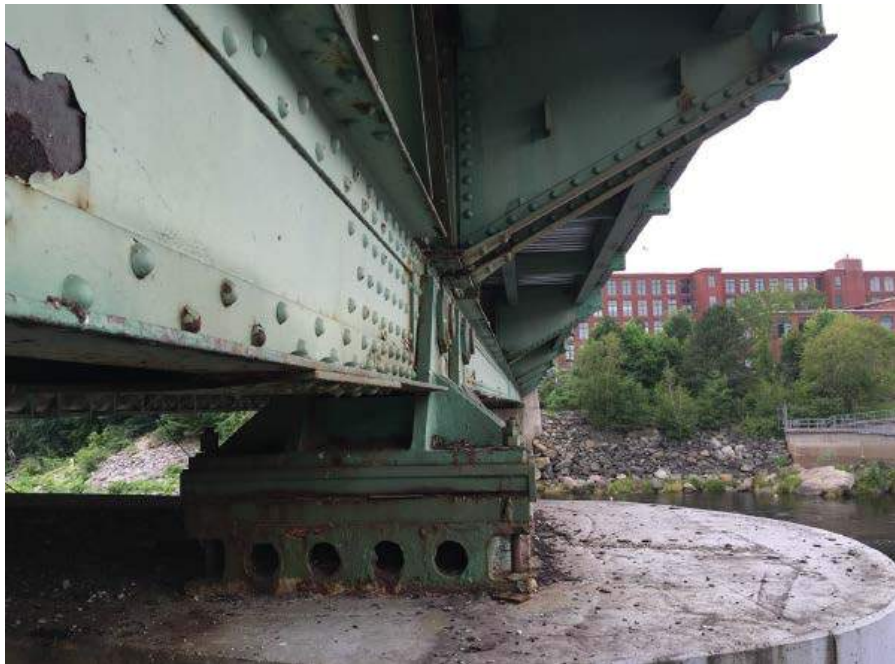
Photo #56: Typical view of the bearings at pier 1 (8/1/16)

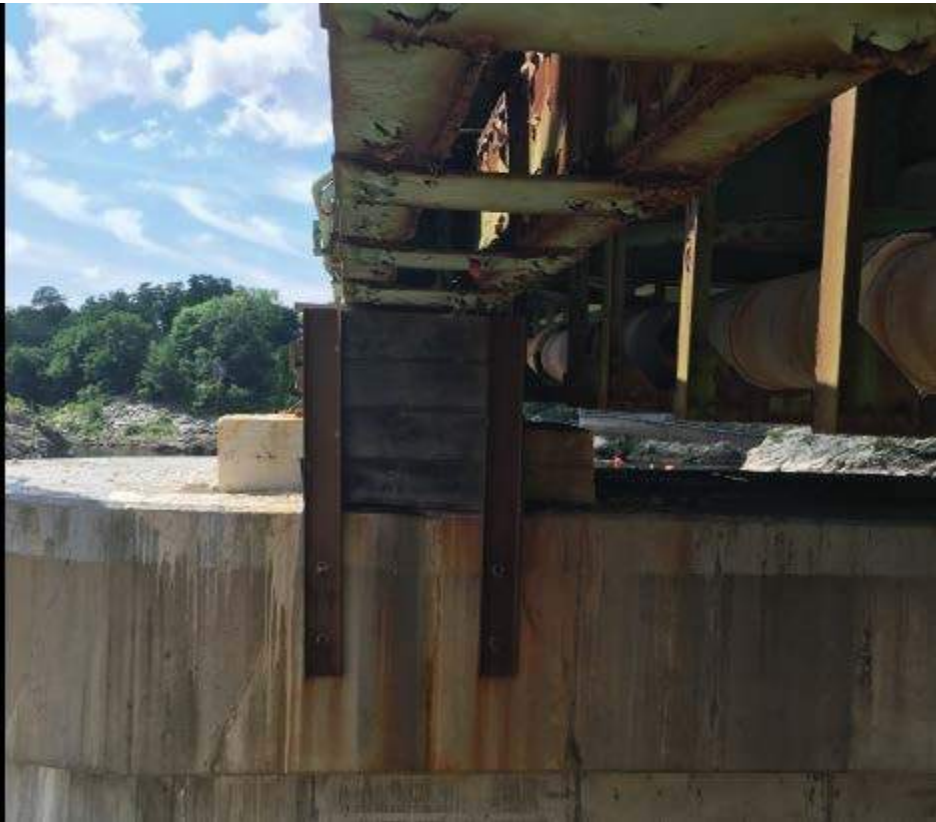
Photo #58: Shoring of non-sidewalk bearing, pier 2, span 3 (looking south) (8/2/16)

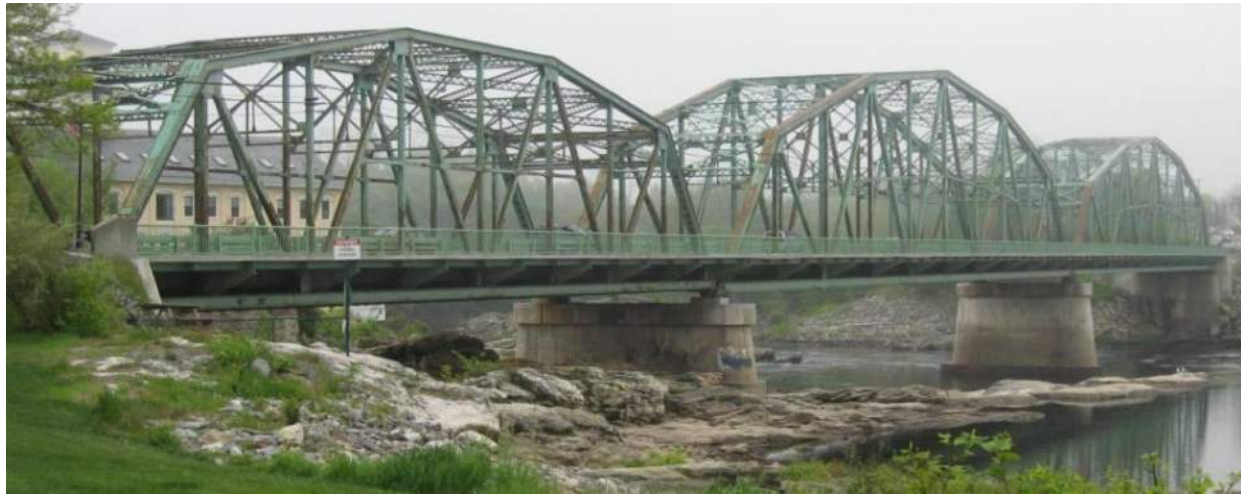
Maine DOT CONTRACT NO. 2011102600000002063

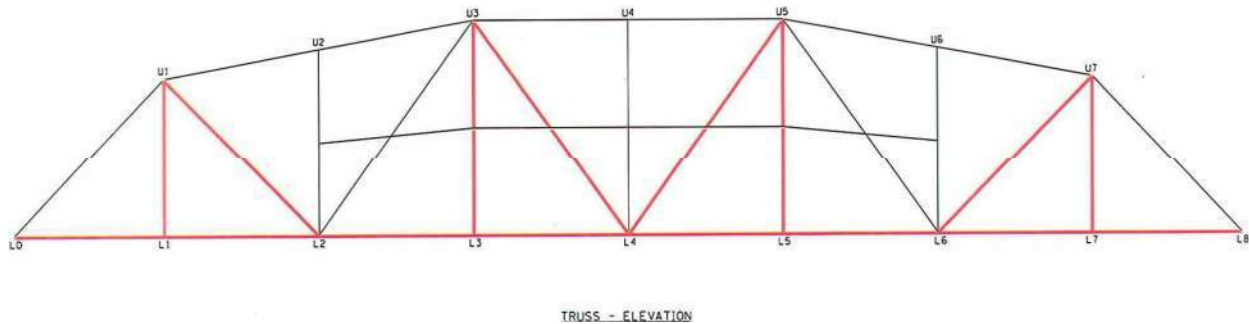
Truss diagram showing Panel Point numbering system for Span 3

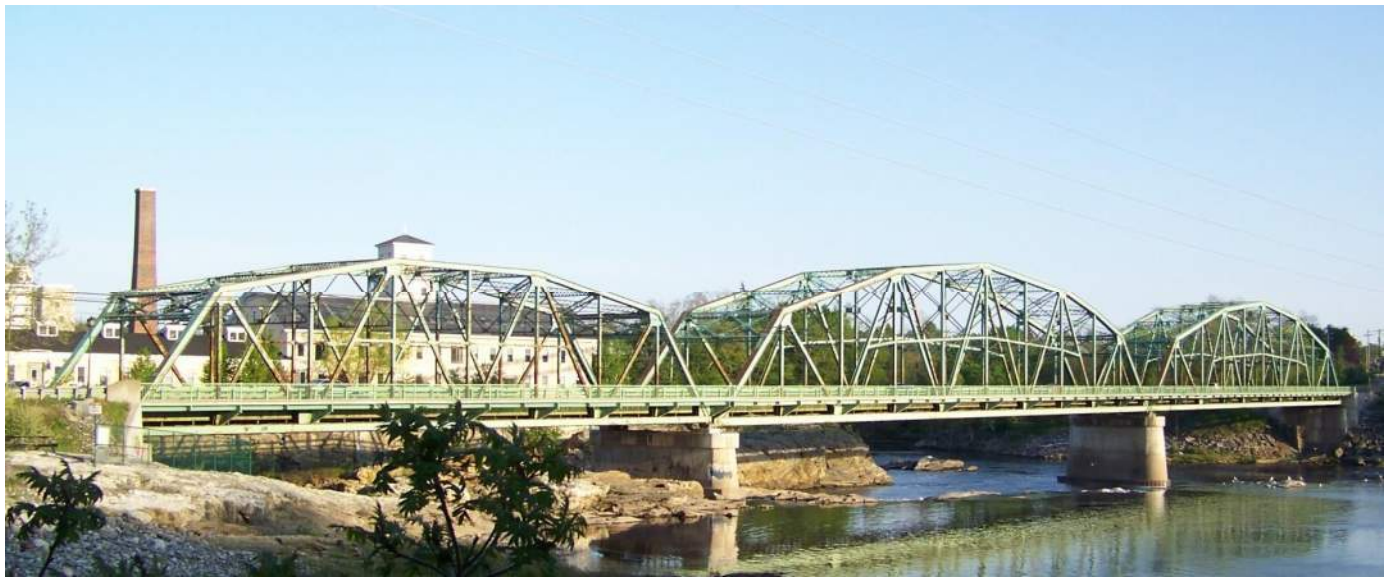
Photo 1 – Partial upstream elevation looking southeast with Span 1 at right. (Note- See Report cover for similar photo).

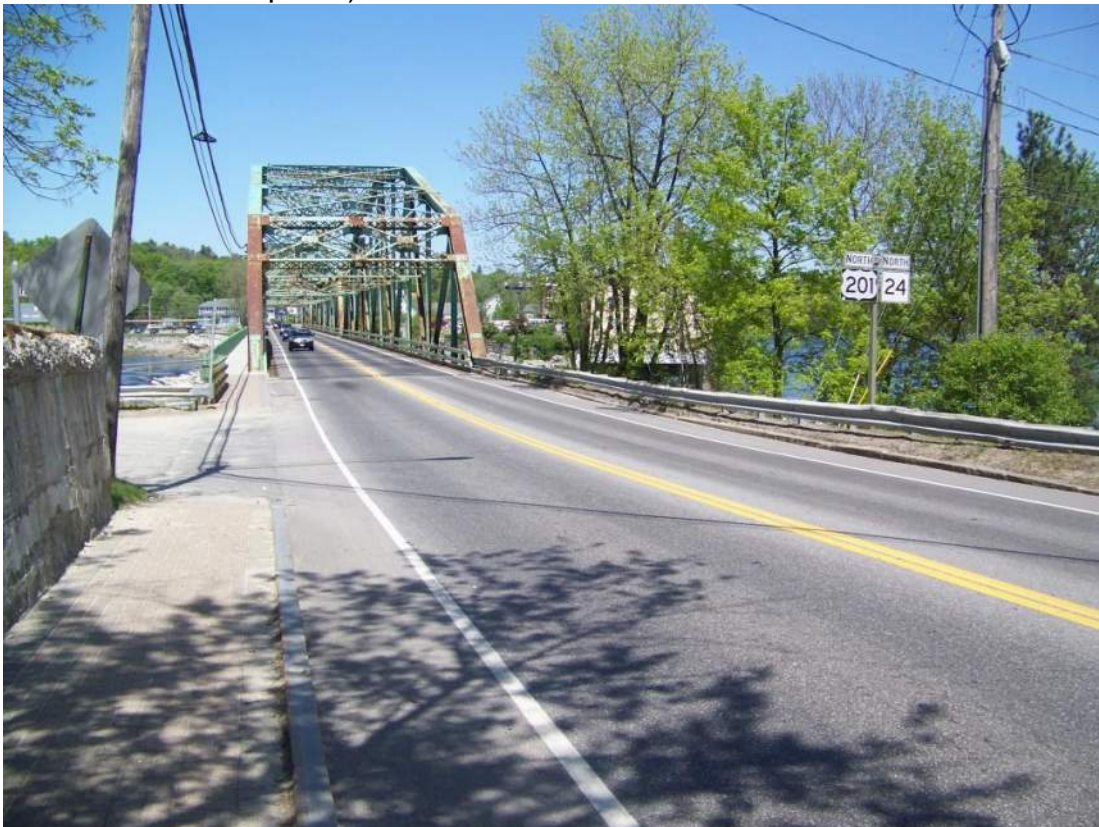
Photo 2 – View of bridge looking north from the south approach roadway. Note minor impact damage to southeast corner guiderail at right.

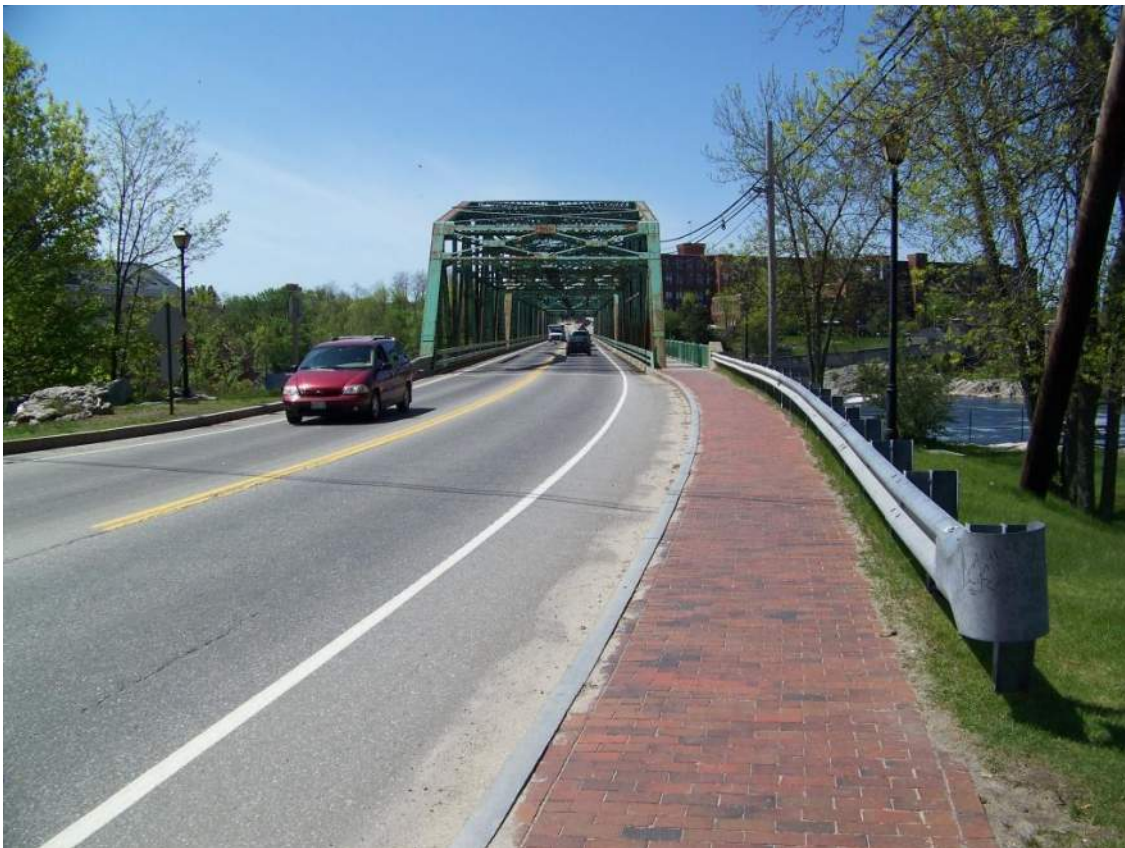
Photo 3 – View of bridge looking south from the north approach roadway.

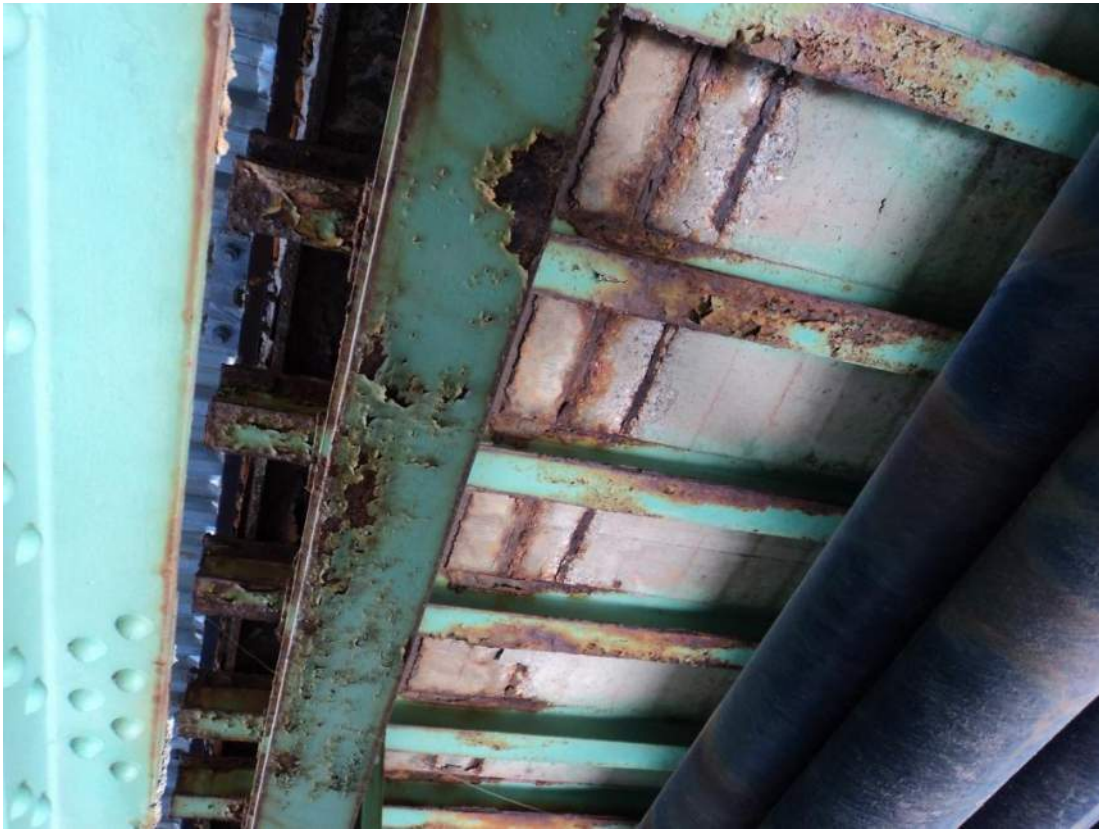
Photo 5 –Along outer edges of deck at S3 and S8 exposed main longitudinal grid deck bars were visible and exhibited active corrosion. Looking north in Span 1 along S3.

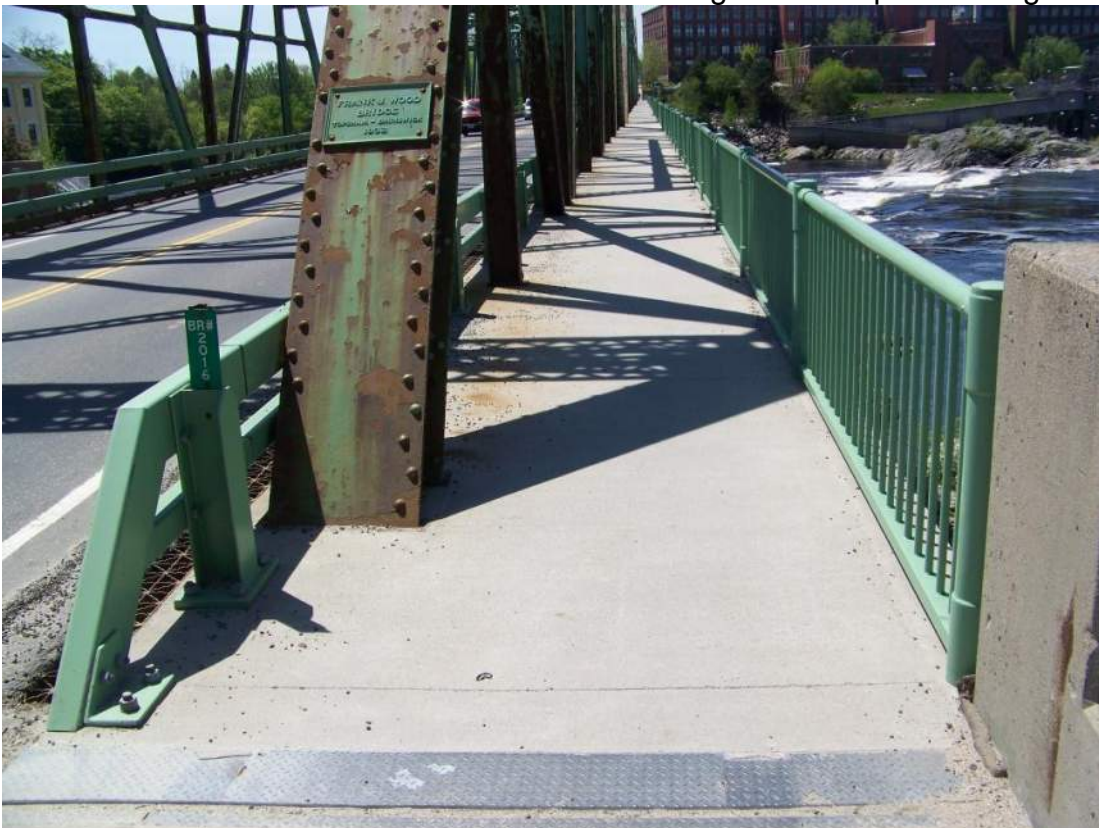
Photo 6 – The concrete curbs and sidewalk on the west side of the bridge are in good condition having been rehabbed relatively recently. Looking south from north abutment.

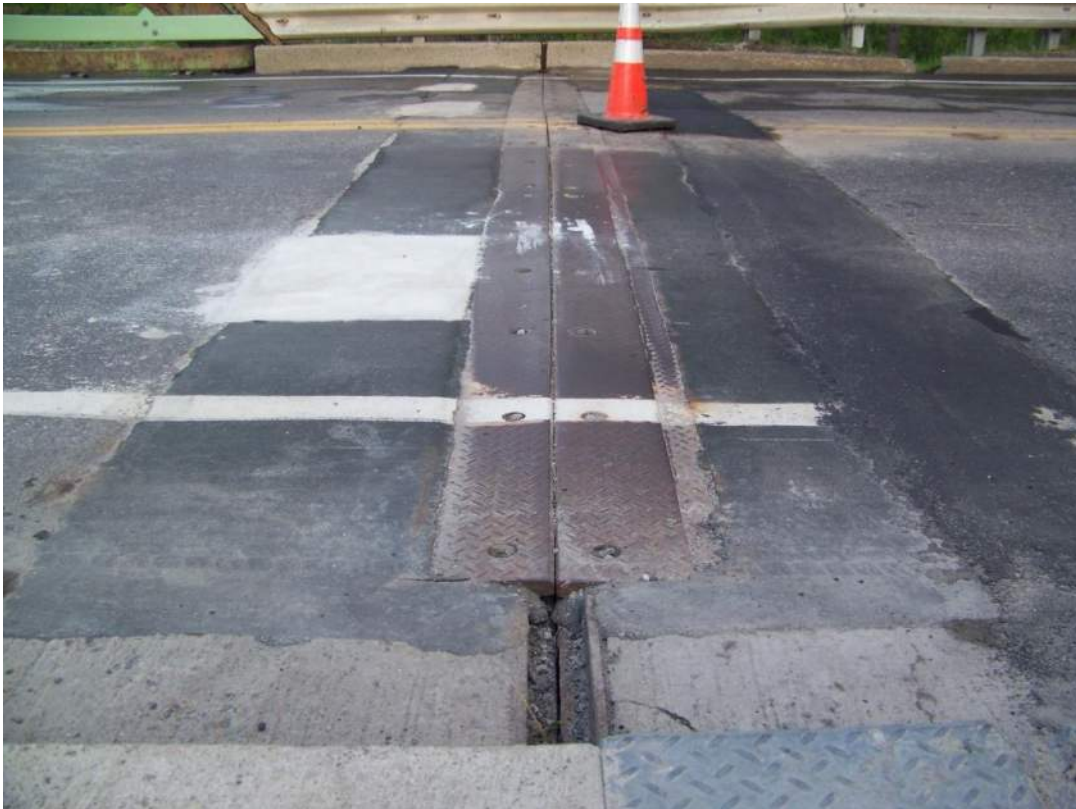
Photo 7 – South abutment open plate deck joint was previously patched with bituminous material; additional bituminous and concrete patching and other repairs were being performed during the inspection.

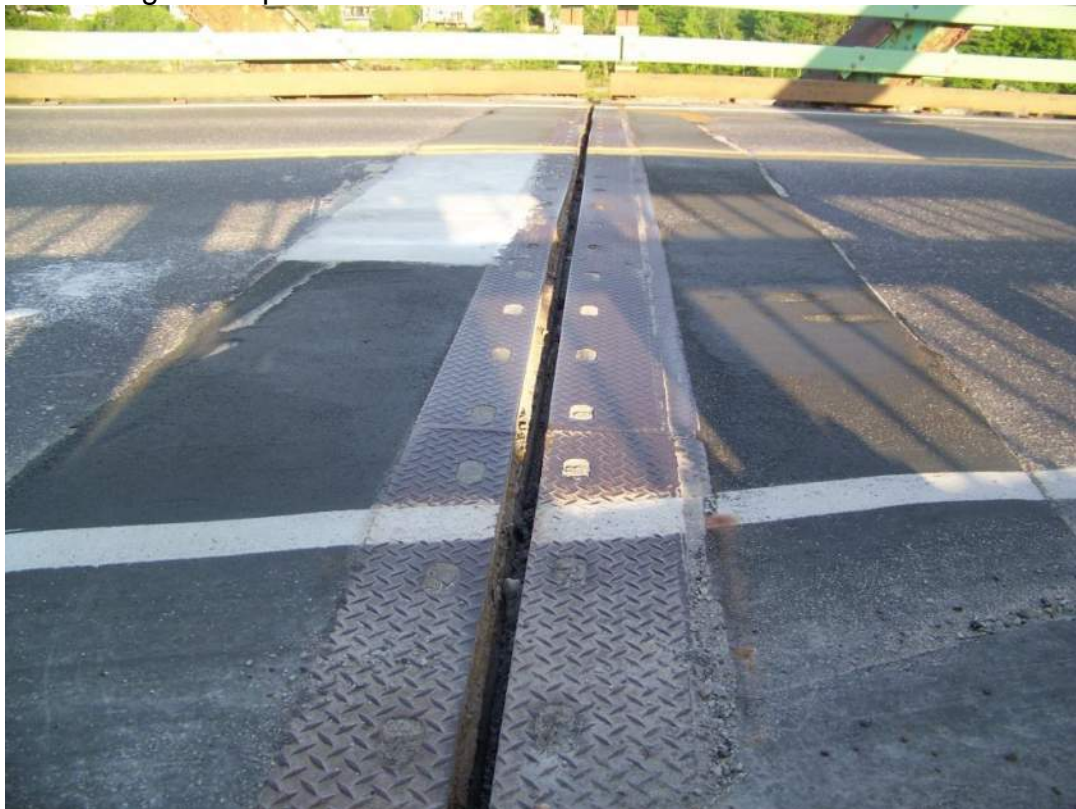
Photo 8 – The south pier strip seal type deck joint was previously patched with bituminous material and a concrete patch was placed during the inspection.

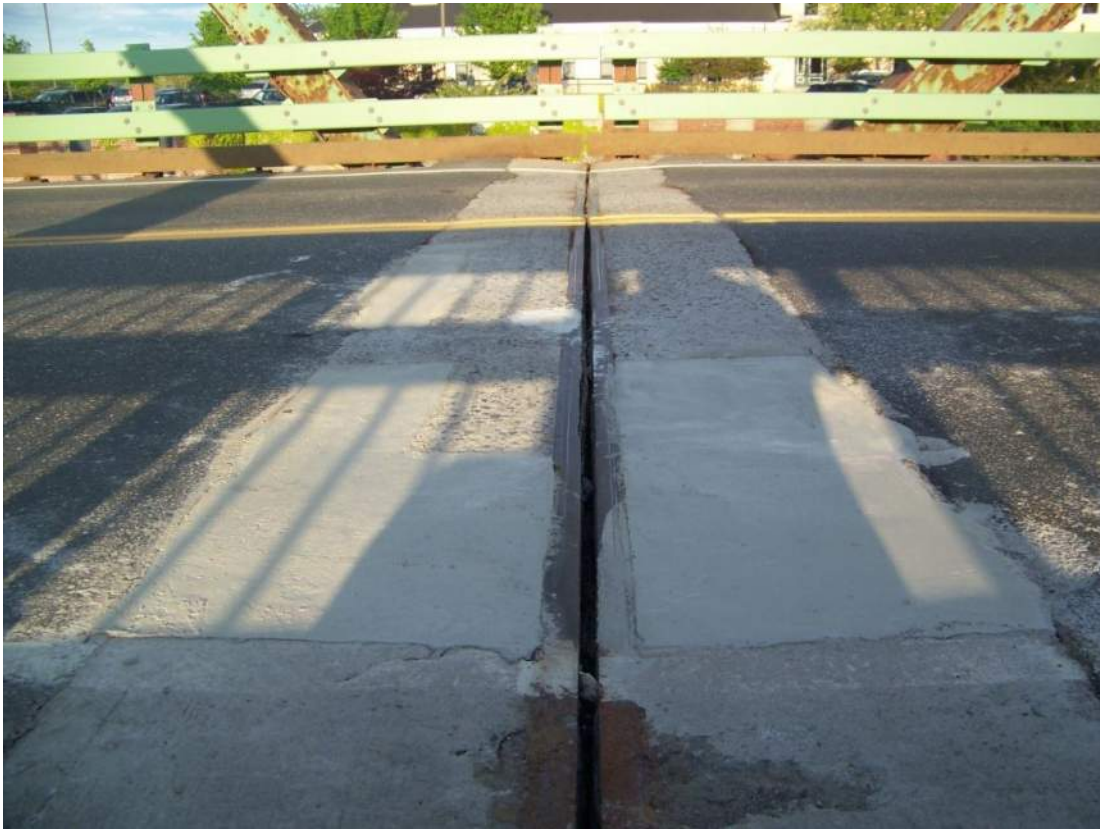
Photo 9 – The north pier strip seal type deck joint has three quick-setting concrete patch repairs placed during the lane closures implemented for the inspection. Looking east.

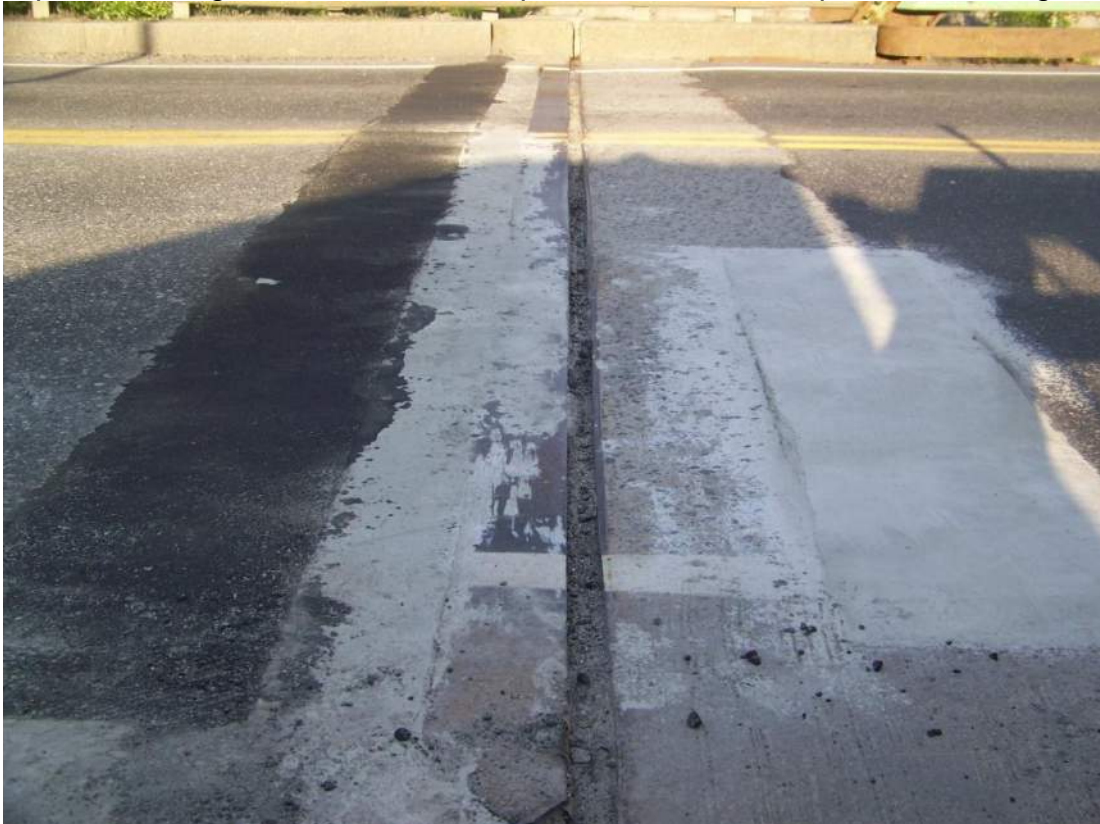
Photo 10 – The north abutment compression seal type deck joint is filled with debris and the concrete headers were patched with quick-setting concrete during the inspection.

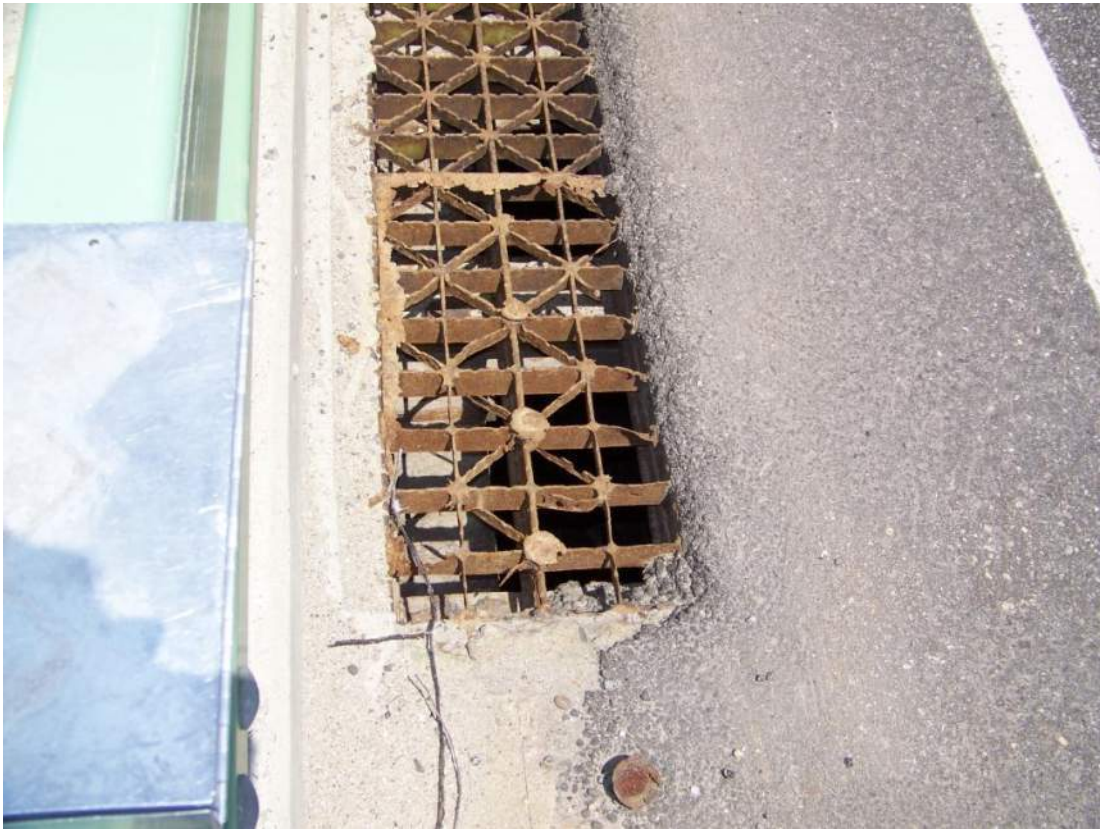
Photo 11 – Several damaged, perforated, and failed secondary distribution bars were observed in open grid gutter drainage strips. Looking north along west curb near Pier 2.

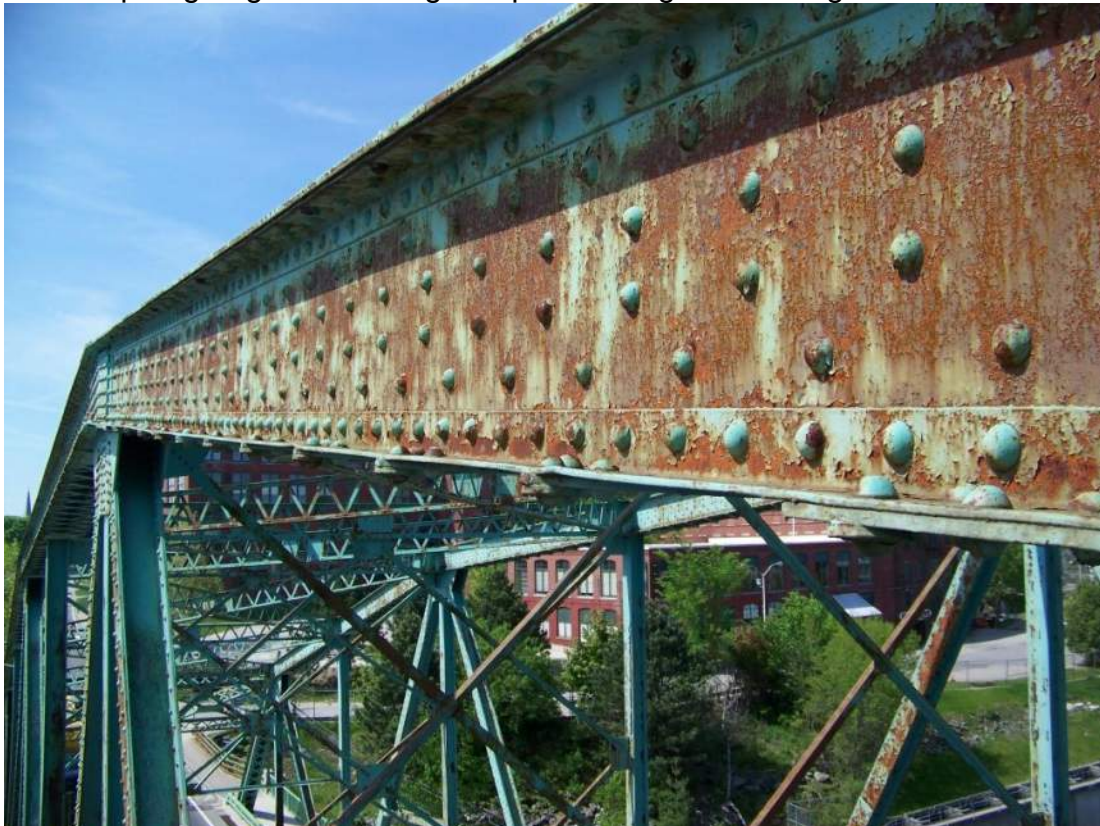
Photo 12 – Paint system is failed over more than 40% of exterior surfaces of upper chords with significant and widespread areas of missing paint and active corrosion.

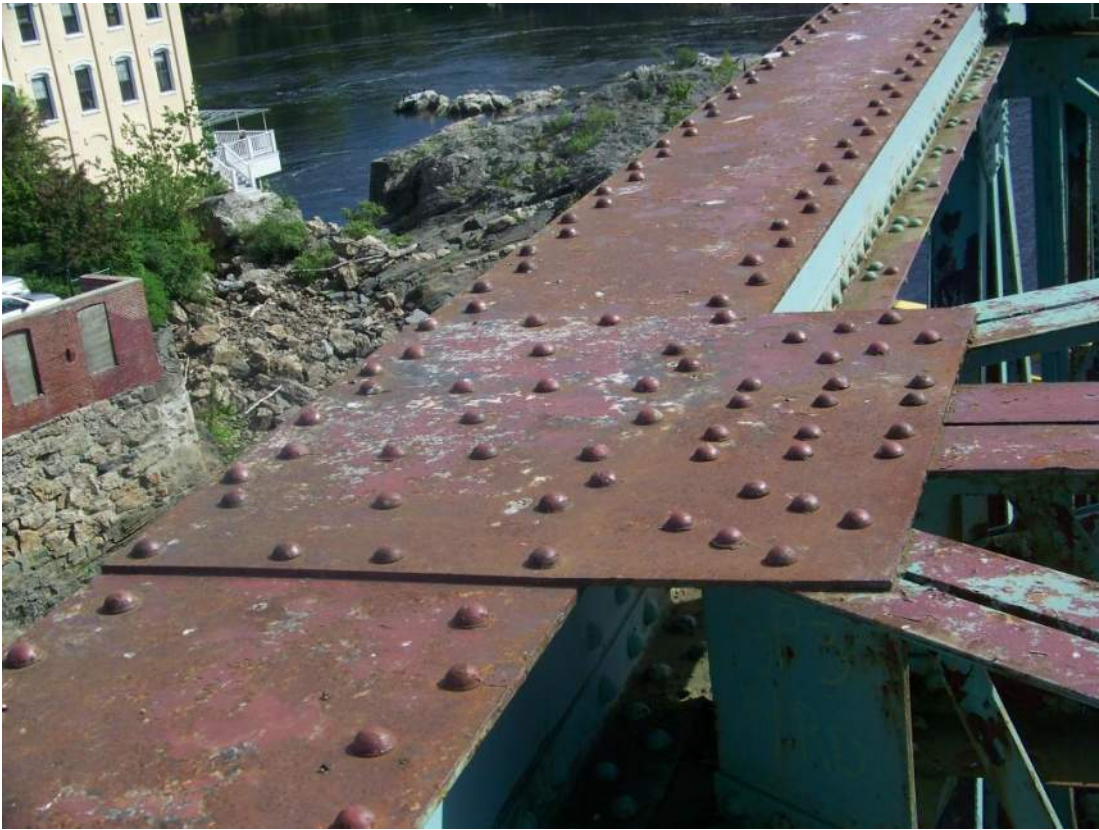
Photo 13 – Paint system is failed over more than 40% of exterior surfaces of upper chords with significant and widespread areas of missing paint and active corrosion.

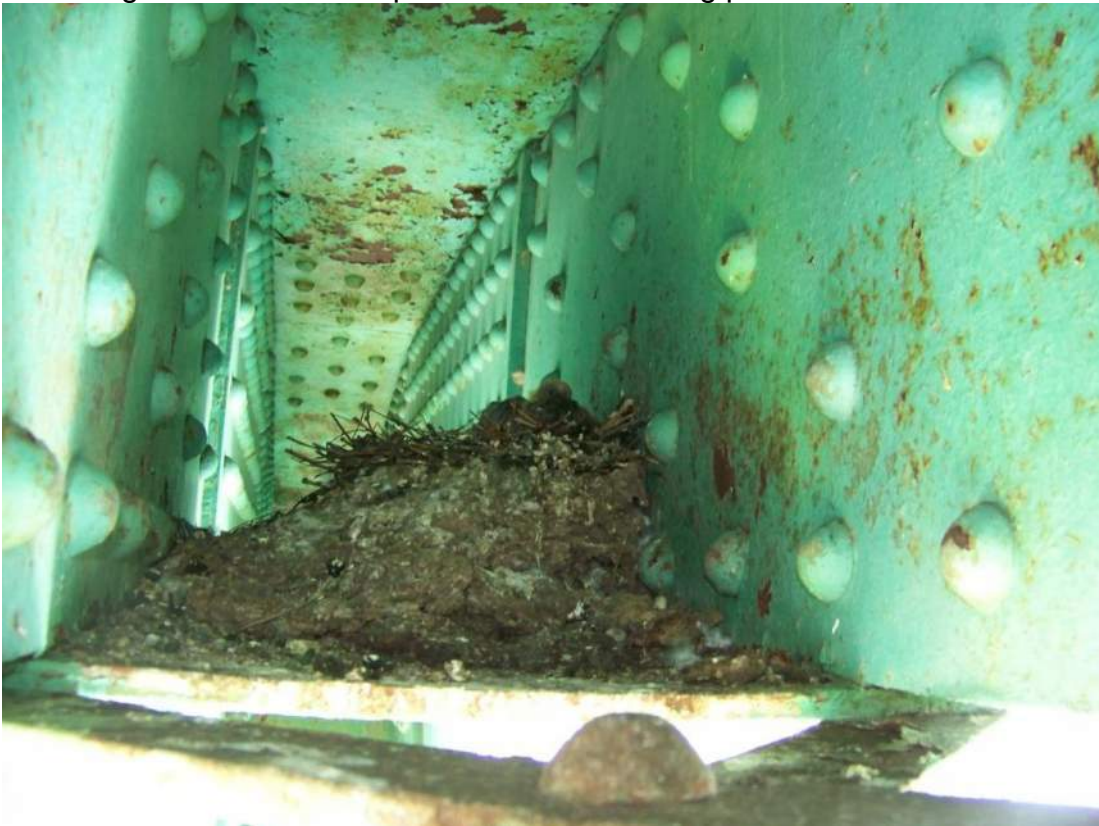
Photo 14 – The interior surfaces of upper chords exhibit paint failure rates averaging 10% and there are bird nests present on top of nearly all of bottom face batten plates.

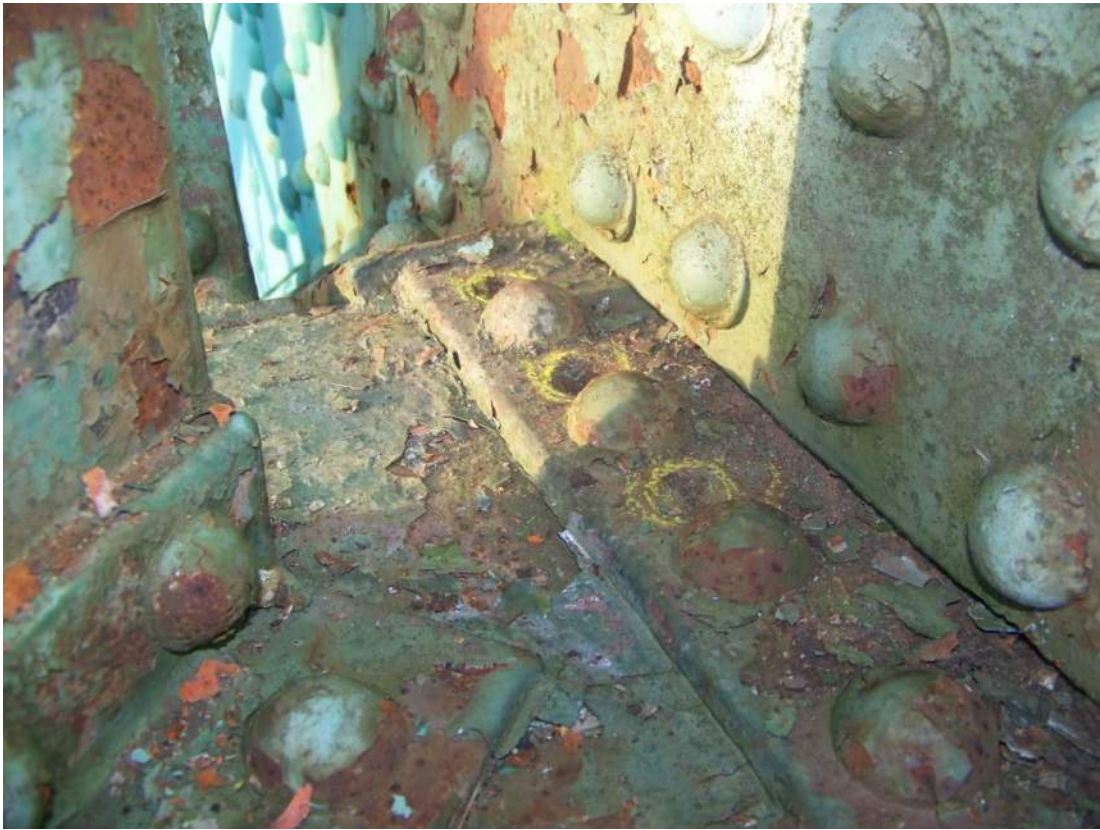
Photo 15 – Three additional mis-drilled rivet holes interspersed with the rivet holes were observed at the Span 2 roadway truss U9 west side channel lower angle. Looking north.

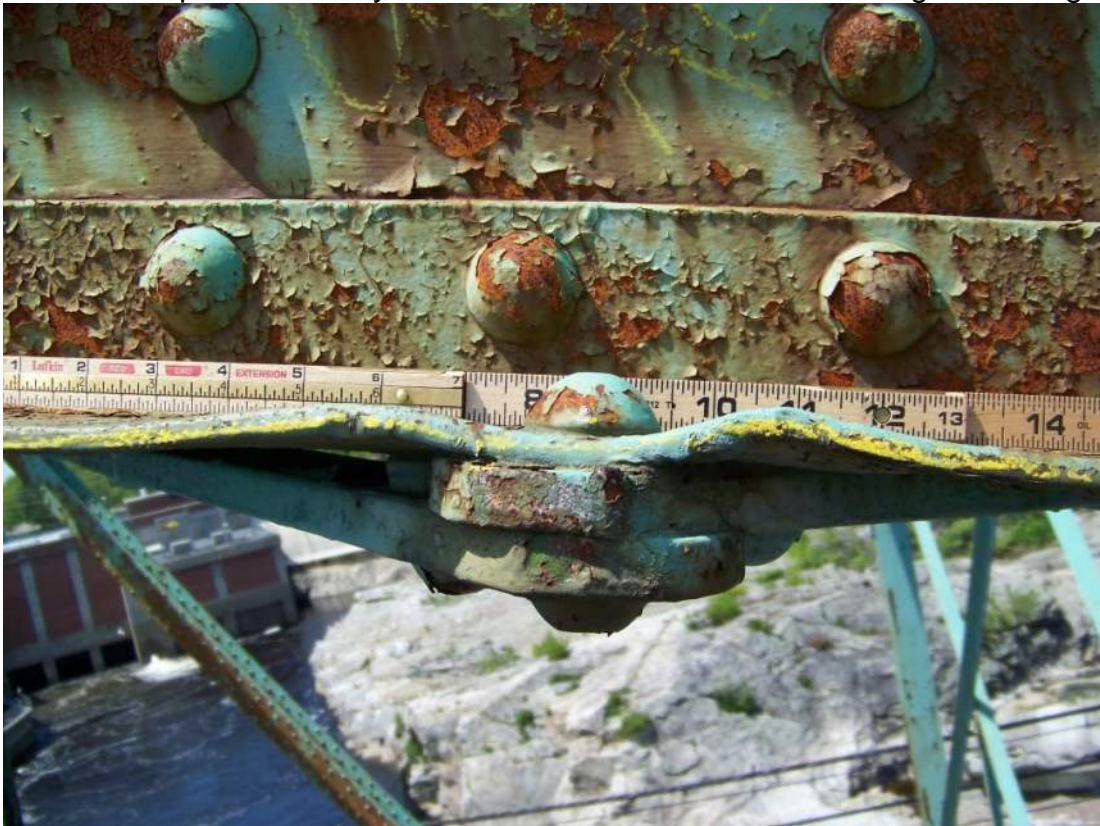
Photo 16 – Slight vertical distortion was noted in the bottom flange angles at and/or between the lacing bars at various locations. View at Span 1 U7-U8 sidewalk truss.

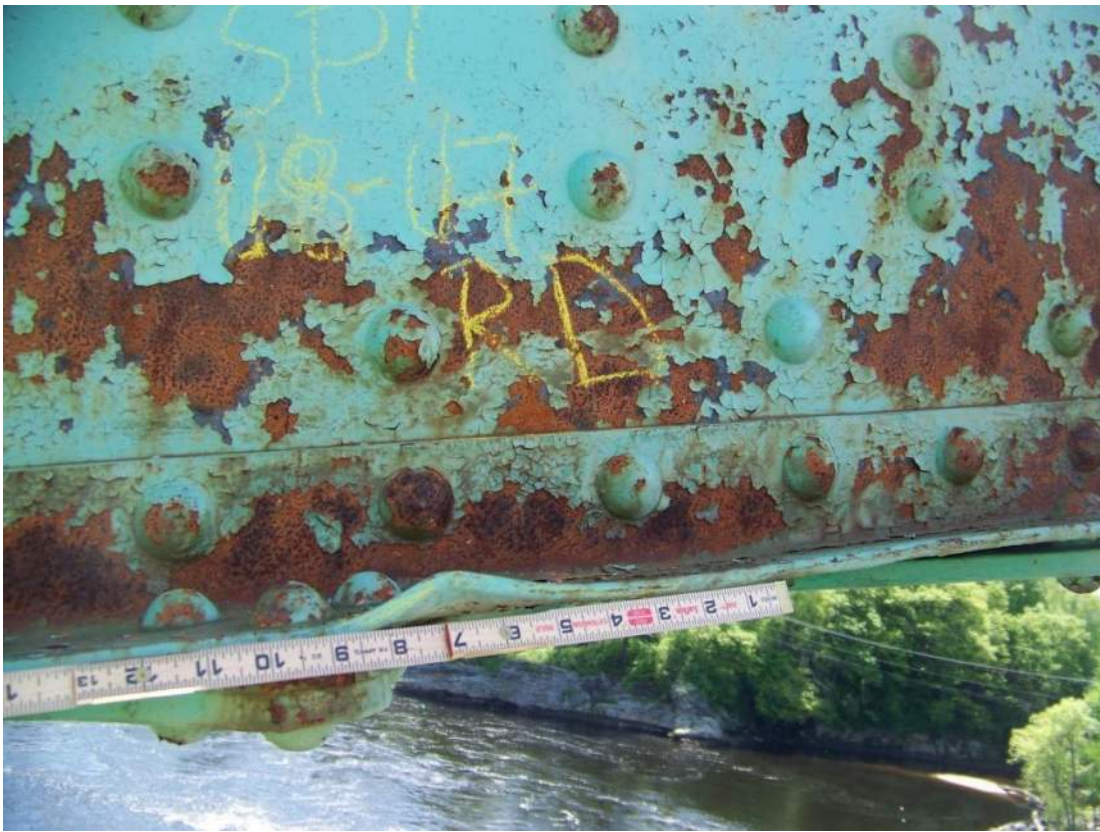
Photo 17 – Minor localized bends in flange angles with up to 5/8 inch vertical deflection of flange tip were observed at a few locations. View at Span 1 U7-U8 sidewalk truss.

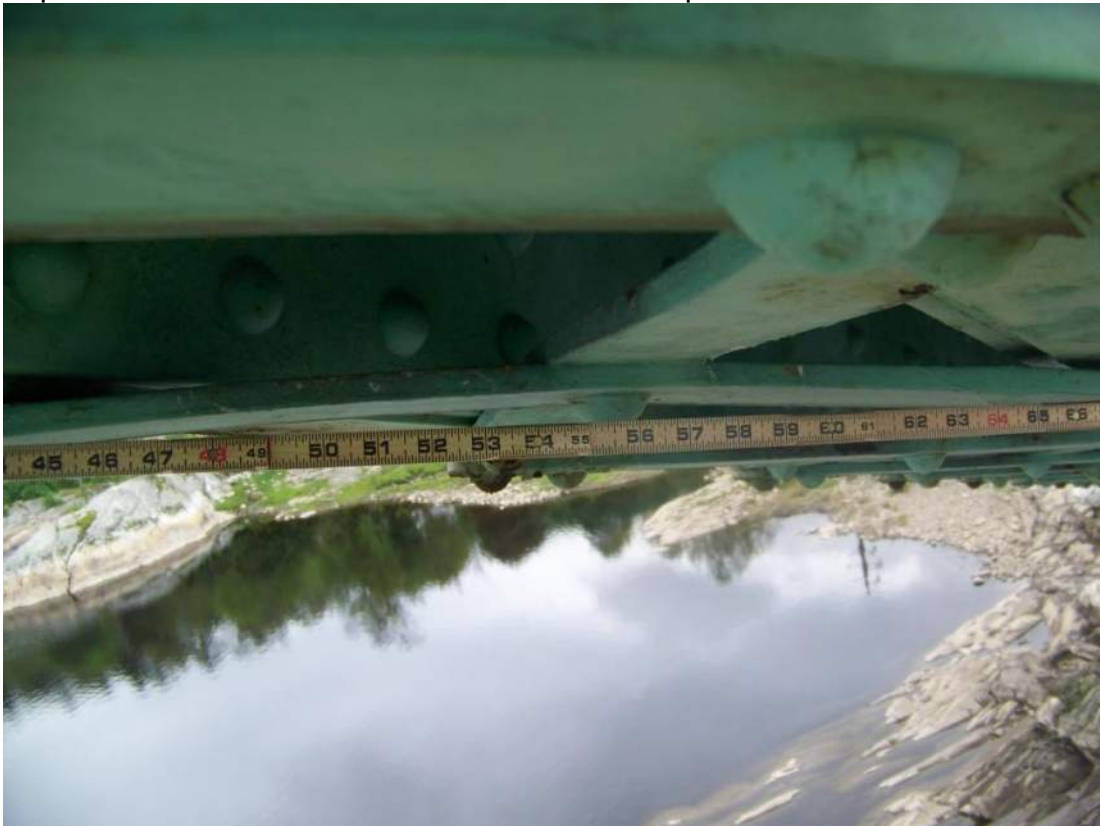
Photo 18 – The double lattice lacings bars in the Span 2 sidewalk truss U7-U8 upper chord have noticeable upward deflection. View is looking west.
