Preliminary Design Report

Frank J. Wood #2016

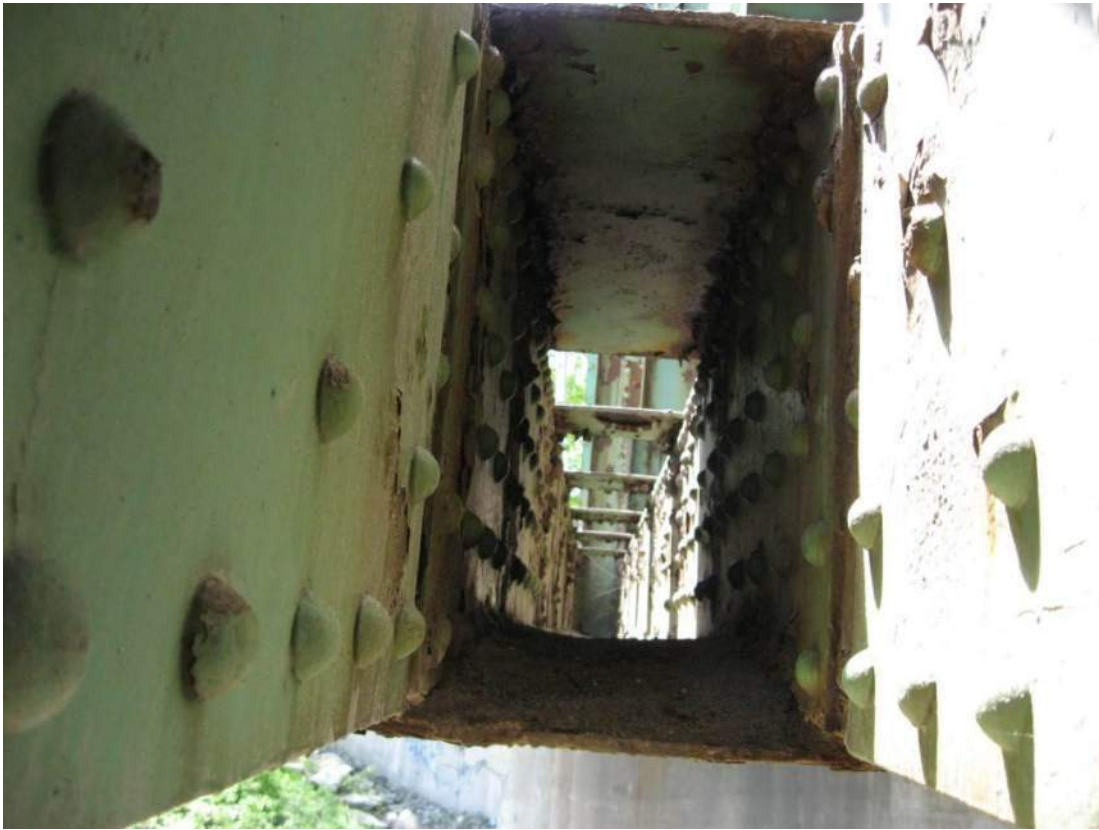
Photo 19 – Heavy debris accumulations up to four inches deep were observed on the top of the lower chord bottom plate near the Span 1 roadway truss L2 splice region.

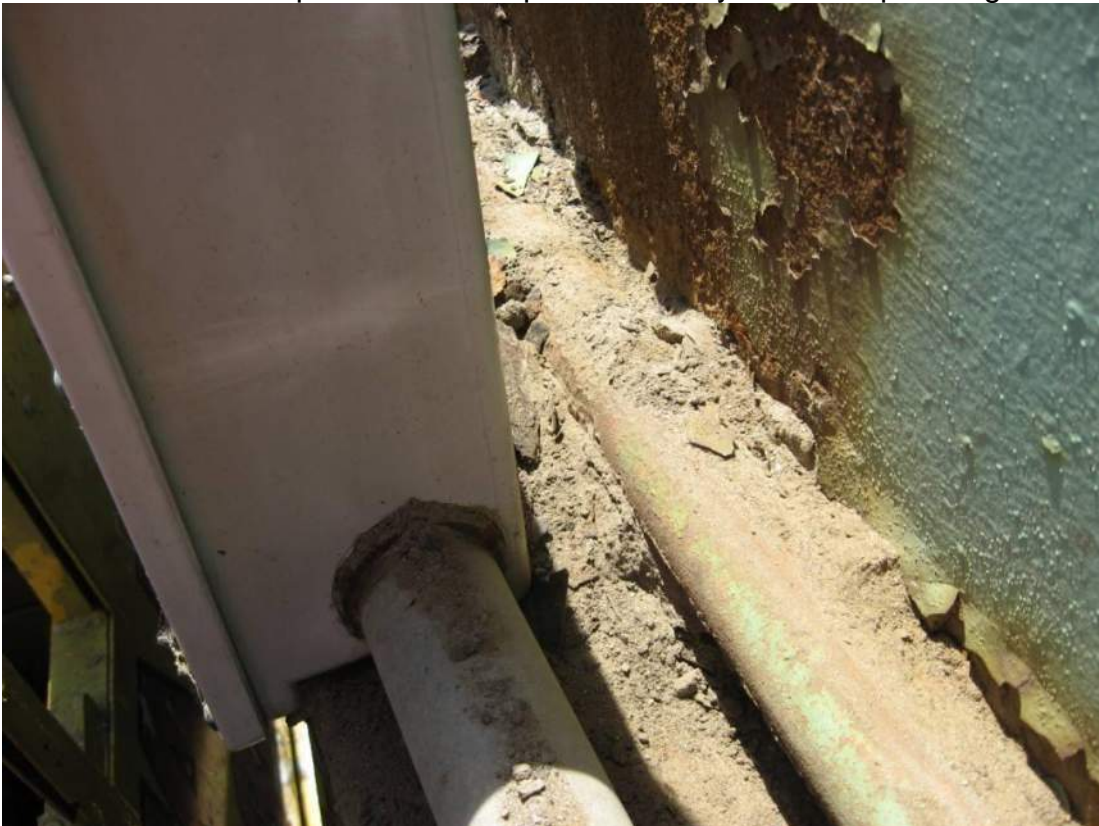
Photo 20 – Packed debris up to two inches deep on top of Span 1 roadway truss L2 lower chord outboard channel where electrical conduits and junction box trap and collect dirt.

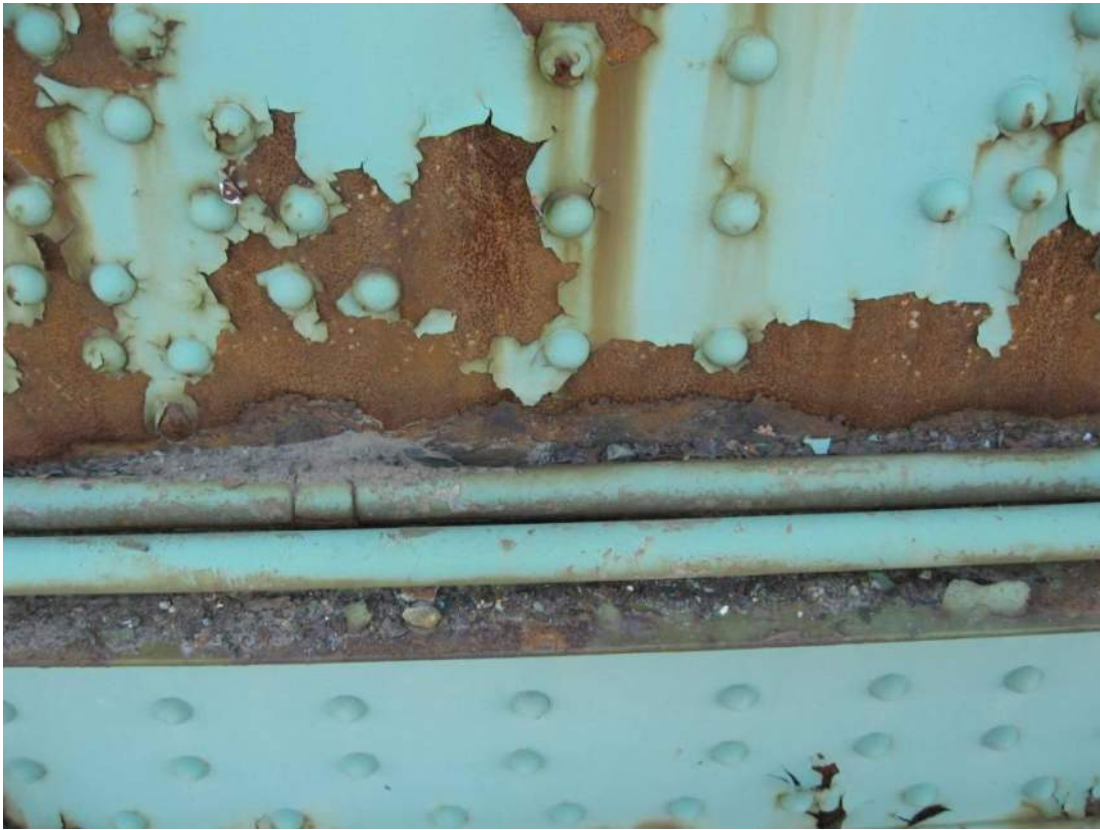
Photo 21 –In Span 1 roadway truss L4 joint minor exfoliated rusting was noted over 3” of outboard gusset plate due to moisture and dirt accumulation caused by the conduits.

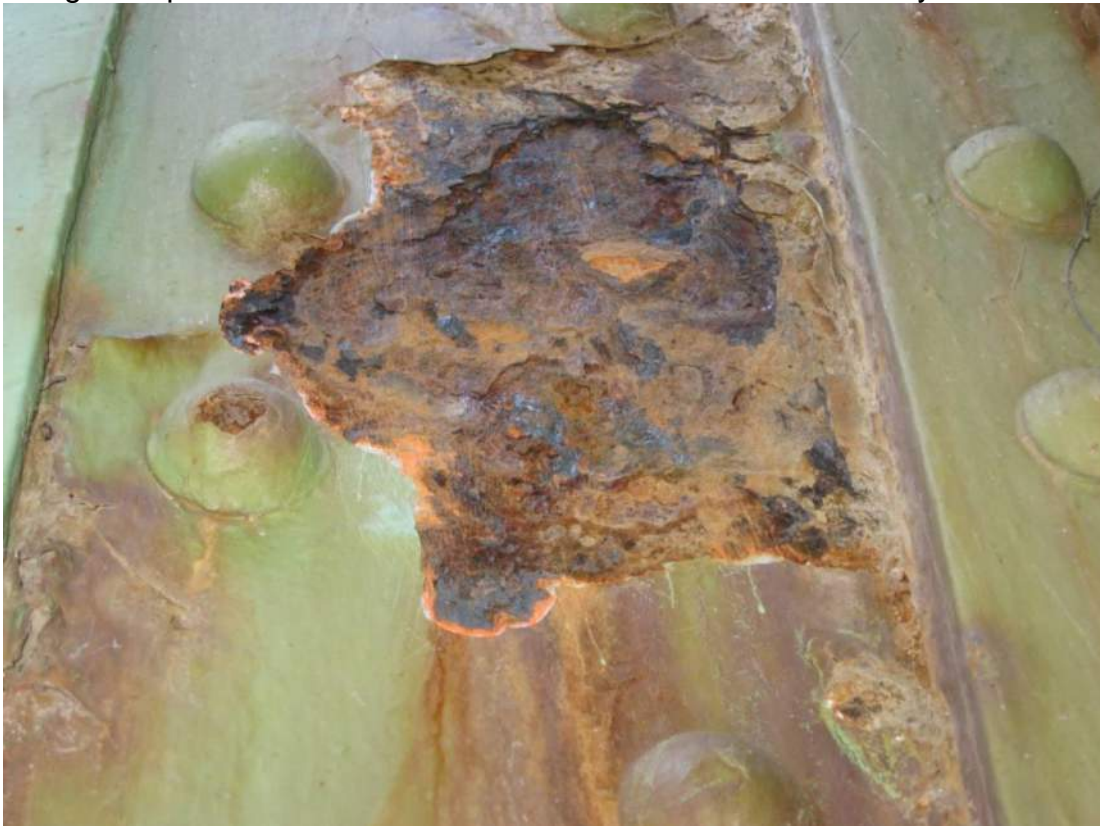
Photo 22 – In Span 1 roadway truss at L4 section loss of 1/16 inch depth was observed over a 4” long by 8 “ high area on east face of L3-L4 chord west side channel cover plate.

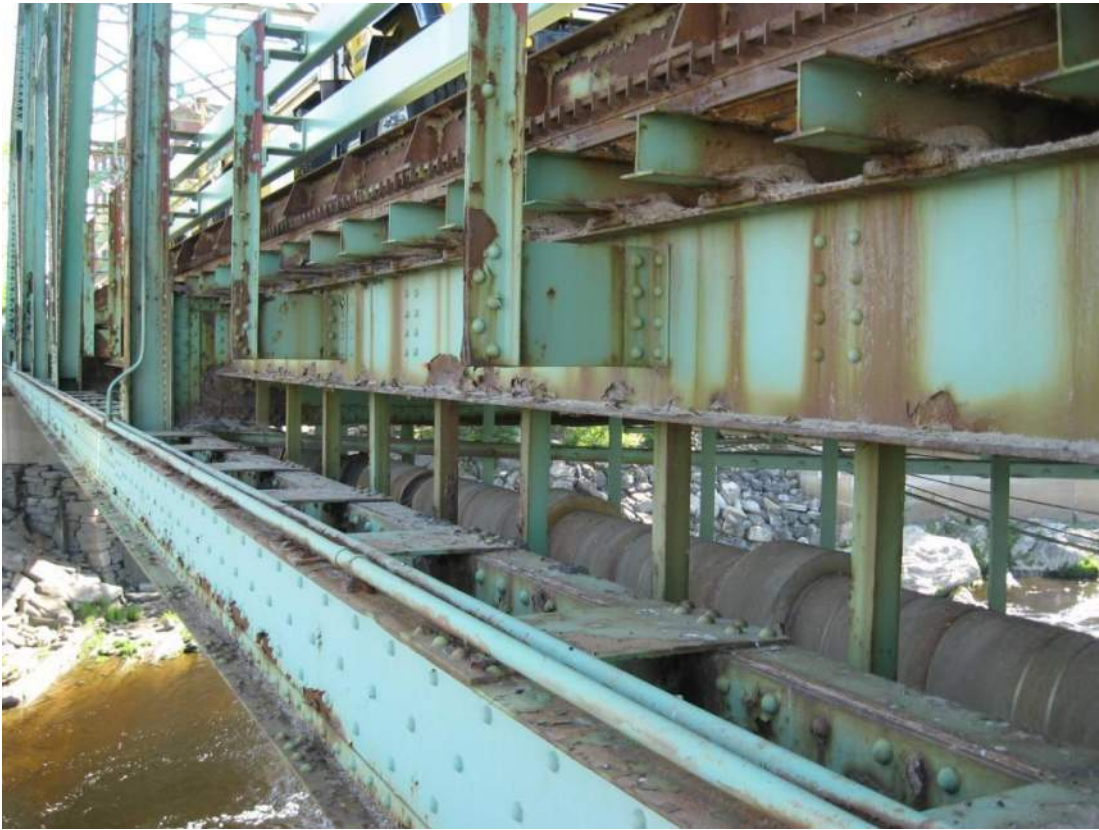
Photo 23 – The roadway truss lower chord top face exhibits poor paint condition with missing paint and active corrosion typical throughout bridge. View of Span 1 L5-L6.

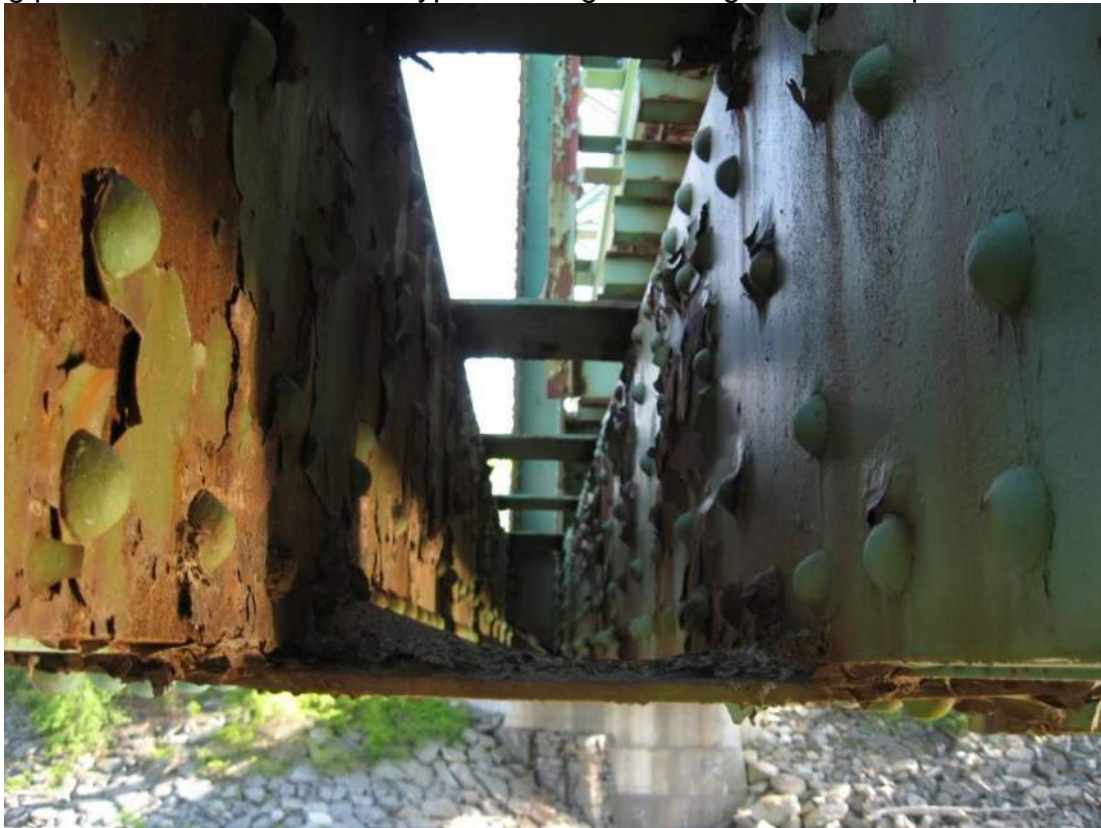
Photo 24 – The interior vertical faces of the roadway truss lower chord also exhibit poor paint condition with missing paint and active corrosion typical throughout. Span 1, L6-L7.

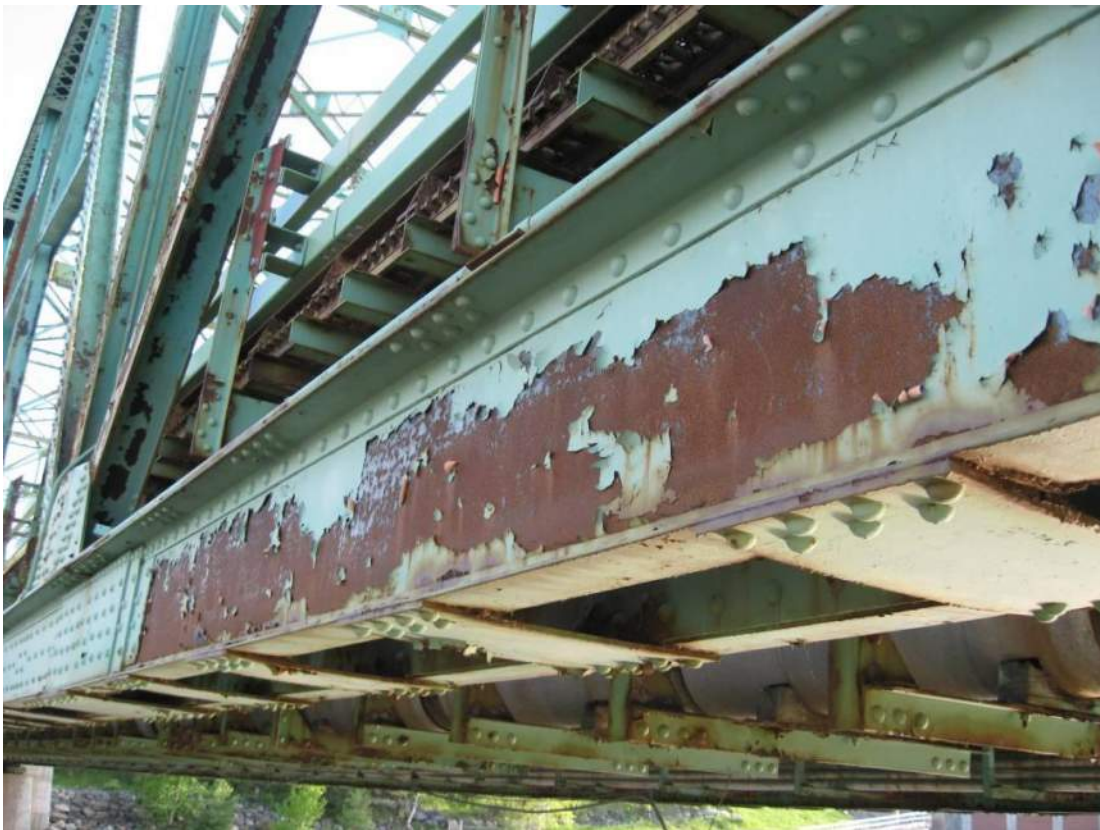
Photo 25 – The east face of the Span 1 roadway truss between L8 and L9 exhibits missing paint and active corrosion over a 15 foot length.

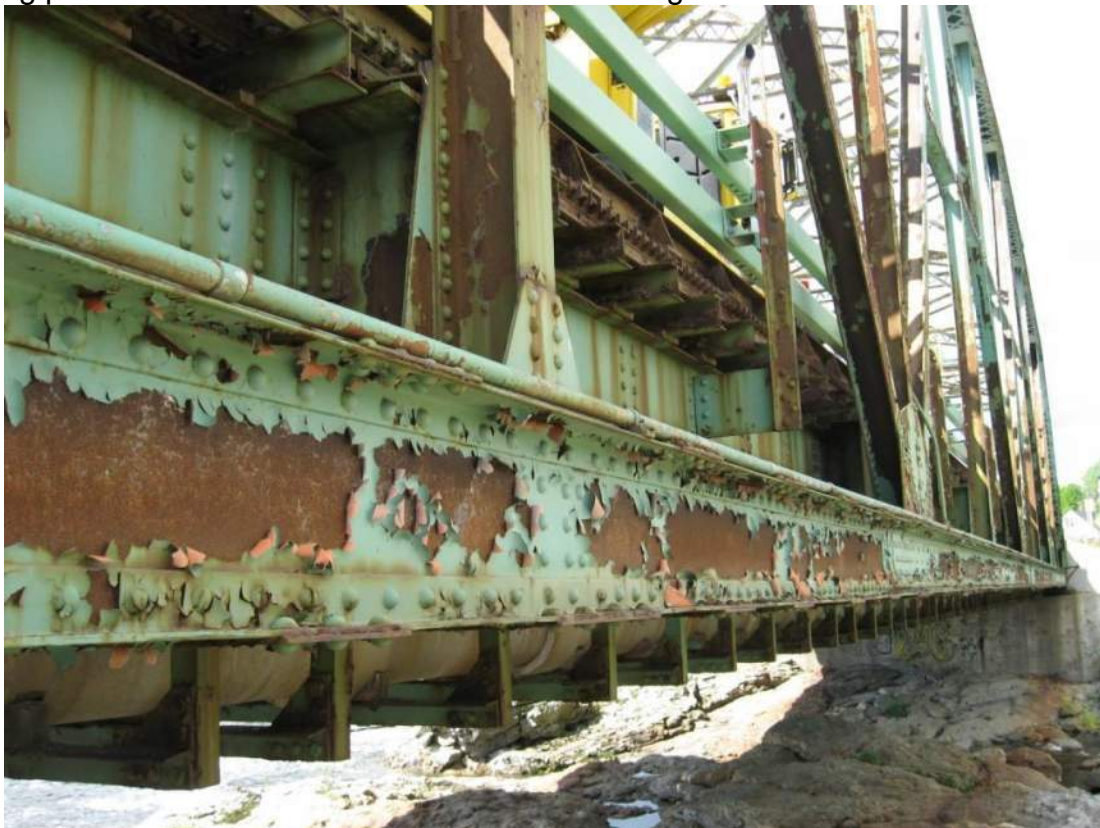
Photo 26 – In Span 3 the entire length of the east face of the roadway truss has severe paint failure with active corrosion. Looking north toward north abutment.

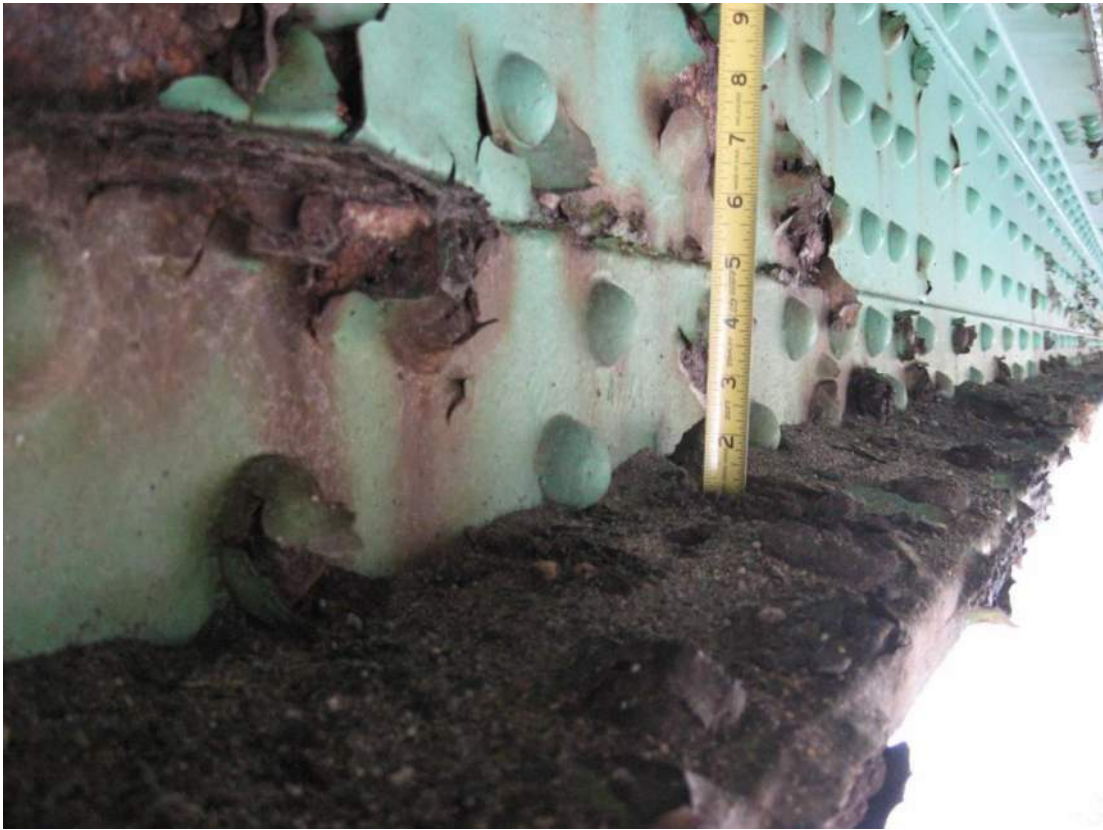
Photo 27 – Span 2 sidewalk truss lower chord east face has debris accumulations up to an inch deep over top of bottom flange of side channel for at least half of the span length.

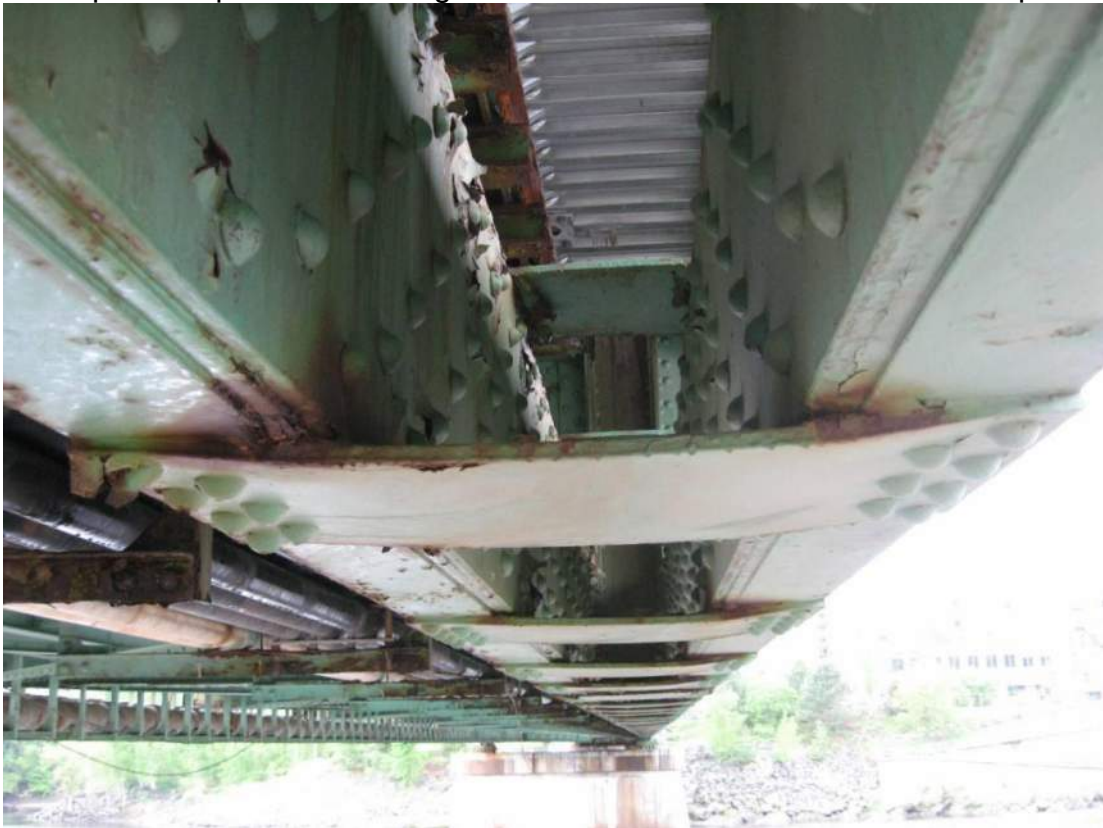
Photo 28 – Span 2 sidewalk truss lower chord bottom face tie plates bowed downward due to pack rust at the interfaces with the bottom of the lower chord side channels.

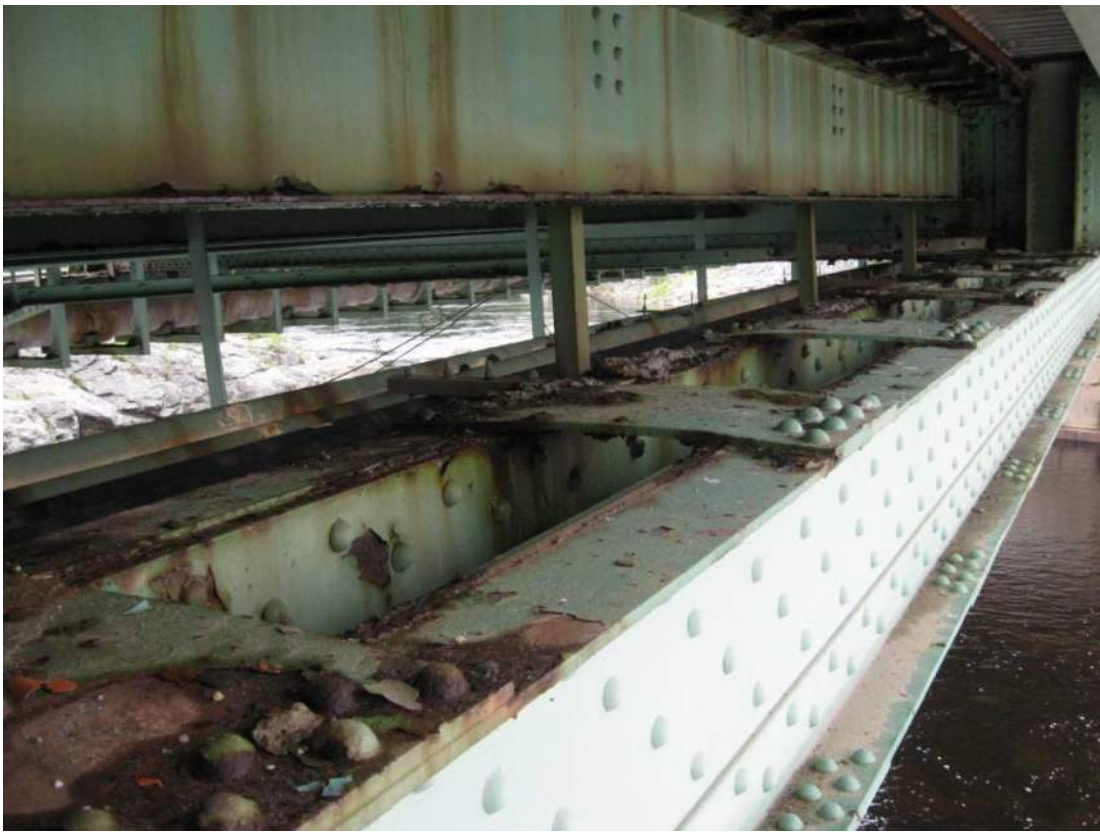
Photo 29– Top face tie plates are similarly bowed in the upward direction due to pack rust at the interfaces with the top of the lower chord side channels.

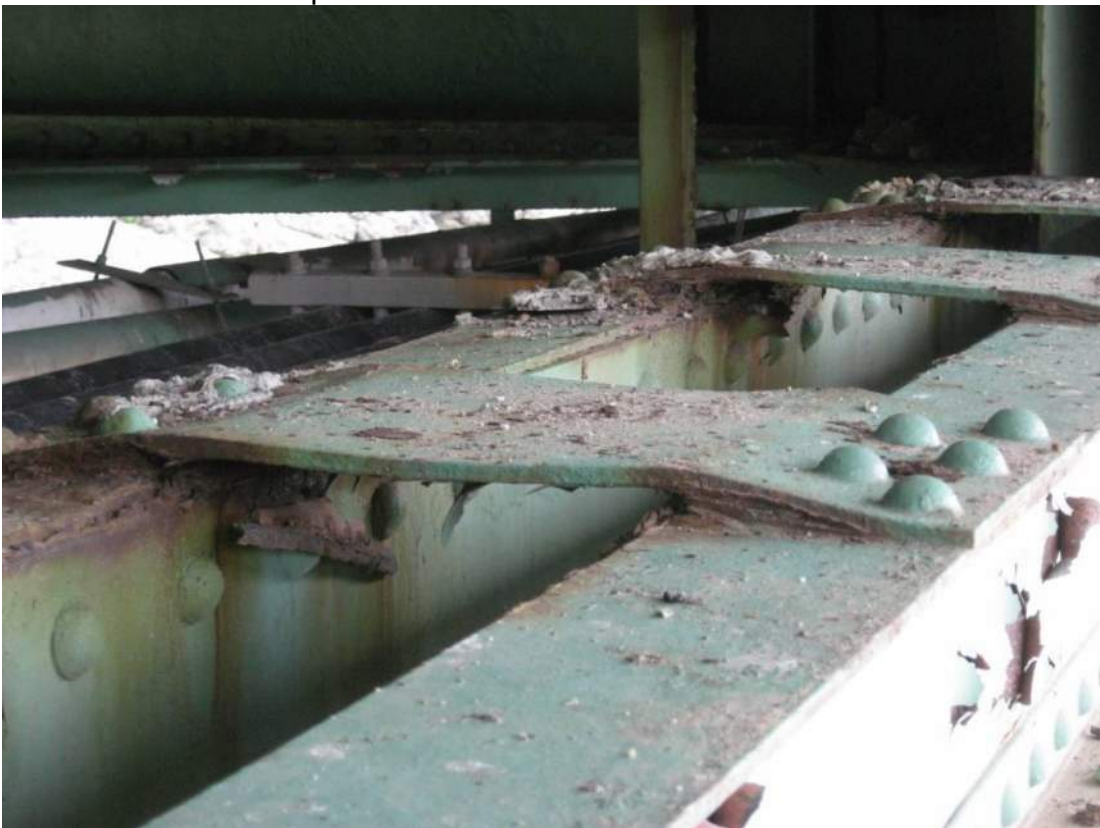
Photo 30 – The most severe instance of bowing of the top face lower chord tie plates was observed at Span 3 sidewalk truss at the third tie plate north of L0.

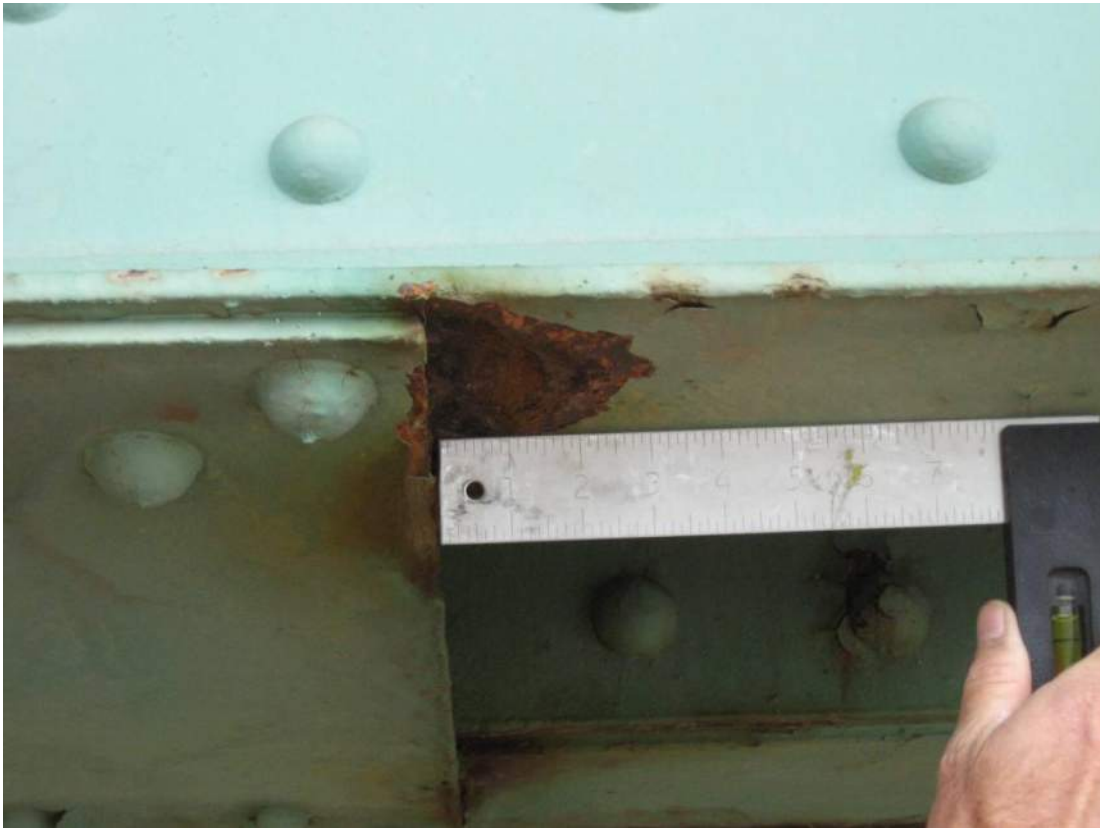
Photo 31– Zone of 1/8 inch deep by 3 inch wide section loss to Span 3 L4-L5 sidewalk truss outboard side channel located at corner of first tie plate south of center splice.

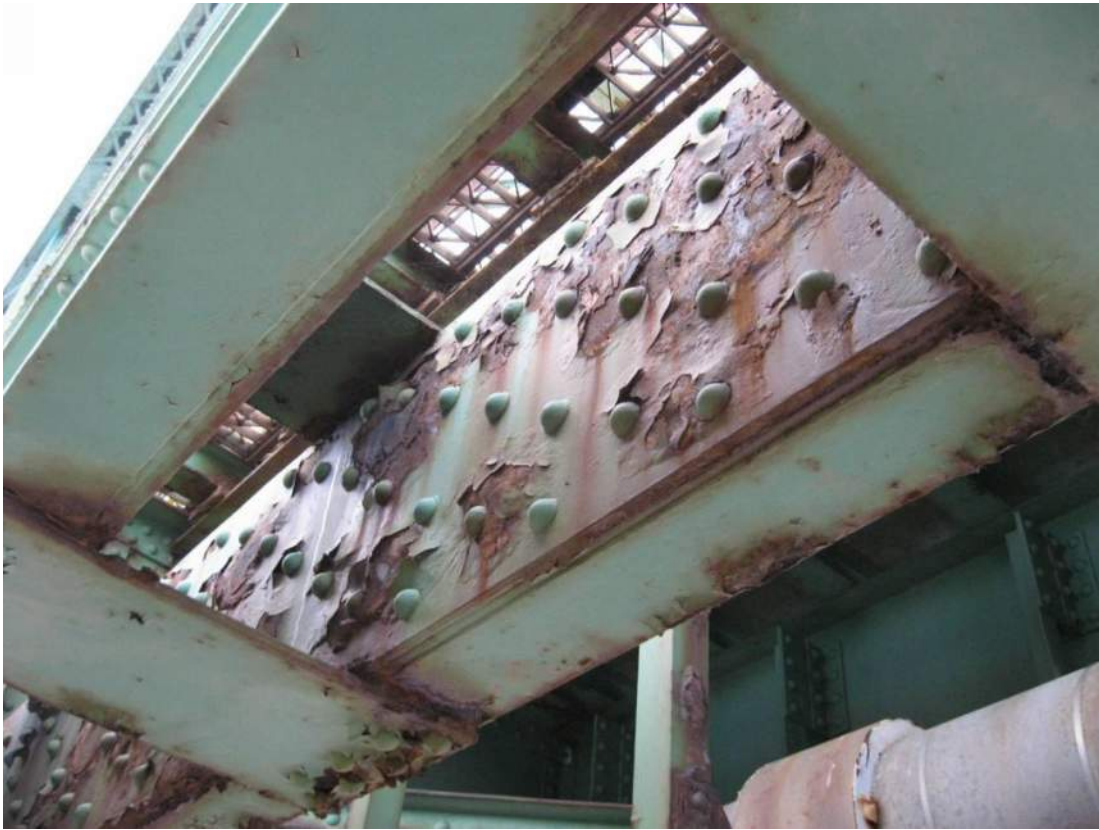
Photo 33– Interior vertical side channels of Span 3 roadway truss L3-L4 exhibit areas of failed paint, active corrosion, and raised expansive exfoliation similar to pack rust.

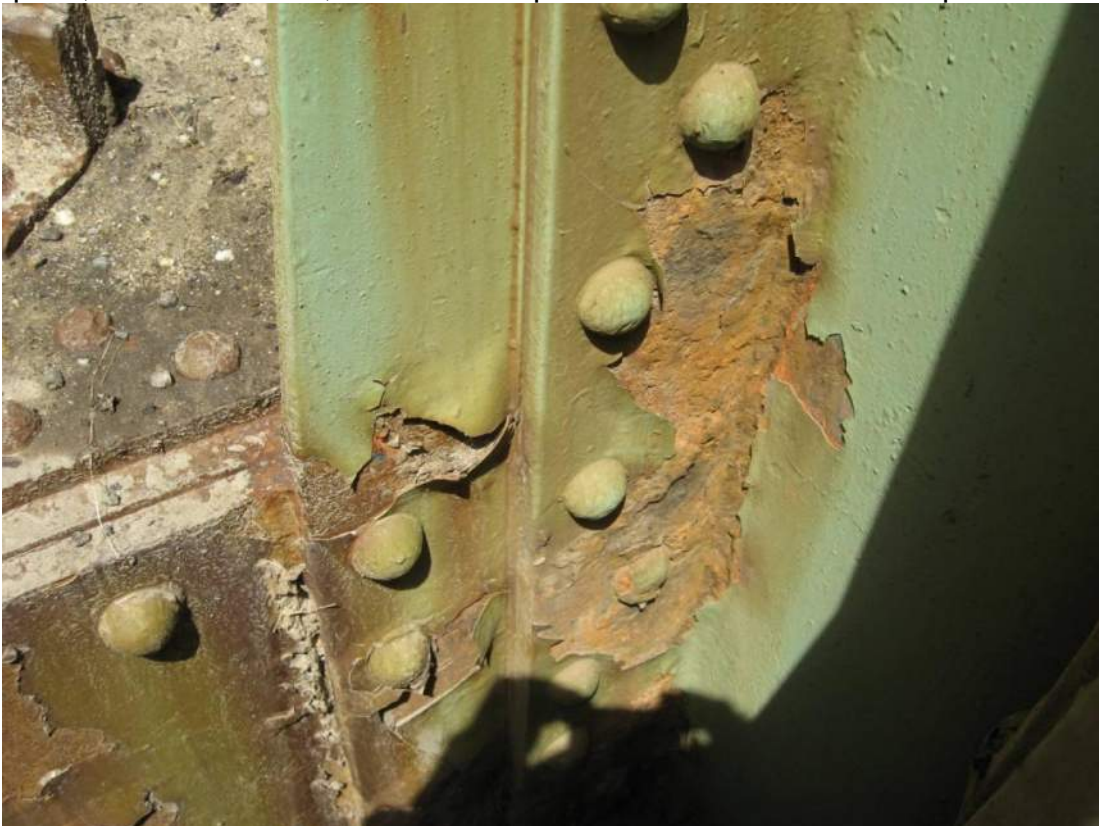
Photo 34 – Span 1 roadway truss U1-L1 has section loss of 1/16 inch to the east face of the vertical west flange over the half of the flange width south of the vertical web.

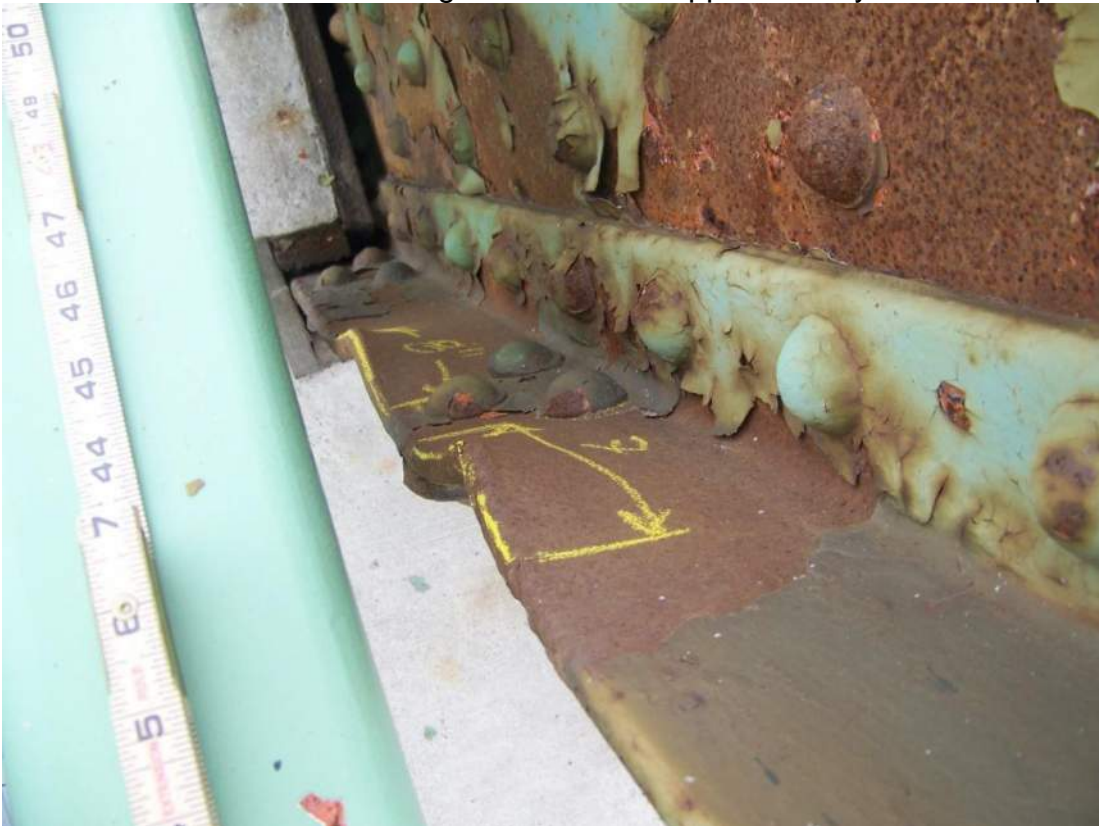
Photo 36 – Impact damage to the Span 3 sidewalk truss L0-U1 end post was observed which has caused two bends of $\frac{3}{4}$ to 1 inch to the northeast corner angle.

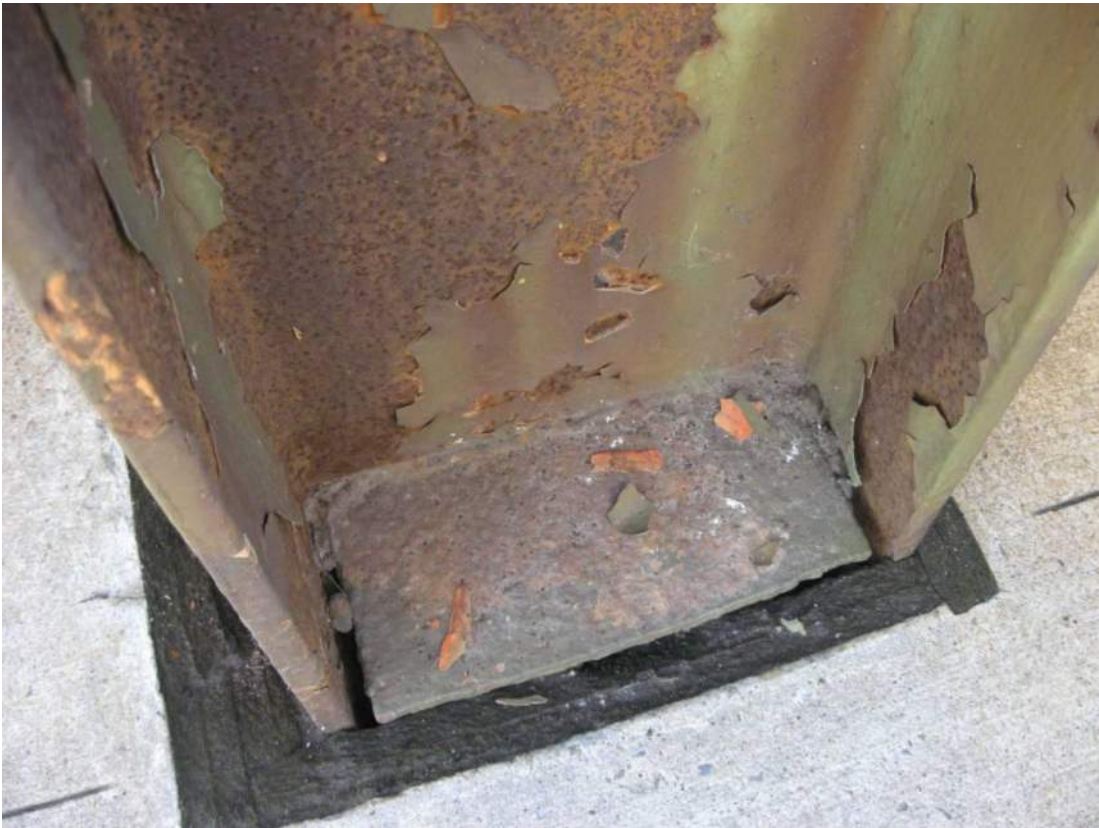
Photo 37– Sidewalk truss verticals and diagonals have welded plates at sidewalk level openings. These plates represent FSD's in FCM's (wherever base members are FCM's).

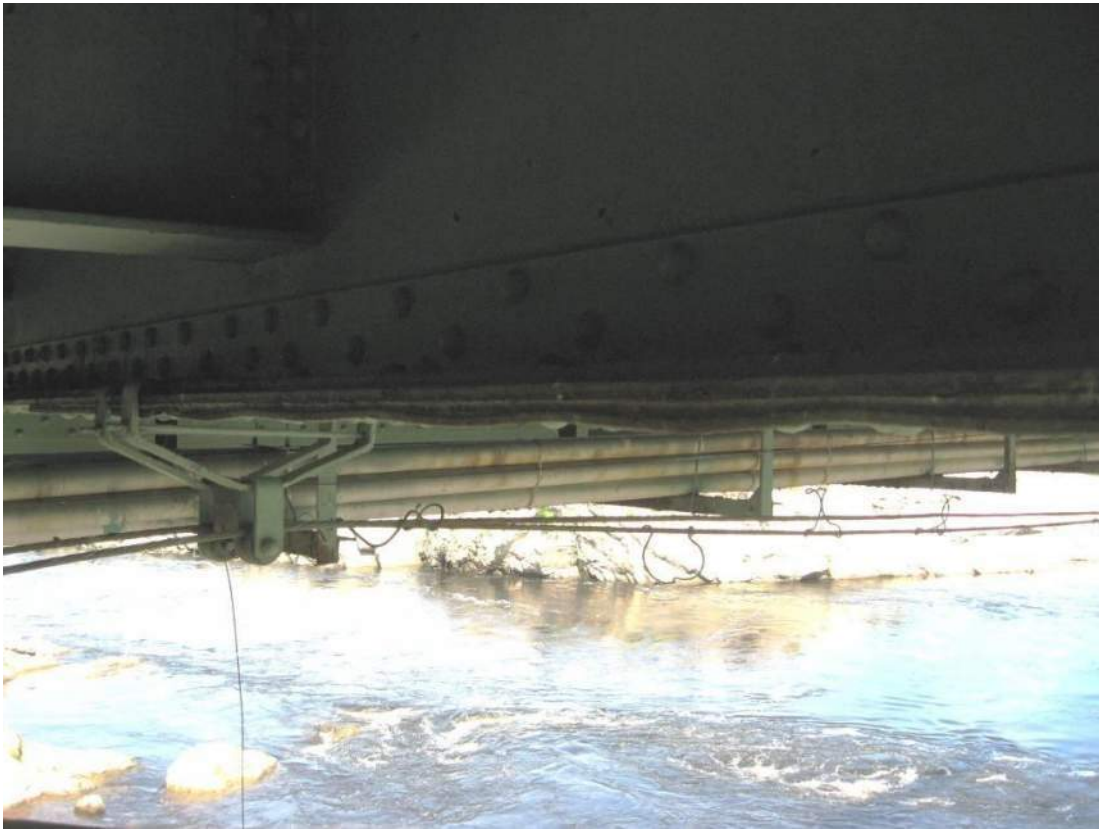
Photo 39– Previously arrested pack rust was observed in the Span 1 FB1 floorbeam between the bottom flange cover plate and the edges of the bottom flange angles.

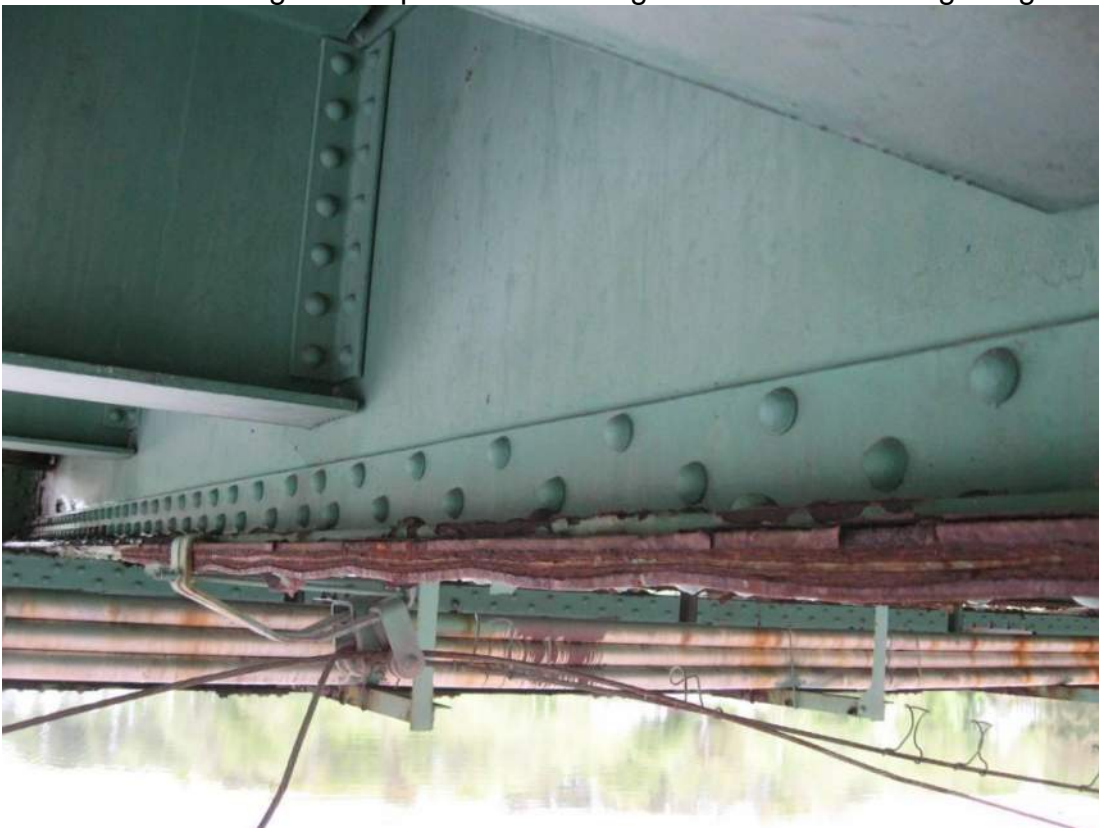
Photo 40 – An active pack rust condition was noted in the Span 2 FB5 floorbeam between S5 and S6.

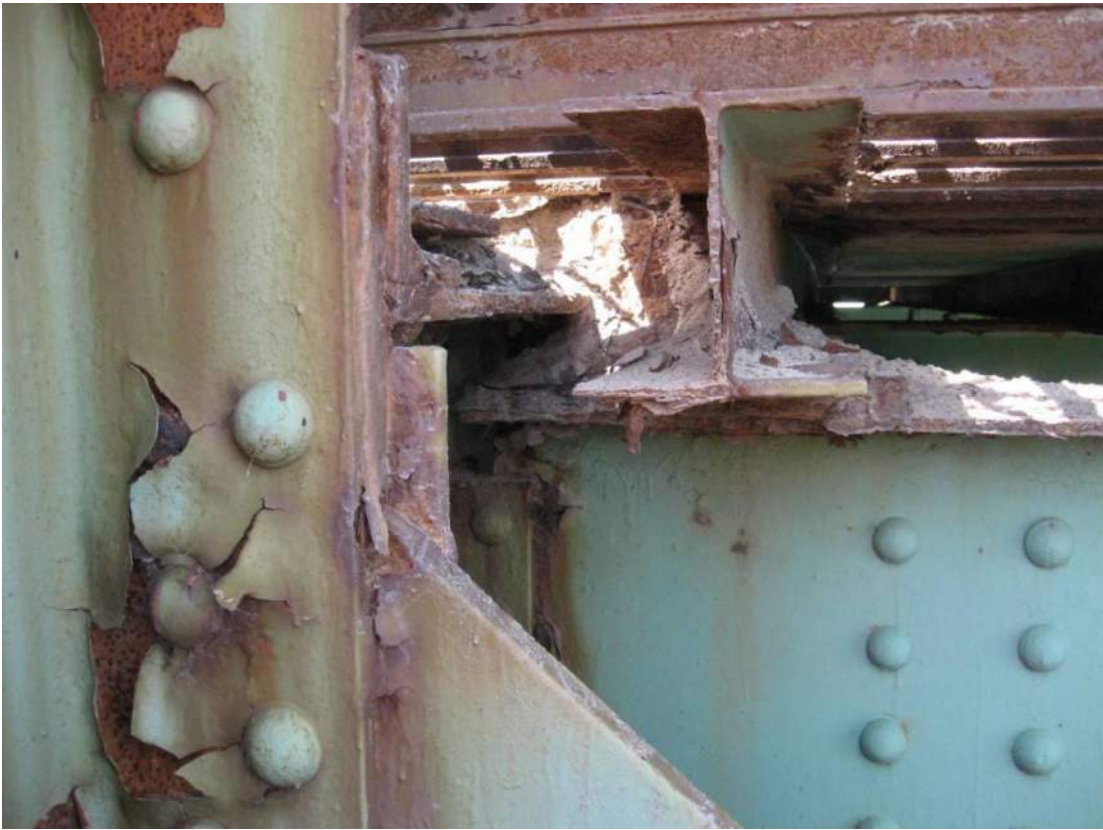
Photo 41– Span 1 FB2 has heavy debris accumulation from 4 to 6 inches deep on the top of the floorbeam flange. View looking west at roadway truss.

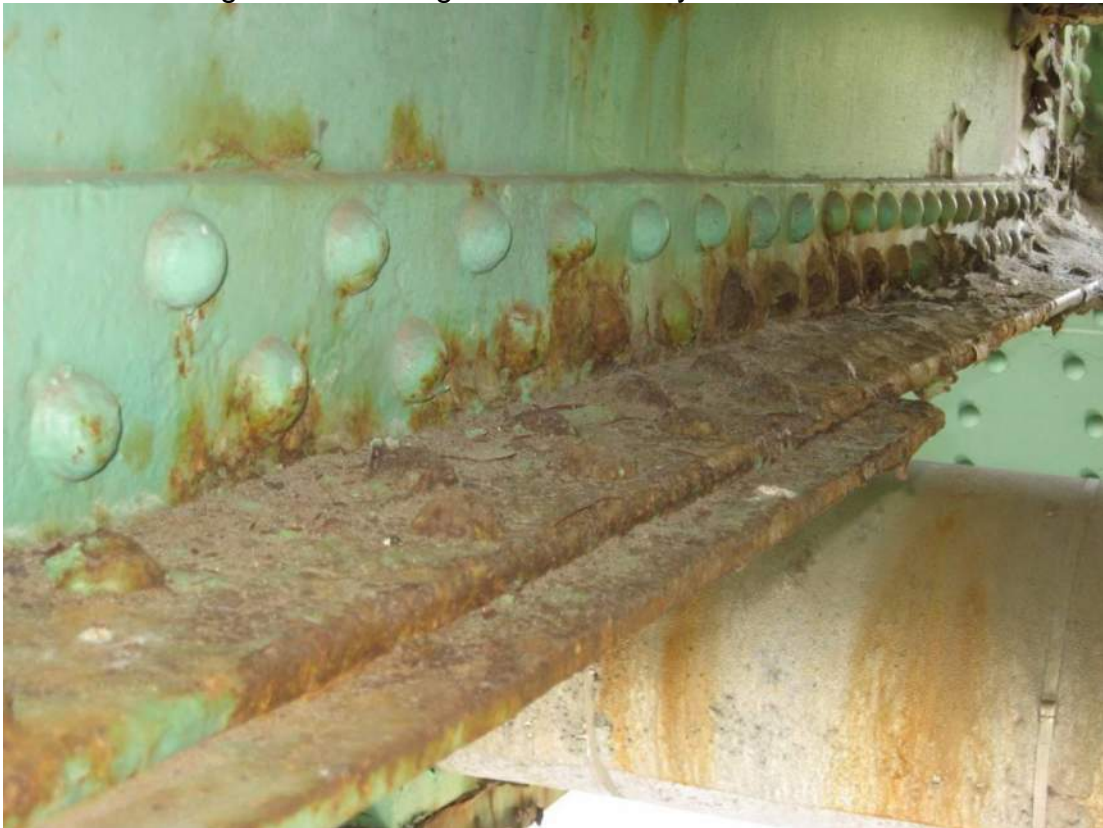
Photo 42 – Span 1 FB3 has moderate active corrosion to the bottom flange on the south side of the web between S6 and S8. View looking east.

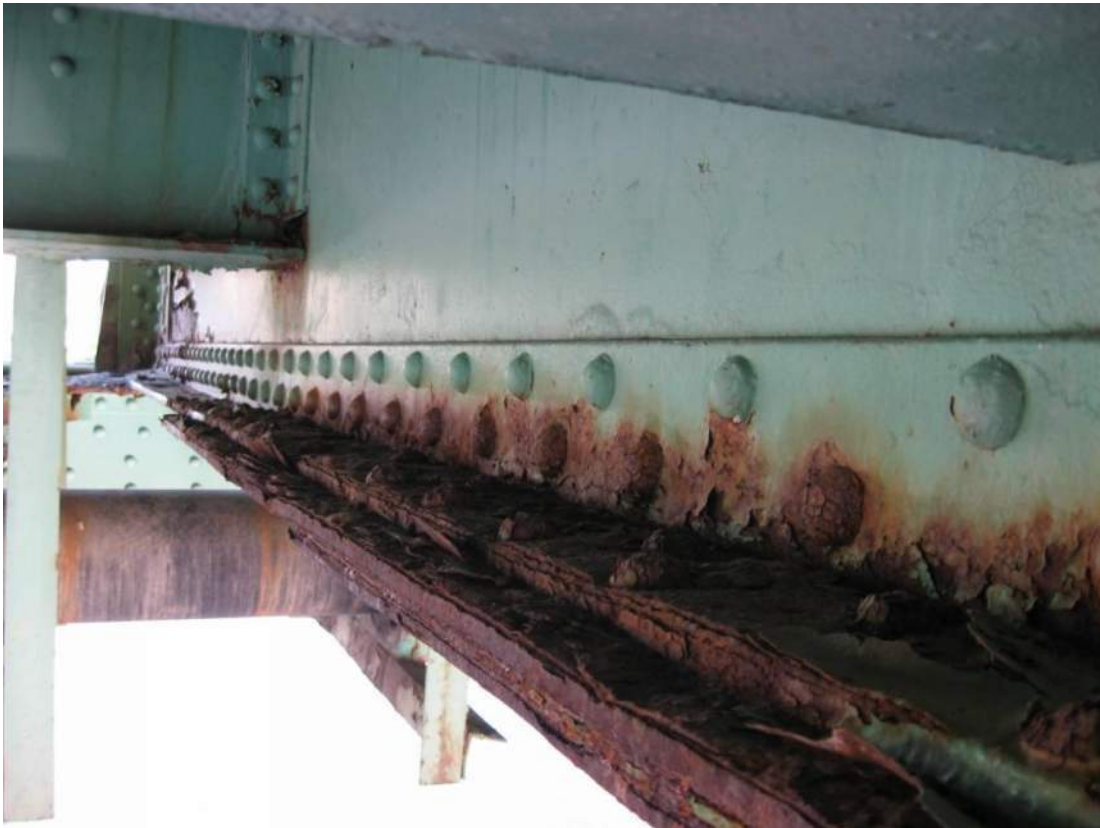
Photo 43– Span 1 FB5 has a zone of significant active corrosion to top of bottom flange on north side of web between S6 and S7 with up to 1/8 inch section loss to rivet heads.

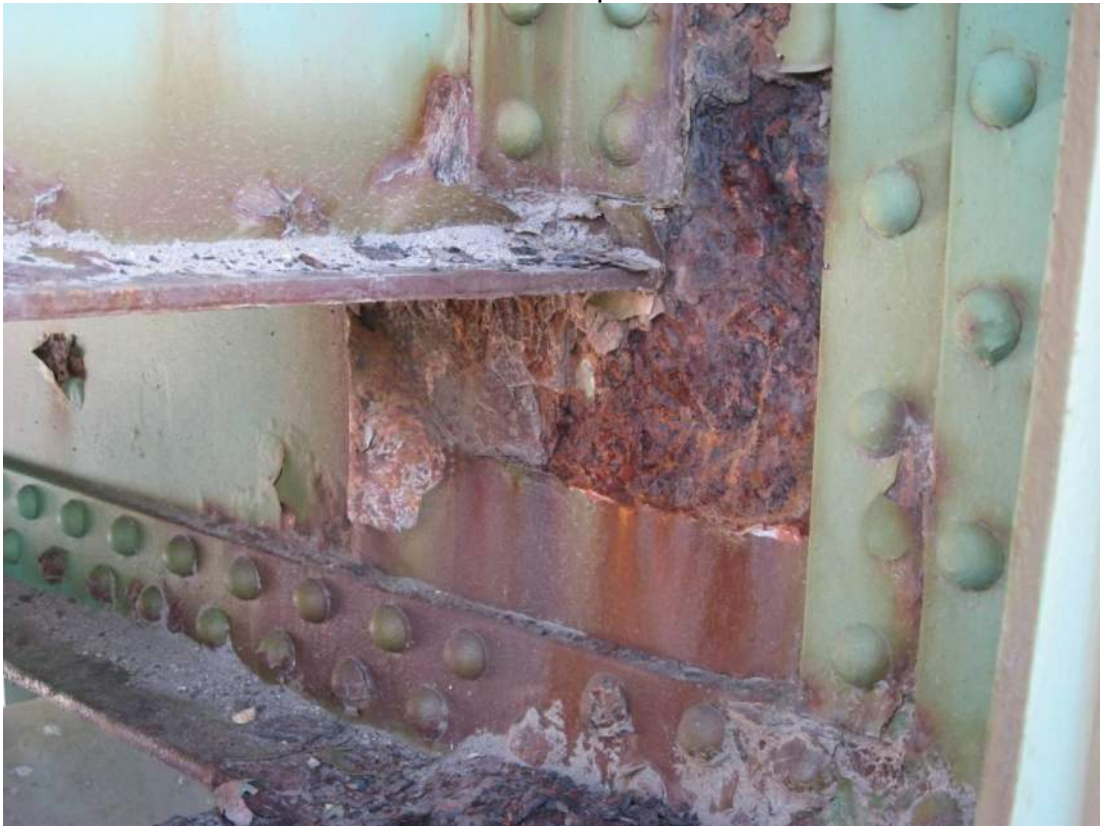
Photo 44 – At Span 1 FB7 below S8 both faces of the web exhibit active corrosion with section loss of 1/8 inch depth over a height of 8 inches and length of 12 inches.

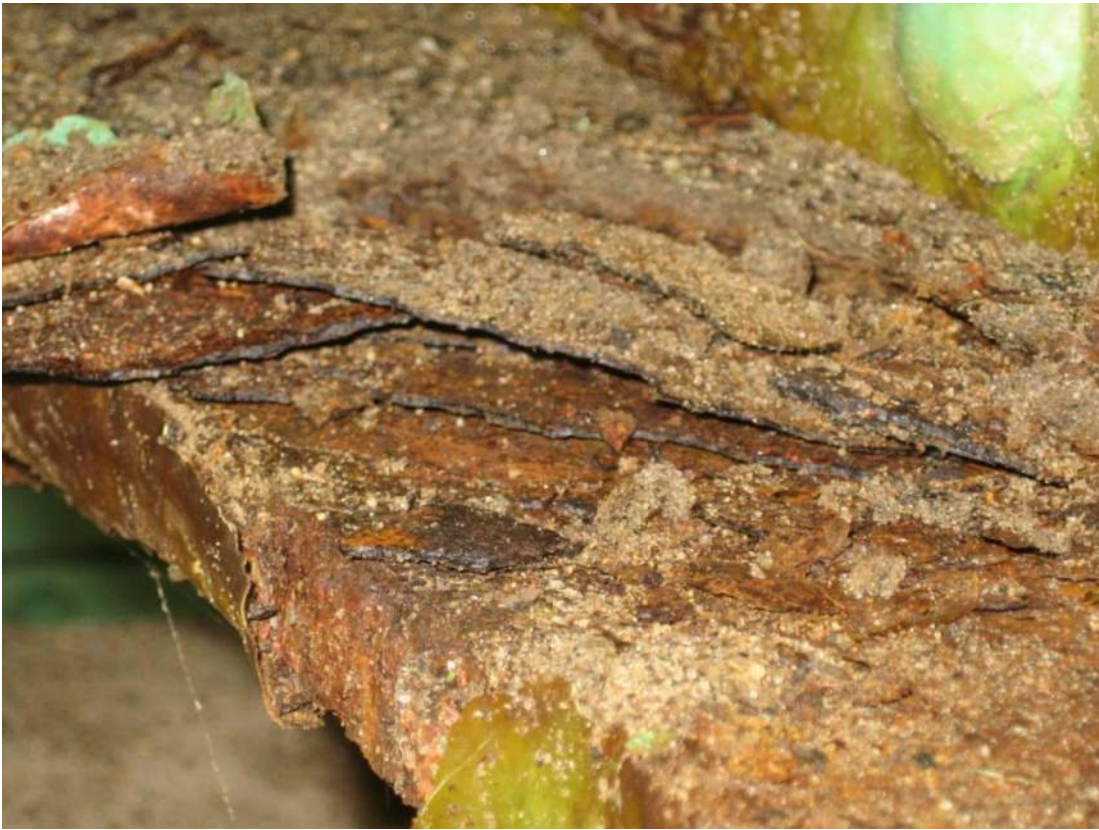
Photo 45– Span 2 FB8 has significant active corrosion and delamination to top of bottom flange angle on north side of web between S6 and S8 with up to 1/8 inch section loss.
