Preliminary Design Report

Frank J. Wood #2016

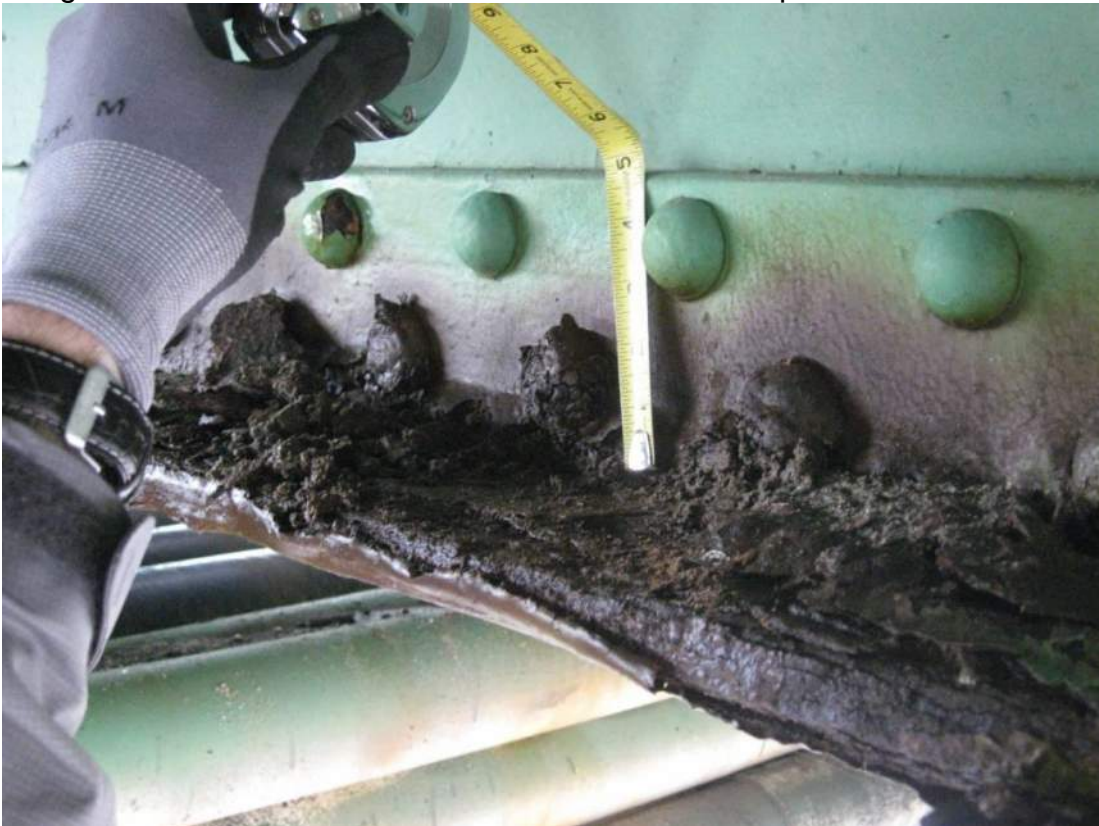
Photo 46 – Span 2 FB6 has a zone of significant active corrosion and 1/8 inch section loss to the top of the bottom flange on the south side of the web between S3 and S4.

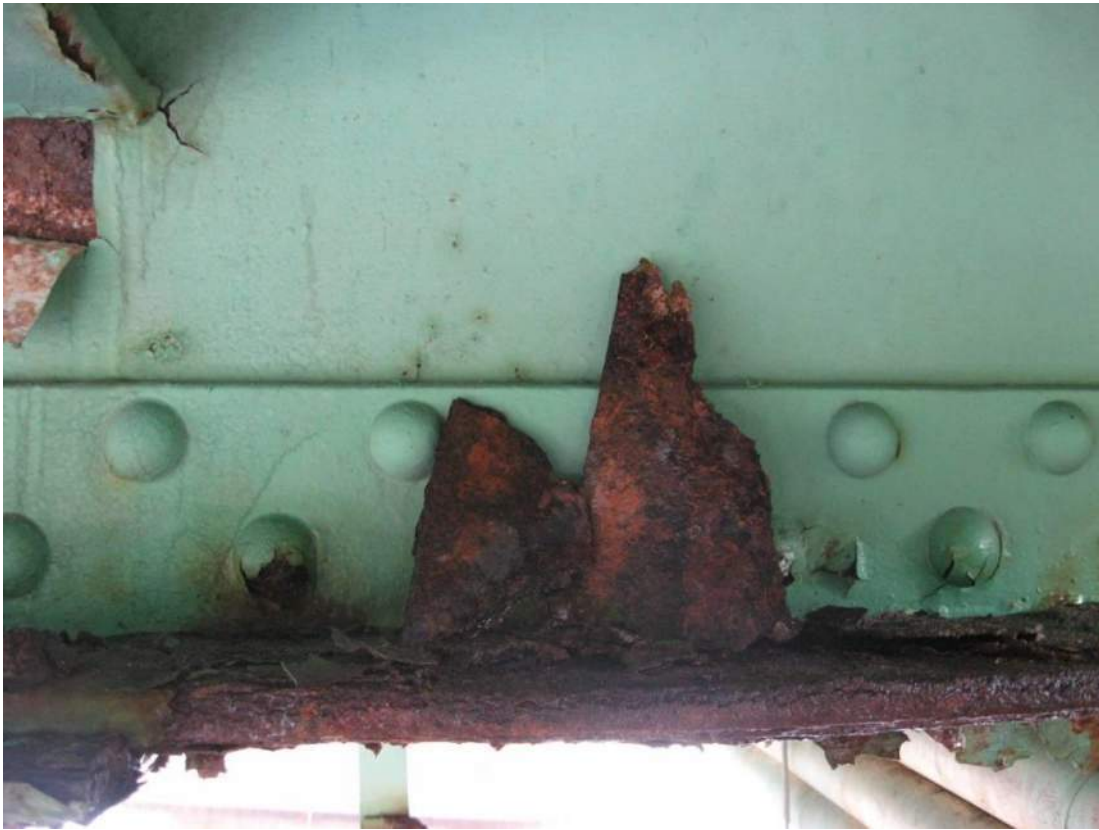
Photo 47– Span 2 FB4 has a 4” wide by 8” long zone of active corrosion/ delamination with 1/8” section loss to top of bottom flange on north side of web at 2 feet west of S4.

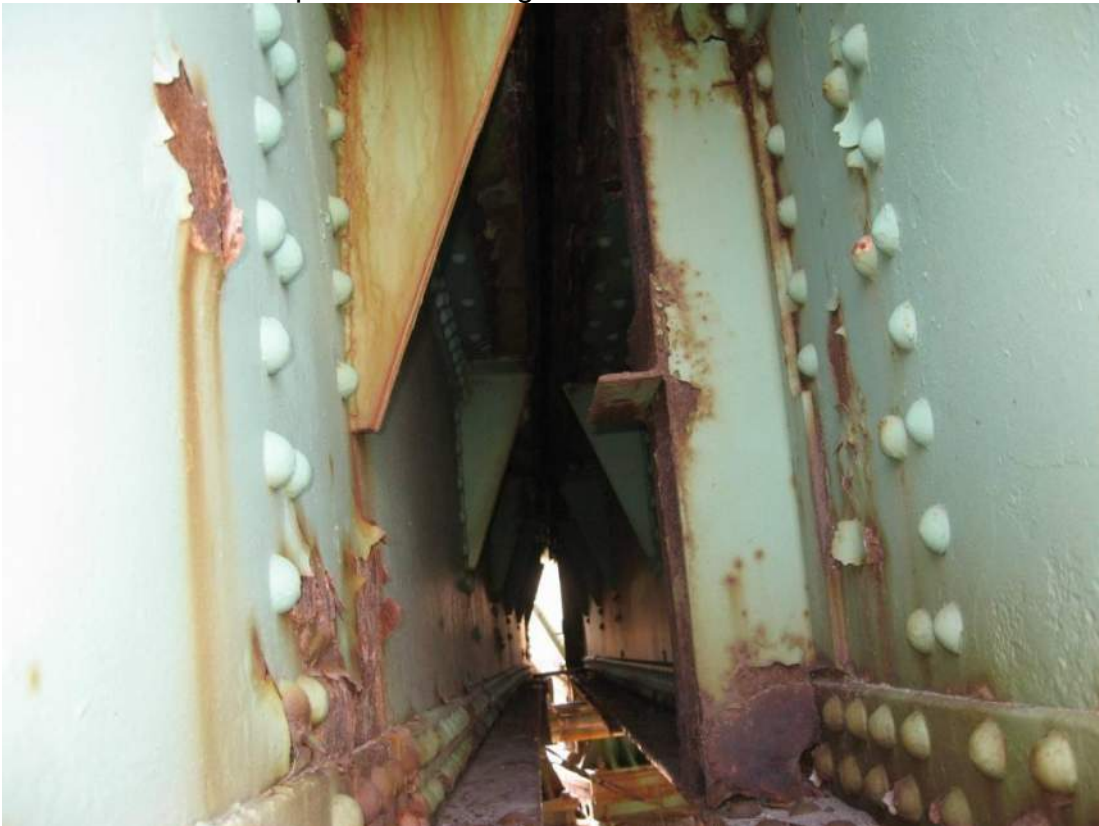
Photo 48 – The end floorbeams over Pier 1 have partial height welded stiffeners on face of web below deck joint, which constitutes a number of fatigue-sensitive details in FCM's.

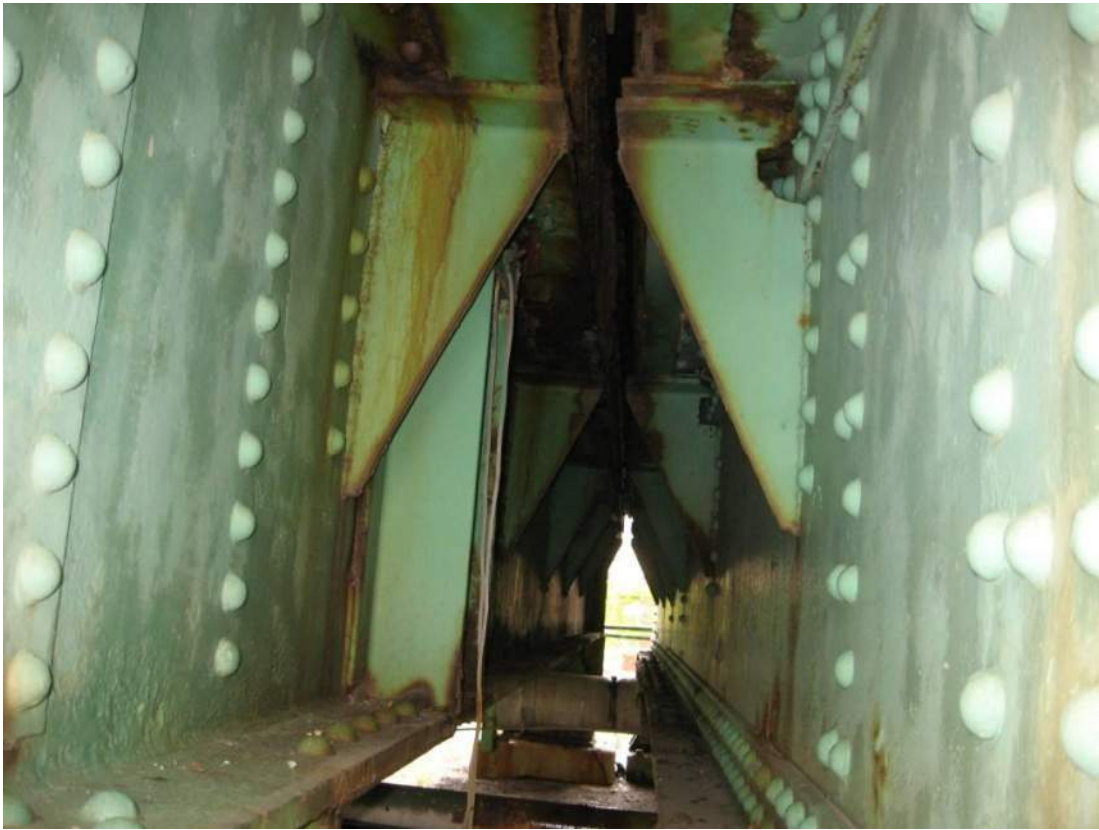
Photo 49– Partial height welded stiffeners on face of web below deck joint also observed at Pier 2 for the Span 2 and 3 end floorbeams (fatigue-sensitive details in FCM's).

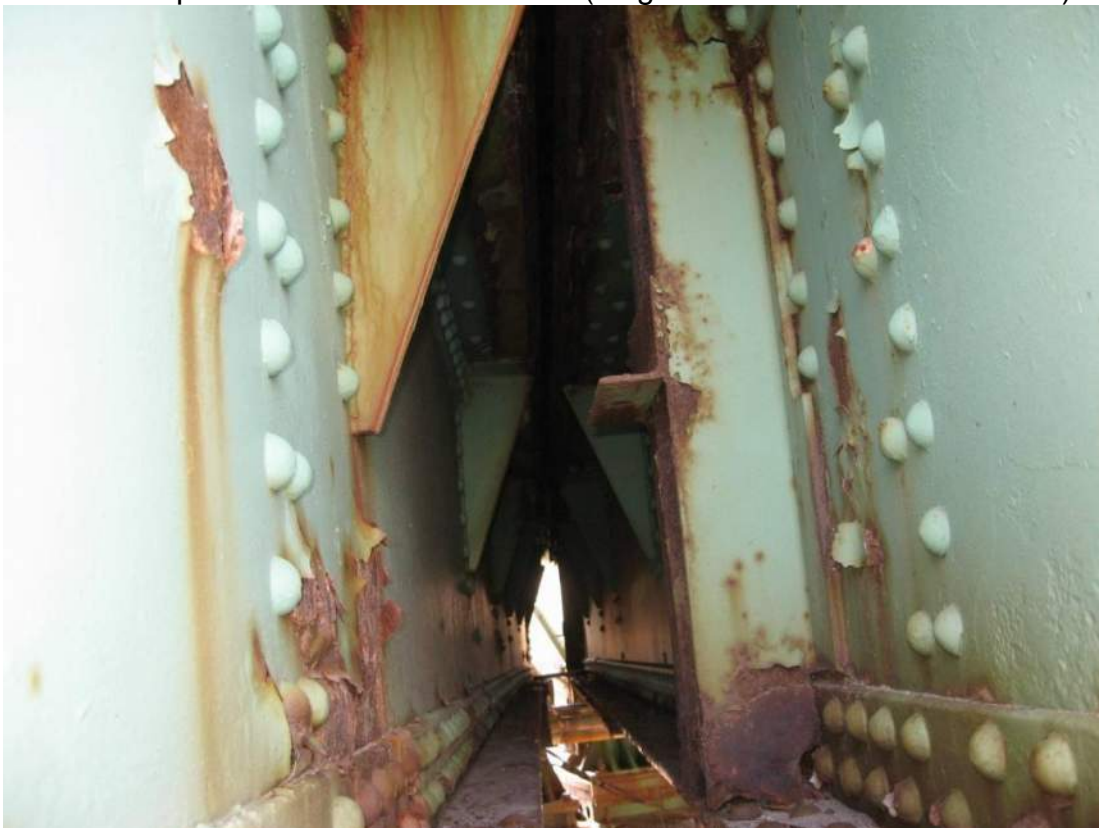
Photo 50 – Span 2 FB0 on right also has full height welded jacking stiffeners at both ends (FSD's in FCM's). Jacking stiffeners are also present on opposite face of web.

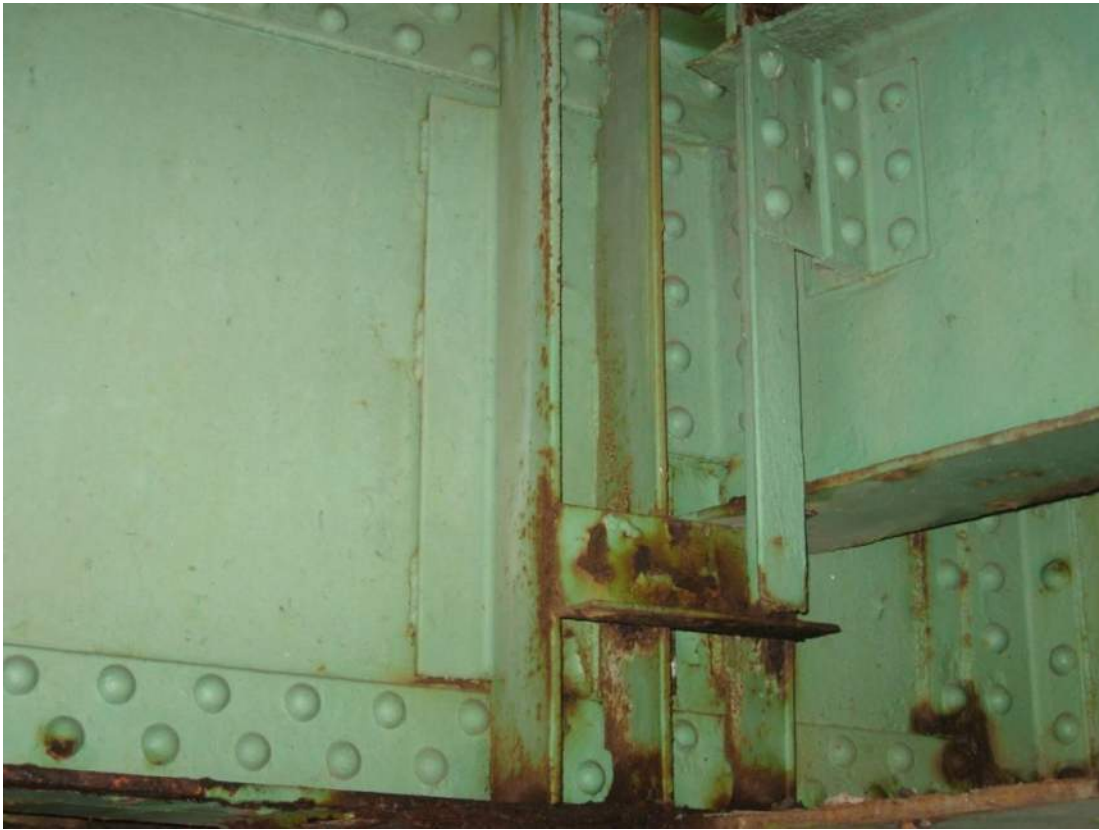
Photo 51– Full height welded jacking stiffeners were also noted on north face of Span 2 and 3 FB0 webs (on face opposite deck joint) at sidewalk and roadway truss ends.

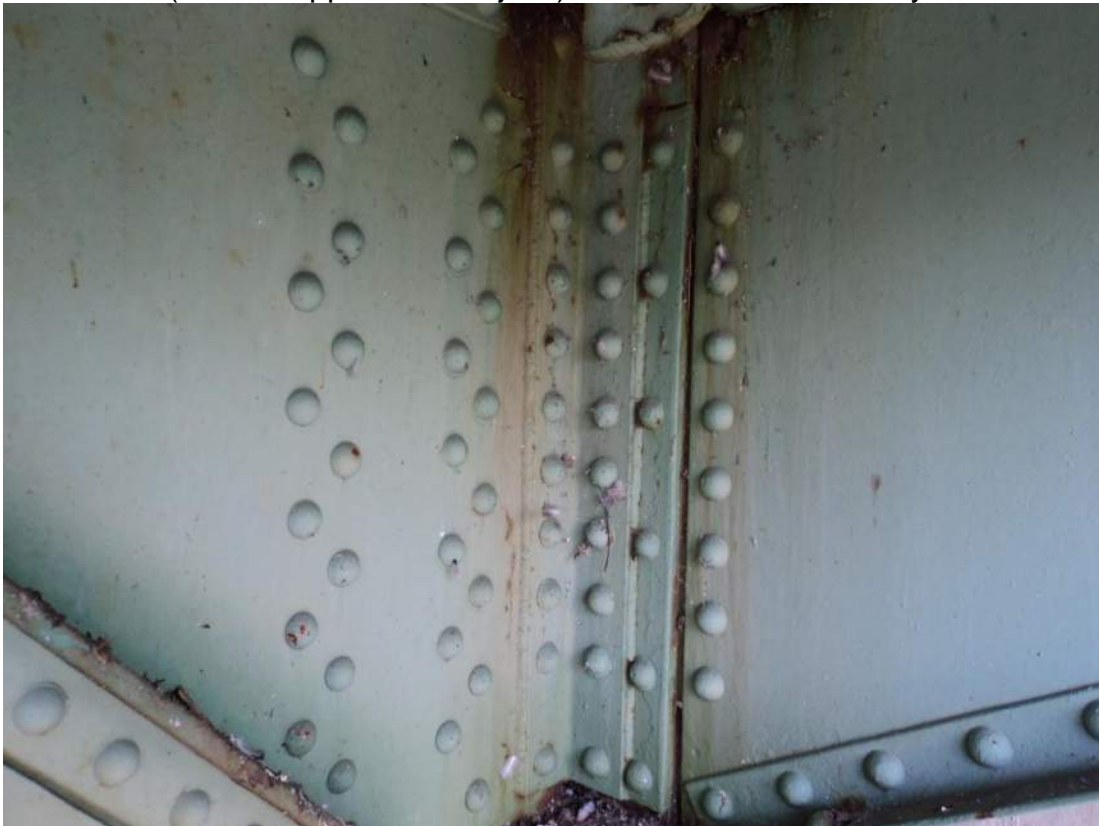
Photo 52 – Sidewalk cantilever bracket clip angles were observed to be welded full height to the gusset plate and to the web fill plate on the bracket web at Span 1 L0.

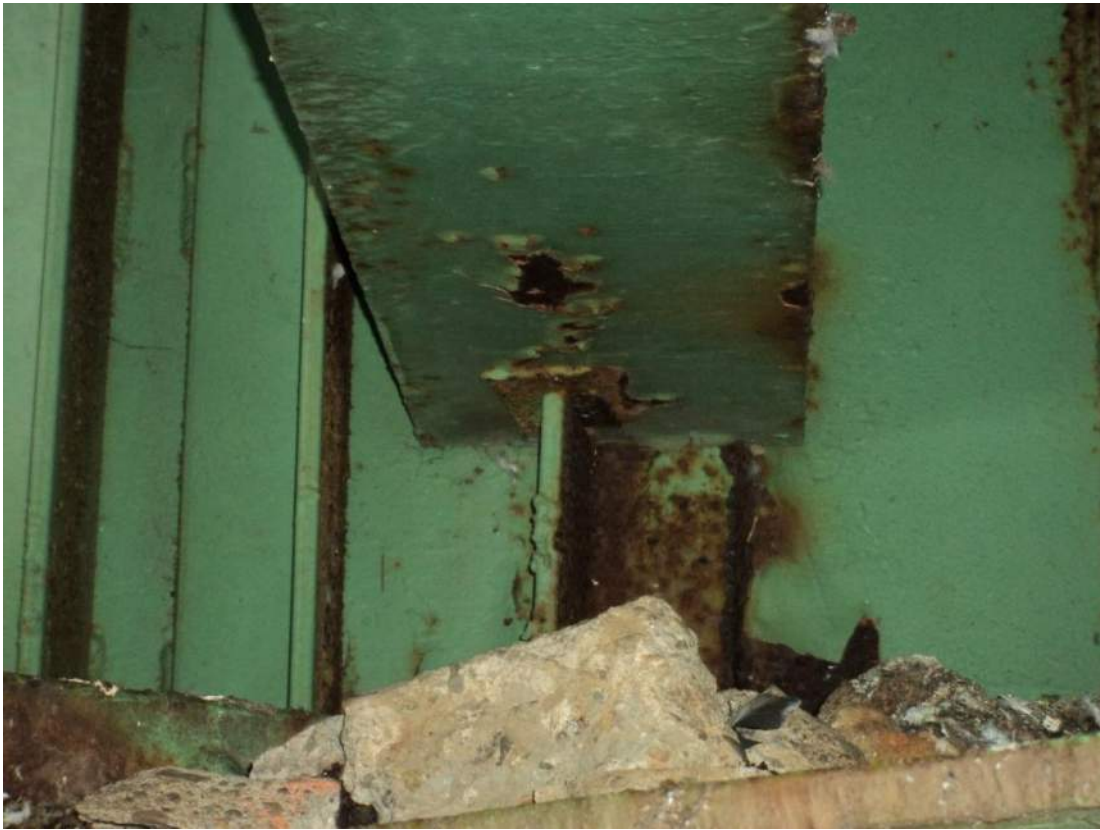
Photo 53– The north face of the Span 1 end floorbeam FB0 has a welded plate stringer bearing stiffener below S3 which constitutes a fatigue-sensitive detail in a FCM.

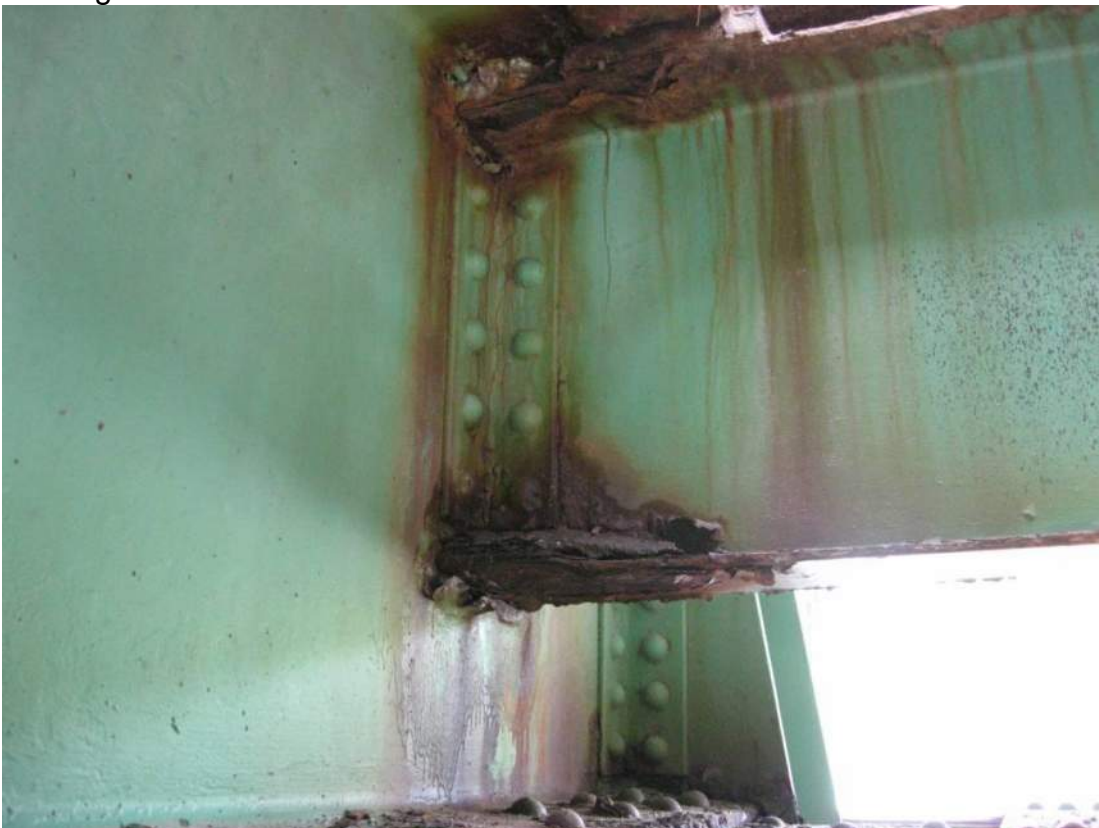
Photo 56 – Stringer S3 has pack rust on bottom flange and bottom of web at connection to north face of Span 3 FB3. Similar conditions noted at three other S3 stringer ends.

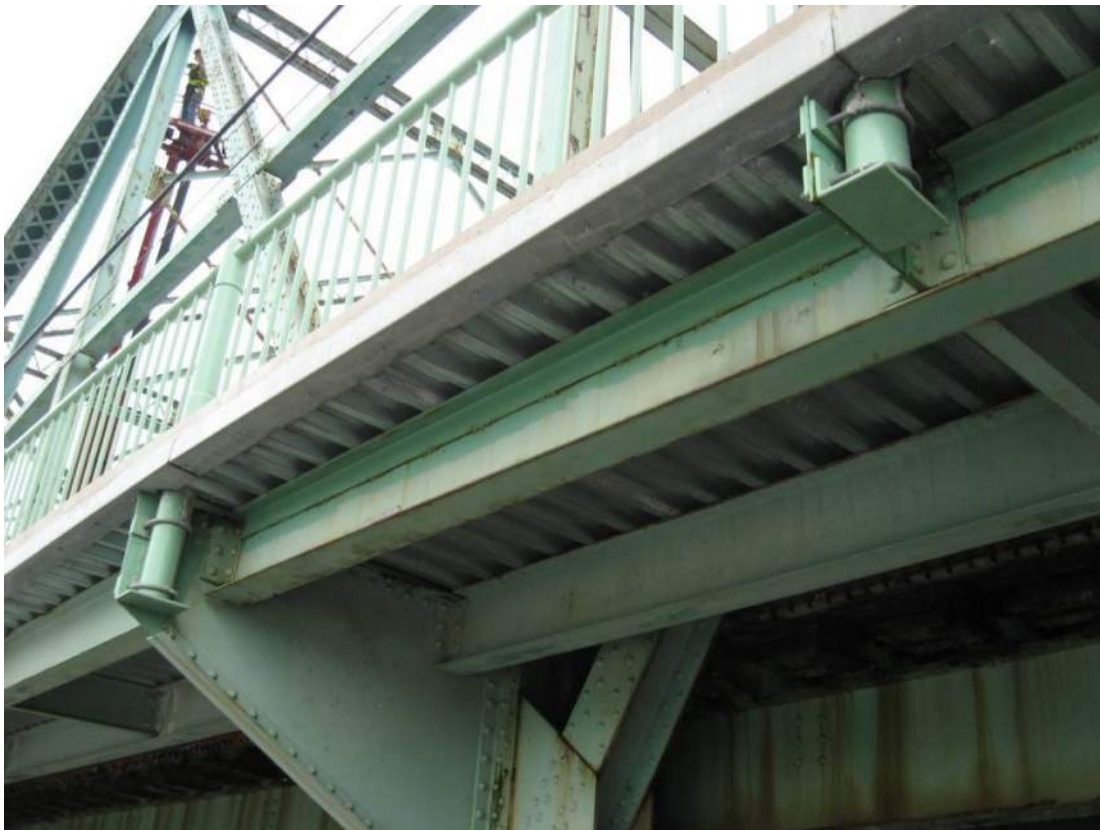
Photo 57– Sidewalk stringer S1 has been previously repaired at numerous panels by stitch welding a pair of angles to top of web, to restore section loss to original top flange.

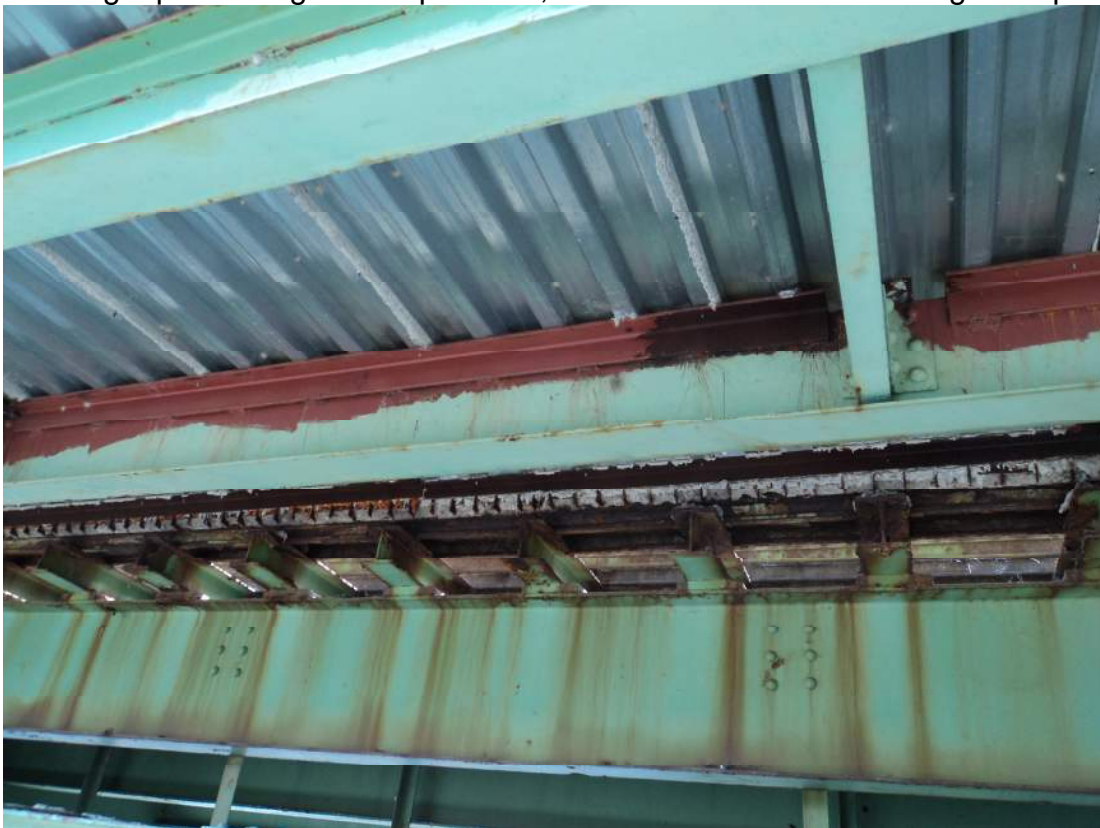
Photo 58 – Similar repairs were also observed on sidewalk stringer S2 where the top flange angle repair was left prime-painted only on both sides of the stringer.

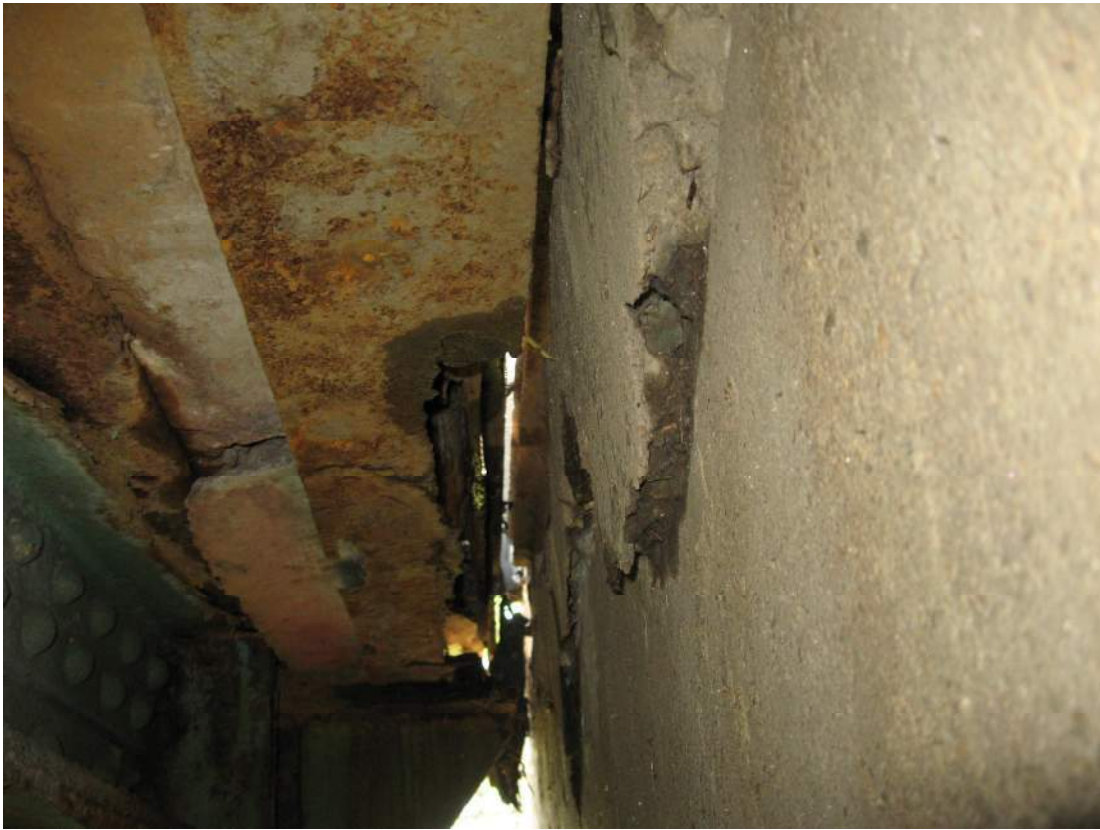
Photo 59– A three inch width of the bottom flange south edge is missing from the south abutment transverse cross-beam over a 4 foot length between S7 and S8.

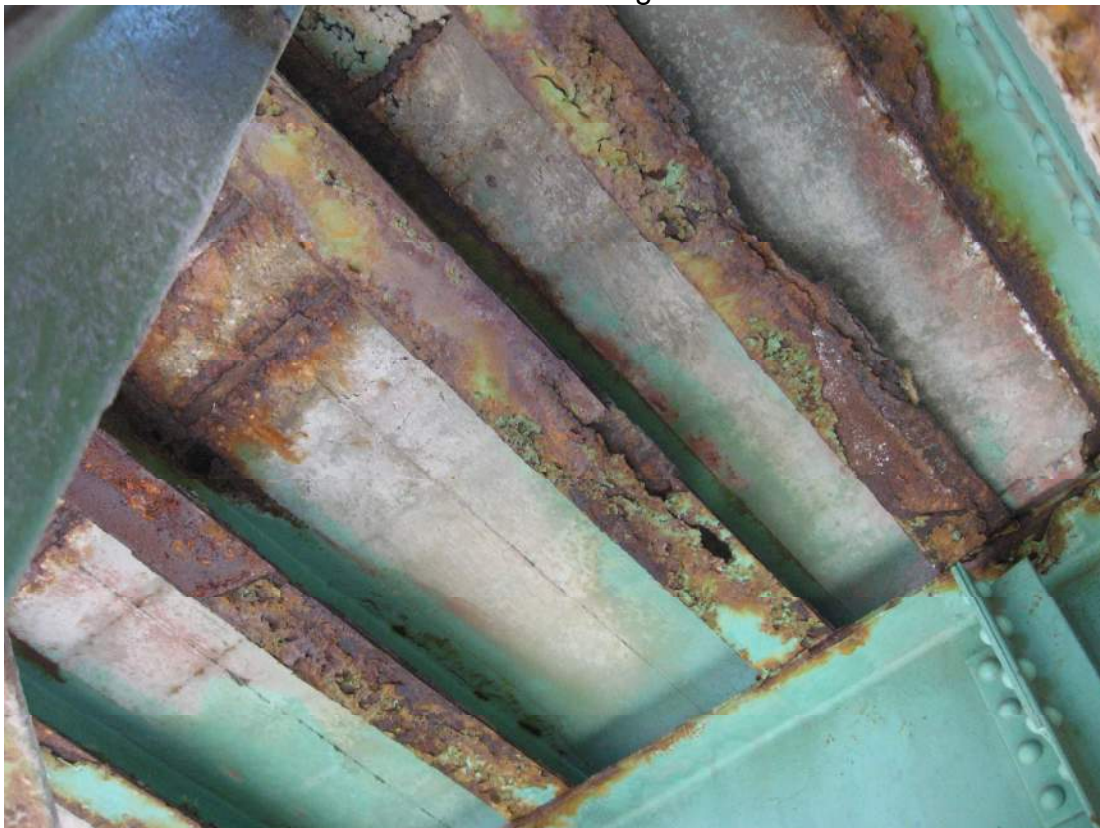
Photo 60 – Section loss and perforation to two cross-beams in Span 1 near FB2 between S7 and S8 where bottom flange has up to 3/16" section loss over 2 inches along edge.

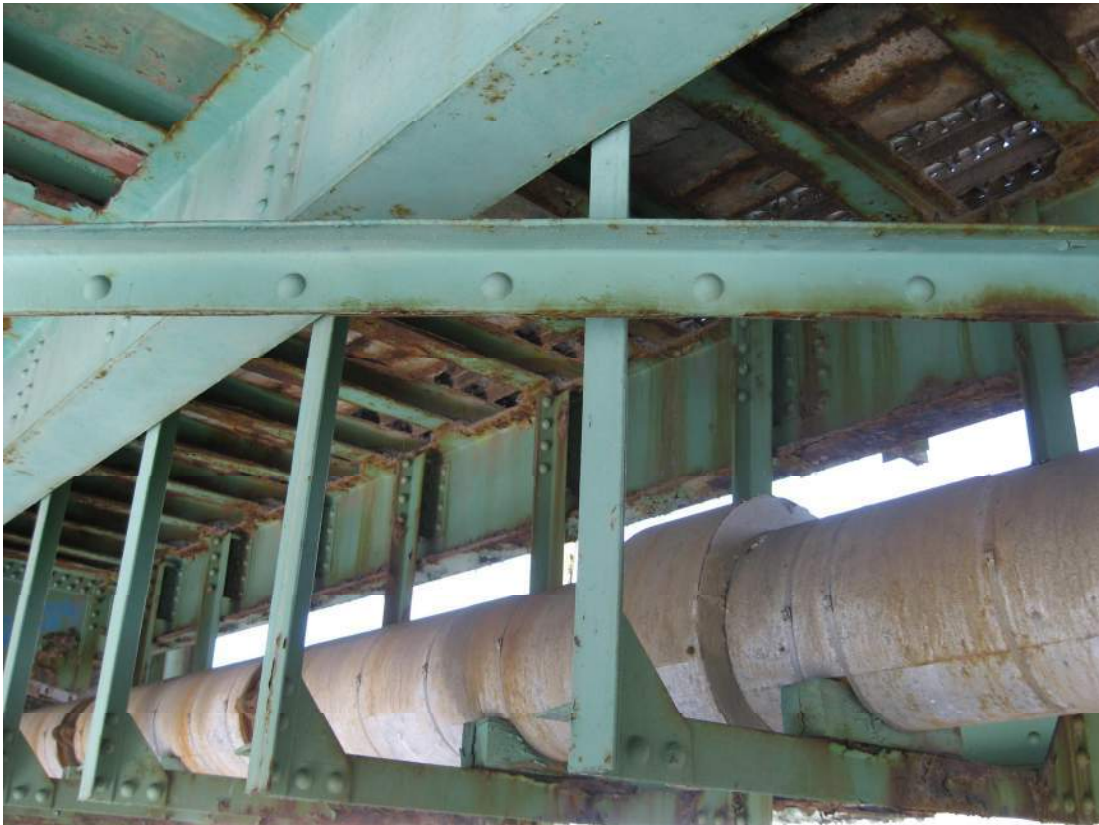
Photo 61– The typical paint condition on grid deck cross-beams between S7 and S8 is poor throughout the bridge length with active corrosion on most cross-beams this bay.

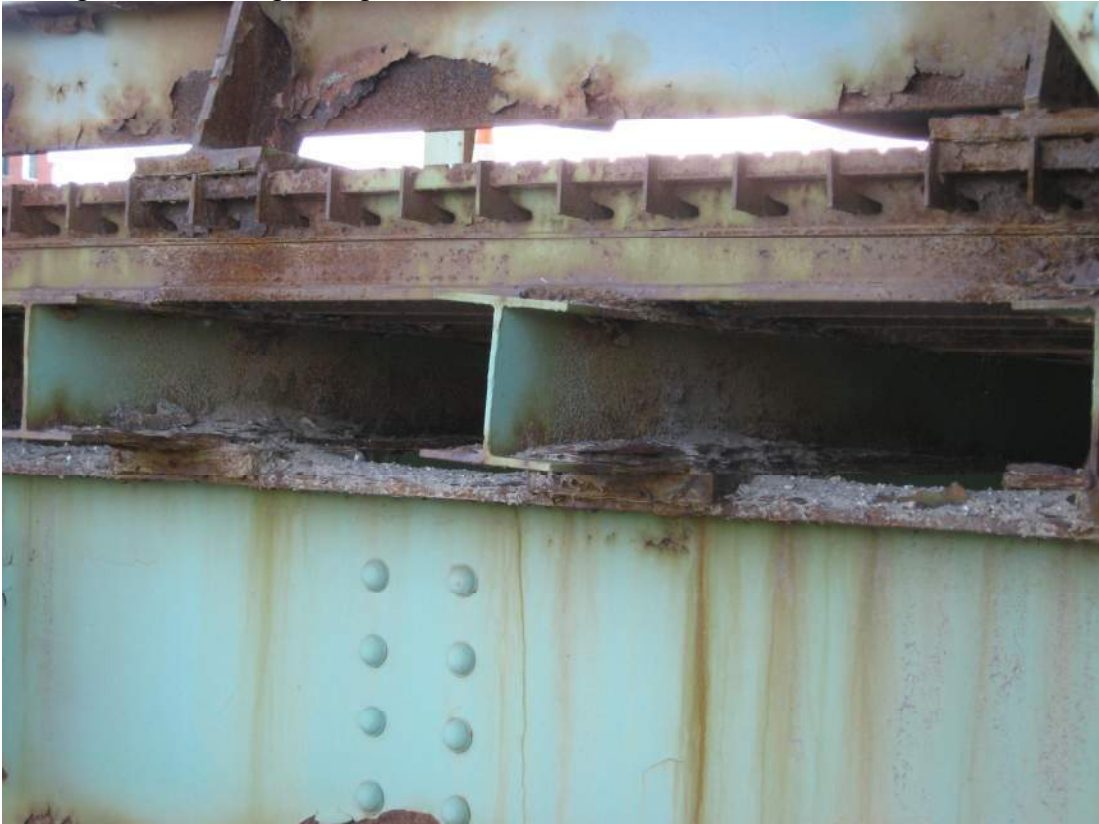
Photo 62 – The east end of a grid deck cross-beam above S8 between L7 and L8 was observed to be twisted around cross-beam axis due to pack rust at the S8 connection.

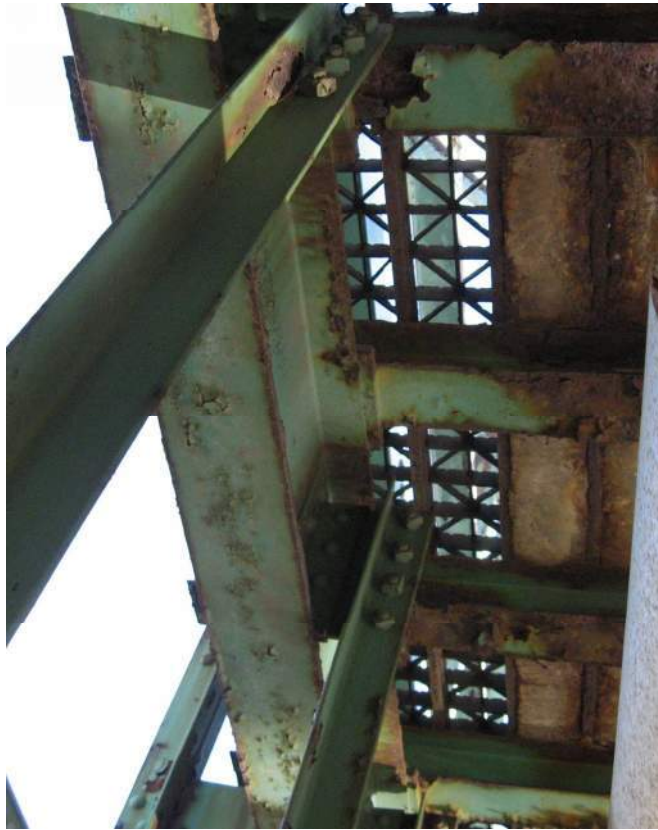
Photo 63– Perforations at the flange edges and in the bottom flange of the cross-beams was observed in Span 3 near L6 in the ends of the cross beams.

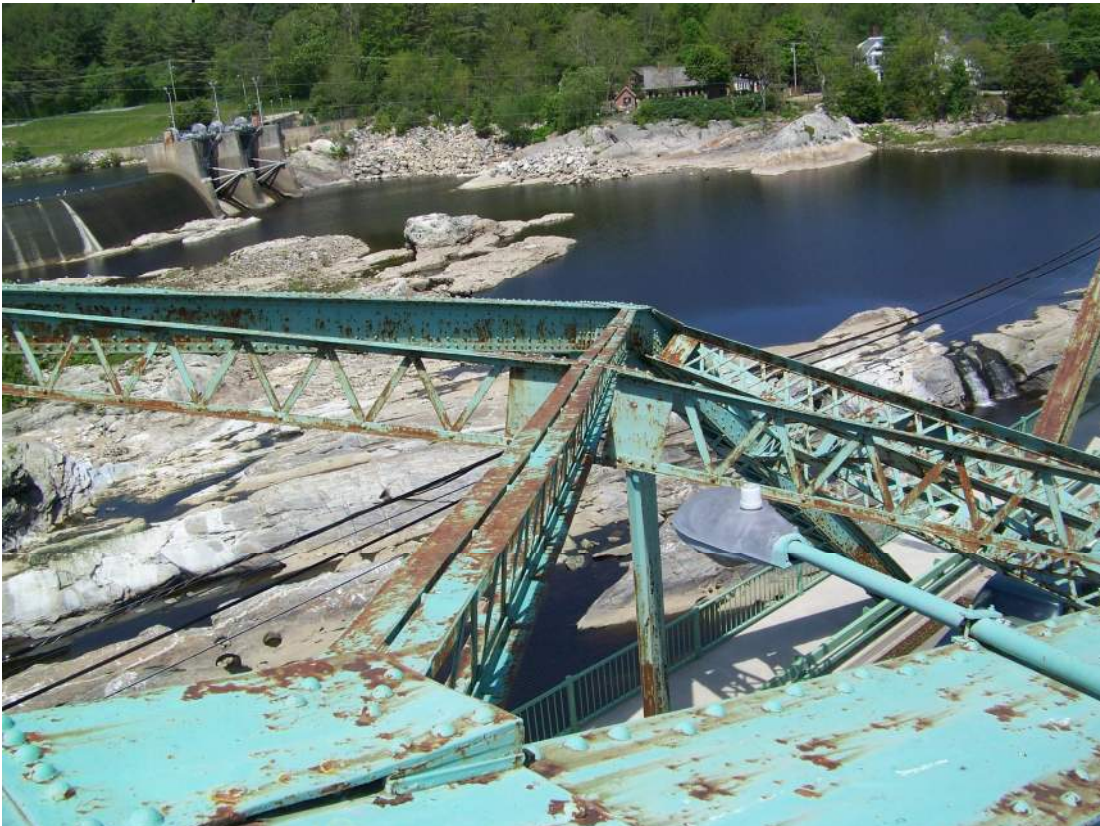
Photo 64 – The paint system is failed over more than 30% of the surfaces of the top chord lateral bracing. View looking northwest in Span 1 toward U9 sidewalk truss.

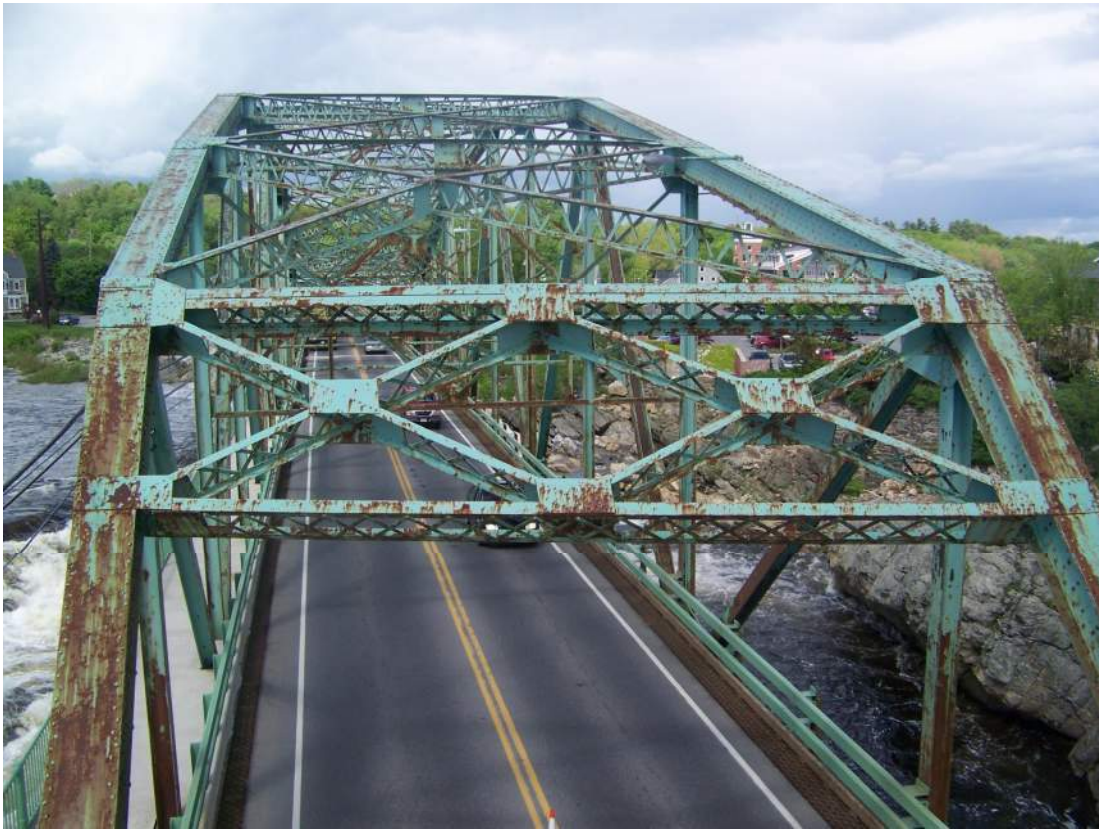
Photo 65– The paint system is failed over more than 30% of the surfaces of the top chord lateral bracing. Looking north toward Span 2 portal.

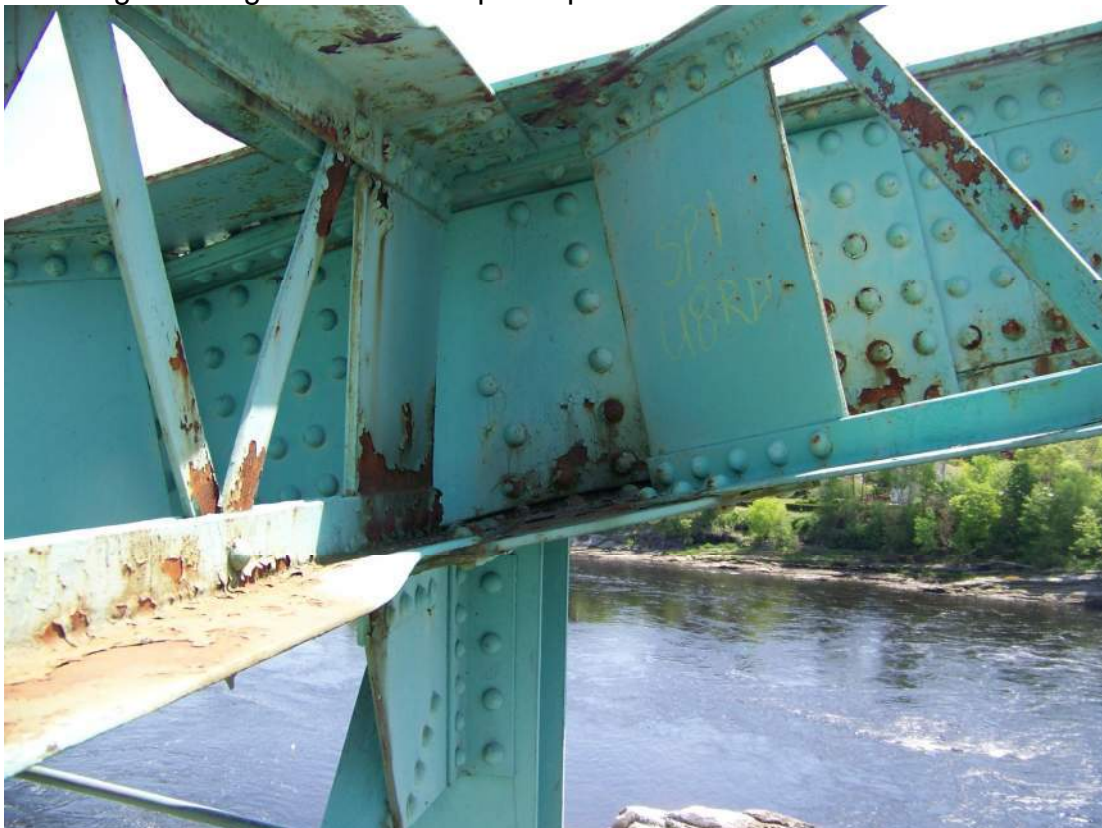
Photo 66 – The ends of the top laterals at numerous locations have intentional crimping-related distortion to accommodate the member slopes at the upper panel points.

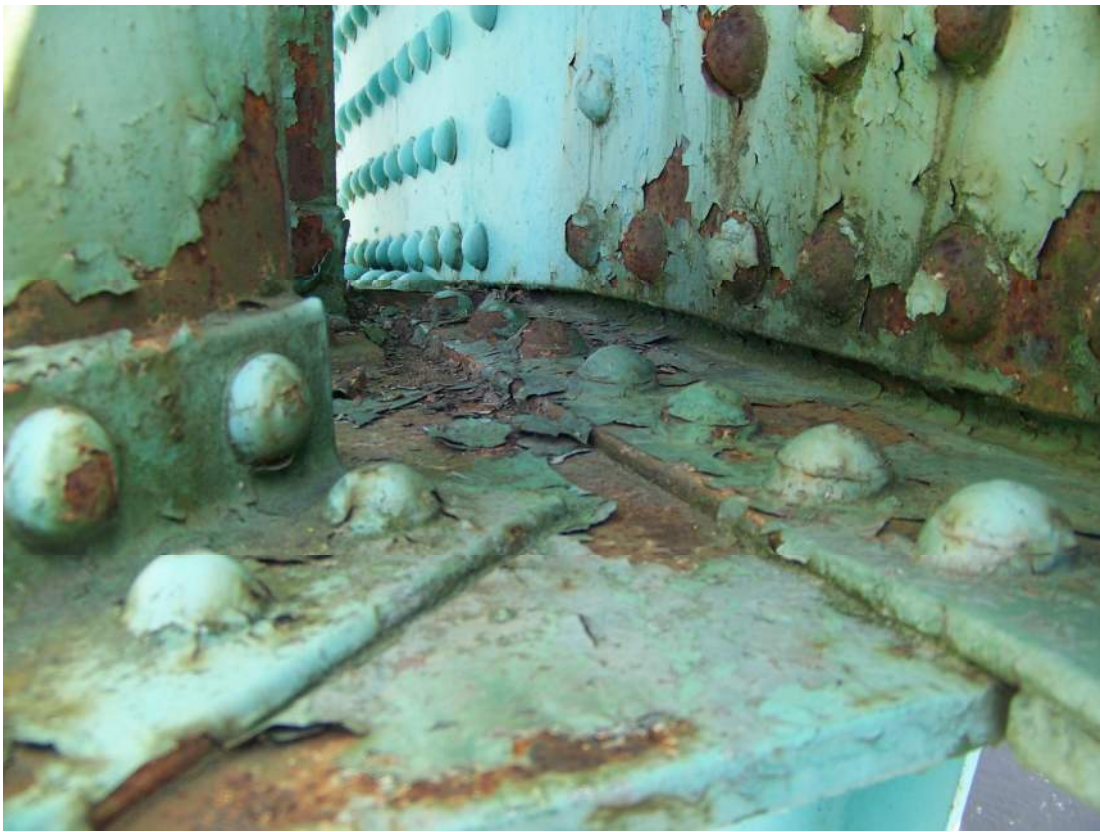
Photo 67– Many of the upper chord lateral bracing connection plates have paint failures and active corrosion. View at Span 1 roadway truss U8.

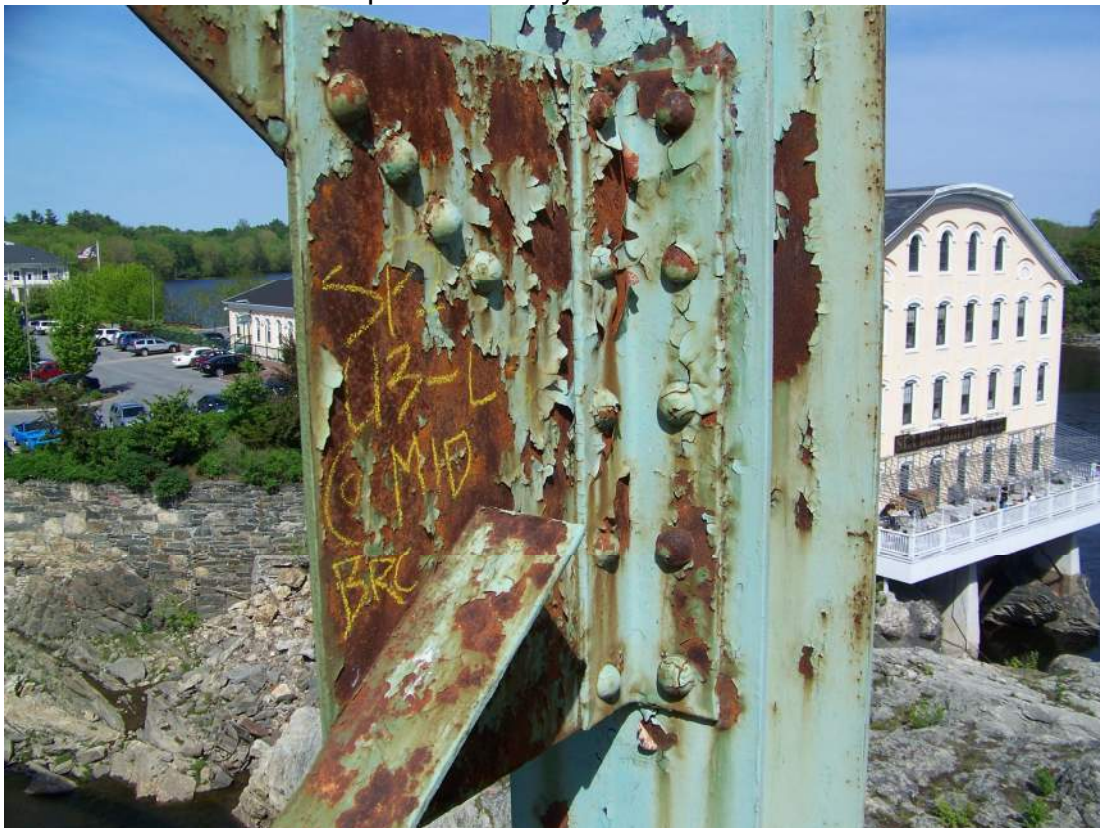
Photo 68 – The mid-lateral sway frame bracing connection plates at U3 to U7 typically have peeling or failed paint. View at Span 2 roadway truss U3-L3 mid-lateral.

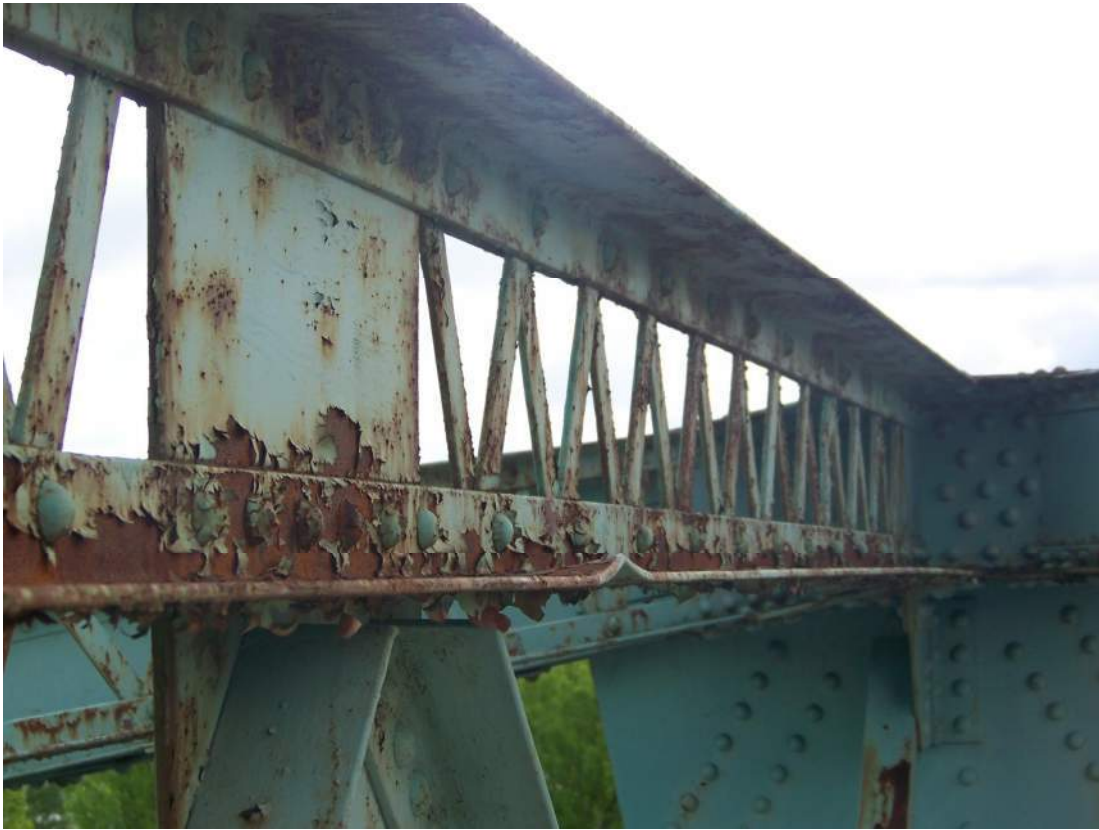
Photo 69– The Span 3 U5 upper chord lateral bracing transverse top strut has a $\frac{3}{4}$ inch upward bend in the south side lower angle edge at one foot east of roadway centerline.

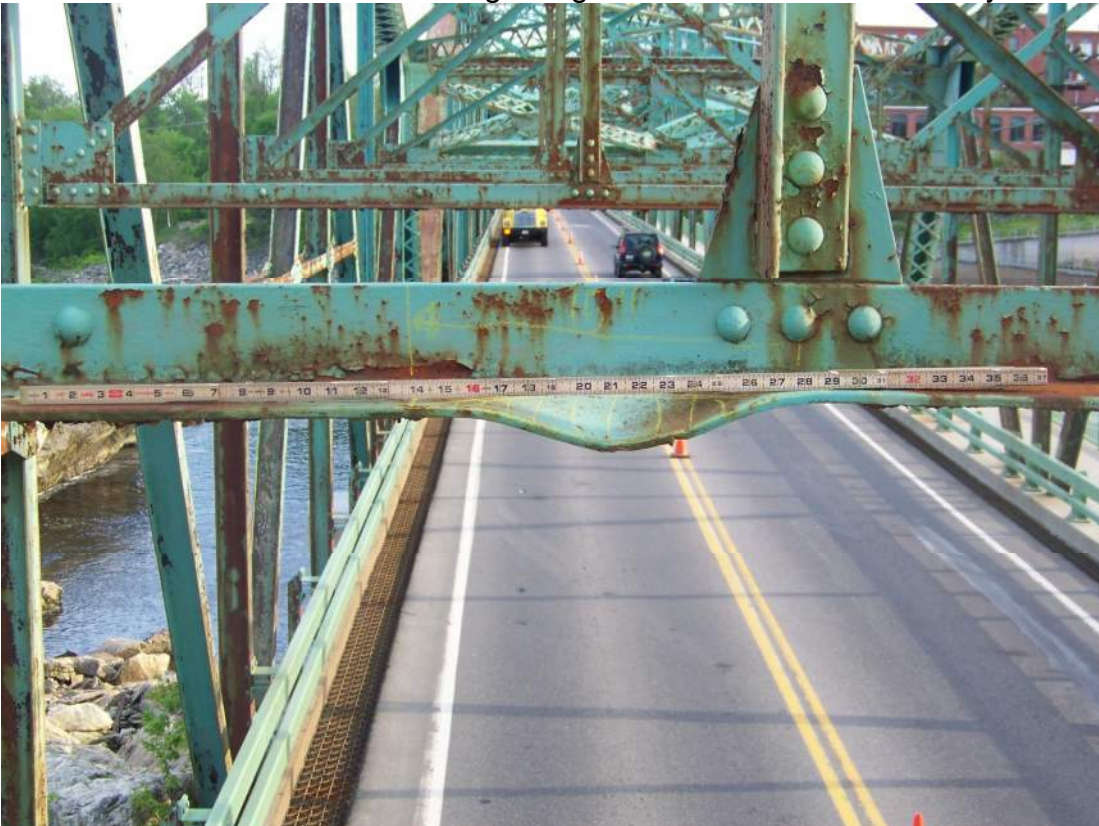
Photo 70 – Span 3 U6 sway frame strut has impact damage which has deflected the north horizontal leg downward by $1\frac{1}{4}$ " over northbound lane just east of bridge centerline.

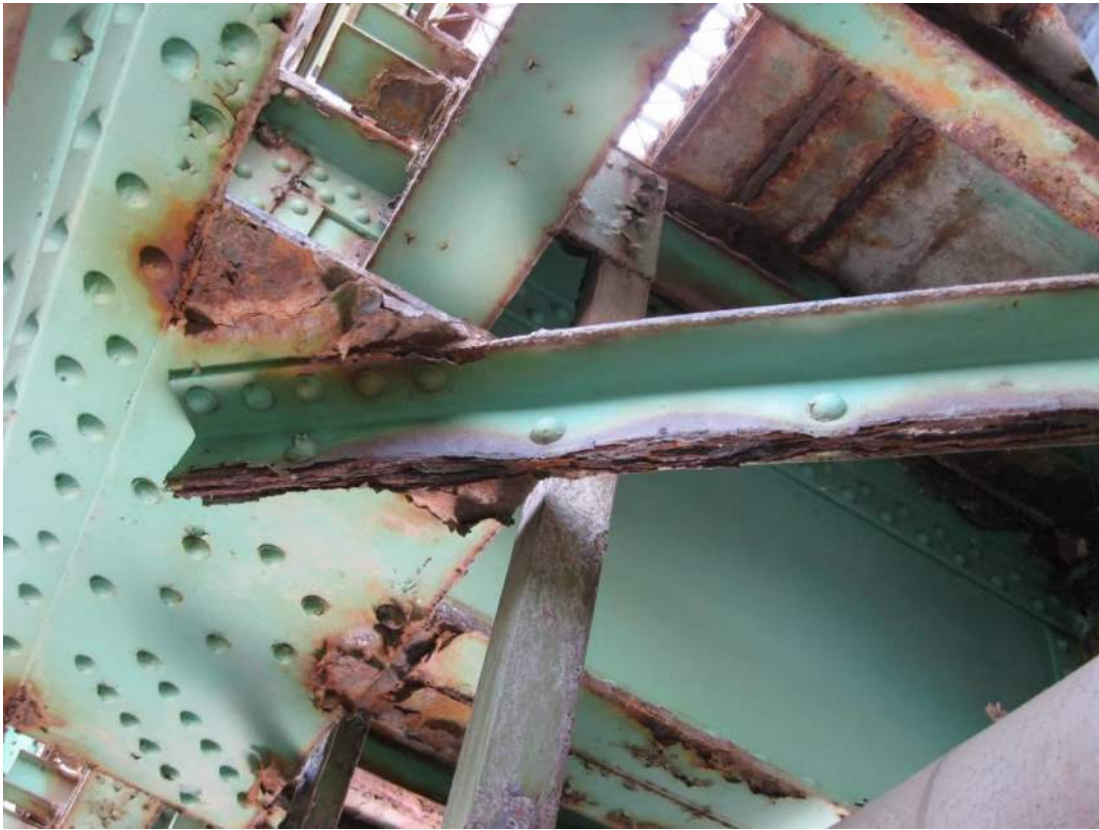
Photo 71– Severe pack rust with active corrosion over a 4' length of lower lateral bracing angle connecting Span 1 L3 roadway truss and L4 sidewalk truss at the L3 end.
