Preliminary Design Report

Frank J. Wood #2016

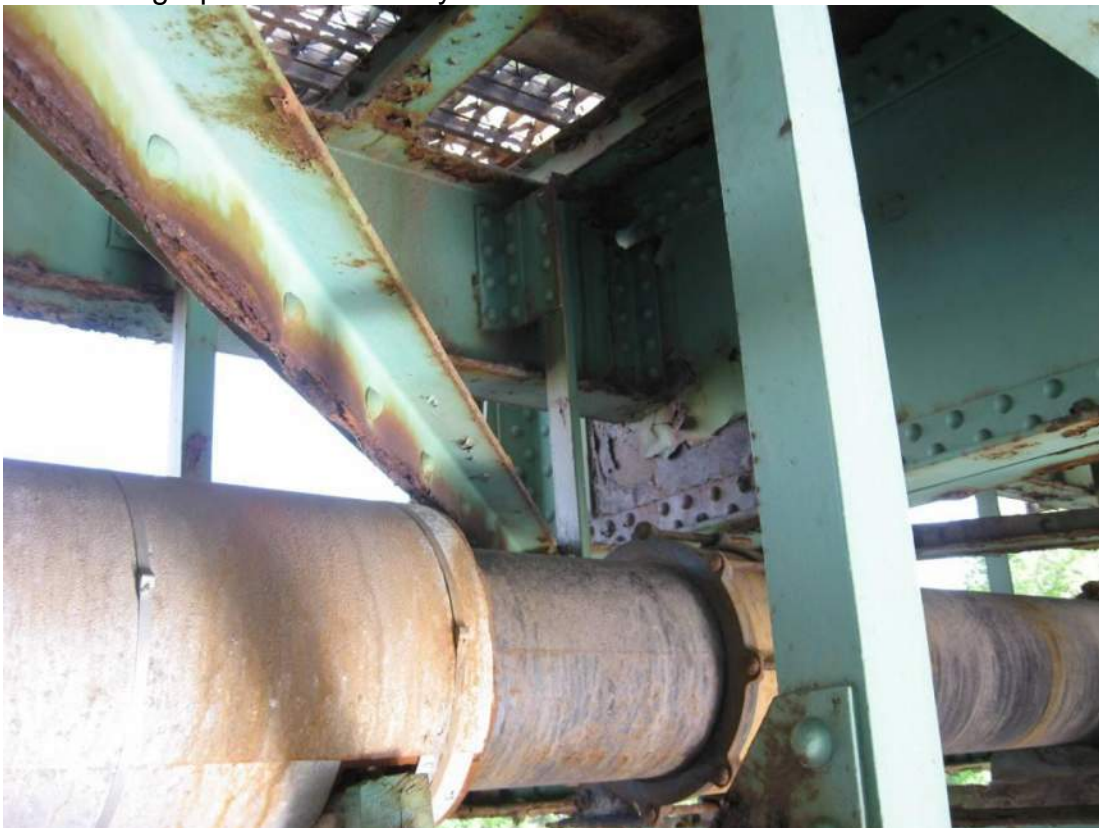
Photo 72 – Severe pack rust with active corrosion between back to back angles of lower lateral bracing connecting Span 1 L5 roadway truss and L6 sidewalk truss at L5 end.

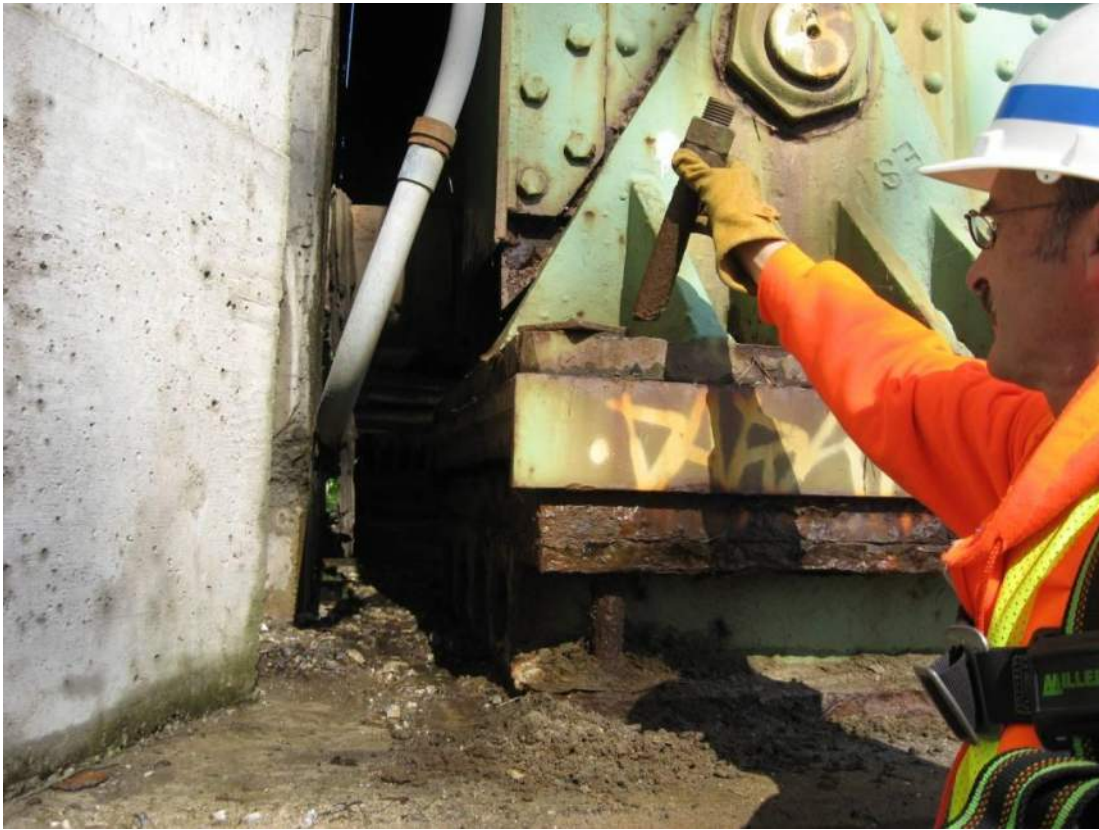
Photo 73– The roadway truss bearing at the south abutment has a loose anchor bolt which was removed, photographed and loosely re-inserted by the inspection crew.

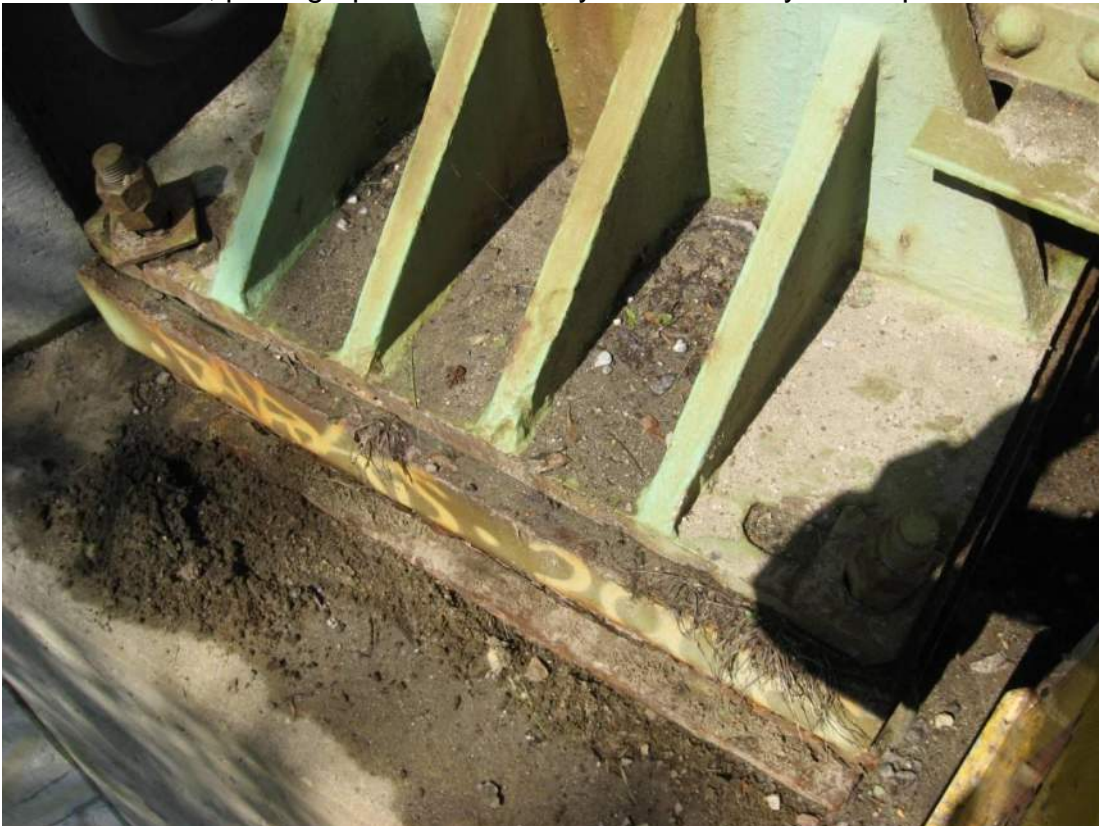
Photo 74 – Expansion slots in the south abutment roadway truss bearing upper shoe are completely filled with debris accumulations which preclude normal thermal movement.

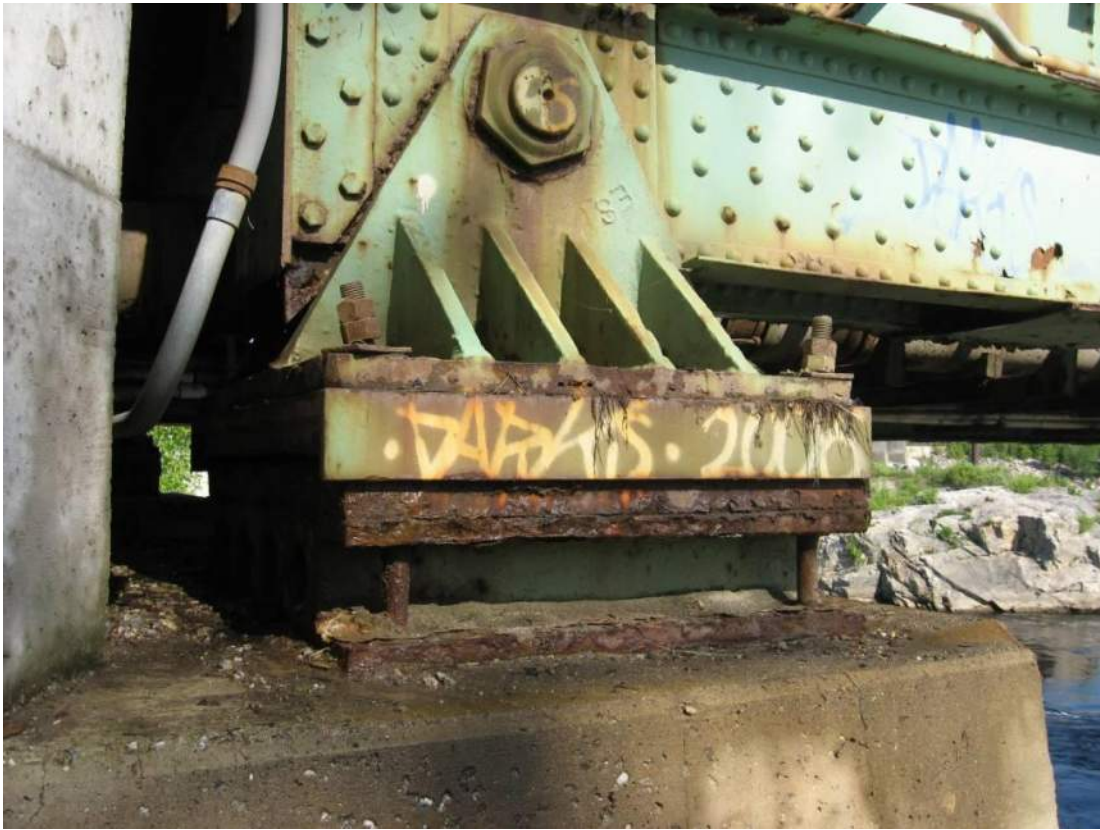
Photo 75– The two anchor bolts on the east side of the south abutment roadway truss bearing were noted to be bent off plumb in opposite directions.

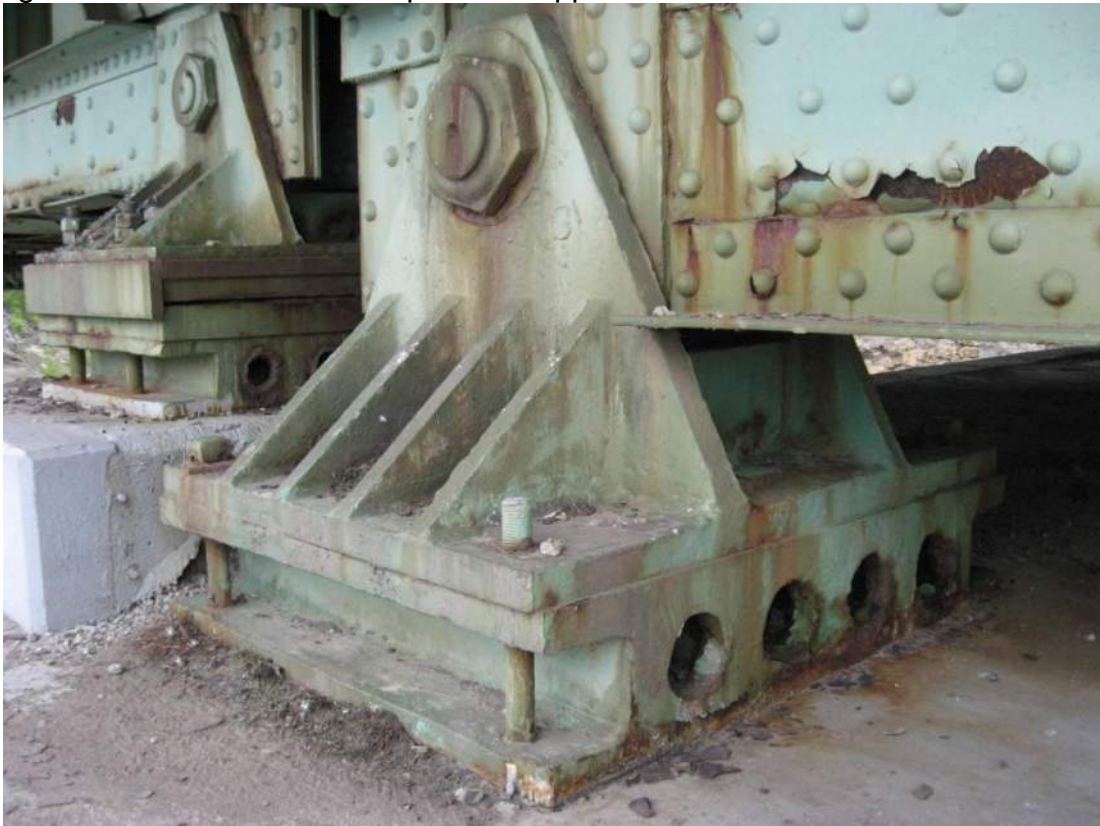
Photo 76 – The Span 2 sidewalk truss fixed bearing at Pier 2 is missing a nut on the southwest anchor bolt. View looking northeast.

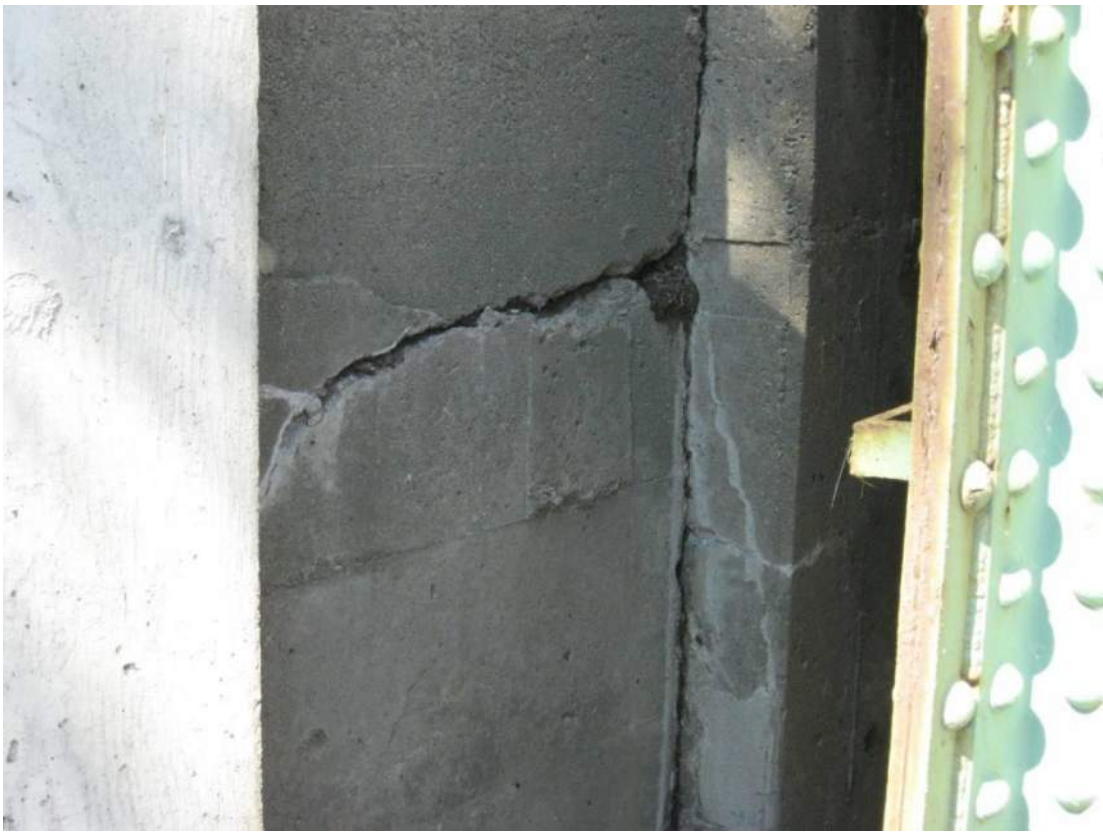
Photo 77– The south abutment backwall has a wide 2 foot long horizontal crack near the wingwall corner at approximately 4 feet above the bridge seat.

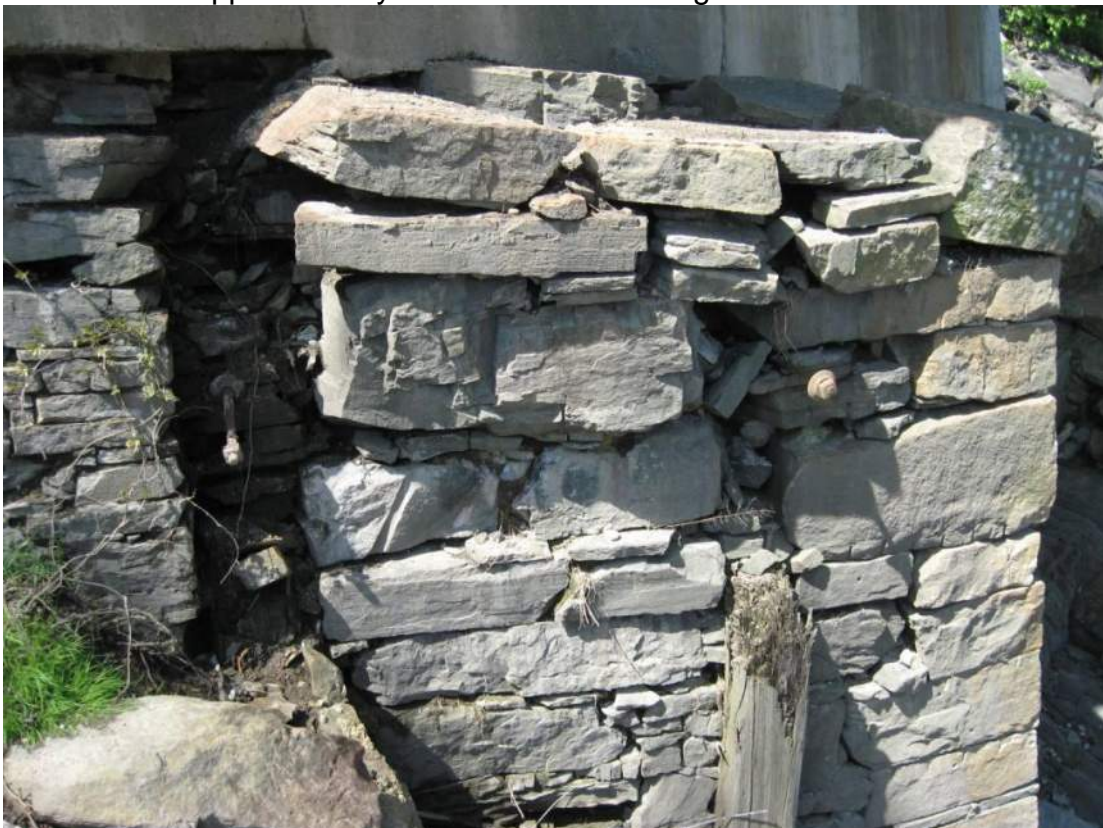
Photo 78 – Older stone masonry portions of south abutment exhibit remnants of missing timber bracing anchors and possible signs of outward shifting of a few of the stones.

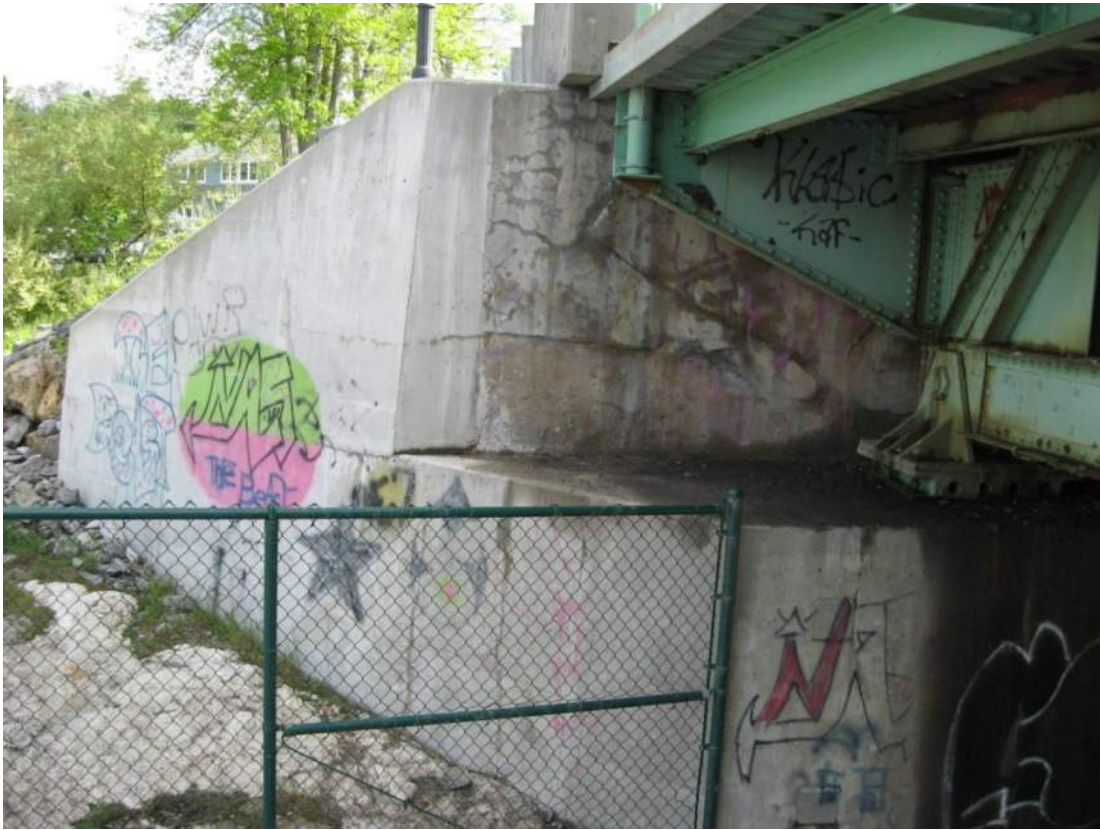
Photo 79– The north abutment backwall has numerous medium diagonal cracks in the portion below the sidewalk. View looking north along sidewalk truss.

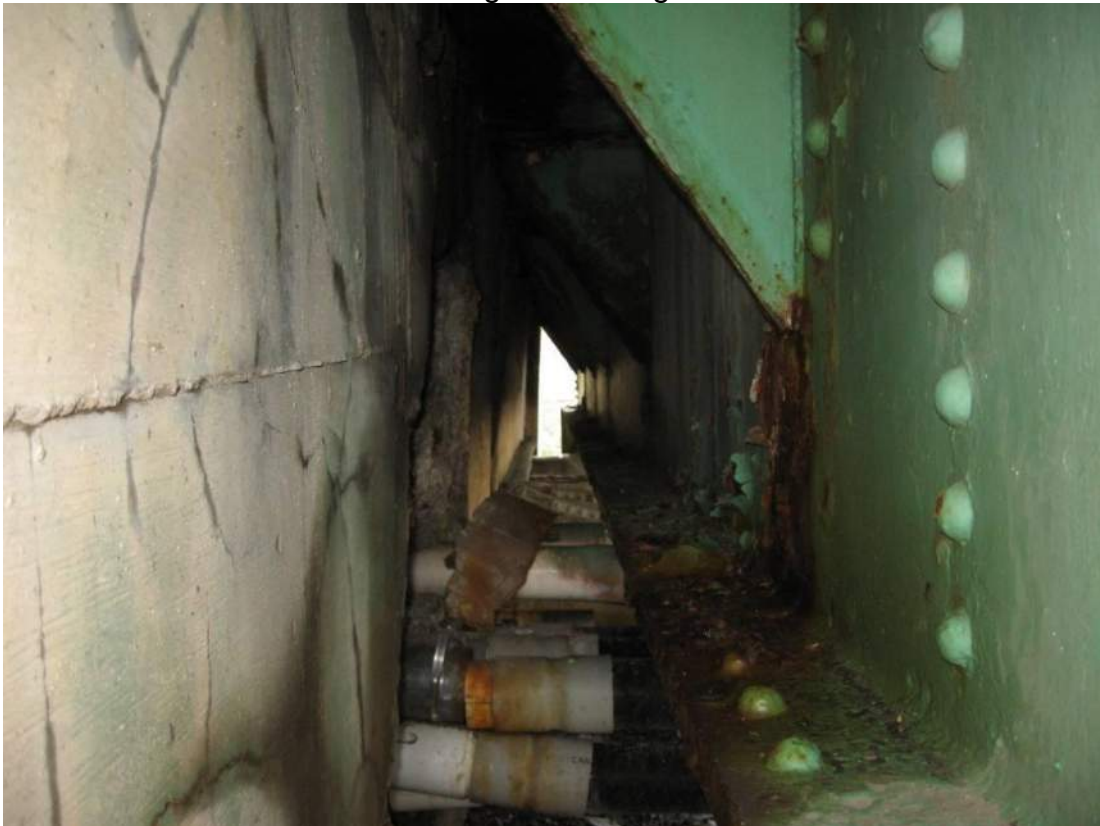
Photo 80 – There is a large 3 foot by 3 foot by 3 inch deep spall in lower portion of backwall around edges of utility conduit penetration and extending behind sidewalk truss.

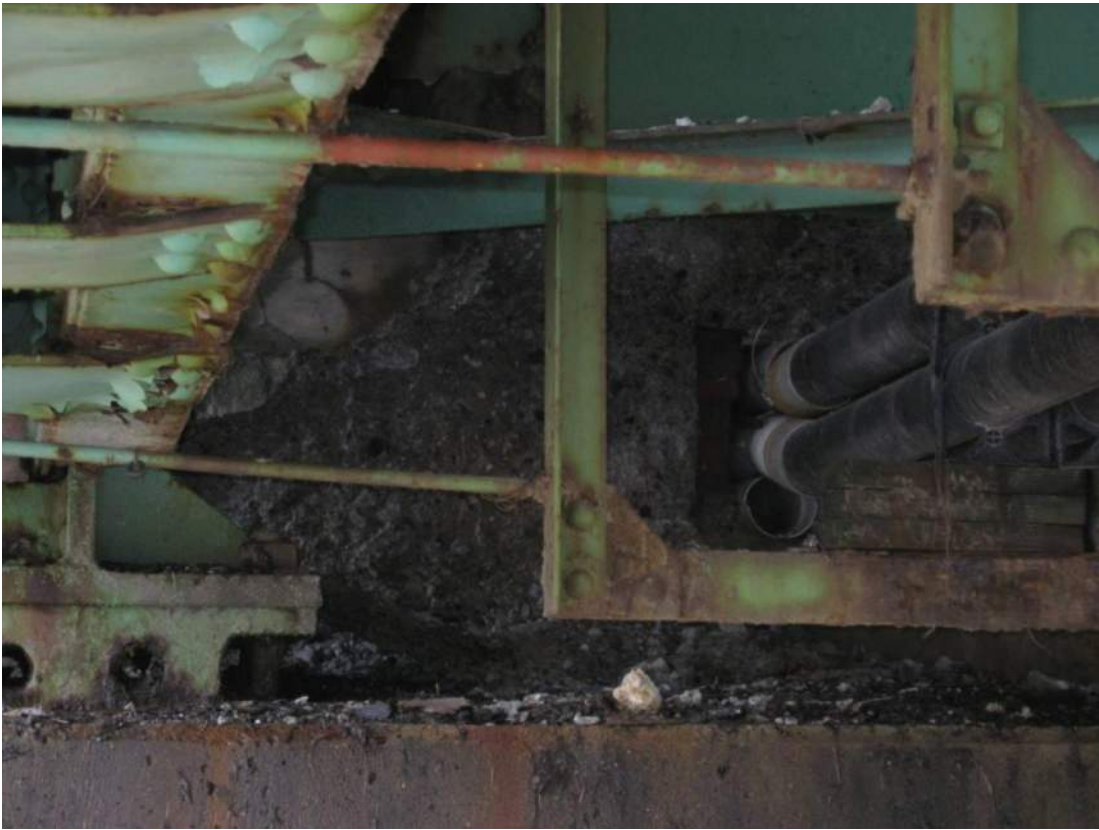
Photo 81– There is a large 3 foot by 3 foot by 3 inch deep spall in lower portion of backwall around edges of utility conduit penetration and extending behind sidewalk truss.

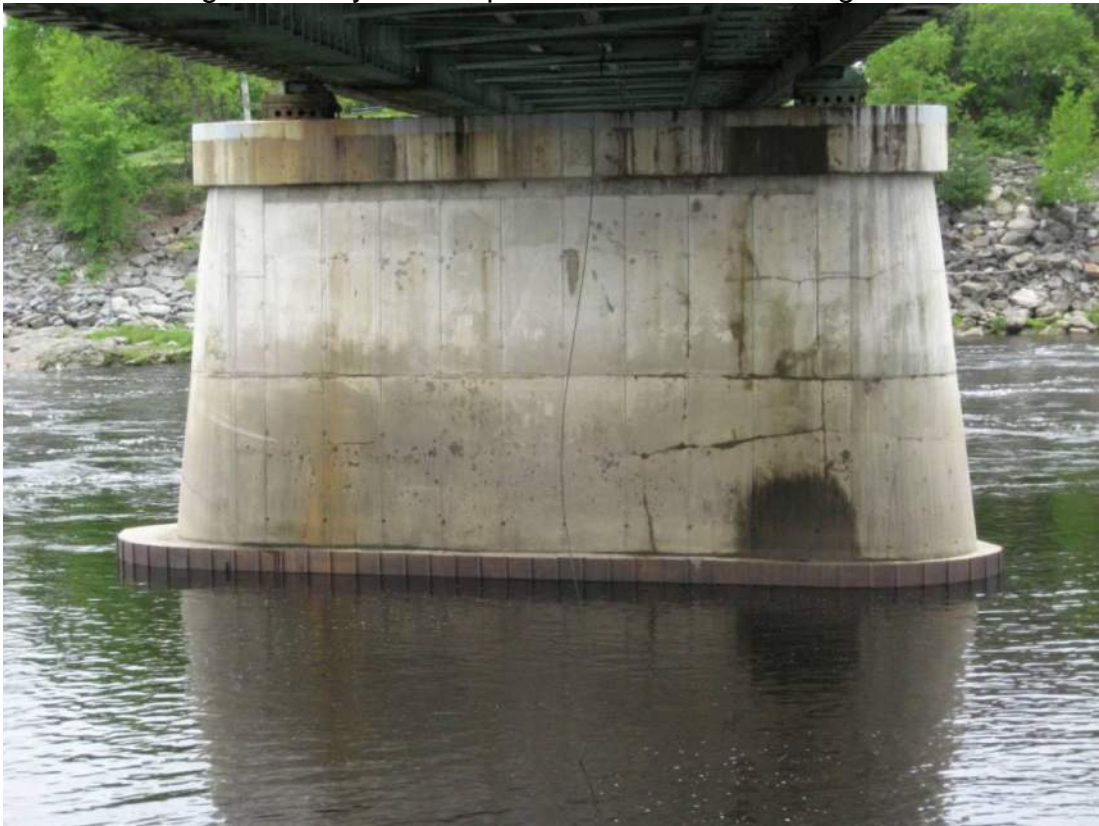
Photo 82– Piers are in satisfactory condition with no significant visible defects. View looking south at north face of Pier 1.

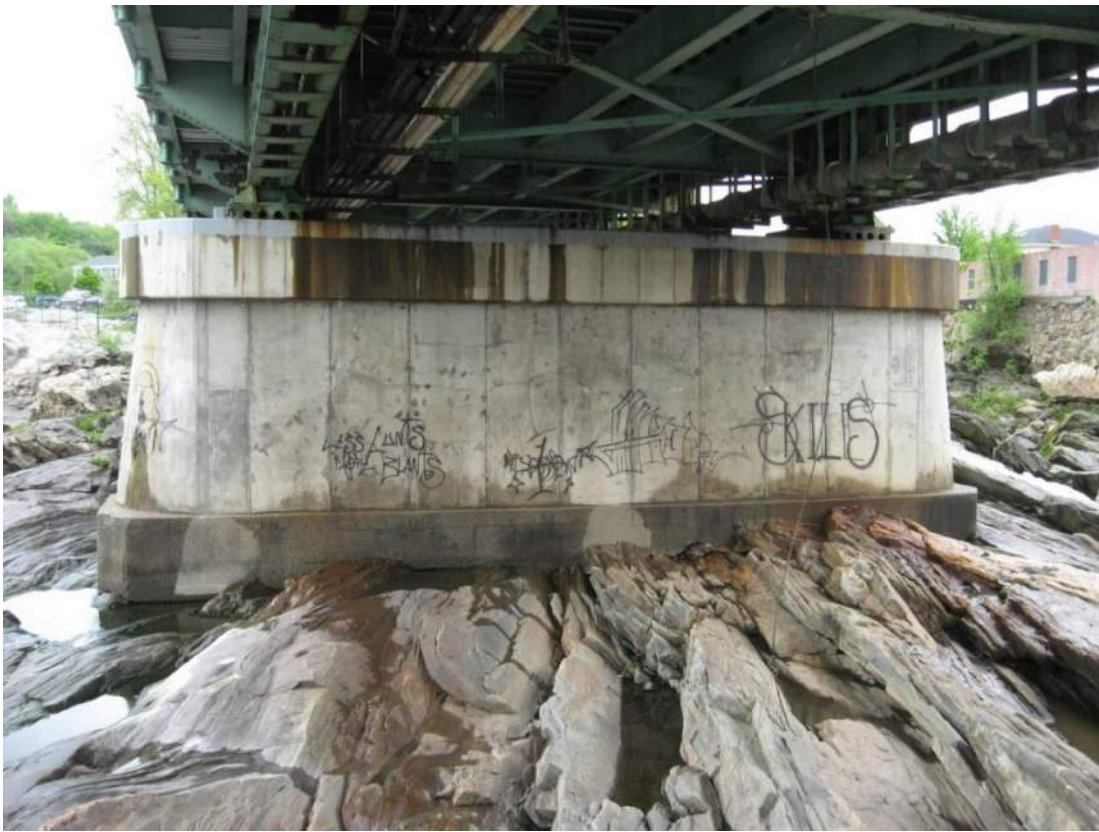
Photo 83– Piers are in satisfactory condition with no significant visible defects. View looking north at south face of Pier 2.

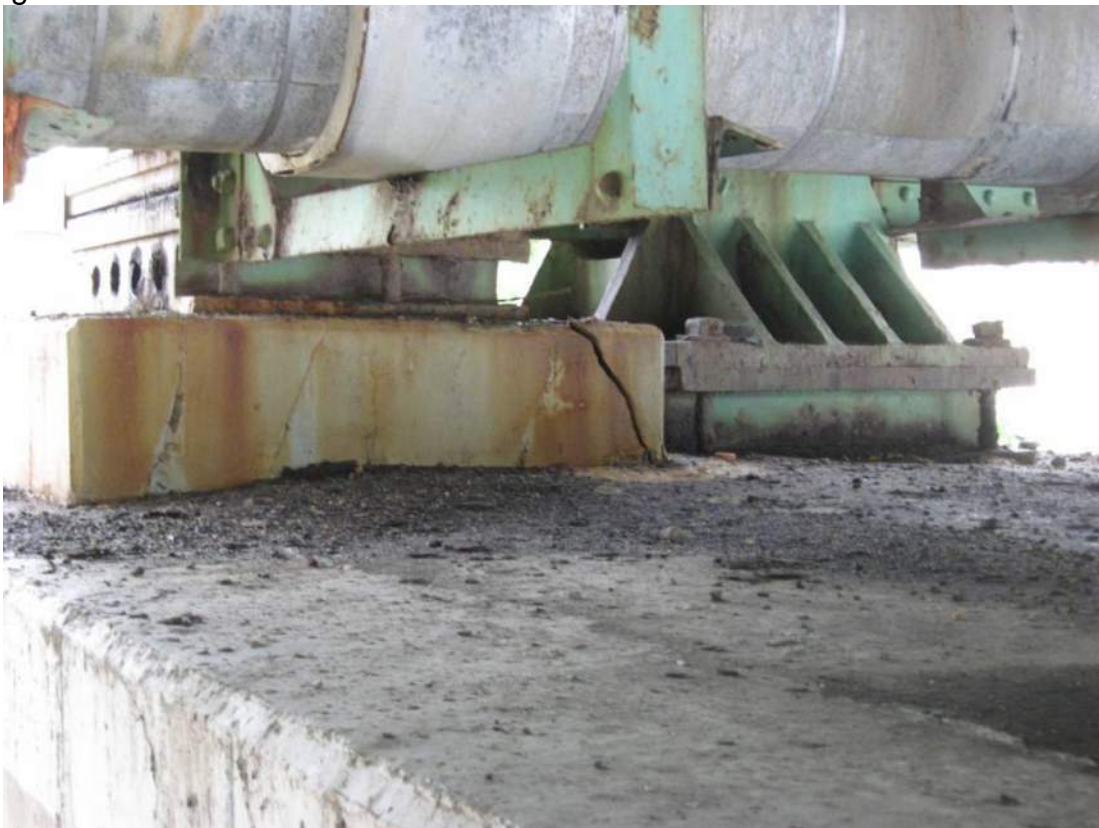
Photo 84 – Pier 2 has a wide diagonal crack in the southwest corner of the sidewalk truss bearing pedestal which extends for the full height of the concrete pedestal.

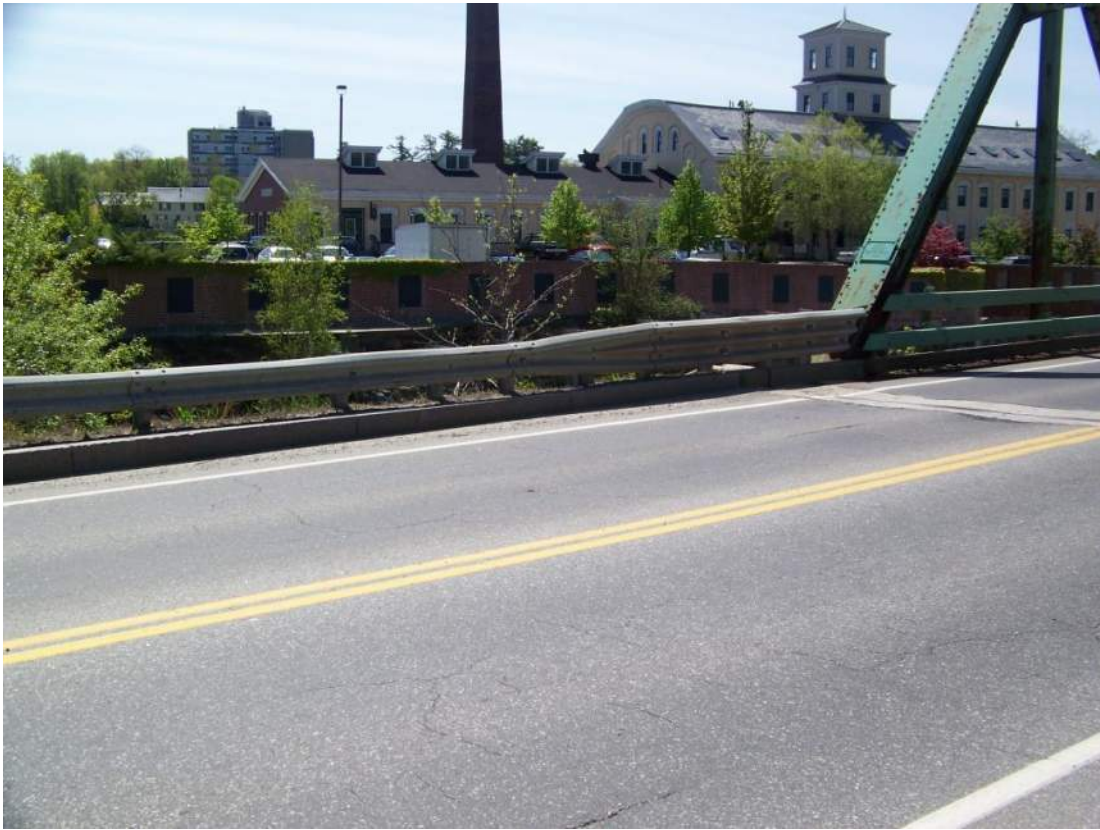
Photo 85– Both approach pavements are in fair condition with several transverse and longitudinal cracks clustered in the wheel paths. Looking southeast at northeast corner.

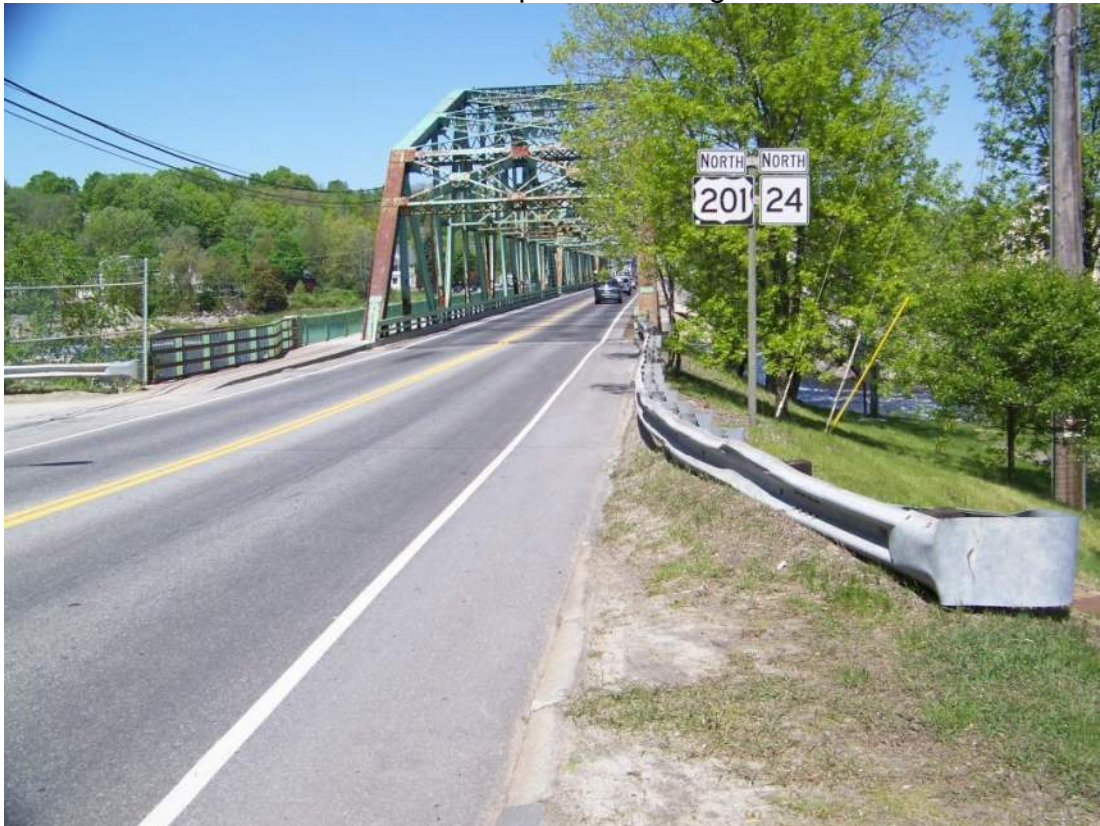
Photo 86 – No guiderail is present at southwest bridge corner (at left) because there is a section of railing attached to the U-shaped wingwall. Also note guiderail impact damage.

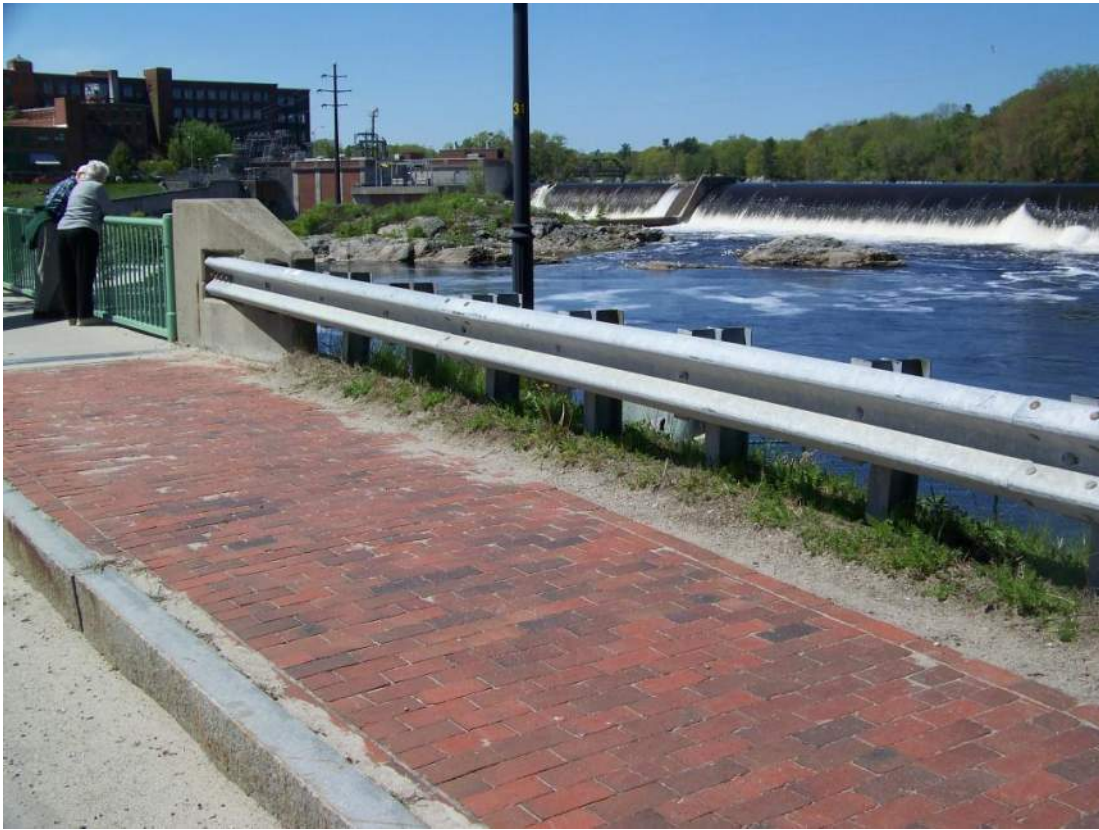
Photo 87– The approach guidrail at the northwest corner of the bridge is aligned with the outboard edge of the sidewalk and connected to the west pylon.

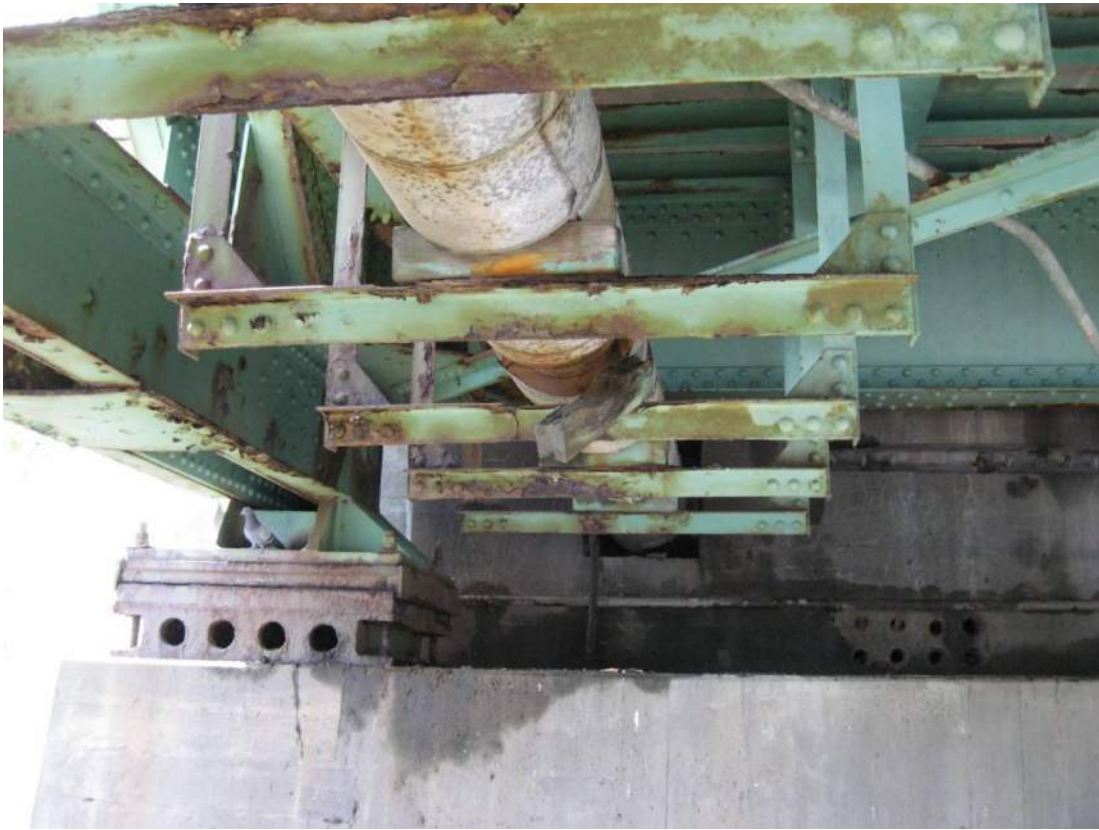
Photo 89—Large insulated under-deck utility located just inboard of roadway truss has missing blocking at several locations. View looking south In Span 1 at south abutment.

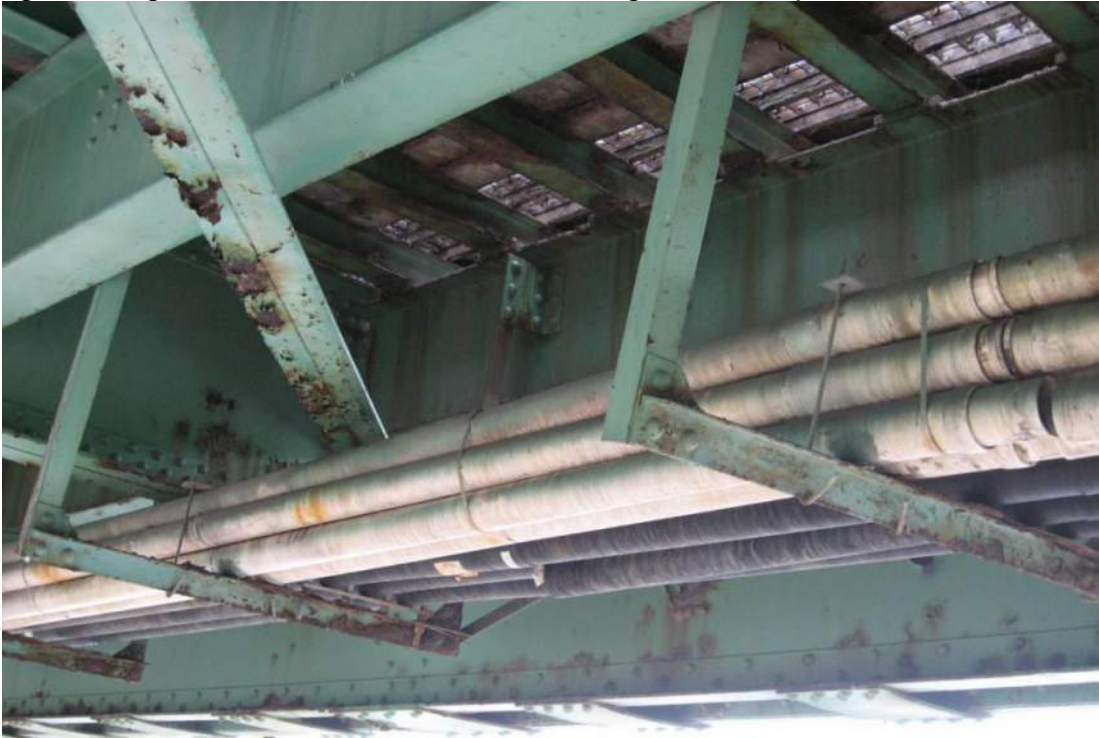
Photo 90 – In Span 2 between L9 and L10 both conduit banks have open one inch gaps in the conduits along with two consecutive twisted support hangers.

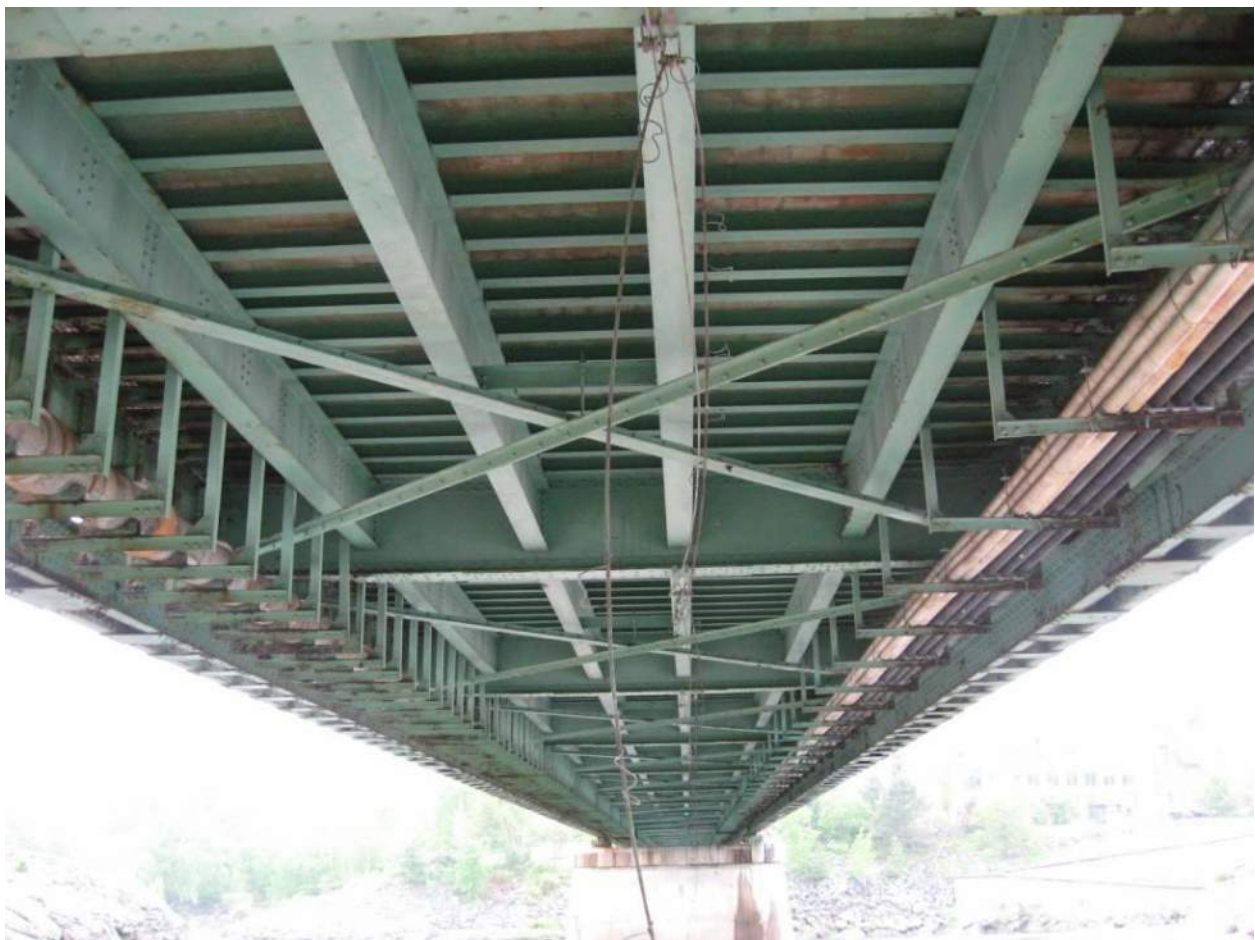
Photo 91– Remnants of an abandoned wire cable attached to the floorbeams were observed dangling at several locations. View looking south in Span

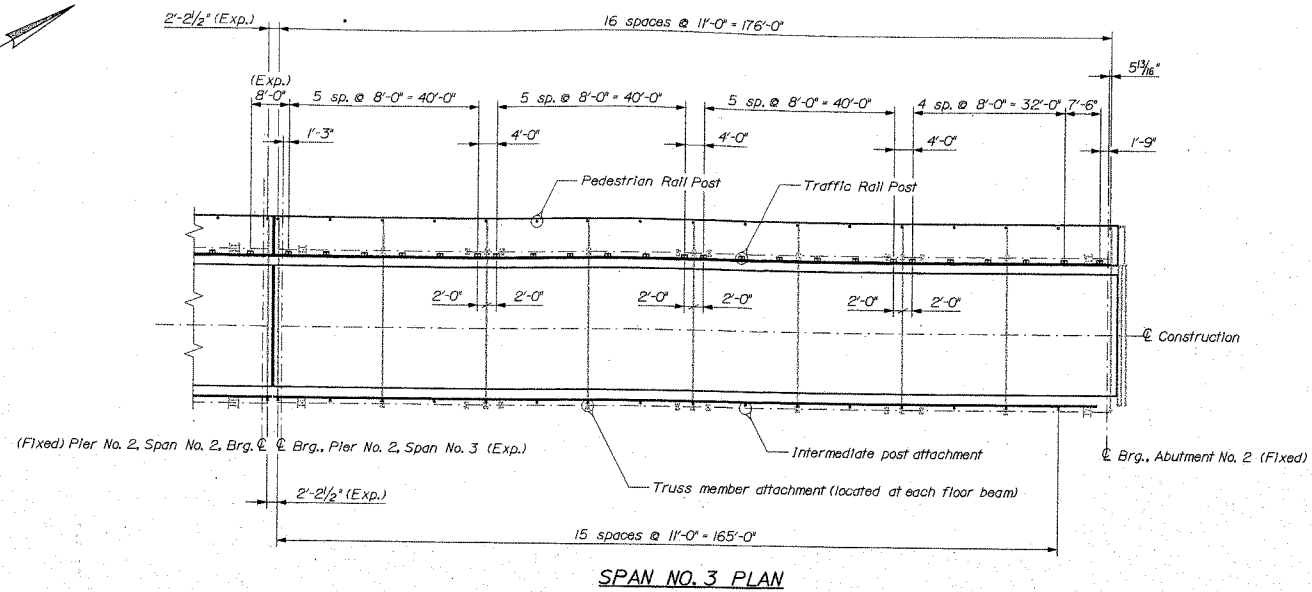
SUPERSTRUCTURE NOTES

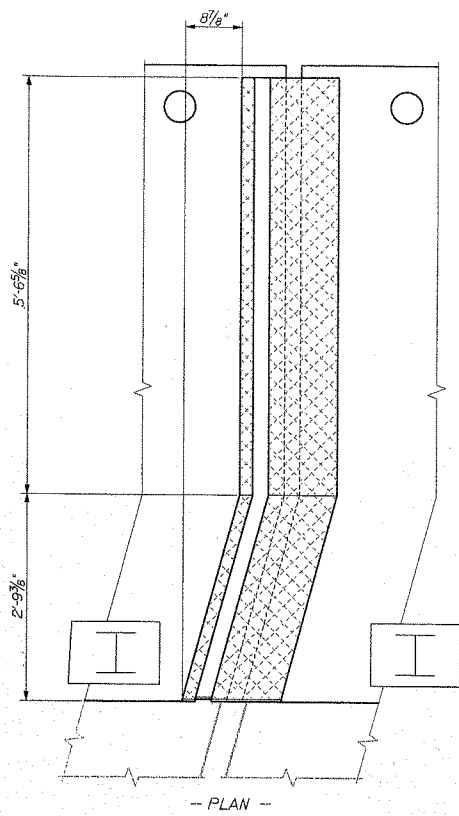
STATE OF MAINE		DEPARTMENT OF TRANSPORTATION		BH-1108(900)X		BRIDGE NO. 2016		PIN 11089.00		BRIDGE PLANS	
FRANK J. WOOD BRIDGE				ANDROSCOGGIN RIVER				BRUNSWICK & TOPSHAM			
EXPANSION JOINTS				SHEET NUMBER		20		OF 21			
DATE	BY	DESIGNED BY	CHECKED BY	DESIGNED BY	CHECKED BY	REVISIONS 1	REVISIONS 2	REVISIONS 3	REVISIONS 4	SIGNATURE	P.E. NUMBER

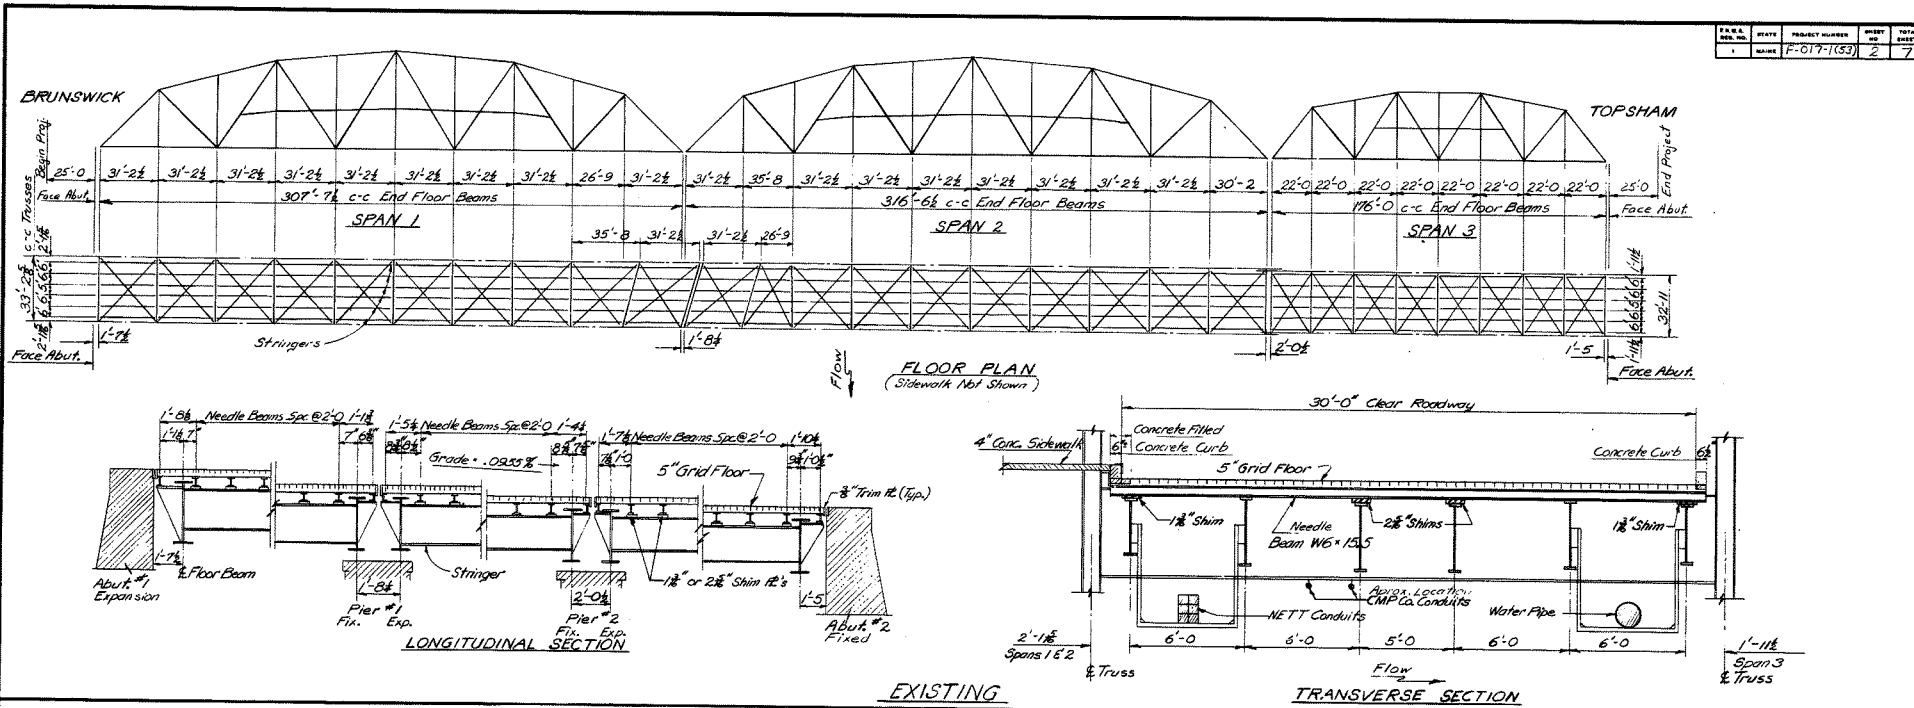
DATE	BY	PROJECT NUMBER	SHEET NO.	TOTAL SHEETS
10/17/85	...	F-017-1(53)	2	7

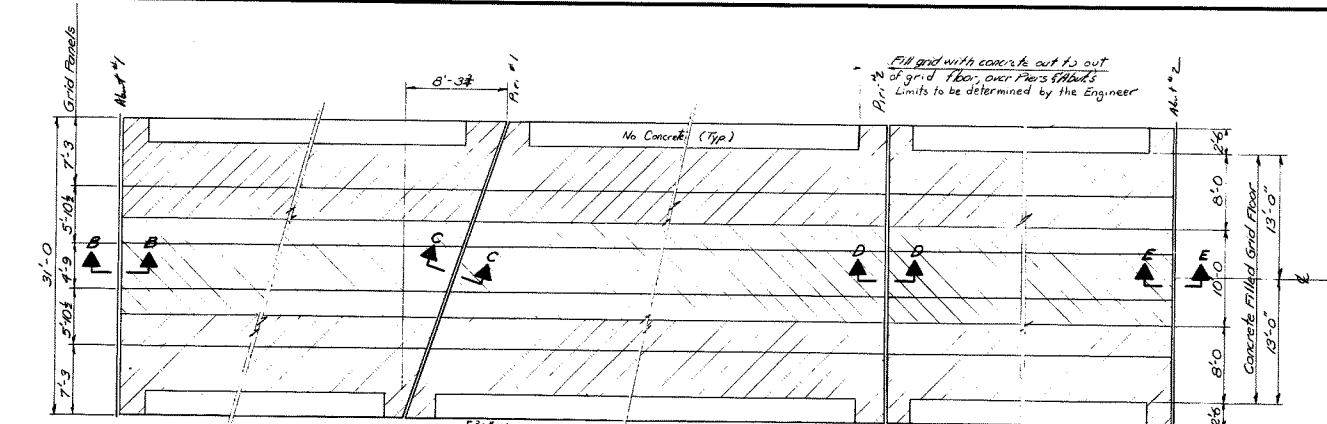
- BRIDGE JOINT NOTES**
1. Remove sections of the steel grid as required to clear the expansion joint anchors and adjustment devices as directed by the Engineer.

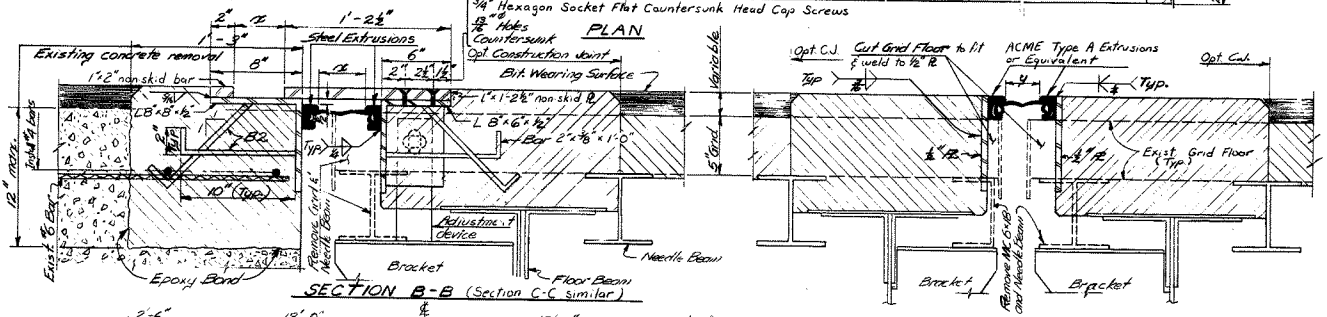
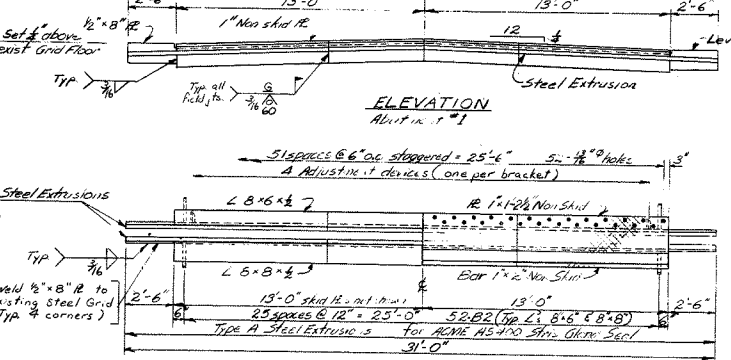
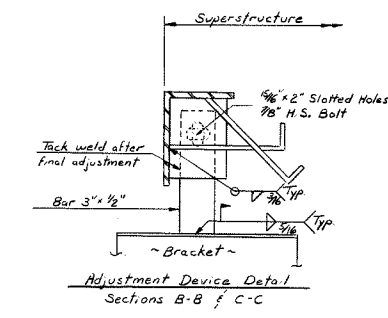
REVISED AS BUILT'S MSB 31-90
