Preliminary Design Report

Frank J. Wood #2016

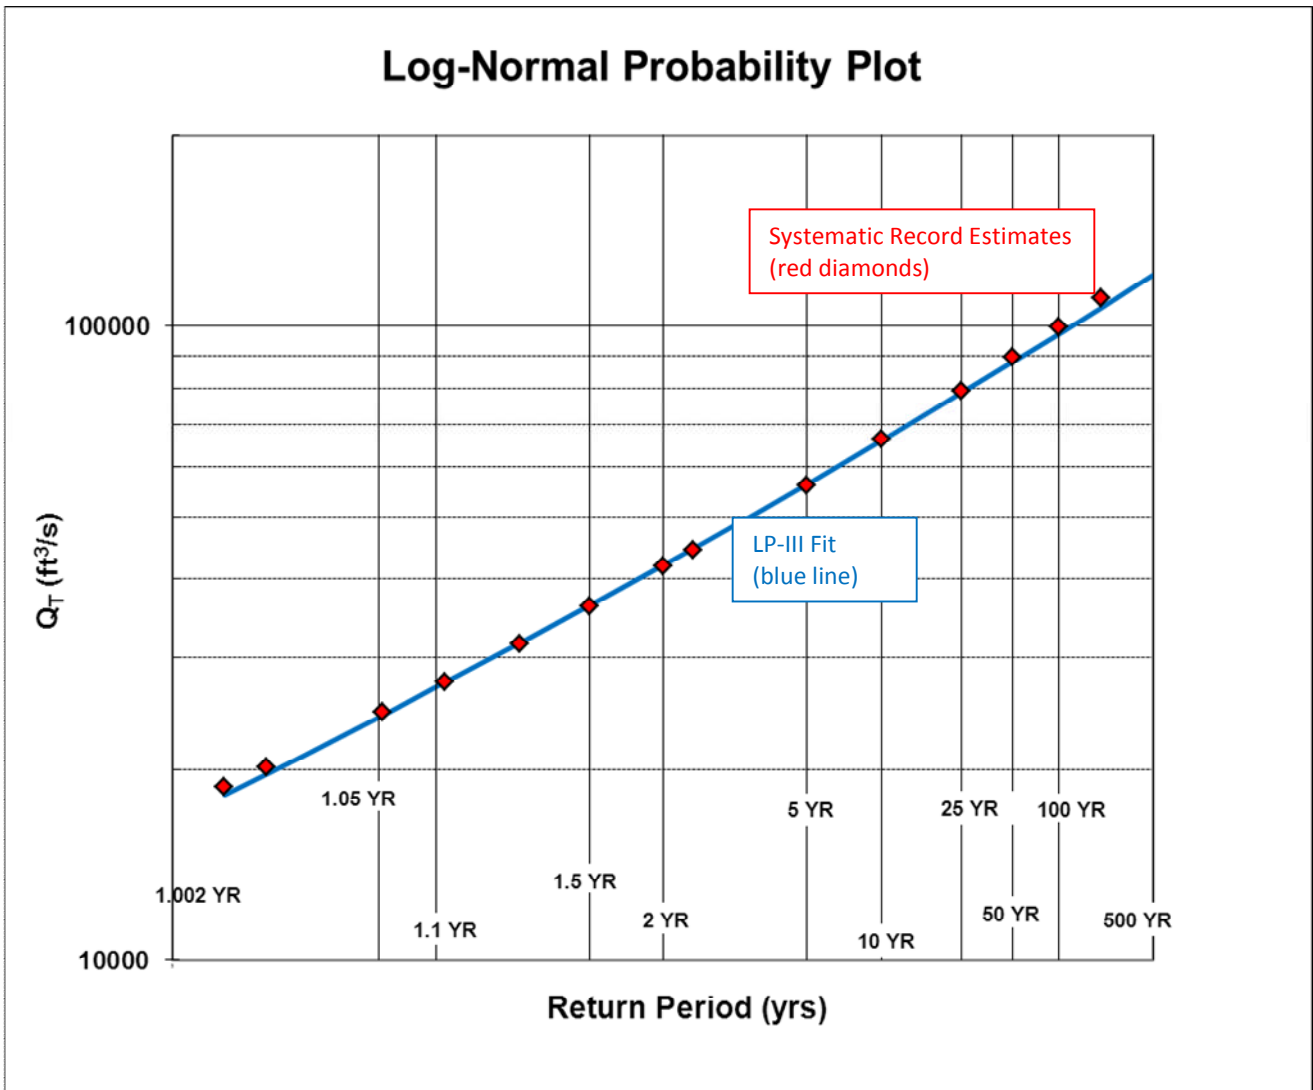
Figure 1. Annual Maximum Probability Plot – Androscooggin River at Frank J Wood Bridge #2016

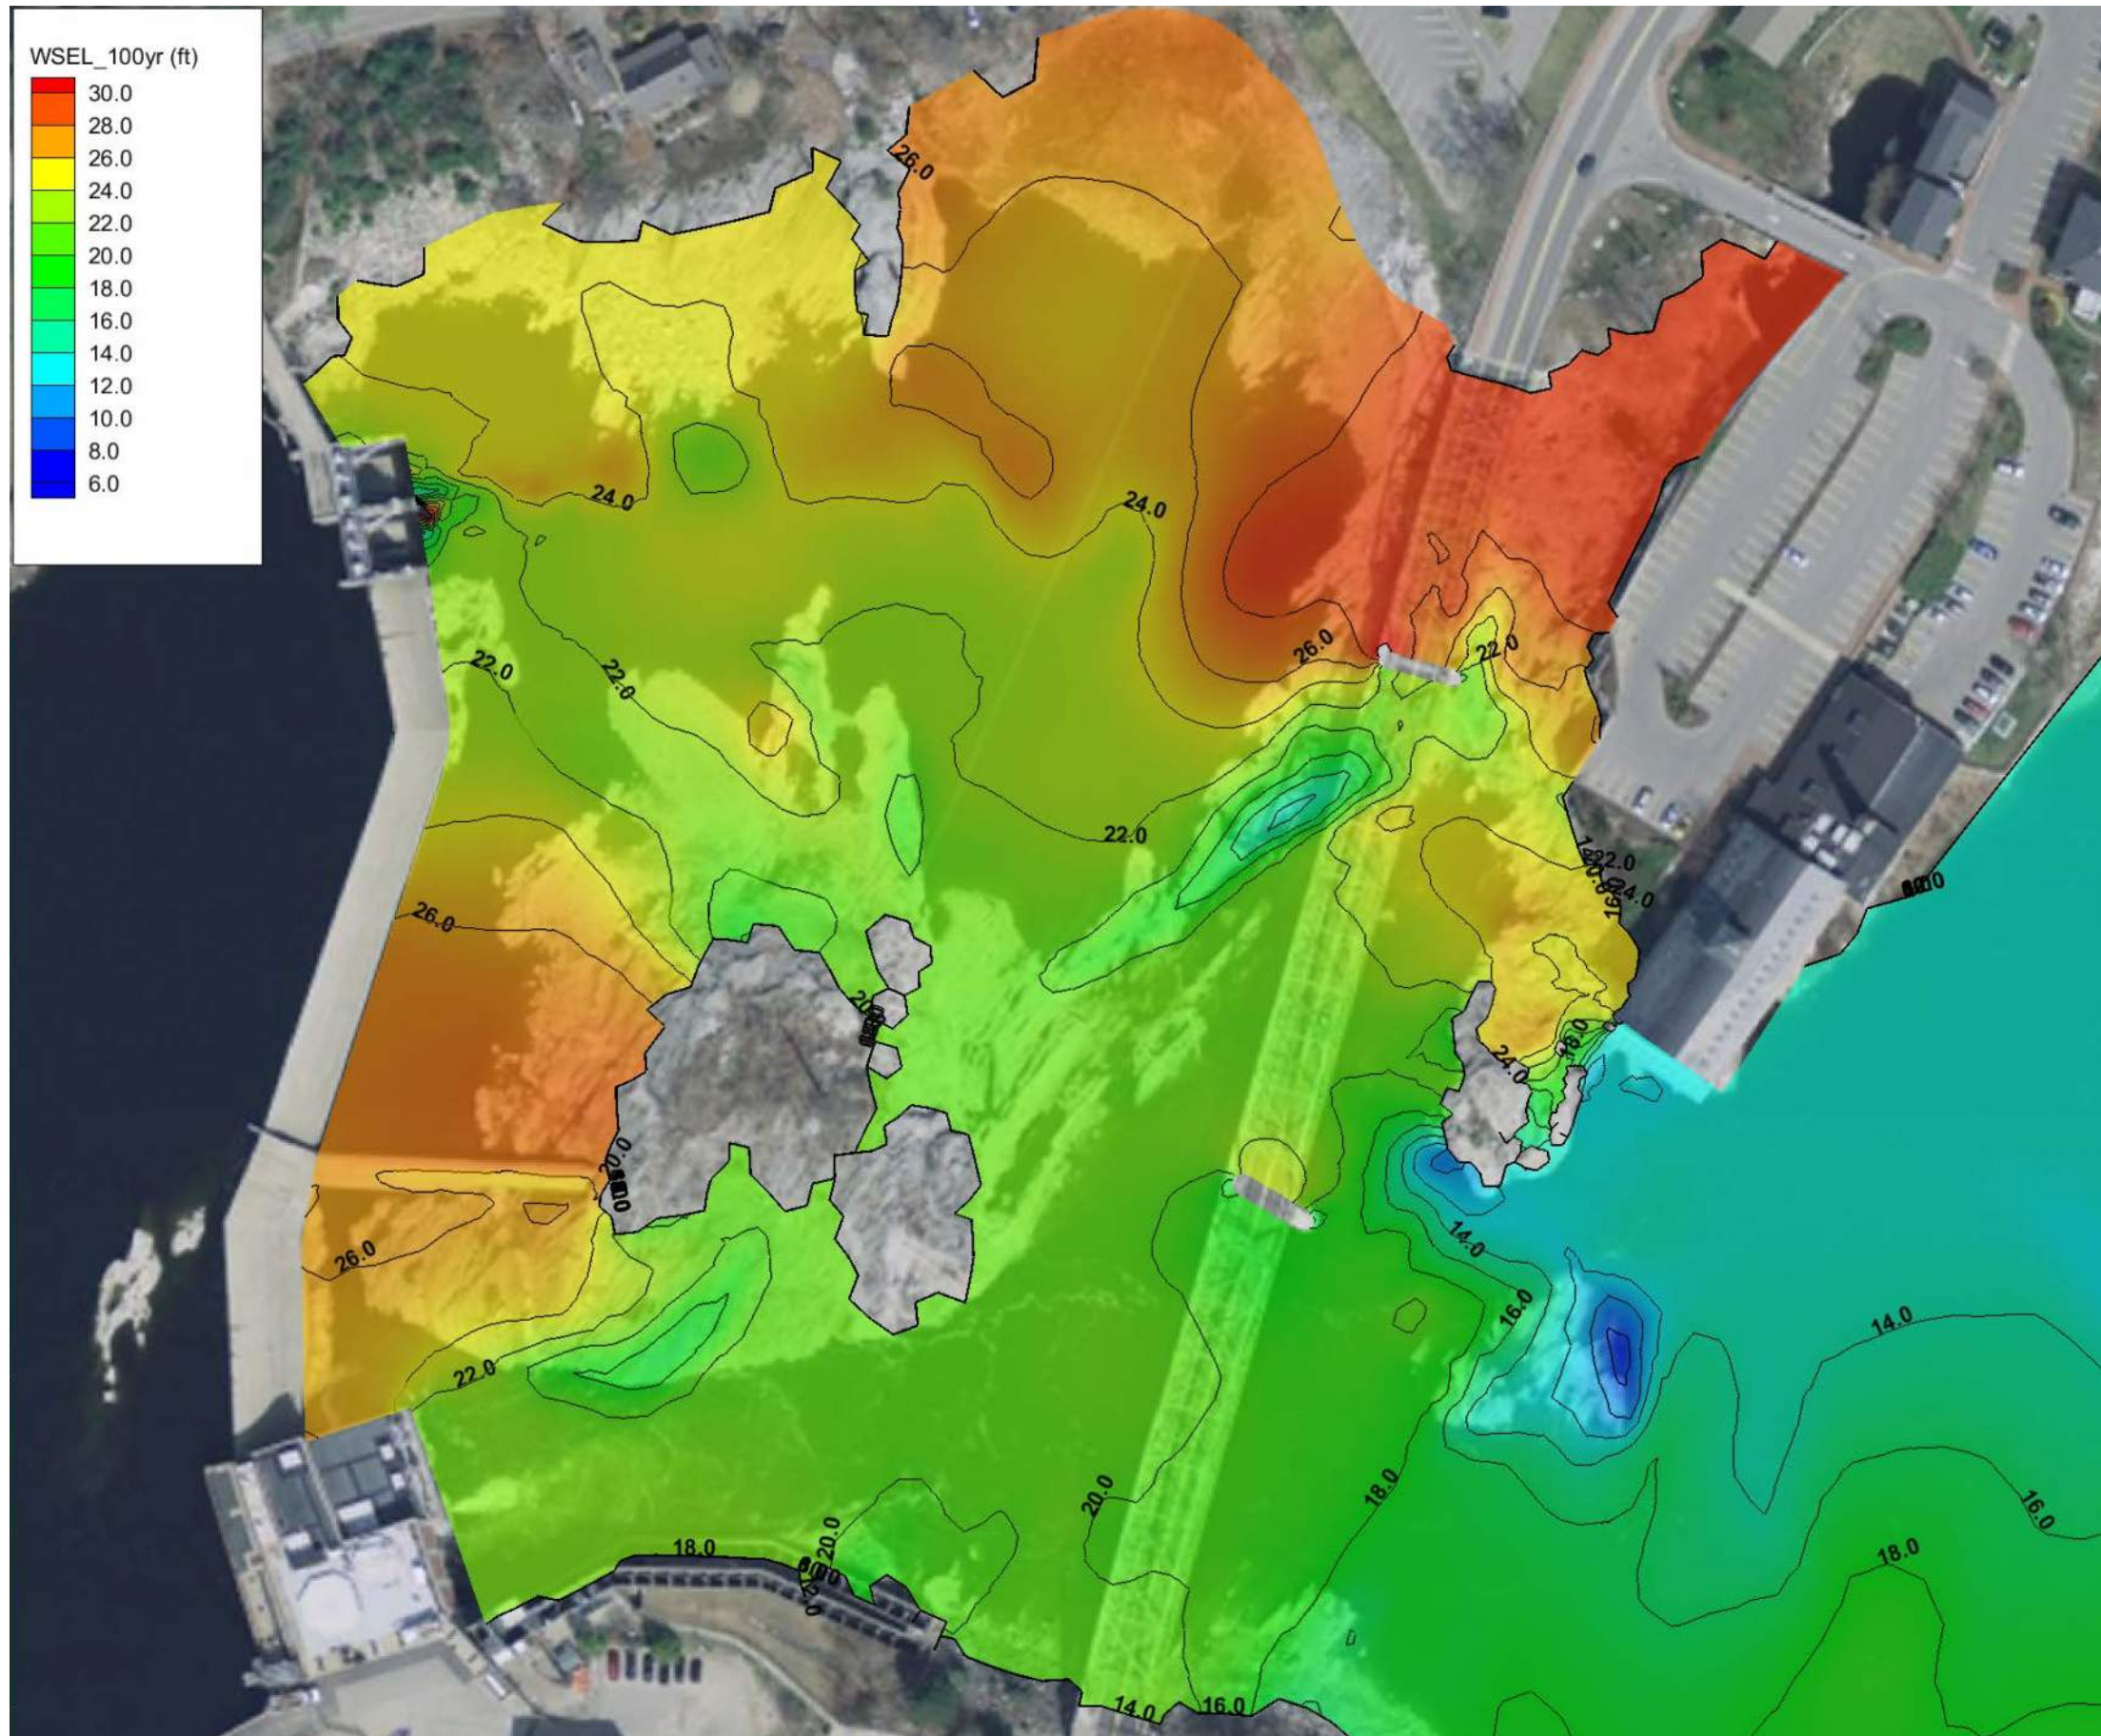
Existing Conditions (100-Year Event)

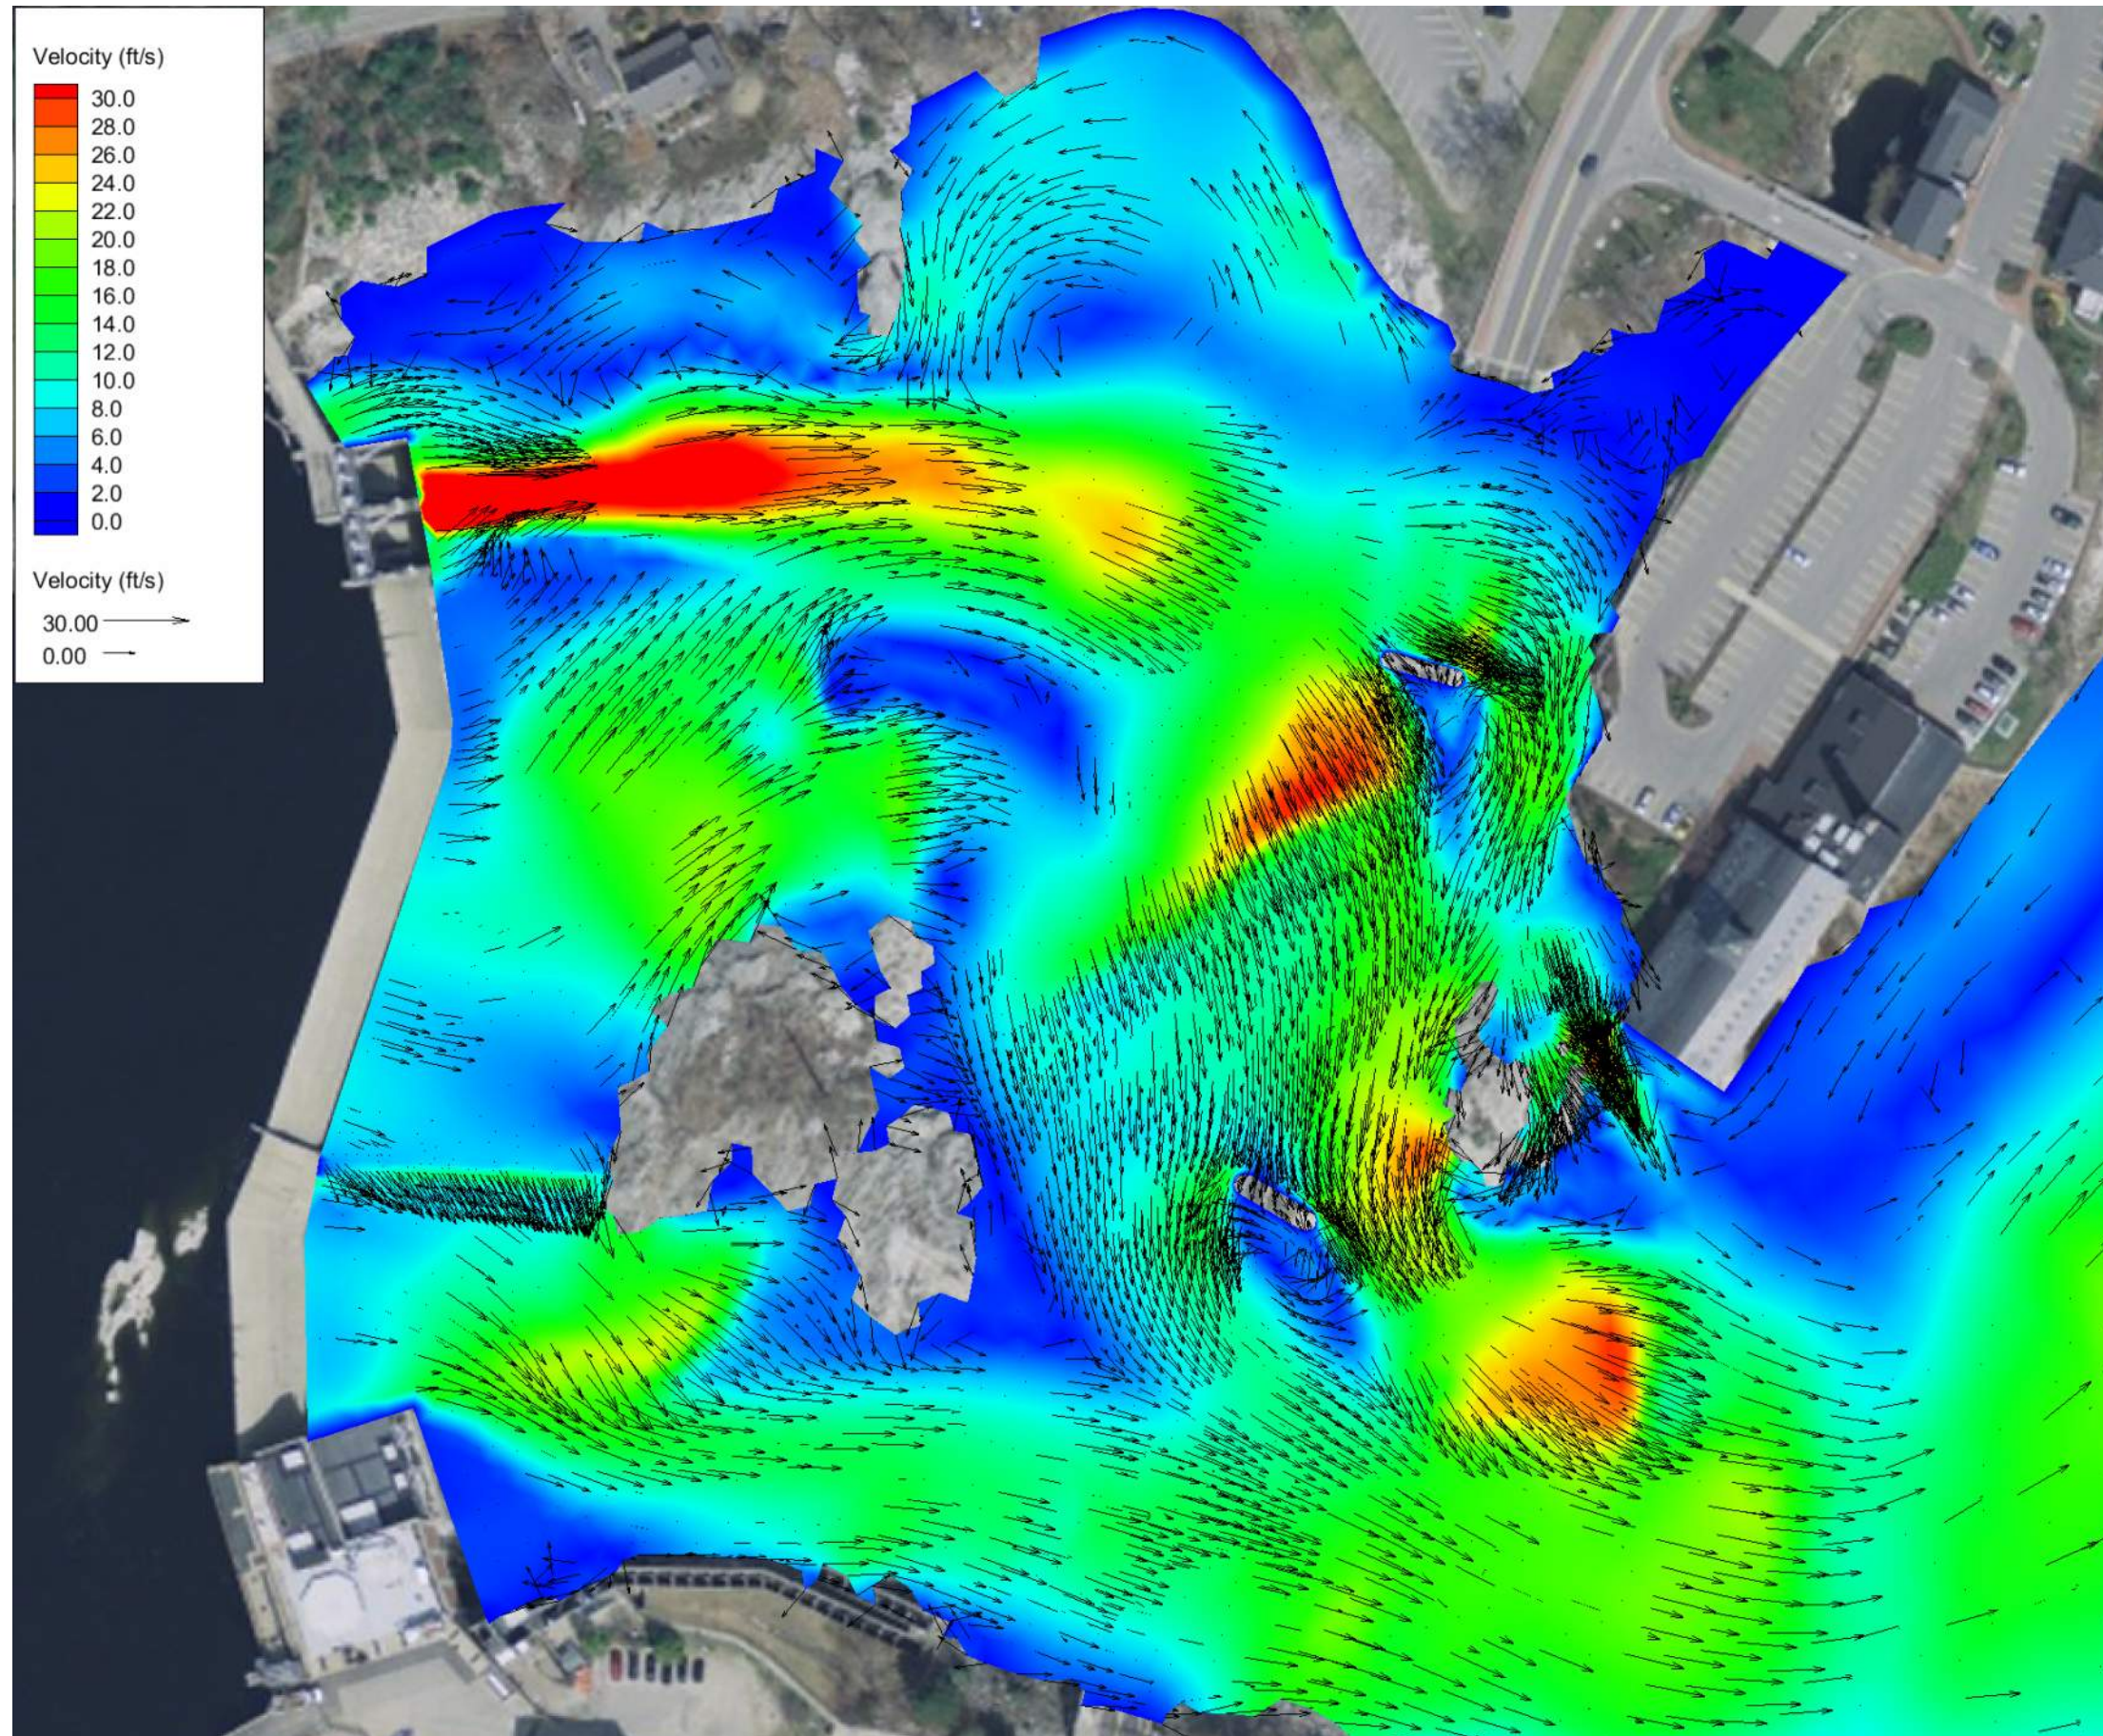
Modified Design (Pier Rotation) with Existing North Pier

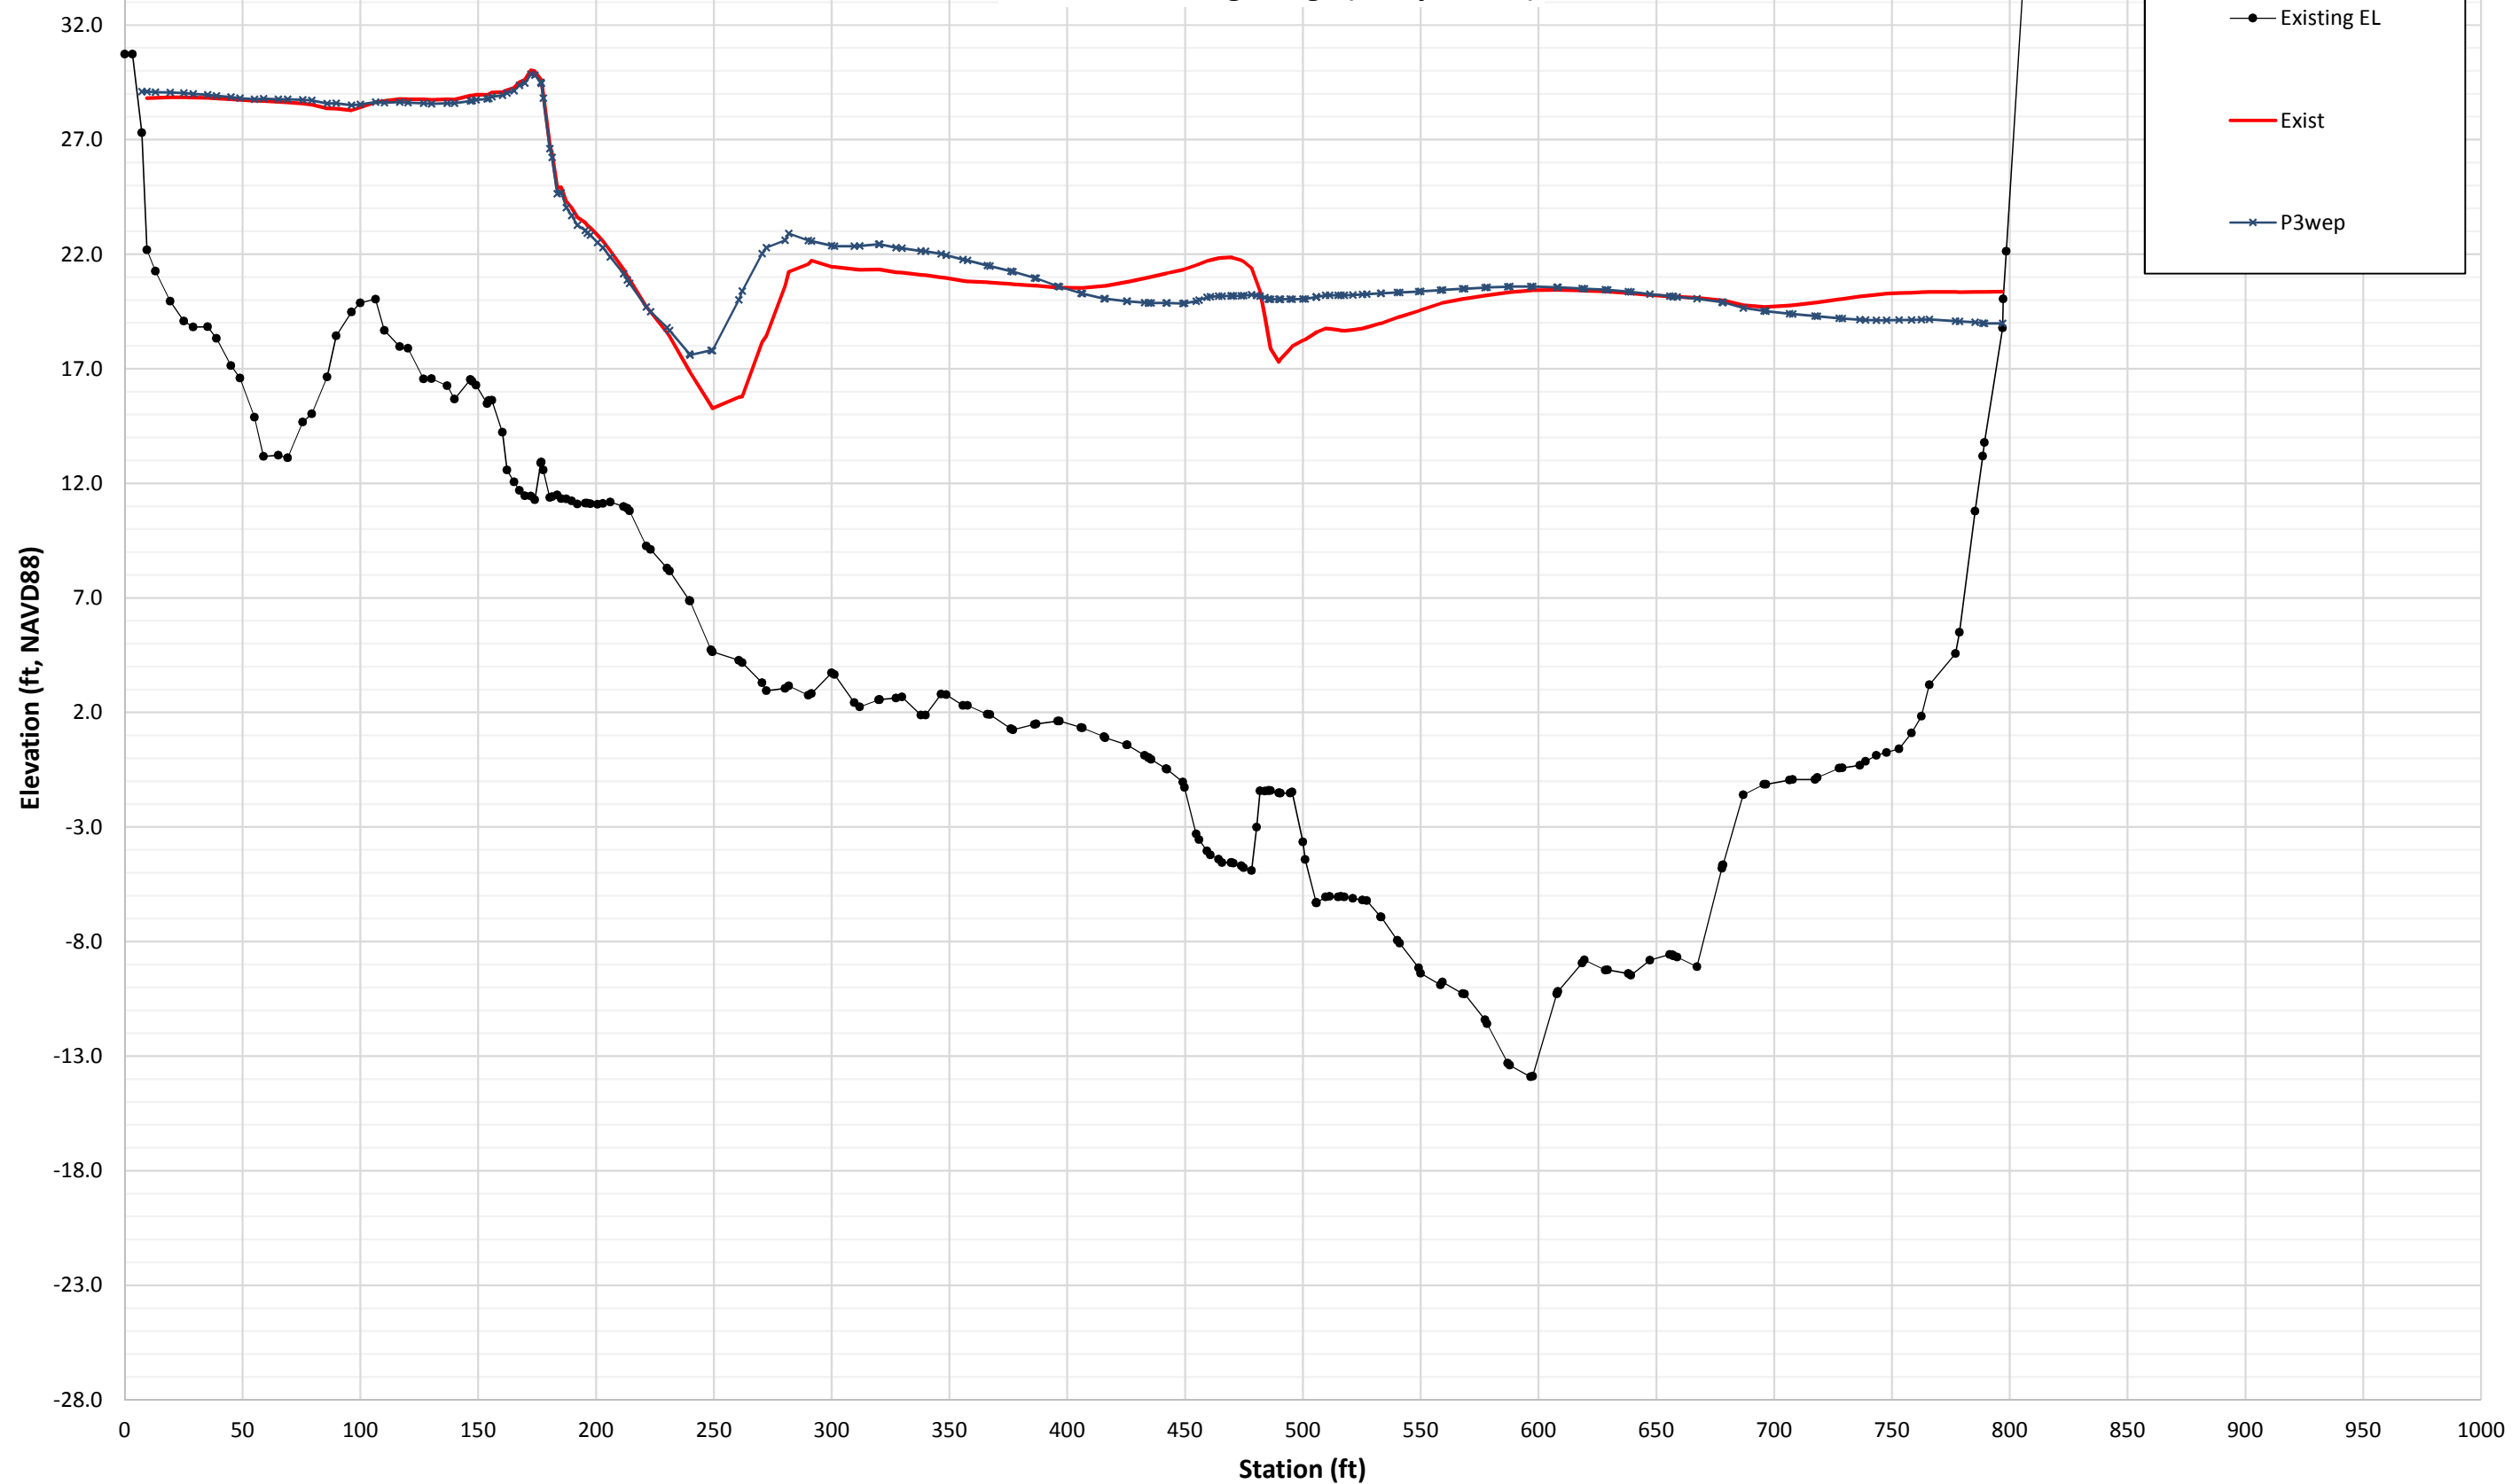
US_100 / At Replacement Bridge (100-yr Event)

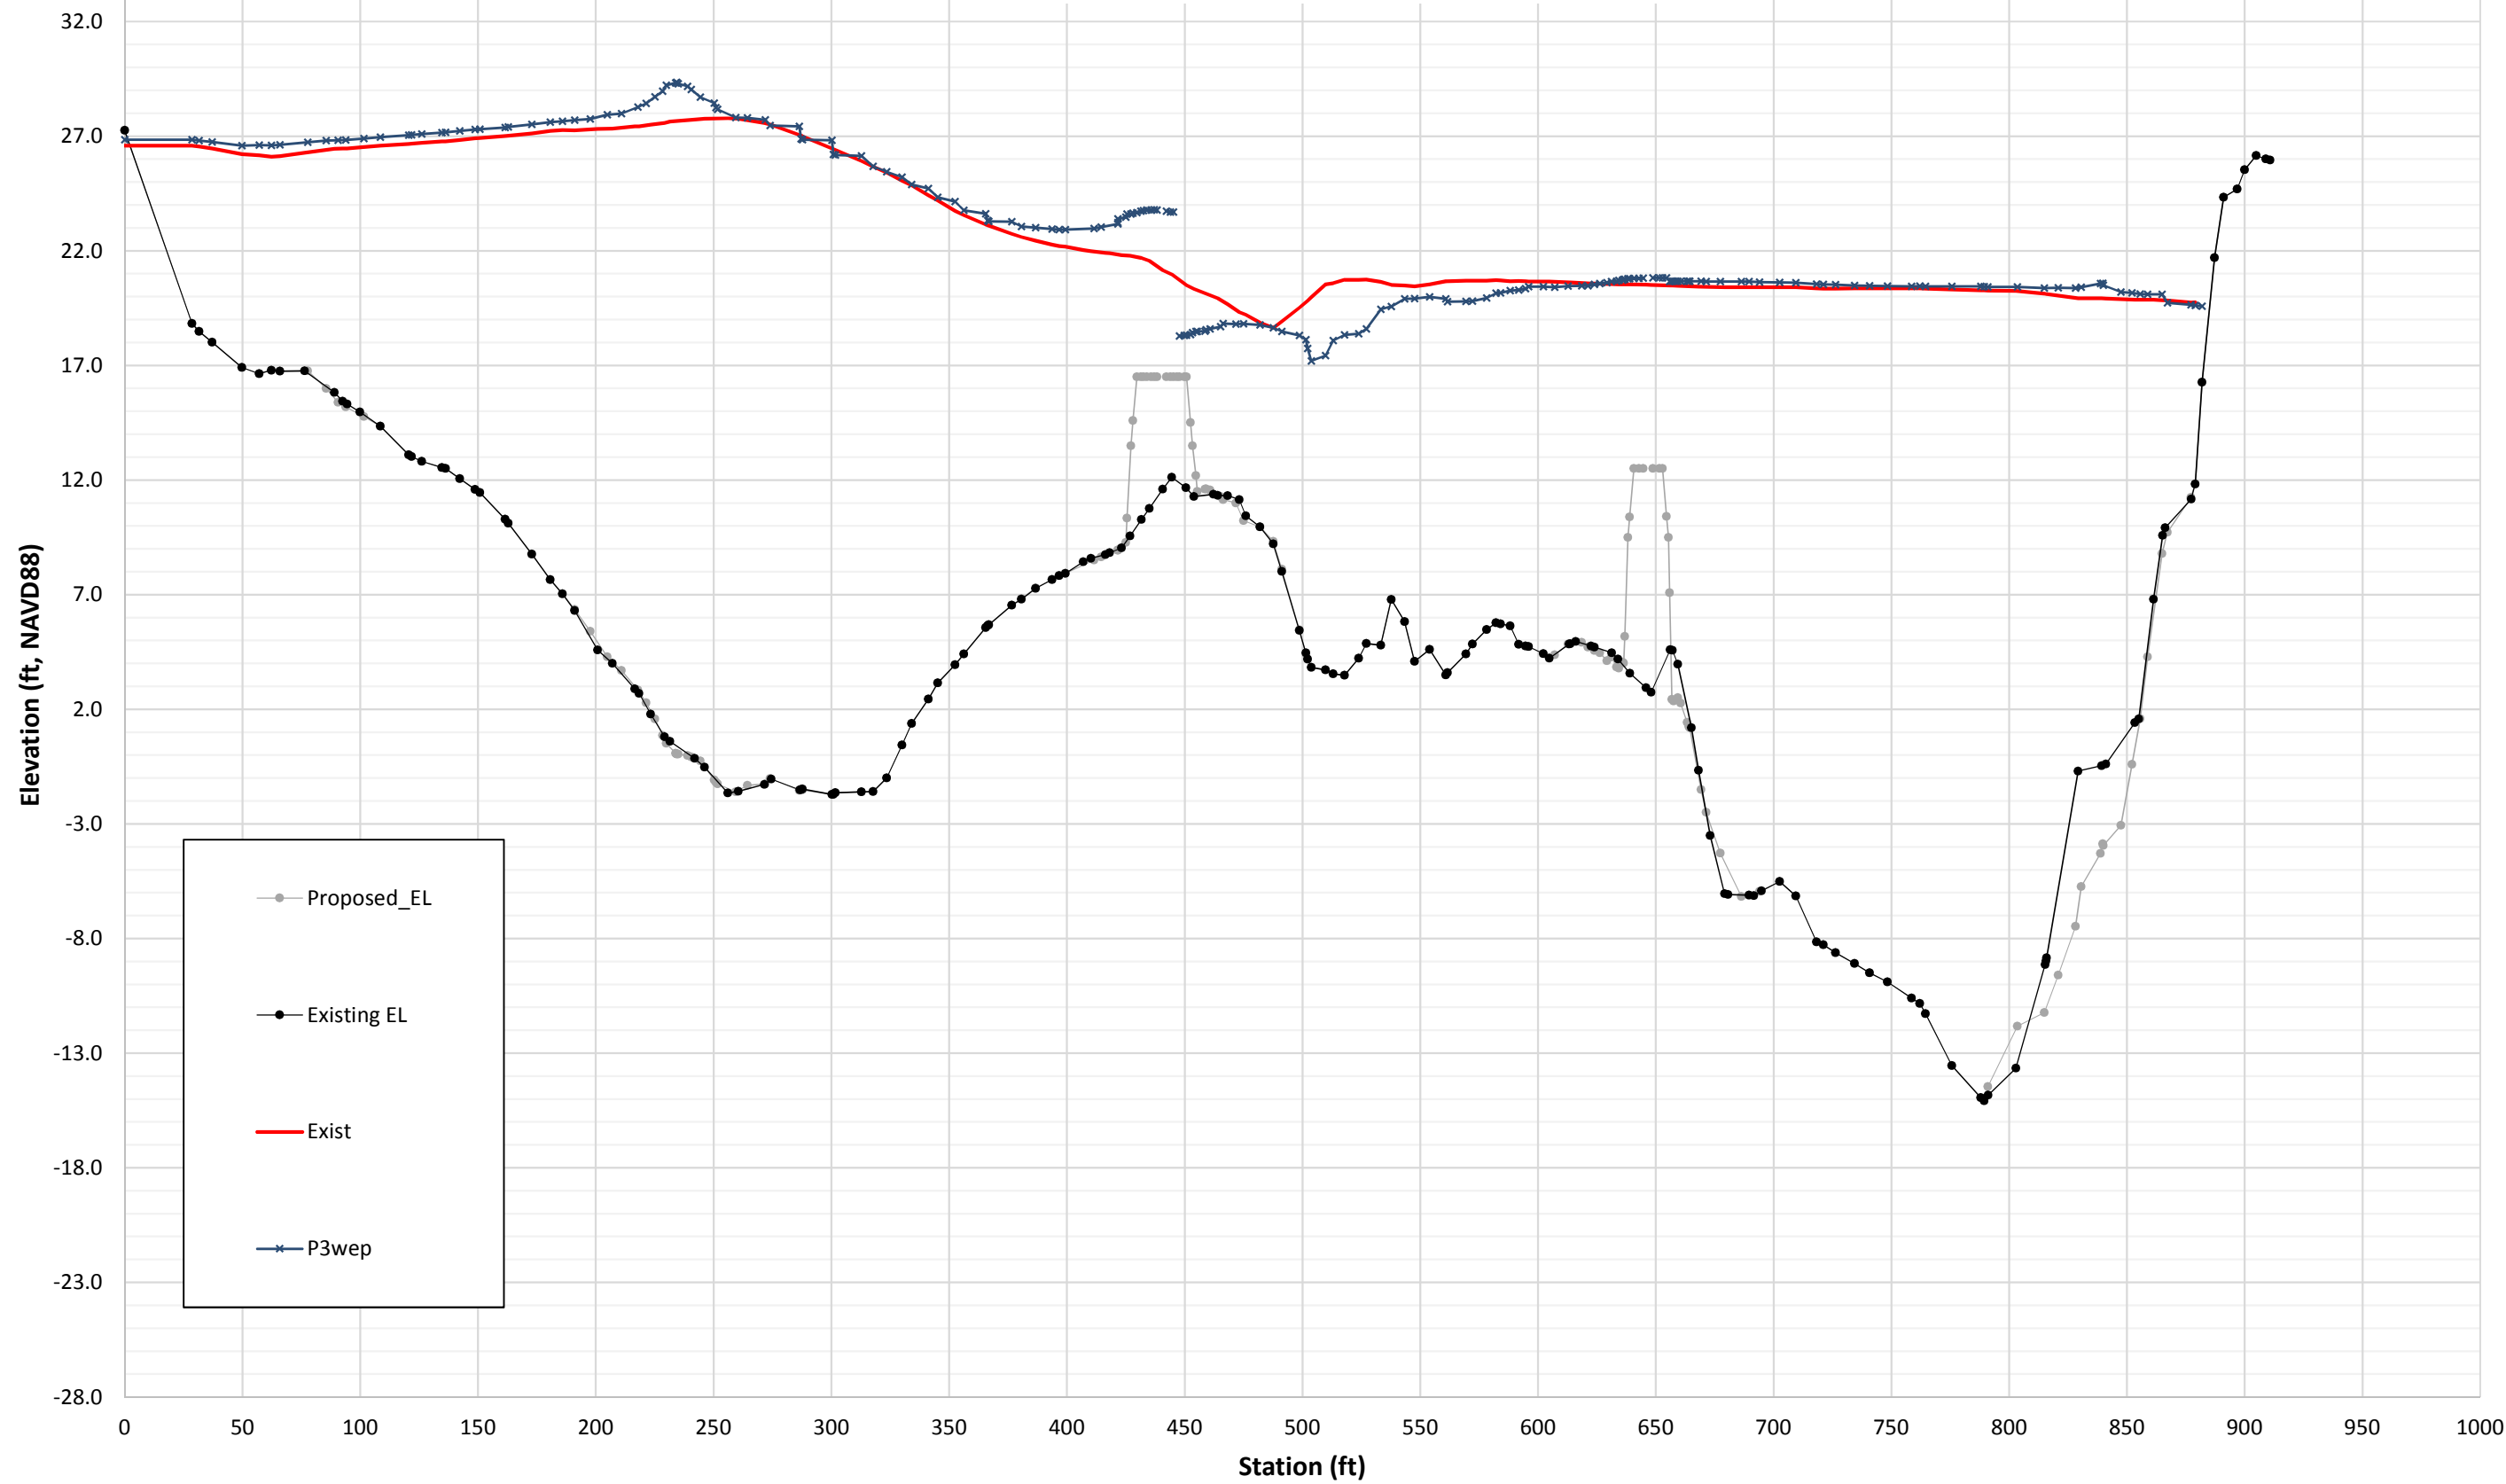
US_200 (100-yr Event)
