20 December 2019

Project Number: 3611191238

**Subject: Vulnerability Assessment and Resilience Planning, Public Landing and Harbor Park, Camden, Maine  
Penobscot Bay Working Waterfront Resiliency Analysis  
State of Maine, Department of Marine Resources**

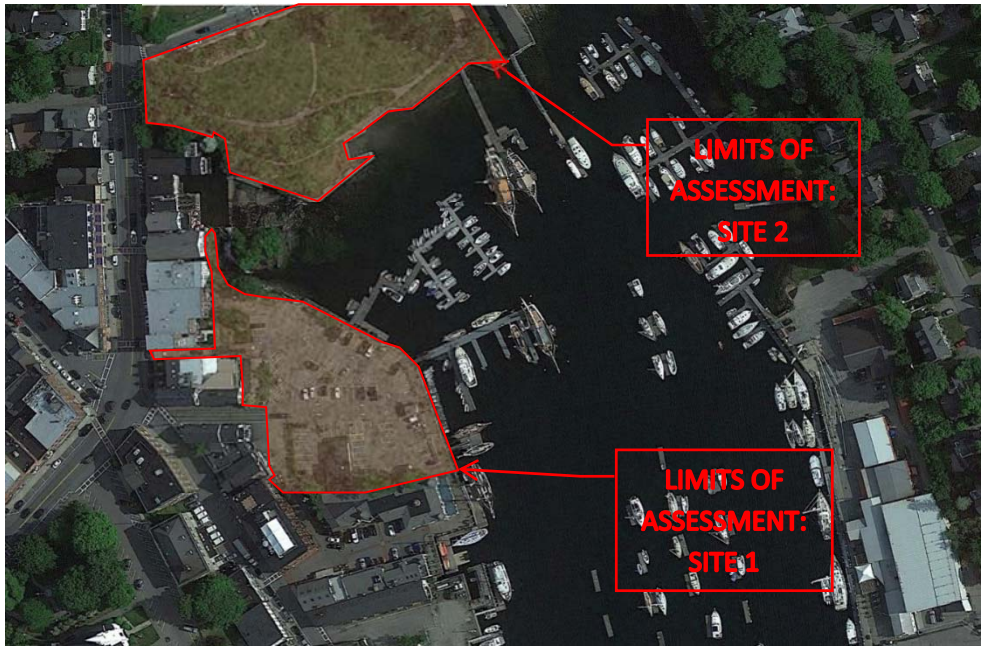
**Photograph No. 1:**

Overview of Sites

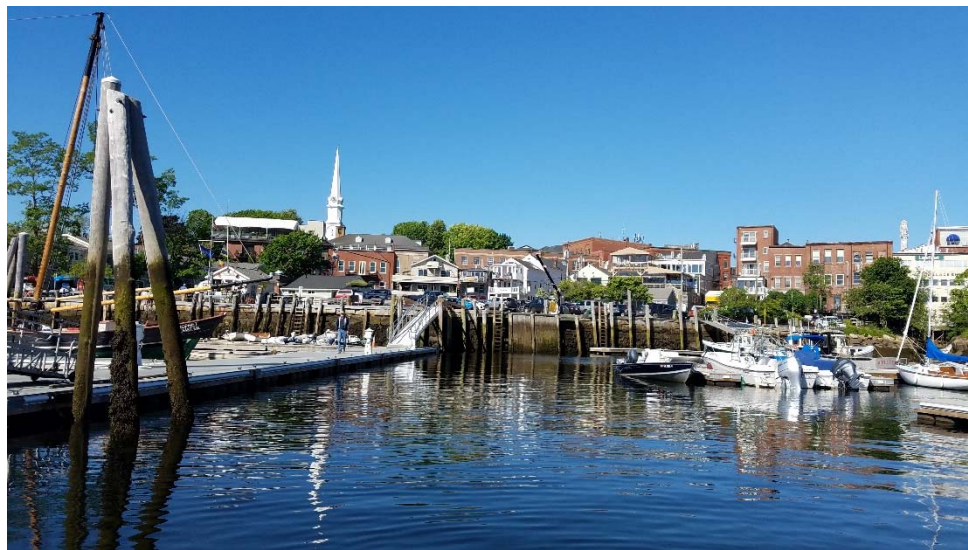
**Photograph No. 2:**

View of Public Landing,  
Camden looking west.

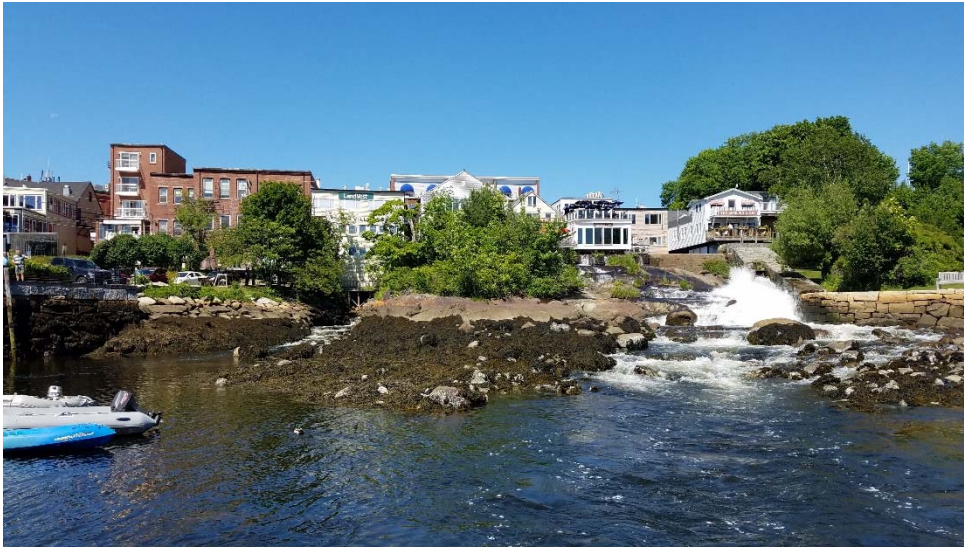
**Photograph No. 3:**

View of Megunticook River outfall and shoreline north of site.

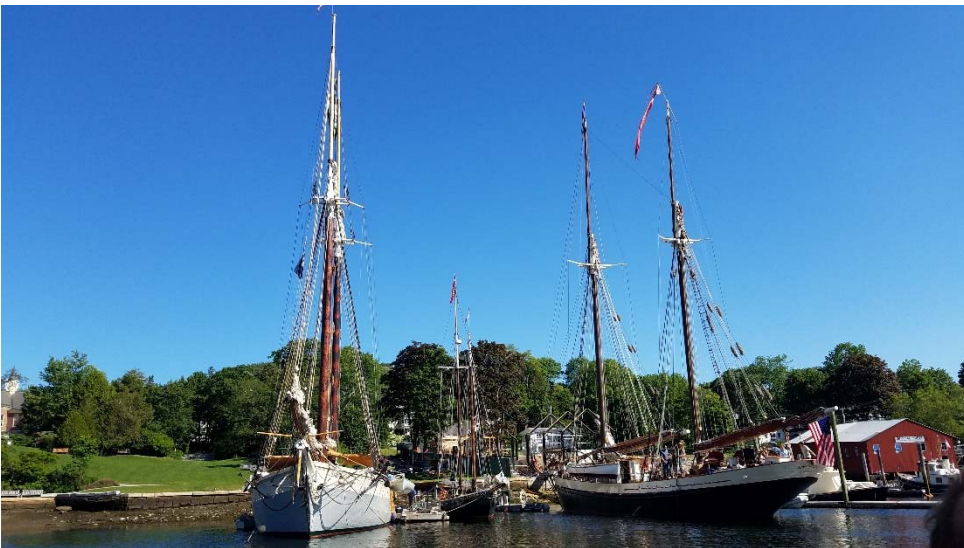
**Photograph No. 4:**

View of Camden Harbor Park looking north.

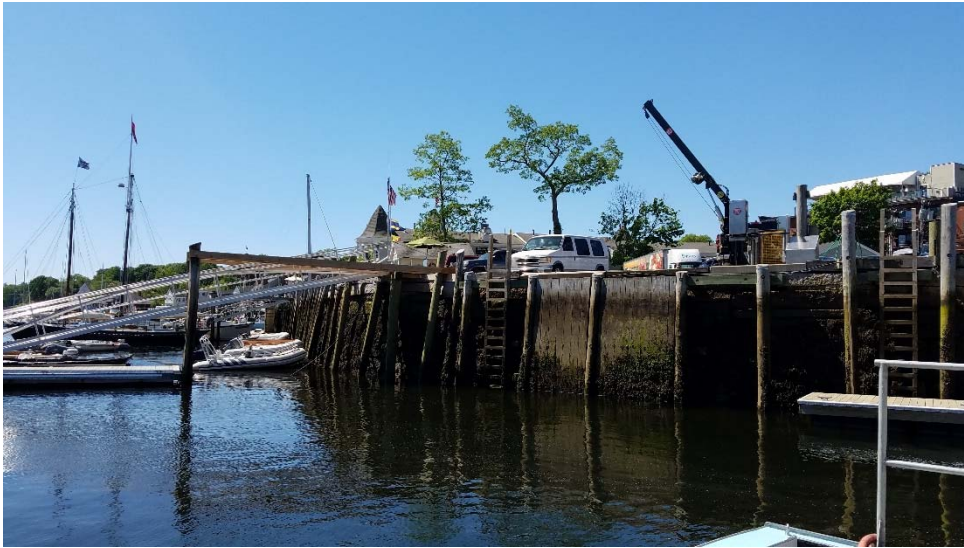
**Photograph No. 5:**

View of typical construction of wharf (Looking south).

Stacked granite at exterior face of wharf for the Public Landing.

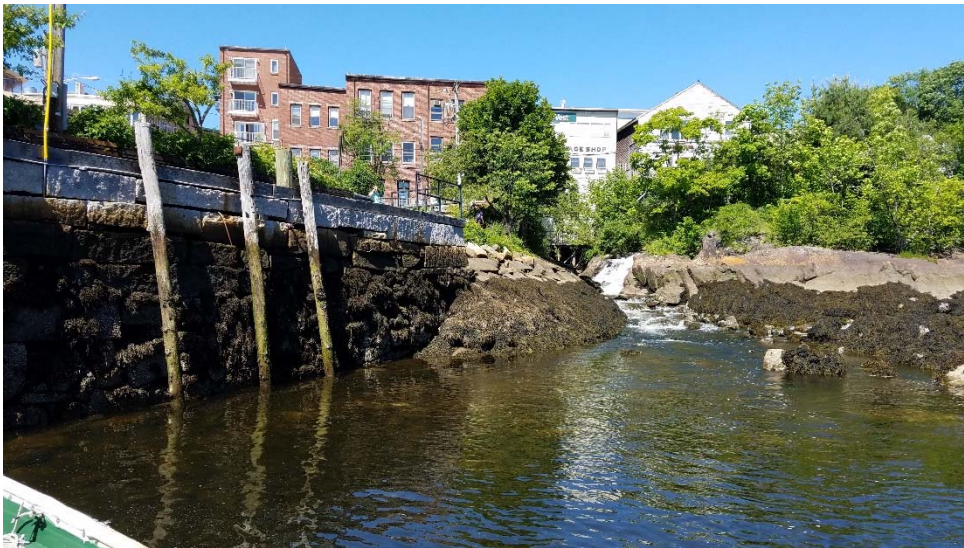
**Photograph No. 6:**

View looking north of the wharf and transition to the river outfall.

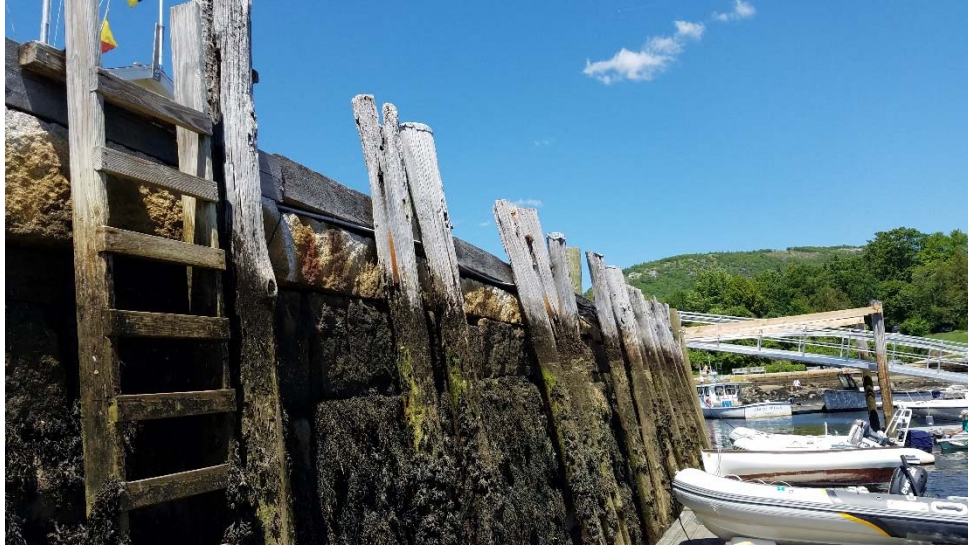
Photograph No. 7:

**Closer view at face of stacked granite.**

**No signs of failure noted at location of harbor.**

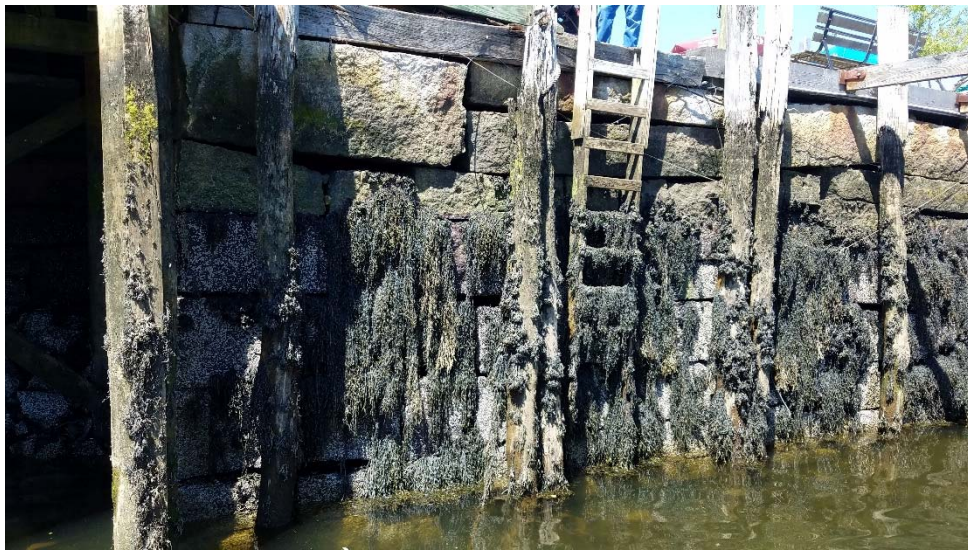
Photograph No. 8:

**Closer view at face of stacked granite, similar to Photograph No. 7. No obvious signs of delamination or deflection noted.**

**Cables noted at face of wall.**

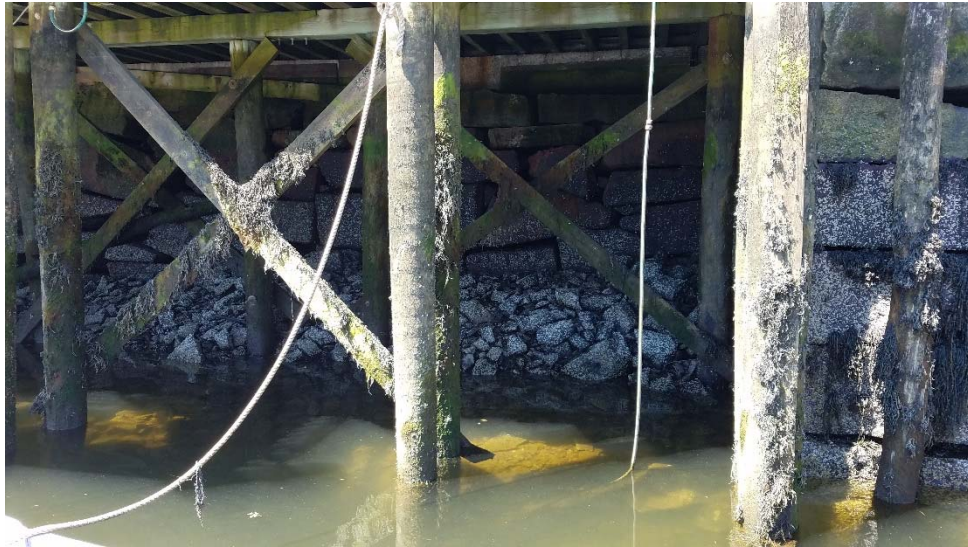
**Photograph No. 9:**

Transition of stacked granite, typical of Public Landing, and adjacent property.

View of pier framing and continuation of stacked granite beyond.

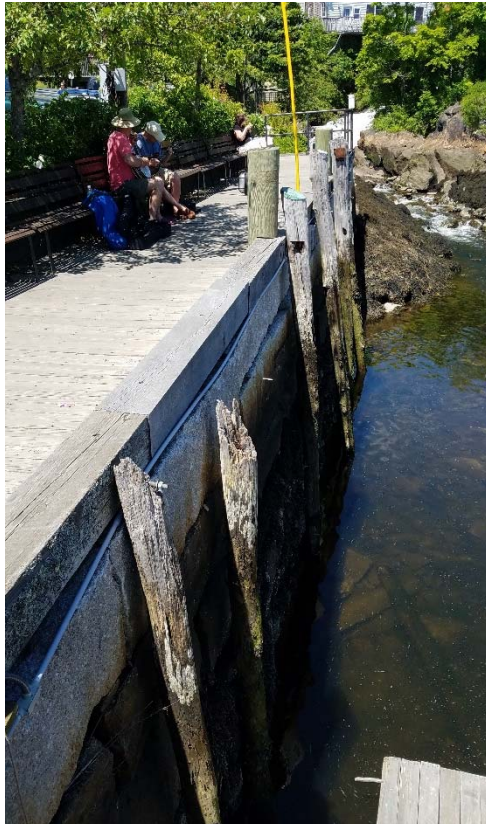
**Photograph No. 10:**

The wharf structure, particularly the stacked granite wall, exhibited no apparent signs of extreme translation or dislodgment for the members observed. Smaller stone material was noted between the surface and granite blocks, observable through the large openings between the blocks (**Photographs 6 – 9**). This material appears to be loosely placed and possibility for washout during an extreme event exists. Wooden members, which include bearing and fender piles, stringers, and decking exhibit signs of minor to moderate deterioration depending on their exposure and location in relation to the water. Some minor to moderate conditions of shakes, checks and splits were observed throughout. Some piles exhibited signs of infestations such as marine borers, weathering, or combination of both (**Photograph 10**).

View of northern section of public landing.

Timber piles exhibit signs of deterioration which may stem from weathering or microbial attack.

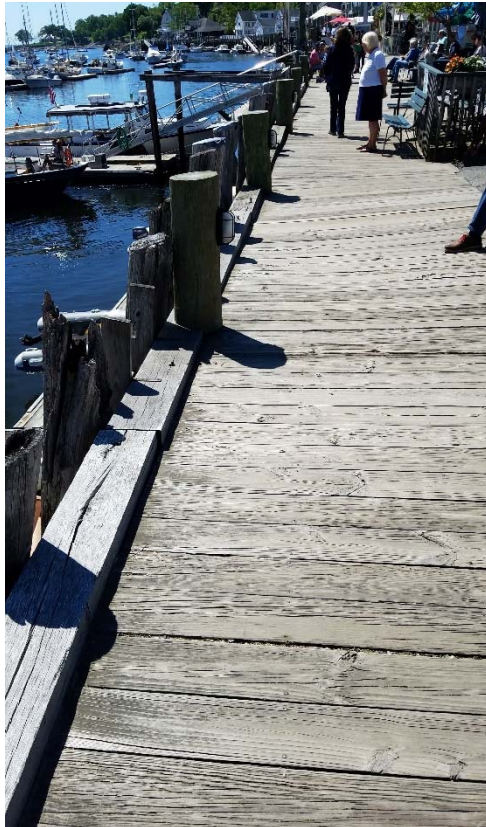
**Photograph No. 11:**

View of southern end of public landing wharf and timber boardwalk.

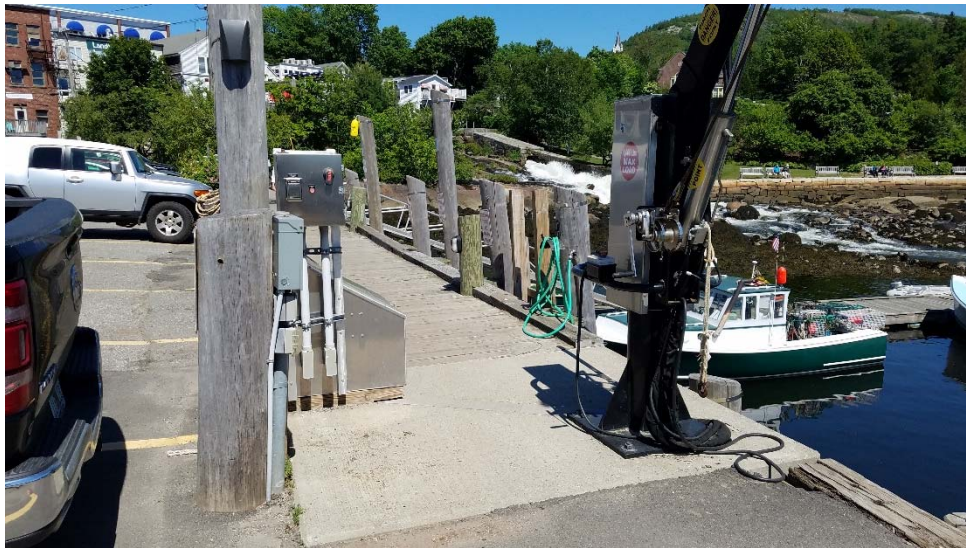
**Photograph No. 12:**

View facing north at Harbor Master's office.

Harbor hoist and site utilities noted.

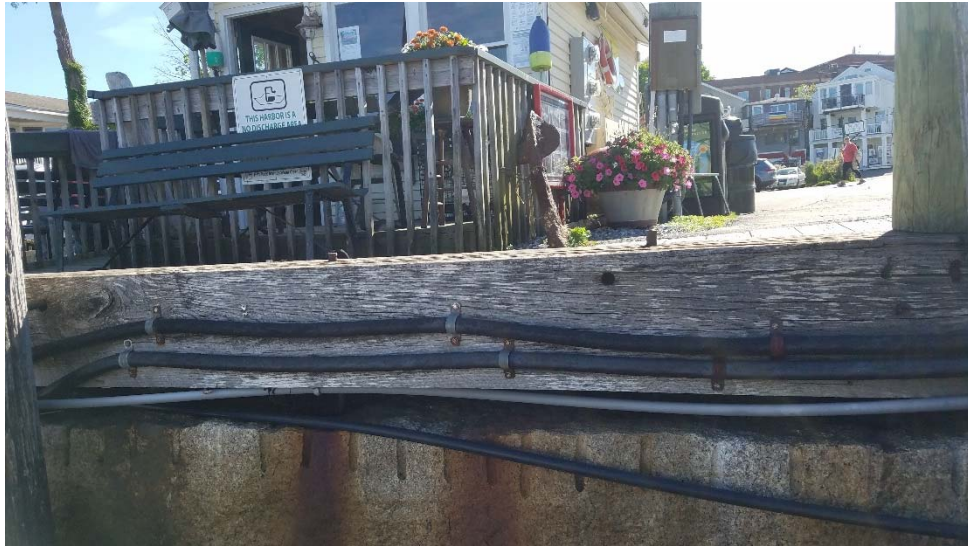
**Photograph No. 13:**

Boardwalk framing on granite block.

View of utilities at face timber framing and granite at wharf.

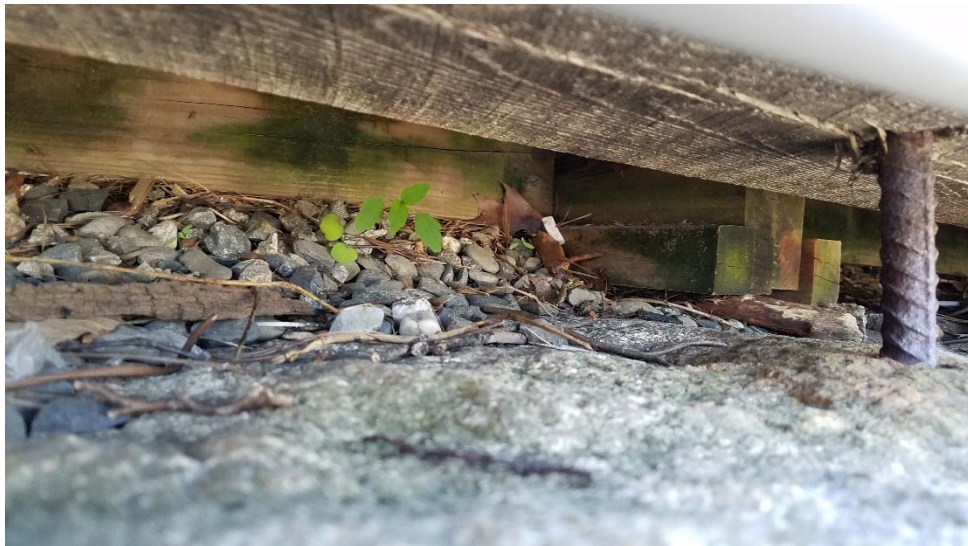
**Photograph No. 14:**

The wharf appears to be constructed by a combination of stacked granite blocks, timber framing and backfill. Indications of a select backfill such as crushed stone bedding were noted at the underside of timber boardwalk (**Photograph 14**). The Subsurface conditions of the site were not probed or verified by testing as part of Wood’s scope of work. Granite blocks are stacked to make up the exterior face of the wharf. The depth of the blocks could not be verified. Timber framing is applied at the surface which is seen at the boardwalk and timber header beam. Timber framing appears to be attached using a combination of through bolts, nails, or screws. Attachment of the timber to the granite was observed at some locations by means of a metal dowel. Decking is attached to framing via framing nails.

Close-up of timber framing at boardwalk on granite block and gravel bedding.

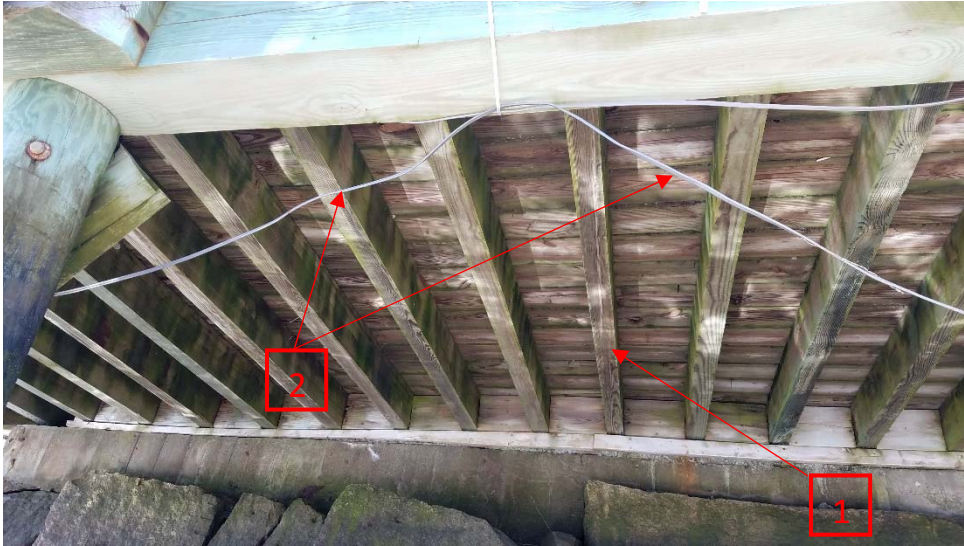
**Photograph No. 15:**

1. View of underside of deck at adjacent property.
2. Hanging wires which appear to be electrical are attached at underside of framing.

Electrical service conduits and cables below the Design Flood Elevation (DFE) shall be waterproofed or conform to the provisions of NFPA 70 National Electrical Code (NFPA 2011 ) for wet locations.

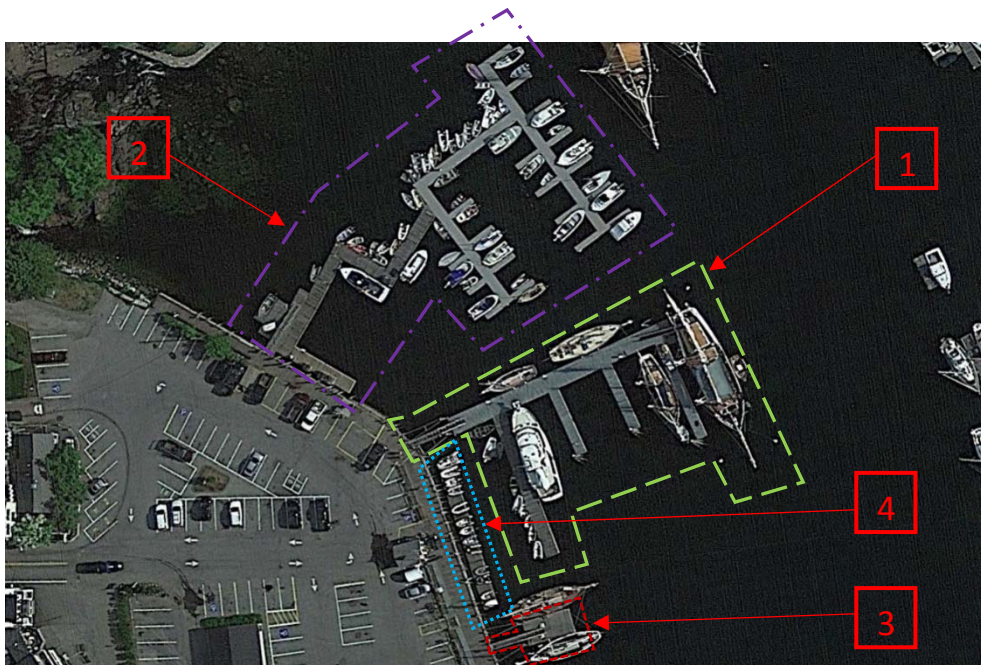
**Photograph No. 16:**

Floating Dock Key

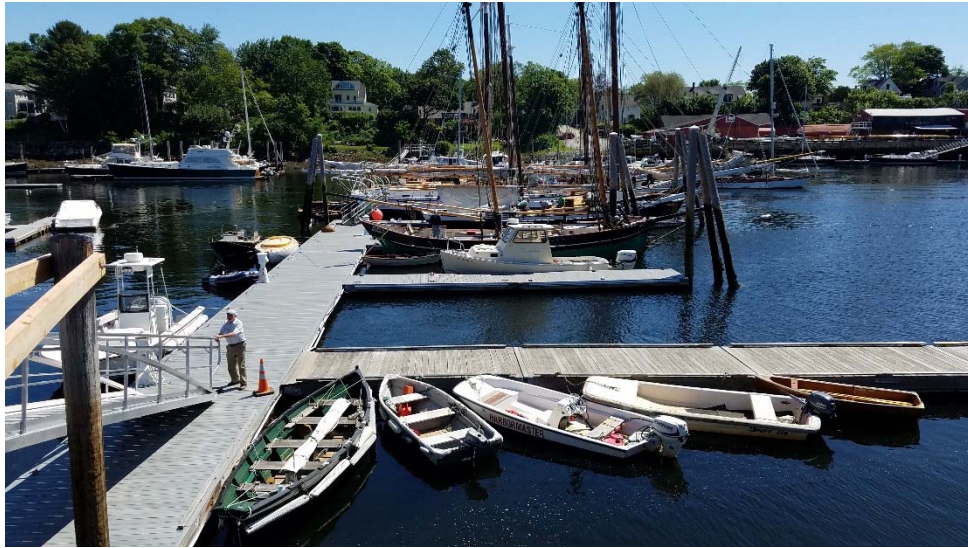
**Photograph No. 17:**

**View of floating dock 1**

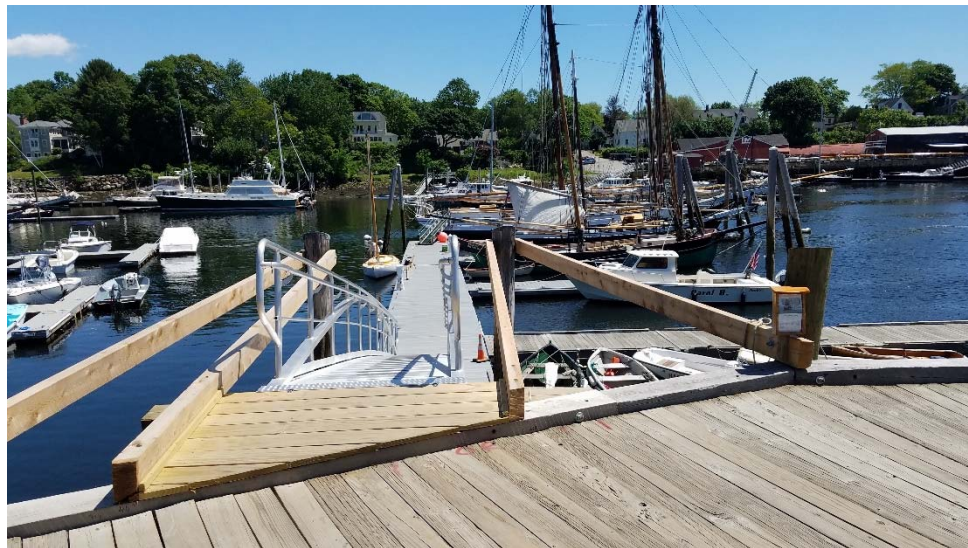
**Photograph No. 18:**

**View of gangway attachment to wharf/boardwalk.**

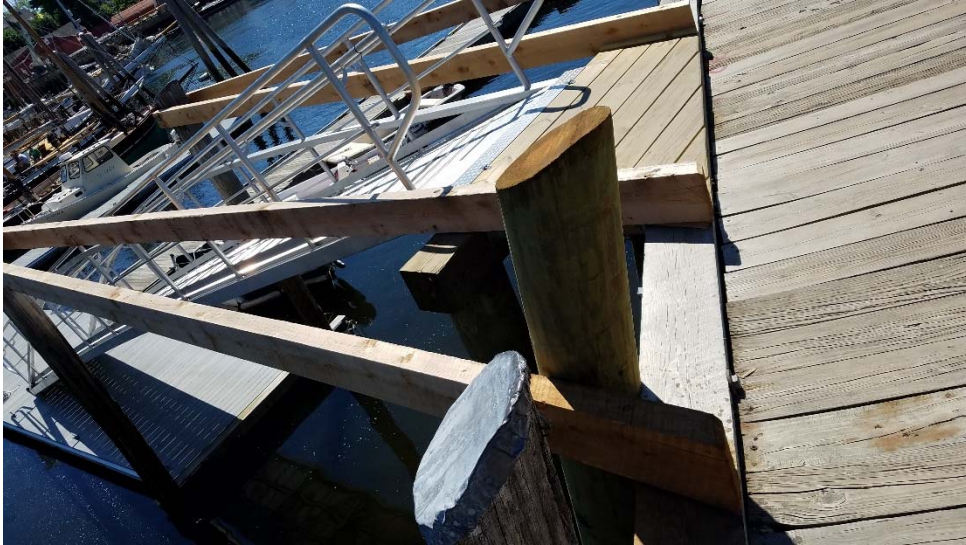
**Photograph No. 19:**

Close-up of gangway attachment to wharf.

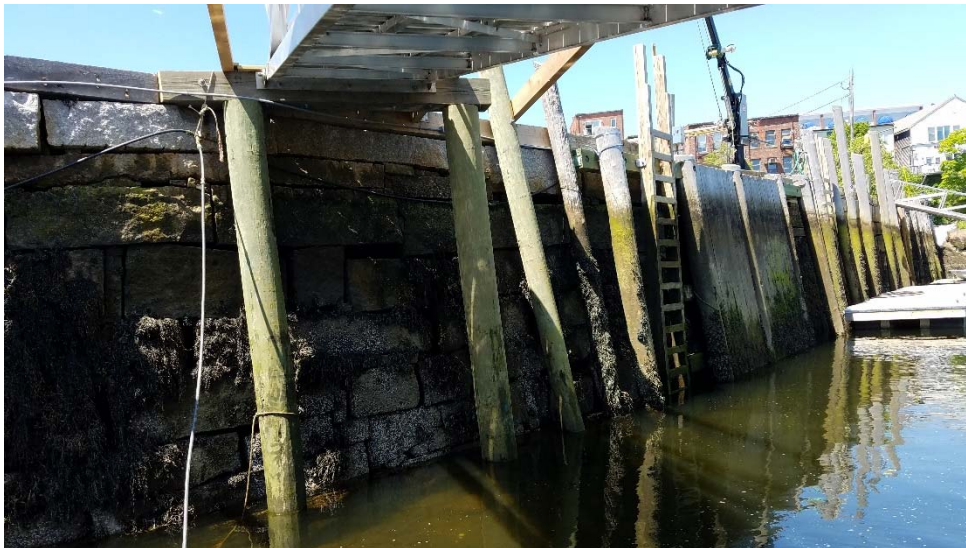
**Photograph No. 20:**

View from below of support structure for gangway of floating dock 1.

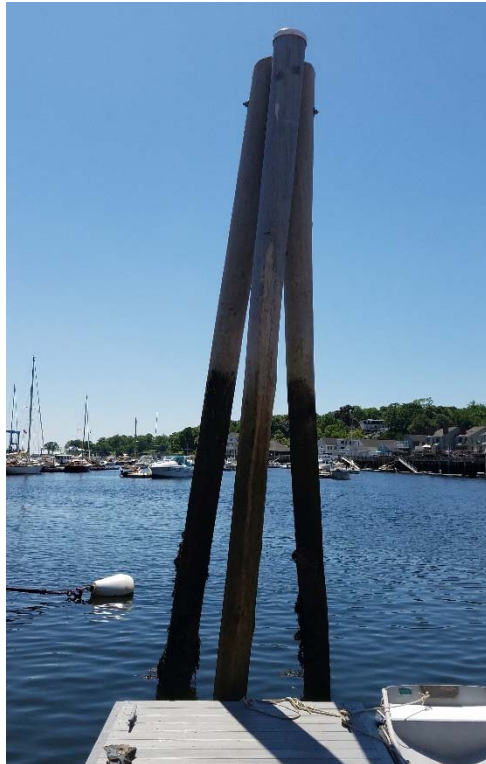
**Photograph No. 21:**

**Typical battered pile support of dock and slips.**

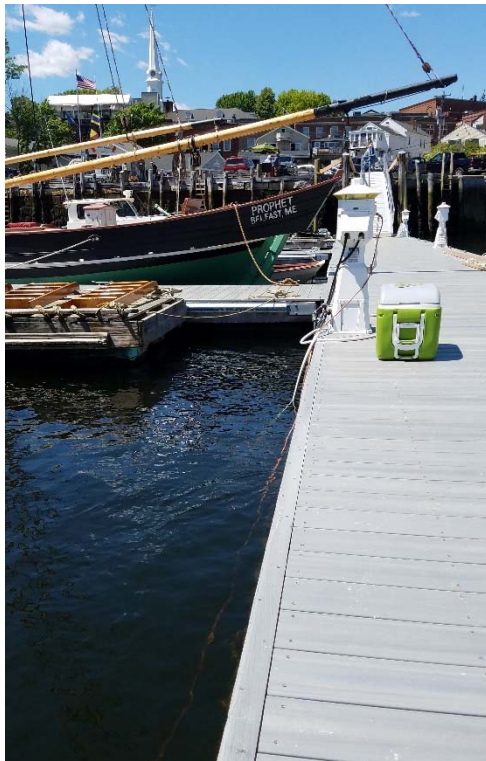
**Photograph No. 22:**

**View of floating dock.**

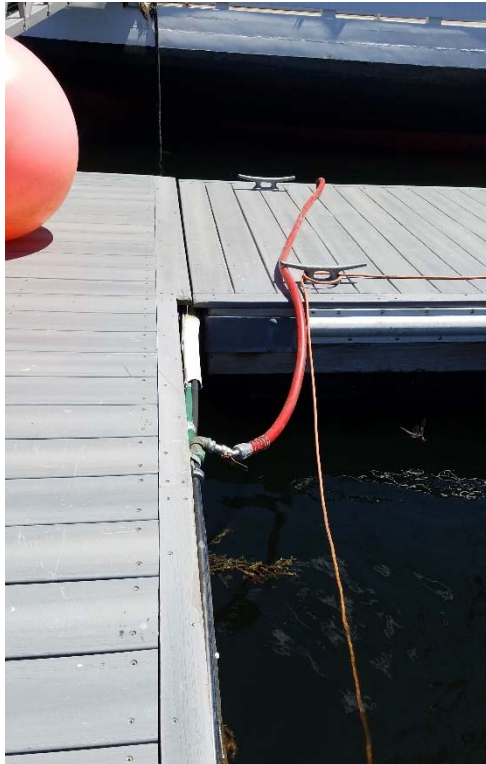
**Photograph No. 23:**

View of floating dock.

View of dock supply water hoses and fittings.

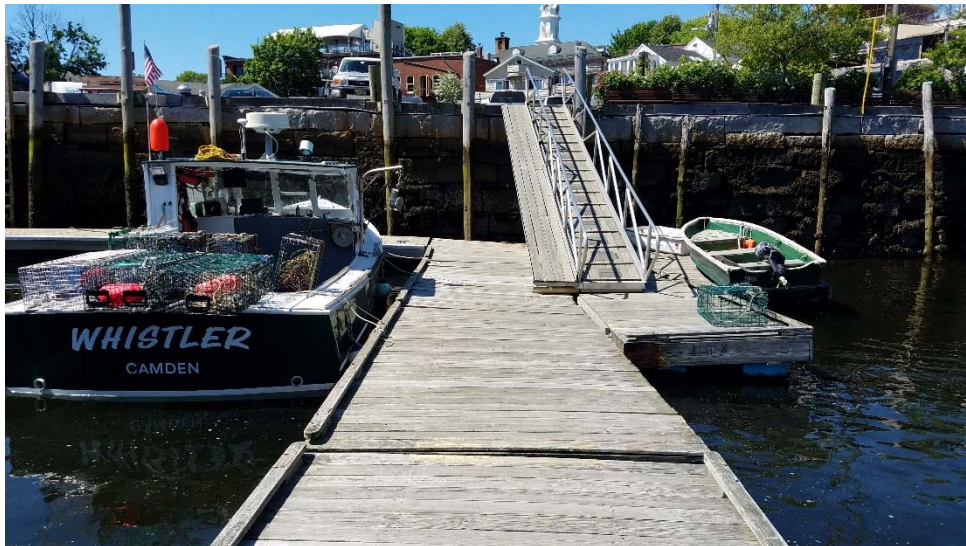
**Photograph No. 24:**

Overview of Floating dock 2

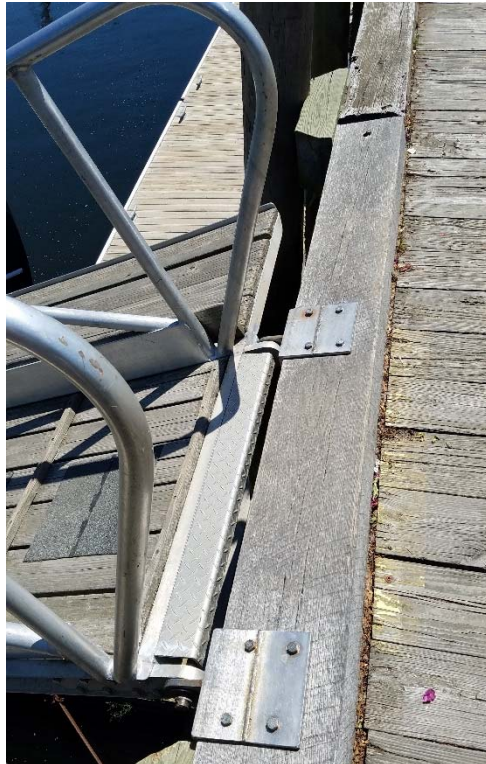
**Photograph No. 25:**

Close-up of gangway attachment to wharf.

Hinge hardware appear in decent condition.

Embedment of fasteners not apparent.

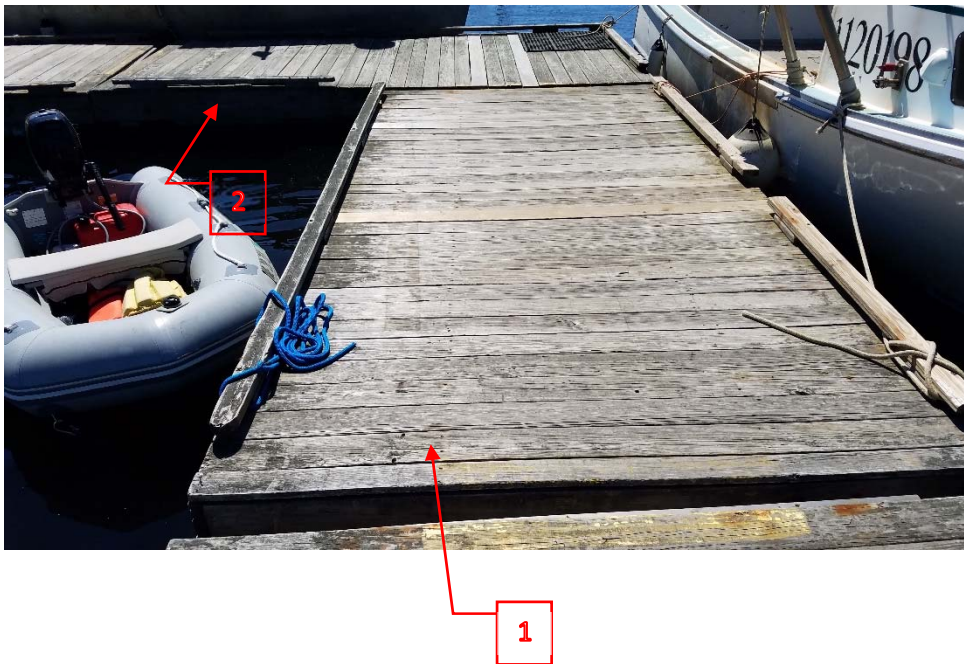
**Photograph No. 26:**

View of typical condition of a float at Floating Dock 2.

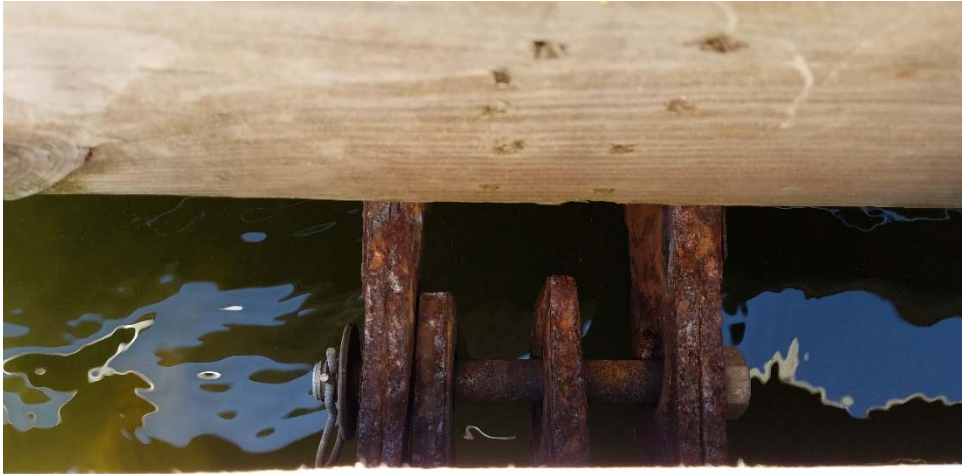
**Photograph No. 27:**

Close-up of the adjacent float connection.

Bolt and hinge appear moderately corroded. Bolt appears to be galvanized steel.

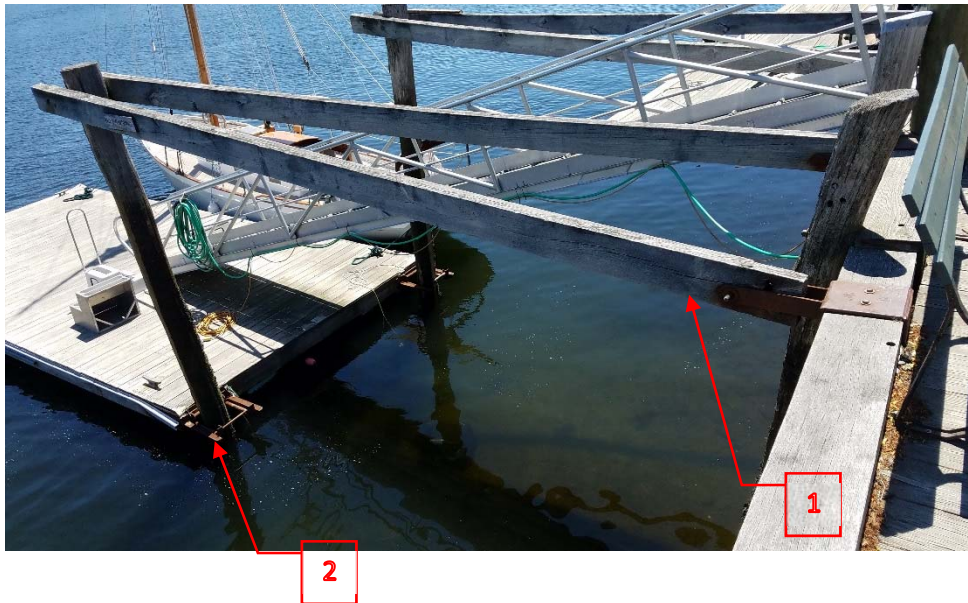
**Photograph No. 28:**

Overview of floating dock 3.

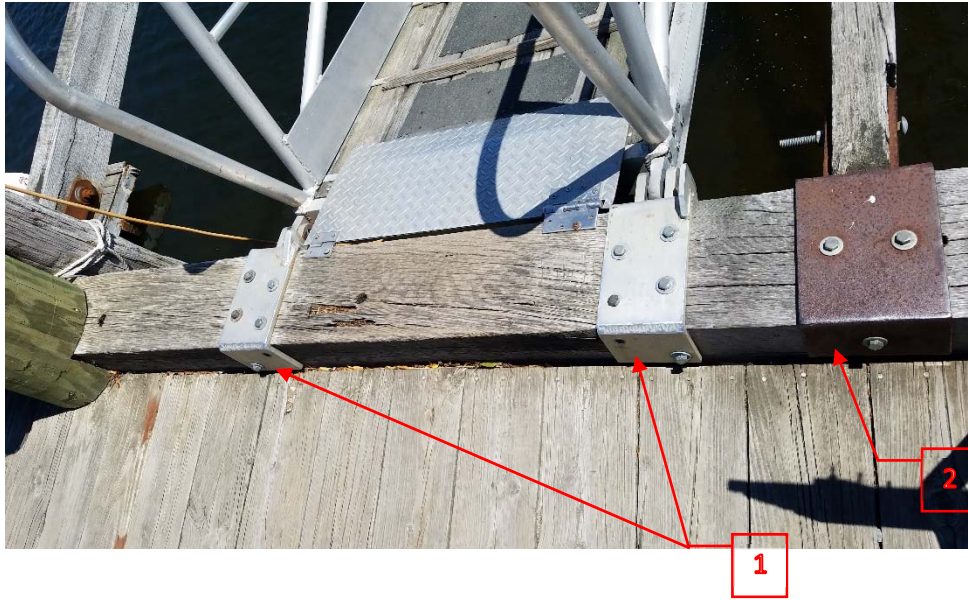
**Photograph No. 29:**

Close-up of gangway attachment to wharf.

1. Hardware for attachment of gangway to wharf appears in decent condition.
2. Hardware for attachment of pile bracing to wharf appears mildly corroded. Bracing appears to be moderately weathered.

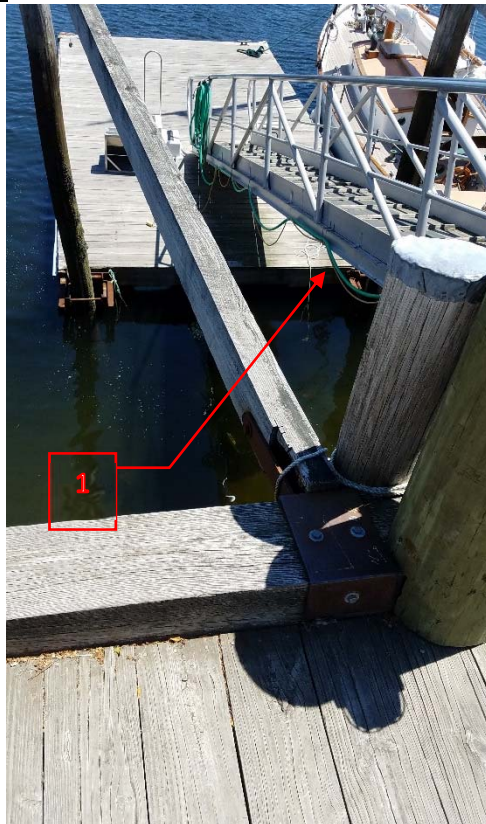
**Photograph No. 30:**

Additional view of gangway.

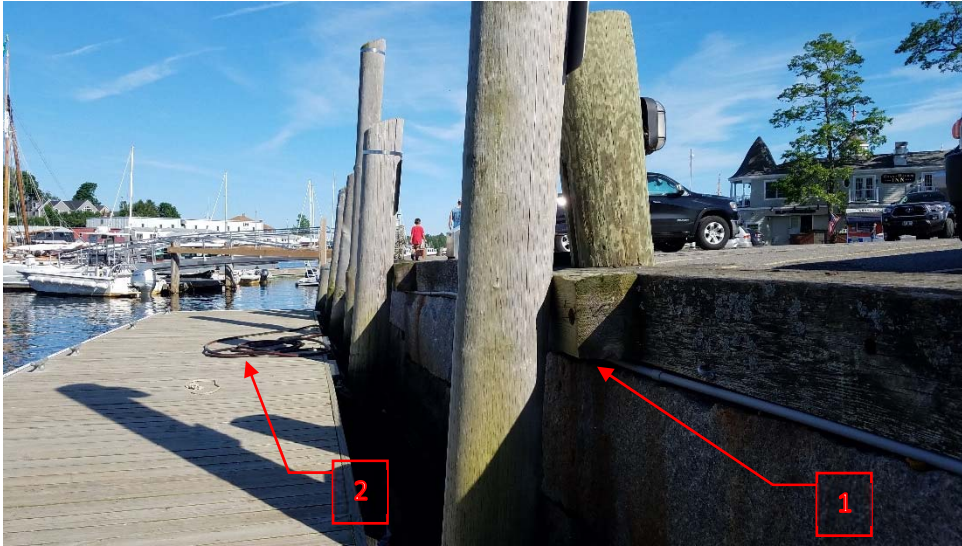
**Photograph No. 31:**

**View of floating dock 4.**

- 1. Support piles attachment to wharf**
- 2. Water hoses for supply to dock.**

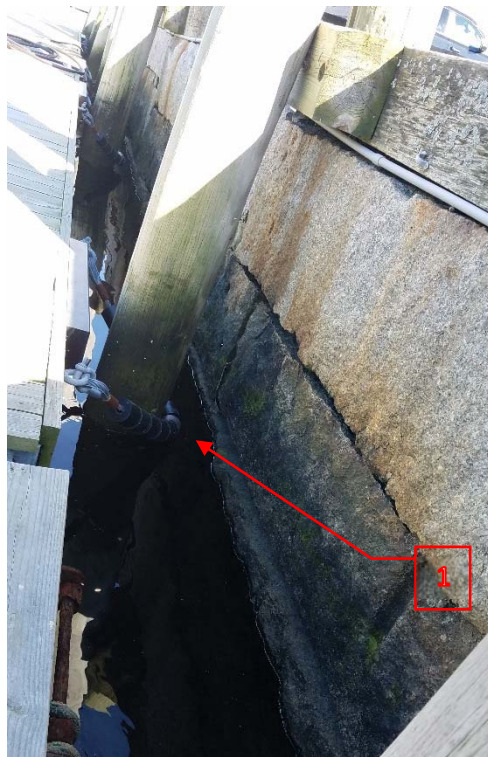
**Photograph No. 32:**

**Close up of dock attachment to support piles by means of mooring chains.**

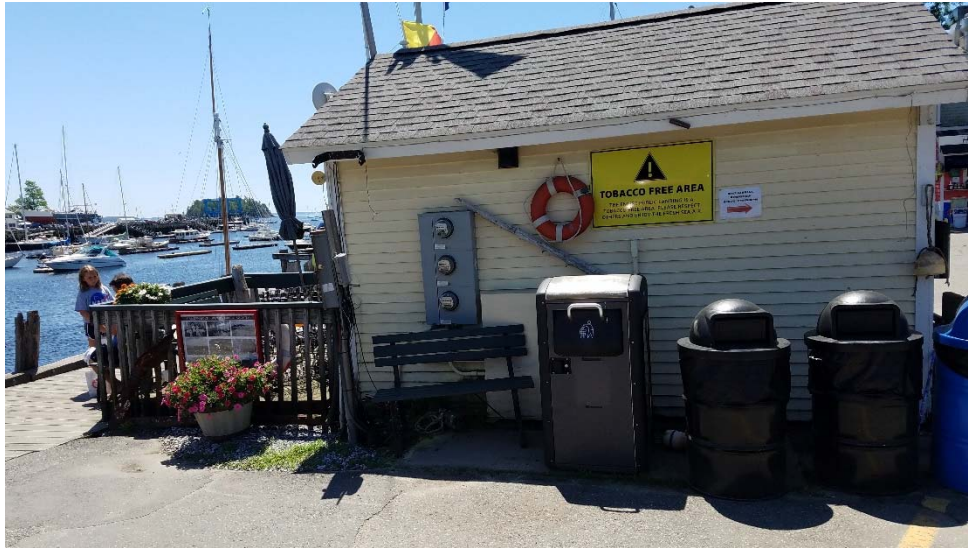
**Photograph No. 33:**

**View of Harbor Master's Office.**

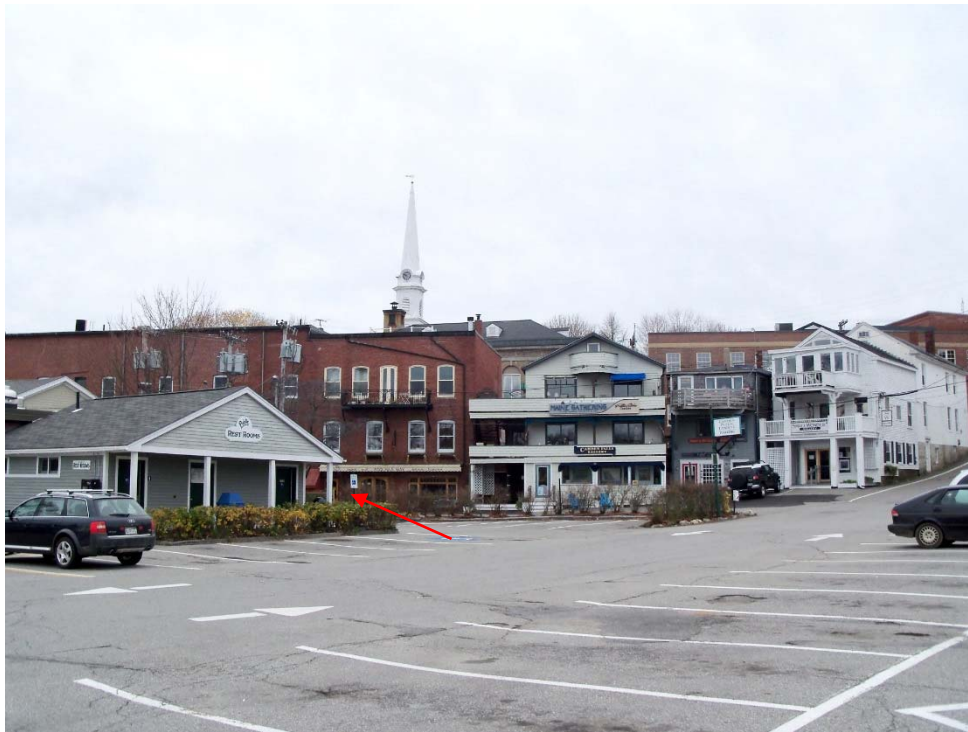
**Photograph No. 34:**

**View of public restrooms and other building on site.**

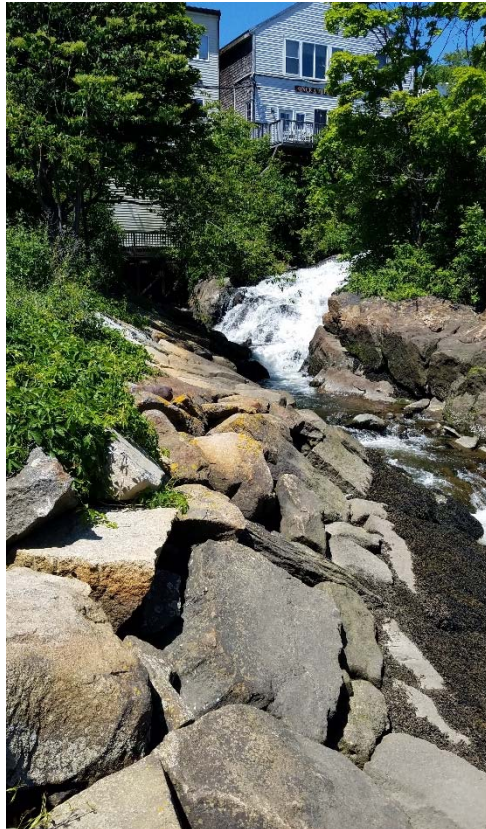
**Photograph No. 35:**

Shoreline/outfall protection adjacent to the public landing and waterfall.

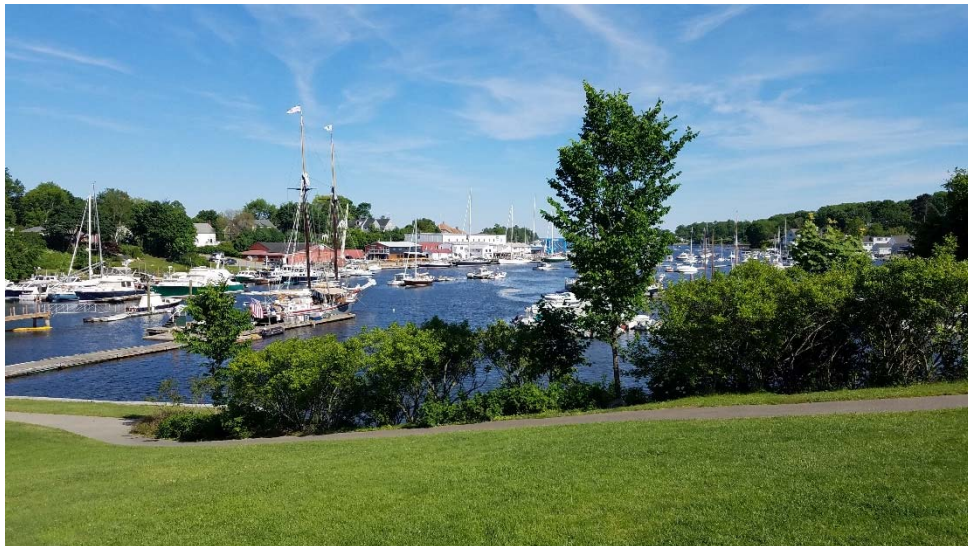
**Photograph No. 36:**

Overview of Harbor Park looking south from the field.

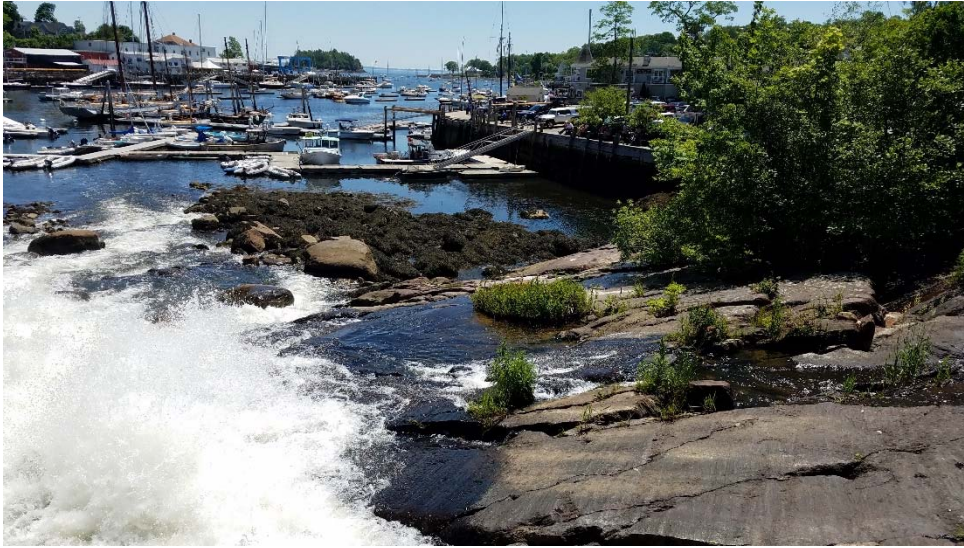
**Photograph No. 37:**

**View of harbor and outlet of Megunticook River.**

**Large rocks and vegetation noted.**

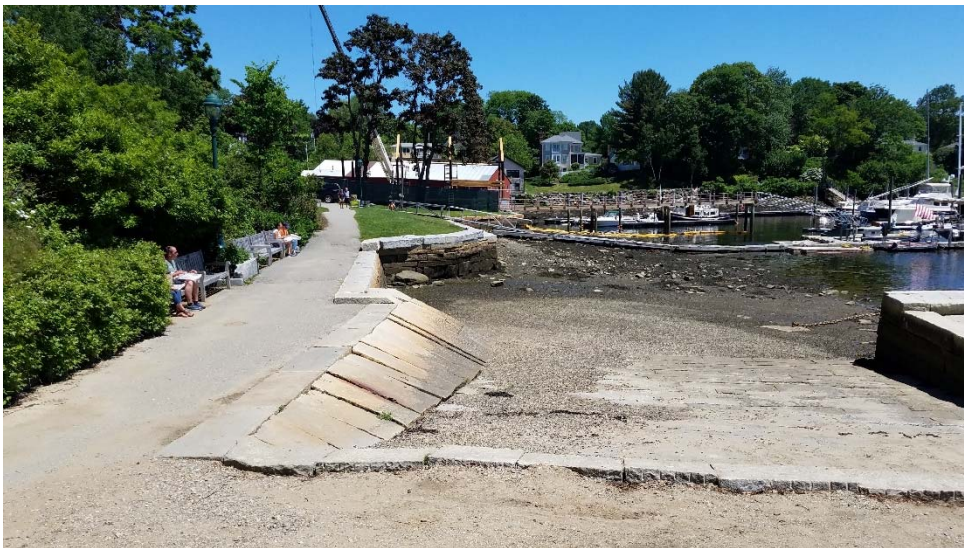
**Photograph No. 38:**

**View of park and shoreline.**

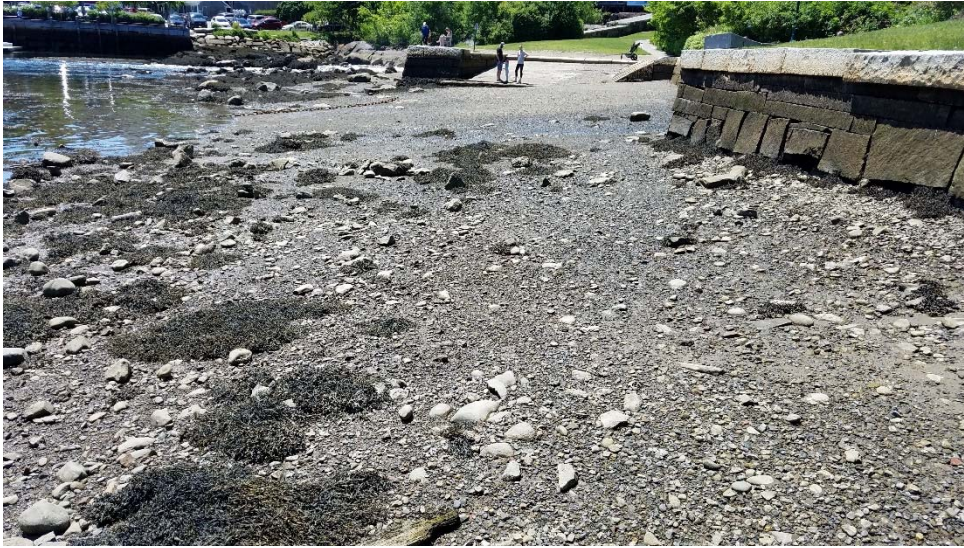
**Photograph No. 39:**

Close-up of beach looking west.

View of stacked granite wall at upper right side of photo.

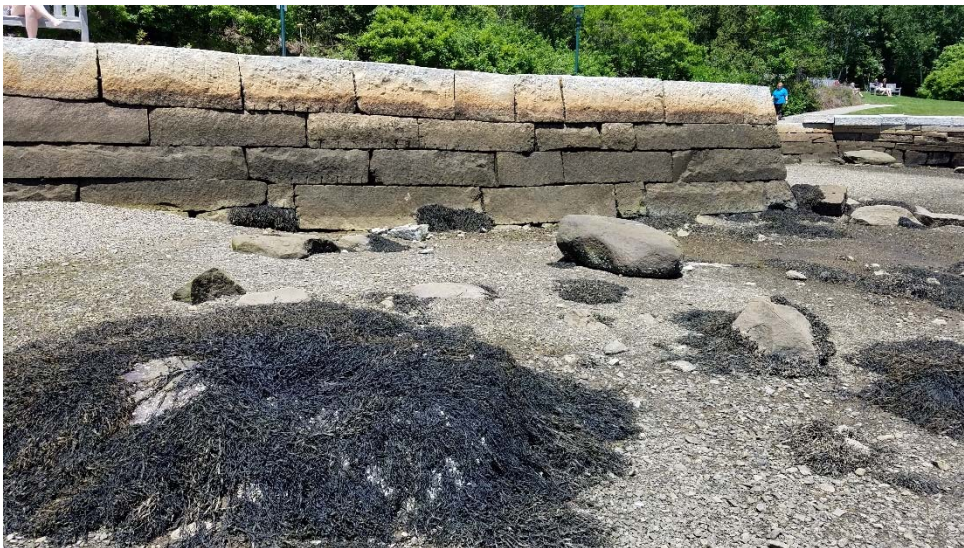
**Photograph No. 40:**

View of stacked granite walls and various other large rocks.
