20 December 2019

Project Number: 3611191238

**Subject: Vulnerability Assessment and Resilience Planning, Middle Pier, Rockland, Maine
Penobscot Bay Working Waterfront Resiliency Analysis
State of Maine, Department of Marine Resources**

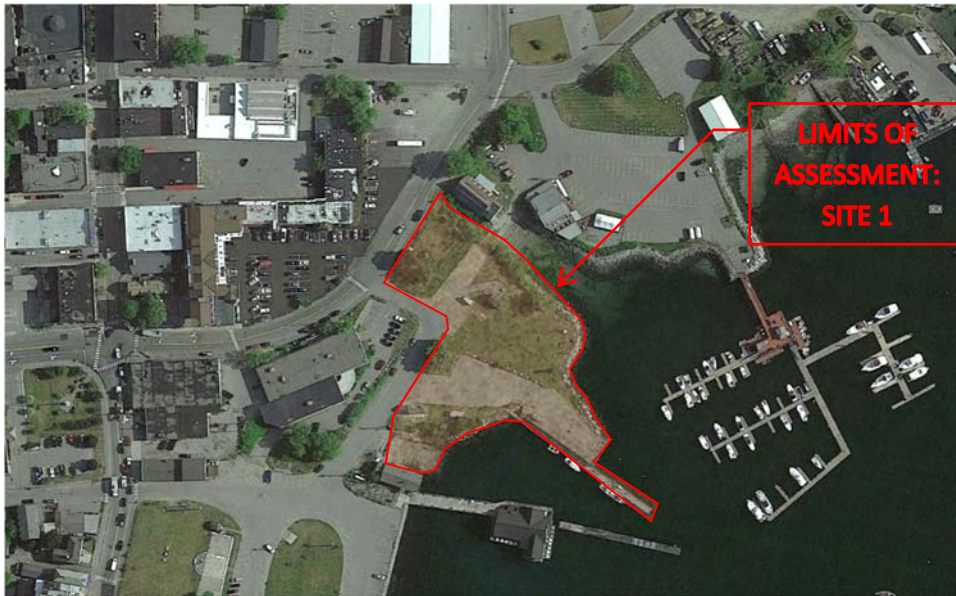
Photograph No. 1:

Overview of Site 1.

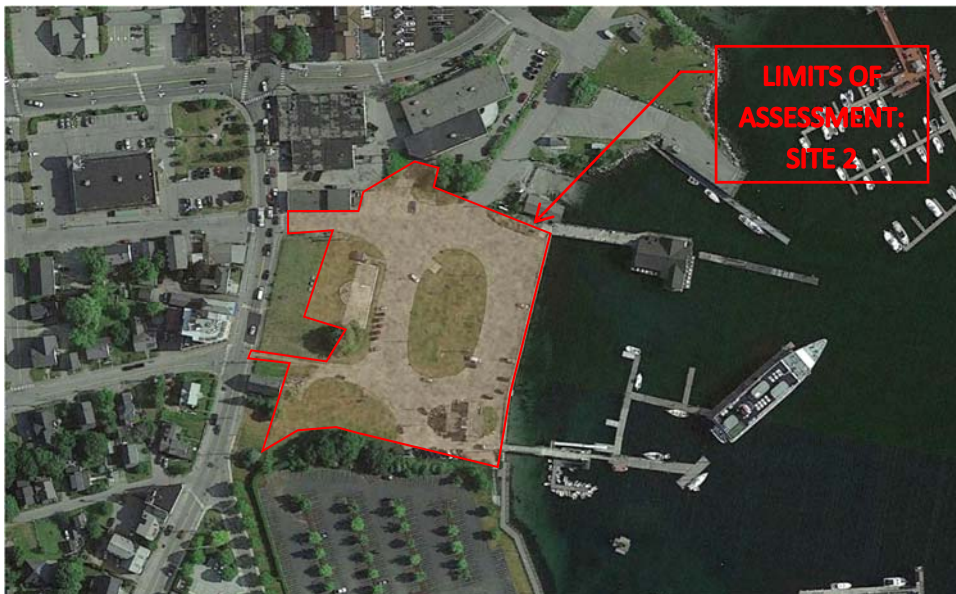
Photograph No. 2:

Overview of Site 2.

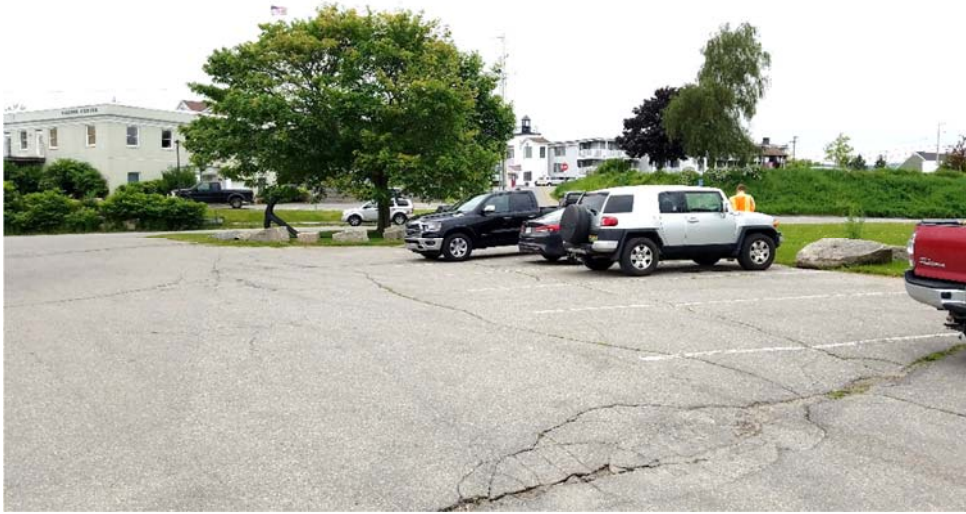
Photograph No. 3:

View of parking area near park.

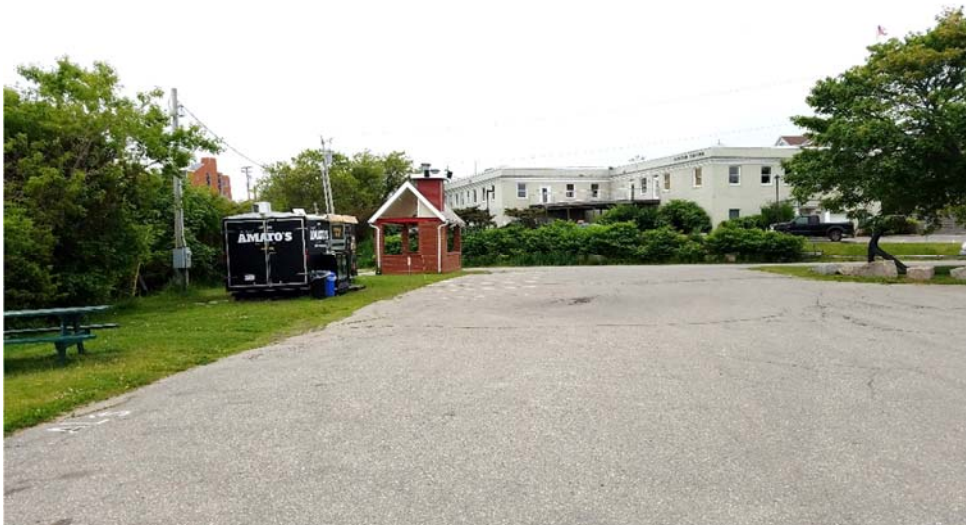
Photograph No. 4:

View of parking area near park.

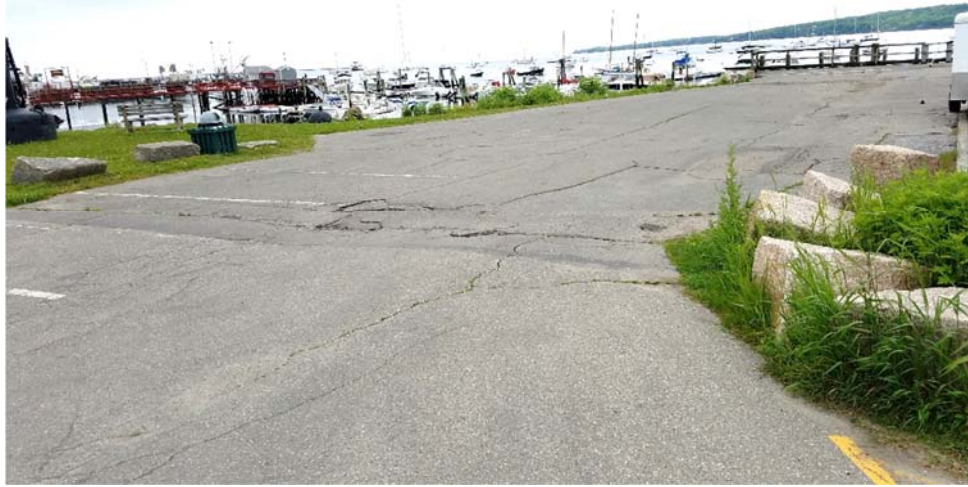
Photograph No. 5:

View of wharf from above.

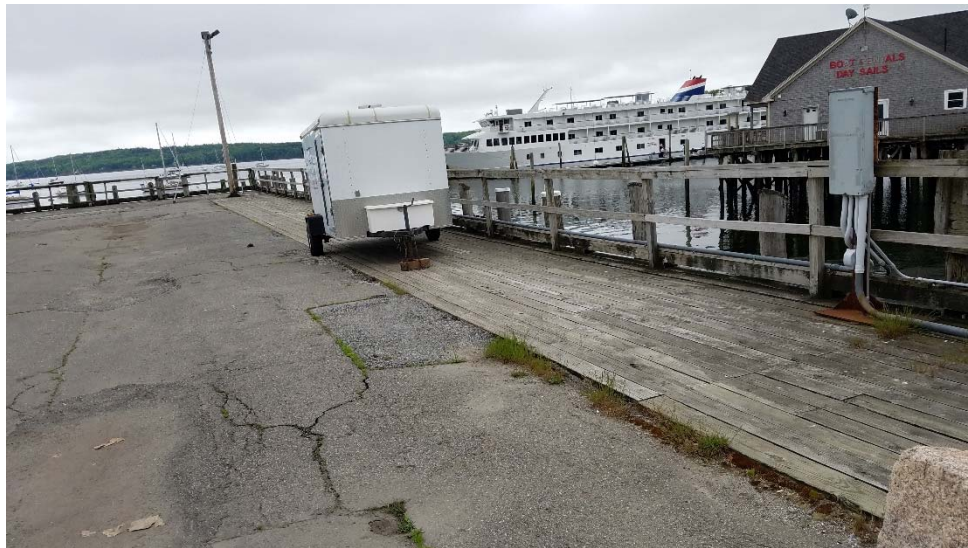
Photograph No. 6:

View of South Pier from above.

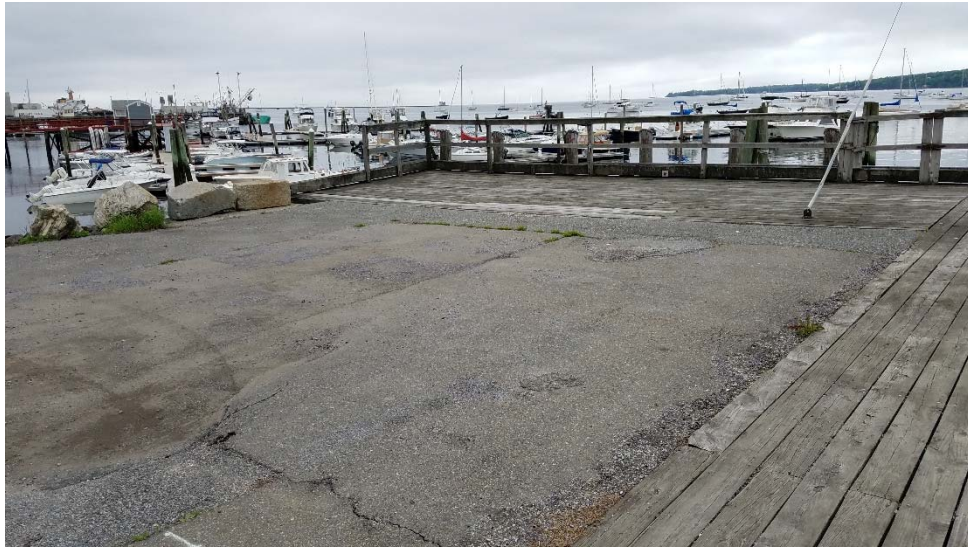
Photograph No. 7:

View of West Pier from above

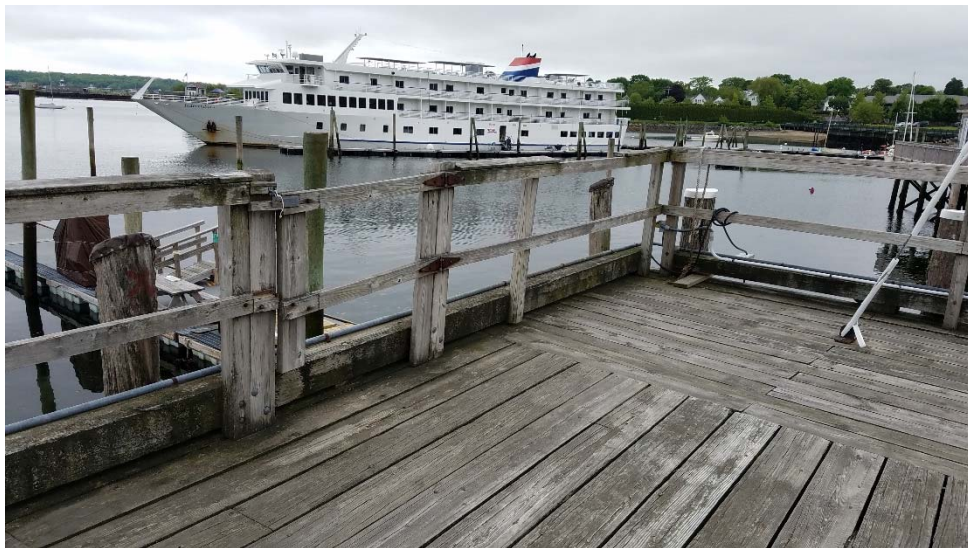
Photograph No. 8:

Close-up of timber members at pier.

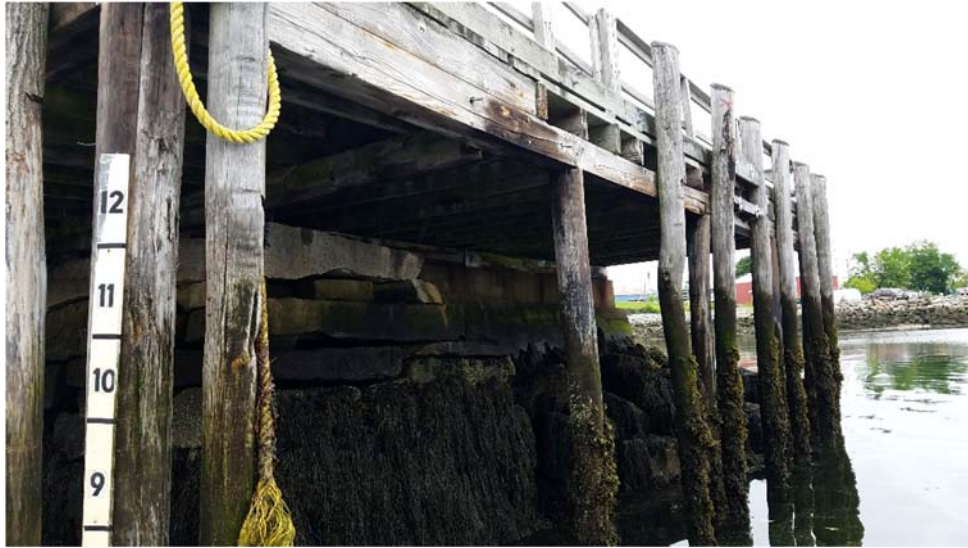
Photograph No. 9:

The wharf appears to be constructed of stacked granite blocks as a substructure with crushed stone fill of large to medium diameter between the granite blocks and the surface above (**Photograph 9 & 10**). Subsurface conditions for the site were not verified by testing, however information provided from the United States Geological Survey (USGS) indicate silty and gravelly sandy loams are typical for this area.

View facing northeast at front of pier and wharf.

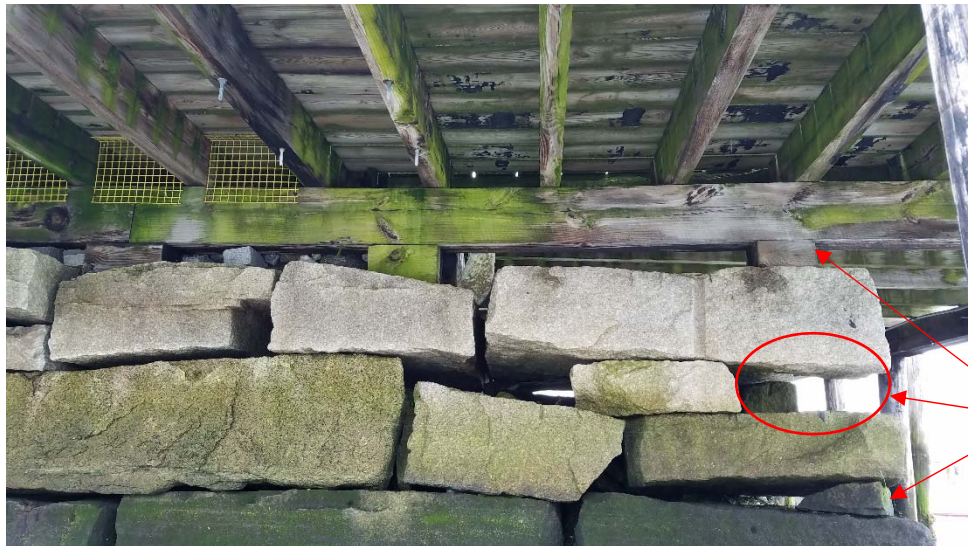
Photograph No. 10:

View facing north at south side of wharf and pier.

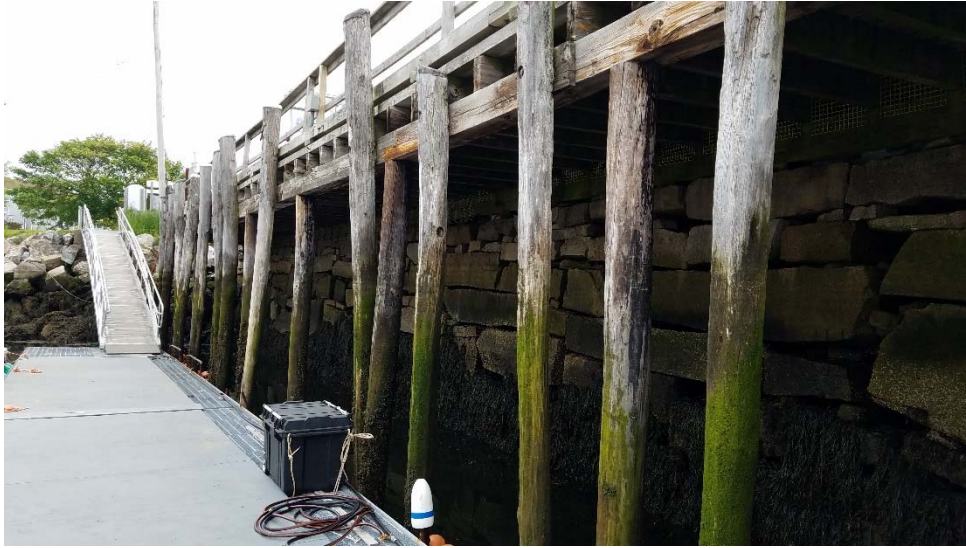
Photograph No. 11:

View of south pier at wharf and floating dock.

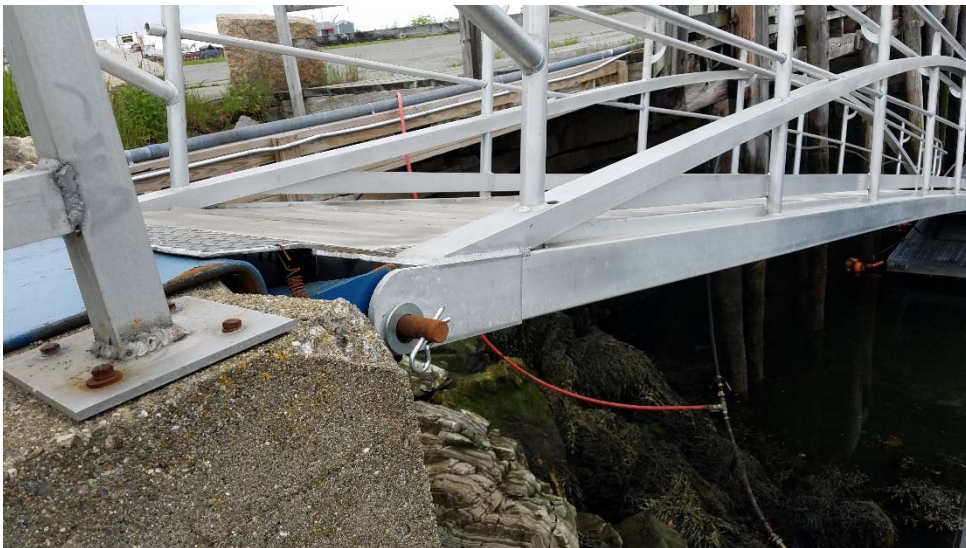
Photograph No. 12:

View of floating dock gangway attachment to concrete footing.

- Confirm the gangway attachments are sufficient to resist the design loading and repair or replace as needed.

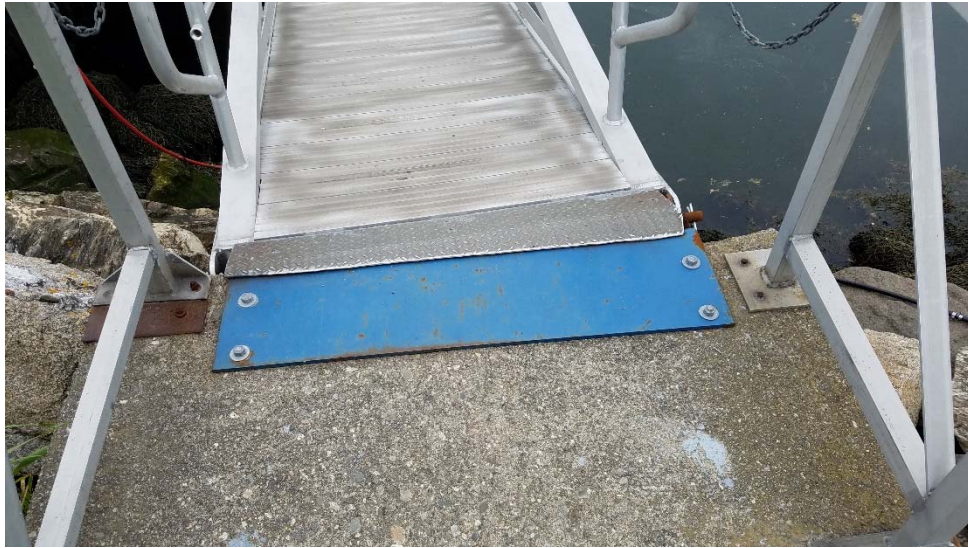
Photograph No. 13:

View from above at location in Photograph 12.

Attachment of sill and cover plate.

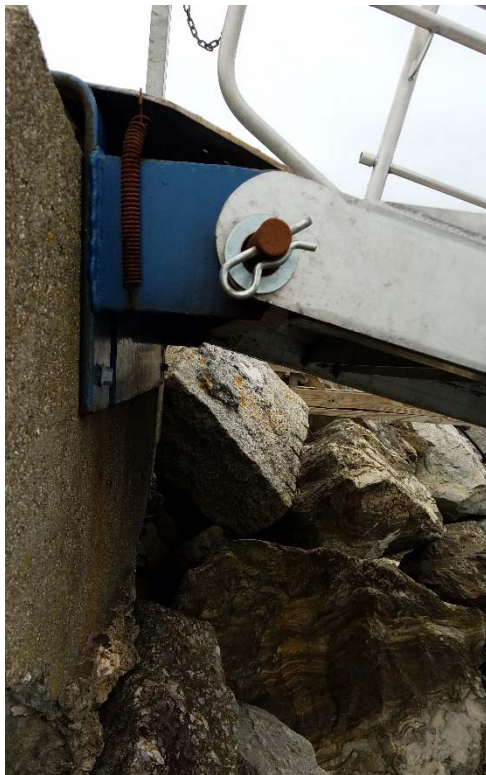
Photograph No. 14:

Side view of gang way attachment facing north.

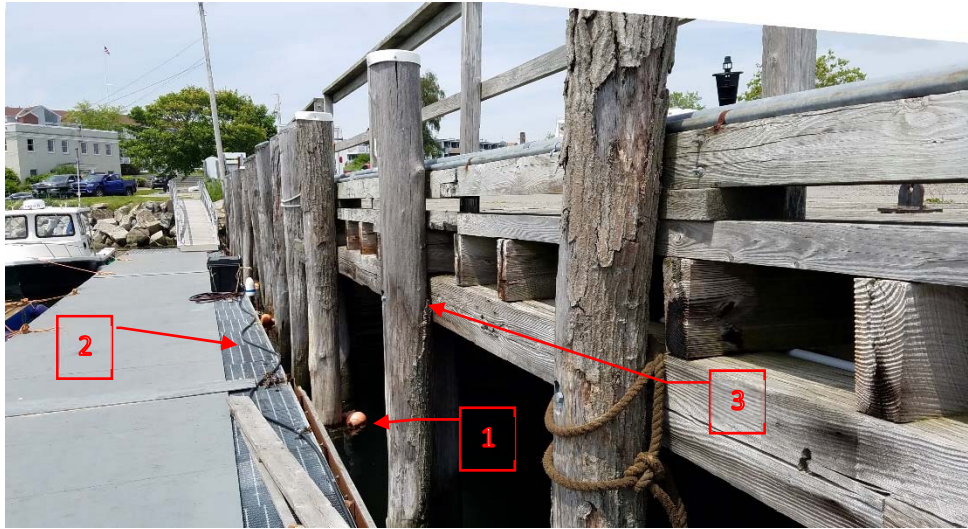
Photograph No. 15:

1. Mooring Chain attachment at float.
2. Floating deck water supply line.
3. Limits of floating dock mooring chain at high water level.

- Conduct a detailed evaluation for the mooring system of the floating dock and the buoyancy and wave loads imposed on the float and wharf structures due to future water level rise and storms. Design and install separate mooring piles for the floats to avoid attachment to the pier. Piles should be installed to accommodate a BFE of at least the Mid Term condition with the addition of 2 ft of freeboard.

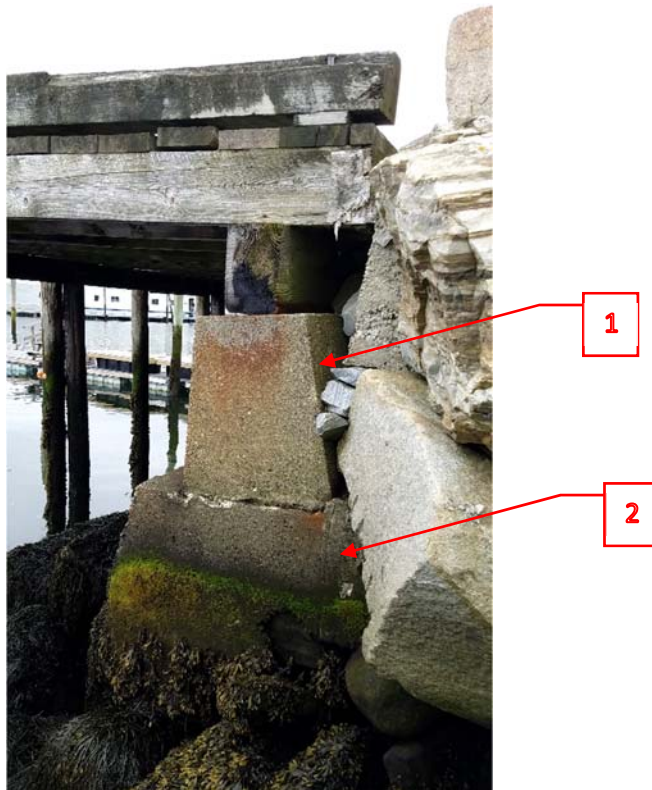
Photograph No. 16:

As earlier mentioned, an abutment is used to support the pier framing at one end. Positive attachment (anchorage or other mechanical fastener) of the concrete abutment to the granite blocks or attachment of the wood framing to the abutment and/or the granite blocks could not be confirmed. The abutment stem and footing appear to be composed of two separately poured elements (**Photograph 16**). Wooden members, which include piles, stringers, and decking exhibit signs of moderate deterioration due to weathering and/or microbial attack. Some minor to moderate conditions of shakes, checks and splits were observed throughout. For those piles observed, signs of infestations such as marine borers were not noted in the tidal zone.

View of abutment support of pier at north side.

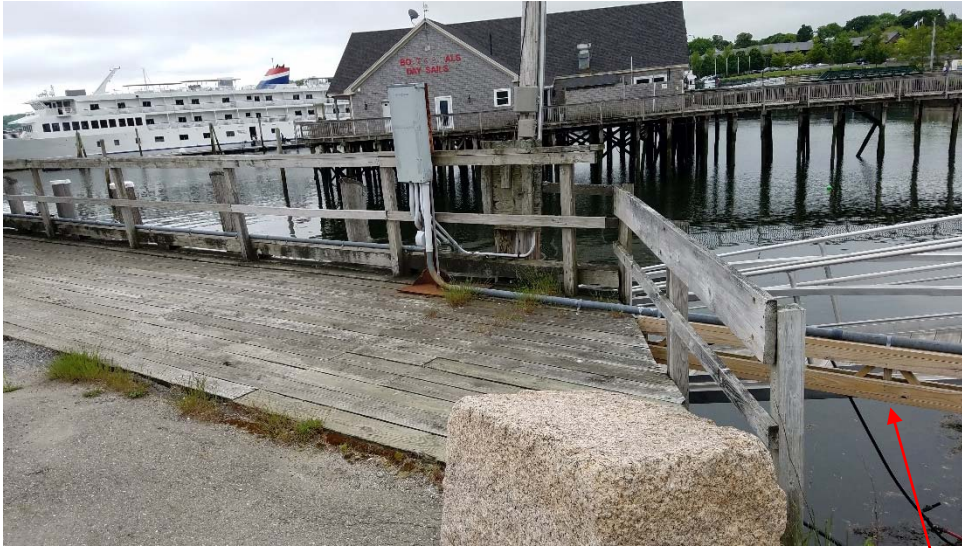
Photograph No. 17:

View of pier and pipe bridge for electrical conduit which is vulnerable to wave action.

- Replace current electrical cabinet with stainless steel watertight cabinet. Design and Construction **\$12,000.**
- Utilities should be properly secured to resist design wind and water loading or relocated above the design flood elevation as specified in ASCE 24. Design and Construction **\$175,000.**

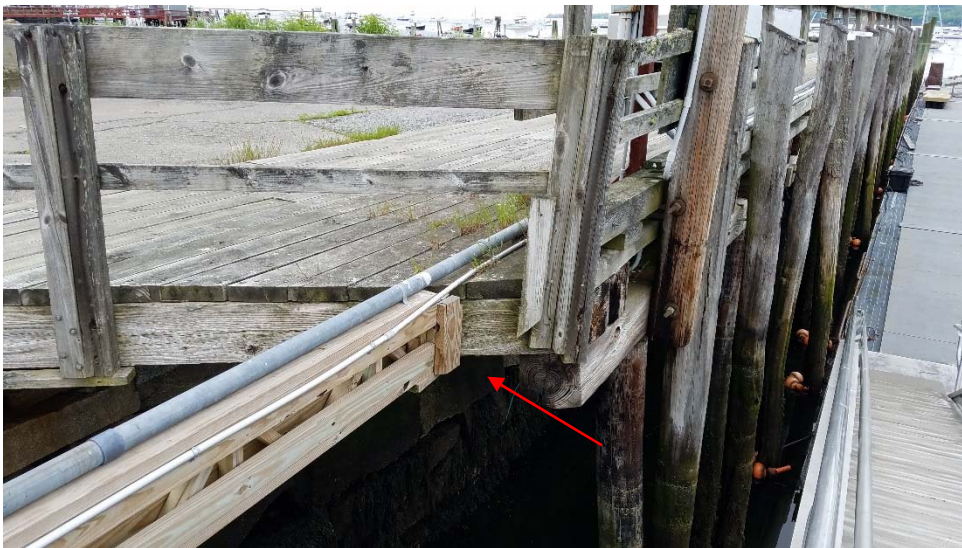
Photograph No. 18:

Close-up of electrical conduit and pipe bridge attachment to pier as noted in previous photo.

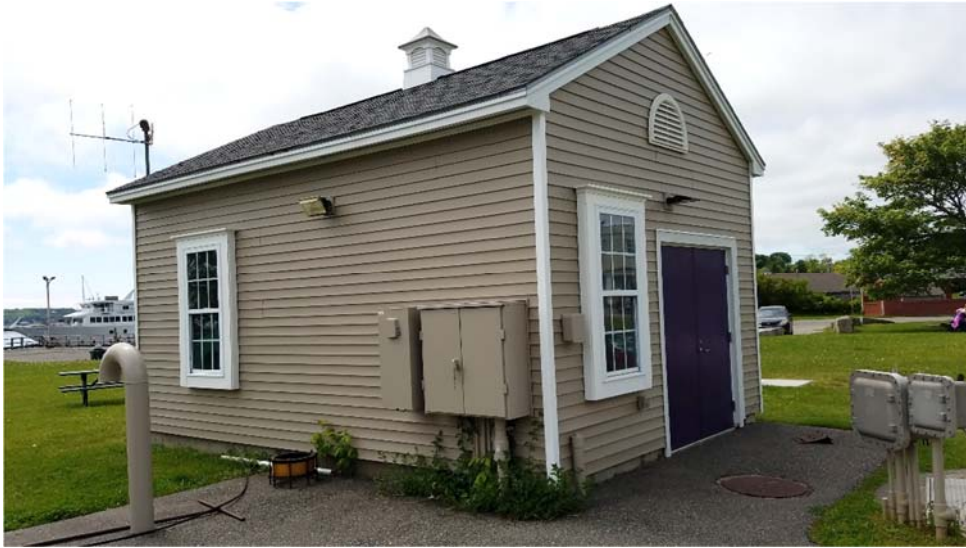
Photograph No. 19:

The two structures observed at the site are the lobster pavilion and the sewer pump station. The estimated top of slab elevation at the pump station is elevation 14.4 feet. The BFE at this location as shown in Table 2 for the Present Day scenario is 15 feet; however, waves can be expected to dissipate at this inland distance to equal the 1% Stillwater elevation of 9 feet NAVD 88. The roughly 15 ft FFE of the building is also above the Short, Mid and Long Term scenarios' Stillwater elevation. At Long Term scenarios, above-ground architectural and structural elements will likely be impacted, during which coatings, coverings and their fastenings will be subjected to moisture. Also, openings such as doors, windows, and louvers will be a means for moisture intrusion. Depending on the interior architectural finishes, some delamination and material degradation can be expected. Given the elevation of the pump station and wet well hatch, inundation at the long term and possibly the Mid Term scenario is of concern. During our site visit we were unable to confirm whether these elements are sealed systems due to lack of access.

View of sewer pump station and wet well cover.

- Where the Sewer Pump Station and associated wet well are impacted by future scenarios, incorporation of a flood-proof design is recommended such as stem walls extending above the design flood elevation as dry floodproofing, sealed openings, and sealed or gasketed floor/ground openings. Confirm that all building utilities are placed above the design flood elevation and/or sealed from inflow of flood water. In general, existing structures and their foundations should be assessed for the applicable design loading. Repairs, retrofits, or improvements should be per the local

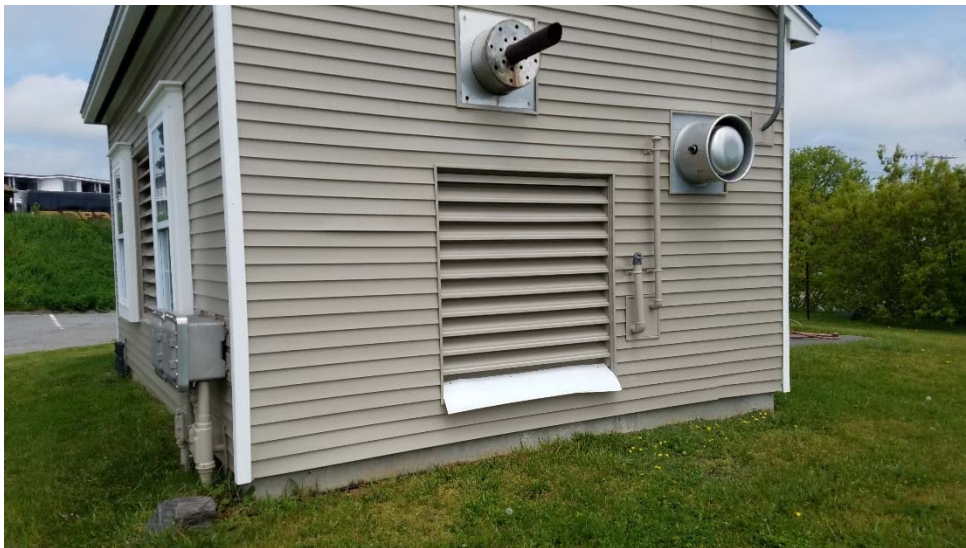
Photograph No. 20:

Rear view of sewer pump station building.

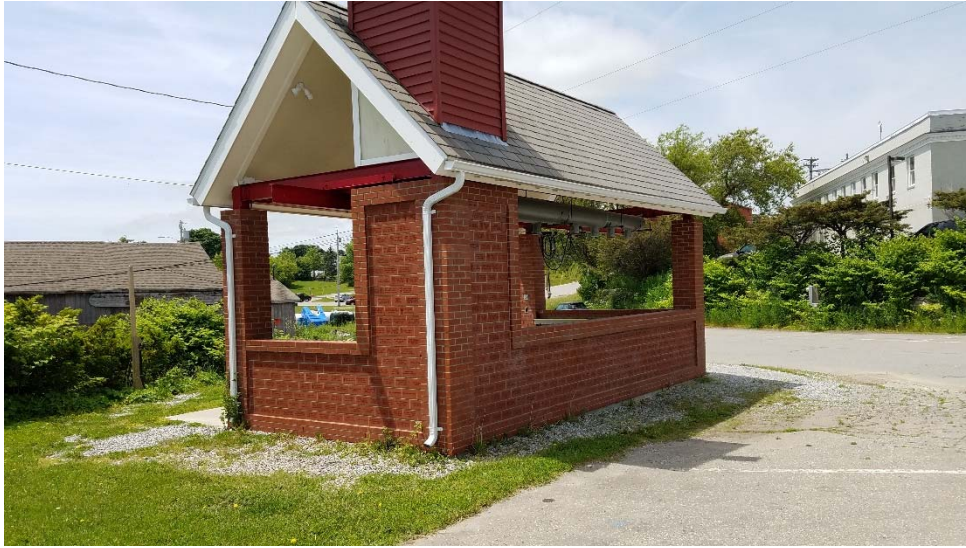
Photograph No. 21:

Similar concerns exist for the lobster pavilion, which sits at a FFE of approximately 11.3 feet NAVD88. During the Long Term Scenario, flooding of the area can be expected from the design Stillwater elevation. No serious wave action however is expected at this inland location for this scenario. We expect more frequent inundation of the area during the Long Term scenario for the HAT. For the type of construction, minimal material degradation is expected from inundation, however factors such as the existence of horizontal ties, reinforced and/or grouted cells, or type of footing will define the behaviour of the structure from moisture intrusion, which can be expected for the Long Term scenario.

View of lobster cooking station near entrance of property.

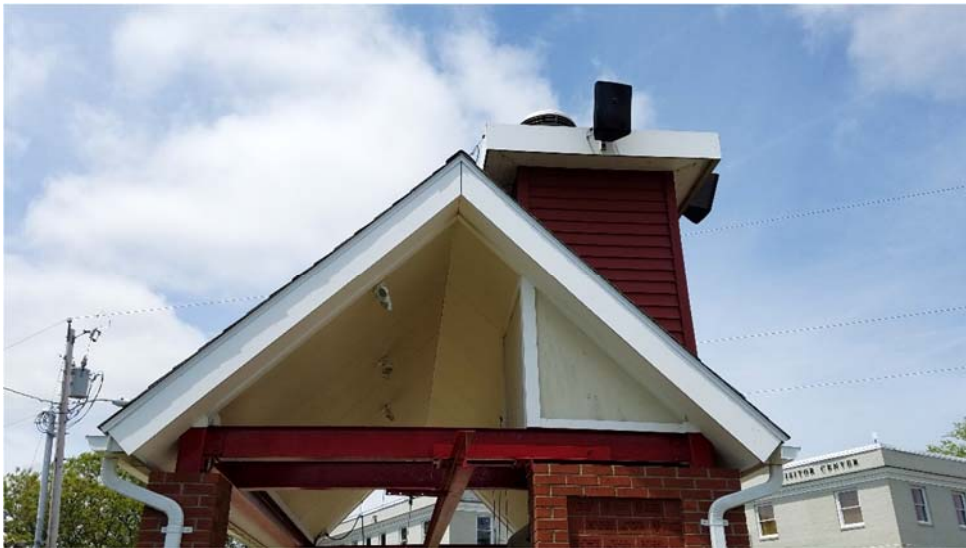
Photograph No. 22:

View of roof structure; open gable.

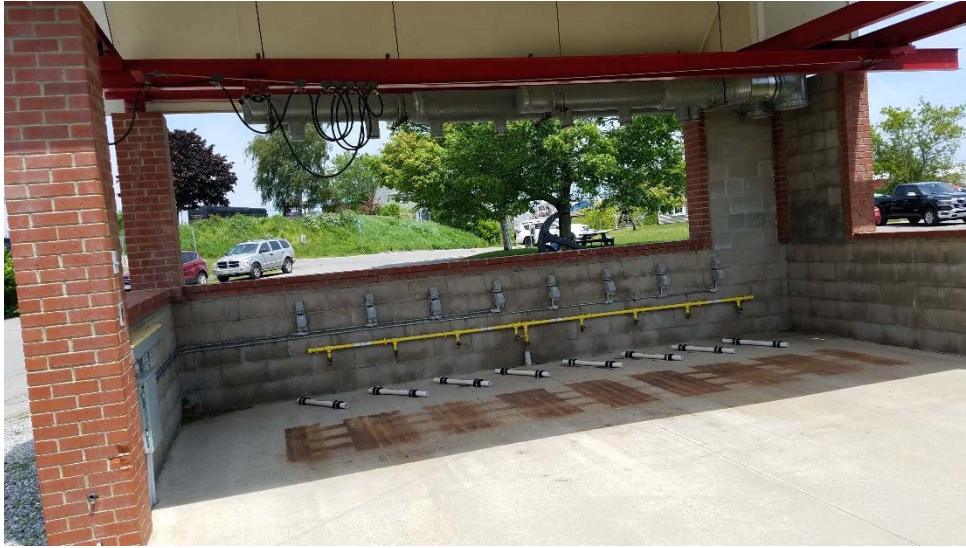
Photograph No. 23:

View at open side of lobster cooking station.

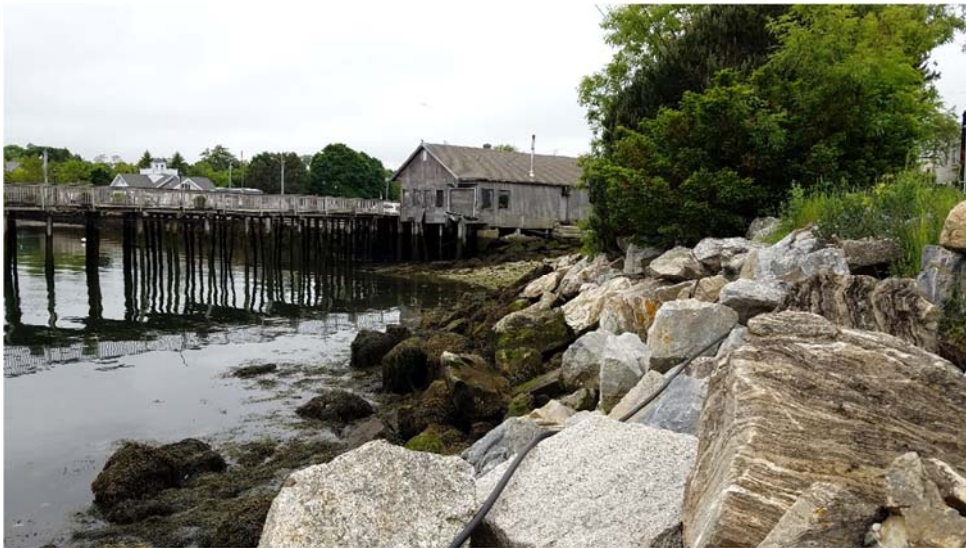
Photograph No. 24:

Shoreline protection is provided by a revetment ranging in elevation from about 11 feet to 12 feet. Large diameter (roughly 1.5 to 4 ft) riprap is provided along the perimeter of the site extending from below the low tide level to the top of grade (**Photographs 24 & 25**). The estimated slope is a maximum of 3 to 1, horizontal to vertical, and gradation appears to be suitable based on condition of slope. No signs of material degradation or slope instability or piping were noted. Based on existing conditions, the risk of overtopping during the Present Day scenario is relatively low. Overtopping is more likely for the Short and Mid Term scenarios. Some landward flooding in the range of 2 to 7 feet will occur during the overtopping during these scenarios but it will not undermine the revetment. Under wave attack, randomly placed riprap will experience some settlement and readjustment; however, the risk of wide-scale riprap slope failure appears low. The risk of localized scour or dislodging of riprap is low and given their inherent stability they will likely require minimal remediation for the Short Term and future scenario.

View of revetment at south side of property.

- Verification of the layer thickness is at least 2.5 feet.
- Sample verification of the D_{50} size of material to be 1.3 ft or greater.
- For extreme events or wave height is beyond 5 feet, a hydraulic model test is recommended for existing conditions.

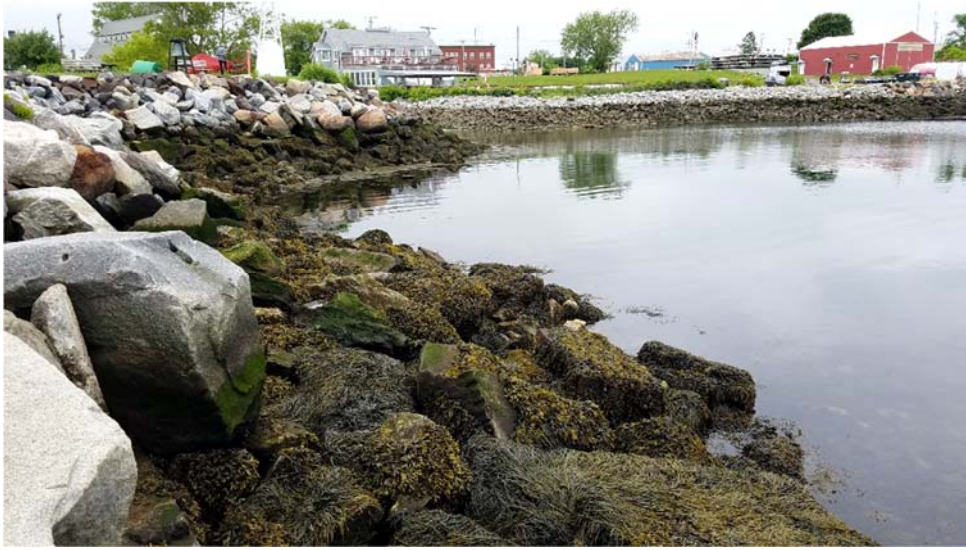
Photograph No. 25:

View of riprap revetment at north side of property.

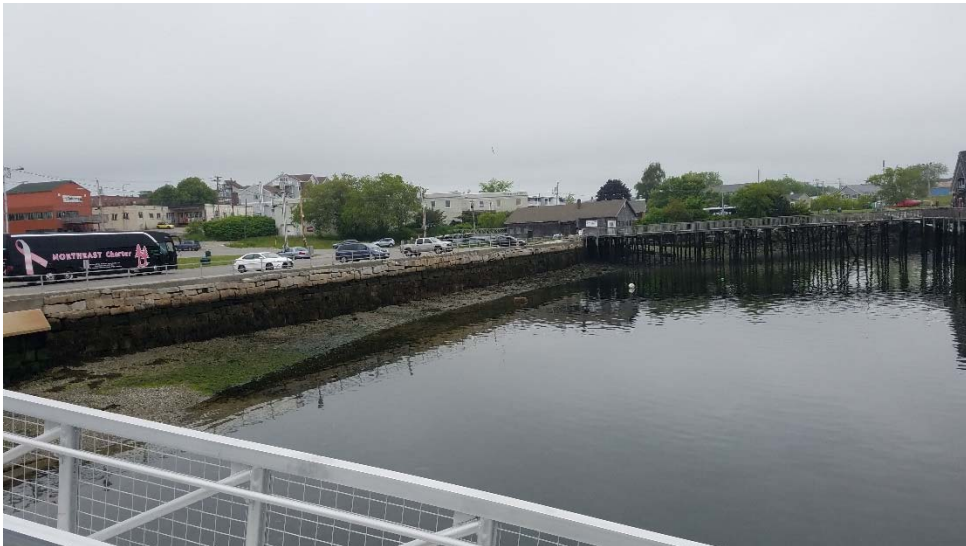
Photograph No. 26:

Shoreline protection at this location was not directly assessed however appears to be a stacked granite sea wall which may also support the wharf. Delamination of material was not observed, and structure appears to function as intended.

View of sea wall at harbor park near Harbormaster's office.

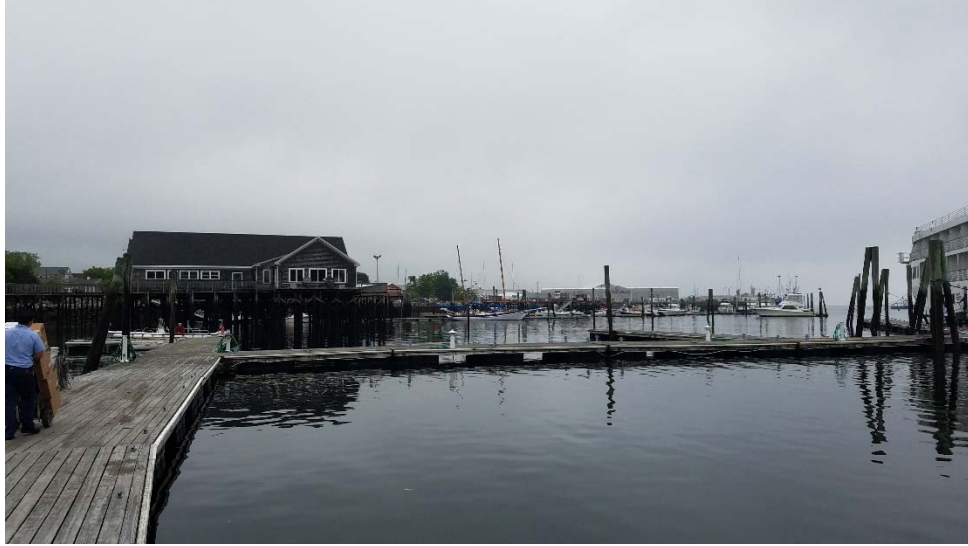
Photograph No. 27:

View facing north at series of docks for large carriers.

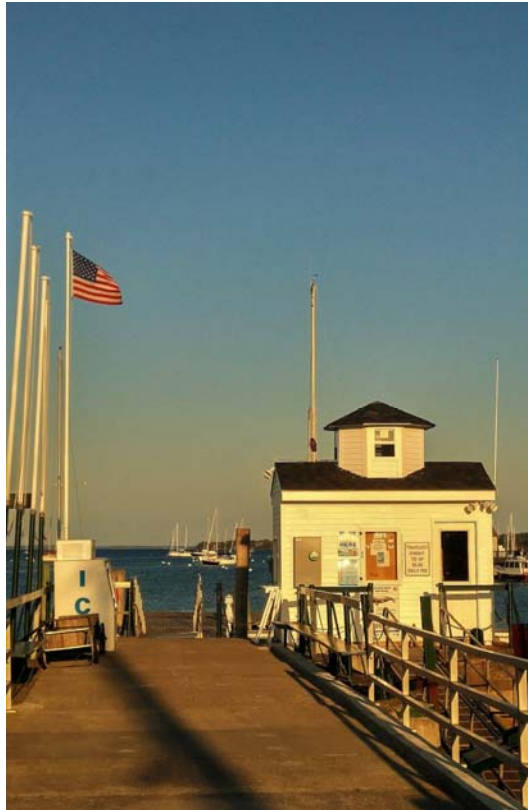
Photograph No. 28:

View of Harbormaster office.

- Based on the design Stillwater and its influence on the Harbor Master's office, re-evaluation of the structure will be required based on its functionality (Serviceability requirements). The assessment will be per current design standards to estimate adequacy to support the intended design loads. Following analysis, a likely recommendation is to retrofit or replace the existing building. This may constitute the minimum, whereas relocation may be recommended based on cost.

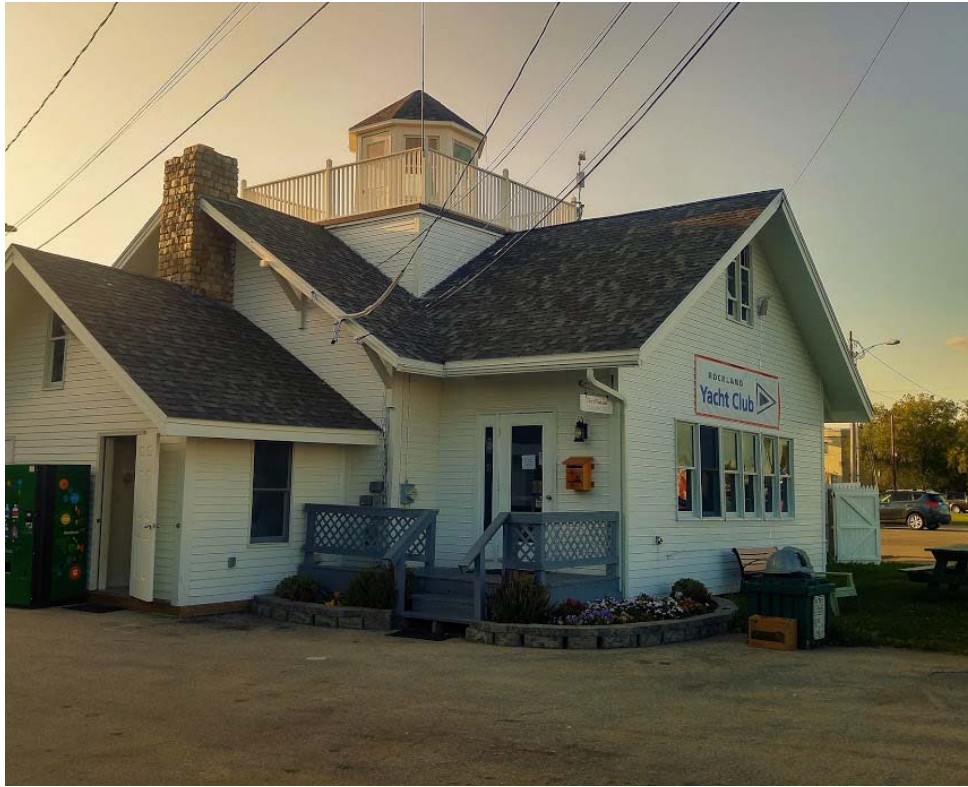
Photograph No. 29:

View of building housing the yacht club and public restrooms.

- The Yacht Club and associated facilities should be evaluated for flood and wind loading per the current design standard. The pressure to relocate the structure due to frequent inundation of the MHHW is not predicted, but nonetheless flooding is expected for this period during the design Stillwater with some influence of residual wave action based on the structure's proximity to the shore. Some repair effort is foreseen of minimal to substantial improvements for the scenario, and considering the BFE and Stillwater elevations, it will be practical to re-build the structure completely either with a FFE above the BFE and 2 feet of freeboard. Design for improvements should be per the local Building Code and performed under recommendation and guidance of a Professional Engineer Registered in the State of Maine.

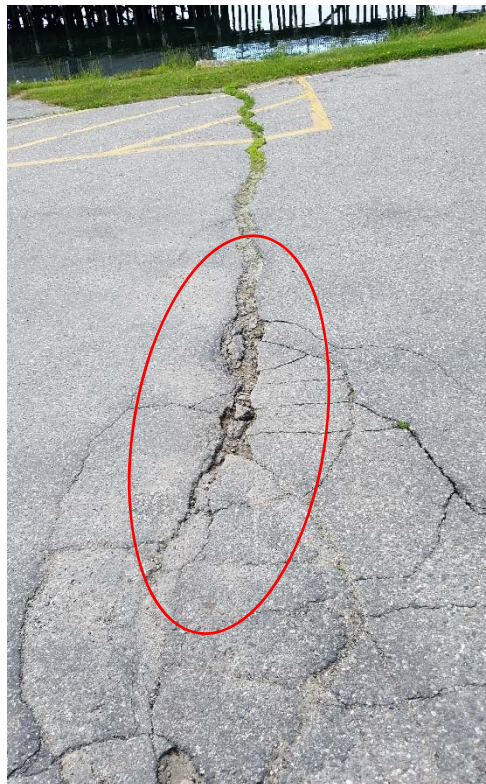
Photograph No. 30:

View of paved area above wharf. Close-up of deflection cracking.

- Subgrade conditions under paved areas of the wharf should be verified, voids should be filled, and the subgrade should be compacted per local requirements.

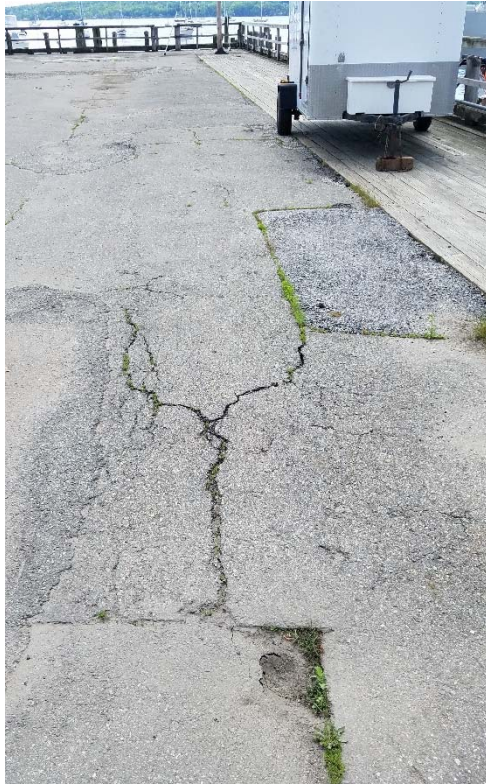
Photograph No. 31:

The wharf structure, particularly the stacked granite foundation, exhibited no apparent signs of translation or dislodgment for the large members. Smaller stone material was noted between the surface and granite blocks, observable through the large openings between the blocks. Above this area on the pavement, large cracks and dips are observed (**Photographs 30 – 32**). Previous repair work was also noted at some locations (**Photographs 31 & 32**).

View of cracks and surface delamination at pavement for wharf.

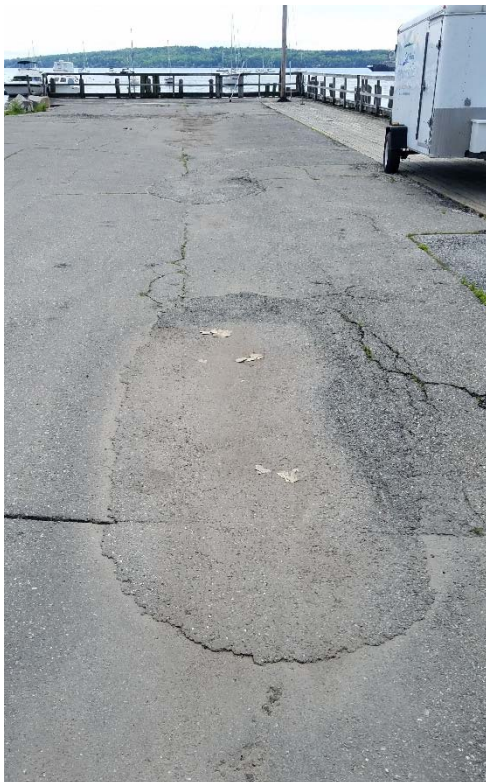
Photograph No. 32:

**Additional signs of failing at paved area.
Signs of previous repair work.**
