Prepared in cooperation with the Maine Department of Agriculture, Conservation & Forestry, Bureau of Parks and Lands, and the Maine Coastal Program within the Department of Marine Resources.

Submerged Object Investigation Summary of Colonial Pemaquid: Pemaquid River – John’s Bay, New Harbor, Lincoln County, Maine

Benjamin Kraun, Hydrographer, Contractor to the Maine Coastal Program

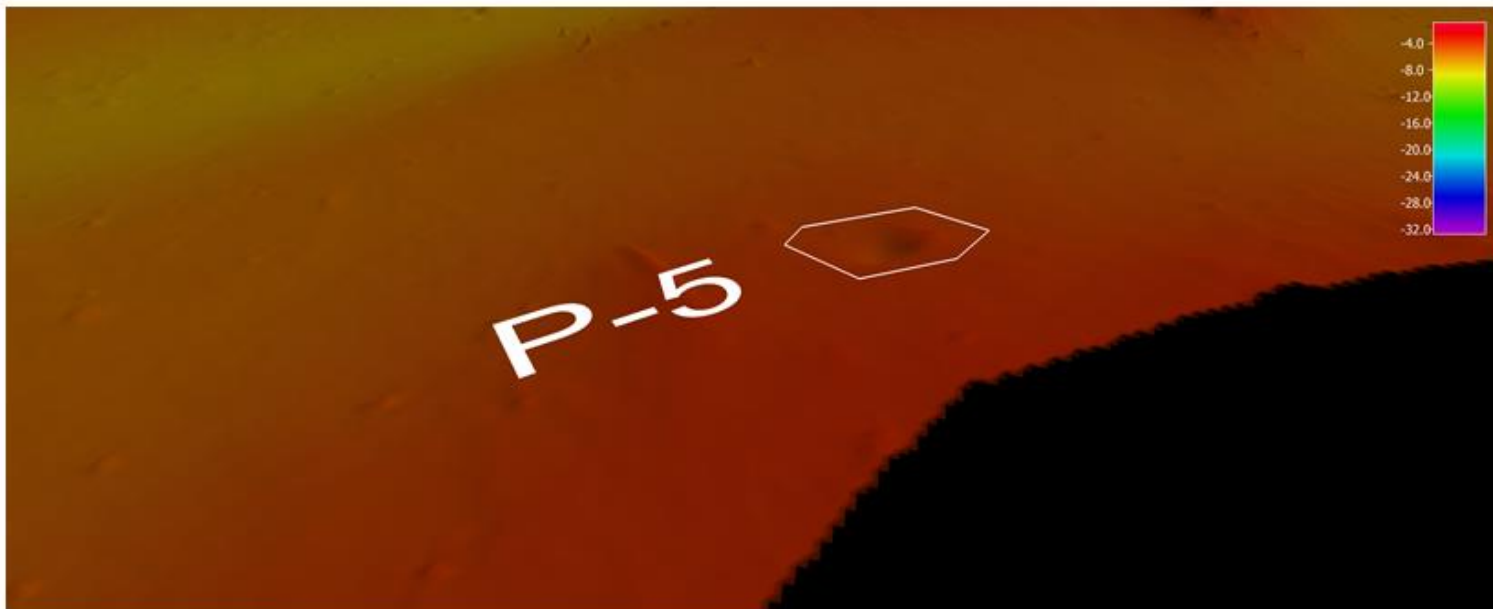
Anomaly ID	P5
Northing / Easting (m):	4858693 N / 457979 E
Depth (m):	4.13
Perspective:	View towards northwest
Anomaly Description:	irregular, suspected mooring

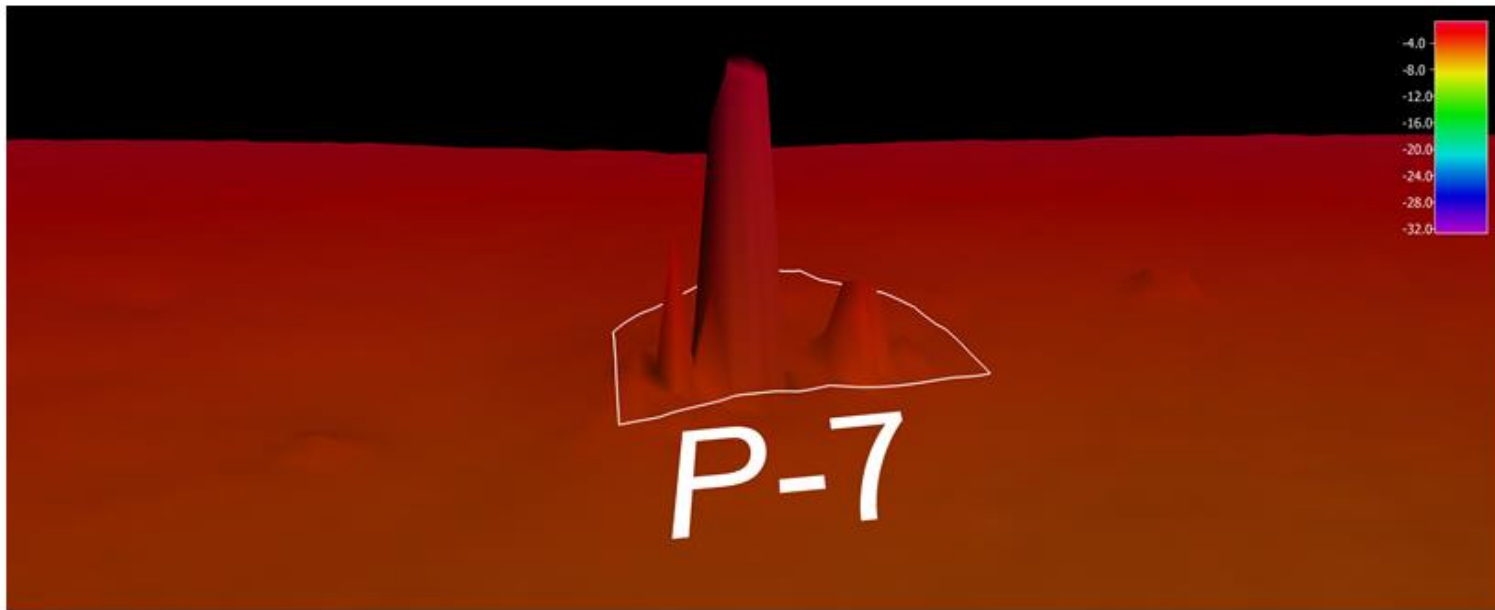
Anomaly ID	P7
	Northing / Easting (m):	4858719 N / 457761 E
	Depth (m):	0.94
	Perspective:	View towards southwest
	Anomaly Description:	round/cylindrical, suspected piling or wooden post, marked as black circle on ENC (electronic navigational chart)

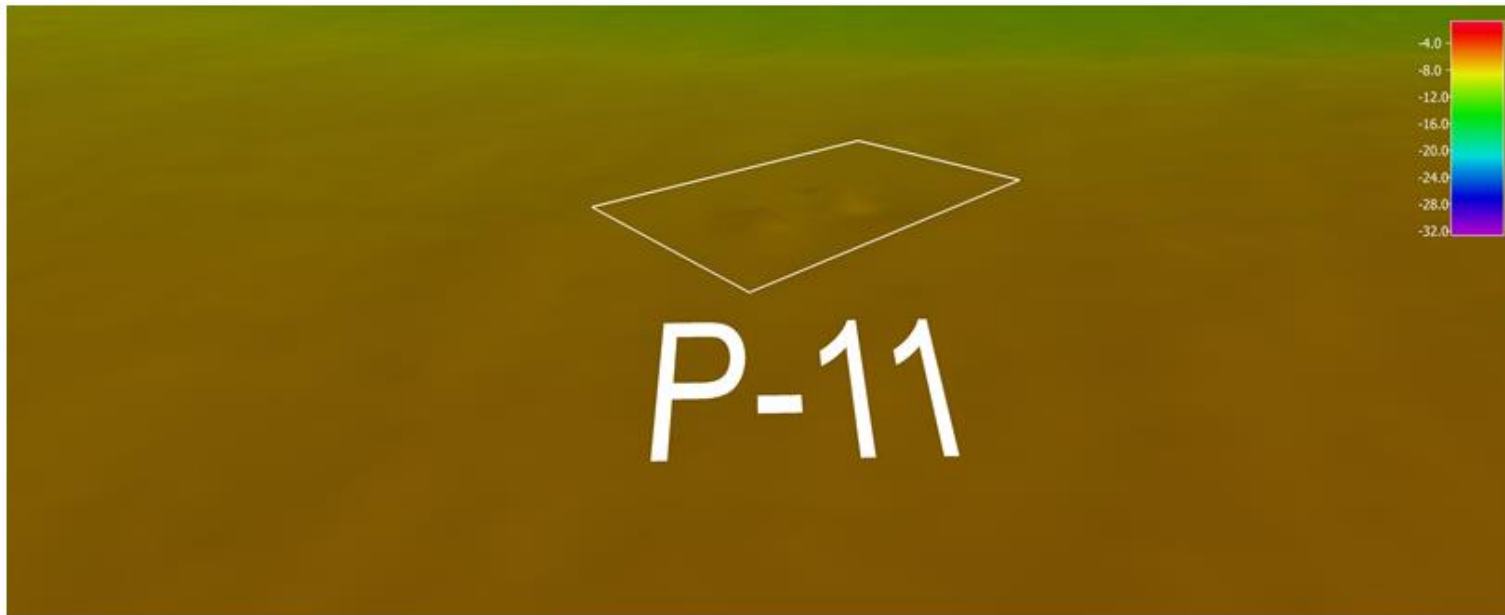
Anomaly ID	P11
	Northing / Easting (m):	4857988 N / 457684 E
	Depth (m):	6.15
	Perspective:	View towards northwest
	Anomaly Description:	rectangular, small, suspected former mooring

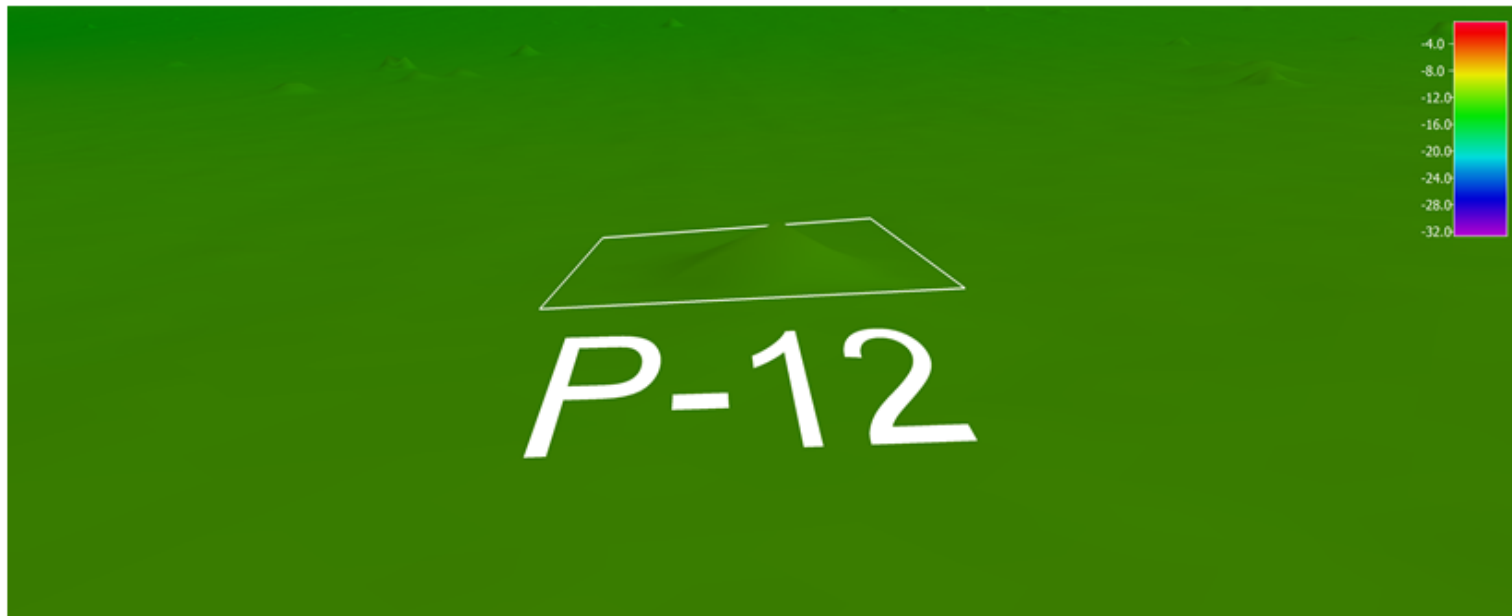
Anomaly ID	P12
	Northing / Easting (m):	4857858 N / 457462 E
	Depth (m):	11.94
	Perspective:	View towards northwest
	Anomaly Description:	elliptical, small, suspected rock/rocky area

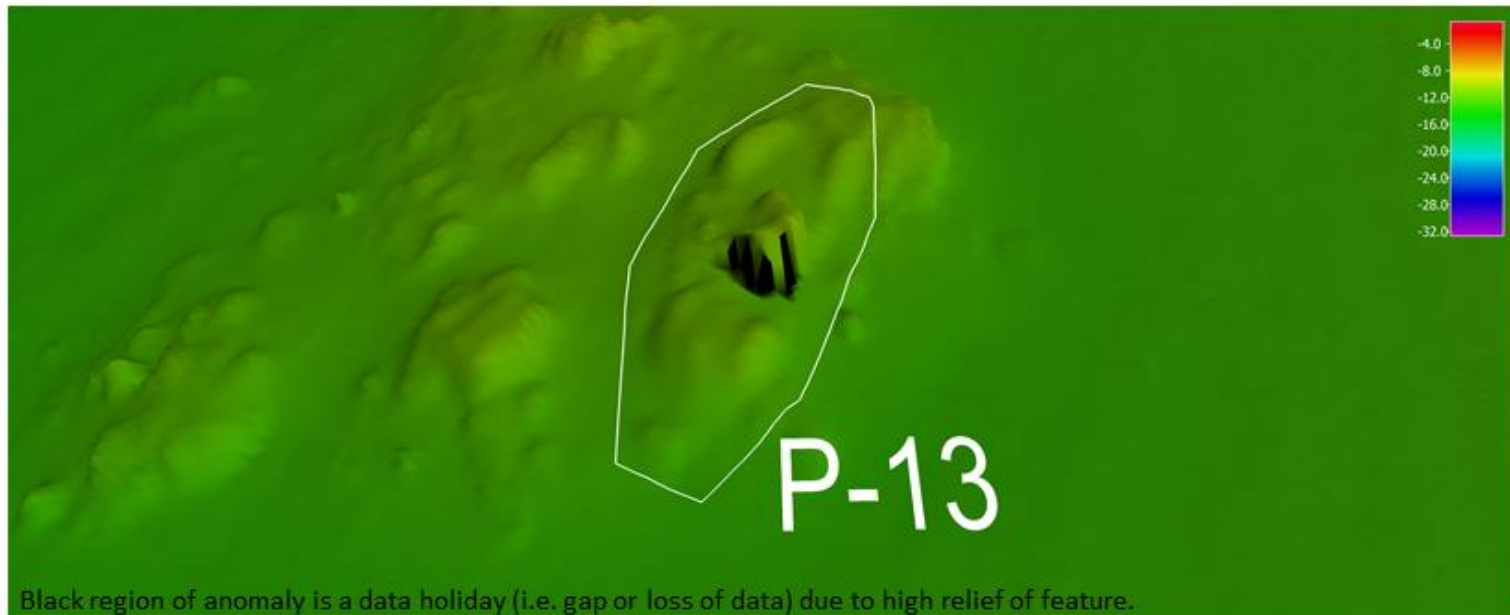
Anomaly ID	P13
	Northing / Easting (m):	4858027 N / 457354 E
	Depth (m):	10.93
	Perspective:	View towards west
	Anomaly Description:	elongate/polygonal, medium relief, suspected rocky area

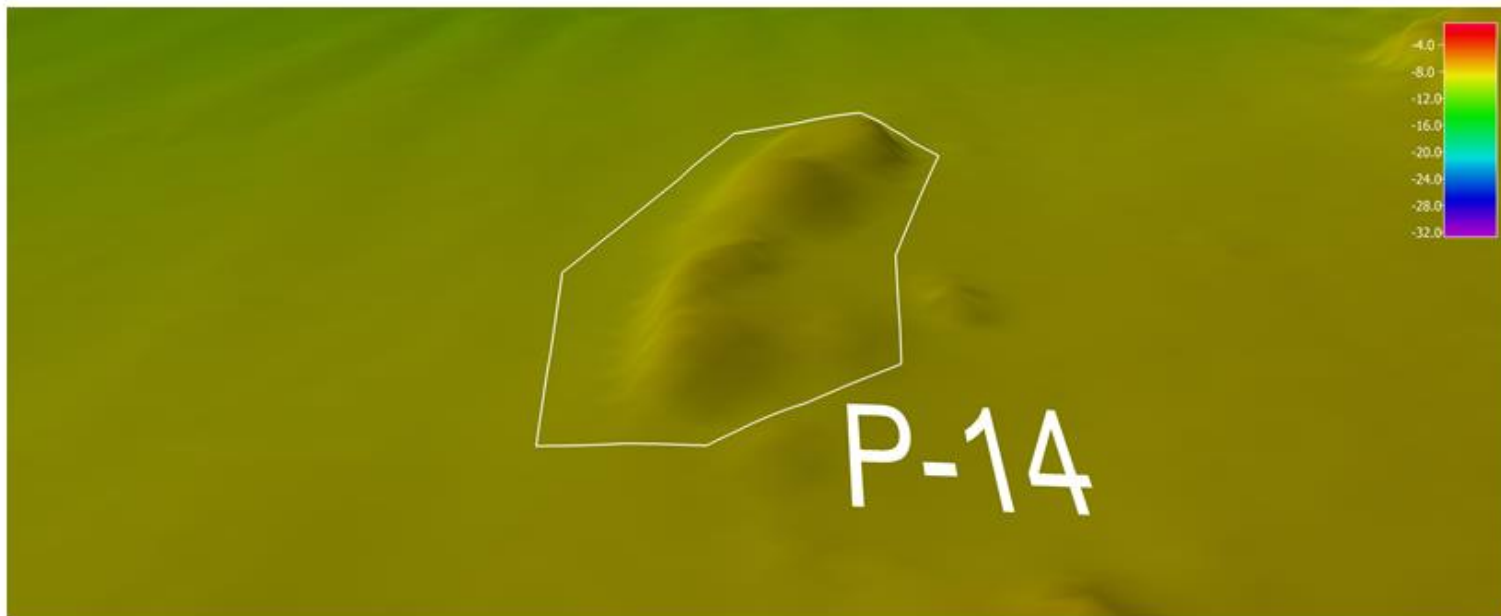
Anomaly ID	P14
	Northing / Easting (m):	4858272 N / 457351 E
	Depth (m):	7.90
	Perspective:	View towards southeast
	Anomaly Description:	polygonal/irregular, relatively low relief, suspected rocky area

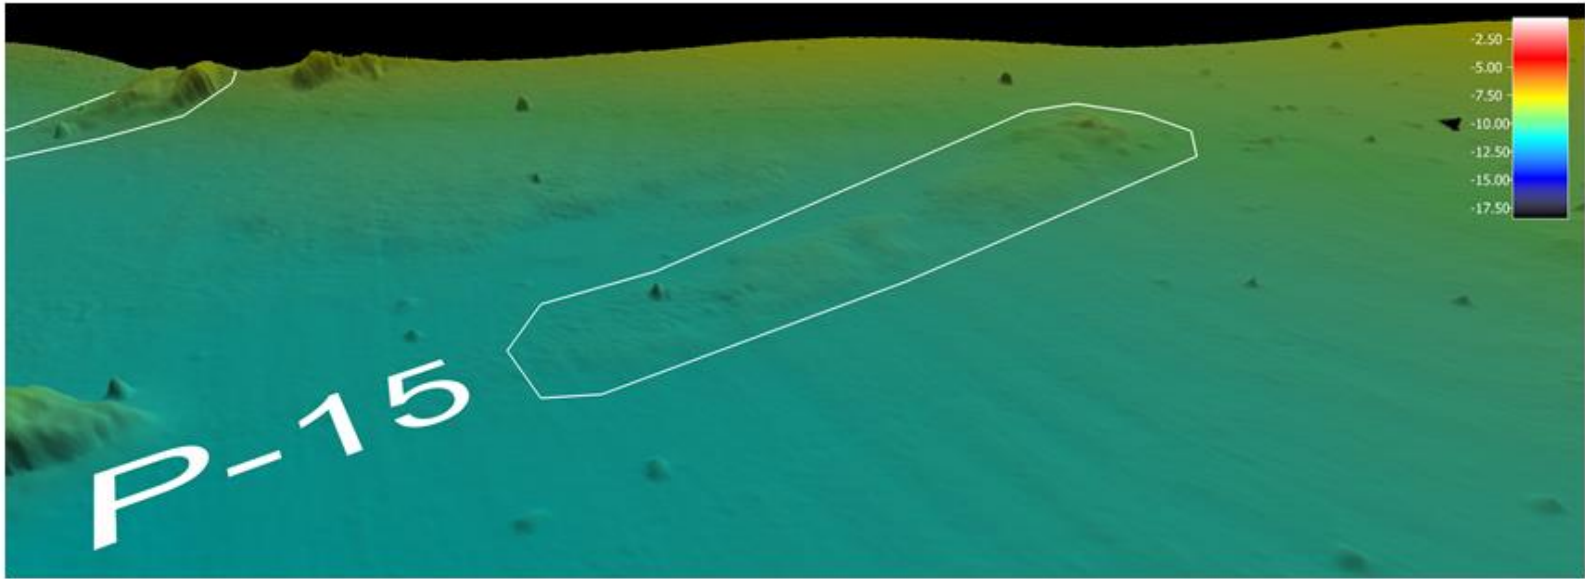
Anomaly ID	P15
	Northing / Easting (m):	4858321 N / 457063 E
	Depth (m):	10.28
	Perspective:	View towards southwest
	Anomaly Description:	elongate/polygonal, large footprint, low relief, suspected sand bar, surface area similar to Angel Gabriel

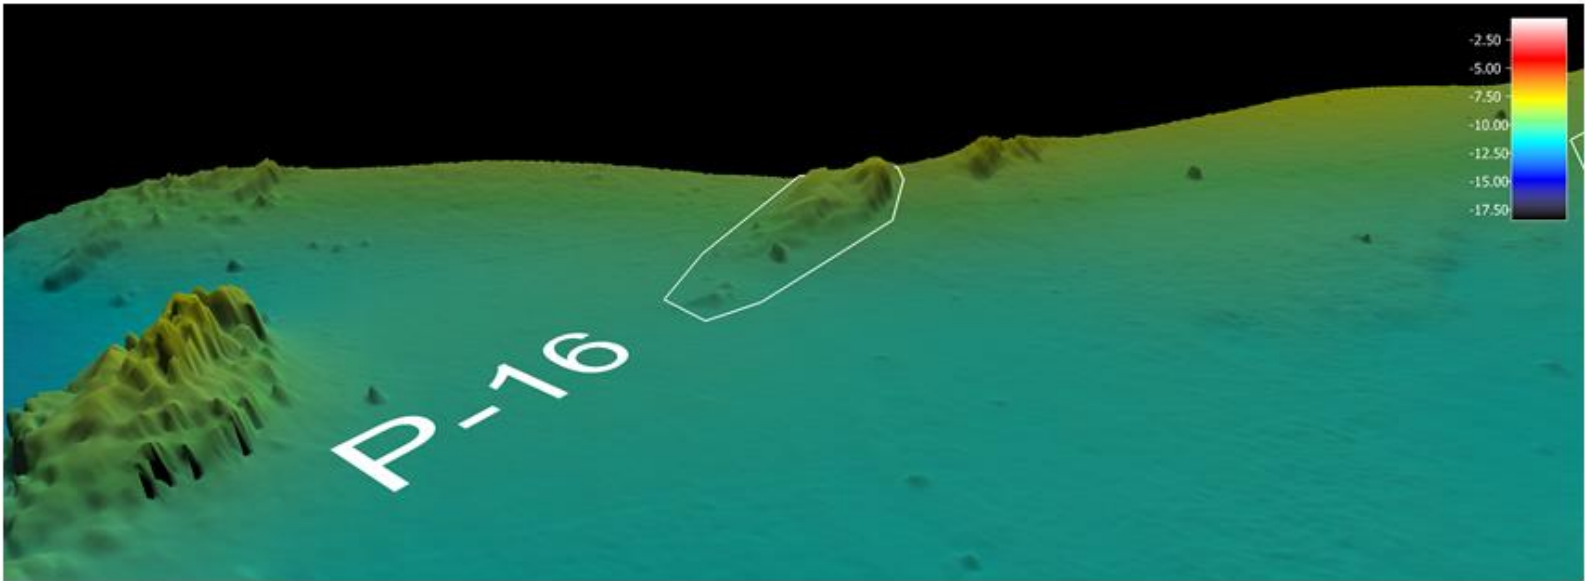
Anomaly ID	P16
	Northing / Easting (m):	4858321 N / 457063 E
	Depth (m):	8.89
	Perspective:	View towards northwest
	Anomaly Description:	polygonal/irregular, medium relief, full extent of anomaly not surveyed due to shallow depths, suspected rocky area

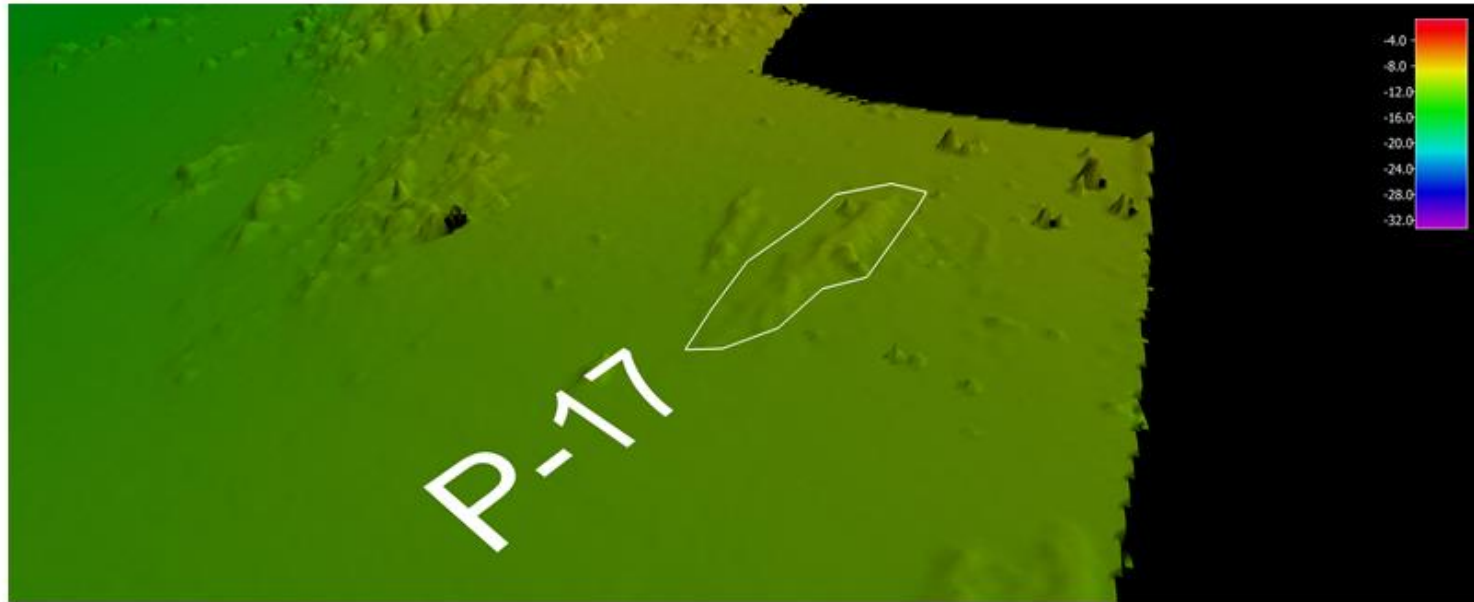
Anomaly ID	P17
	Northing / Easting (m):	4856140 N / 458113 E
	Depth (m):	9.98
	Perspective:	View towards north
	Anomaly Description:	elongate/irregular, low relief, suspected rocky area

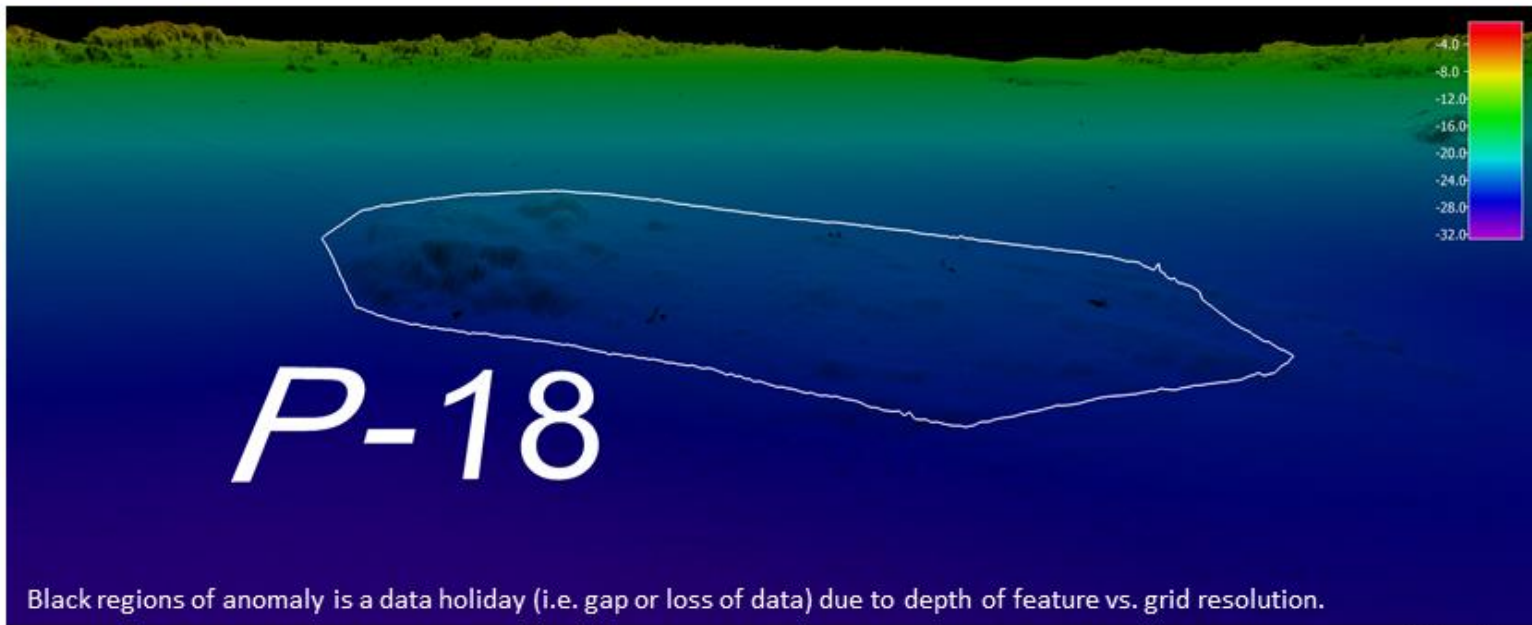
Anomaly ID	P-18
Northing / Easting (m):	4855942 N / 457792 E
Depth (m):	24.03
Perspective:	View towards east
Anomaly Description:	Polygonal/irregular, very large footprint, low relief, suspected sand bar/rocky area

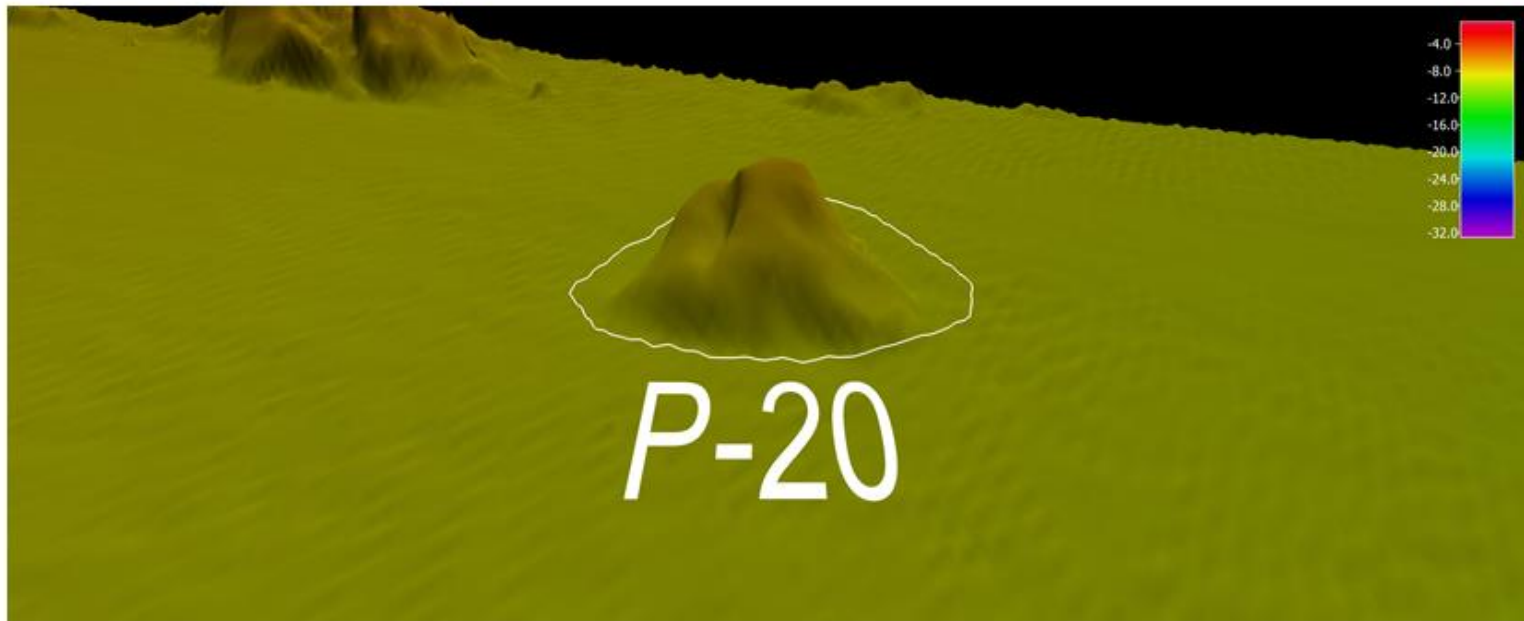
Anomaly ID	P-20
	Northing / Easting (m):	4857637 N / 457647 E
	Depth (m):	7.41
	Perspective:	View towards northeast
	Anomaly Description:	Polygonal/round, high relief, feature highly contrasts with surrounding area, suspected rock

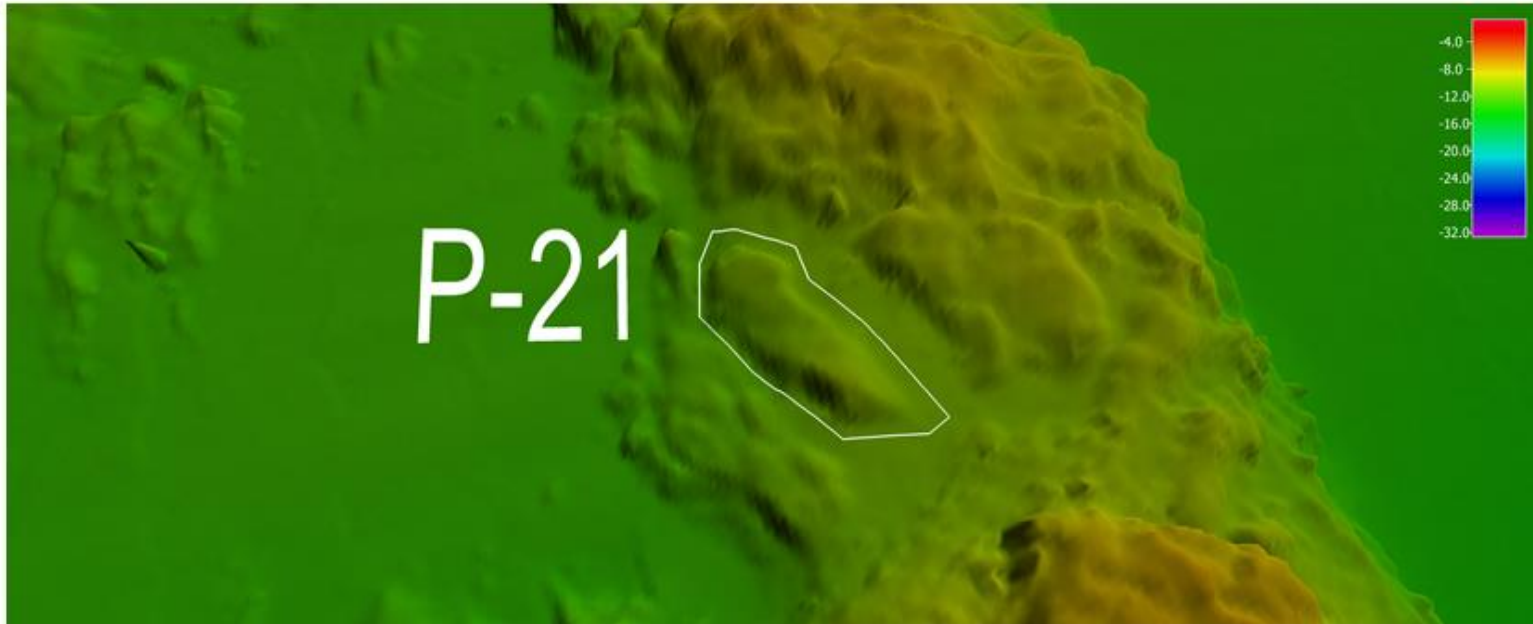
Anomaly ID	P-21
	Northing / Easting (m):	4857312 N / 457619 E
	Depth (m):	10.29
	Perspective:	View towards north
	Anomaly Description:	elongate/polygonal, medium relief, suspected rocky area

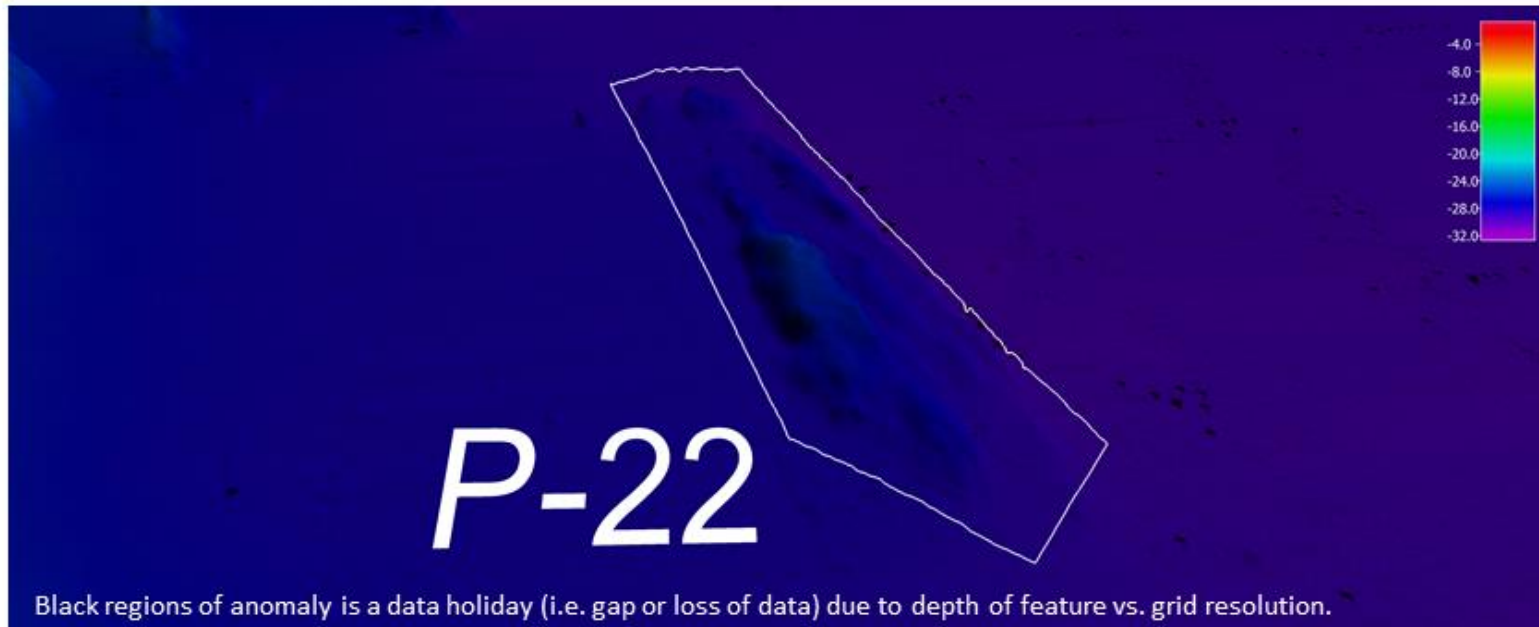
Anomaly ID	P-22
	Northing / Easting (m):	4856251 N / 456663 E
	Depth (m):	28.01
	Perspective:	View towards northeast
	Anomaly Description:	Polygonal/elongate, very large footprint, low relief, suspected rocky area

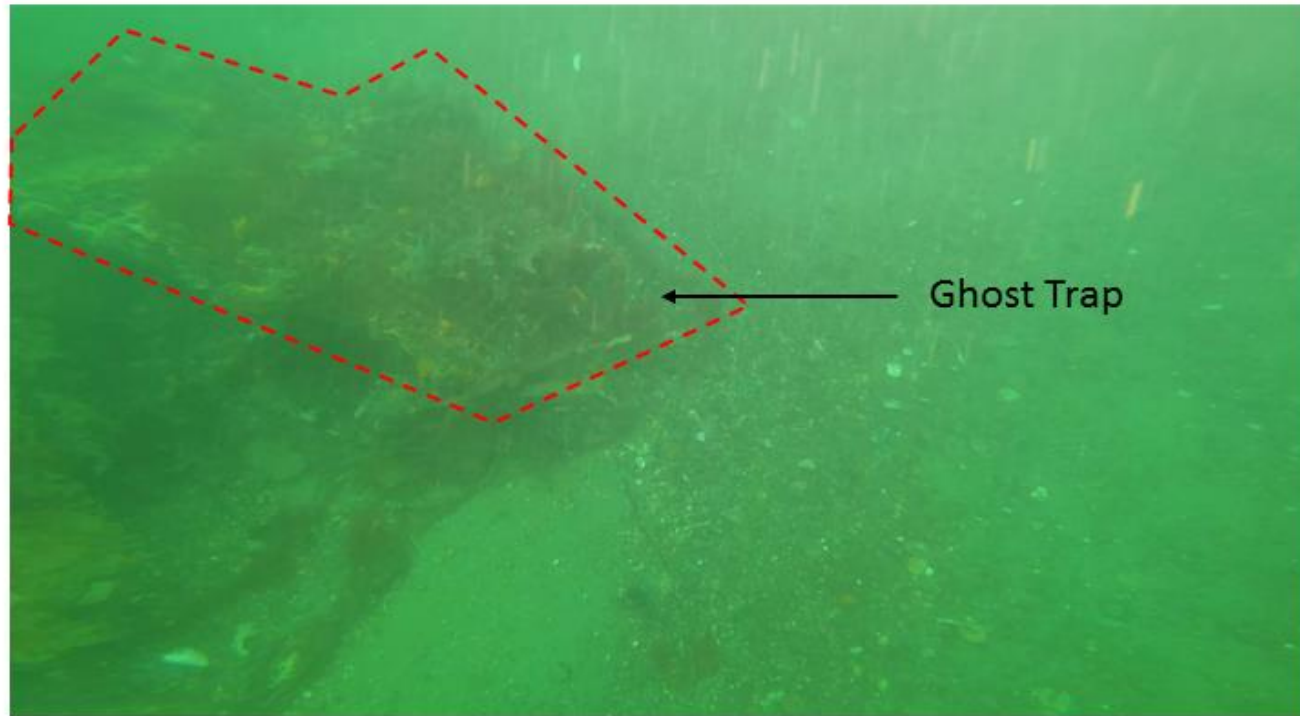
Anomaly ID / Drop #:	P5 / Drop 1
Date / Time of Deployment (EST):	10/23/2018 / 12:00
Depth (m):	4.13
Northing / Easting (m):	4858693 N / 457979 E
File Name / Time Stamp (mm:ss)	P5 Drop 1 / 01:22

Video Notes: The seafloor appears to consist of poorly sorted coarse sand and gravel with shell hash. A ghost lobster trap is seen at 01:18, 01:43, and 02:34. Patches of sponge and brown algae are seen throughout the video. An anemone is seen at 02:01. A patch of larger rocks is seen at 02:05. Sand dollars are seen throughout the video.

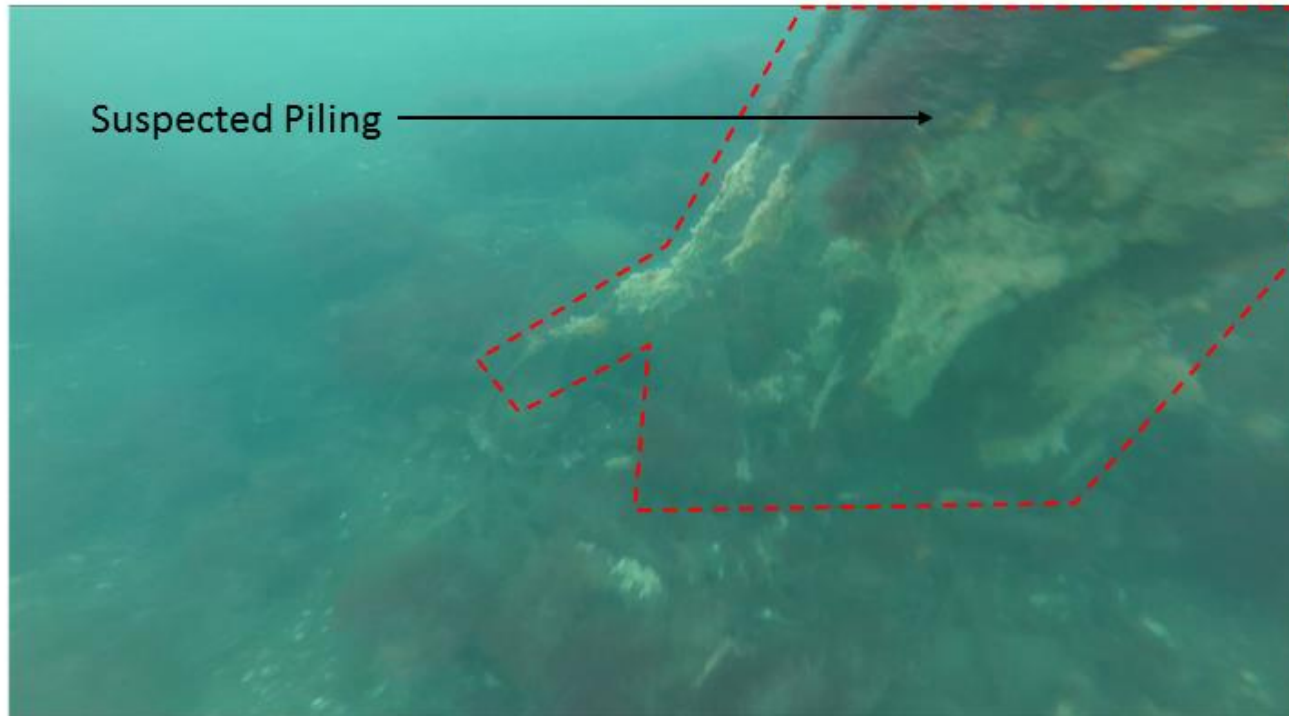
Anomaly ID / Drop #:	P7 / Drop 1
	Date / Time of Deployment (EST):	10/23/2018 / 12:07
	Depth (m):	0.93
	Northing / Easting (m):	4858719 N / 457761 E
	File Name / Time Stamp (mm:ss)	P7 Drops 1 & 2 / 01:33

Video Notes: The seafloor appears to consist of mud with some shell hash. Small, unidentified crab are seen at 00:13 and 00:17. Green crabs are seen at 00:19 and 00:42. The camera impacts a large piling at 01:01. Shell hash appears to be most abundant near the piling. The piling is weathered, covered in sponge and algae, and appears to have two ropes attached.
