20 December 2019

**Subject: Vulnerability Assessment and Resilience Planning, Ferry Terminal, Vinalhaven, Maine
Penobscot Bay Working Waterfront Resiliency Analysis
State of Maine, Department of Marine Resources**

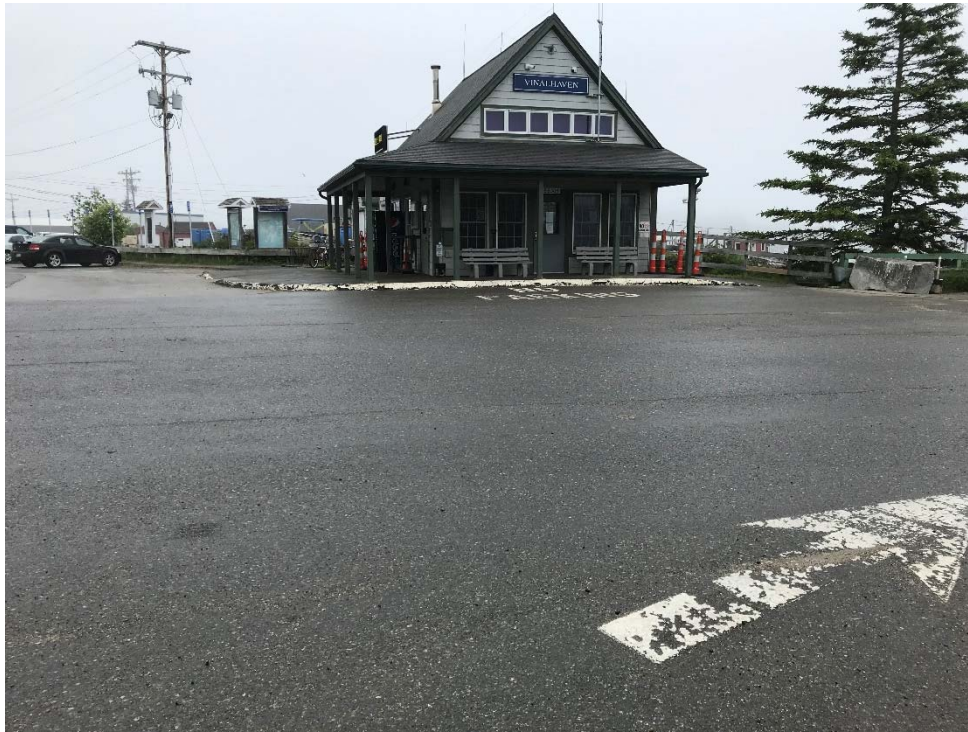
Photograph No. 21:

View of west side of ferry services building

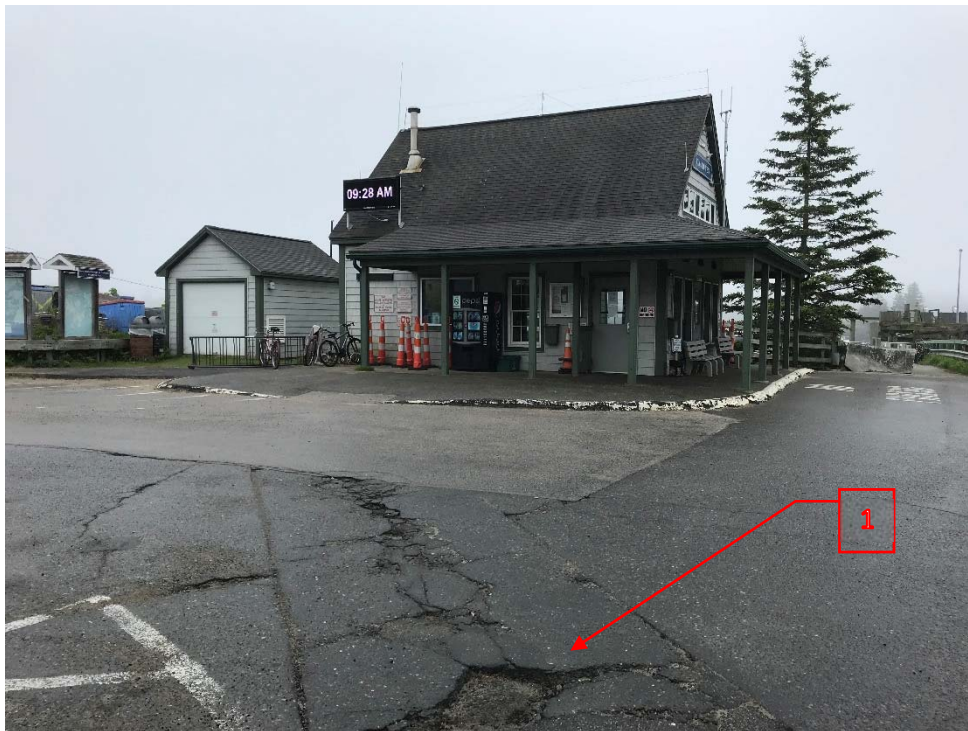
Photograph No. 22:

View of north side of ferry services building

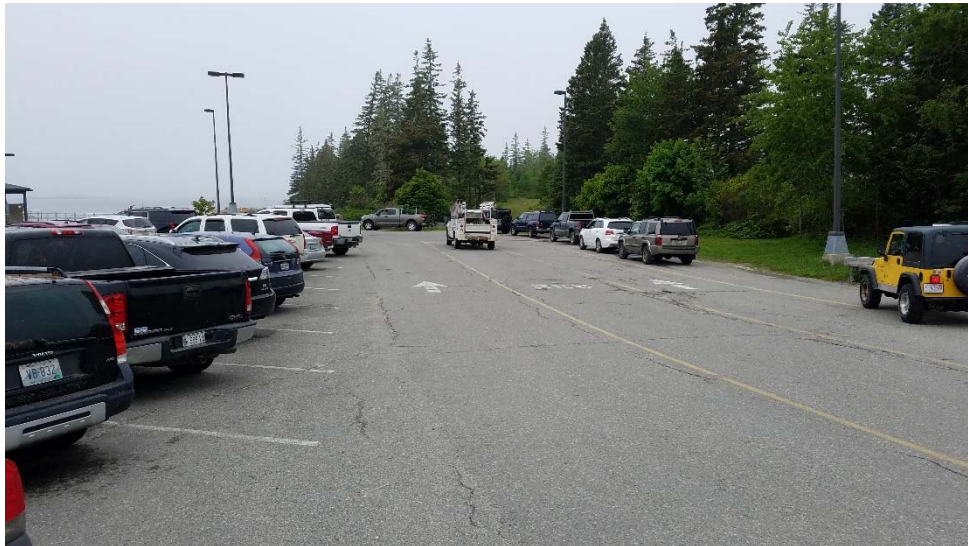
Photograph No. 24:

- Delamination and cracking of asphalt (**Photographs 22, 24 & 25**) - the parking lot top coat appears to be moderately weathered with signs of surface delamination and 1/8 inch or greater cracks. Repair patches have been observed throughout indicating maintenance work.
- Wood deterioration (**Photograph 27 – 29**) - Wood framing at wave attenuator (crib) structures exhibit moderate to severe weathering.
- Corroded Electrical Box (**Photograph 14 & 16**) – Metal electrical / utility box has corrosion on the exterior, and one appears to have experienced delamination of the cover.

View of parking lot at northwest corner looking south.

- No pressing concerns were identified beyond regular maintenance required due to normal wear and tear.

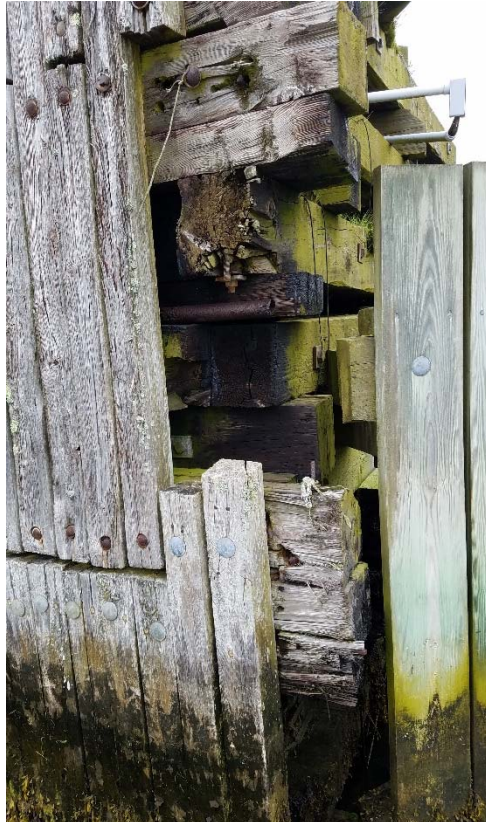
Photograph No. 29:

The five (5) crib structures, which are the remaining elements of the original terminal, now serve as wave attenuators to protect the floating docks and smaller boats at the north side of the terminal from wake waves generated by the ferry. The crib is constructed of a wood framed structure filled with large rocks and gravel. The structure has been installed for almost 70 years and the structural fill appears to remain in stable condition. The wood framing has, however, experienced moderate to major weathering and possibly rot as evidenced from the splitting and checks observed (**Photograph 26 – 29**).

Close-up of crib indicating construction and condition of timber framing.

Moderate to major weathering noted.

- Many members of the structure appear to have experience major deterioration and require replacement. Opportunity should be taking to perform detailed analysis of the structure's ability to support the design loading during any repair or retrofit effort. Deteriorated and damaged members should be replaced immediately following a detailed assessment.

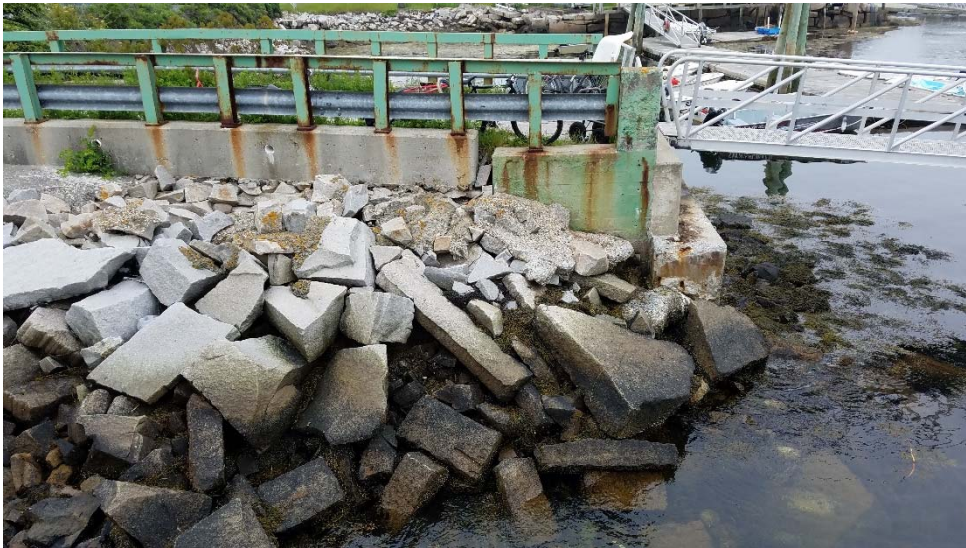
Photograph No. 30:

View of shoreline projection near floating dock gangway.

Riprap noted beyond the abutment.

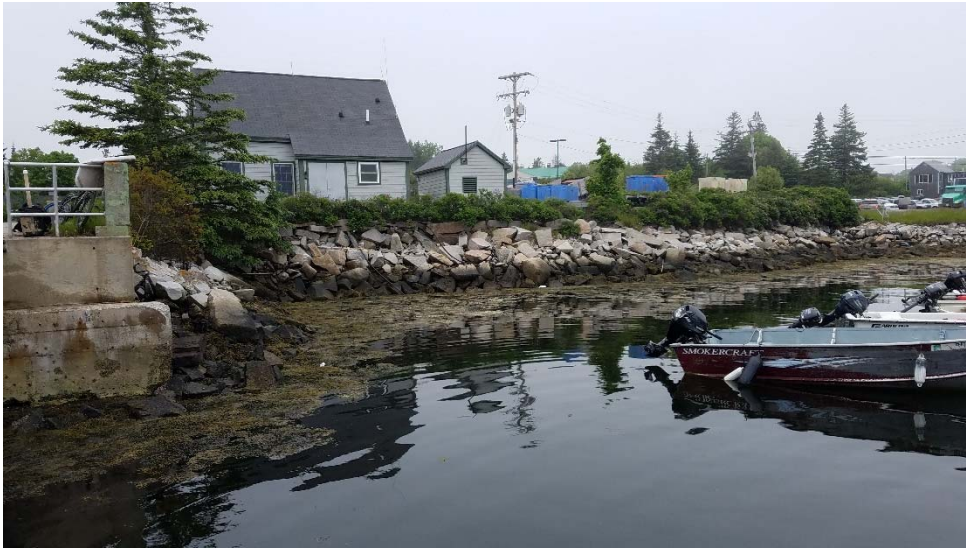
Photograph No. 33:

Comment:
View of shoreline protection at the north side of the ferry terminal and floating dock.
