Mackworth Island

Conceptual Utilization
Master Plan

Final Report

January 27, 2023

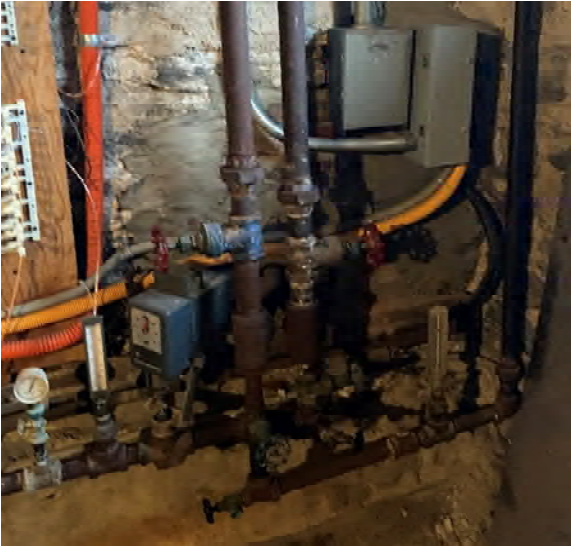
<p>Zone pumps in the basement circulate water from the load side of the heat exchanger to individual zones in the building. The 3 story building is divided into 2 zones. The first floor is zone 1. The second and third floor makeup the other zone. Each zone is controlled by a single thermostat located in a hallway. Portable, electric heaters were observed in multiple rooms indicated that the building lacks sufficient zone control.</p> <p>There are no central mechanical ventilation systems nor is there a central cooling system for the building.</p>

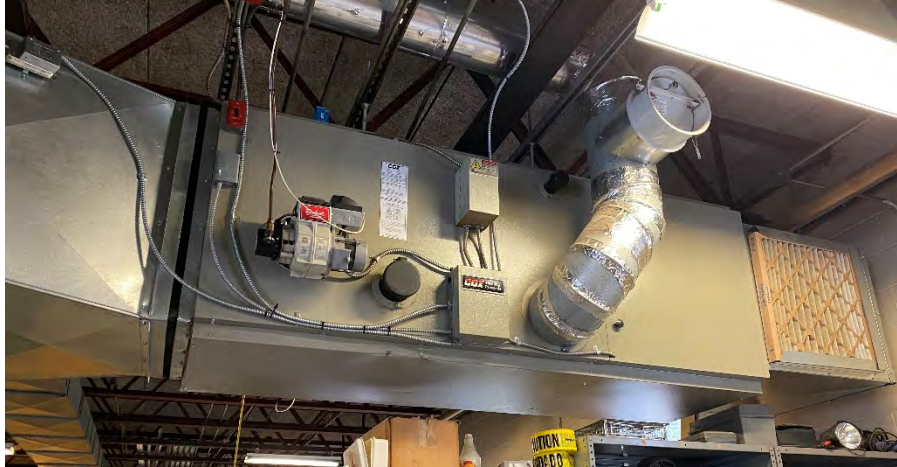
Figure 3 - Oil-fired Furnace

The main garage is served by a single, oil-fired furnace which is connected to a simple ducted air distribution system. The furnace was installed approximately 6 years ago and appears to be in excellent condition.

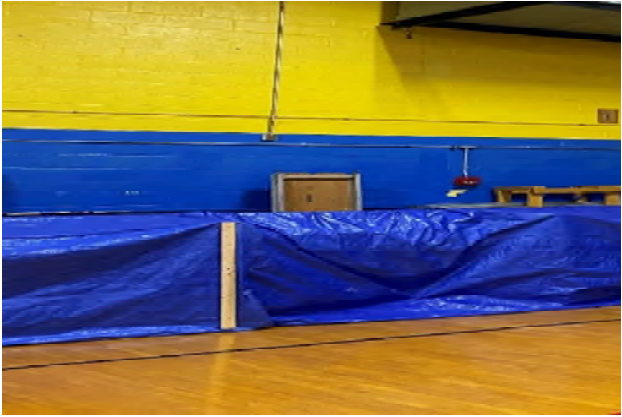
<p>The main gym is served by two air handlers that are hung from the structure and mounted high in the space and appear to be in good condition. The air handlers provide heat and ventilation with some exposed ductwork and low returns. The smaller auxiliary space is served with unit ventilator hung in the adjacent storage room. The supply grille is missing and return air is transferred through louvers in the storage room doors which are in need of repair.</p>
<p><i>Figure 5 - Gym AHU</i></p>
<p>The locker rooms exhaust systems were installed in manner that required drip trays or diverters to prevent cold air drafts.</p>

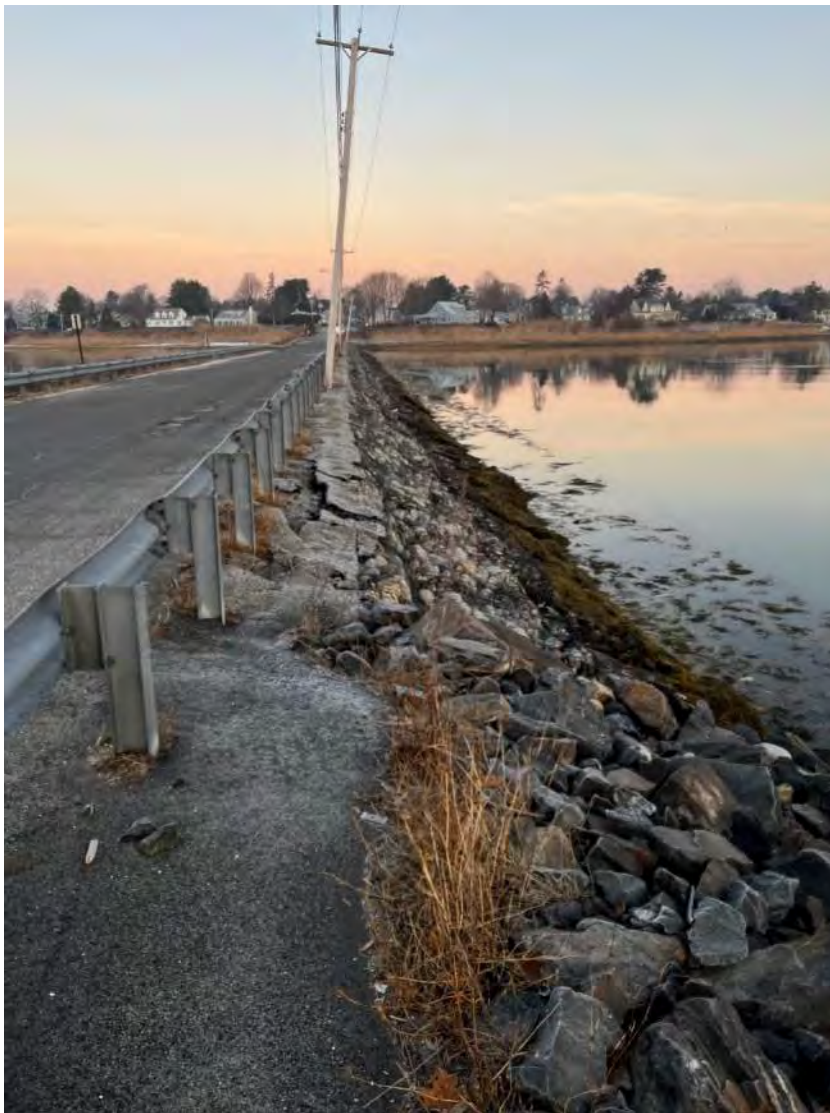
Fig. 11. West Causeway - Northside Armoring in Need of Repair

It is recommended that with any future upgrade or replacement of the causeway that overhead utilities be eliminated and placed in conduits buried on the embankment and/or supported under a bridge structure.
