Callahan Mine September 2015
039
FYR Background Information

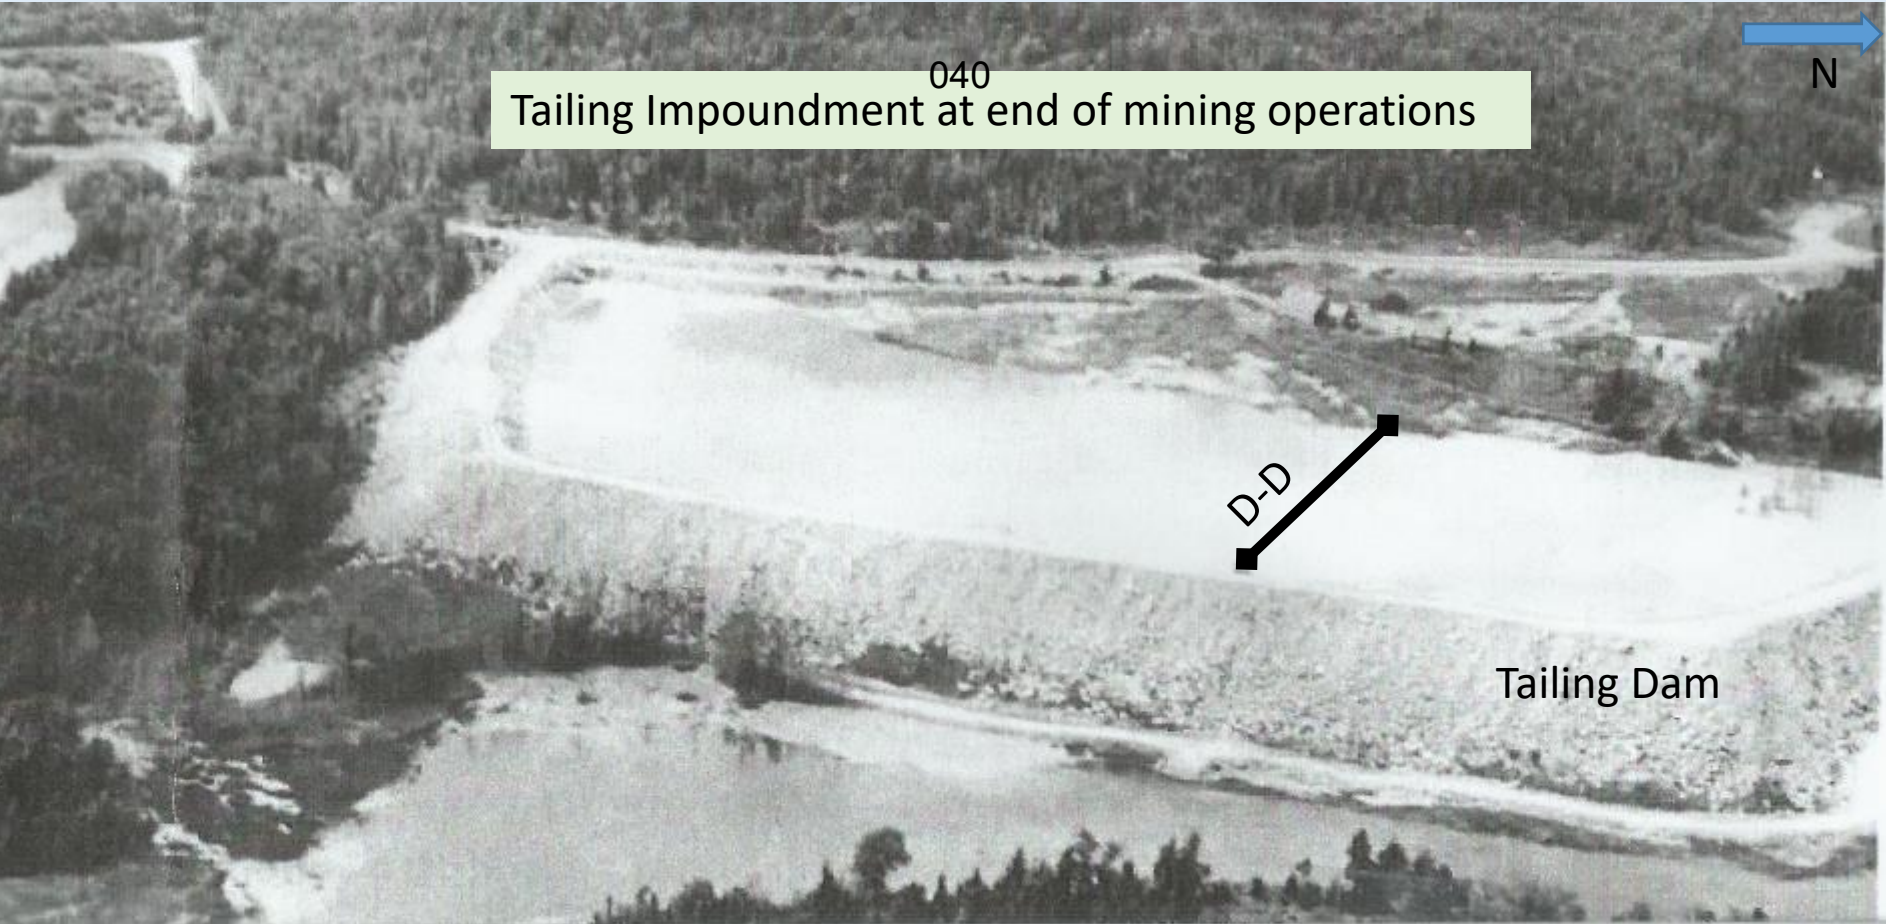
Tailing Impoundment at end of mining operations

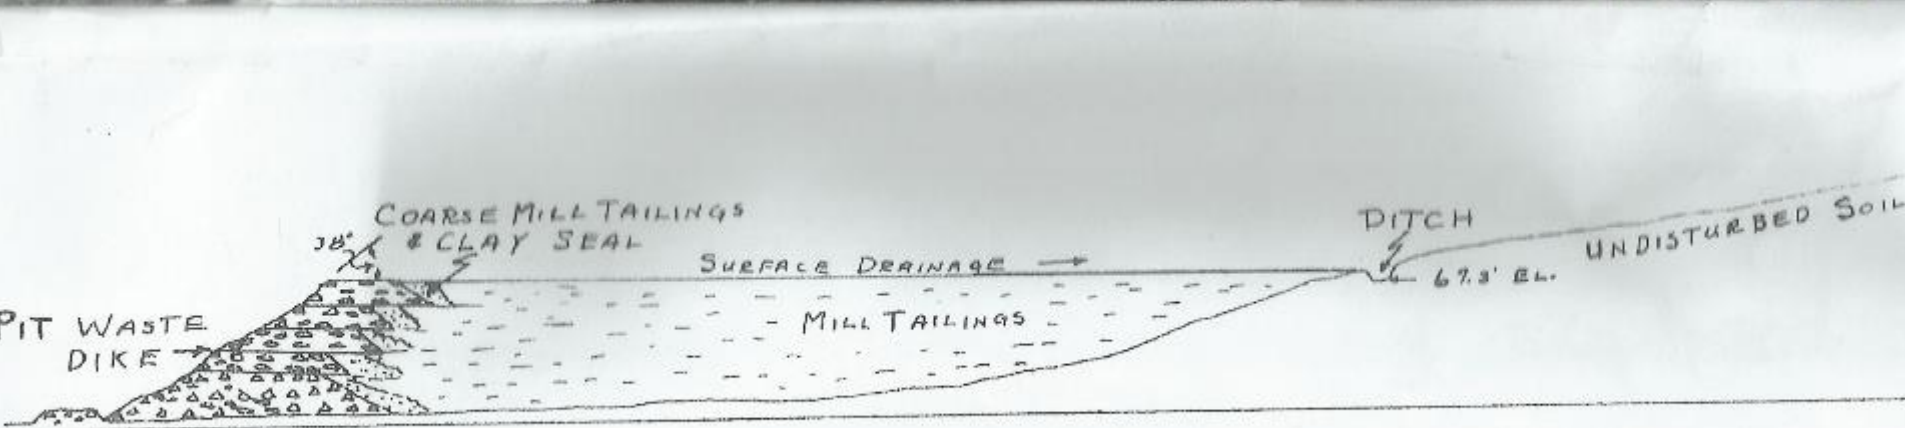
Tailing Dam

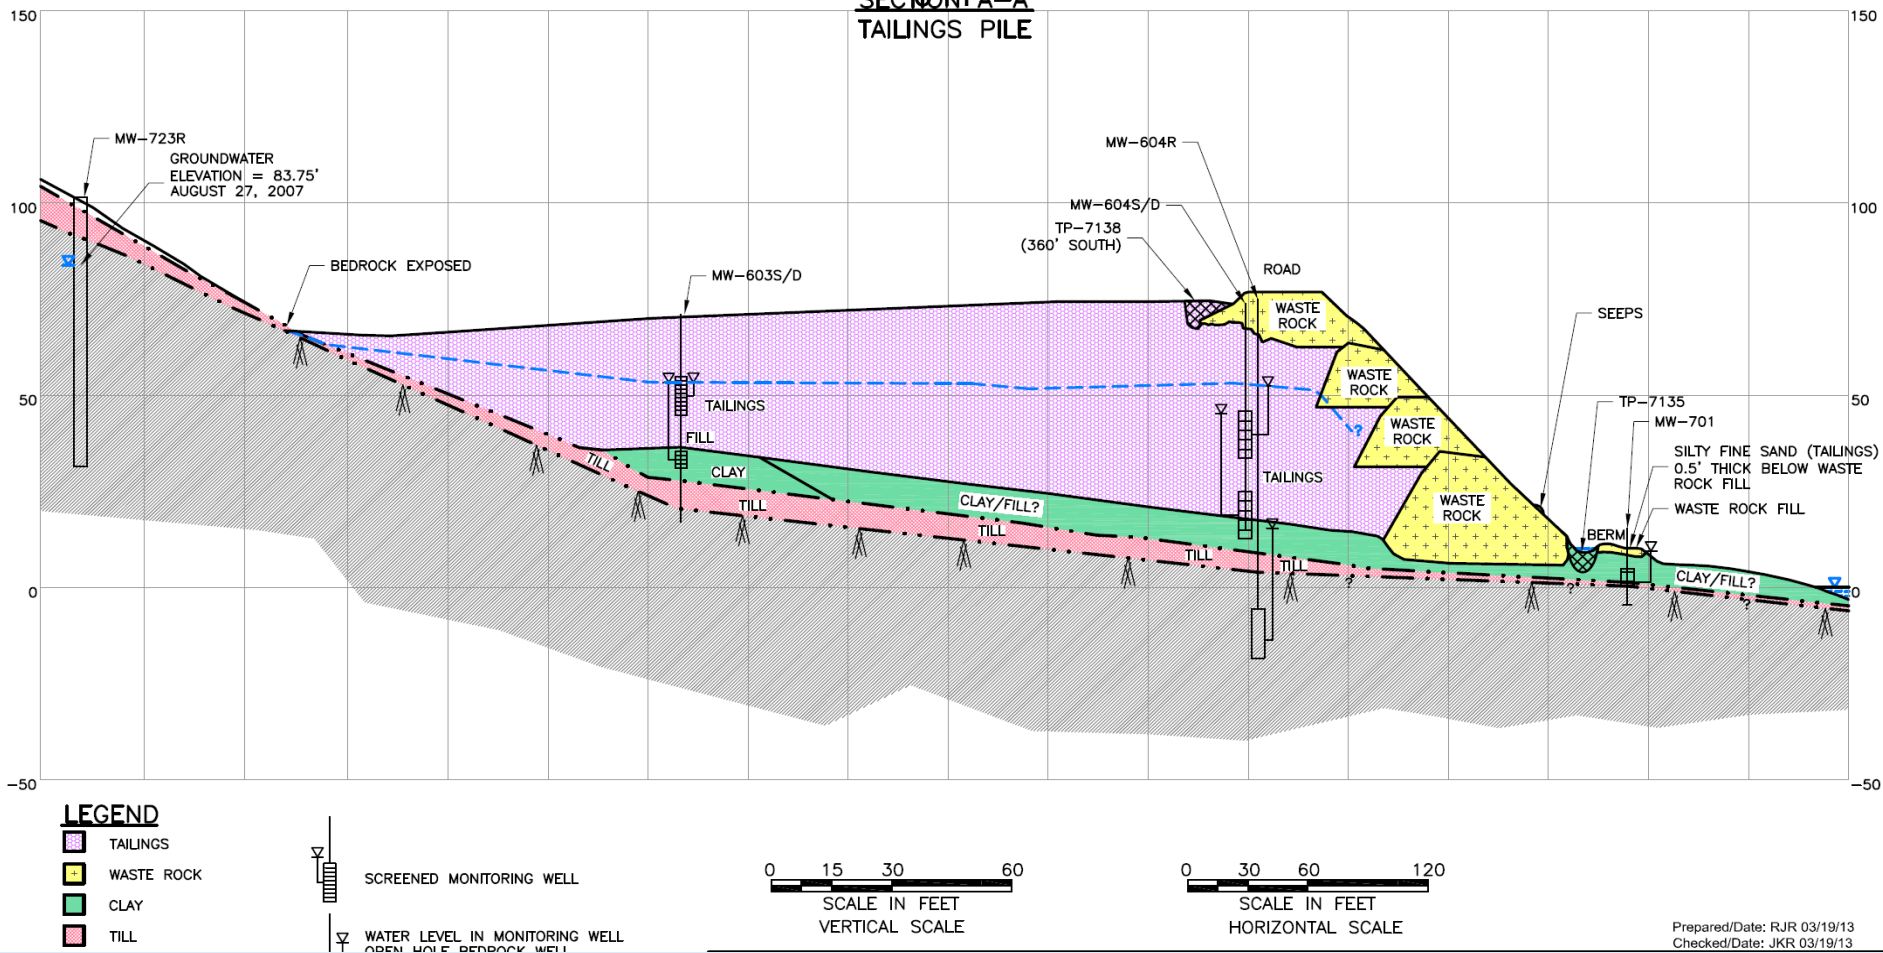
SECTION A-A' TAILINGS PILE

- This tailings impoundment is unique. The design includes a rock wall with clay backing to create a bathtub effect.
- The intent was to keep water in the impoundment to allow for re-use of the water.
- The native soil at the base is clay and does not transmit water well.
- The water creates instability in the tailings material and the dam.
 - Static stability Factor of Safety is 1.04 – 1.2 based on existing current conditions, generally accepted Factor of Safety is 1.5
 - Factor of Safety is below 1.0 for a scenario where an earthquake triggers liquefaction.
