January 27, 2016

**Re: Potential Hazardous Building Materials Inventory | Former Chinet Groundwood Mill
69 Kennebec Street, Shawmut Village, Fairfield, Maine**

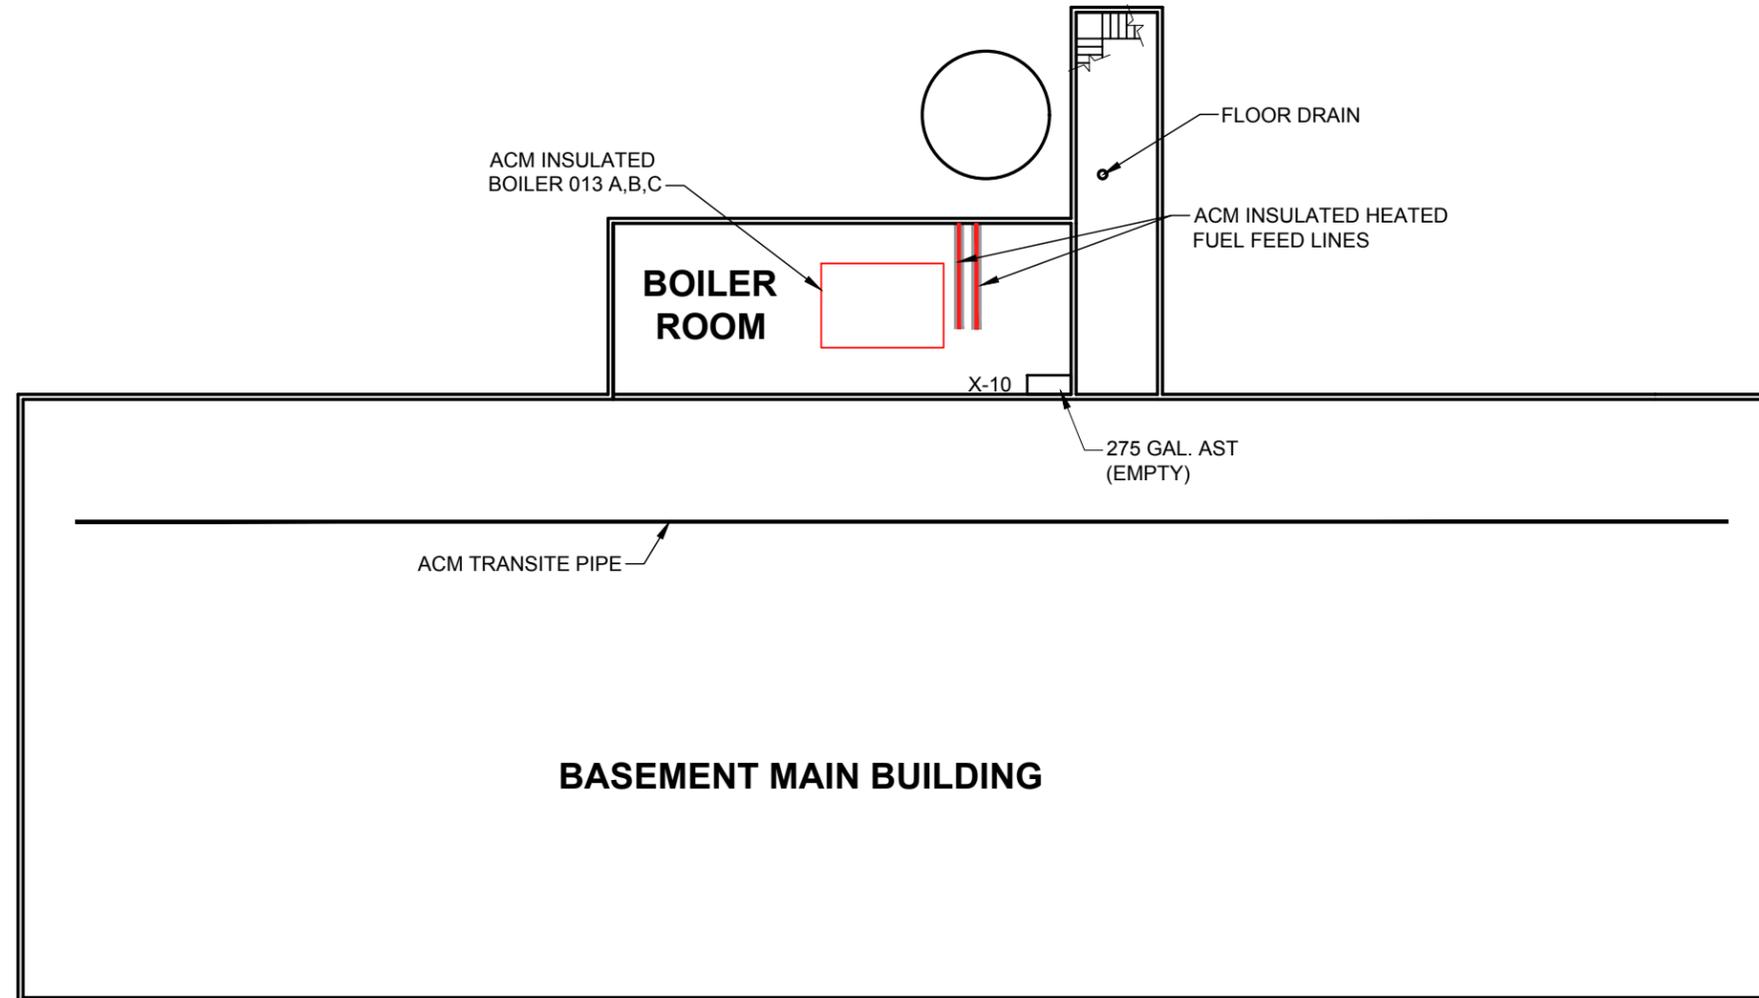
BASEMENT

OIL STAINING MAY BE PRESENT THROUGHOUT THE BUILDING

NOTE: PIPE/ACM LOCATIONS APPROXIMATE

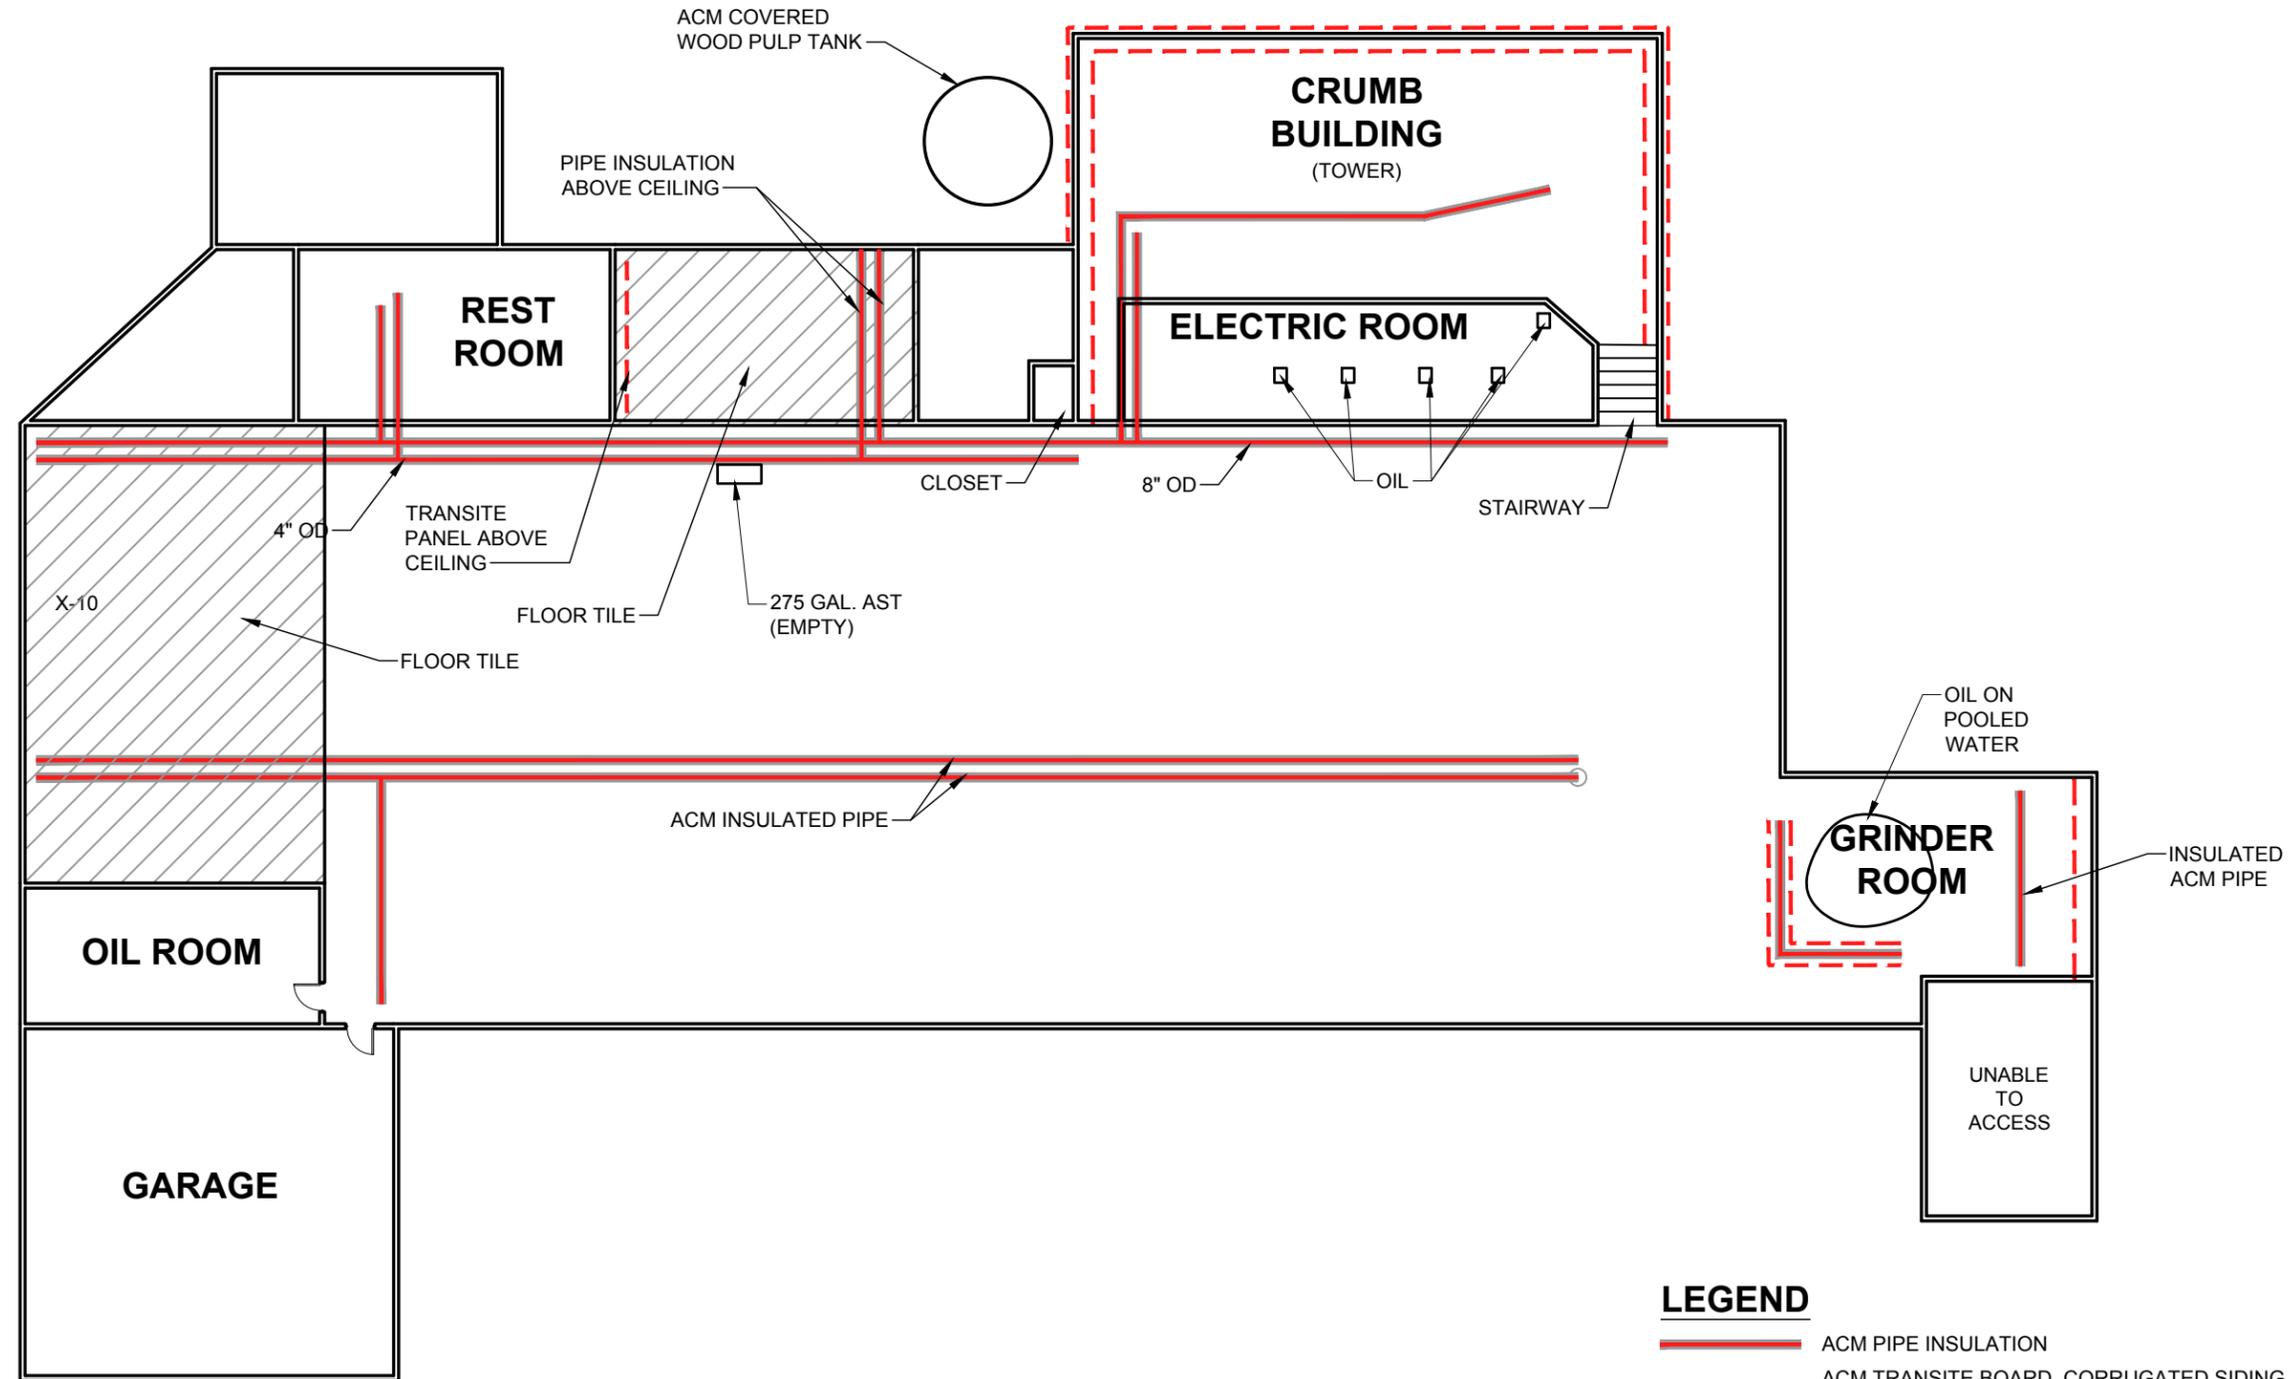
GROUND FLOOR
NOTE: PIPE/ACM LOCATIONS APPROXIMATE

NOTE:
OIL STAINING MAY BE PRESENT THROUGHOUT THE BUILDING

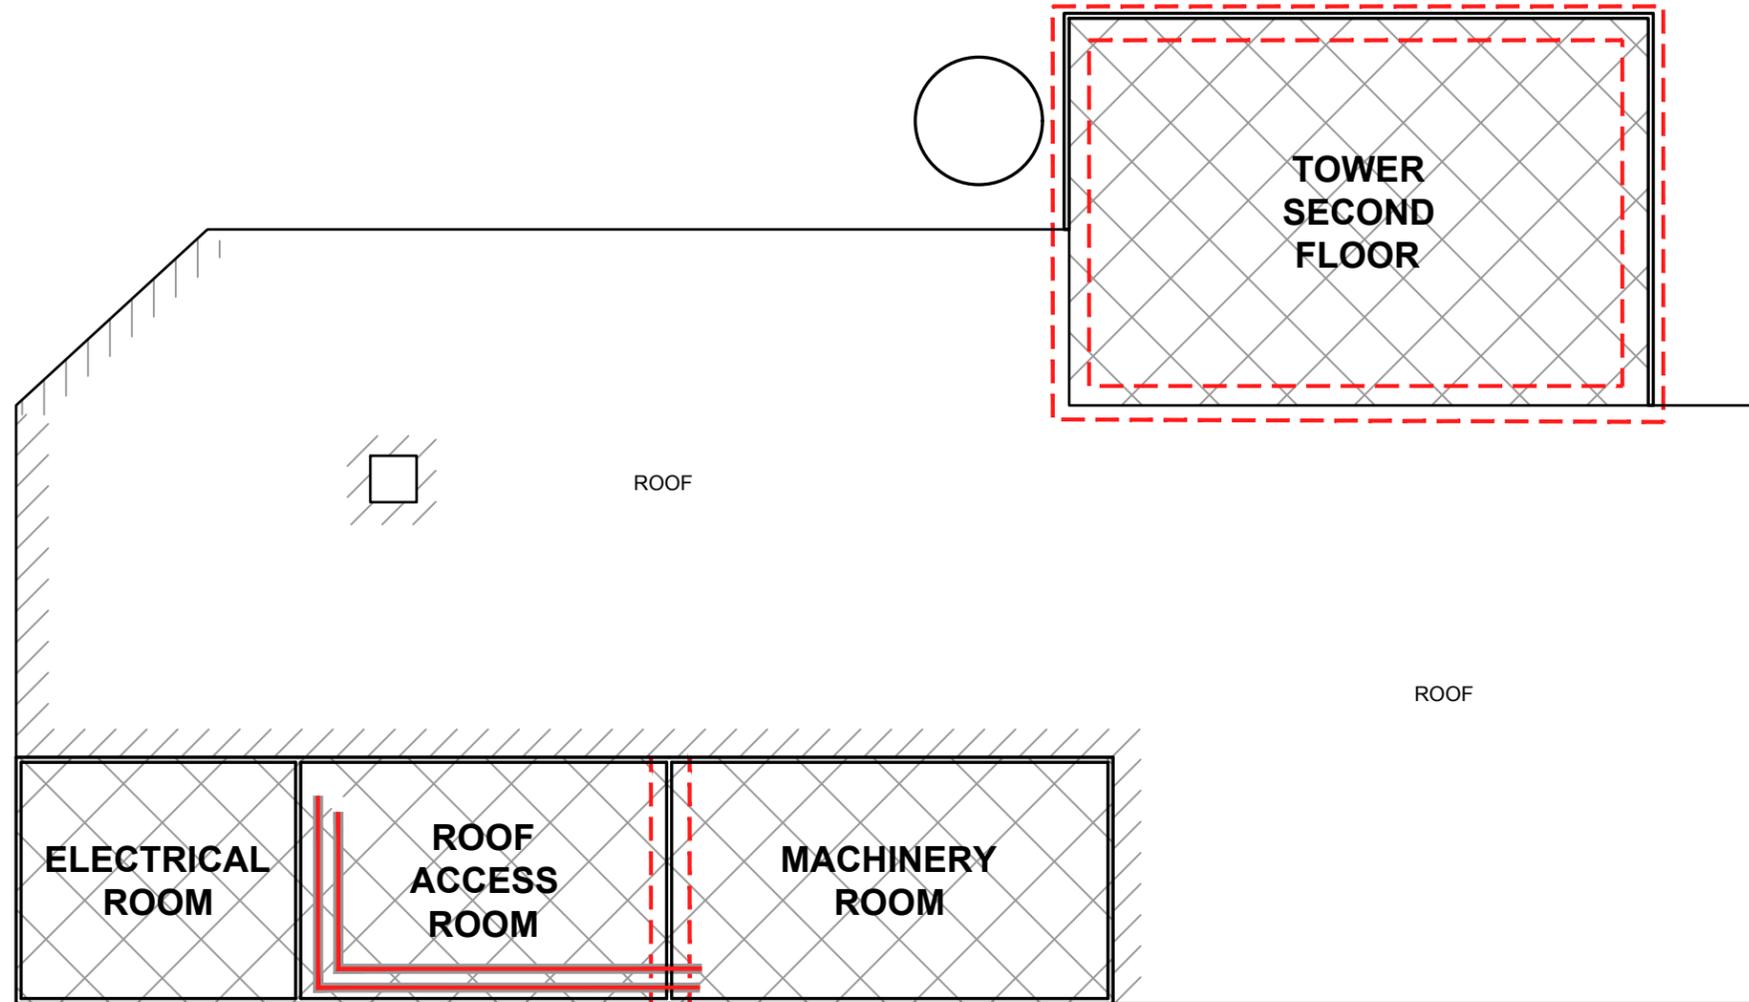
SECOND FLOOR

NOTE:
OIL STAINING MAY BE PRESENT THROUGHOUT THE BUILDING

NOTE: PIPE/ACM LOCATIONS APPROXIMATE
