Suspect ACM Inventory Lincoln Tissue.

Disclaimer: On July 13, 2016 Maine DEP Lead and Asbestos Unit staff conducted a limited on-site facility walk-thru to overview assumed suspect asbestos-containing materials at the Lincoln Tissue Mill.

Twenty-nine buildings were overviewed during the walk-thru and are referred to by building name and number on the Power Distribution Overview Map(attached). The results of the walk thru are summarized in this document. No samples were collect by staff and quantities of assumed suspect ACM are rough estimates and are provided only as a frame of reference.

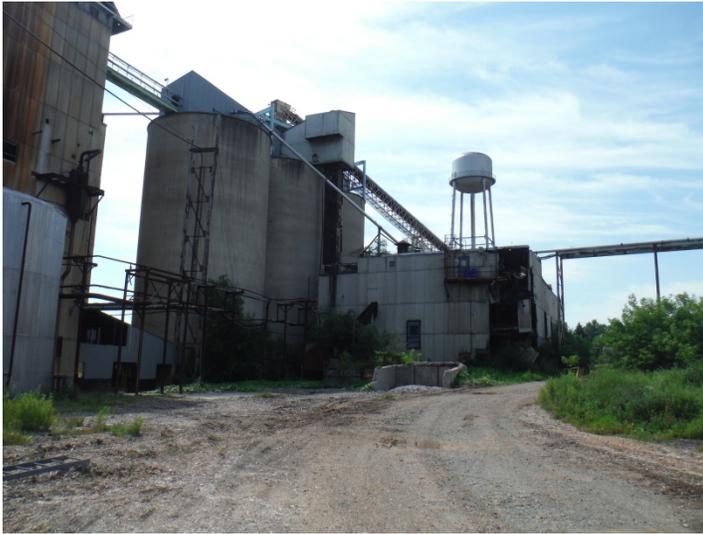
Building #9 Old Wood Room 134Lx 80W x 32 H

Exterior Transite Panels (~ 13,000 square feet) and Roofing ~ 10,700 square feet

Interior ~200 linear Feet of TSI on runs. Ceiling tiles in the control room 10x10. Interior Transite panels ~8000 square feet

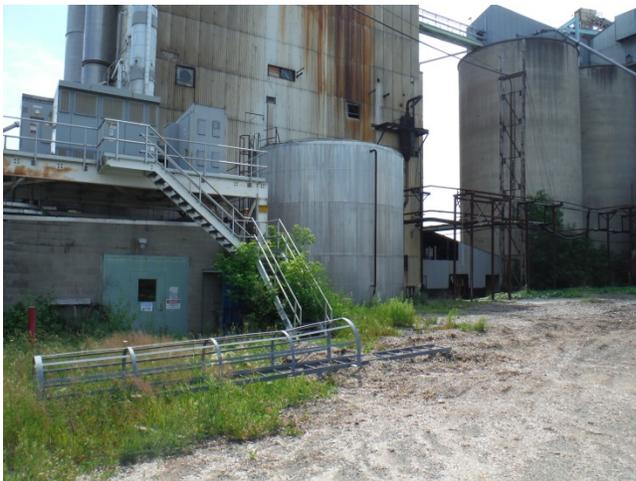
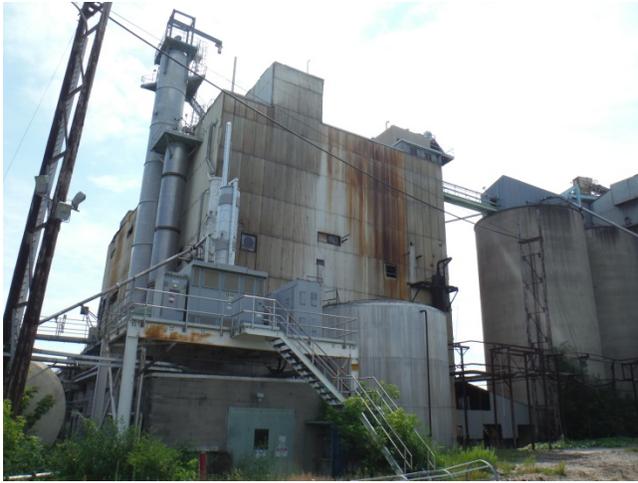
Building #10 Pulp Mill Building 72Hx150Lx80W (exterior only) Transite With 20x10x10 penthouse

Transite total ~ 36,000 square feet.

Interior of pulp mill is a mixing of debris. Suspect ACM, pulp and concrete.

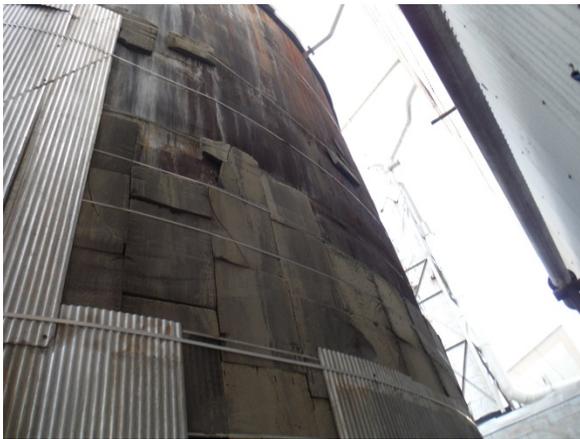
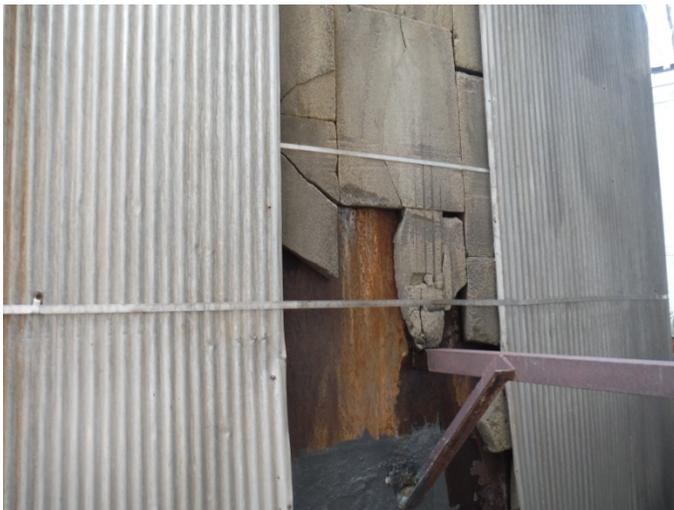
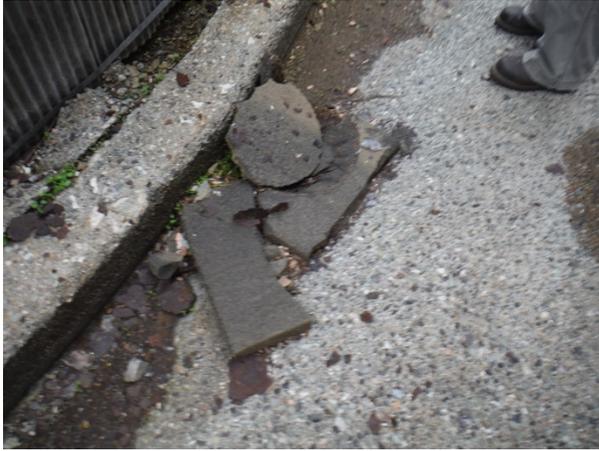
Object #11 Black Liquor tank: Encased by some sort of black/gray material. 92 feet around and 23 feet high 1600 square feet. Picture #1-3 Much of the material is in poor condition and some laying on the ground.

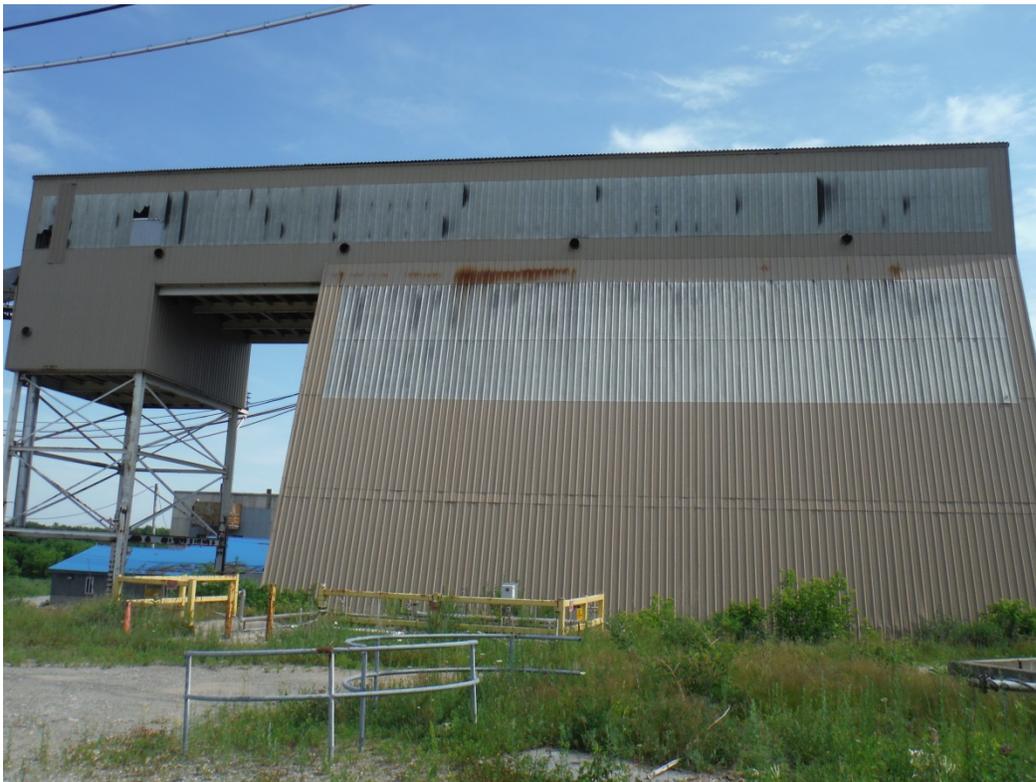
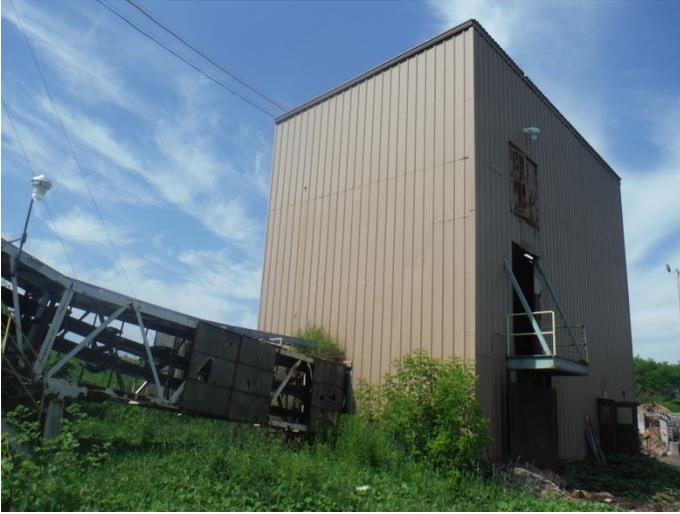
Building Number #12 A-Frame Top row appears to be transite (see picture below) ~2500 square feet

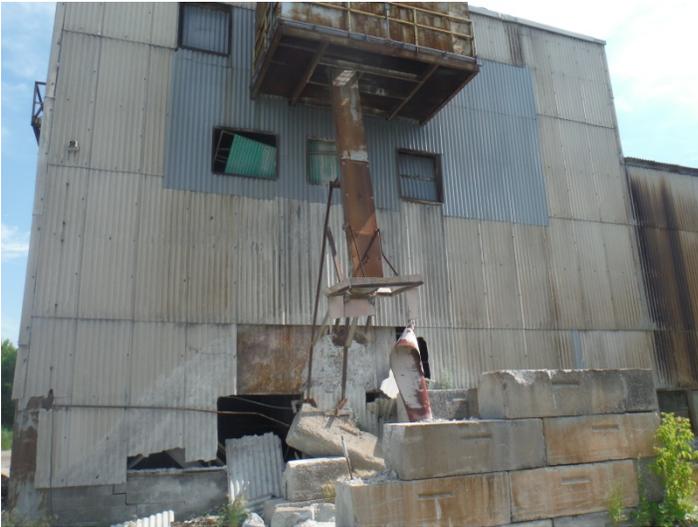
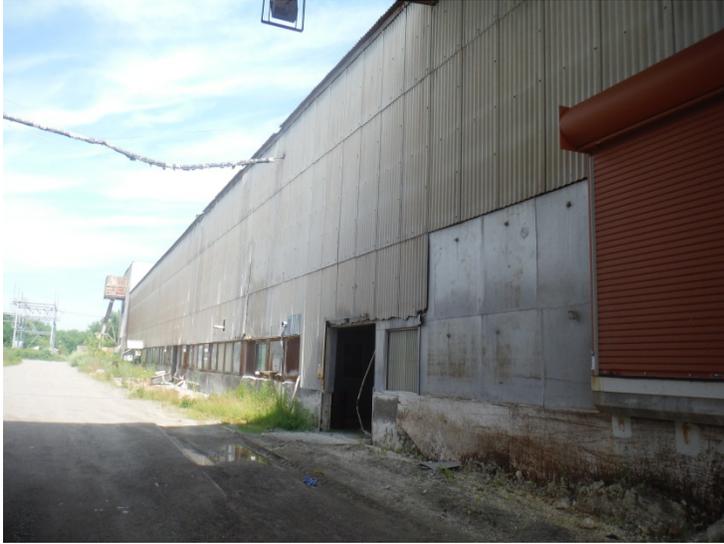
Building 17 the Lime Kiln /Caustic Building : The exterior is mostly covered with transite . Building is approximately 300 feet long by 32 feet wide. There is a 75 foot section that is 30 feet high and the rest is 24.

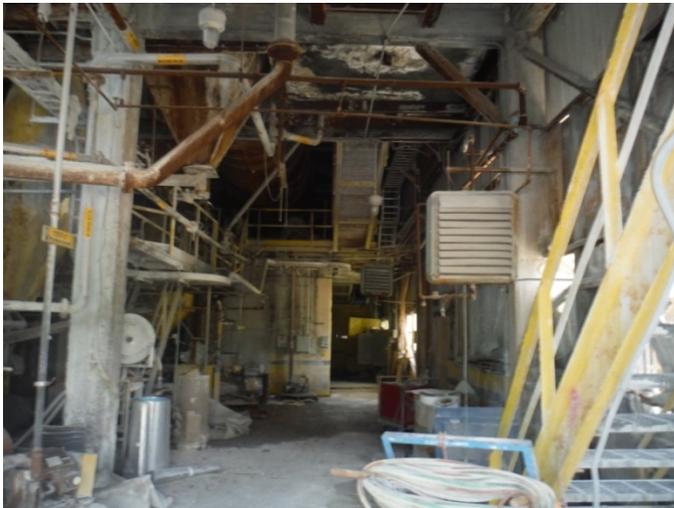
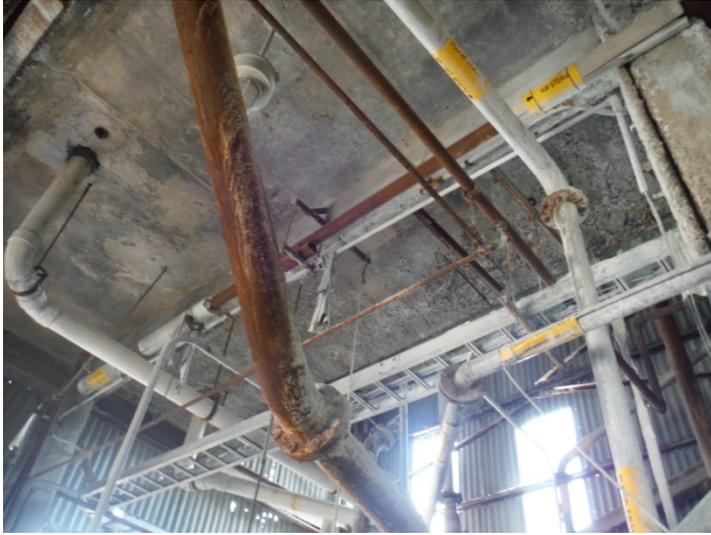
Interior of the building is littered with mix materials on the floor (suspect ACM, cement, lye.) There is TSI approximately 8 linear feet in the section of the building in the taller section of the kiln. Caustic Tank is also lined and maybe ACM. Roof is a built up and is suspect material.

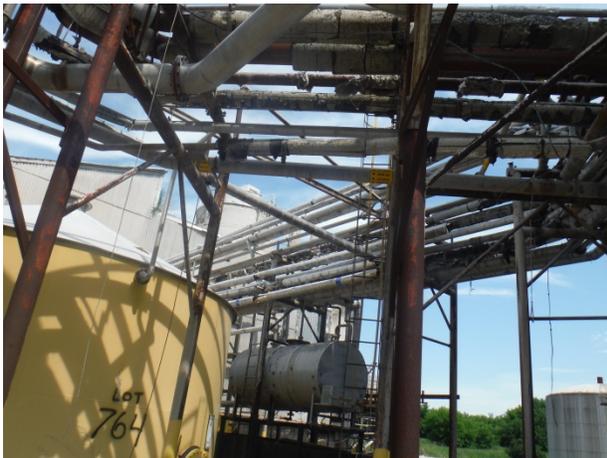
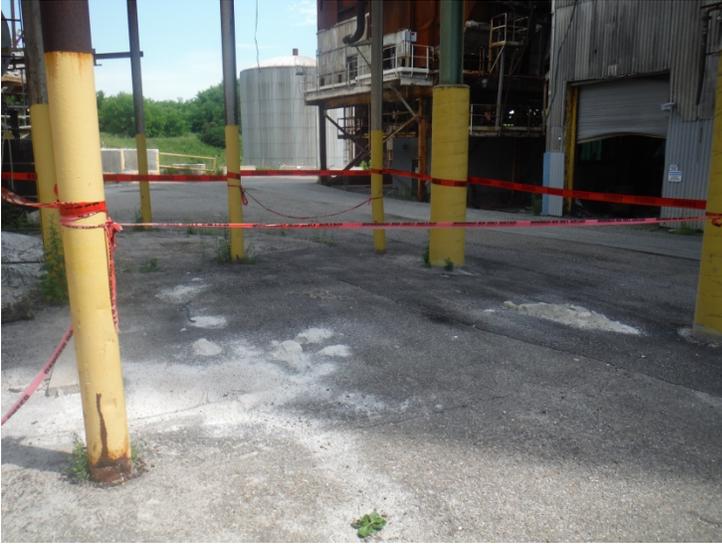
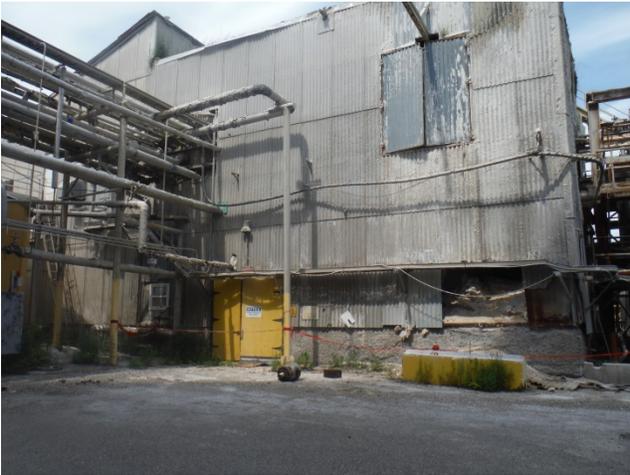
The Caustic Building #17 is connected to the Recovery Boiler building by 20 or so pipes that are mostly TSI. An area under this Pipe bridge has been cordoned off with asbestos danger tape. However most of the TSI has been dispersed by natural forces. Remaining TSI on piping approximately 1000 linear feet.

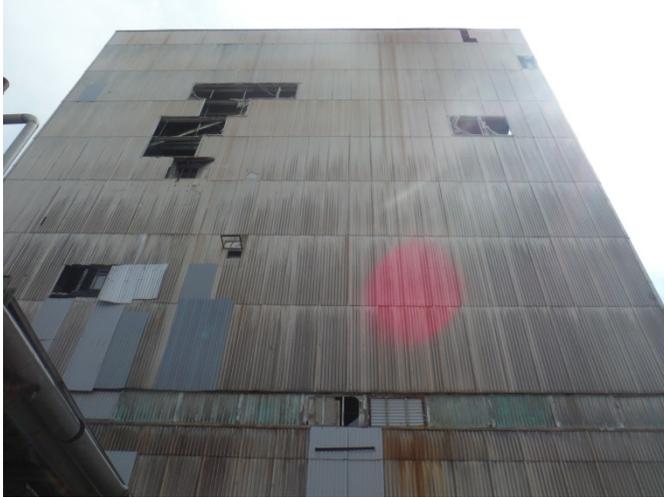
Building #18 Recovery Boiler Building (Exterior only). Siding is a mix of transite, fiberglass and metal. Because of several tanks , other obstructions and size of the building the length dimensions were not walked out with the exception of the side facing the Lime Kiln. 96 feet high by 108 wide. Suspect ACM in poor condition.

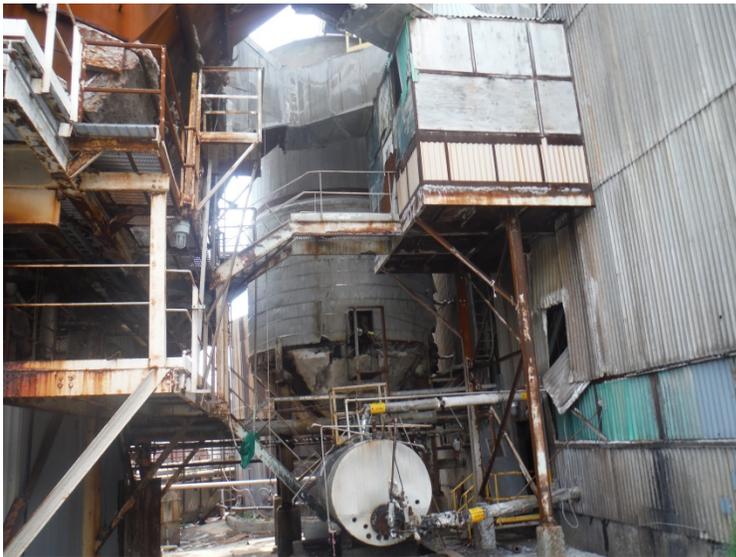
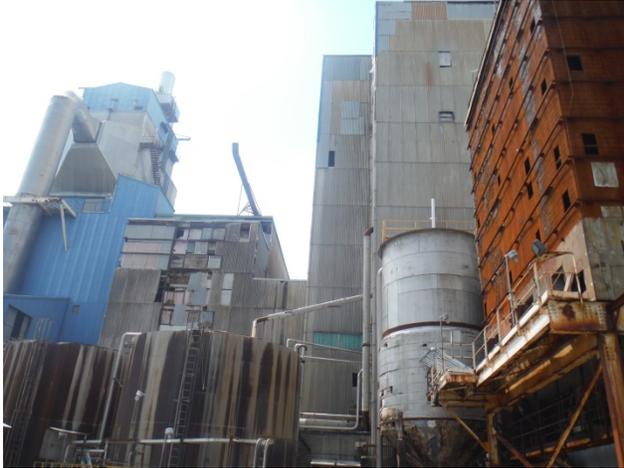
The evaluation of tour proceeded to walk on the back side of the Recovery Boiler where more TSI pipe runs and lined tanks were observed.

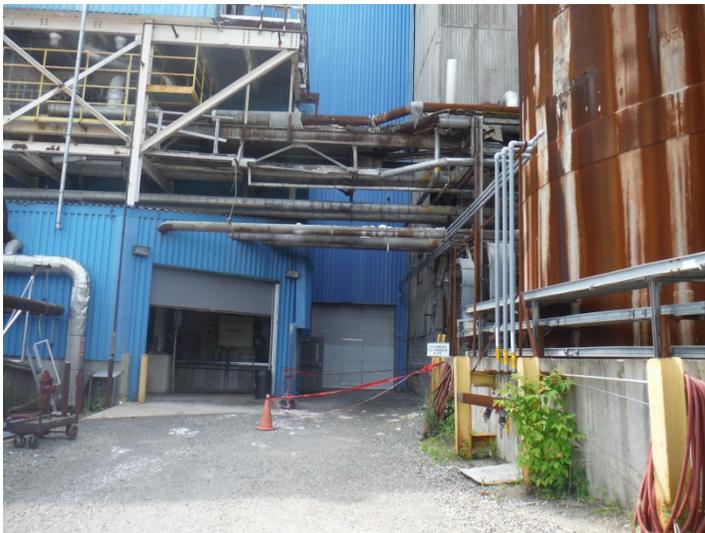
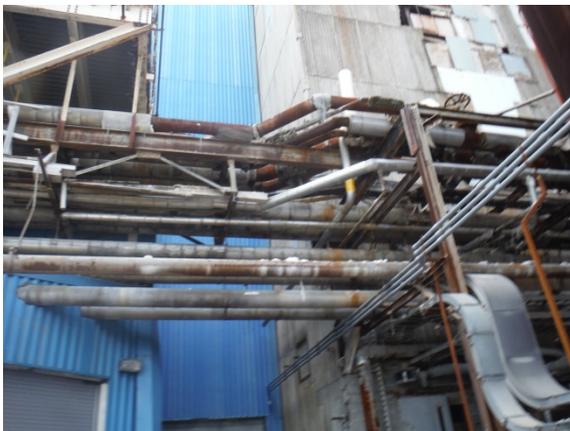
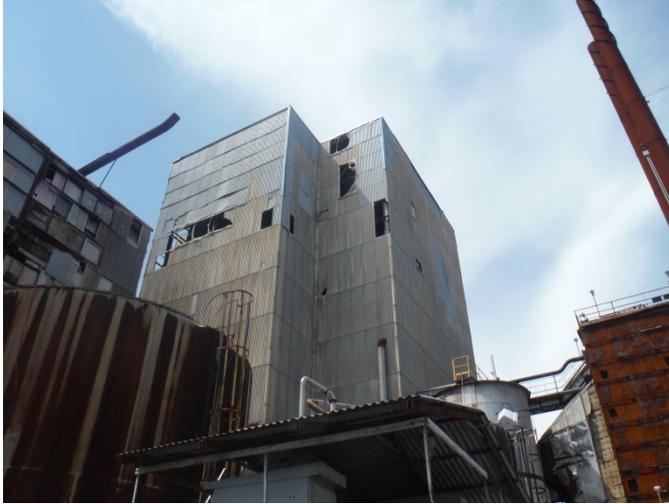
Where the Recovery Boiler House and Bio Mass Building- building 24 (Big Blue#24—which we were unable to access) meet there is another asbestos danger taped off area under exterior deteriorated TSI.

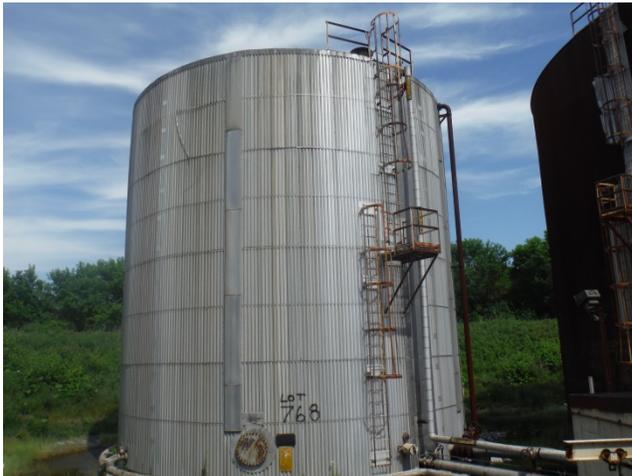
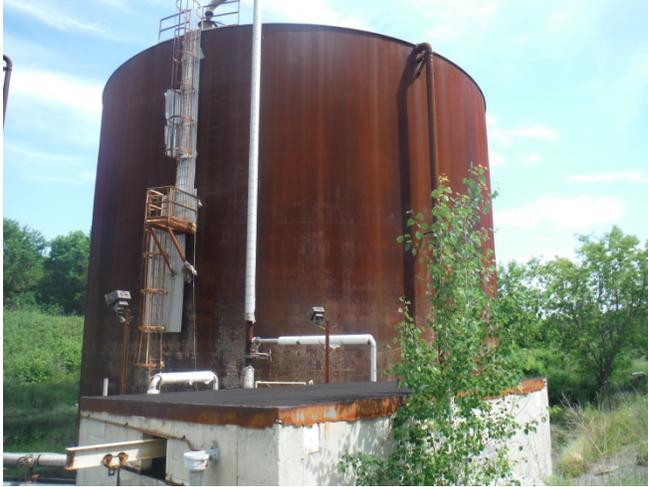
Area #19 Consist of 2 tanks and pump house. Tanks have suspect TSI and unknown if there are ACM liners on/in the tanks.

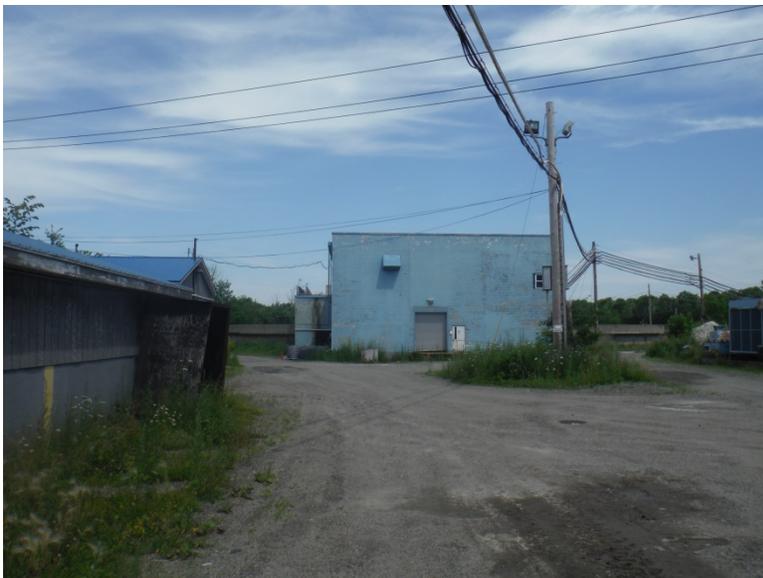
Building Number 20. Blue Cinder Block adjacent to Maint. shops. Blue painted concrete. Interior second floor has suspect ceiling tiles and lab tables. Built up flat roof also.

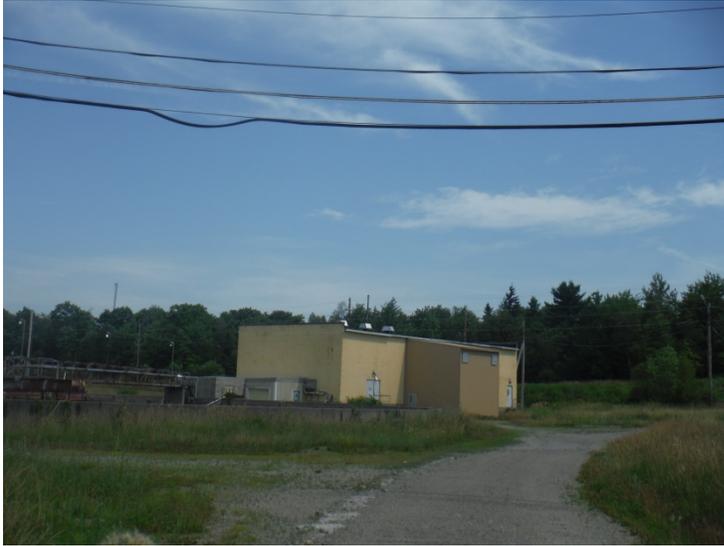
Building # 21 Waste Treatment. No Suspect seen

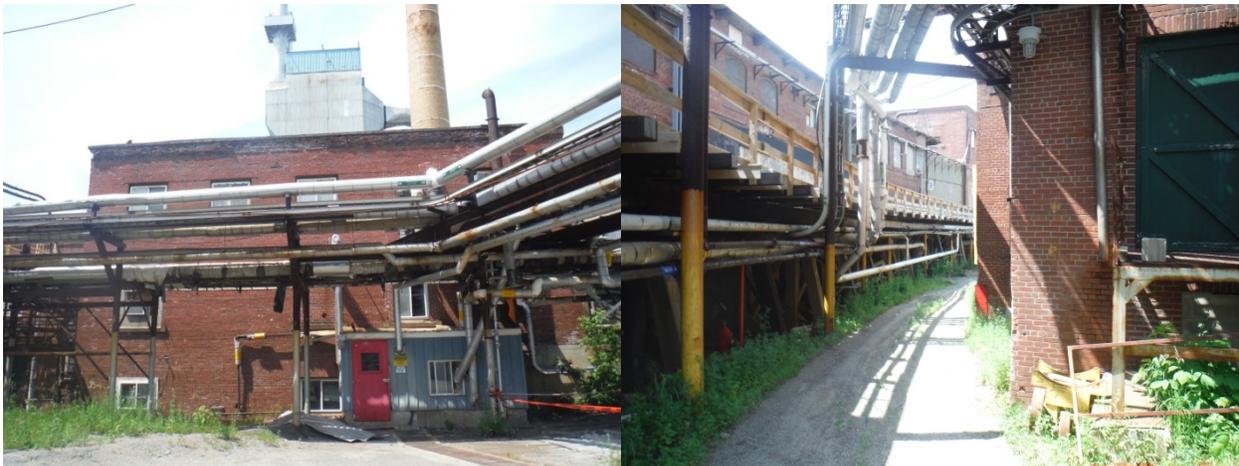
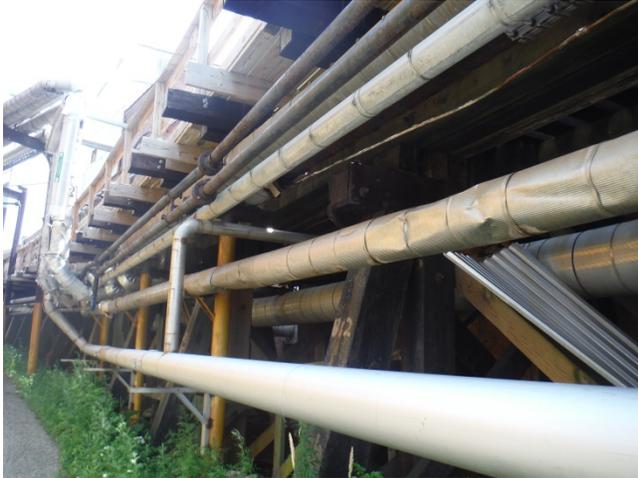
The Paper mill Building #22 exterior. 1000s of feet of suspect TSI runs (some in very poor condition. Some labeled and others in jackets) Suspect Roofing.

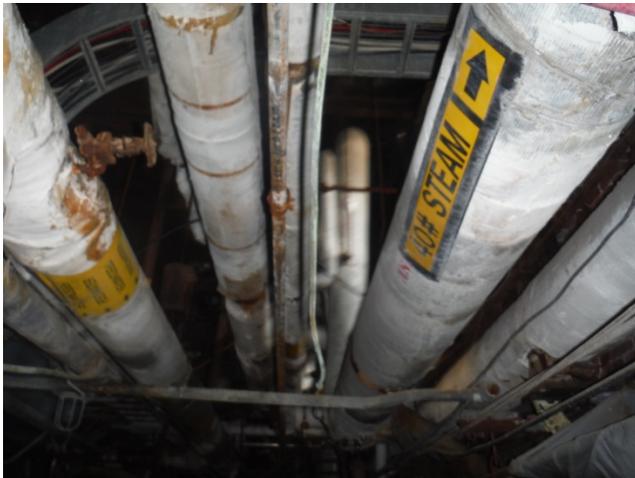
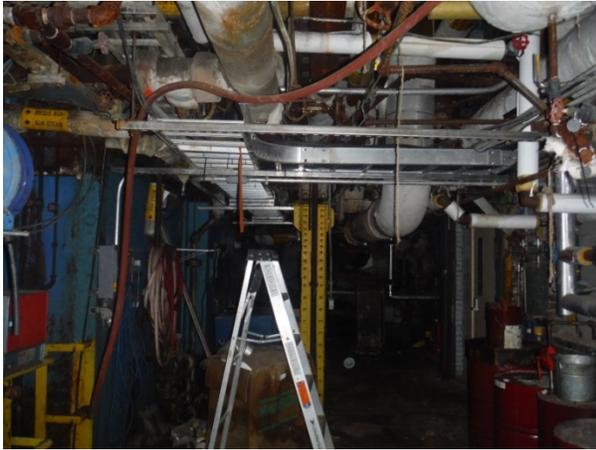
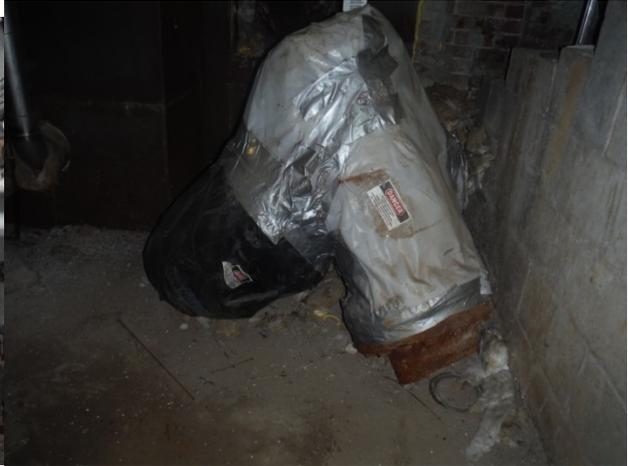
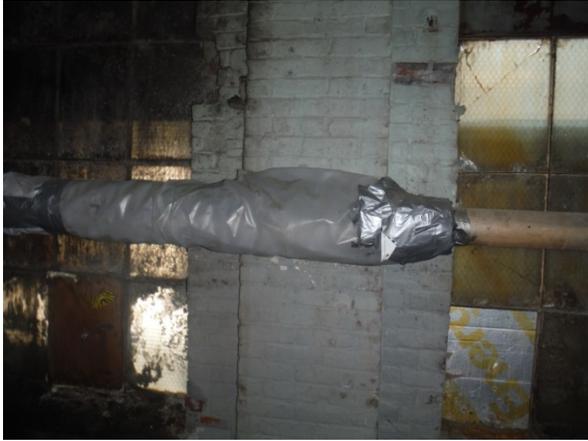
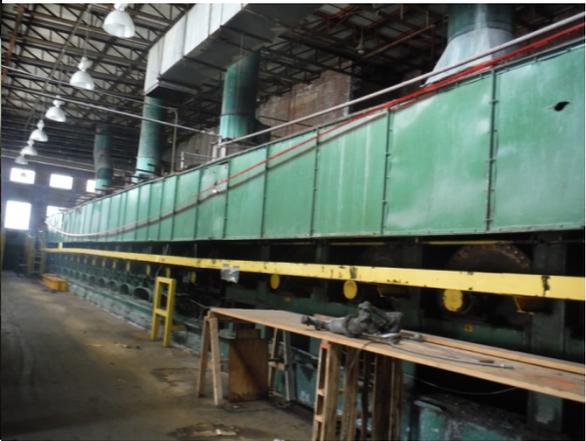
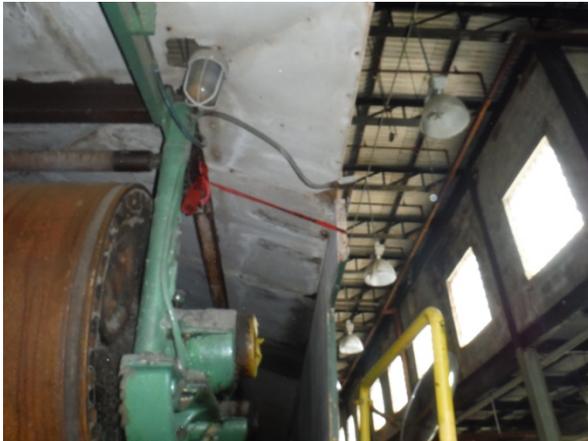
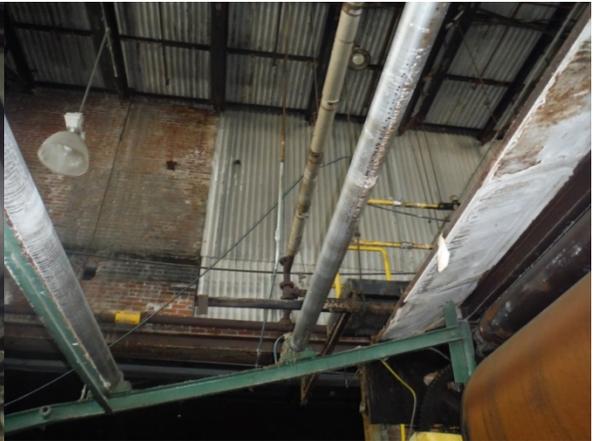
Building #22 Papermill interior. First floor various TSI sections/runs. 150 Linear feet. Ceiling tiles and floor tile or linoleum in out office ring and site control offices. Wrapped fittings. Mastics. Transite panels on dryers. Basement was briefly walked into TSI multiple runs.

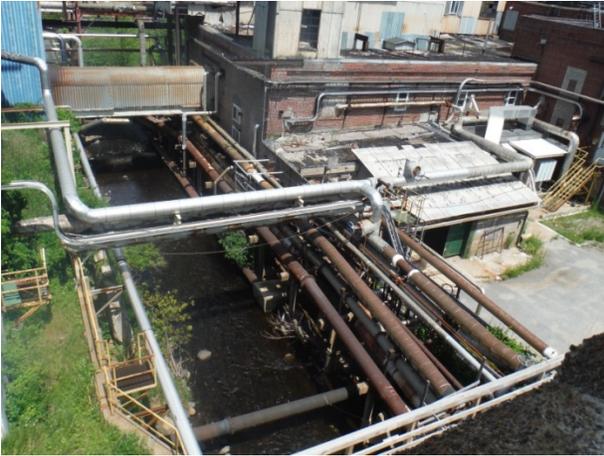
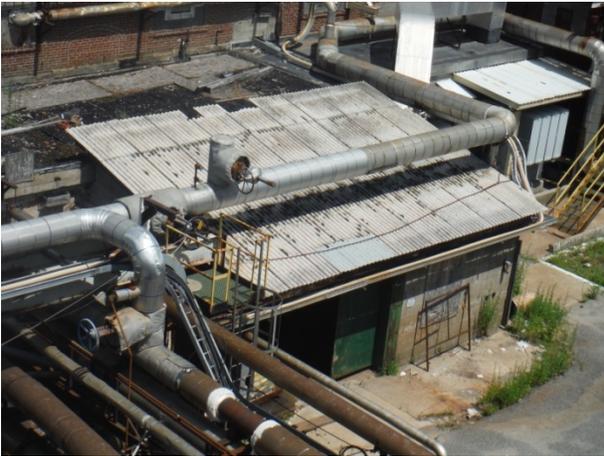
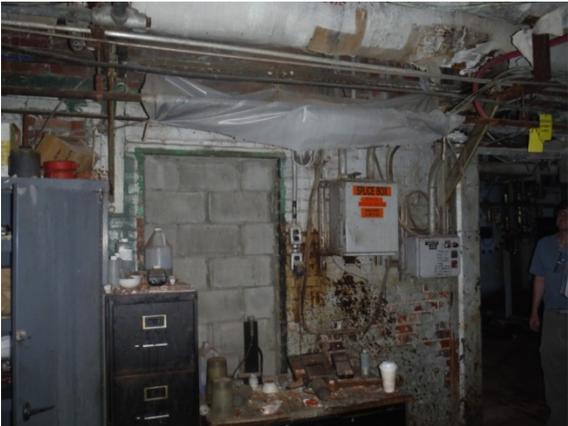
Building #23 Powerplant roof and pipe bridge with one picture interior. Multiple levels of TSI runs 1000s of linear feet. Transite paneling.

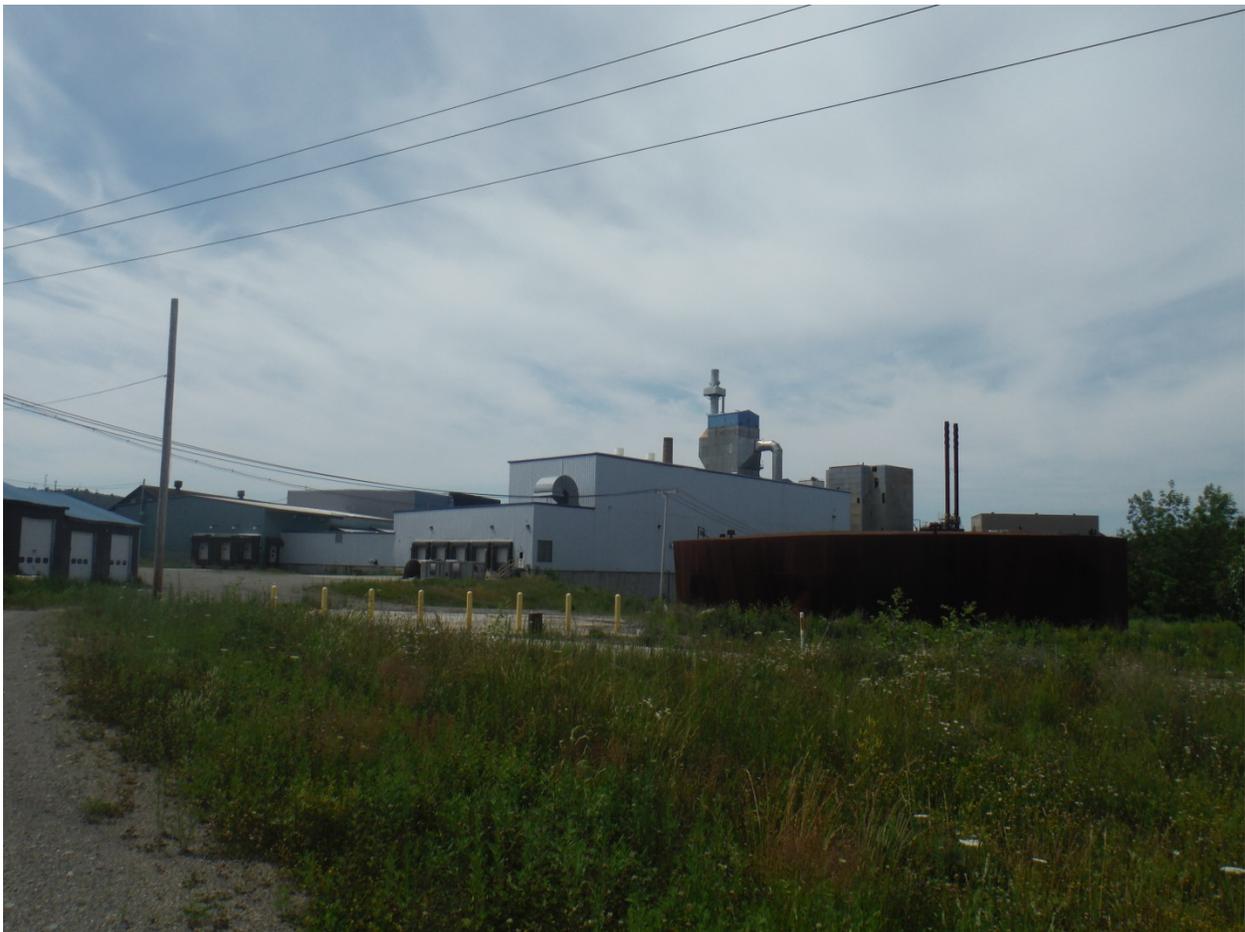
Building #25 WTP Gen. 4 Garage bays were locked (adjacent Waste Treatment). ACM warning signs on building. Left side in the picture.
