POTENTIAL HAZARDOUS BUILDING MATERIALS INVENTORY

**Derby Shops Site
18 B & A Avenue
Milo, Maine**

November 2015

TRC Project No: 233392

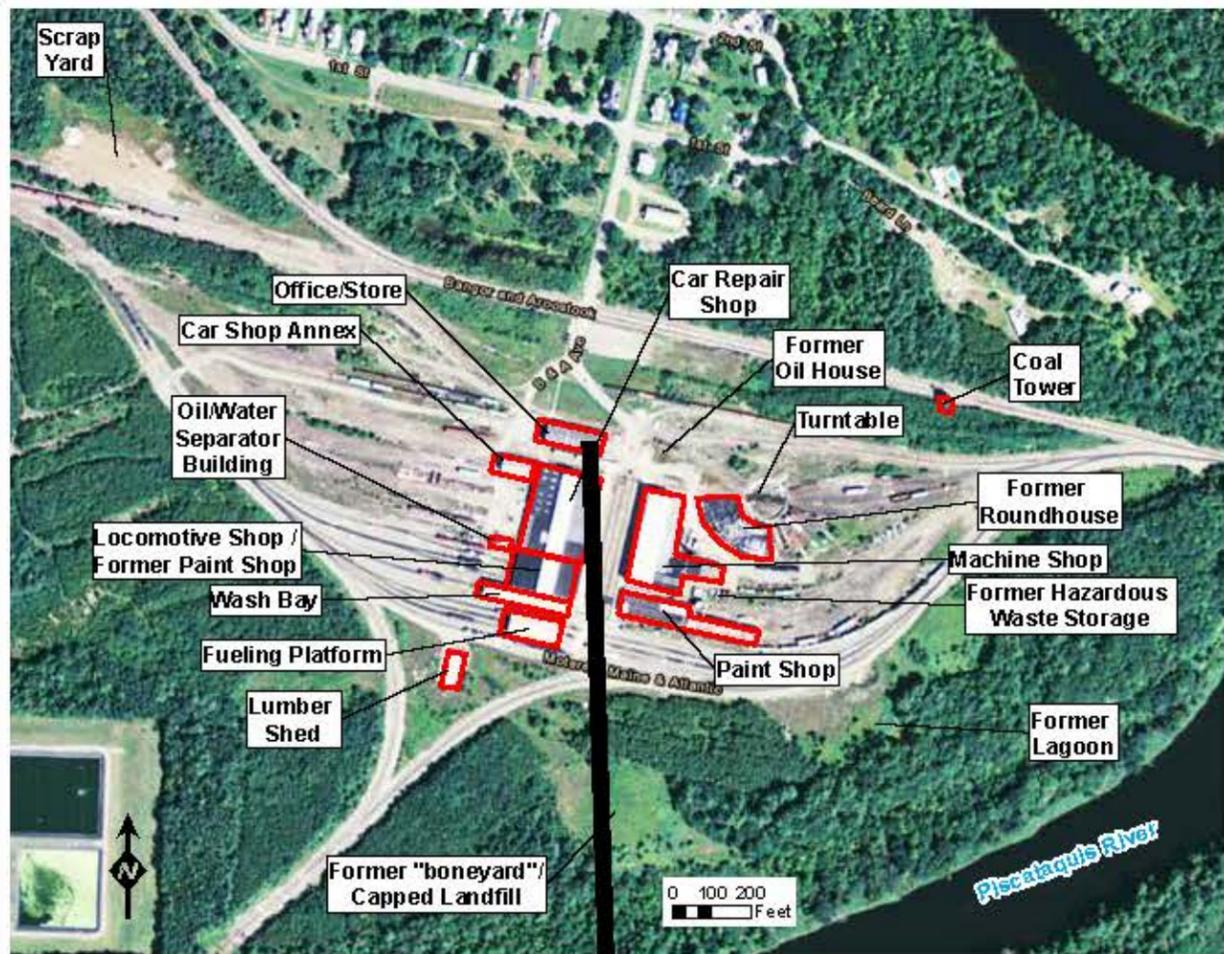
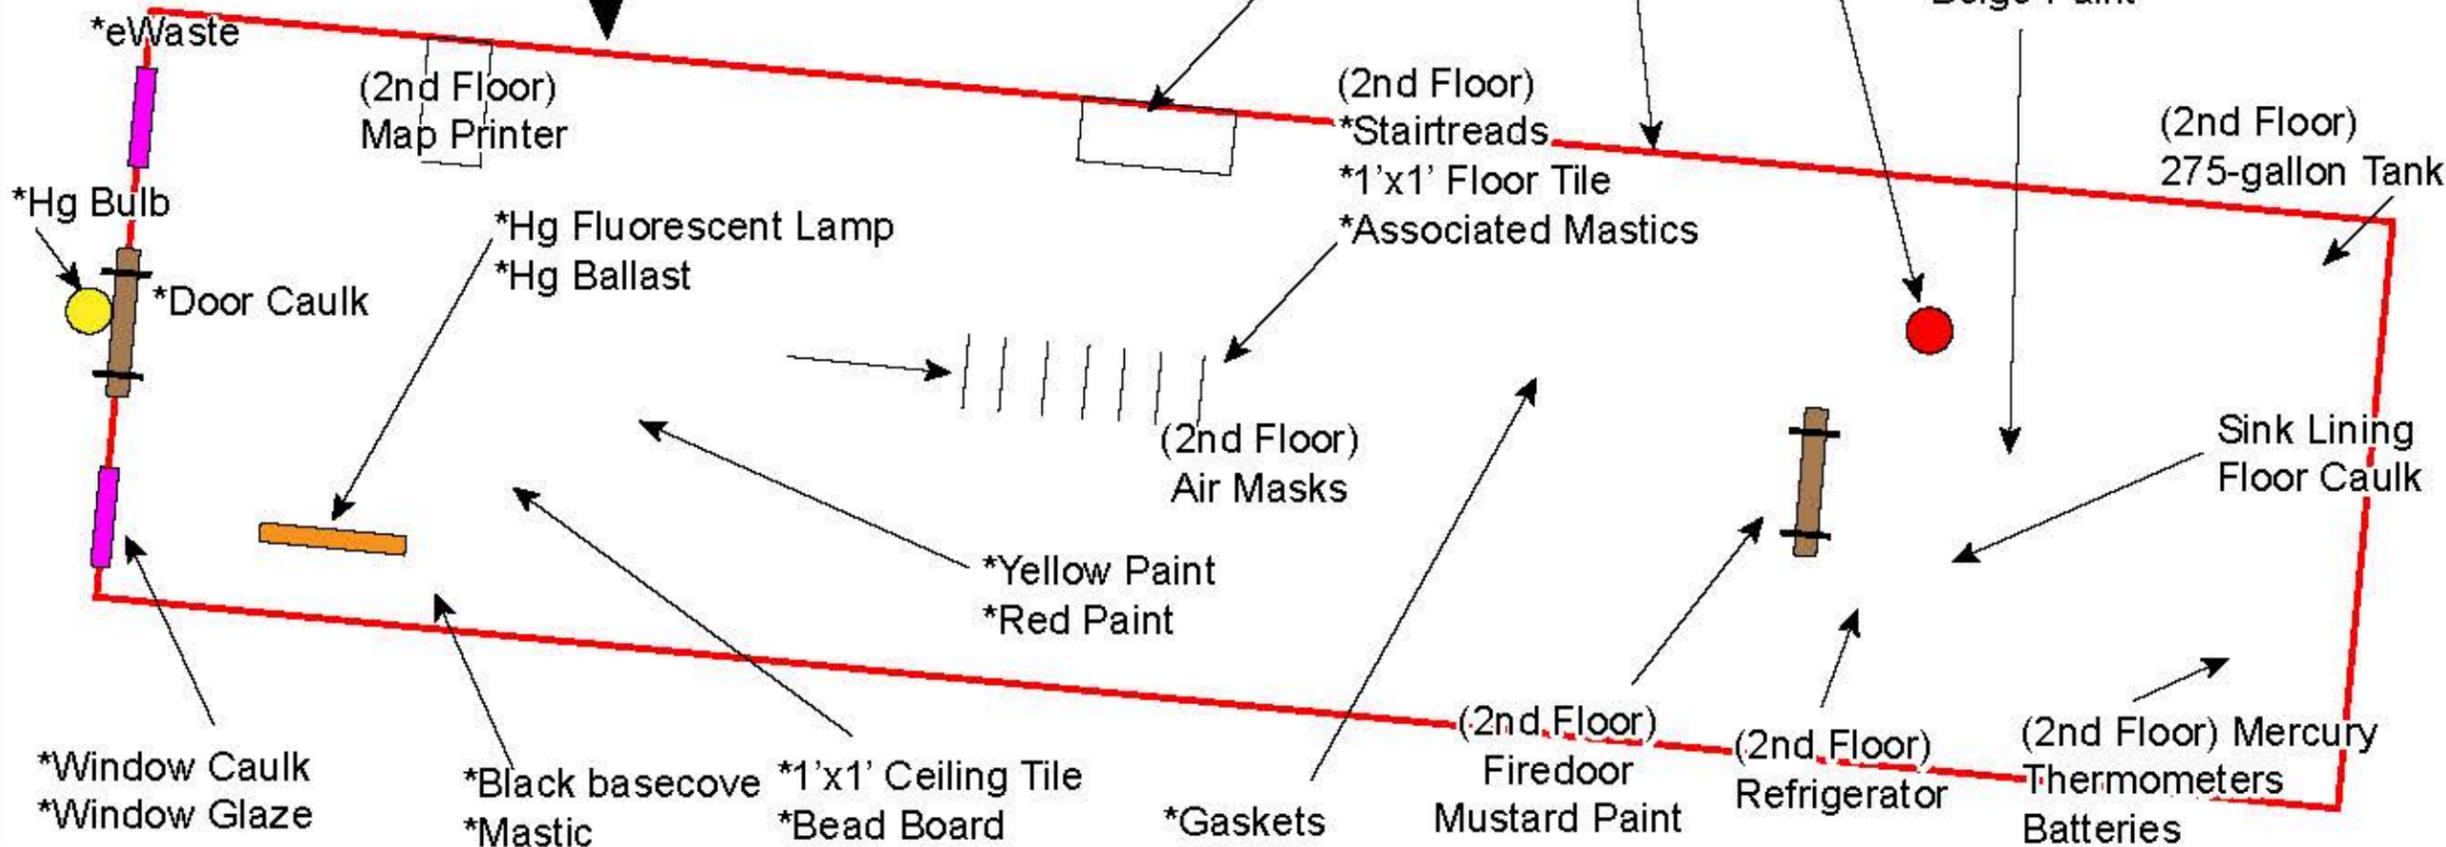
Floor Plan #1 Office / Store

Exterior: Brick & Mortar, Roofing

- (2nd Floor)
- Mint Green Paint
- Dark Mint Green Paint
- Light Gray Paint
- White Paint
- Beige Paint

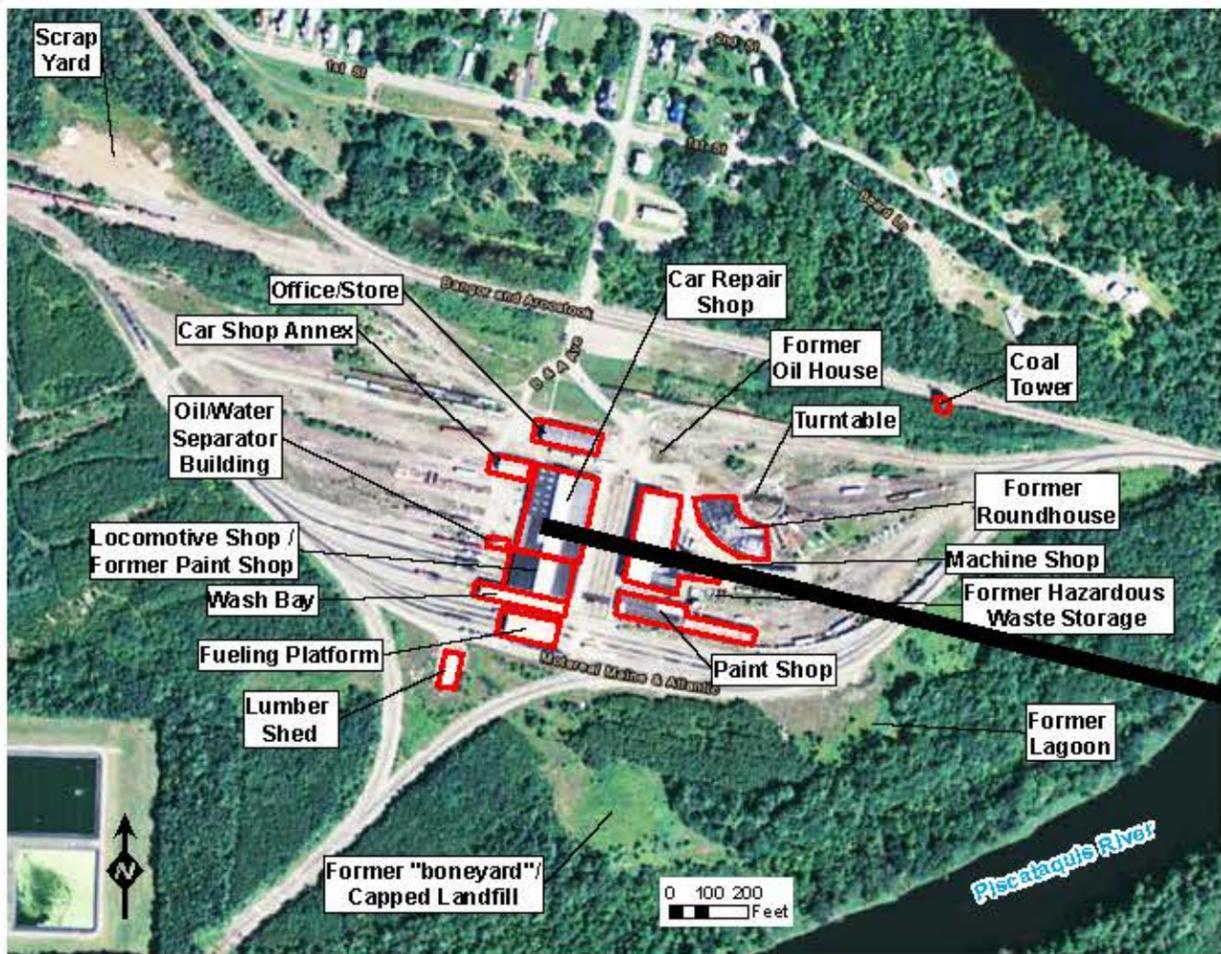
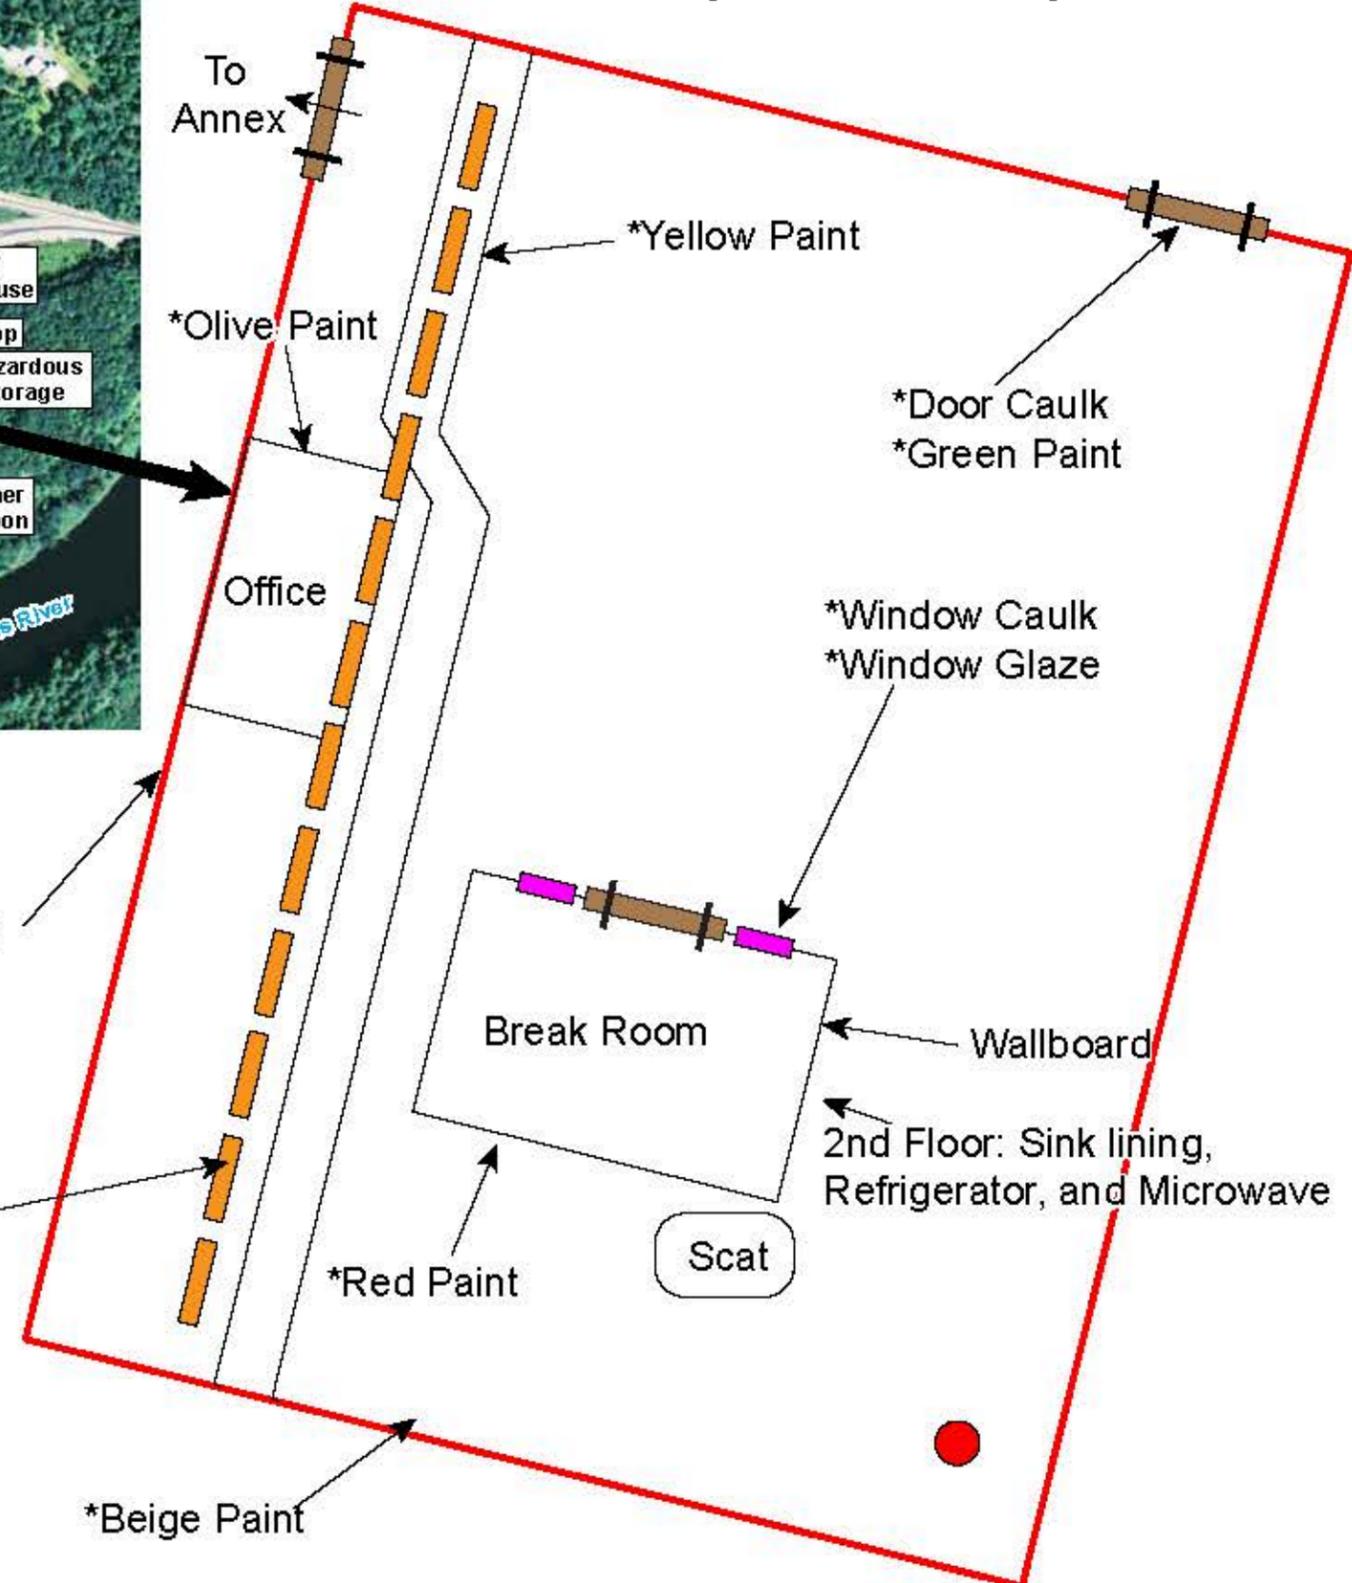
Floor Plan #3 Car Repair Shop

Exterior: Brick & Mortar, Roofing

*Hg Fluorescent Lamp
*Hg Ballast

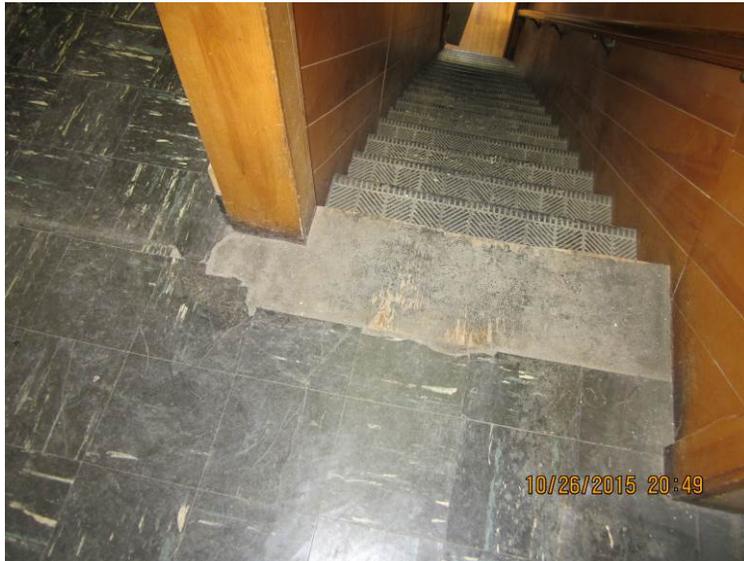
1. Image showing the stair treads (and associated mastic) and the 12" X 12" floor tile (and associated mastic) in the Office/Store.

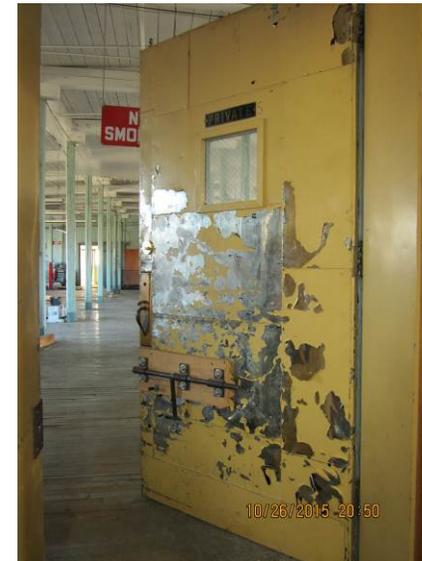
2. Image showing the fire door in the Office/Store. The mint green, dark mint green, light gray, white, and mustard potential LBP can also be seen.

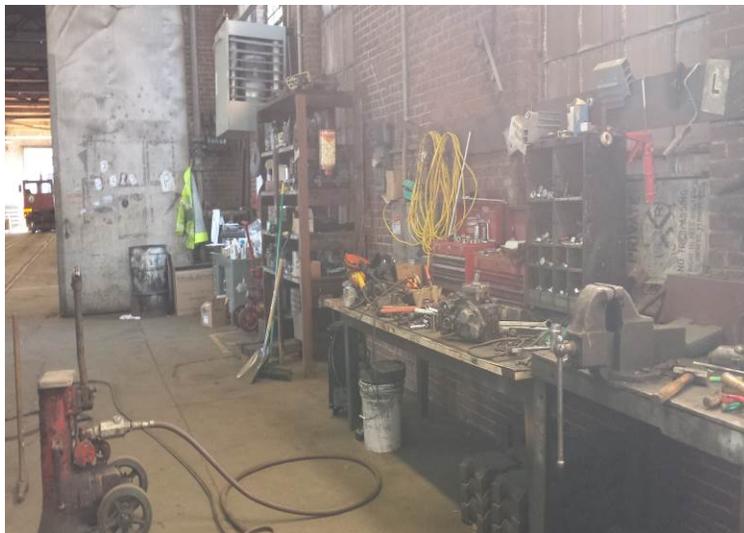
3. Image showing the various tools and RR parts/supplies stored in the Car Shop Annex.

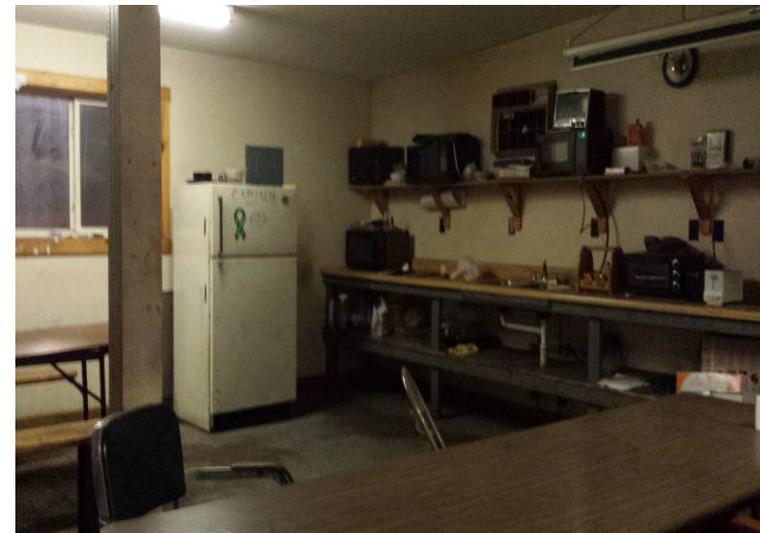
4. Image showing a refrigerator and several microwaves in the break room of the Car Repair Shop.

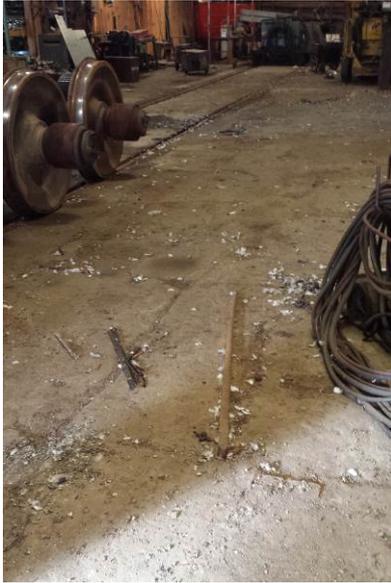
5. Image showing the scat located in the southern portion of the Car Repair Shop.

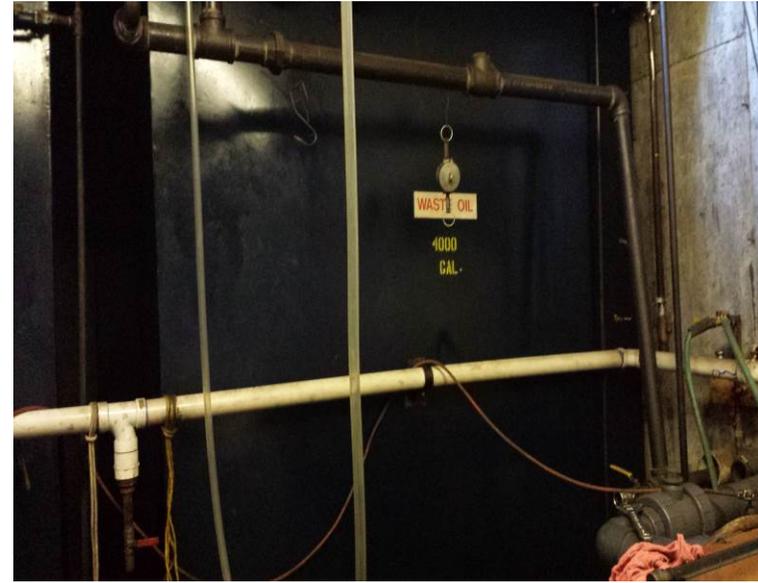
6. Image of navy 4,000 gallon waste oil tank on the lower level of the O/W Separator Building.

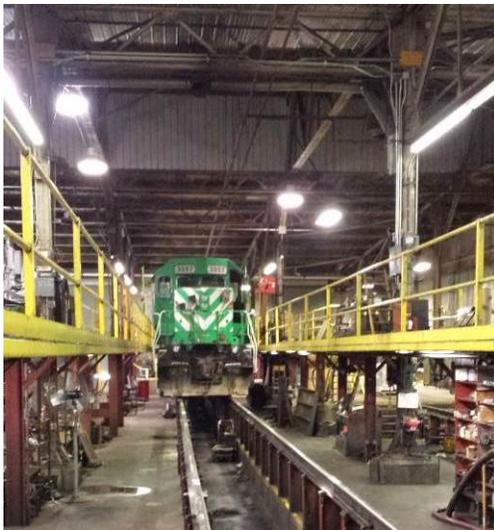
7. Image showing yellow and red potential LBP, as well as pit(s) and fluorescent lamps and ballasts.

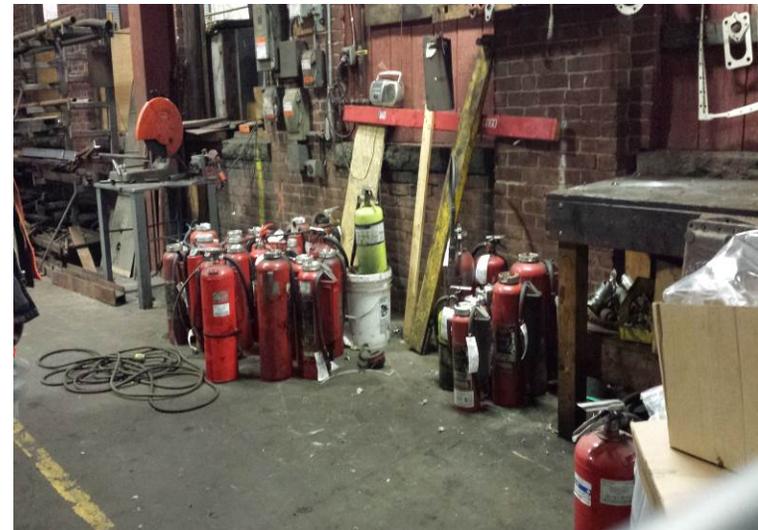
8. Image showing fire extinguisher storage in the Wash Bay.

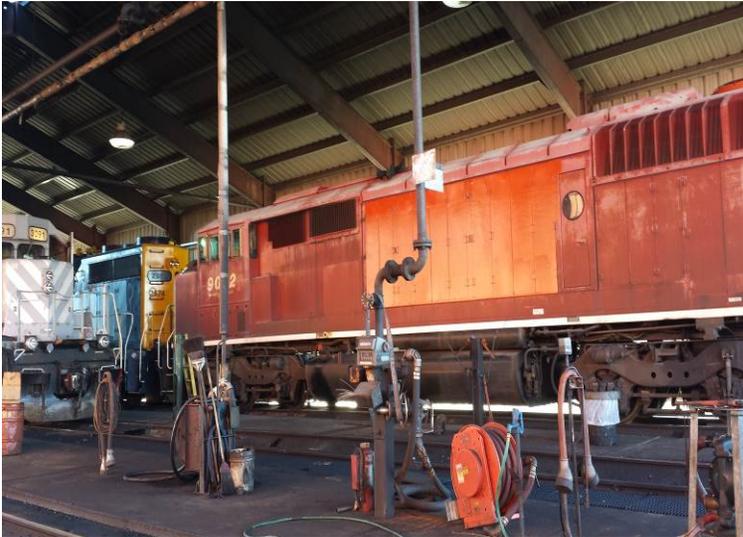
9. Image showing potential ACM gaskets in the Fueling Platform.

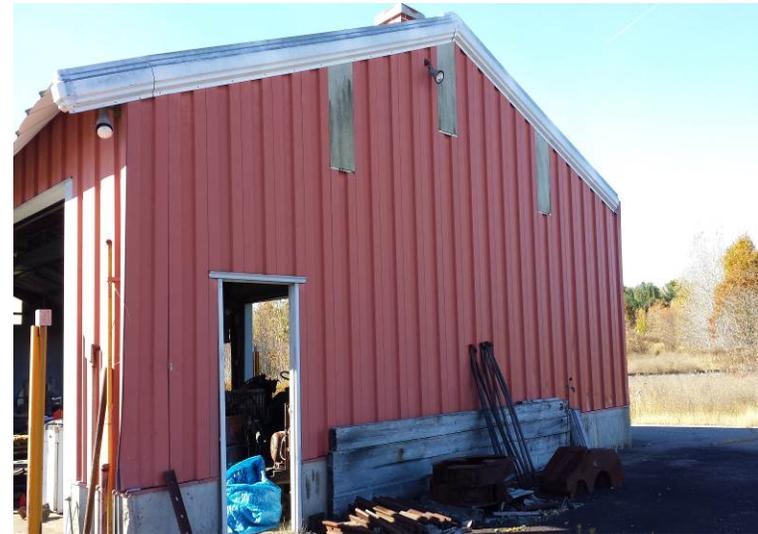
10. Image showing red and yellow potential LBP, potential Hg bulbs, windows and associated caulking/glaze, and the brick with associated mortar chimney.

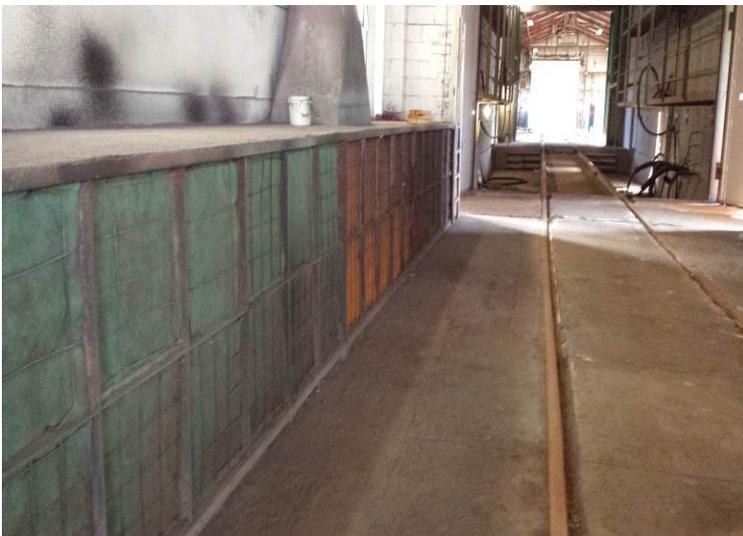
11. Image showing potential LBP and ACM filters in the Paint Shop.

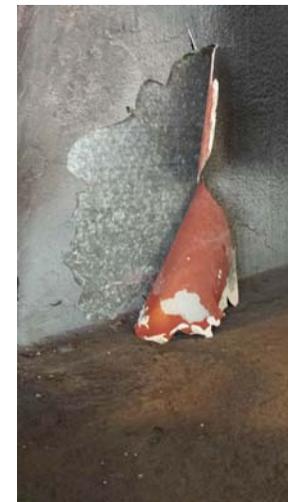
12. Image showing layers of potential LBP on the wall(s) of the Paint Shop.

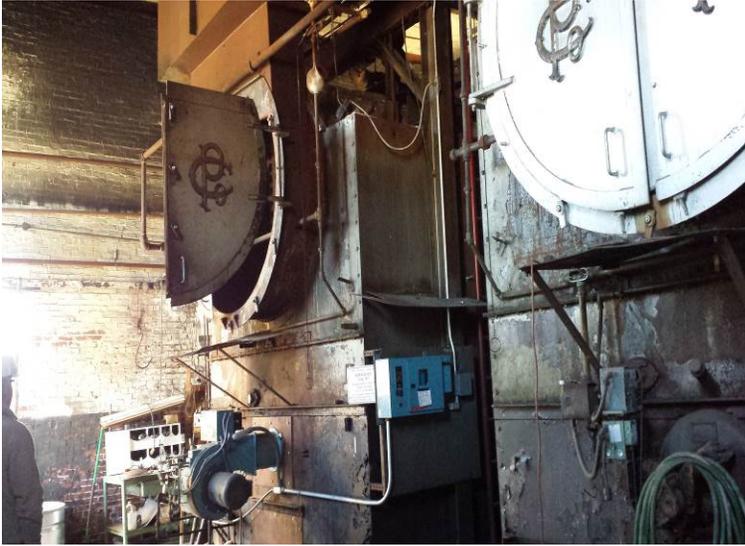
13. Image of the face of the boilers in the Machine Shop.

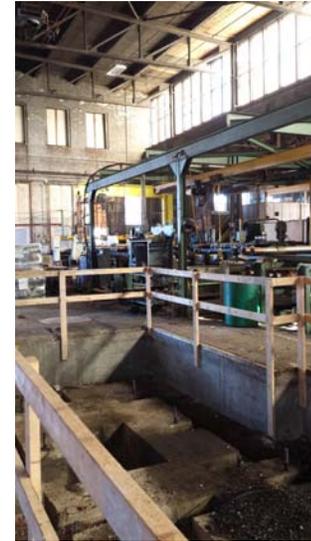
14. Image of the pit in the Machine Shop; windows and associated caulking/glaze, 55-gallon drums, and fluorescent lamps in the background.

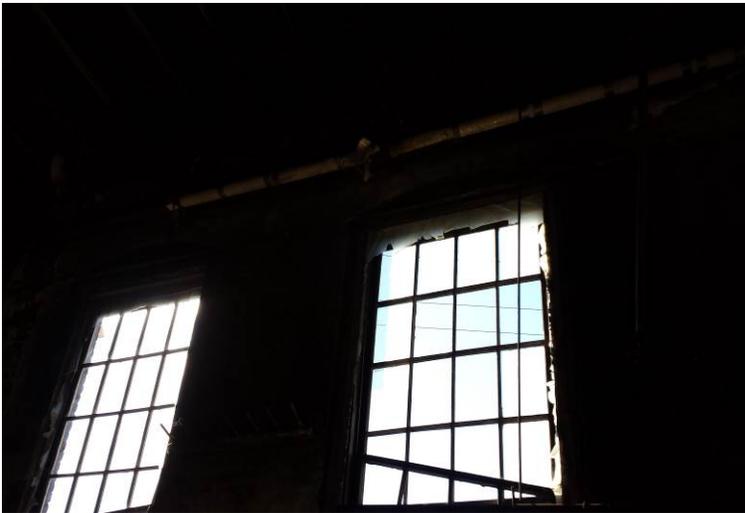
15. Image of the potential ACM pipe wrap in the Former Roundhouse.

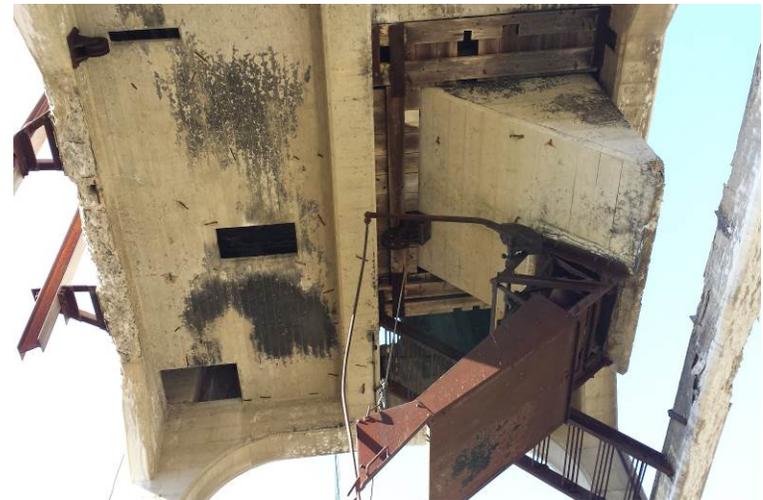
16. Image of the beige and red potential LBPs on the Coal Tower tank.

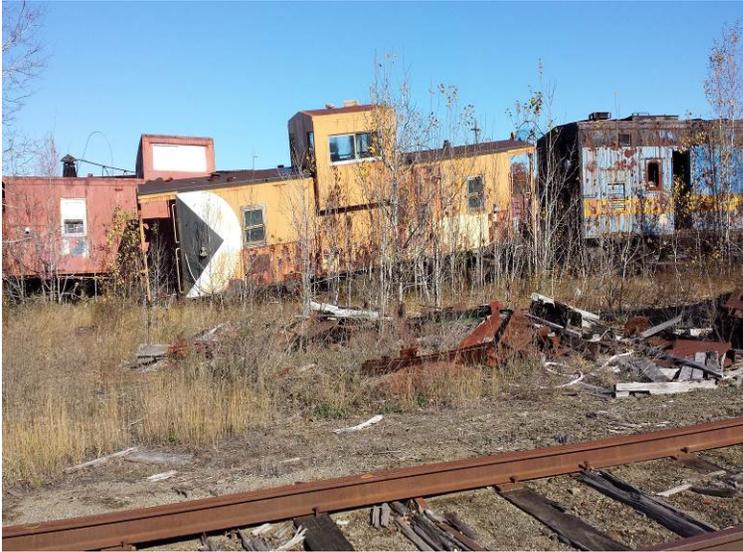
17. Image showing some of the many railcars stored throughout the Site.

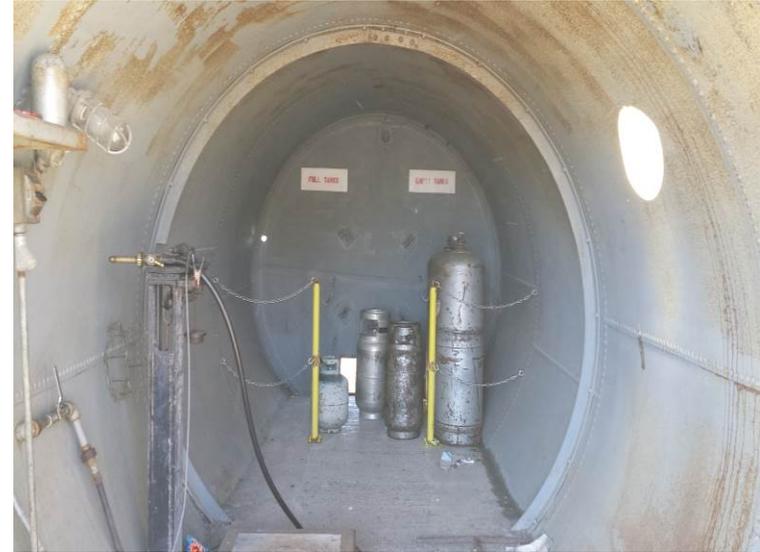
18. Image showing the propane refilling station located east-adjacent to the Office/Store.

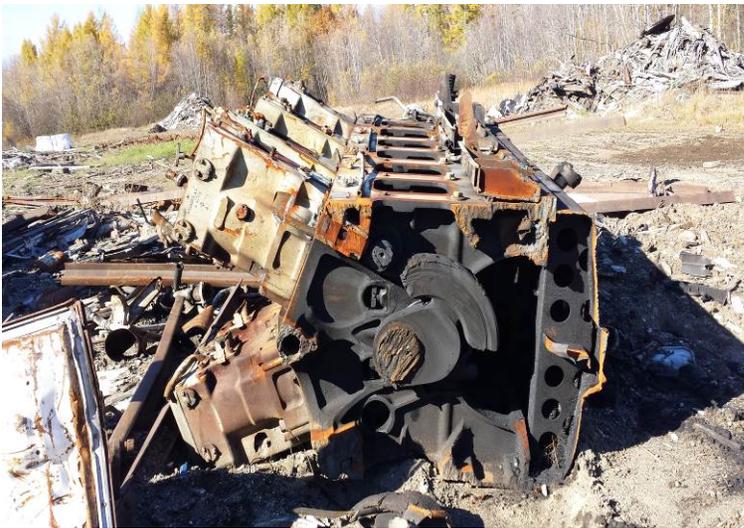
19. Image showing the C&D debris in the Scrap Yard.

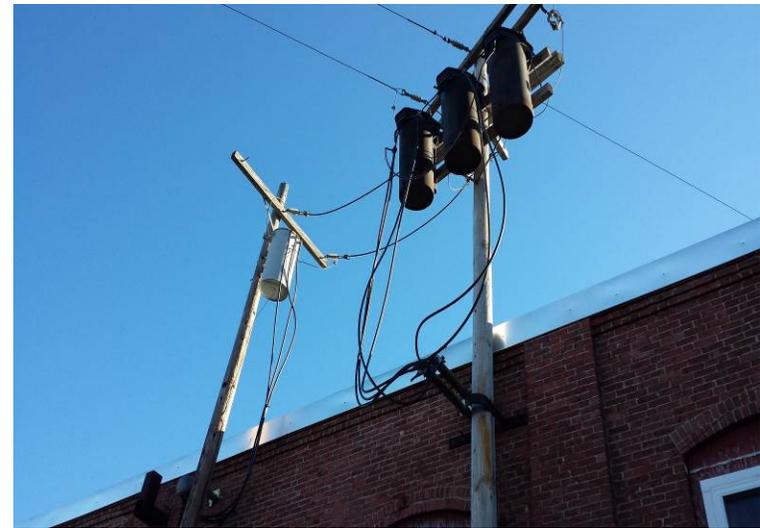
20. Image showing one location of pole-mounted transformers on Site.
