MDEP Site Inspection Figure 1.

Notes recorded by David Burns (MDEP) during a Mallinckrodt Landfill 1-5 site inspection on 4/1/10. Accompanied by Fred Lavallee and Stacy Ladner (MDEP) as well as Dave Tonini (CDM). Basemap taken from Sevee Expert Report for BEP Hearing. Photo references are to photos taken by D. Burns during the inspection.

FIGURE SME-1
GROUNDWATER
EXPLORATIONS MAP

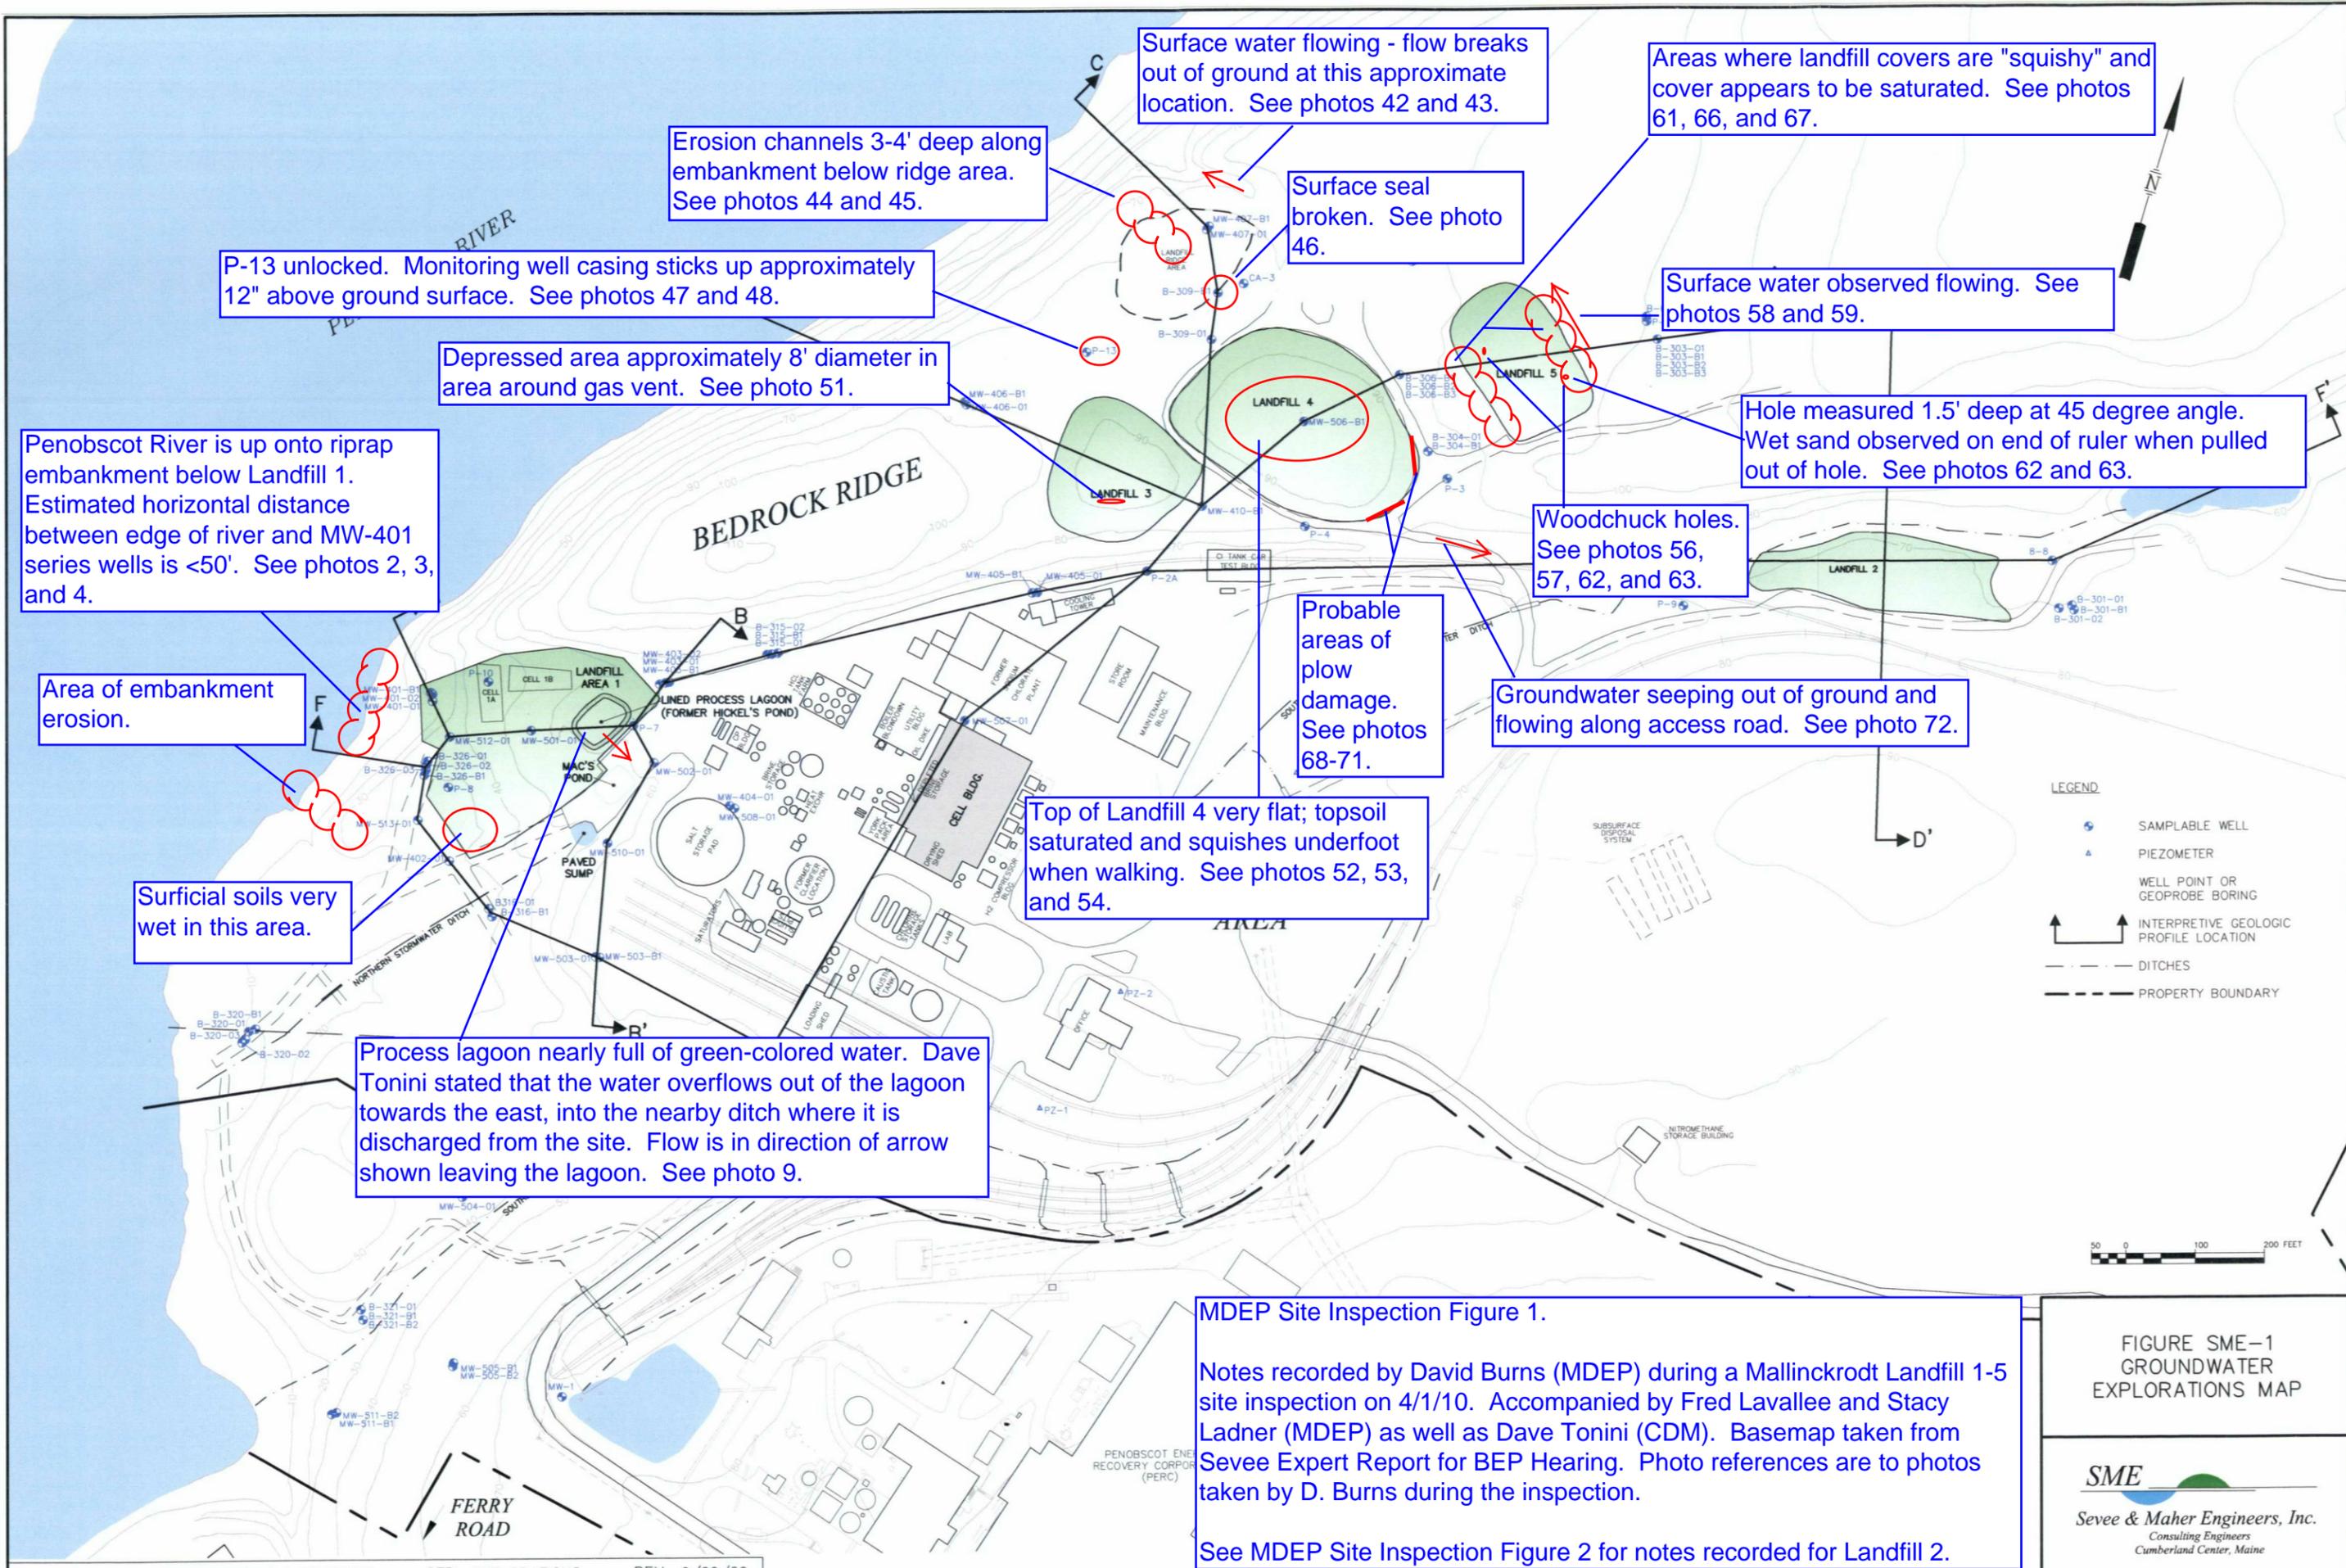
P-13 unlocked. Monitoring well casing sticks up approximately 12" above ground surface. See photos 47 and 48.

Erosion channels 3-4' deep along embankment below ridge area. See photos 44 and 45.

Surface water flowing - flow breaks out of ground at this approximate location. See photos 42 and 43.

Areas where landfill covers are "squishy" and cover appears to be saturated. See photos 61, 66, and 67.

Surface seal broken. See photo 46.

Surface water observed flowing. See photos 58 and 59.

Depressed area approximately 8' diameter in area around gas vent. See photo 51.

Hole measured 1.5' deep at 45 degree angle. Wet sand observed on end of ruler when pulled out of hole. See photos 62 and 63.

Penobscot River is up onto riprap embankment below Landfill 1. Estimated horizontal distance between edge of river and MW-401 series wells is <50'. See photos 2, 3, and 4.

Woodchuck holes. See photos 56, 57, 62, and 63.

Area of embankment erosion.

Probable areas of plow damage. See photos 68-71.

Groundwater seeping out of ground and flowing along access road. See photo 72.

Surficial soils very wet in this area.

Top of Landfill 4 very flat; topsoil saturated and squishes underfoot when walking. See photos 52, 53, and 54.

Process lagoon nearly full of green-colored water. Dave Tonini stated that the water overflows out of the lagoon towards the east, into the nearby ditch where it is discharged from the site. Flow is in direction of arrow shown leaving the lagoon. See photo 9.
