September 1, 2010
Subject: **Kennebunk**
State Pin No: 015098.00
Amendment No. 1

NOTE: A memo titled “Summary of South Approach Sinkhole Issues” has been posted to the website for Kennebunk, PIN 015098.00. The address for the site is posted below; <http://www.maine.gov/mdot/comprehensive-list-projects/015098.00.php>

NO.	ISSUE/DESCRIPTION	BY	DATE
KENNEBUNK BRIDGE REPLACEMENT			
KENNEBUNK, MAINE			
HISTORICAL AND SUBSURFACE DATA ESTIMATED SLUICeway & SINKHOLE LOCATIONS			
PREPARED FOR:			
GZA Geoscientists, Inc. 4 FREE STREET PORTLAND, MAINE 04101 (207) 879-9190		MAINE DEPARTMENT OF TRANSPORTATION	
PROJ MGR:	CLS	REVIEWED BY:	ARB
DESIGNED BY:	ARB	DRAWN BY:	JRB
DATE:	AUGUST 2010	PROJECT NO.:	03.0025697.10
		CHECKED BY:	JVE
		SCALE:	1"=20'
		REVISION NO.:	1
		FIGURE	1
		SHEET NO.

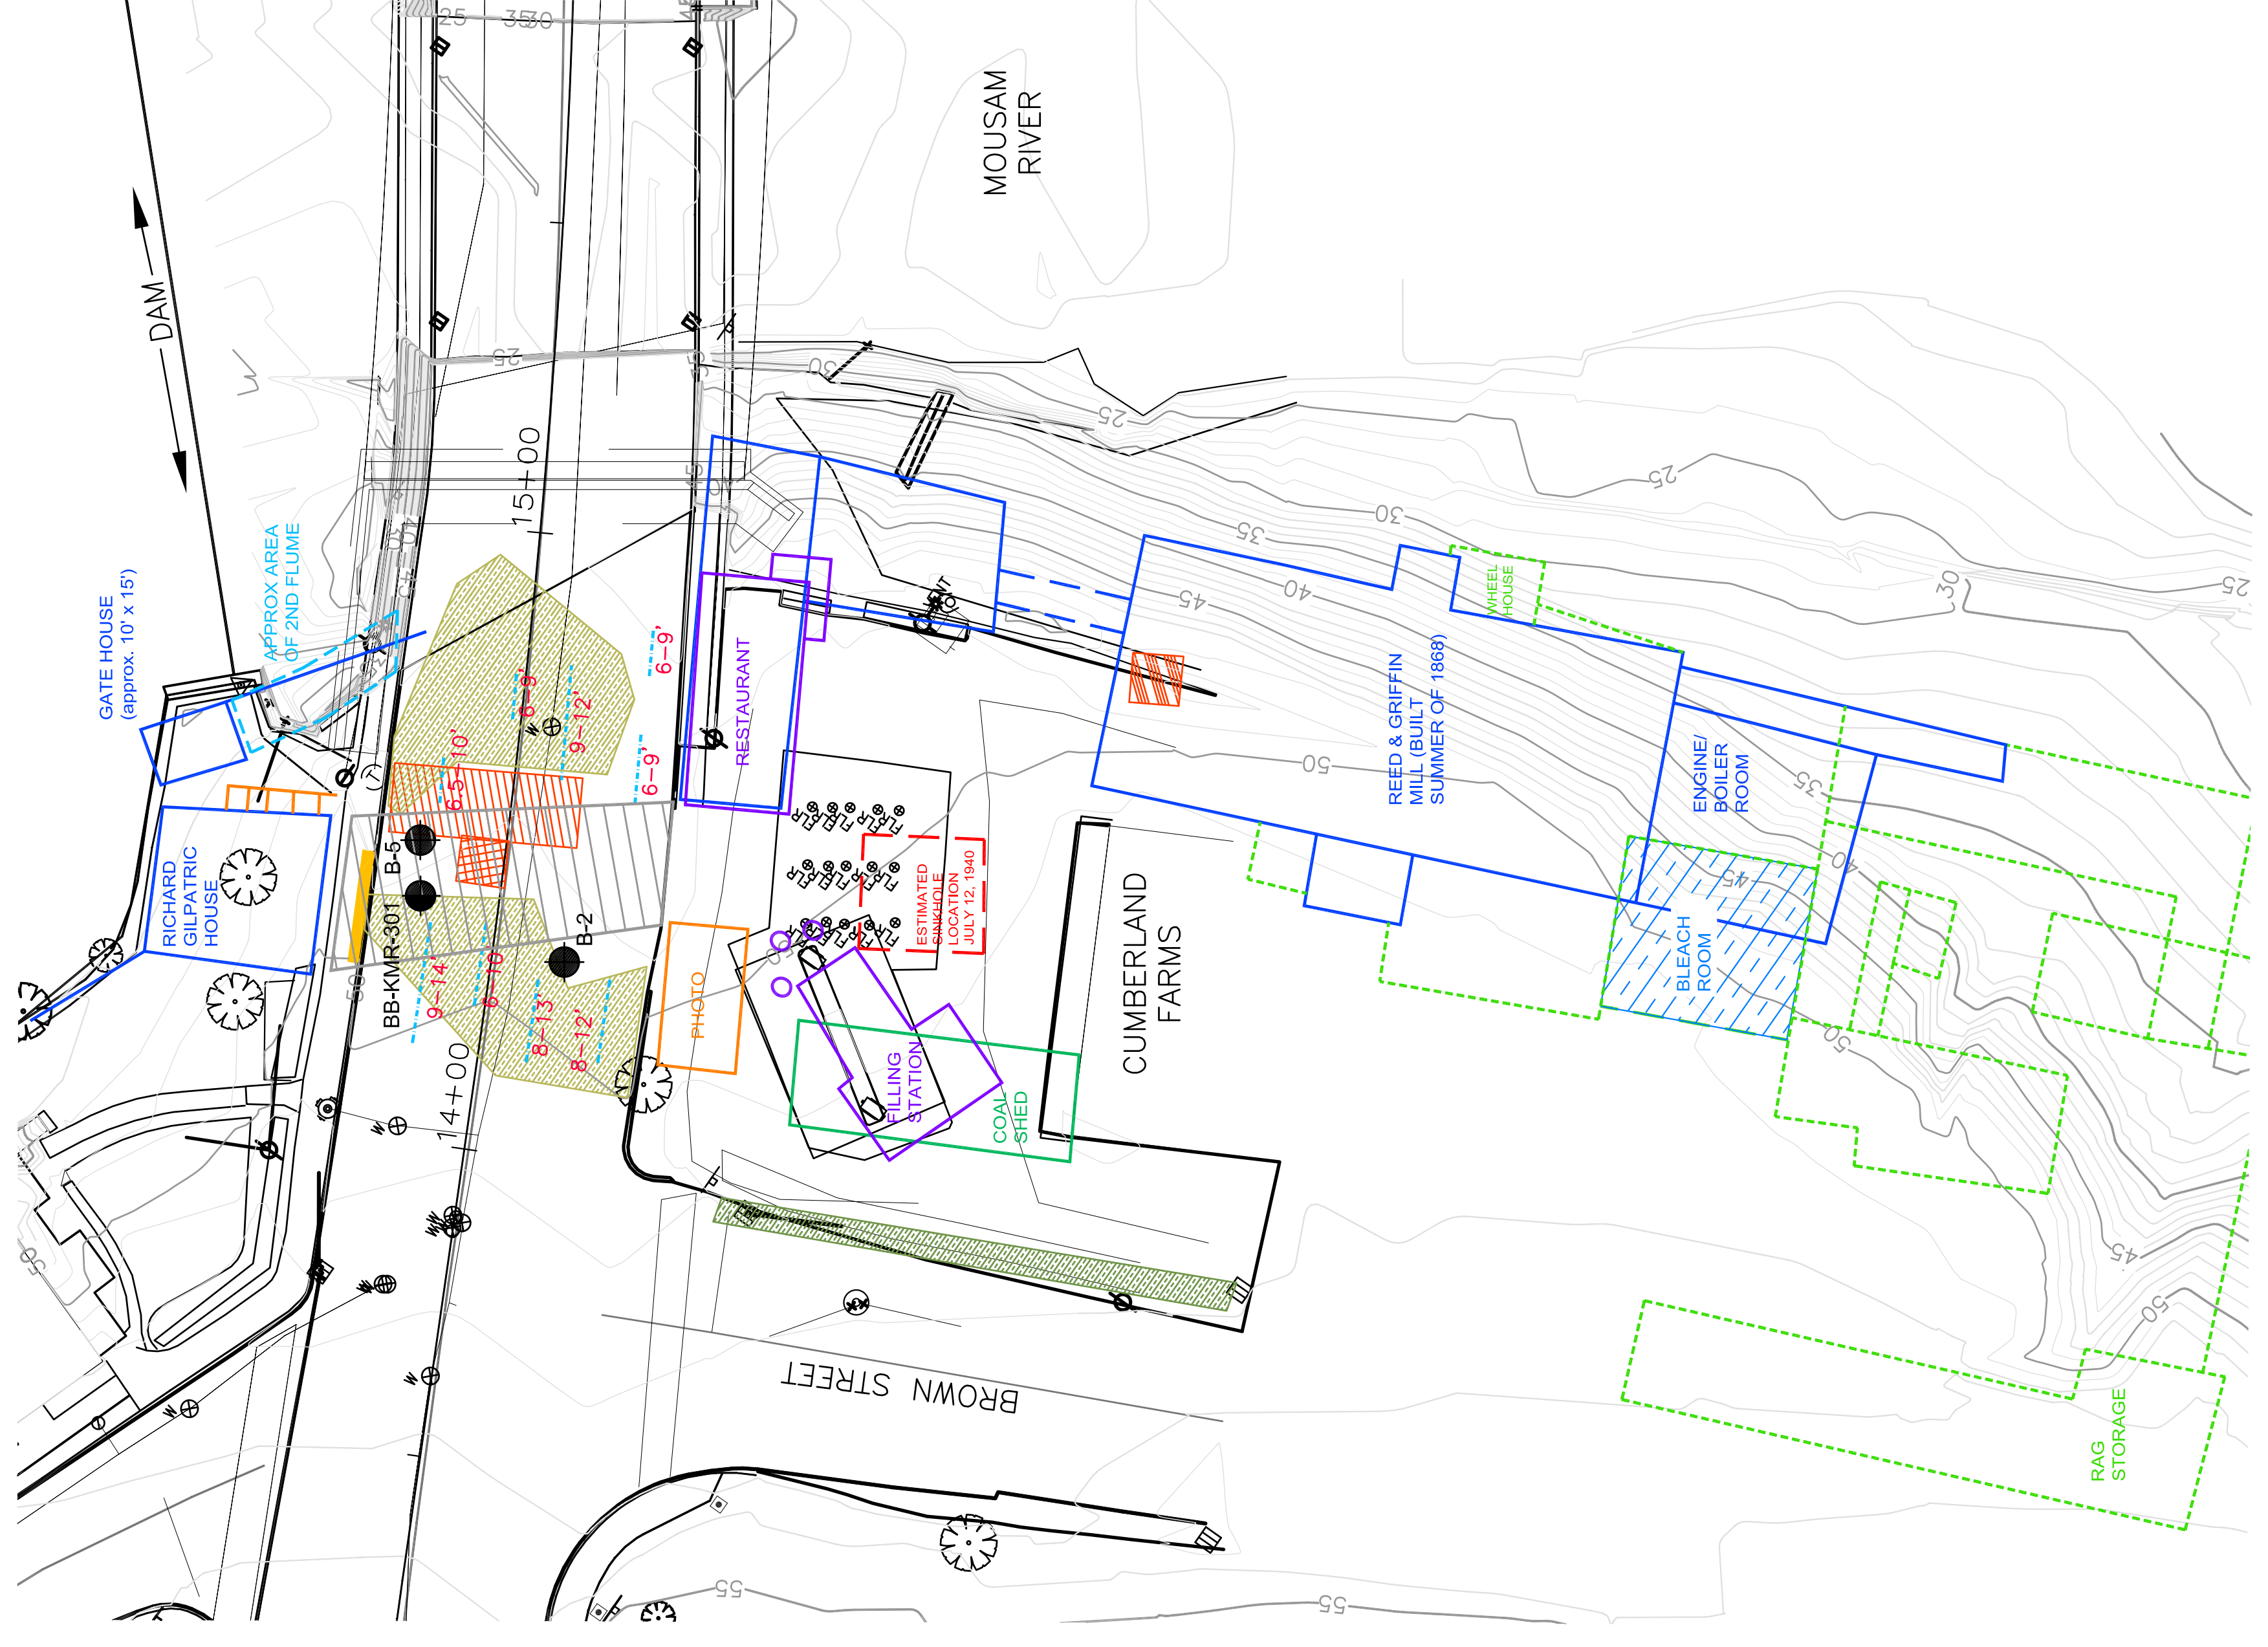
Following preliminary review of historical data, GZA conducted an on-site interview with Michael Claus, P.E., of the Kennebunk Public Works Department on June 29, 2010. Mr. Claus provided clarification on the timeline and location of sinkhole-related events that have occurred since 2004. The information provided by Mr. Claus is included in **Table 1**. During this reconnaissance, GZA observed approximately 6 inches of sag in the granite curb along the northwest side of Route 1, the approximate limits of which are shown on **Figure 1**. According to Mr. Claus, the curb was installed around 1960.

10/6/04	NDT conducts GPR survey for sinkhole investigation ⁸	Results in 10/11/04 report, document location of possible wooden sluiceway and clay drain pipe. GPR areas indicative of settlement or filled sinkholes shown on Figure 1 (brown hatched areas).
10/18/04	RWG drills borings for sinkhole investigation	Results in 11/9/04 report, voids in B2 from 14 to 20' deep, wood and voids in B5 from 11 to 18' deep, potential wooden flume. Recommend remove/backfill flume and grout clay pipes.
2/1/05	Caswell structural assessment	Report describes anticipated staging challenges during flume removal, mostly associated with excavation support and additional loads on abutments. Concludes bridge would not be affected, but wingwall stability would require consideration.
3/05-4/05	Install new Brown St. drainage ⁹	Installed to re-route drainage away from the abandoned clay pipe section in sinkhole. Documentation does not indicate whether clay pipe was removed or not. Drainage routed down Brown St. to a swale. KPWD placed a boot over the outlet from the catch basin at the corner of Brown Street and Route 1 to the abandoned clay pipe during this work. Approximate location of new drainage shown on Figure 1 (green hatched area along Brown Street).

- BORING LOCATIONS WHERE WOOD AND/OR POTENTIAL VOIDS WERE ENCOUNTERED
- INTERPRETED LIMITS OF SETTLEMENT OR FILLED SINKHOLES (BASED ON NDT'S OCTOBER 2004 GPR SURVEY)

- INTERPRETED LIMITS AND DEPTH INTERVAL OF LOOSE MATERIAL (BASED ON HAGER-RICHTER'S 2010 MASW RESULTS)
- INTERPRETED LIMITS WHERE NORTH-SOUTH TRENDDING, 14 FOOT WIDE SLUICeway WAS PROBABLY LOCATED

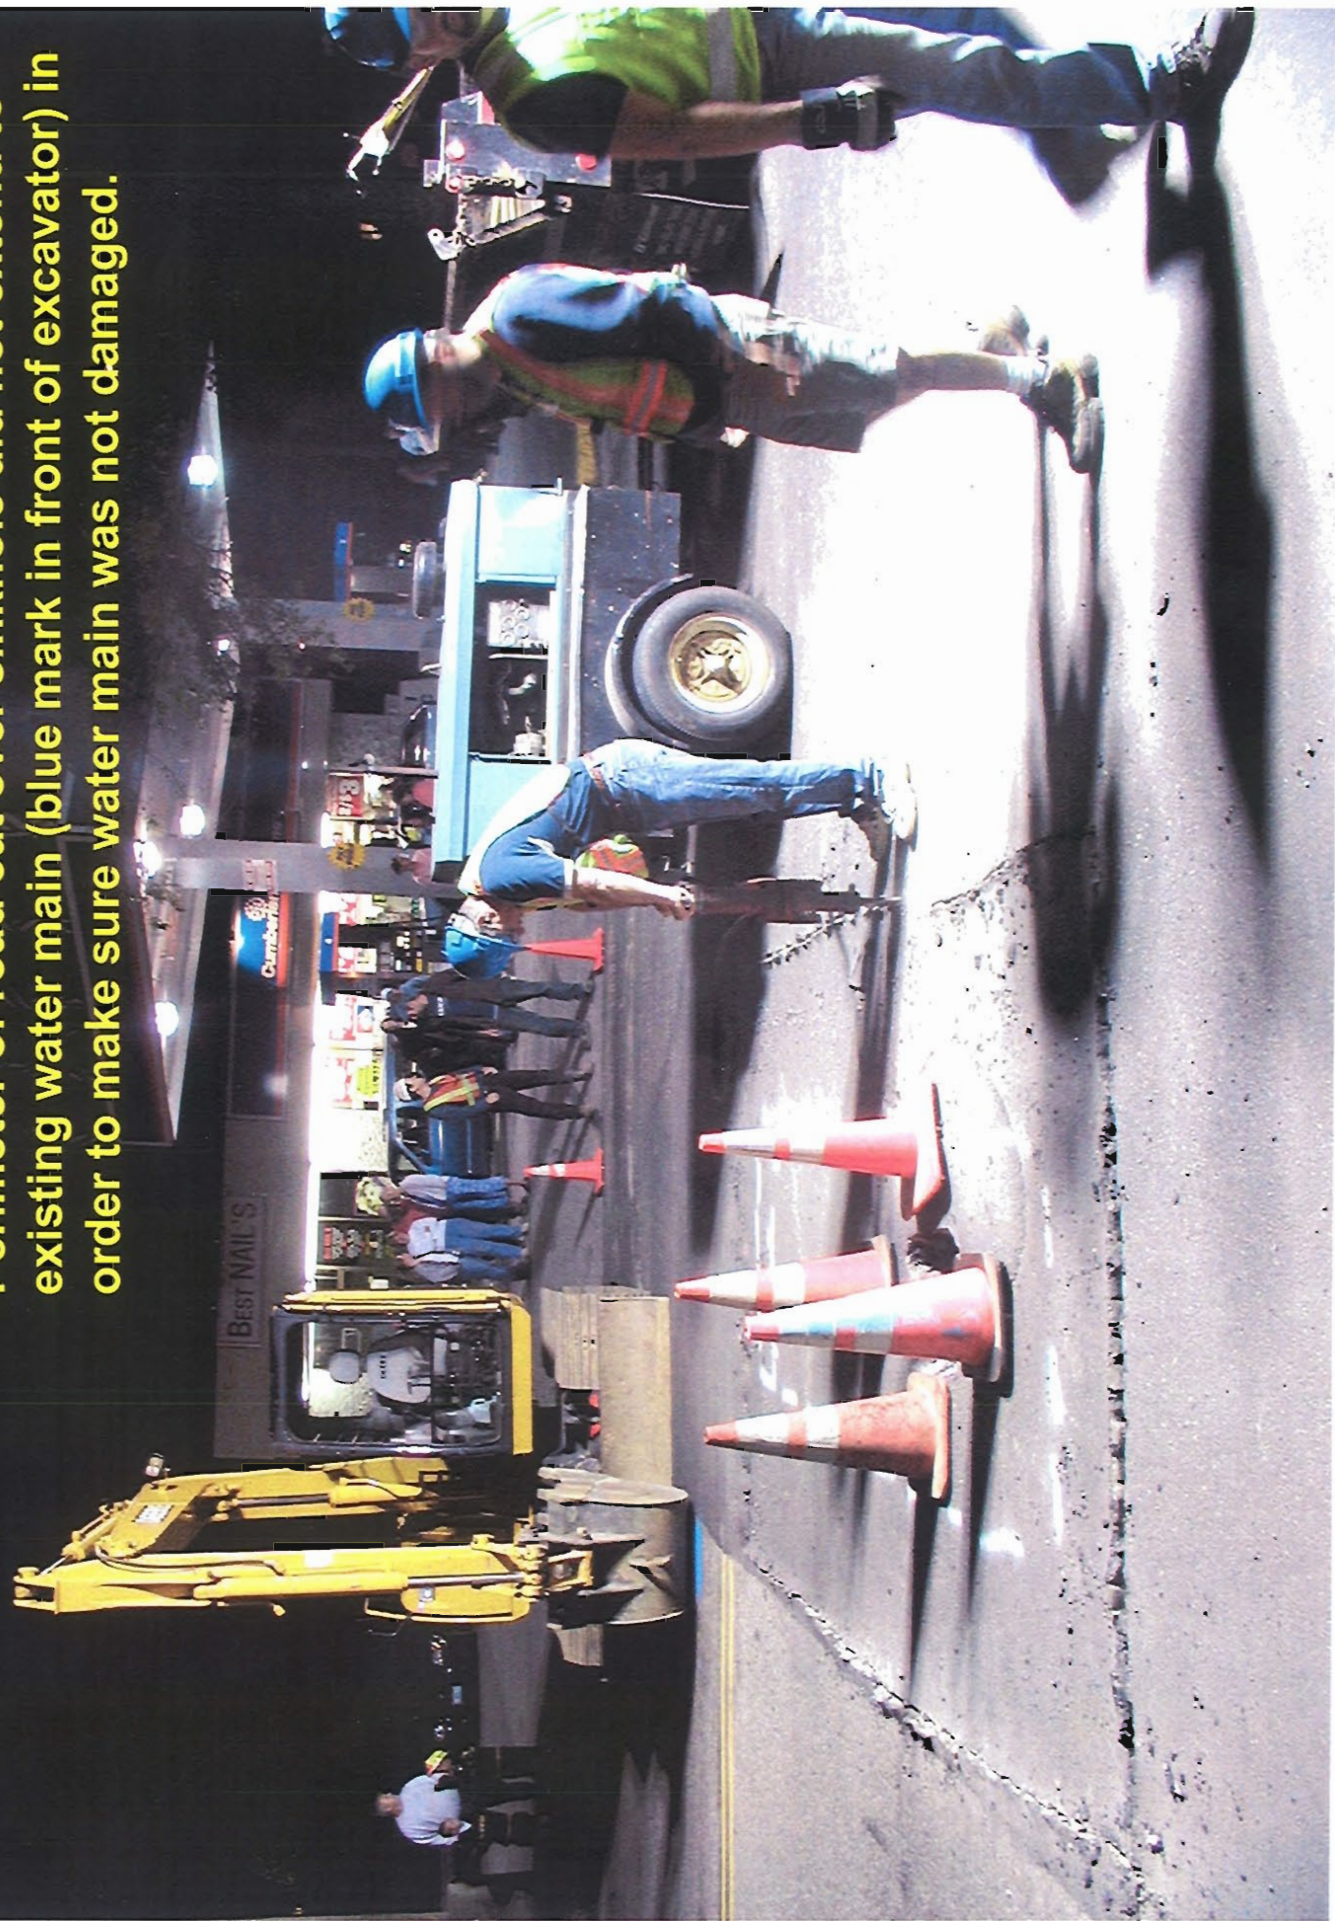
Perimeter of road cut over sinkhole did not extend to existing water main (blue mark in front of excavator) in order to make sure water main was not damaged.

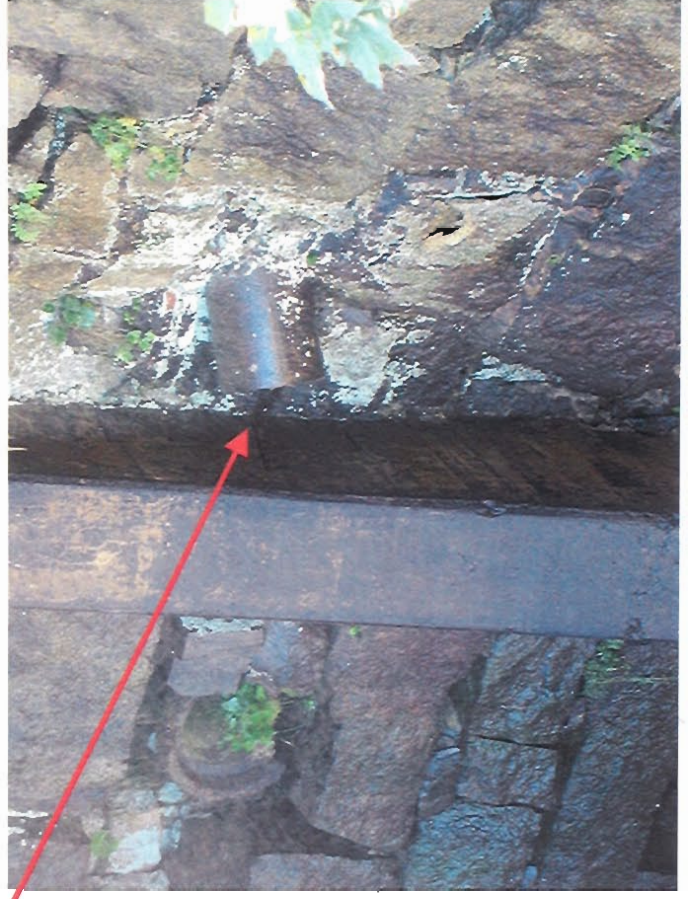
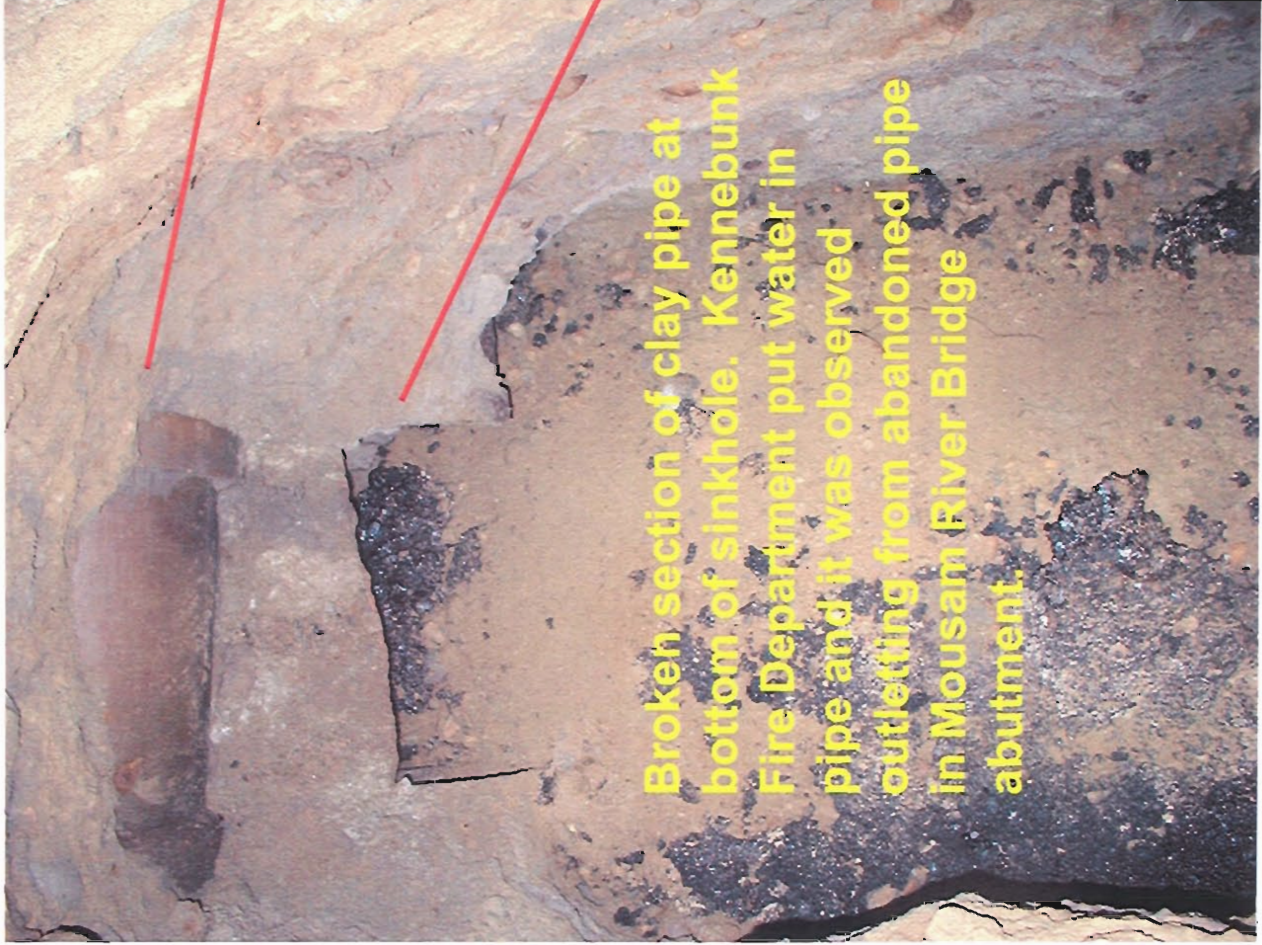
Active storm drain pipe w/ outlet at wing wall of Mousam River Bridge abutment.

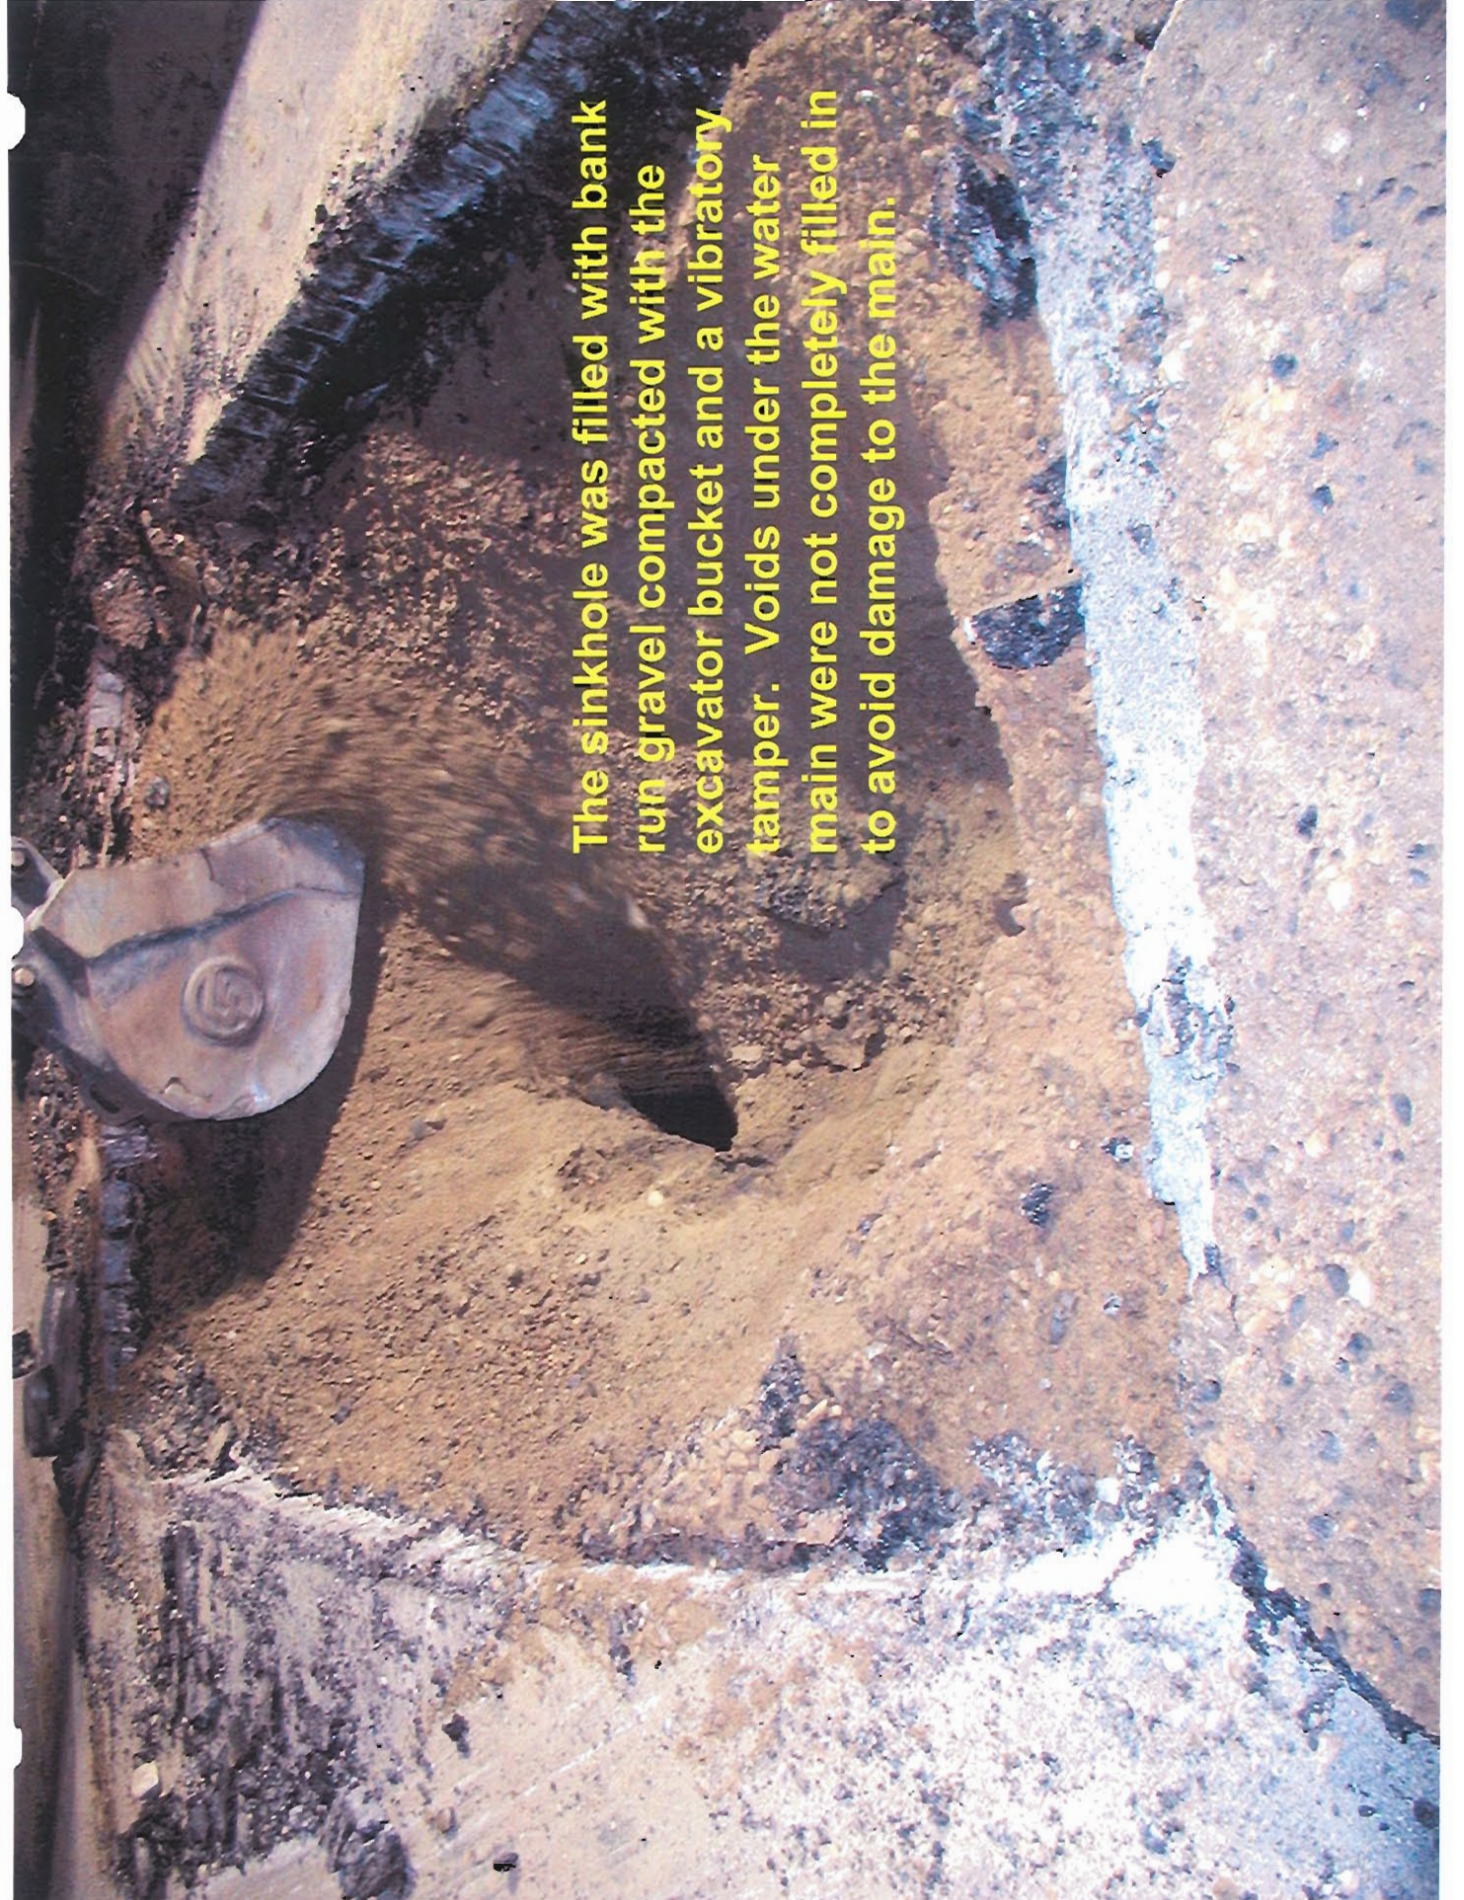
Broken section of clay pipe at bottom of sinkhole. Kennebunk Fire Department put water in pipe and it was observed outflowing from abandoned pipe in Mousam River Bridge abutment.

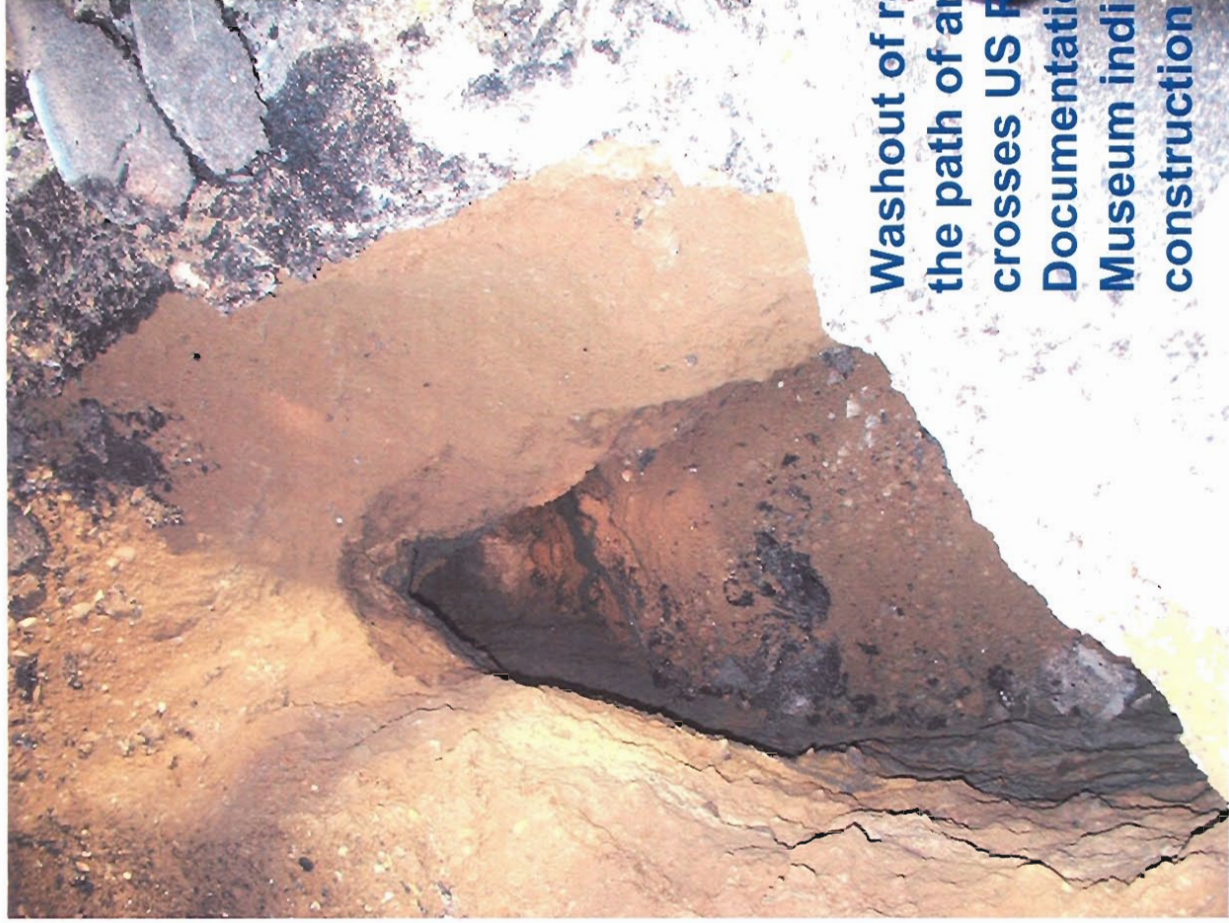
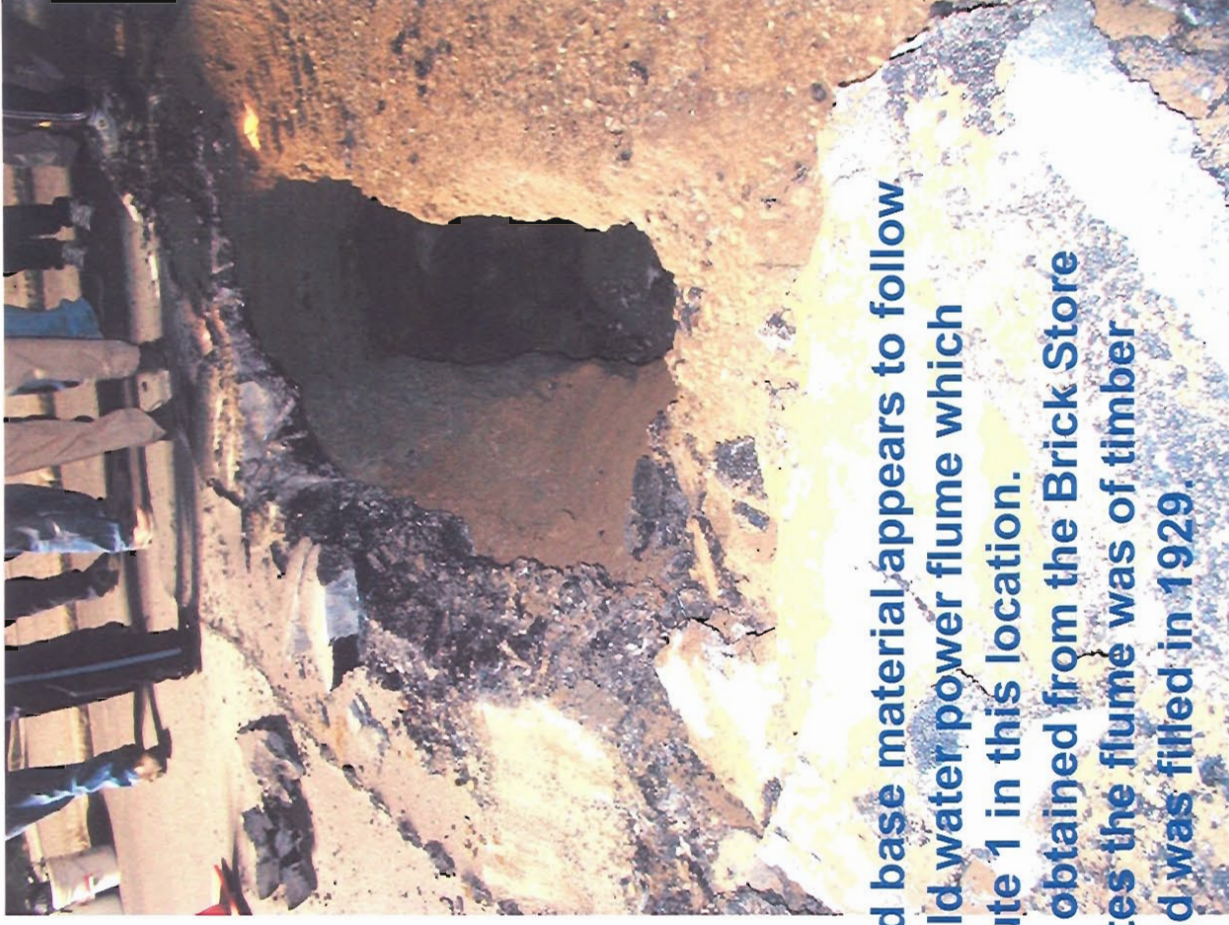
The sinkhole was filled with bank run gravel compacted with the excavator bucket and a vibratory tamper. Voids under the water main were not completely filled in to avoid damage to the main.

Washout of road base material appears to follow the path of an old water power flume which crosses US Route 1 in this location. Documentation obtained from the Brick Store Museum indicates the flume was of timber construction and was filled in 1929.

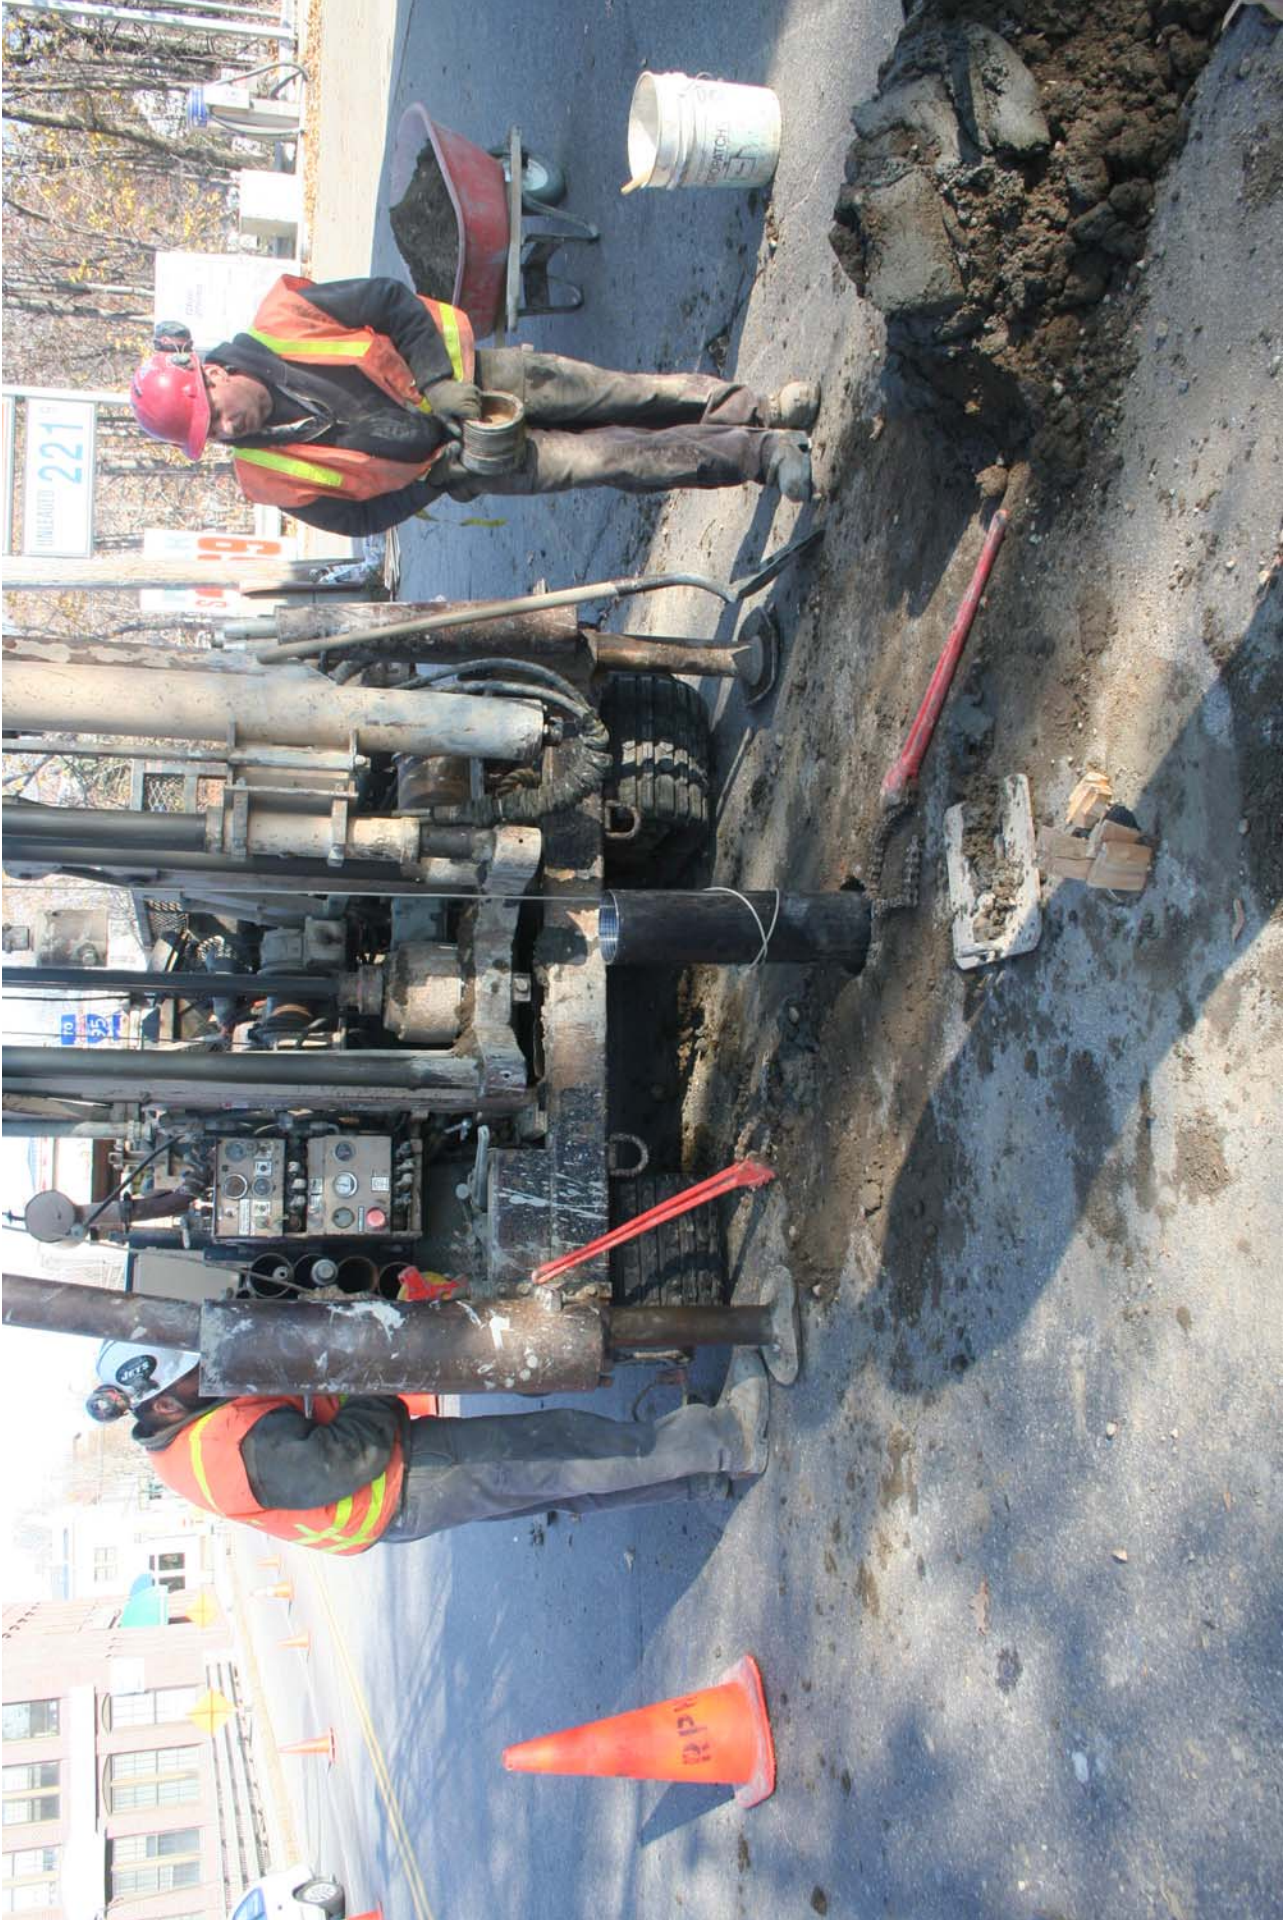
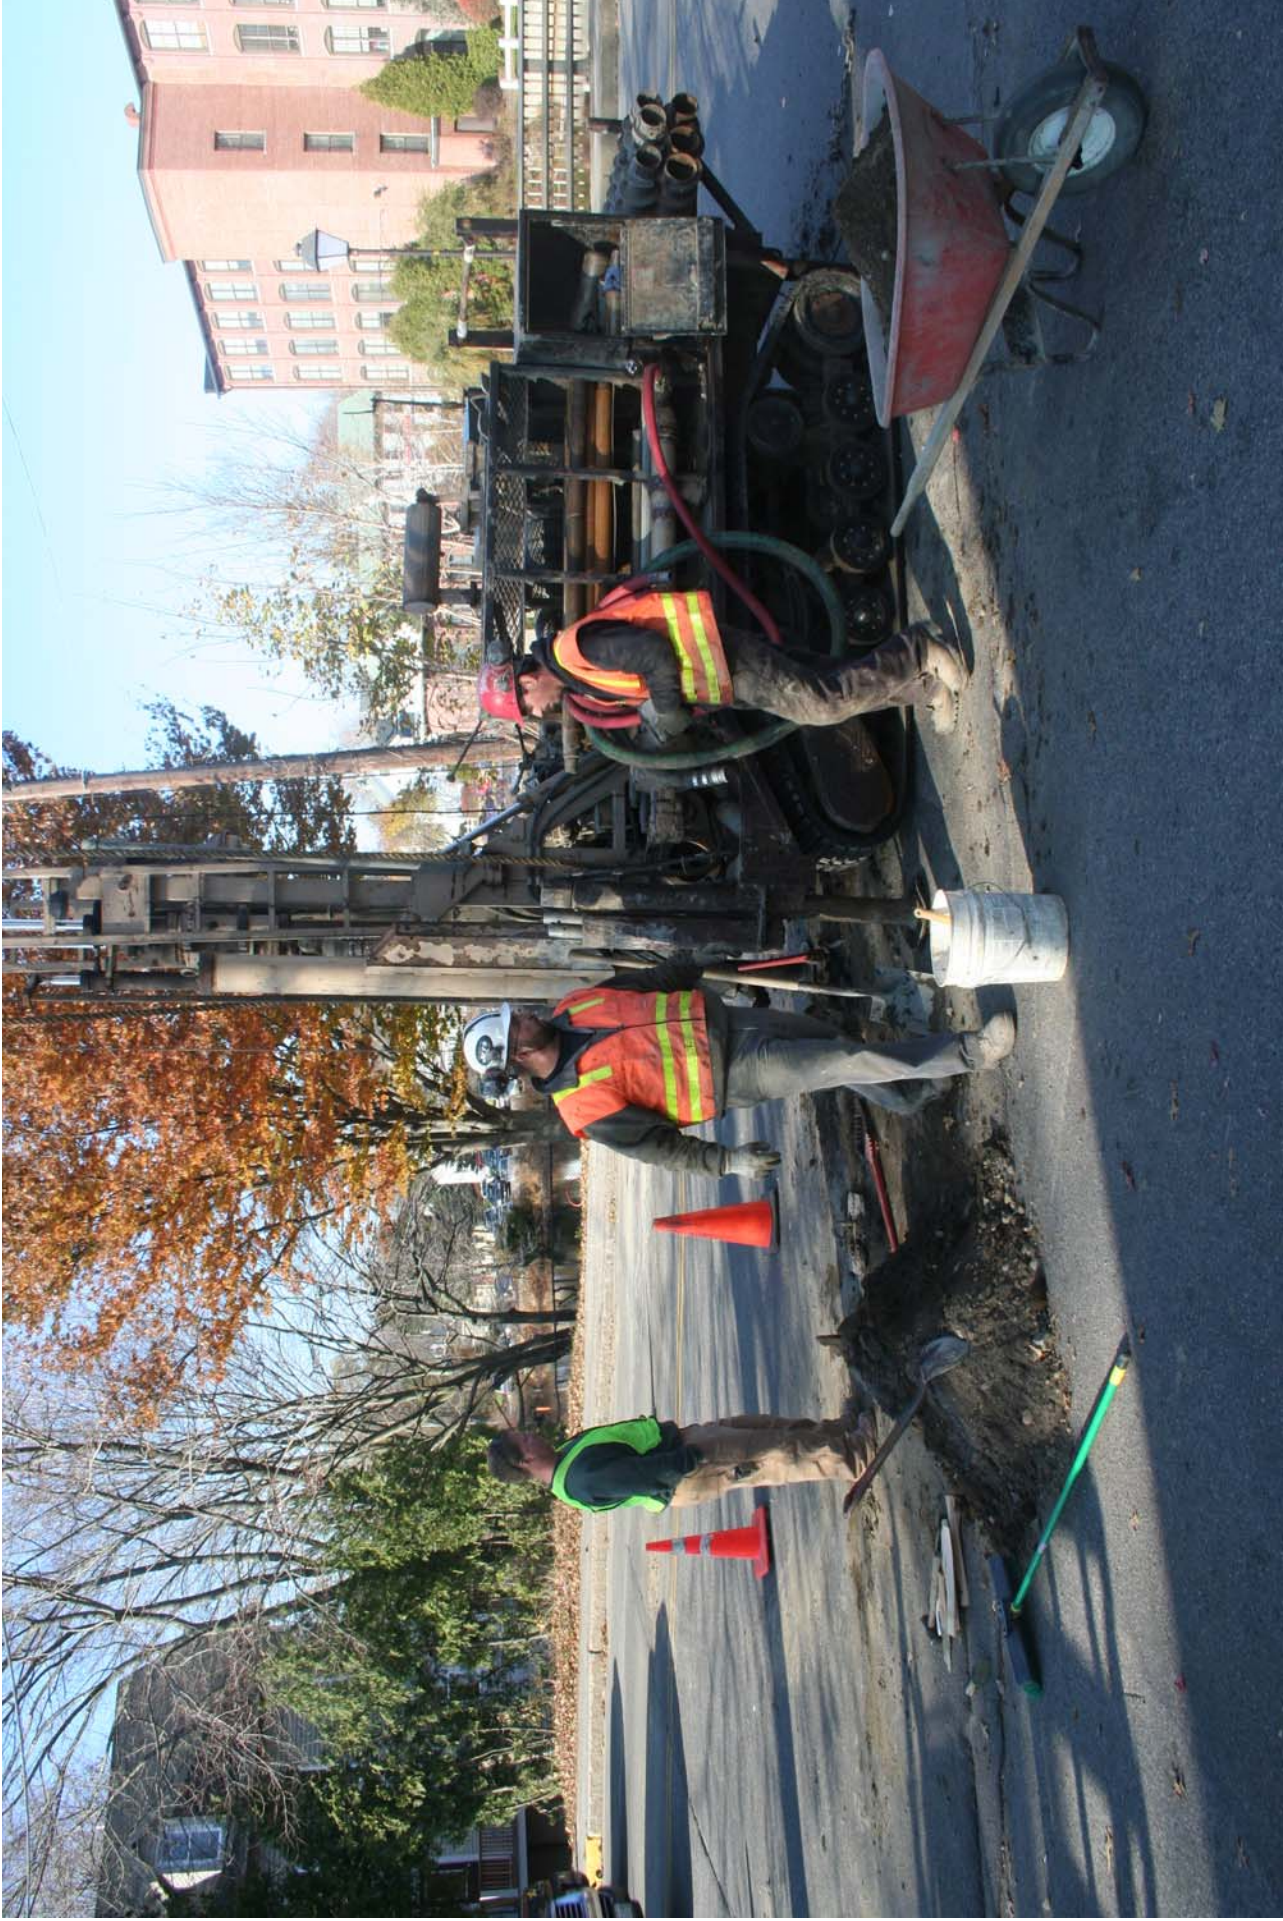
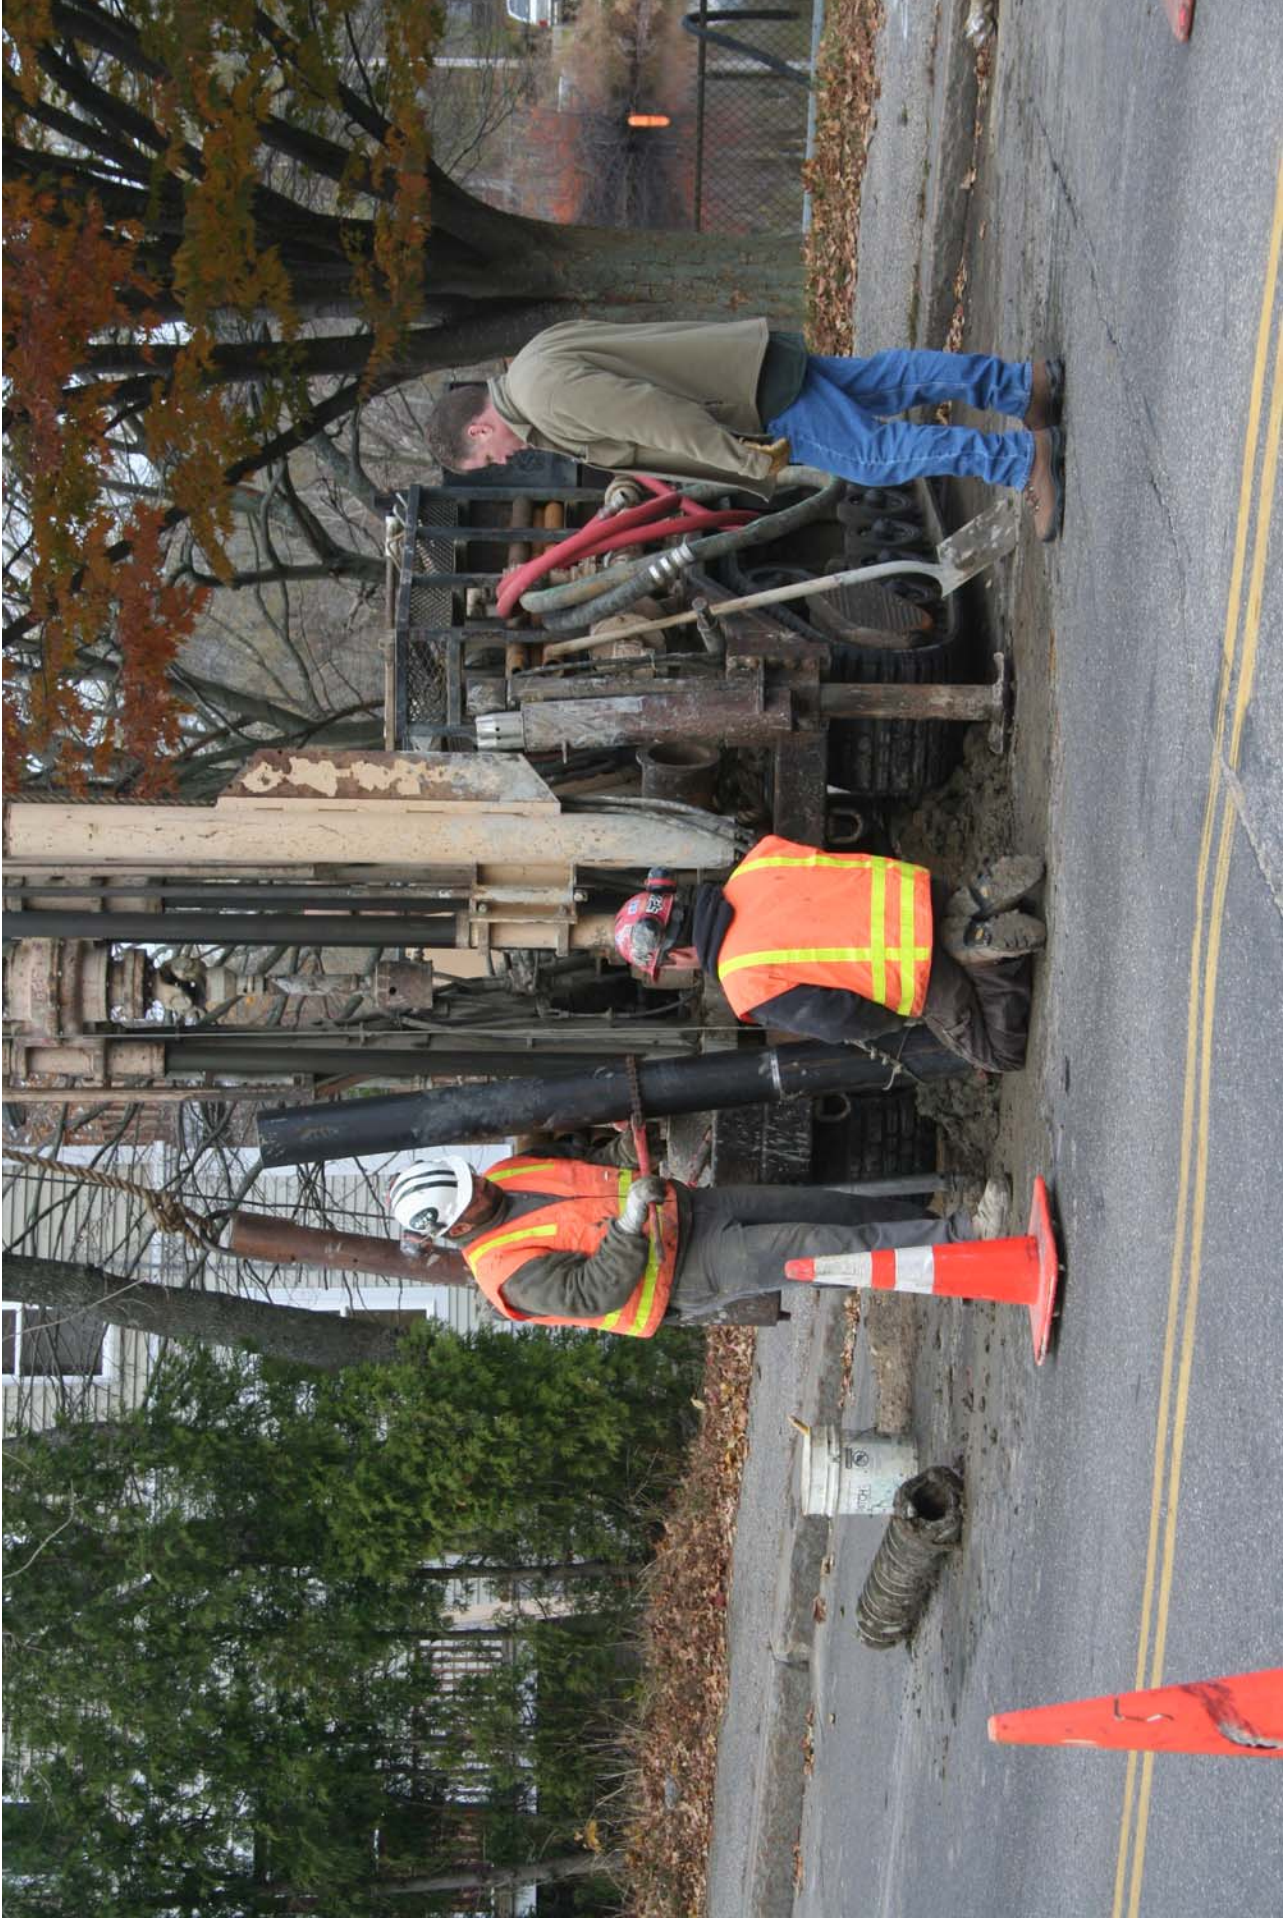
Route One Sinkhole Repair – Kennebunk 11-6-2006

10/19/06	Hascall & Hall letter, solicited by KPWD (Mike Claus) ¹²	Propose to bore holes in road and pump flowable fill, leave casing in place and patch road on 11/6/06-11/8/06. No reference to tie limits of work – sketch indicates hydrant with no other features.
11/6/06-11/8/06	Grouting in area of Sinkhole 2 ^{1, 13}	Northern Test Boring drilled 4 holes for grouting, 2 in NB lane and 2 in SB lane. Encountered wood at 12' in SB lane (upstream), 15' in NB lane (downstream), installed casing to extend below wood layer. Hascall & Hall placed concrete fill in SB holes first, noted concrete fill in NB holes during process, then completely filled holes in NB side. Recent correspondence with Mike Claus, KPWD, indicates expected grout flowable fill volume was 110 cy, actual volume placed was 40 to 50 cy.
