September 1, 2010
Subject: **Kennebunk**
State Pin No: 015098.00
Amendment No. 1

NOTE: A memo titled “Summary of South Approach Sinkhole Issues” has been posted to the website for Kennebunk, PIN 015098.00. The address for the site is posted below; <http://www.maine.gov/mdot/comprehensive-list-projects/015098.00.php>

NO.	ISSUE/DESCRIPTION	BY	DATE
KENNEBUNK BRIDGE REPLACEMENT			
KENNEBUNK, MAINE			
HISTORICAL AND SUBSURFACE DATA ESTIMATED SLUICeway & SINKHOLE LOCATIONS			
PREPARED FOR:			
GZA Geoscientists, Inc. 4 FREE STREET PORTLAND, MAINE 04101 (207) 879-9190		MAINE DEPARTMENT OF TRANSPORTATION	
PROJ MGR:	CLS	REVIEWED BY:	ARB
DESIGNED BY:	ARB	DRAWN BY:	JRB
DATE:	AUGUST 2010	PROJECT NO.:	03.0025697.10
		CHECKED BY:	JVE
		SCALE:	1"=20'
		REVISION NO.:	1
		FIGURE	1
		SHEET NO.

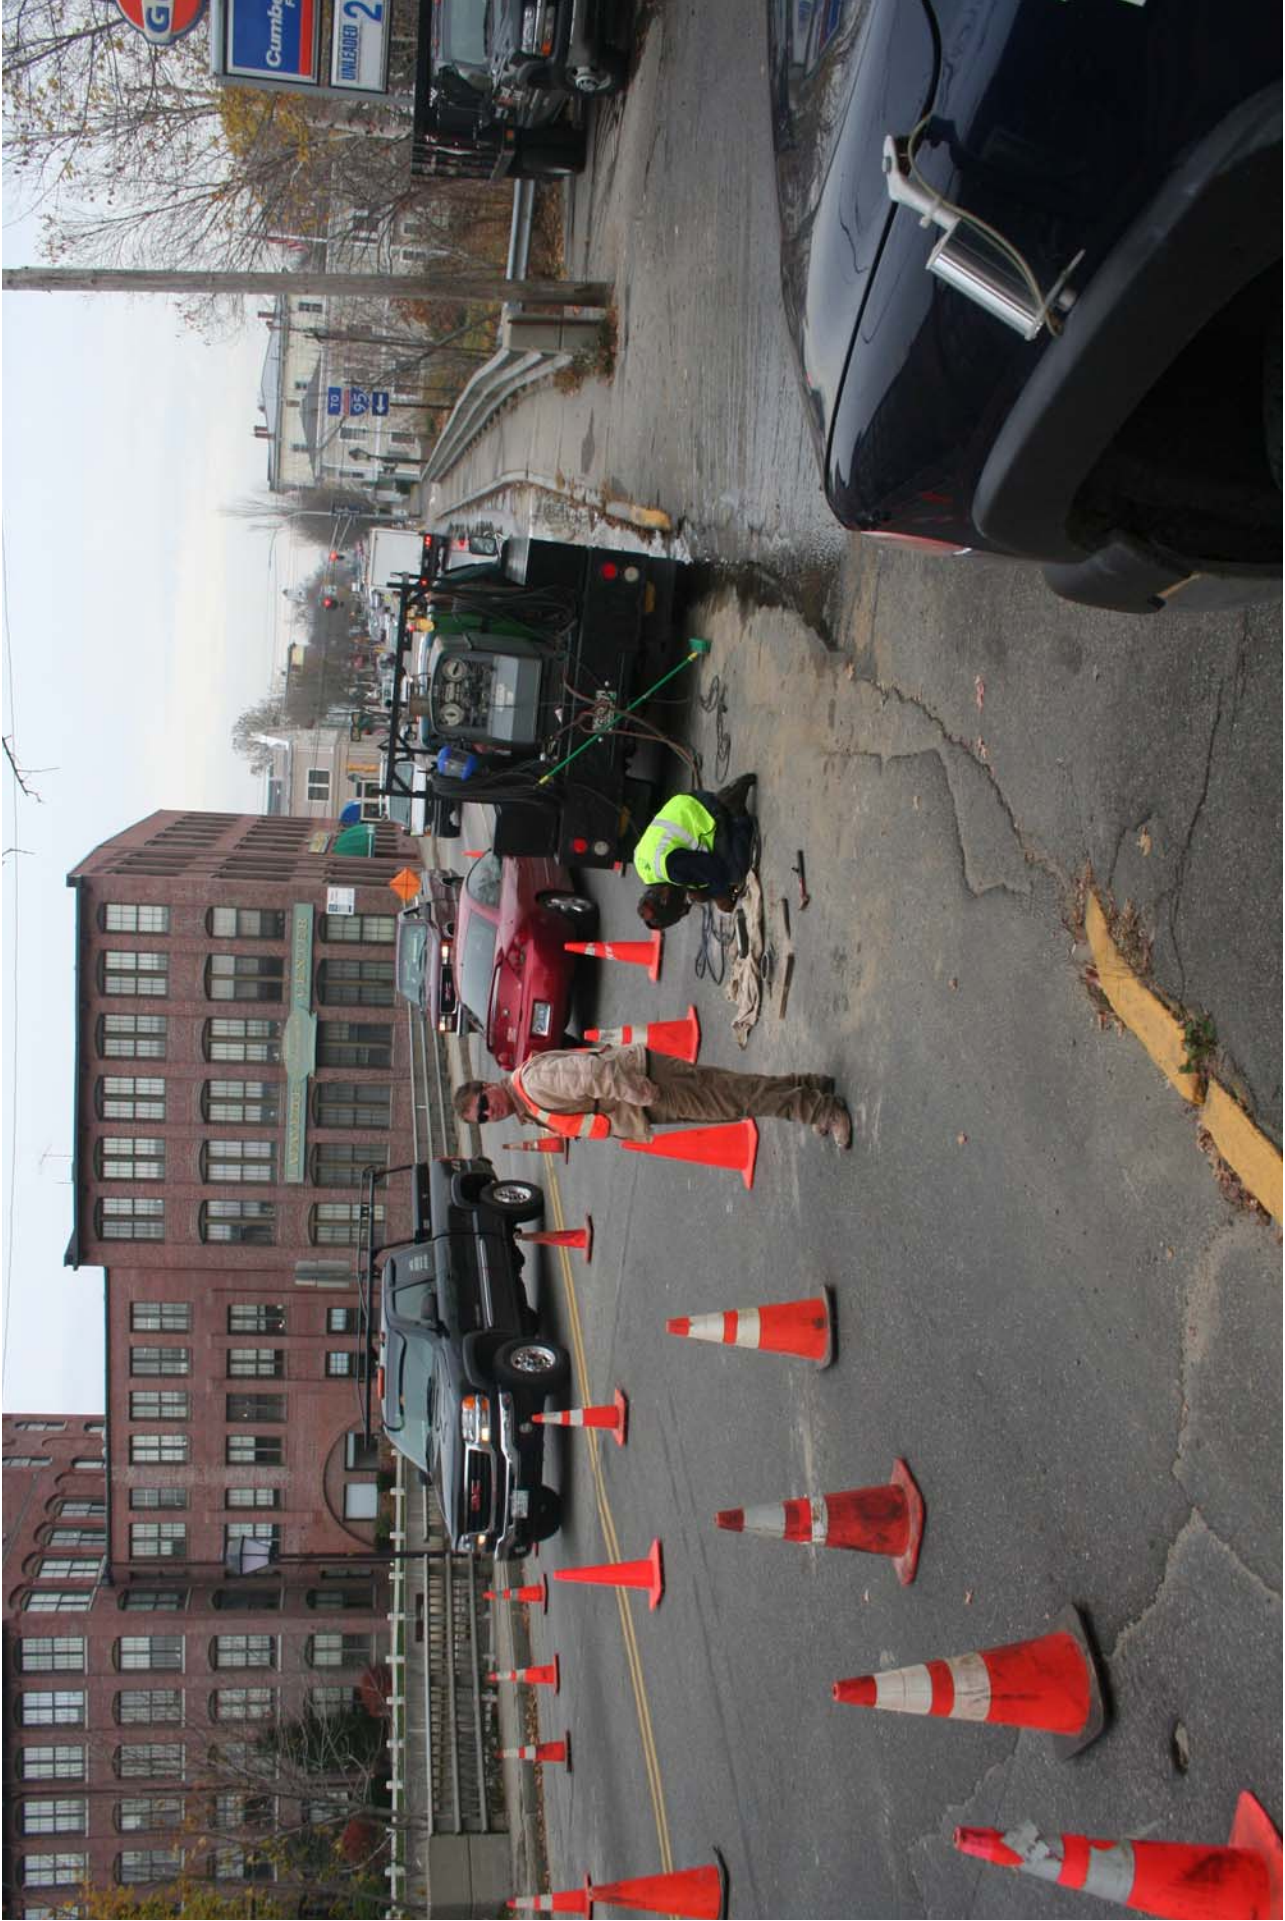
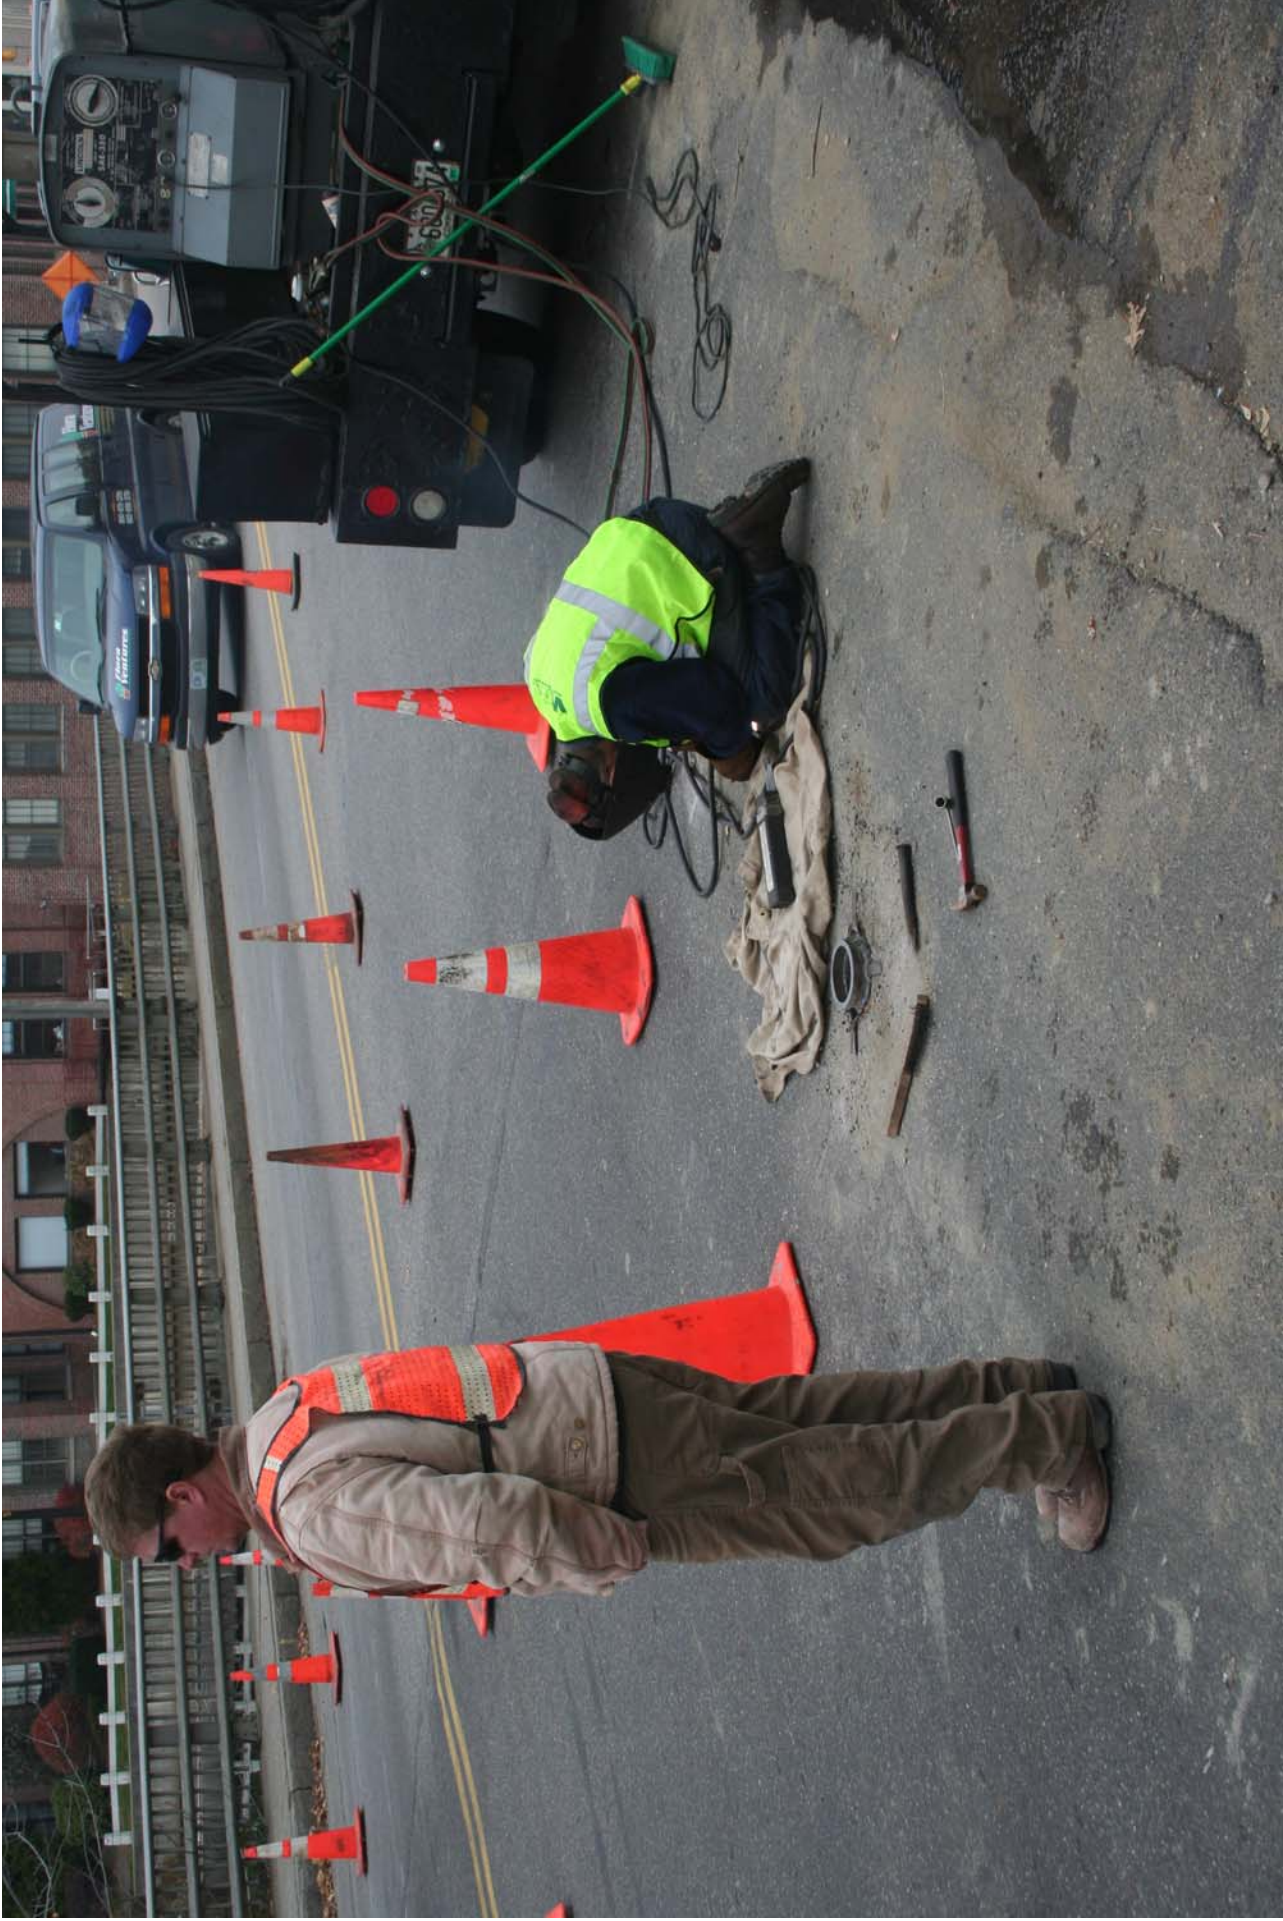
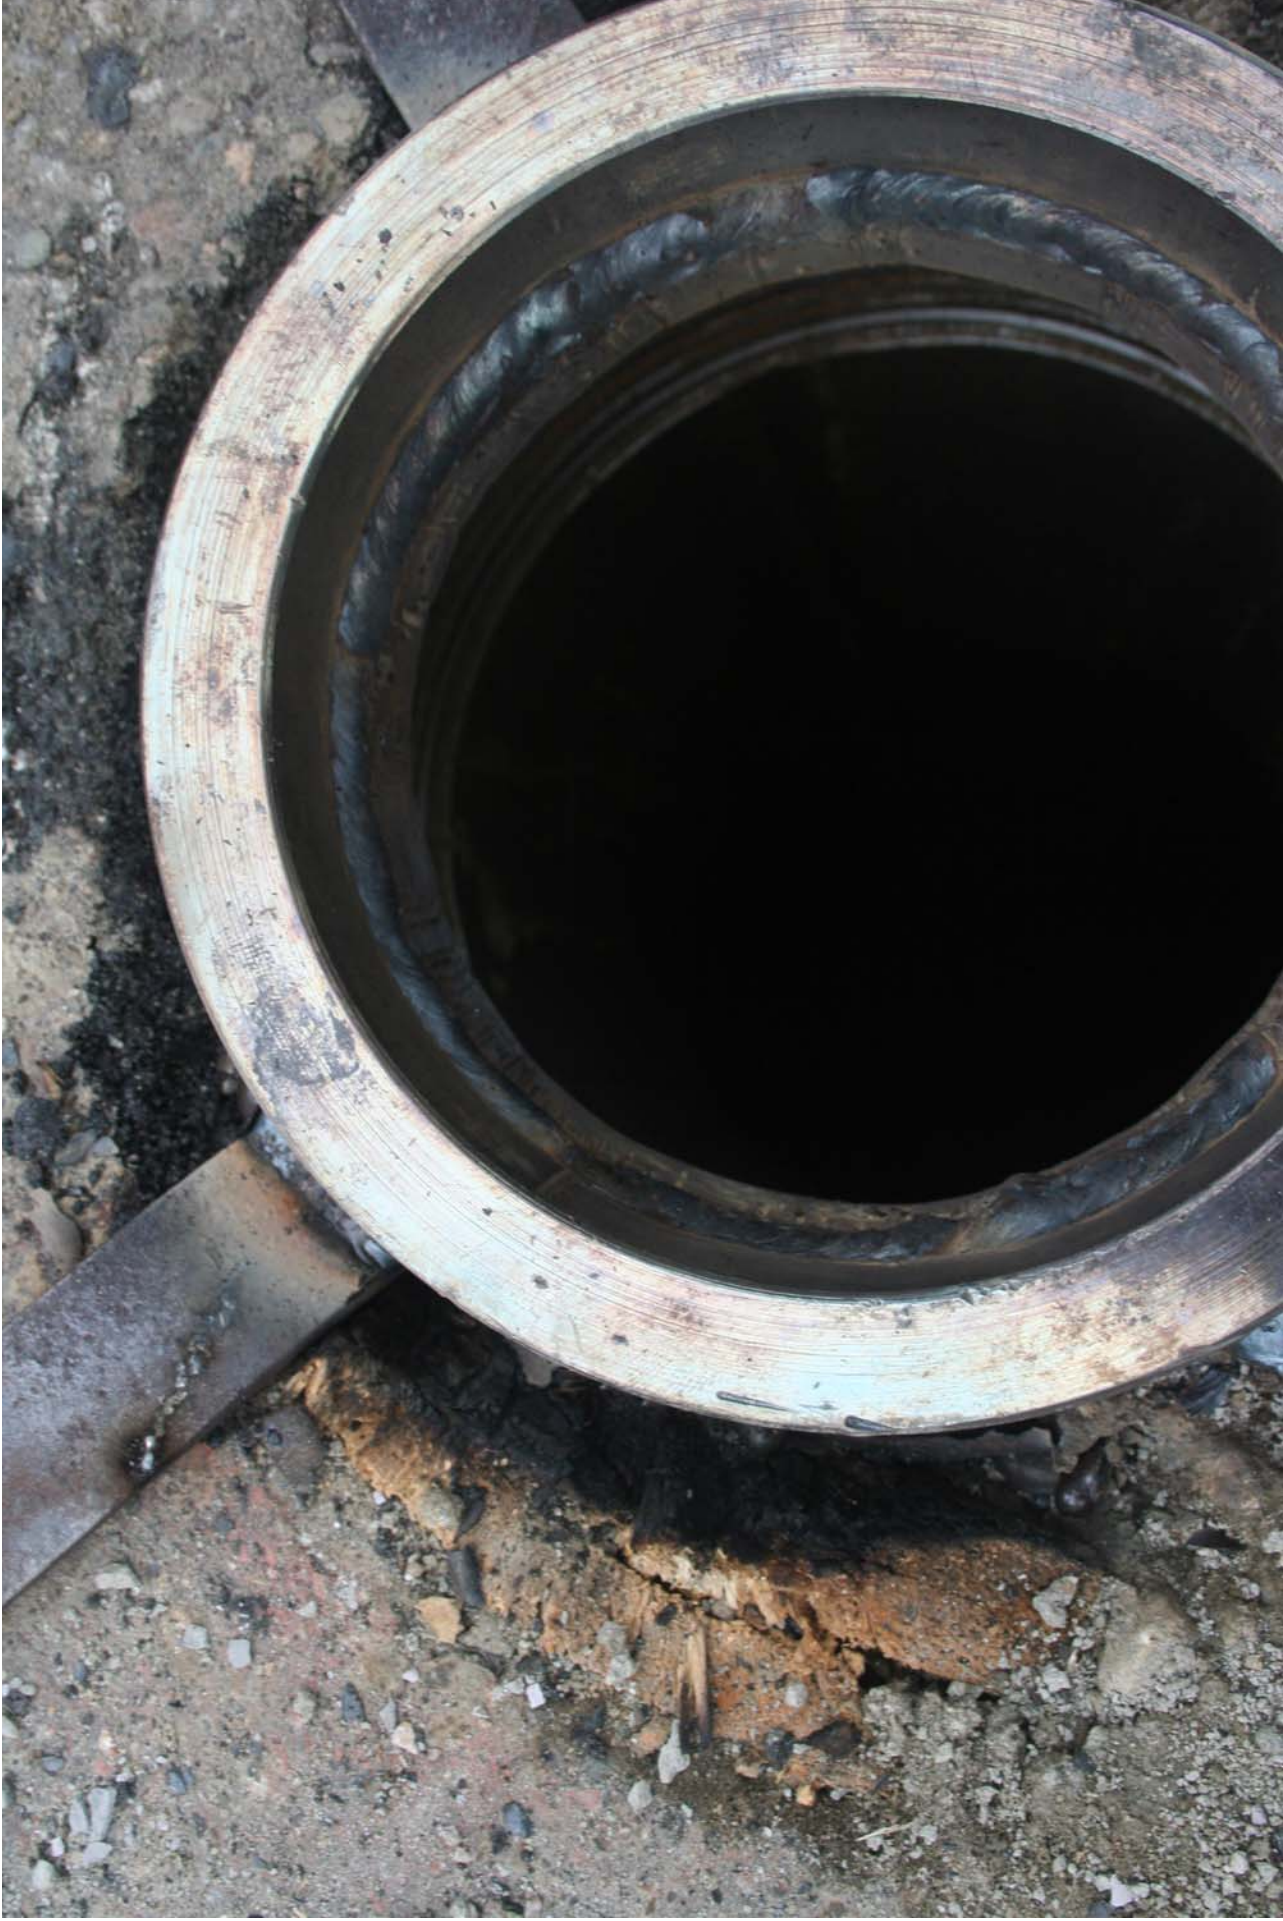
Route One Sinkhole Repair – Kennebunk 11-7-2006

10/19/06	Hascall & Hall letter, solicited by KPWD (Mike Claus) ¹²	Propose to bore holes in road and pump flowable fill, leave casing in place and patch road on 11/6/06-11/8/06. No reference to tie limits of work – sketch indicates hydrant with no other features.
11/6/06-11/8/06	Grouting in area of Sinkhole 2 ^{1, 13}	Northern Test Boring drilled 4 holes for grouting, 2 in NB lane and 2 in SB lane. Encountered wood at 12' in SB lane (upstream), 15' in NB lane (downstream), installed casing to extend below wood layer. Hascall & Hall placed concrete fill in SB holes first, noted concrete fill in NB holes during process, then completely filled holes in NB side. Recent correspondence with Mike Claus, KPWD, indicates expected grout flowable fill volume was 110 cy, actual volume placed was 40 to 50 cy.

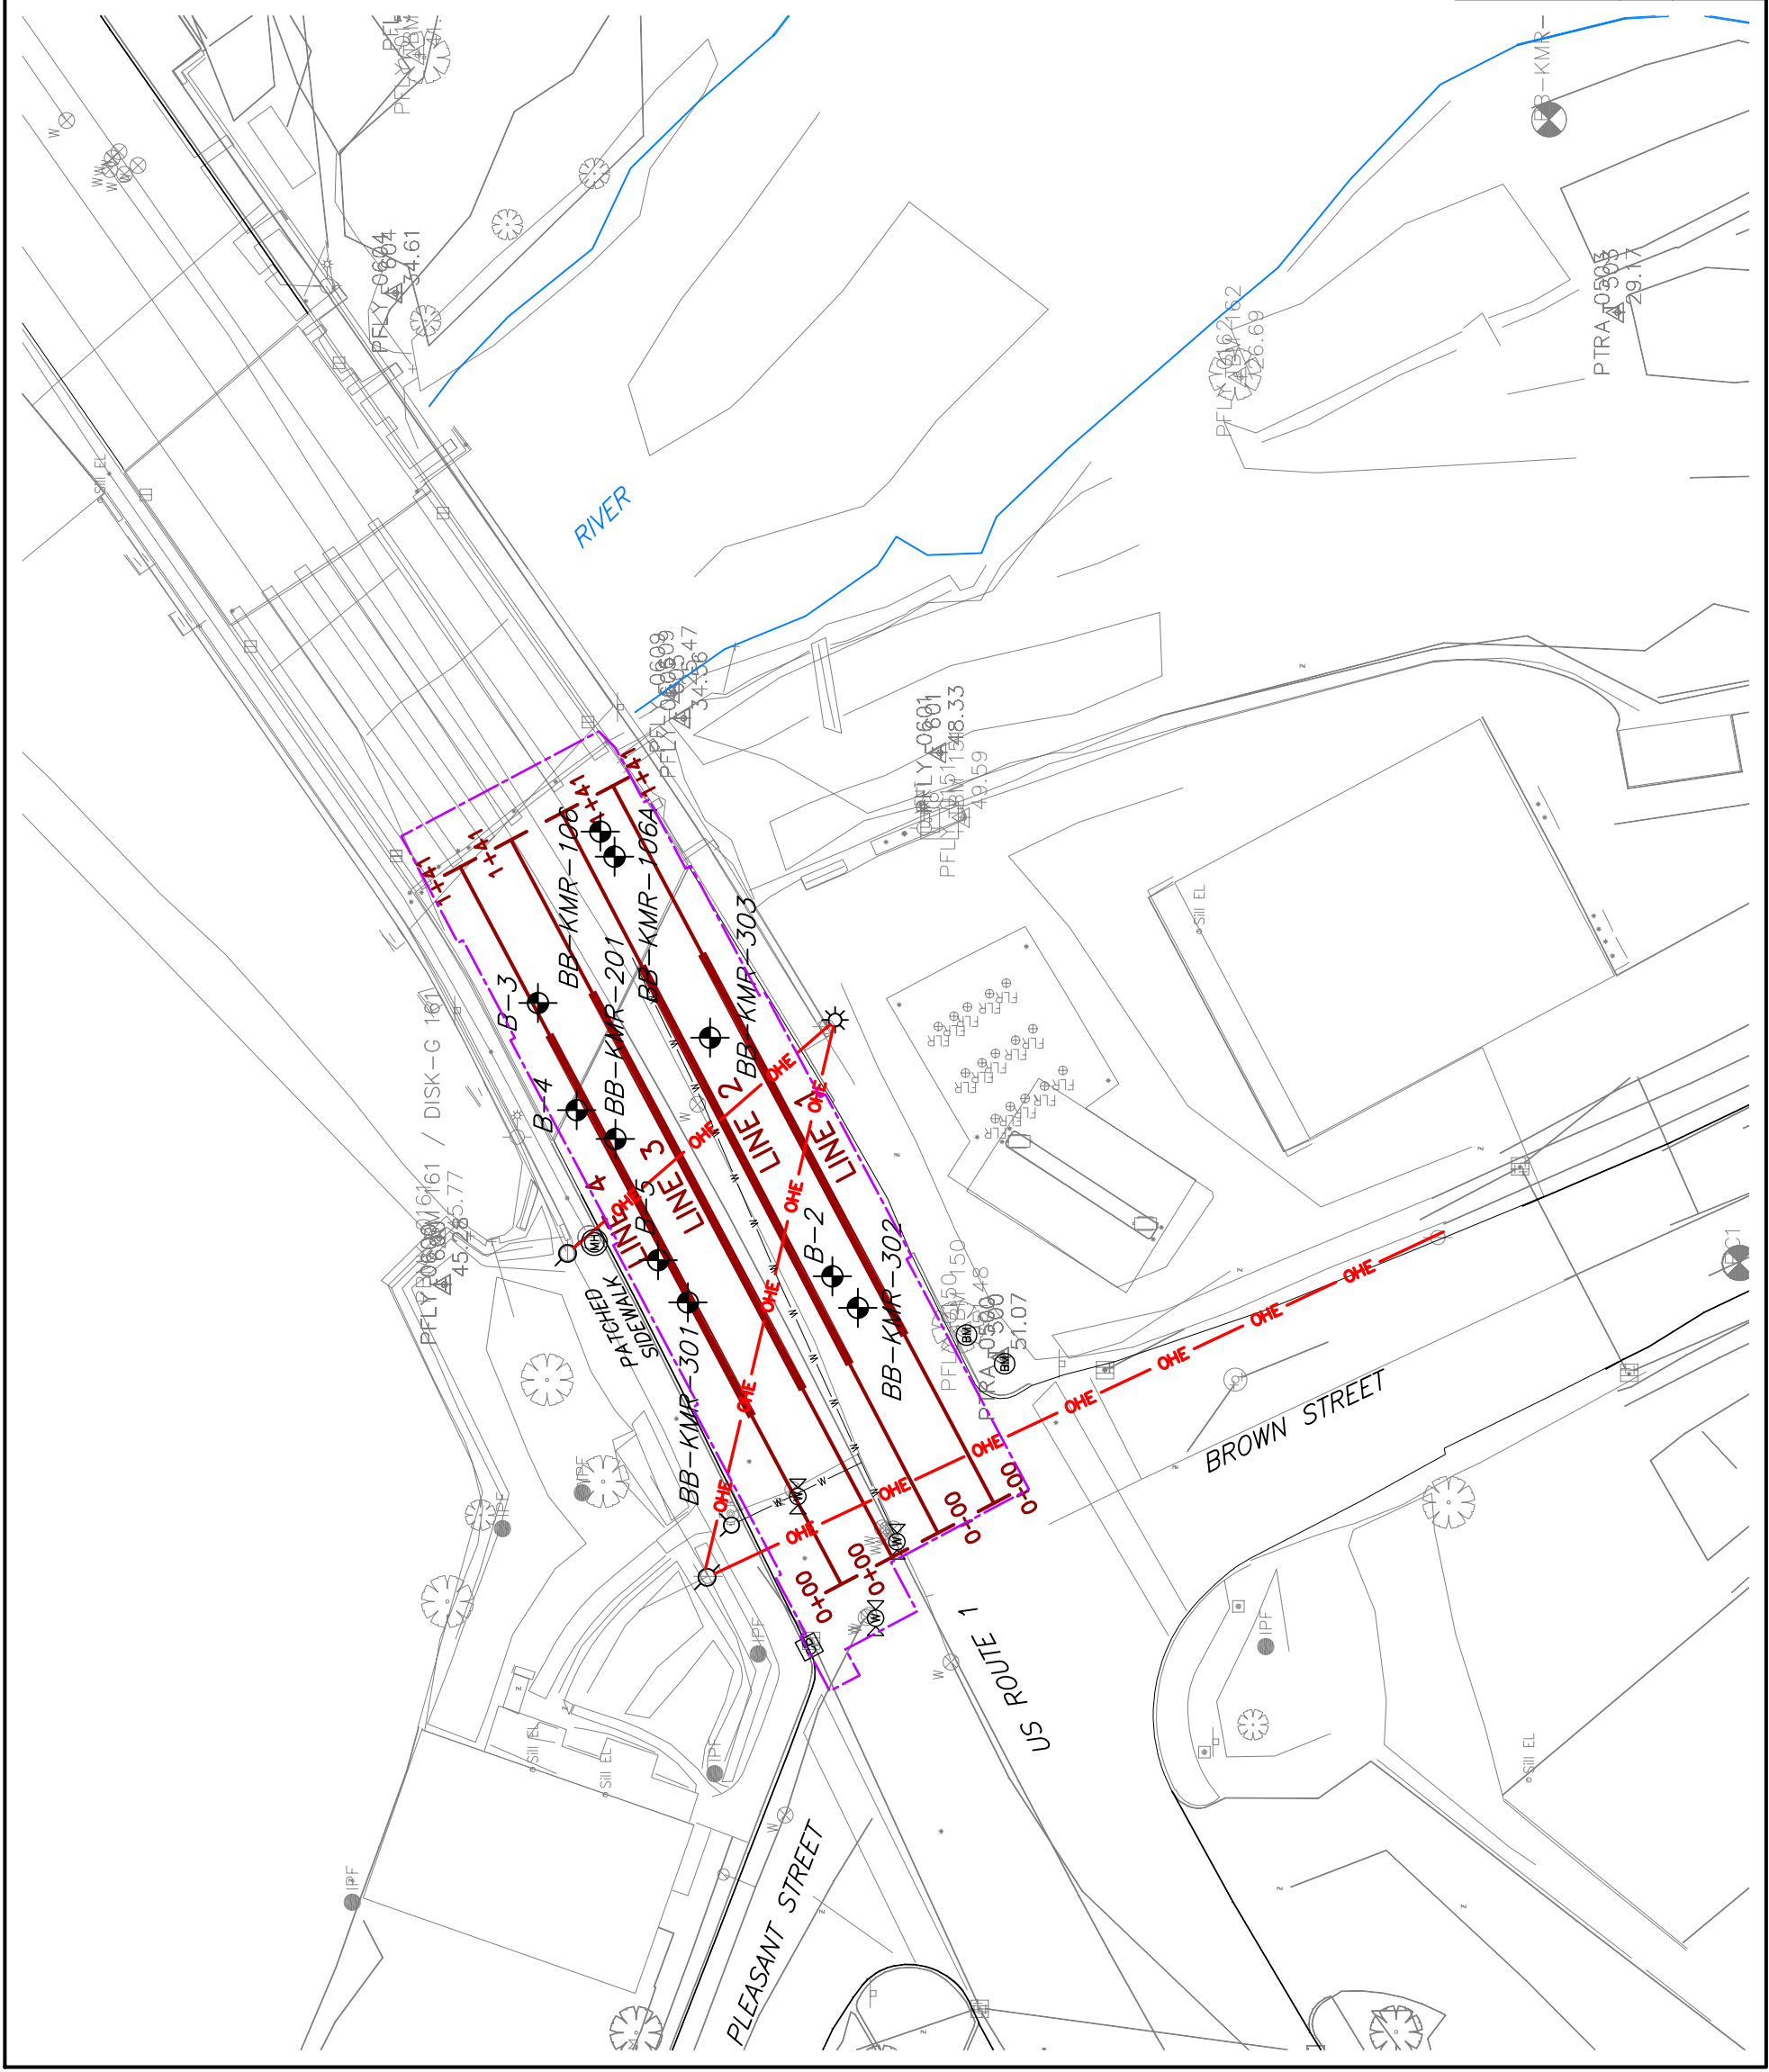
Figure 3
MASW Results
US Route 1 Kennebunk Bridge
Kennebunk, Maine

- Data from the 2010 GPR geophysical work was unable to provide data below depths of 3 to 10 feet due to limited signal penetration. The 2010 MASW results indicated persistent areas of low shear wave velocity material (anticipated loose soil) between depths of about 6 and 14 feet in the expected vicinity of the sluiceway. It is believed that the shear wave velocity of the sluiceway materials may not have contrasted enough with the low velocity material between depths of 6 and 14 feet to be detected. Therefore, the sluiceway limits could not be inferred from the recent geophysical data, and the historical information summarized above was judged to be the best available to estimate the probable sluiceway limits.
