## Scour Critical Bridge Plan of Action (POA) Report

Town: Augusta

Bridge Number: 3077

Bridge Name: Bond Brook No 1

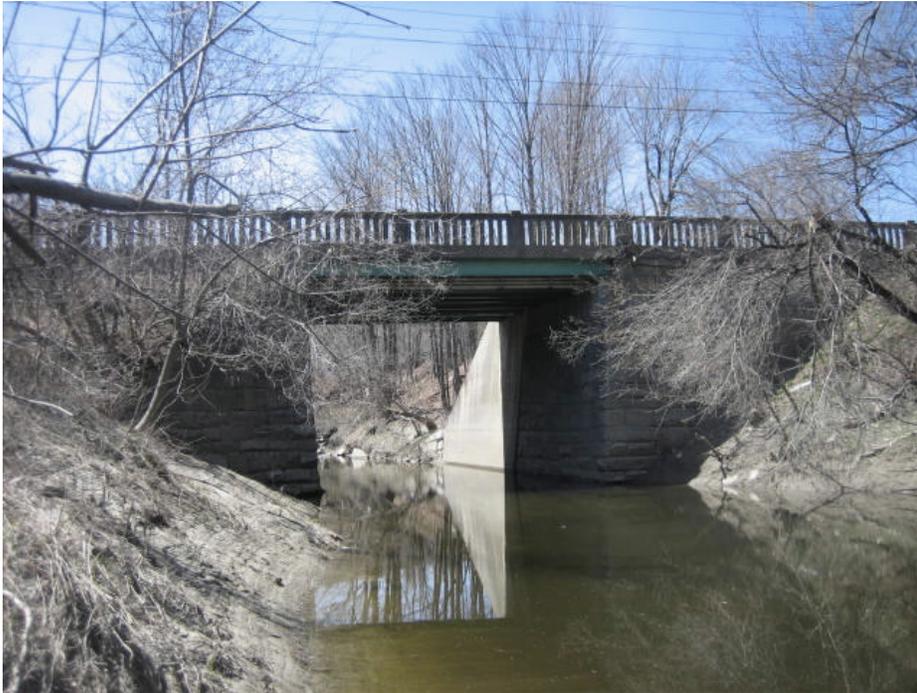
**Bridge:** Augusta 3077  
**Date Taken:** 4/20/2009 1:03:24 PM  
**Source:** CHA  
**Description:** Downstream Elevation

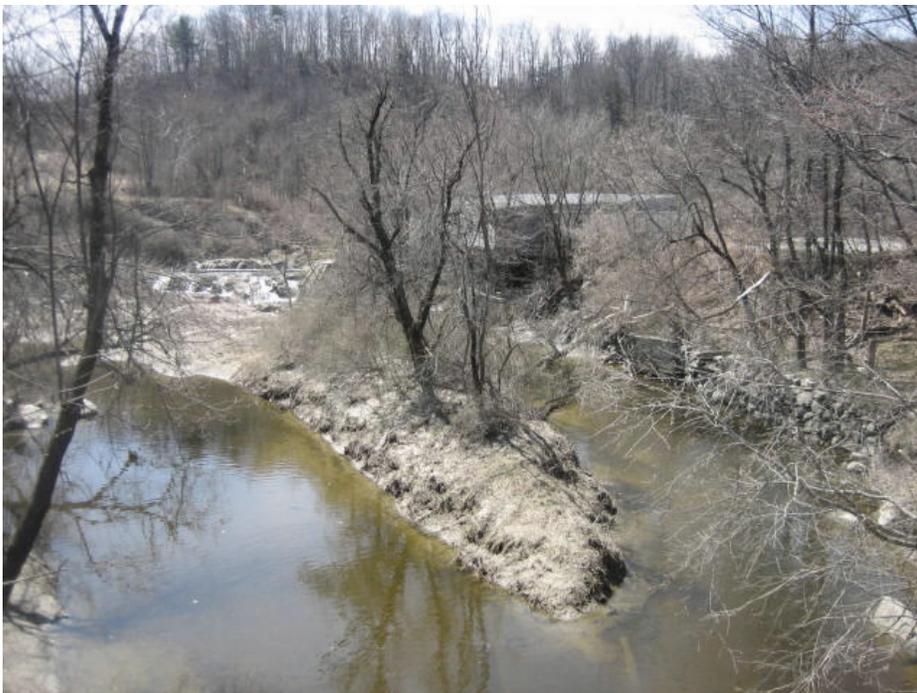
**Bridge:** Augusta 3077  
**Date Taken:** 4/20/2009 1:14:26 PM  
**Source:** CHA  
**Description:** View Looking Upstream.

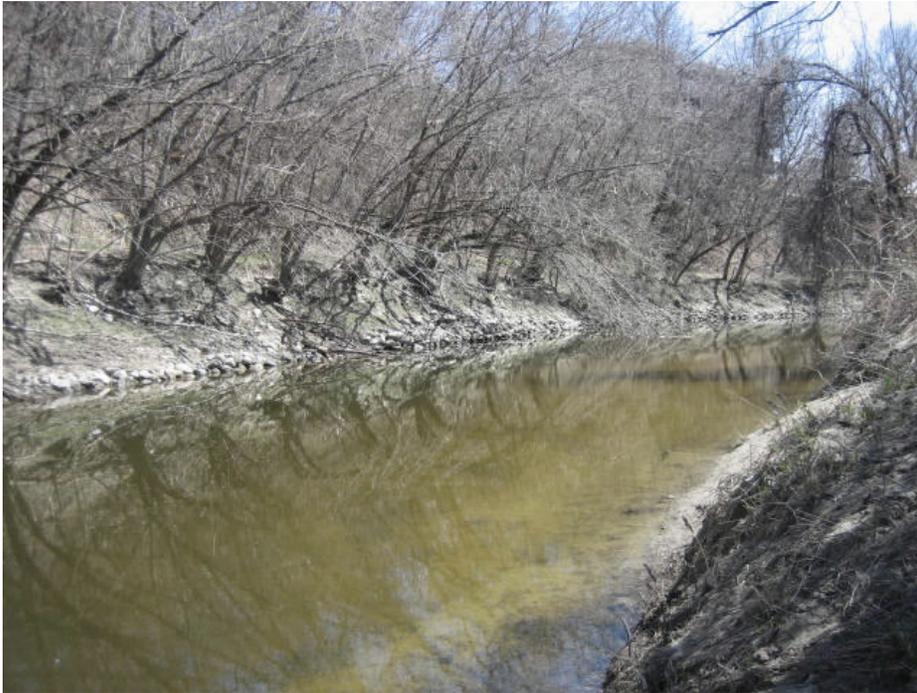
**Bridge:** Augusta 3077  
**Date Taken:** 4/20/2009 1:02:56 PM  
**Source:** CHA  
**Description:** View Looking Downstream

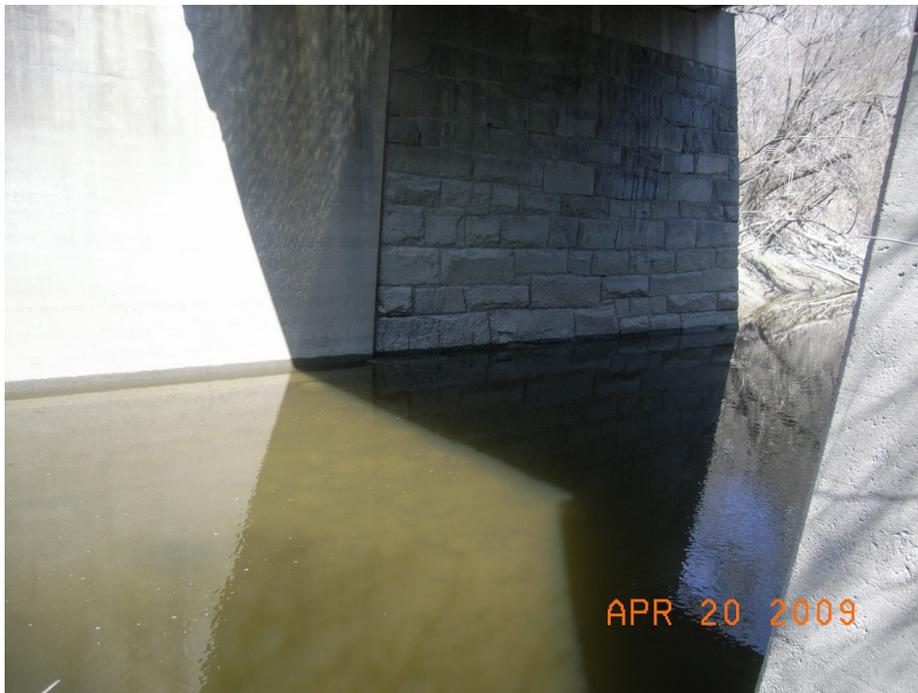
**Bridge:** Augusta 3077  
**Date Taken:** 4/20/2009 6:54:55 PM  
**Source:** CHA  
**Description:** Left Abutment.

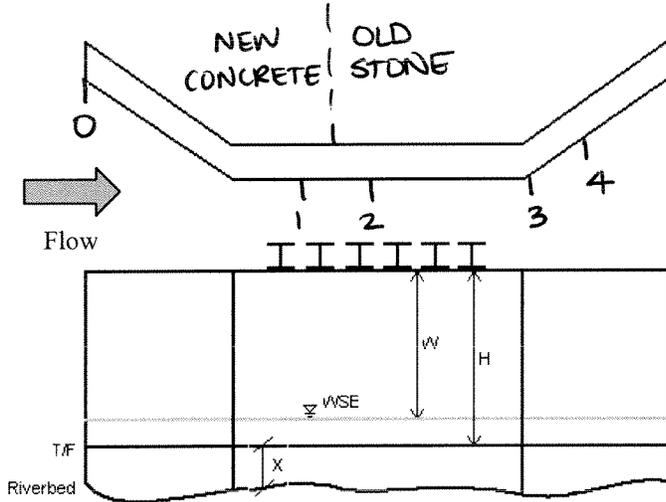
Abutment: Left

W = Distance from Low Chord to Water Surface = 20.7 ft

Notes: Two types of foundations exist. There is a concrete pile cap at the upstream end and cut masonry block at the downstream end.

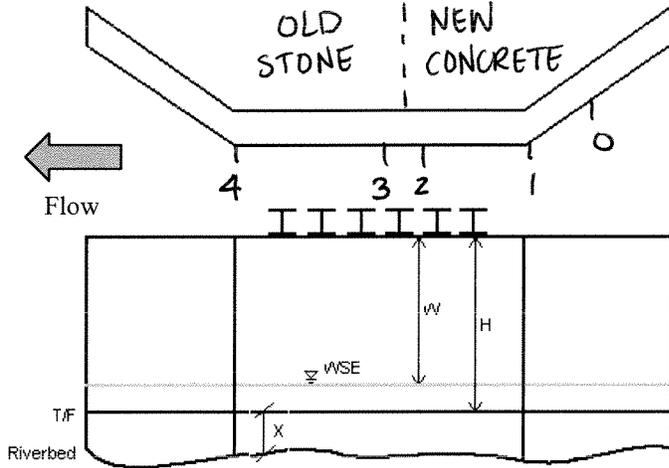
Abutment: Right

W = Distance from Low Chord to Water Surface = 20.7 ft

H = Distance from Low Chord to top of footing = 26.4 ft

Notes: Two types of foundations exist. There is a concrete pile cap at the upstream end and cut masonry block at the downstream end.

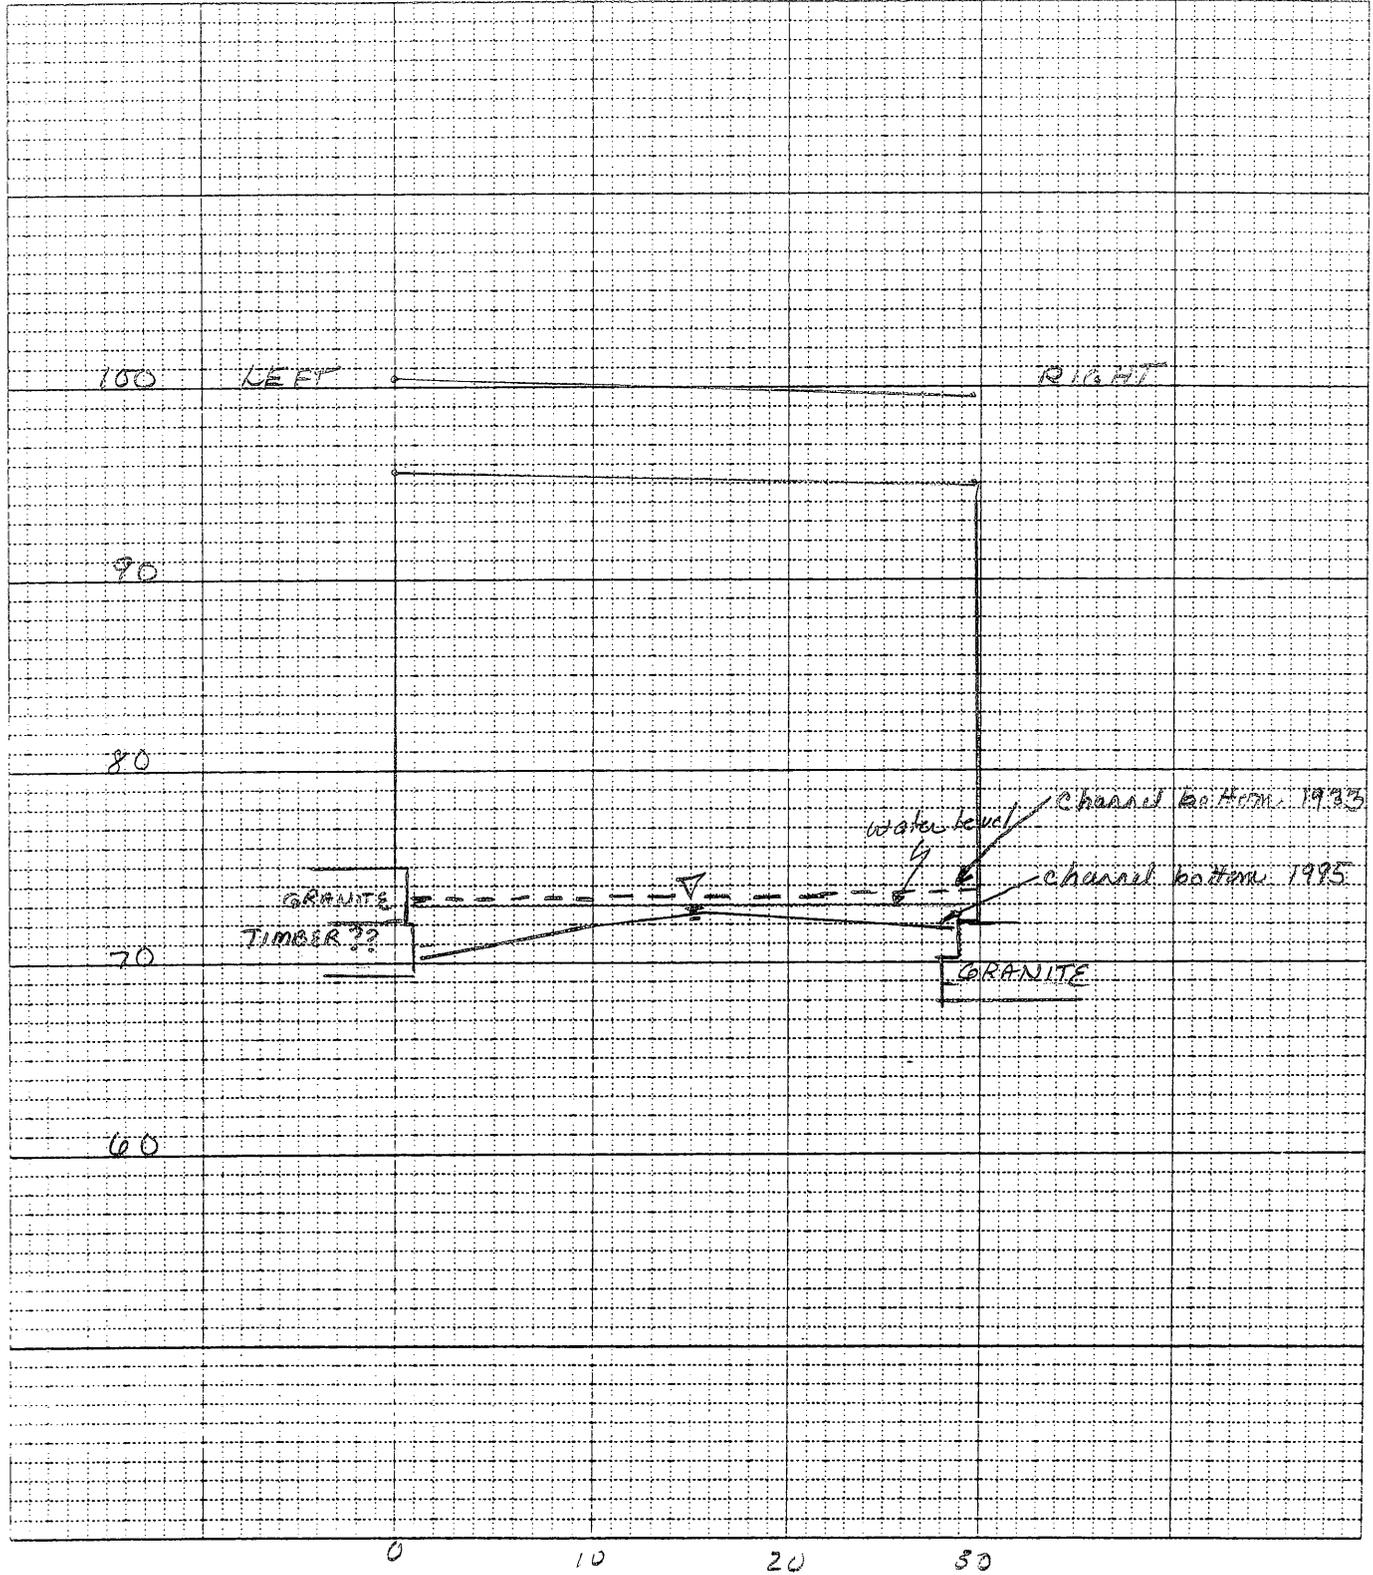
Upstream Side: \_\_\_\_\_ Downstream Side:  (CHANNEL BOTTOM MEASURED FROM WATER SURFACE)  
 (FROM PROBINGS)

WATER LEVEL 293.0  
 5.5'
