Scour Critical Bridge
Plan of Action (POA) Report

Town: Bingham
Bridge Number: 2027
Bridge Name: Austin
Feature Carried: Rt. 201
Waterway Crossed: Austin Stream

Scour Critical Bridge Plan of Action

Bridge Name: Austin	Town: Bingham	Bridge #: 2027
Feature Carried: Rt. 201	Stream: Austin St.	Review Date: 7/23/2009

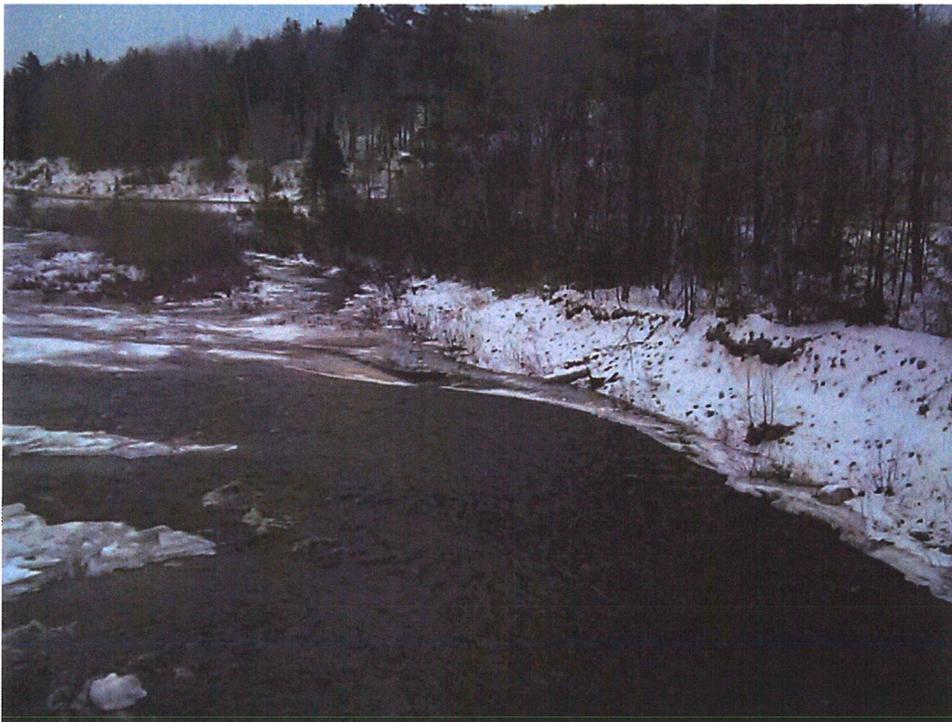
Photo 6.
U/S Left Bank &
Bank Erosion

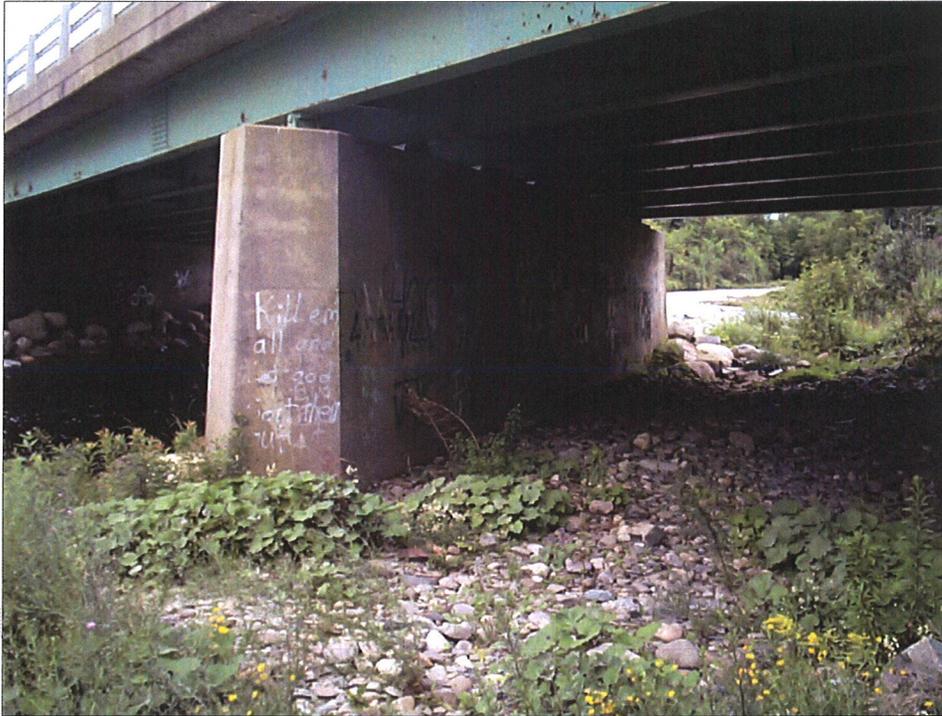
Photo 11.
Left Side of Left Pier
(Pier 1).
Bed Dry at Normal
Water.
No Riprap.

Rehabilitation of existing scour countermeasures or installation of new scour countermeasures is recommended at both abutments. Installation of properly designed pier scour countermeasures is recommended at the piers. A revetment consisting of cable concrete is recommended at the piers. It is further recommended the flood monitoring begin when a Flood Warning is Issued by the National Weather Service; scour monitoring begin at the 10-YR event (4870 cfs, WSE 354.1); and that the bridge be closed at the 50-YR event (7569 cfs, WSE 355.2).

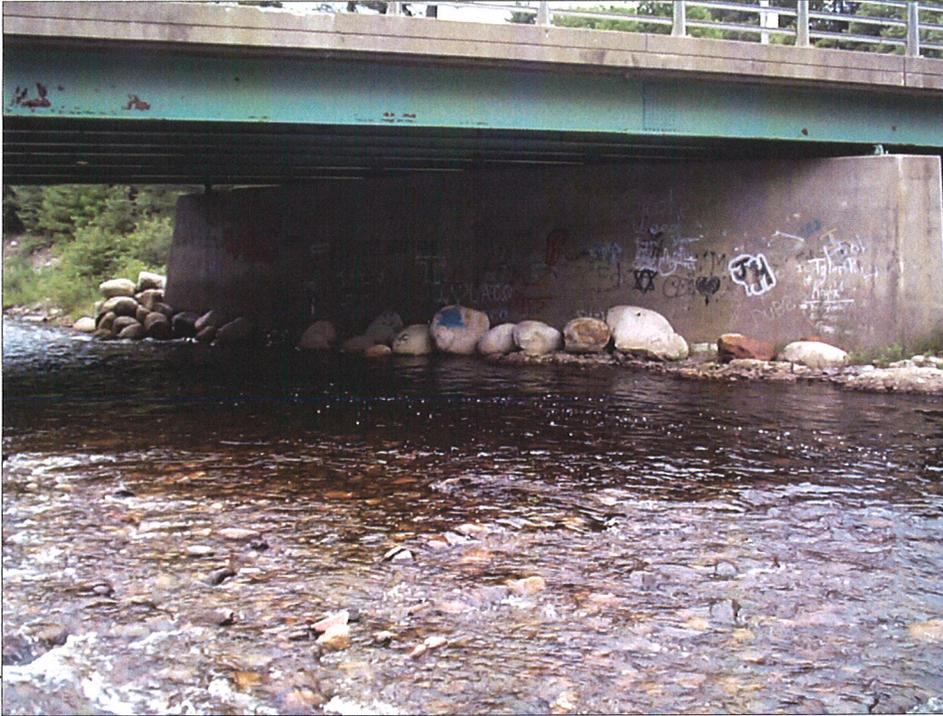
Photo 13.
Right Side of Left
Pier (Pier 1).
Riprap Along
Right Side of Left
Pier (Pier 1)

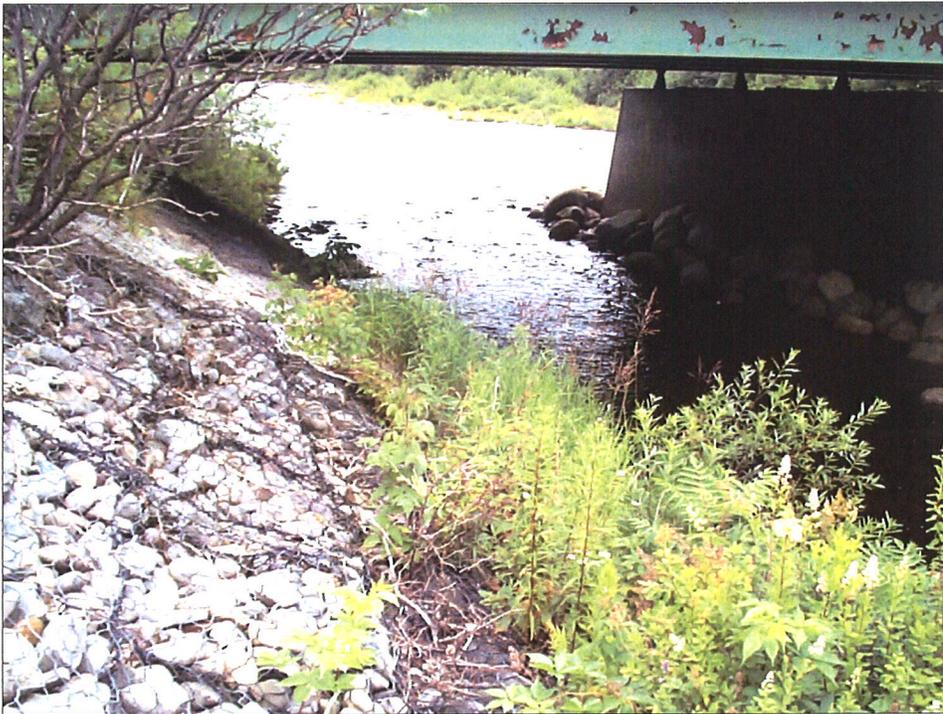
Photo 14.
Right Abutment
Gabion Slope.
Right Side of Right
Pier (Pier 2).
Riprap Along
Right Side of Right
Pier (Pier 2)

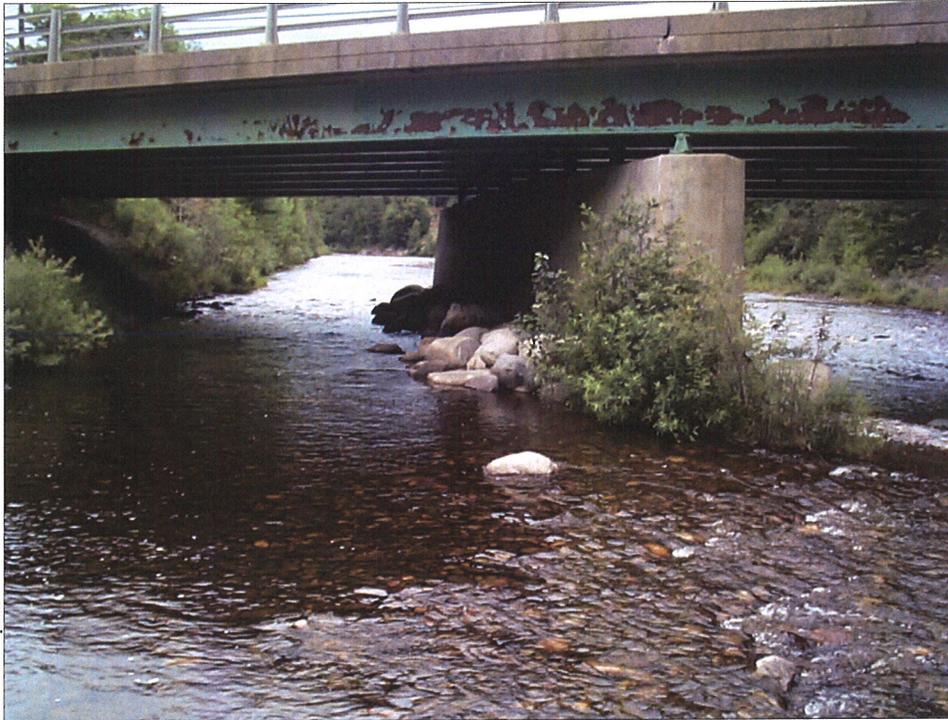
Photo 15.
Right Side of Right
Pier (Pier 2).
Riprap Along
Right Side of Right
Pier (Pier 2)

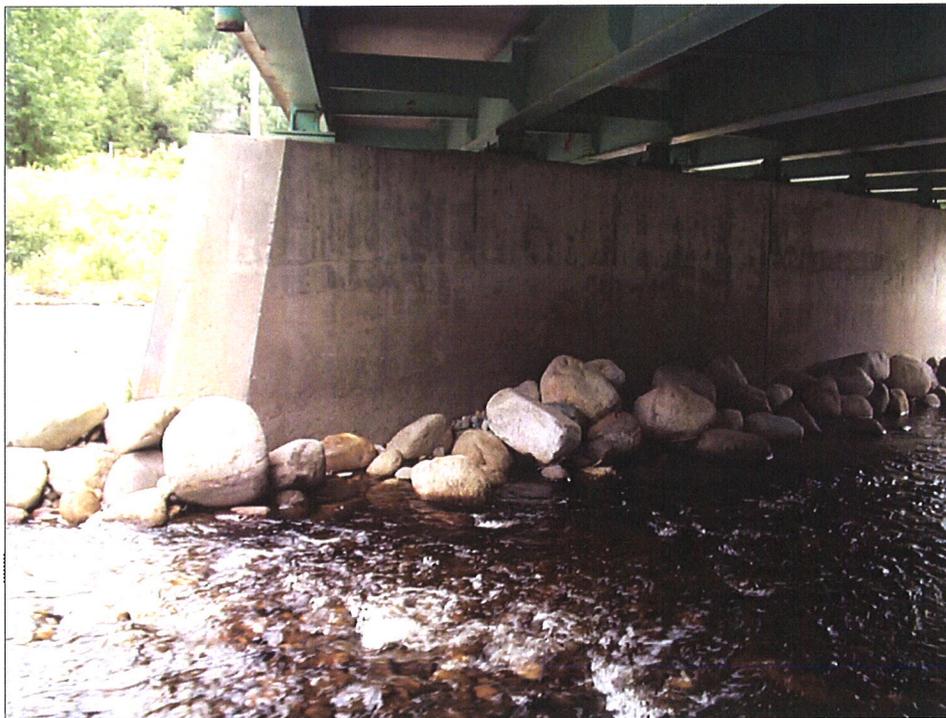
Photo 16.
Right Side of Right
Pier (Pier 2).
Riprap Along
Right Side of Right
Pier (Pier 2)

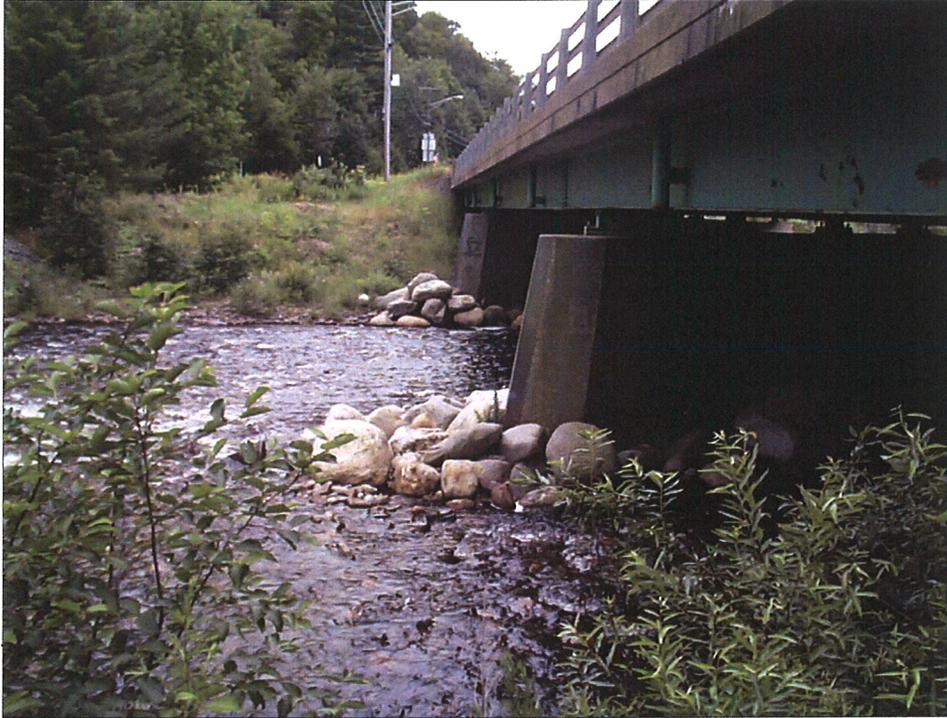
Photo 17.
D/S Fascia
Riprap at U/S Pier
Noses

- Recently installed (2000) pier riprap consists of rounded stones in generally poor condition.

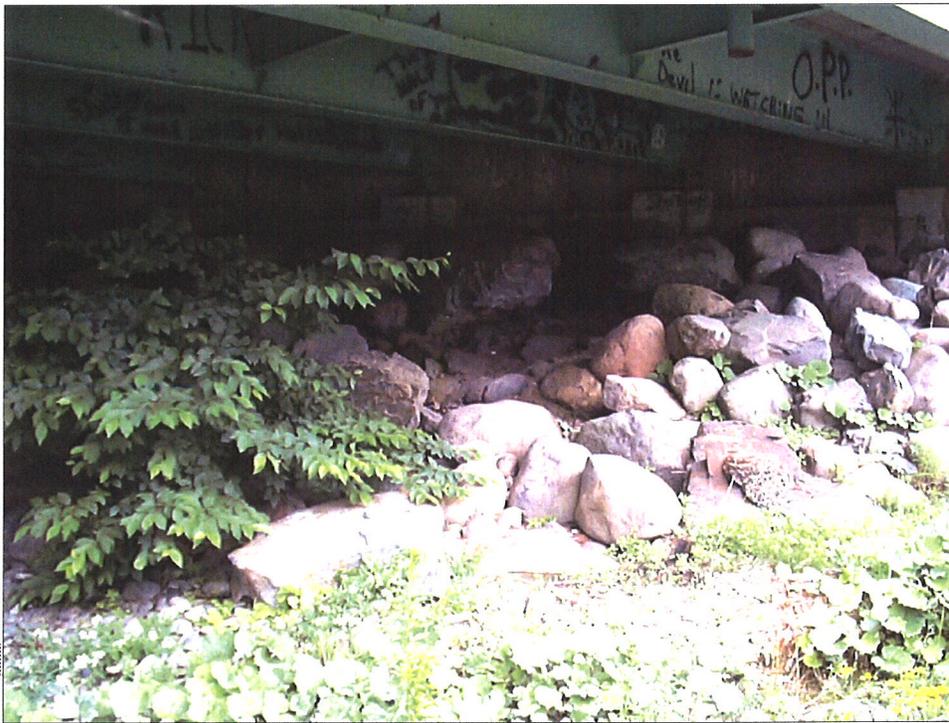
The left abutment is protected by riprap and the right abutment is protected by gabions which were placed in conjunction with other channel repairs in 1988. Revetment at the abutments is not adequately designed. The Plans indicate the toe of the riprap slope at the left abutment and the toe of the gabion protected slope at the right abutment are both embedded 3 feet below the streambed. The bottom of the revetment should be placed below the calculated contraction scour depth. The calculated contraction scour depth for a 50-YR event is 3.30 feet. Events greater than the 50-YR event are anticipated to undermine the toe of the abutment revetment slopes likely resulting in significant damage to the countermeasures and possible failure of the abutment slope and possible undermining at the abutments.

Photo 19.
Riprap
Slope at Left
Abutment

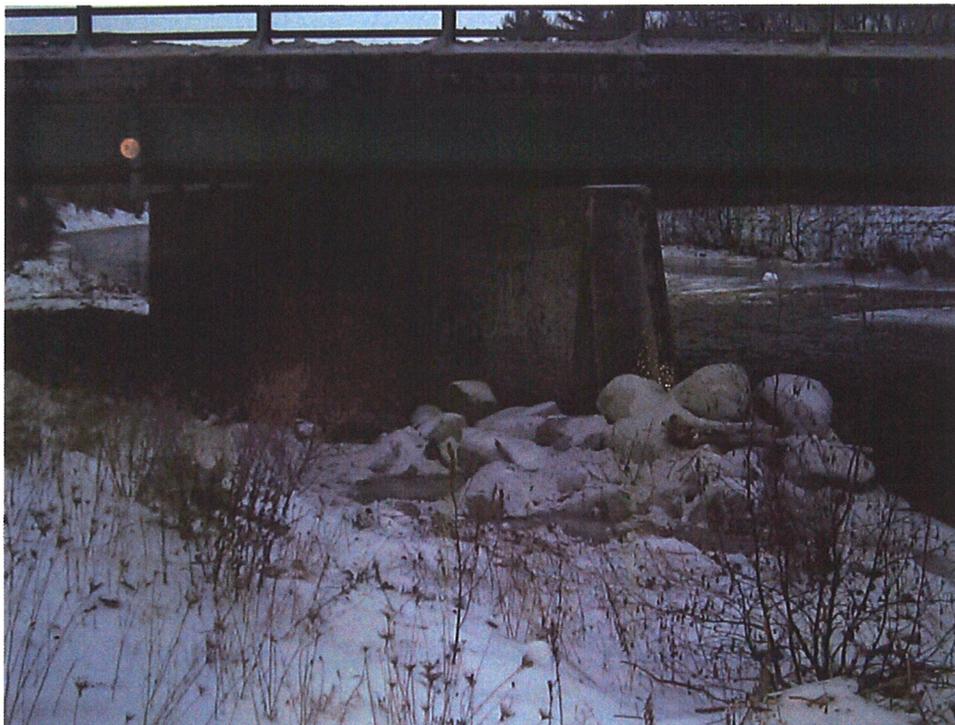
Both piers are protected by riprap that is in poor condition and which appears to have been placed in 2000 based on a review of available inspection files. The riprap revetment at the piers is not adequately designed, and there are areas of missing riprap. This riprap is assessed to be in poor condition. The extent of coverage of the riprap around the piers is also not consistent with the recommendations of HEC-23.

Photo 22.
Riprap at U/S End
of Left Pier
(Pier 1)

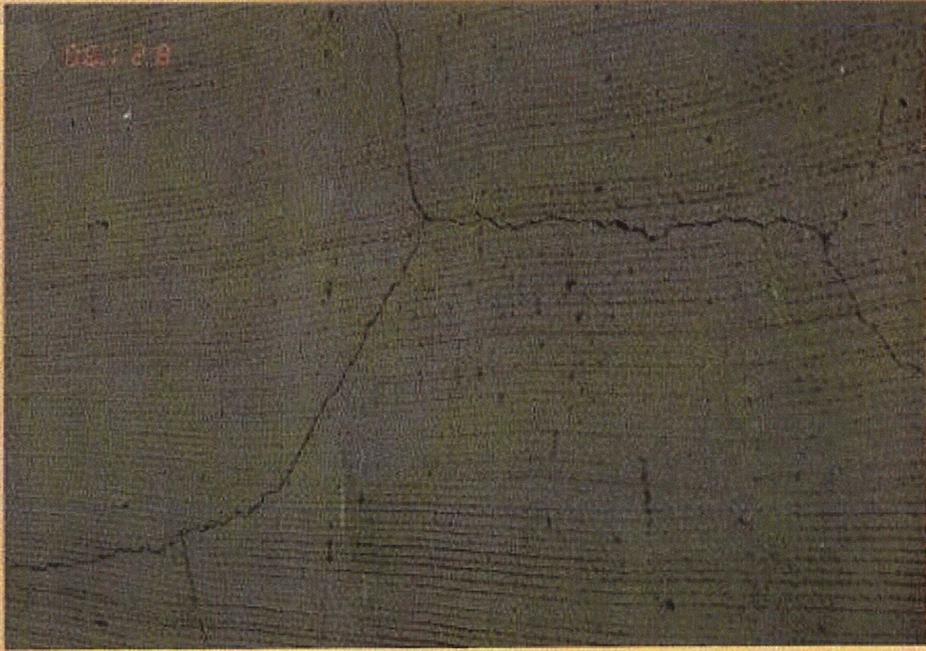
Cracks in wearing surface

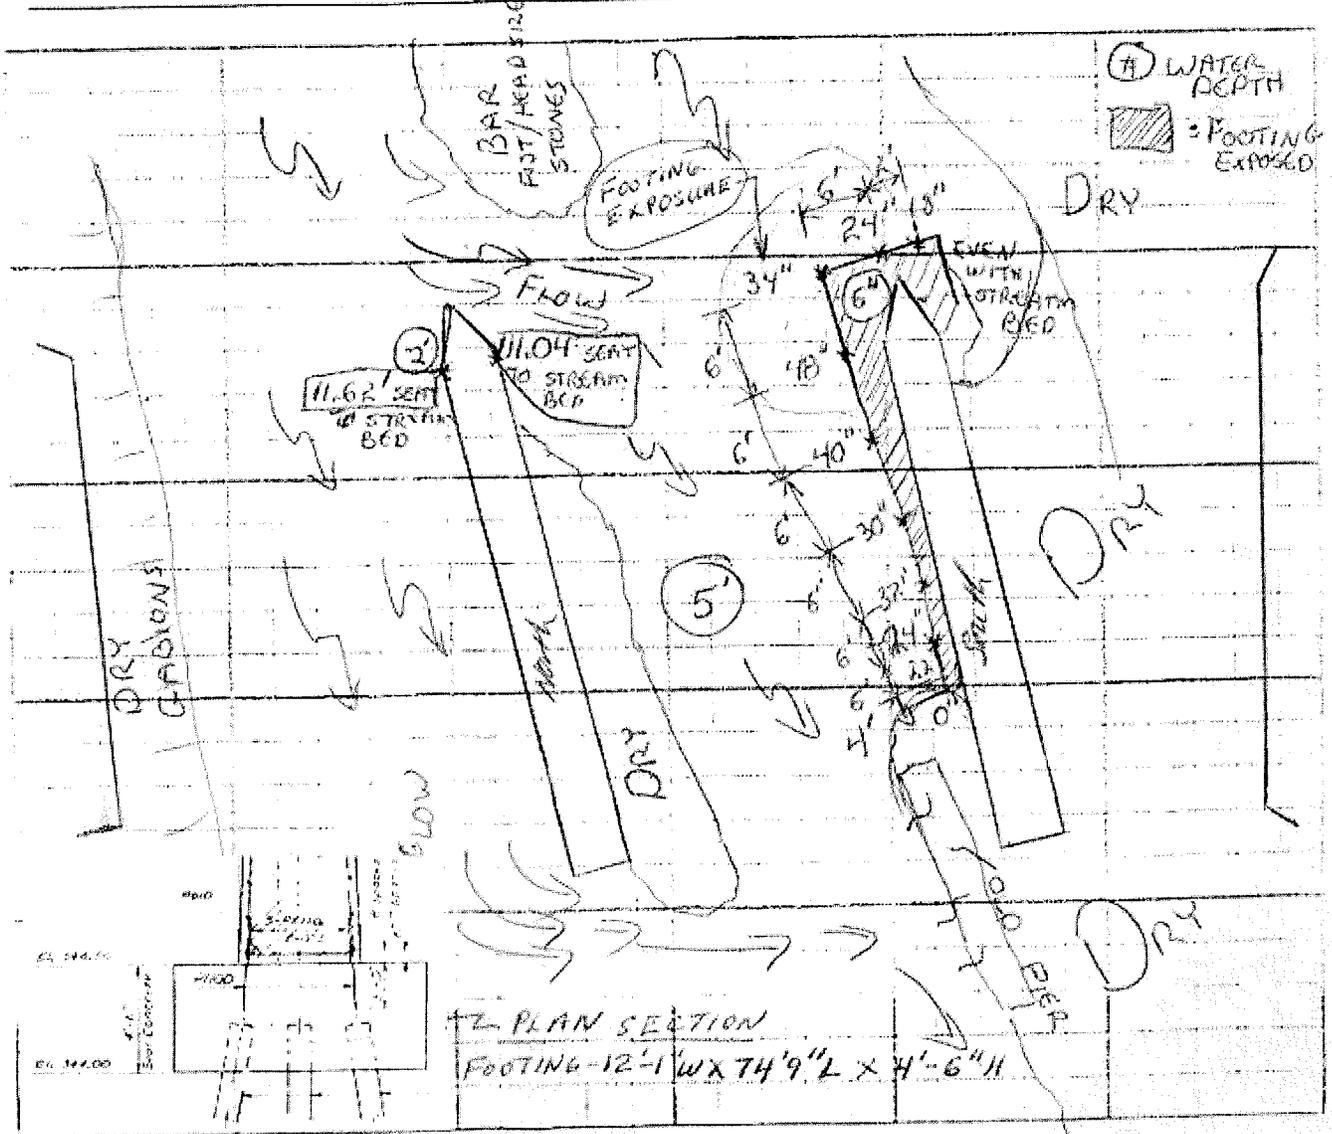
INSPECTION REPORT Note Scour @ US South pier. Prior report (1991)
Stated no footings were exposed. Measured 48" vertical footing face (See sketch)
Plans show 4'-6" footing on TIMBER piles.

RECOM. REPAIRS 7 scout repair

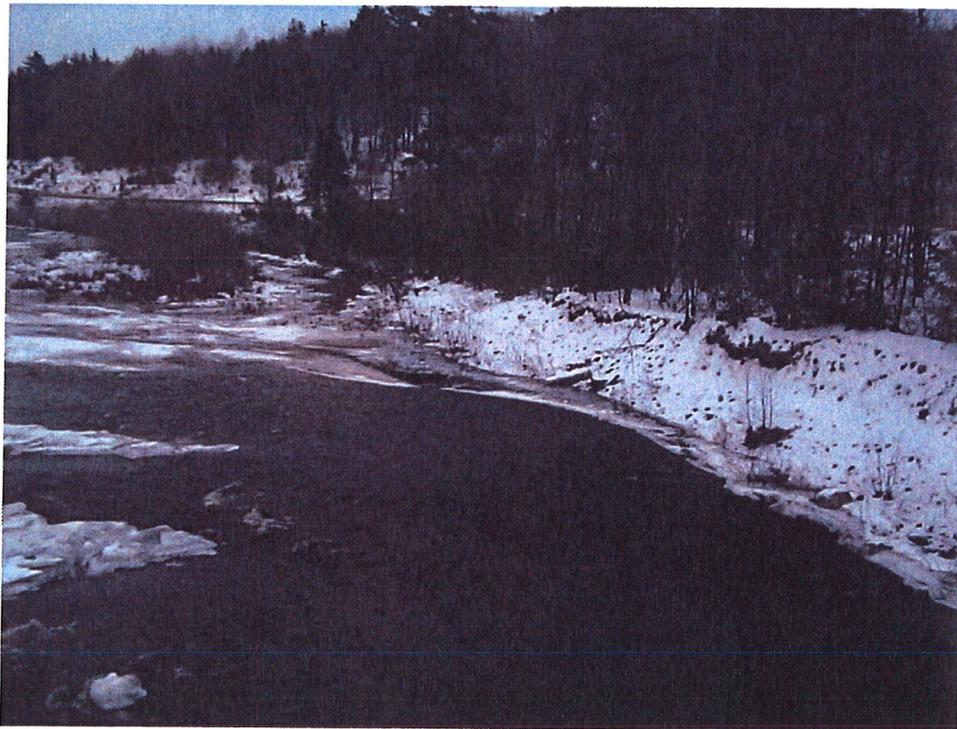
Photo 6.
U/S Left Bank &
Bank Erosion

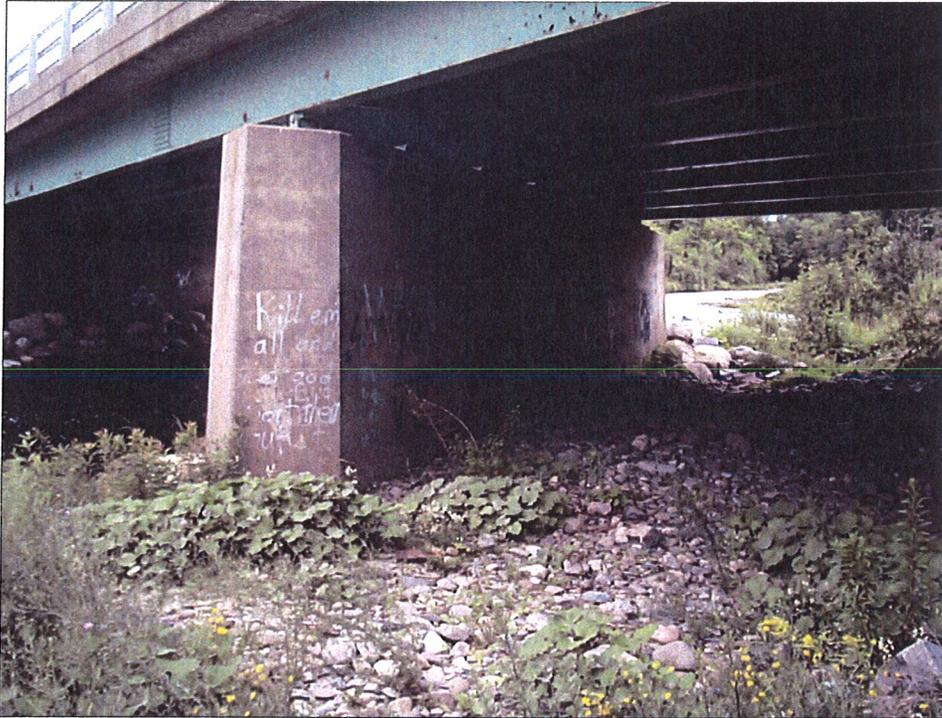
Photo 11.
Left Side of Left Pier
(Pier 1).
Bed Dry at Normal
Water.
No Riprap.

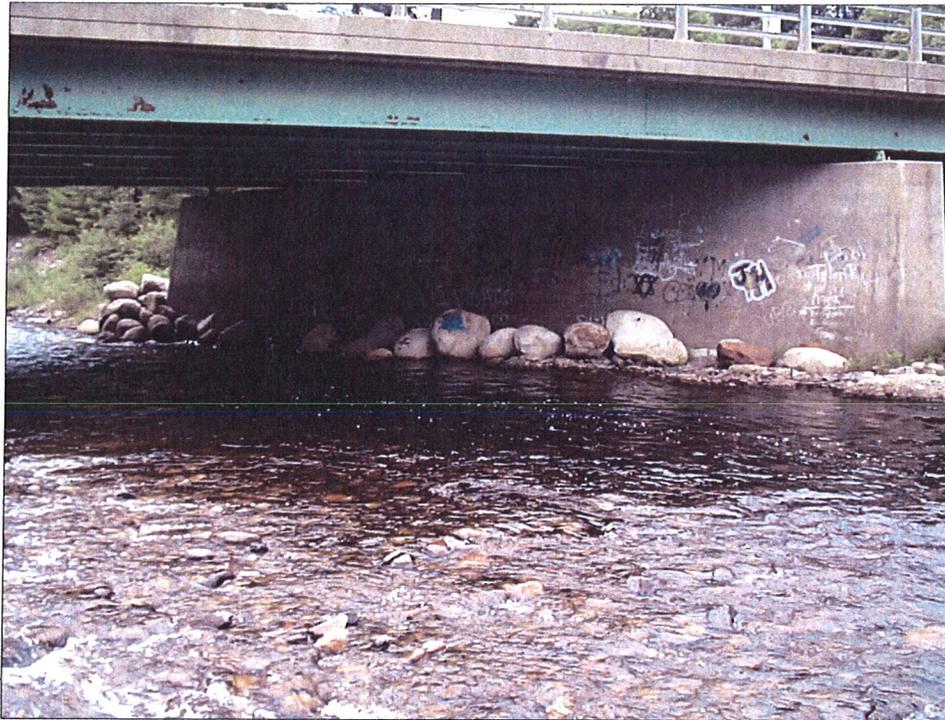
Photo 13.
Right Side of Left
Pier (Pier 1).
Riprap Along
Right Side of Left
Pier (Pier 1)

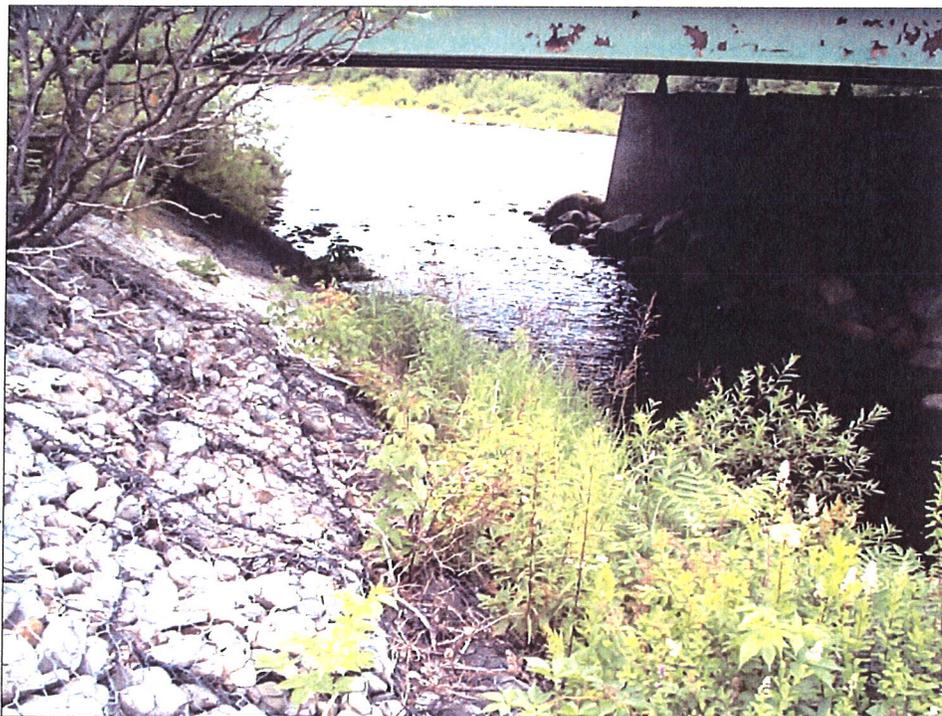
Photo 14.
Right Abutment
Gabion Slope.
Right Side of Right
Pier (Pier 2).
Riprap Along
Right Side of Right
Pier (Pier 2)

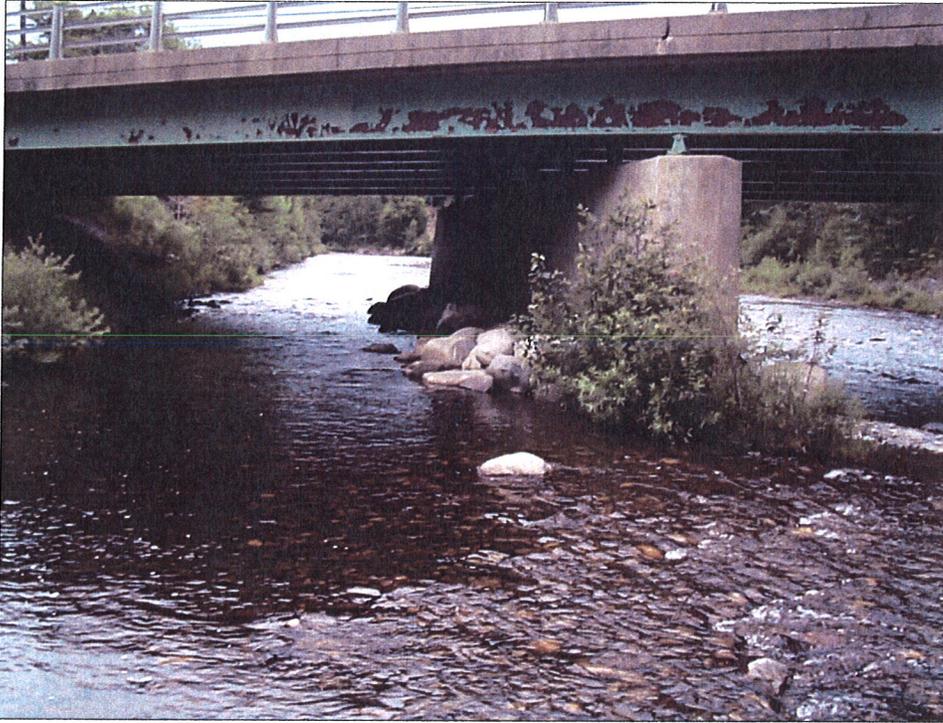
Photo 15.
Right Side of Right
Pier (Pier 2).
Riprap Along
Right Side of Right
Pier (Pier 2)

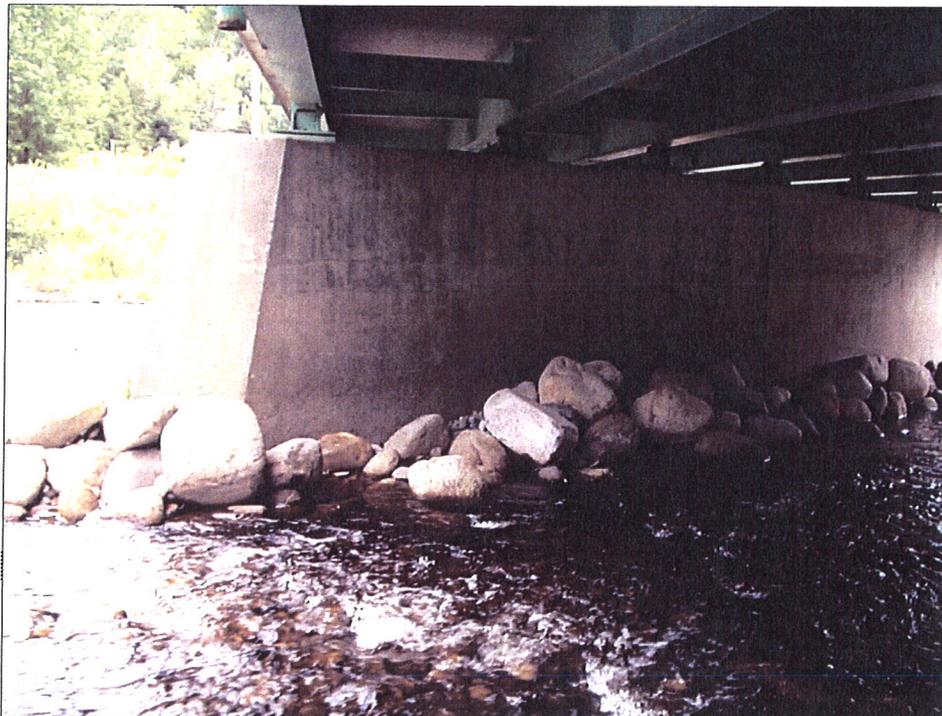
Photo 16.
Right Side of Right
Pier (Pier 2).
Riprap Along
Right Side of Right
Pier (Pier 2)

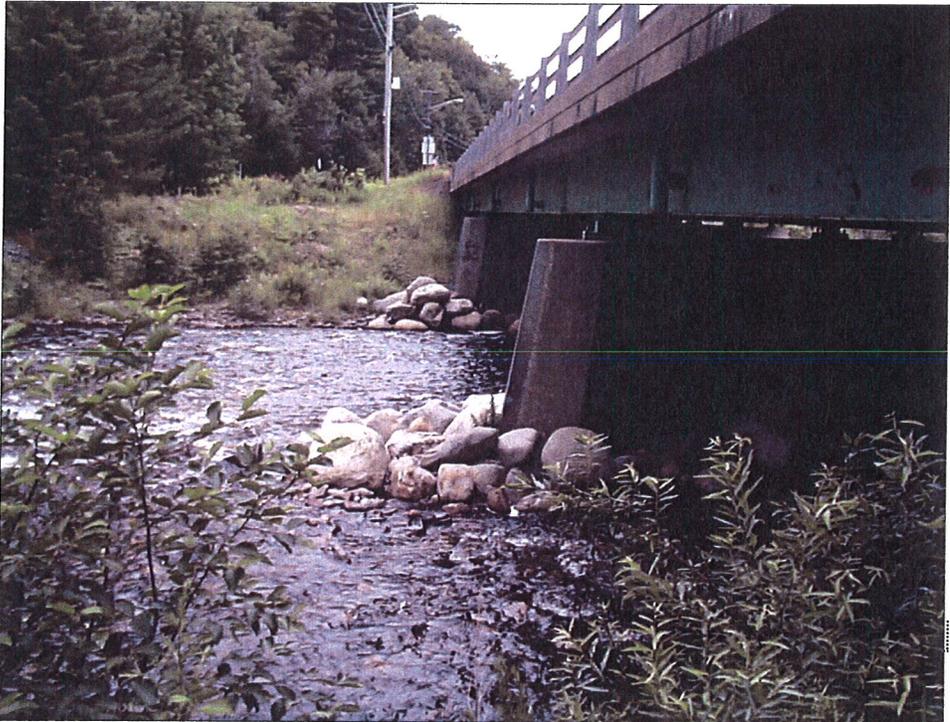
Photo 17.
D/S Fascia
Riprap at U/S Pier
Noses

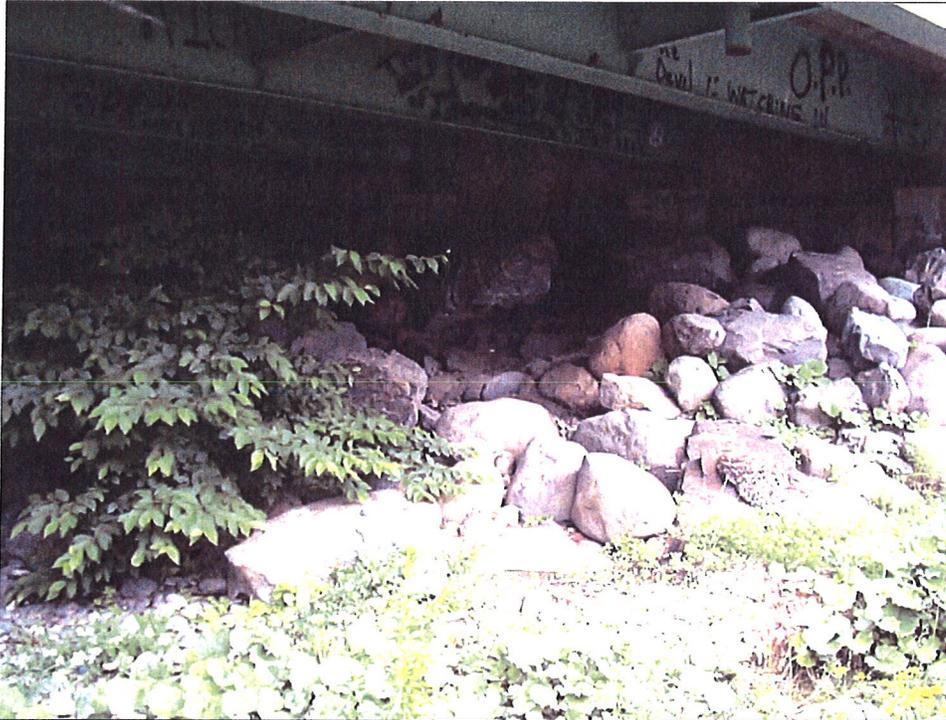
Photo 19.
Riprap
Slope at Left
Abutment

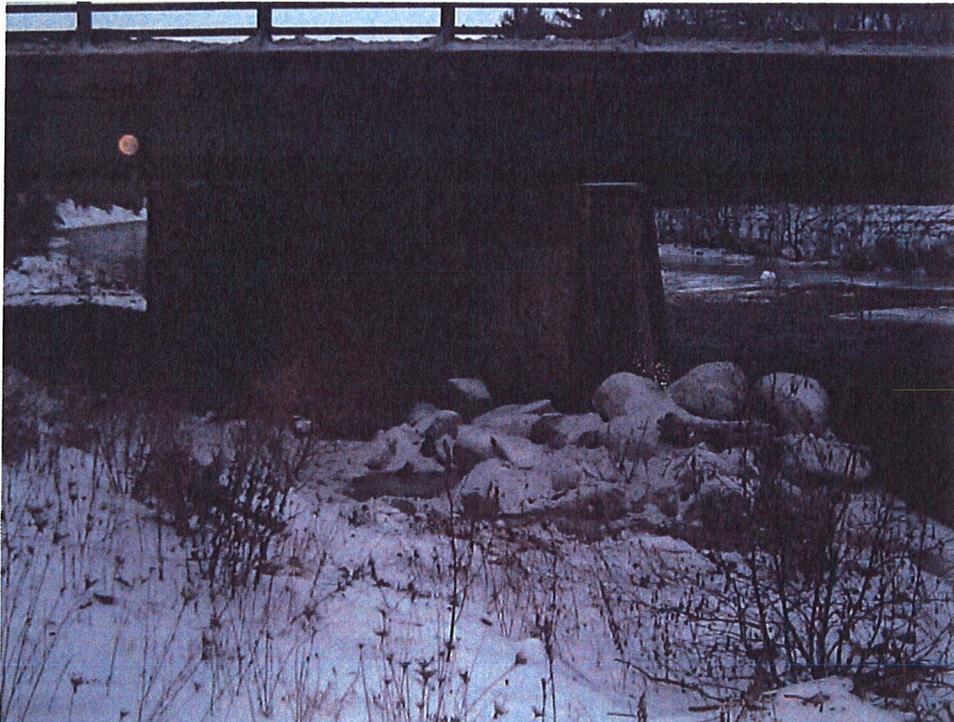
Photo 22.
Riprap at U/S End
of Left Pier
(Pier 1)
