MEMORANDUM

DATE: March 30, 2016

SUBJECT: Geotechnical Engineering Evaluation
Naples Slope Evaluation and Design
Maine Department of Transportation WIN 20466.00, Naples, Maine

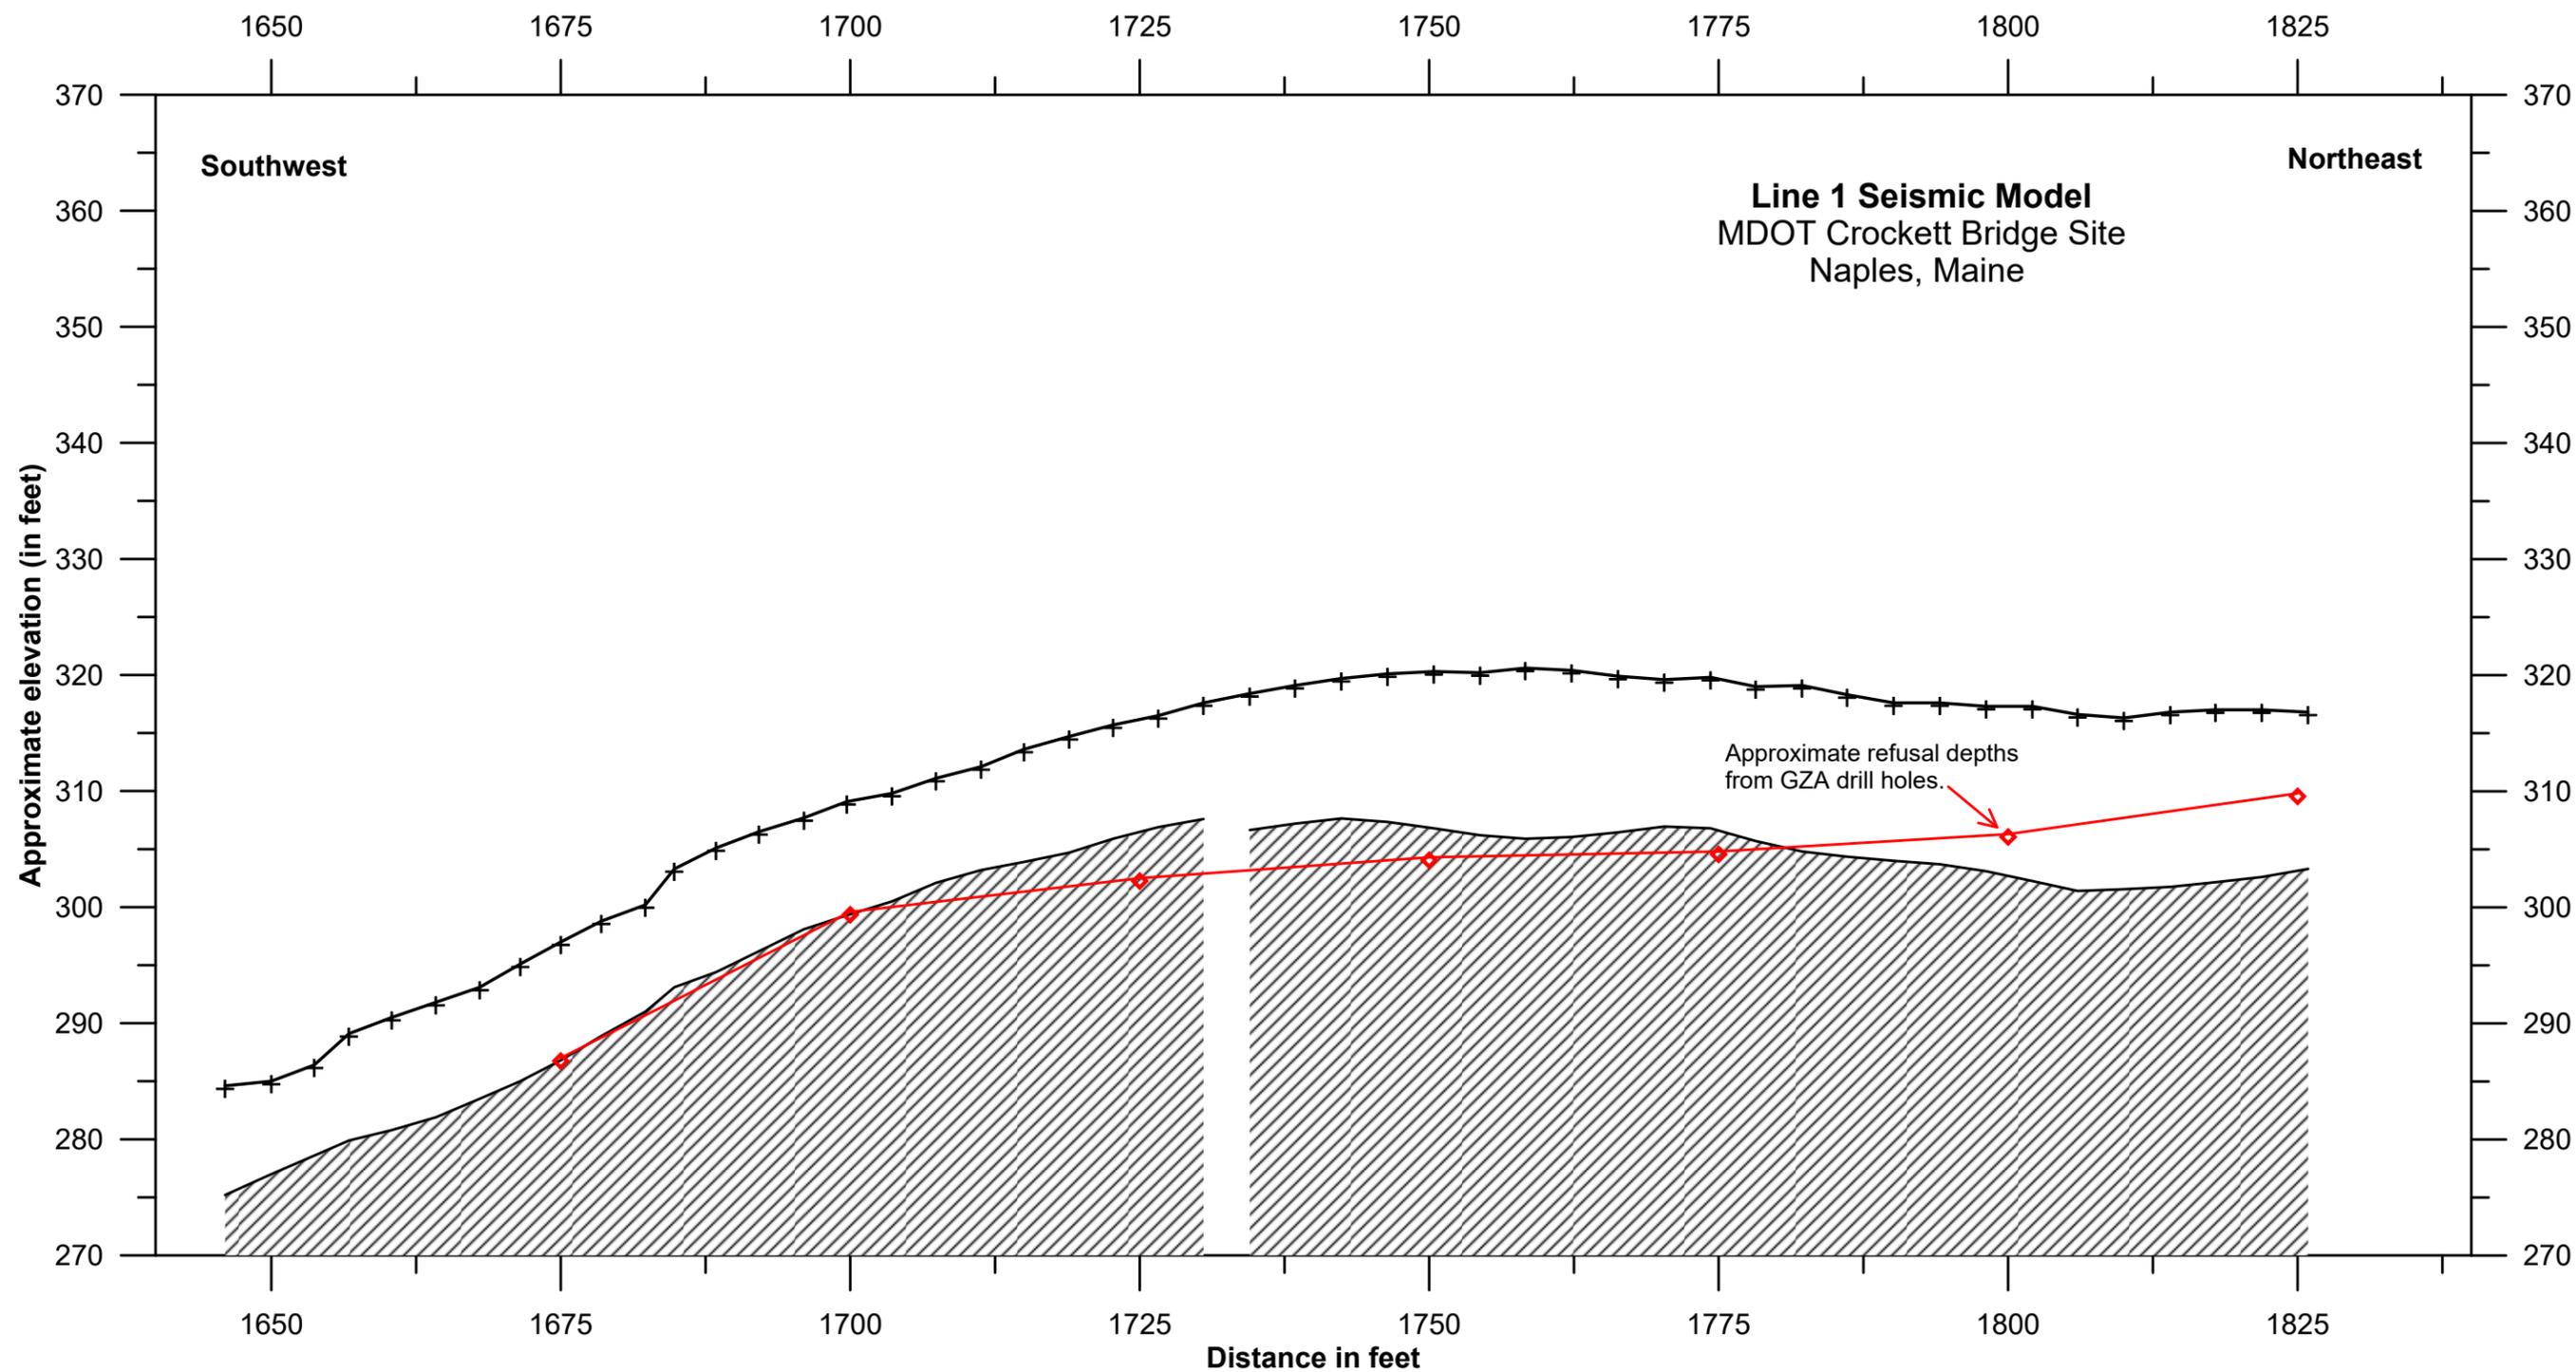
**ATTACHMENT
SEISMIC REFRACTION PROFILE
AND TABULATED DATA**

The seismic refraction results are attached as a profile of the survey line. The seismic results show the seismically interpreted depths to bedrock and configurations. Also shown on the profile are the estimated refusal depths (possible bedrock) derived from the GZA borings that were made proximal to the survey line. The seismically calculated bedrock depths range from approximately 8 feet to over 15 feet deep along the survey line.

At the Naples site these conditions were generally met, however, the soil was very loose and uncompacted which resulted in poor transmission of the seismic energy. The soil was also inhomogeneous, being rocky and frozen in places. This causes lateral variability in the seismic velocity which, in turn, creates uncertainty in the model. This, coupled with the high background noise, resulted in generally fair to poor data quality. We partly overcame this problem by doing multiple shots along the line.

Under favorable conditions seismic refraction results can be fairly precise, within +/- 10 percent or within 5 feet. The conditions at the Naples site were difficult and the data quality ranged from fair to poor across the site. In general, on the survey line the most uncertainty in bedrock depths is at the ends of the line because there is less data at the ends to estimate the depths.

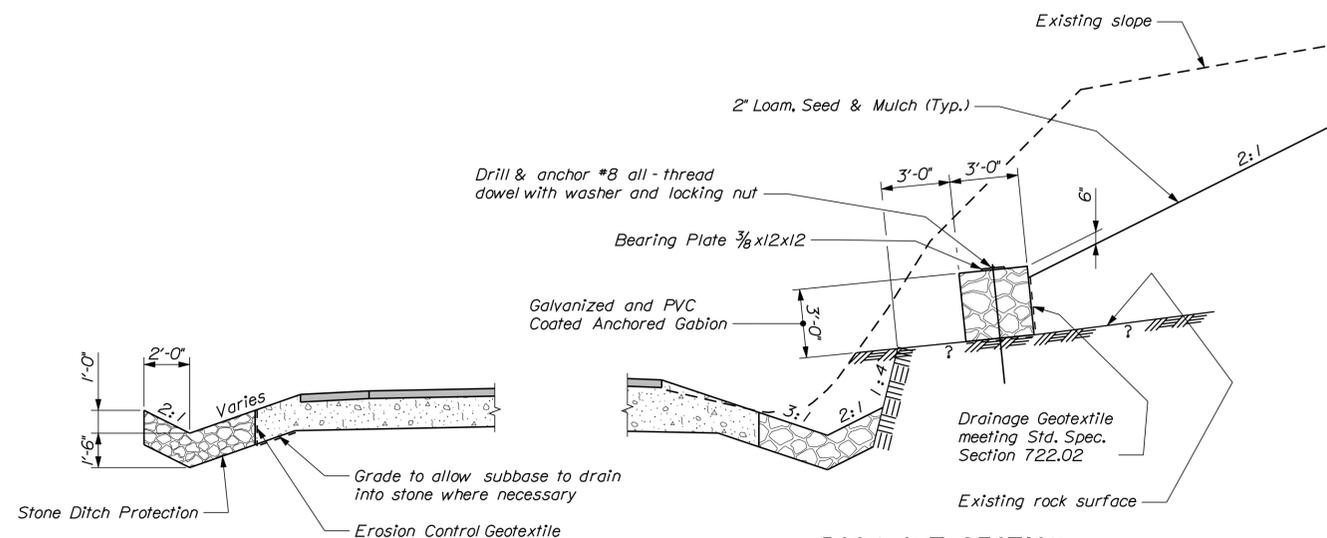
ROCK CUT SECTION
Sta. 117+00 ± to 118+25 ±

In our opinion, the primary geotechnical condition affecting the existing slope is seepage through and erosion of the oversteepened Lake Bottom Deposit. Raveling and falling boulders currently pose a risk to vehicle traffic considering the limited catchment width and depth. We conclude this risk can be mitigated by excavating the soil portion of the slope to a conventional cut slope inclination, 2H:1V, and removing or stabilizing boulders that protrude significantly from the new cut slope. The soil cut slope will terminate above the bedrock cut face and will likely become saturated and periodically weakened over time. In order to contain the toe of the soil slope, a free-draining toe buttress should be constructed where the soil slope meets the bedrock.

We did not observe bedrock discontinuities that would create kinematically-possible planar, wedge or toppling instability. Therefore, in the absence of blasting damage and/or weathering, we conclude the potential for rock slope instability is low. The potential for blasting damage can be limited using controlled blasting techniques as recommended later herein. Based on the presence of dikes, some with differential weathering, in the vicinity of high angle to near-vertical contacts, we conclude there is potential for a blocky bedrock mass to remain after blasting that would result in release of rock fragments over time. Based on the observed joint spacing, typical falling rocks could vary from about 6 inches to 3 feet in diameter. The areas likely to experience rockfall soonest are the most weathered areas, which will be evident when the new rock cut face is exposed. Falling rocks are expected to be retained in the catchment ditch, but persistent rock fall from a localized release zone could undermine the toe buttress over time. Recommendations to promote stability and monitor weathered areas are presented below.

A 1H:4V rock cut slope inclination is considered suitable for this project. The overburden soil should be completely removed to expose bedrock within about 6 feet laterally from the top of rock slope. The catchment geometry shown on the plans is suitable.

The base of the soil cut slope will experience frequent seepage, and saturation of the soil at the toe could result in soil loss, rock fall out and slope instability. A doweled gabion basket system is recommended to be used as a toe buttress to promote stability. The gabions should have a 3-foot by 3-foot cross section. Each basket should be at least 6 feet long, and the edge of the gabions closest to the rock slope should be set back 3 feet from the slope crest. The baskets should be galvanized and PVC- or HDPE-coated to limit the onset of corrosion. Each basket should have a positive connection to the rock consisting of at least two galvanized, No. 8 all-thread dowels, with galvanized bearing plates, washers and locking nuts. The dowel holes should be drilled roughly normal to the bedrock surface and grouted 2 feet into bedrock. Drainage geotextile should be wrapped beneath and along the uphill side of the gabion baskets to prevent migration of fines into the gabion fill. If the bedrock surface beneath the gabions is steeper than 4H:1V, the bedrock should either be benched or leveled with a lean concrete. The recommended detail for the gabion toe buttress is included in **Appendix C**.

The soil above the rock slope is recommended to be constructed with a 2H:1V slope, with the toe starting a minimum of six inches below the top of the gabions, extending back to the intersection with the existing slope.

We recommend that the soil cut slope be covered with Erosion Control Mix to promote stability in consideration of persistent seepage noted during our site visits. Erosion Control Mix should meet the requirements of MaineDOT Standard Specification Item 717.04 – Mulch, Item (e), and should be 4 inches thick. The slope should be seeded using Seeding Method 3 in accordance with MaineDOT Standard Specification 618 – Seeding. Erosion Control Mix should be placed in accordance with MaineDOT Standard Specification 619 – Mulch.
