Building Resiliency Along Maine's Bluff Coastline

Technical Manual for use of the Shoreline Management Assessment Decision Tree

Finalized October 2017
Revised November 27, 2017

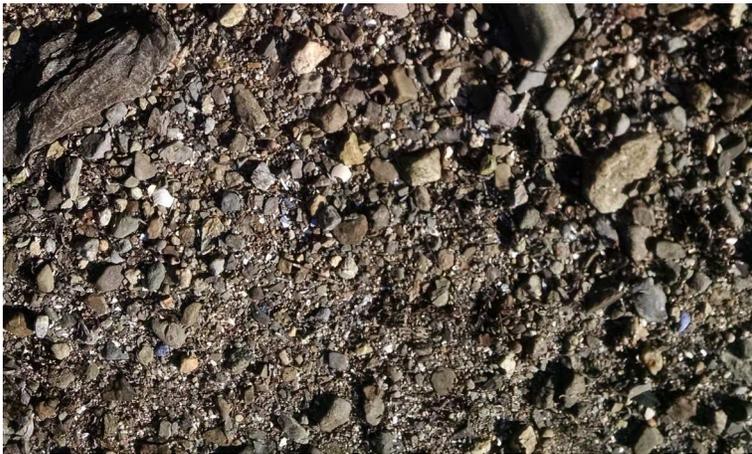
Because the soils in and around Mackworth Island consist primarily of till, the soil matrix has a high pore spacing between the sand and gravel particles. The toe of the bluff had intermittent ledge mixed with gravel and sand. Seaward of the toe intermittent beach is found consisting mainly of larger soil mixture of gravel and cobble with a scattering of boulders.

Figure 2. Soils at the Mackworth Island sites were primarily till.

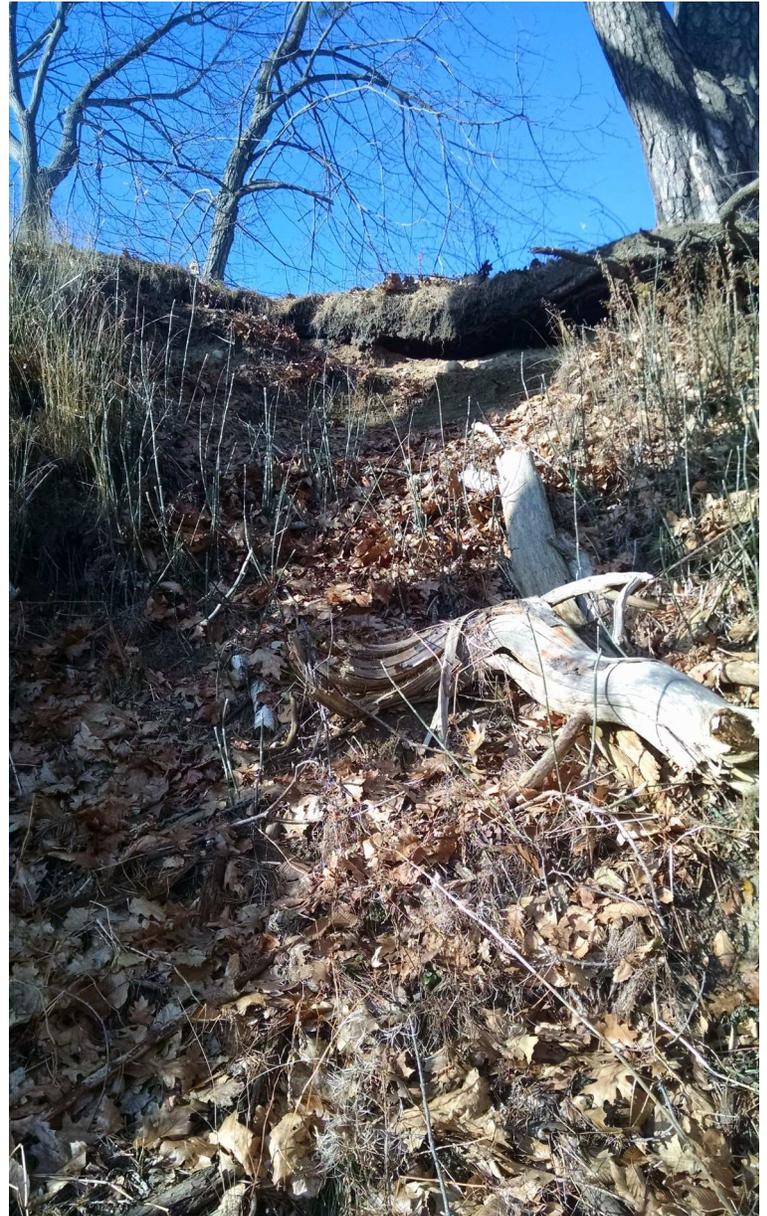
This interaction between runoff and steep exposed banks is being enhanced by the reduced vegetation in the upland area that has reduced the potential for root structure to assist in binding soil near the bluff-upland interface. Areas that have lost vegetation are seeing accelerated erosion from runoff in the form of rills, allowing the vegetated areas to be vulnerable to rapid erosive change.

Figure 3. Removal of upland vegetation increases erosion at the Mackworth Island sites.

Soils and slopes like those in this location require healthy and deep-rooted vegetation to provide soil strength, in turn reducing erosion risk. It is likely that the multiple freeze-thaw events and water runoff from upland areas that reach the top of the bluff or the face through seepage is instrumental in the process. The sand/gravel soil matrix combined with low absorption root structure provided excellent conditions for the bluff to have multiple shallow failures. Water in and around the slope is a common agent in causing slope instability and erosion.

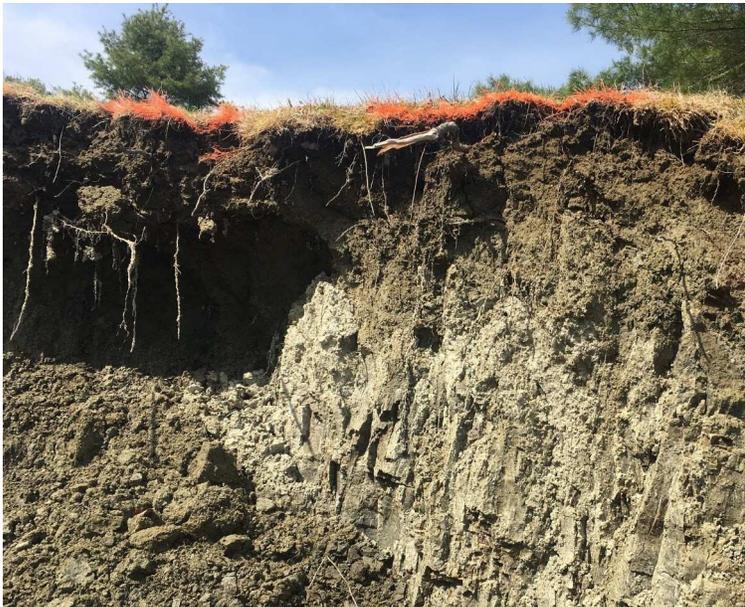
Soils exposed by the landslide are predominantly clay in nature. Because clay particles are small and generally have large aspect ratios, interactions between the particles and water can result in reduced shear strength and underground movement and contribute to landslides. The Maine Geological Survey has identified two landslides along this shoreline of Mere Point.

Figure 2. Clay soils visible in bluff failure at Mere Point Case Study location.

The drainage area that provides overland flow to the top of the failure is approximately 260' by 165' with three concentrated flow paths to the top of the bluff slope. One of these concentrated paths leads to the point of the bluff mass wasting failure (see Figure 2).

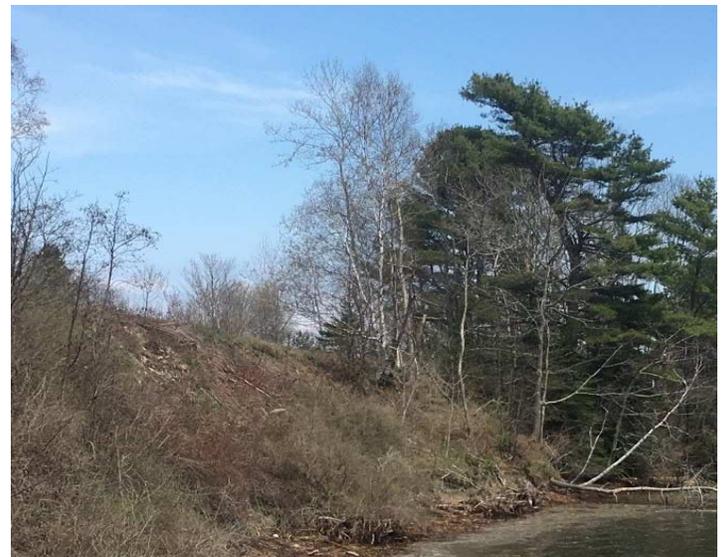
Figure 3. Saturated, clay soils with shallow slope failures.

It is likely that the drought and weather conditions described previously, combined with active surface runoff, created rapid swell in the clay soil. This combination with little root structure to take up water during the saturation period provided excellent conditions for the bluff to fail as a landslide. It appears that this process has been occurring episodically and likely an evolution of failures has occurred in this cove. Evidence of former slumps can be seen in adjacent slopes where shallow failures are currently occurring.

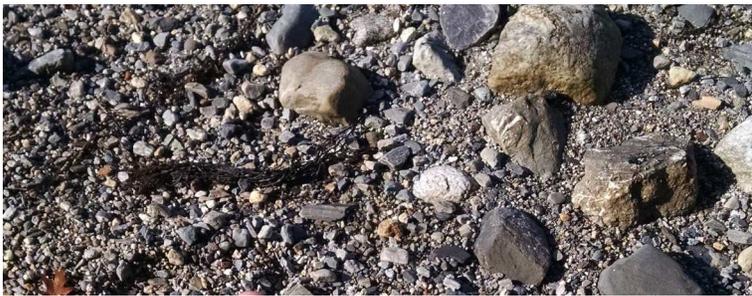
Soils in and around Mitchell Field exposed by the shallow failure appear to be predominantly sandy and gravelly, consistent with the unconsolidated sand/gravel particles common in glacial till. The toe of the bluff is comprised of clay mixed with gravel and sand. The shore beyond the toe of the bluff consists mainly of sand and gravel helping form the beach found here.

Figure 2. Sandy and gravelly soils at Mitchell Field site.

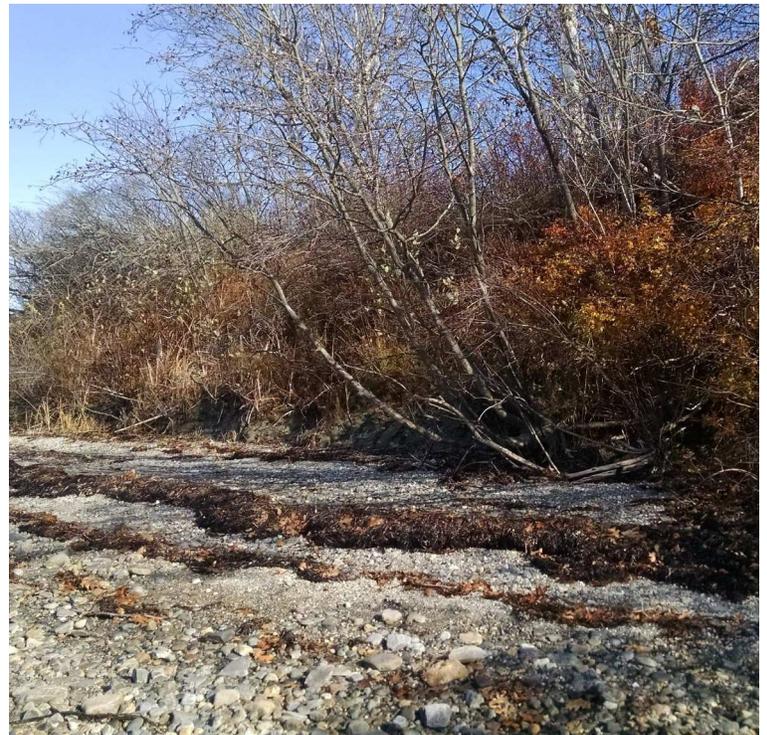
The field upland to this location is regularly mowed, and trees and both woody and herbaceous plants are intentionally removed to maintain a walking and viewing area at the top of the bluff. Several smaller trees and herbaceous growth have slid down the slope, creating exposed soil during movement. Most of the remaining vegetation is currently growing at an angle, likely due to the shallower root structure of this vegetation. Lack of vegetation to stabilize slope is exacerbated by the effect of surface runoff reaching the face at the top of the bluff.

Figure 3. Much of the vegetation at the Mitchell Field site is growing at an angle, likely due to the plants’ shallow root structure.

- Consider a living shoreline approach along the toe, using plantings for stabilization.
- Stabilize the toe with wood to encourage the beach to remain in place.
- Plant additional woody and herbaceous vegetation throughout the face of the shallow failure.
- Establish both woody and herbaceous vegetation in the upland area beyond the top of the bluff.
- Consider heavy planting in the concentrated flow path areas. Use plants that will provide large water absorption in the vadose zone.
- Determine the soil pH to identify native plants that would be most successful.
