Colburn House

33 Arnold Road
Pittston, Maine

Historic Structure Assessment

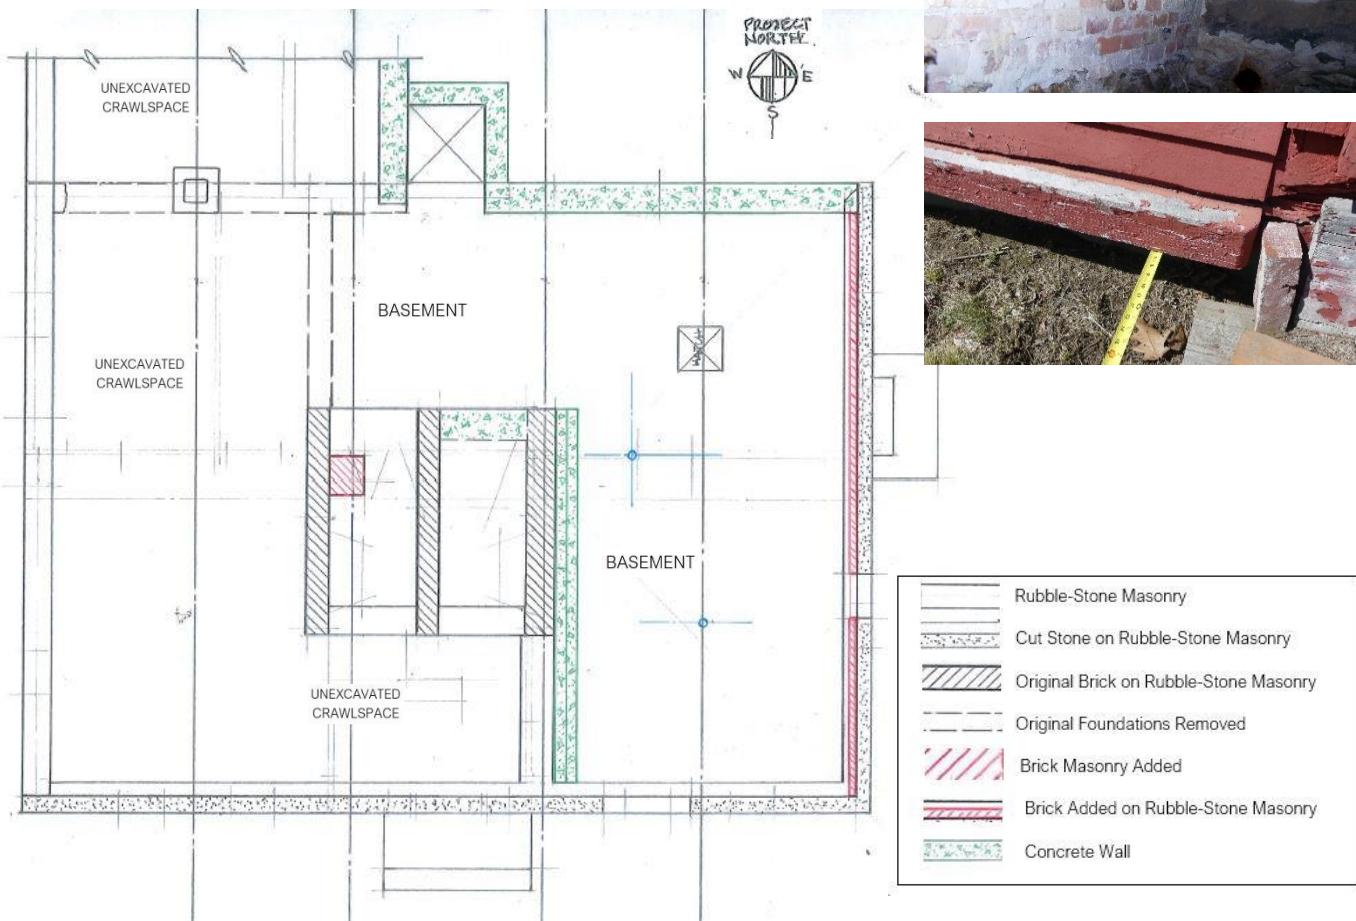
The granite blocks used for the upper foundations of the south and east walls are cut, single slabs set on edge as a both a finish veneer and a supporting element of the timber framing to the rubblestone walls. There are some significant displacements of the granite blocks noted relative to the sills, in excess of several inches in some locations. In an attempt to improve the situation, a single wythe of brick was added along the top of the east wall, possibly with the intent to provide additional support under the timber sill there. This brick obscures the upper portion of the foundation wall from view, and it allows a conduit for intruding moisture through the masonry. There is a bow in the brick, which may be due to the displacements of the granite curb blocks of the outer wythe of the wall.

The displacements are due to frost and frozen soils in the exterior ground pressing on the dry-laid foundation masonry, working the joints along the basement walls, particularly where the granite block top curb meets with the stone masonry. This, combined with a lack of fixity between the granite and the timber framing, has allowed some significant movement of the wood-framed wall sills, some bowing of the stone masonry foundation walls, and separations of the granite block joints, some of which have been mortared-over or filled with caulking. The movements in the foundations over time has opened joints between

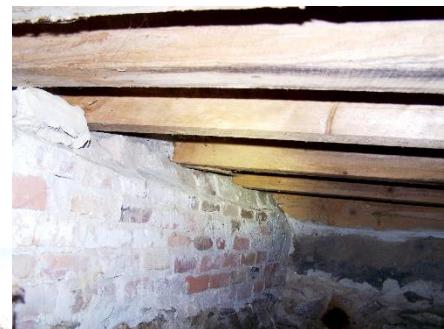
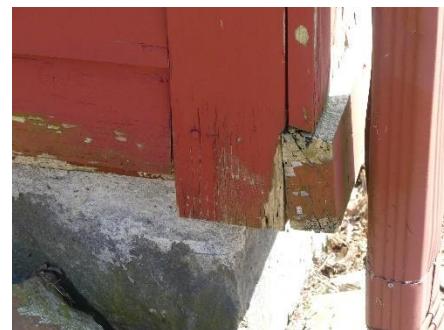
the stones of the masonry, to allow further infiltration of water and subsequent damage to the structure as a whole. The addition of cement mortar into the joints of the basement has had little benefit against this on-going problem. Issues of freeze/thaw resulting from a lack of heat in the building during winter months are extended into the general basement area, increasing the potential for heave damage to the foundations.

The masonry walls of the exterior east, south and west walls generally appear to be in poor to fair condition, due to rotations of the granite curb blocks on the east and south walls, and spalls and mortar loss along the west wall. Viewed from the interior the stone masonry has open joints and cracked mortar. The walls of the crawlspace area could not be viewed due to the high grade of the fill soils. Visible joints of the stone have been mortared, but it is not known when this mortar was added. The added brick masonry infills at the east wall prevent evaluation of the original masonry at the top of the wall; The brick appears to be bowed, and it may need reconstruction due to the effects of water infiltration.

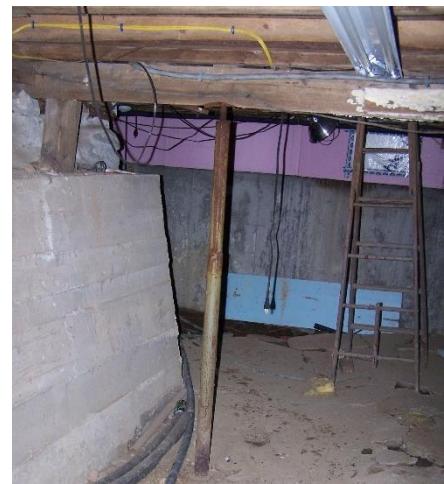
Alternatively, given the historic value of the building, the expected long-term future use of the facility and the need to conserve the exhibits within the building, it may be worthwhile to remove the existing perimeter masonry foundations entirely, and replace the existing foundation with new walls to extend to below the minimum recommended bearing depth of 5 feet below finished exterior grade, so frost and water intrusion through the masonry and basement floor will be reduced or eliminated as a problem. Additional headroom depth and a re-conditioned basement area could be accommodated in the reconstruction.

- 3.2.B.2 *Removal and reconstruction of the foundation walls to provide frost-protection to the foundations is recommended to restore the integrity of the building foundations and stabilize the building structure and envelope.*
- 3.2.B.3 *Investigation of the subsurface conditions along the exterior foundation walls is recommended to ascertain condition of the foundations and site drainage. If results indicate, a scheme for improvements to site drainage and waterproofing around the building perimeter to maintain the integrity of the foundations should be developed and implemented.*

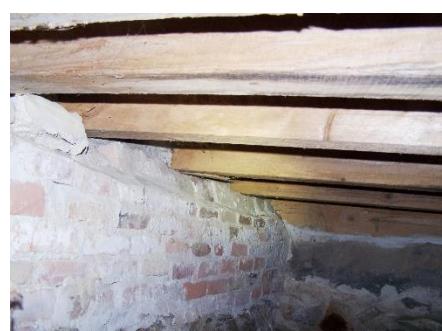
Along the east wall, the replacement joists and reinforcement beams appear to be bearing on pockets constructed in the brick masonry infill that obscures the upper portion of the stone foundations and the timber sill from view. Based on the amount of displacement of the framing wall that can be observed from the exterior of the building, exacerbated by dislocation of the granite curbs supporting the timber sills, it is likely that the sills along this wall have been substantially damaged by rot.

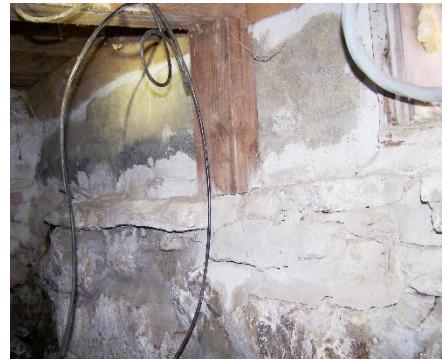
Along the south wall, the remaining foundation walls and timber sills appear to be the most intact, original construction of the basement area. Continuing on along the crawlspace area and turning along the west wall, it appears that the existing construction is substantially as original, also. Based on the amount of displacement of the framing wall and the dislocation of the granite curbing that can be observed from the exterior of the building, it is likely that the timber sills along this wall have been substantially damaged by rot, but this was not verified at the time of the site visits. There are sagged areas of the first floor that were noted, particularly along the front, main entry hall threshold, that suggests that there is a loss of structural support in that area due to degradation of the sills and/or the foundation support.

There were some sags and humps noted in the plane of the floor, which suggests that there may be some differential settlements of the interior foundations or rot damage and shrinkage of the timber framing members, resulting over the lifetime of the building. Otherwise, the condition of the floor framing seems to be fair, generally. From the basement it can be seen that rot and fungal growth is occurring on both new and original framing members.

- 3.2.C.1 *The mitigation of rot and fungi growth on the timbers of the structure is recommended.*
- 3.2.C.2 *No modifications of the first floor framing are anticipated at this time, so long as the current occupancy use remains the same. Replacement of screw-jack posts and ad-hoc timber posting with proper columns, foundations and positive framing connections is recommended.*
- 3.2.C.3 *Because of a lack of access to the timber sills at the masonry foundations, and poor condition noted at some spot-locations, further investigation of the perimeter and interior timber sills is recommended to verify the condition of the sills with regard to deterioration due to rot, etc., and that a scheme for remediation of any damaged or unsound conditions found be developed and implemented as needed.*

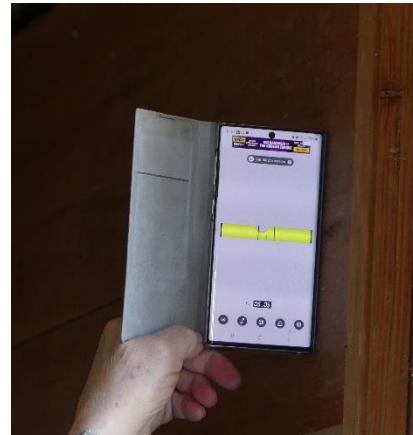
Level reading 5.05 degrees

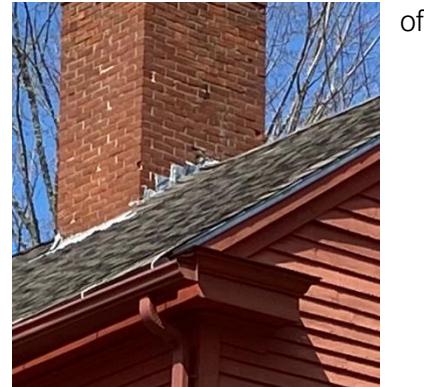
The metal drip edge along the rakes and eaves is conspicuous due to its shiny finish.

- 2. We recommend that at the time of roof replacement a prefinished aluminum drip edge matching the roof trim color be installed.

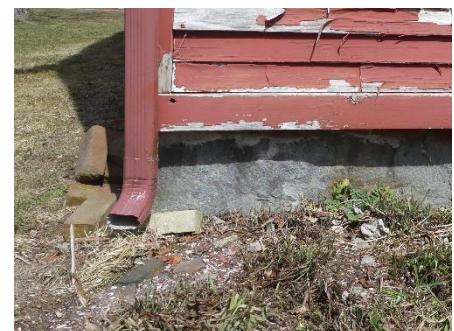
Modern aluminum gutters with downspouts are installed at the north and south roof slopes of the house. The two downspouts at the south elevation discharge directly on the ground at the foundation. One of the downspouts on the north elevation discharges into a wooden trough sending the water away from the building. The other downspout from the north roof gutter discharges directly onto the kitchen ell roof where it is collected by another gutter system.

- *2. We recommend that ground level leaders be installed at downspouts to effectively move rainwater away from the building foundation.*

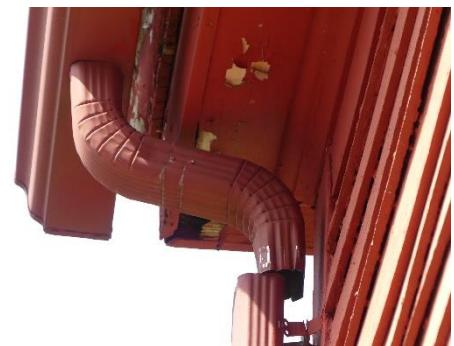
The west downspout on the south side of the building has become disconnected and is discharging water onto the façade of the building. This has resulted in significant loss of paint in this area.

- *3. We recommend disjoined downspout be reconnected.*

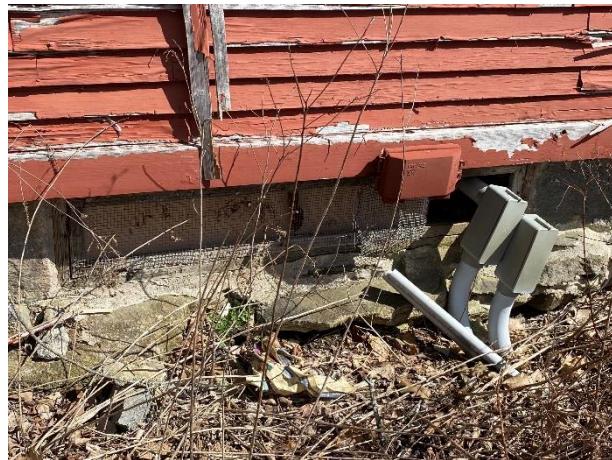
Basement windows have largely been covered over and insulated. A three-lite sash window is present on the ground by a window opening along the west wall. Other openings have been covered with wire mesh. The mesh at the opening on the south wall has been pulled back to allow electrical connections to pass through and currently allows animals to enter the building at this location.

- 2. *We recommend that the basement level opening on the south wall be covered to prevent animals from entering the building. This opening to be replaced when new foundation is installed.*
