PROJECT: Roof Replacement of
Field House, Maine Maritime Academy
Castine, Maine

SUBJECT: ADDENDUM NO. 3

DATE: December 6, 2018

Royal Adhesives & Sealants Pull Test Result Sheet

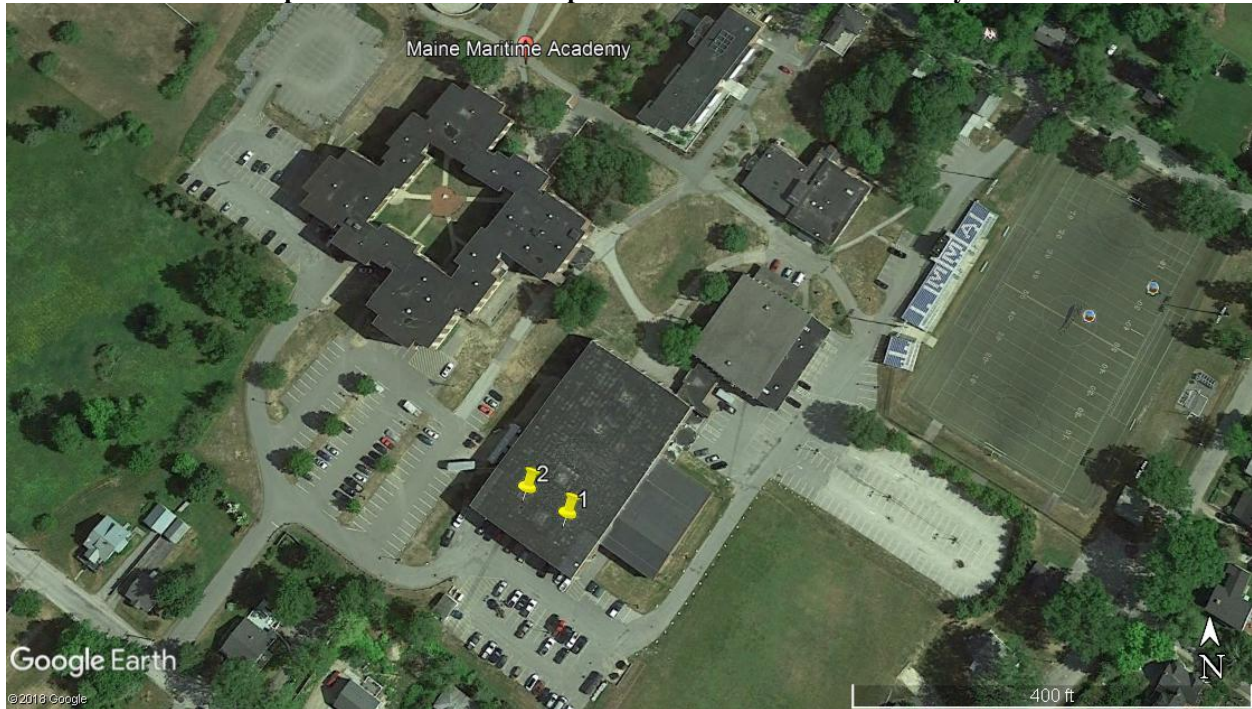
Note on picture where tests were performed. Pull test areas noted by number.

2 square test areas were identified for testing directly to concrete decking using existing ISO.

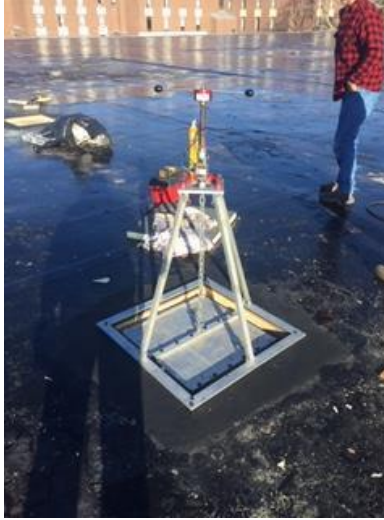
In test area #1 Millennium One Step was applied in a 4" on center pattern over concrete decking. A 2' by 2' piece of 2" polyisocyanurate was set into the wet adhesive and held in place until it was locked into position. Then a 2'x2' piece of 3/4" plywood was set in and held in place. The adhesive beads were left to cure for a minimum of 60 minutes prior to conducting the pull tests per ANSI/SPRI IA-1 2010 specification.

Test area #1 before pulling on assembly

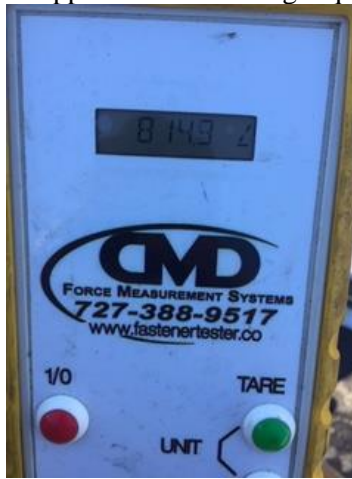
Pull test #1 as test passed 805lbs = 195PSF
Test was stopped after exceeding requirements

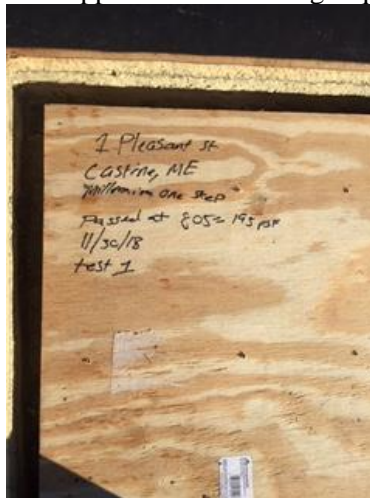
Test #1 was stopped after exceeding requirements

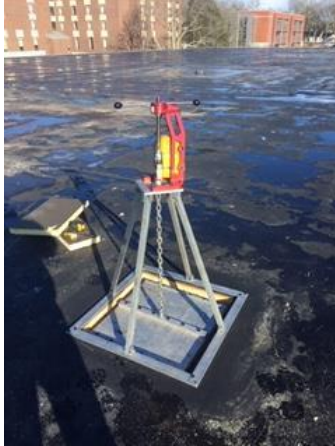
In test area #2 Millennium One Step was applied in a 6" on center pattern over concrete decking. A 2' by 2' piece of 2" polyisocyanurate was set into the wet adhesive and held in place until it was locked into position. Then a 2'x2' piece of 3/4" plywood was set in and held in place. The adhesive beads were left to cure for a minimum of 60 minutes prior to conducting the pull tests per ANSI/SPRI IA-1 2010 specification.

Test area #2 before pulling on assembly

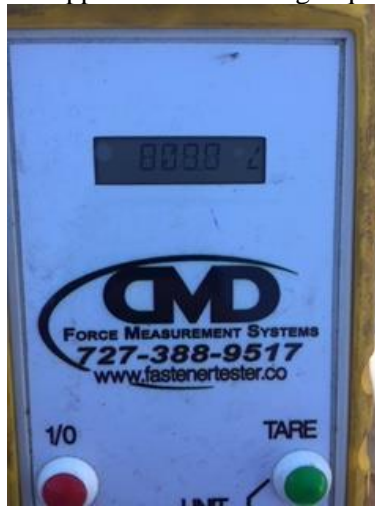
Pull test #2 as test passed 805lbs = 195PSF
Test was stopped after exceeding requirements

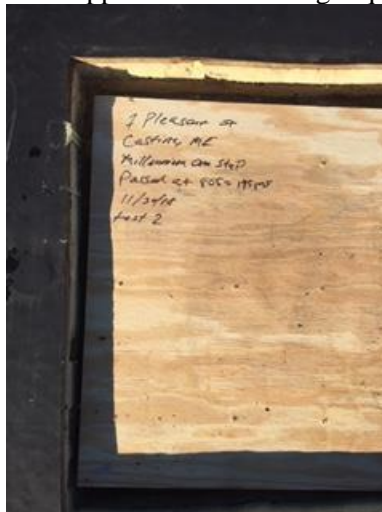
Test #2 was stopped after exceeding requirements

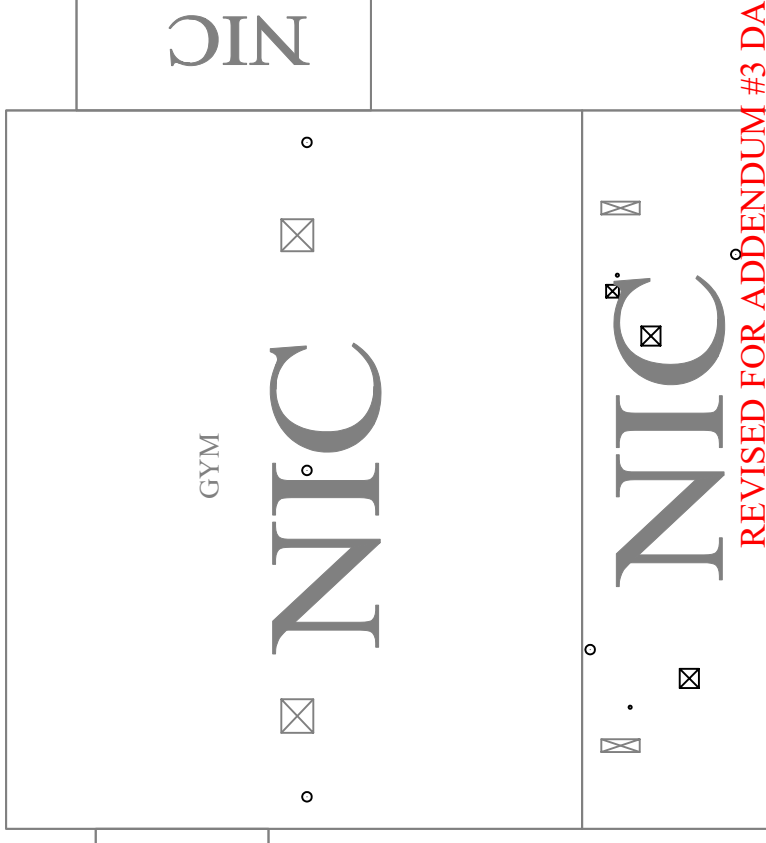
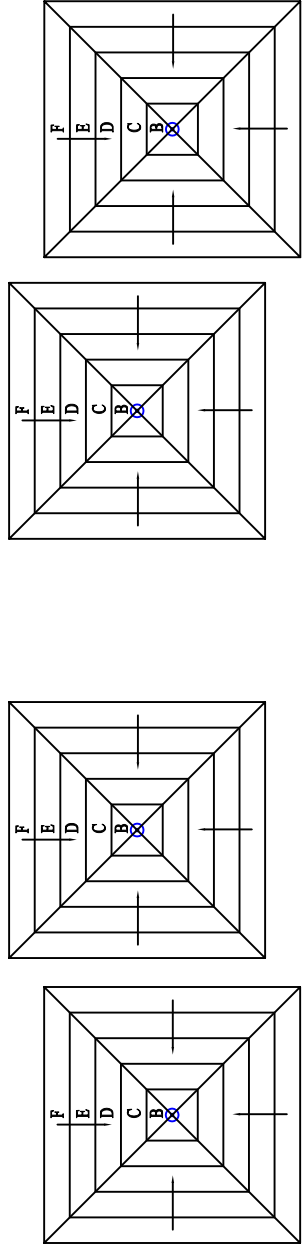
MAINE MARITIME ACADEMY CASTINE, MAINE		DRAWN BY: WEB
INDEPENDENT ROOF SERVICES POWNAU, MAINE	SCALE: 1"=30'	REVISED BY: JLB
TITLE: EXISTING ROOF PLAN		
DATE: 11-6-18	FILE NAME: MMA	DRAWING #: R1

Drawing R1 and R2 have been revised to show an area where 7/16" OSB was used as a cover board and the re-issued drawings no longer show a fan curb that was long ago removed from the roof. Drawing R1 and R2 revised for addendum number 3 are attached hereto.

18'x48' AREA OF OSB COVER BOARD
