RE: LeBlanc Dry Cleaners Investigation
10 Lafayette Street
Lewiston, Maine

At your request, Beacon Environmental Consultants, LLC (Beacon) completed a Ground Penetrating Radar (GPR) survey and limited concrete removal at the former LeBlanc Dry Cleaners (REM#02364) located at 10 Lafayette Street in Lewiston, Maine. See **Figure 1** for a Site Location Map.

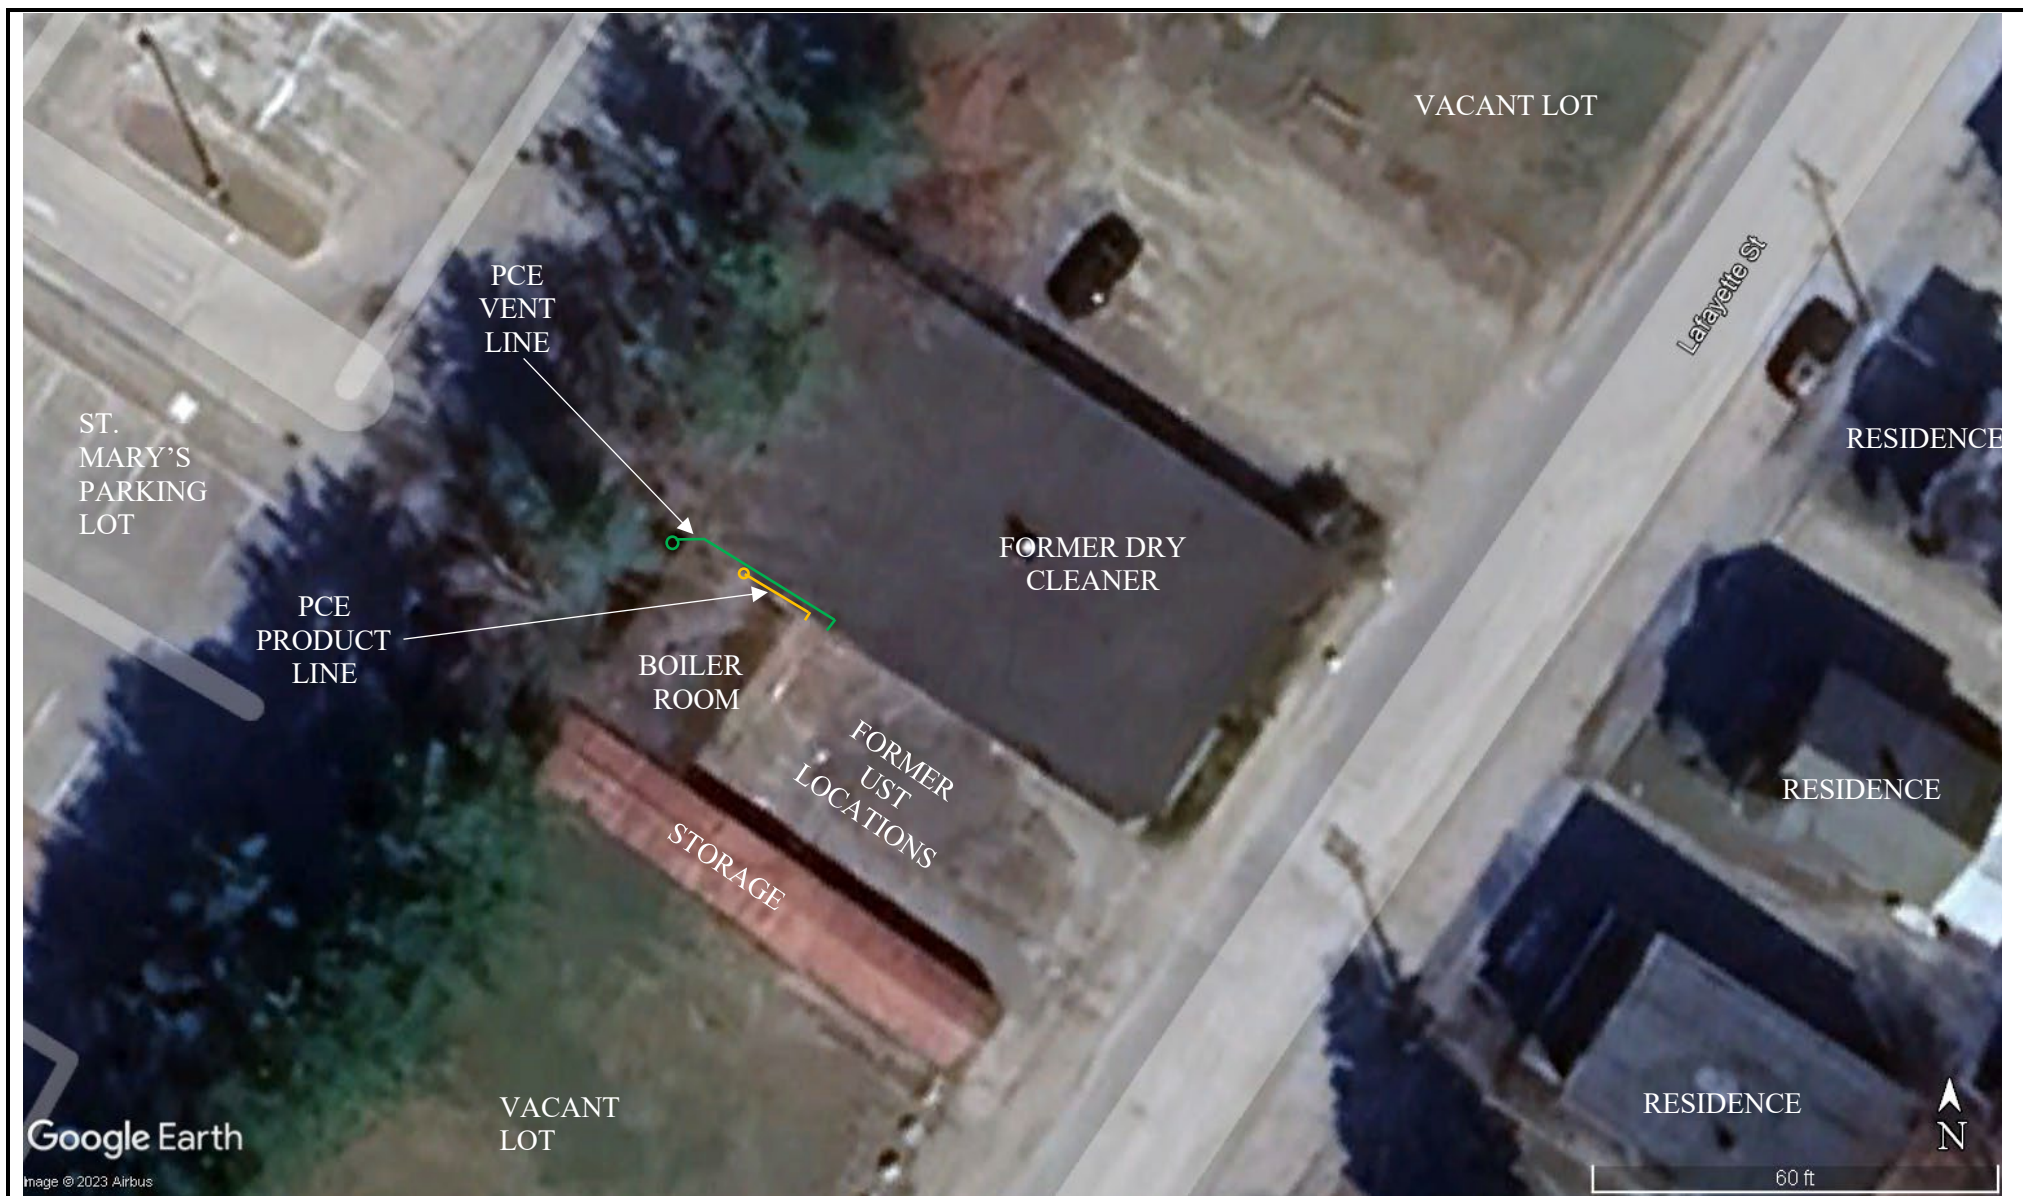
FIGURE 2: SITE FEATURES
LEBLANC CLEANERS, LEWISTON, MAINE
Project No.: BE-661

On November 30, 2023, Beacon, ProMark, EPI, and MEDEP staff completed a GPR survey within the building which also included concrete scanning, electronic sonde locating, and hand excavation. Piping formerly associated with the PCE UST was discovered to be present under the northwestern portion of the building. No USTs were discovered.

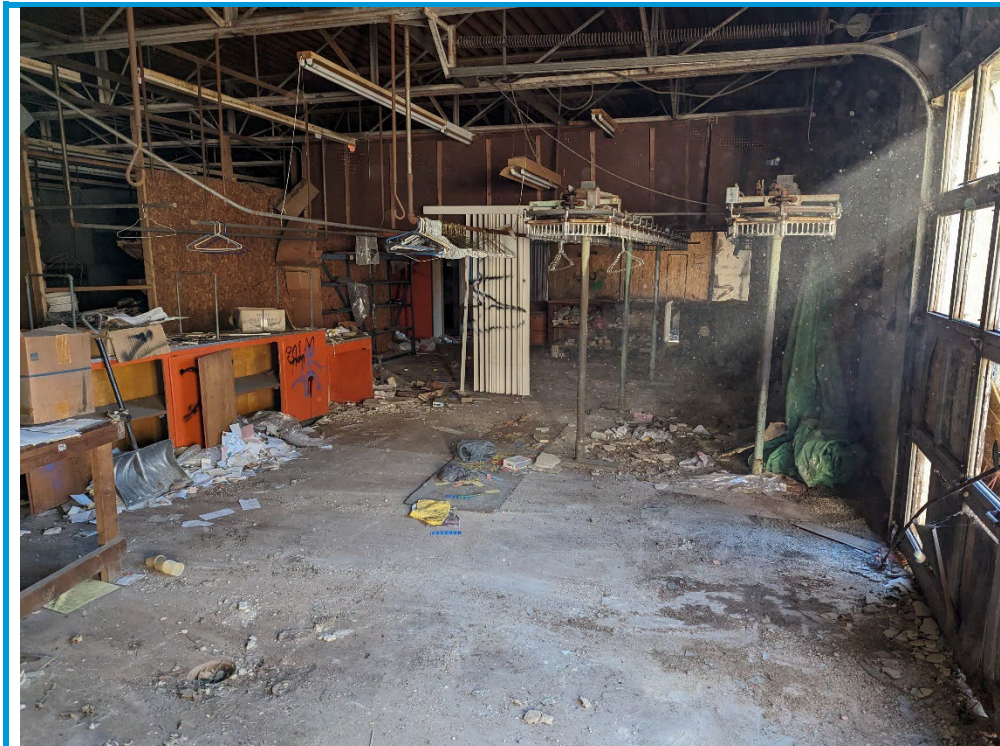
Photo No. 1

Description:
Interior of the site
building.

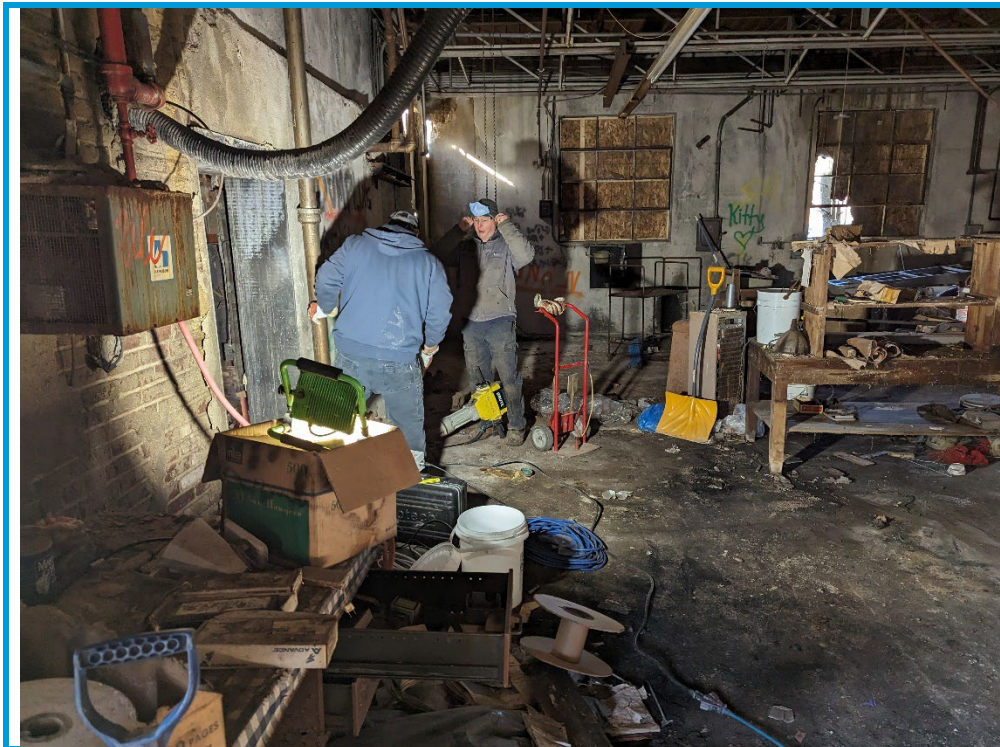
Photo No. 2

At this time, Beacon requested that EPI utilize a jack hammer to remove the concrete around the interior pipe. Removing the concrete around the interior pipe showed that this pipe turned to the south. ProMark used the concrete scanner to determine that the pipe did in fact follow this track and that a second pipe was beside it following in this direction as well.

Description:
Removing concrete
around the interior pipe.

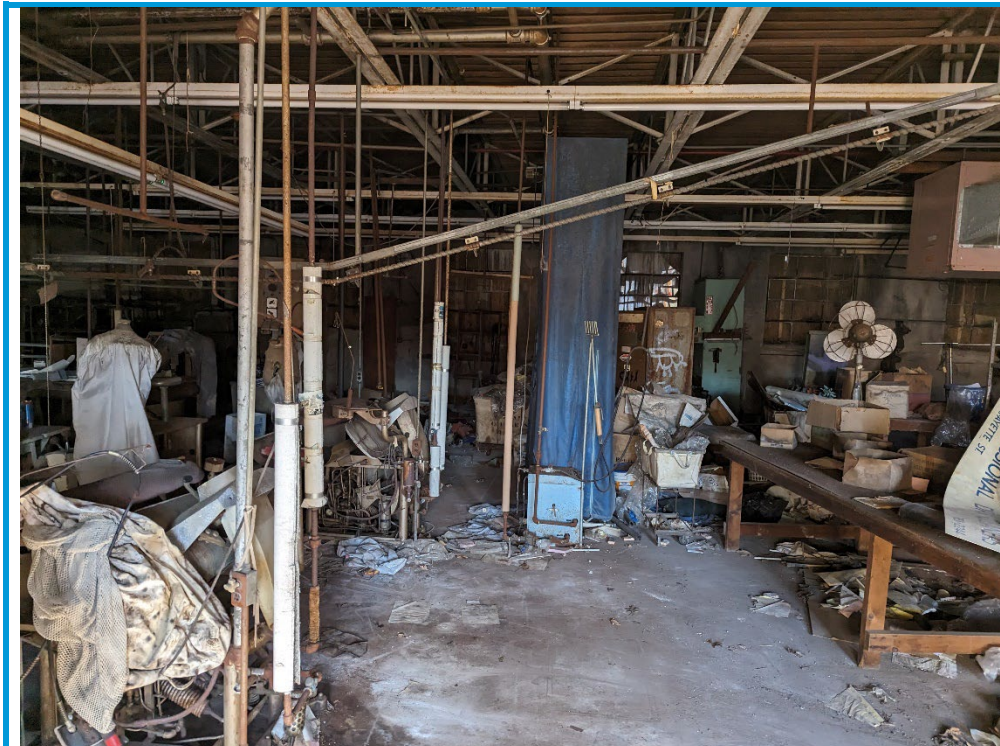
Photo No. 3

Description:
Interior of the building
with a cleared area for
GPR work.

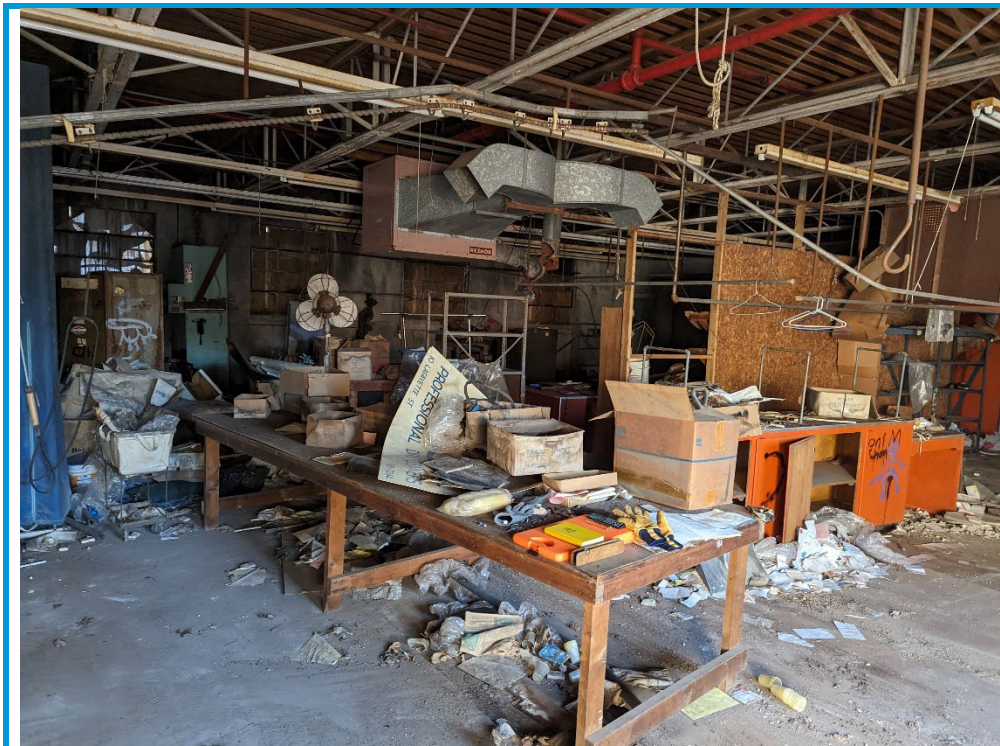
Photo No. 4

Description:
Interior of the building.

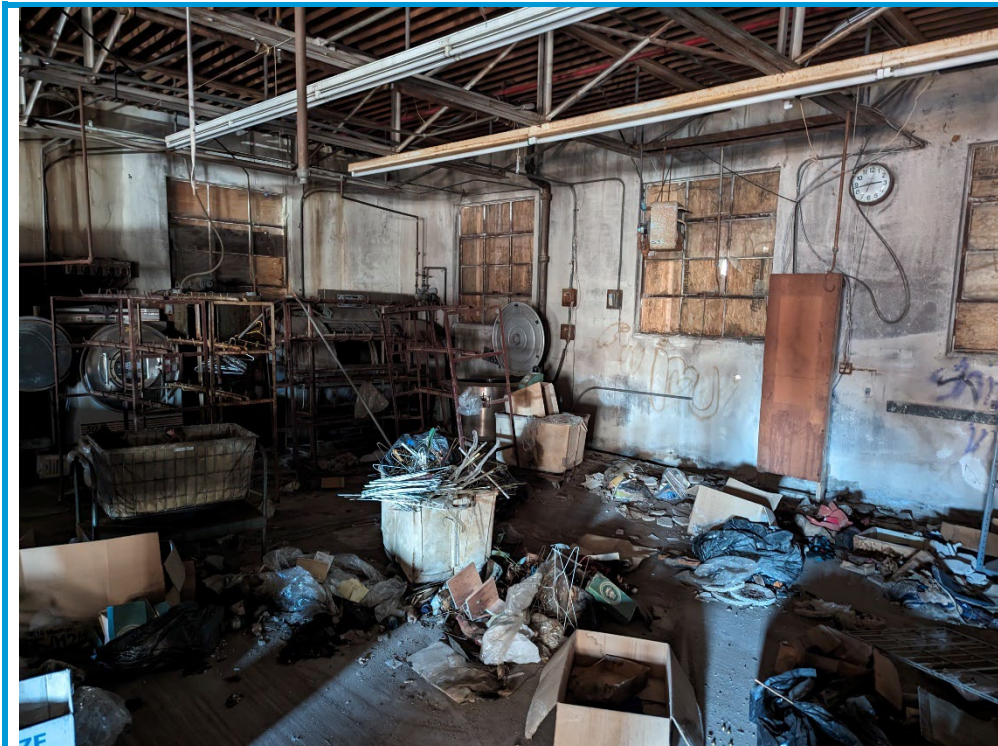
Photo No. 5

Description:
Interior of the building
with debris moved back to
an area after it had been
scanned.

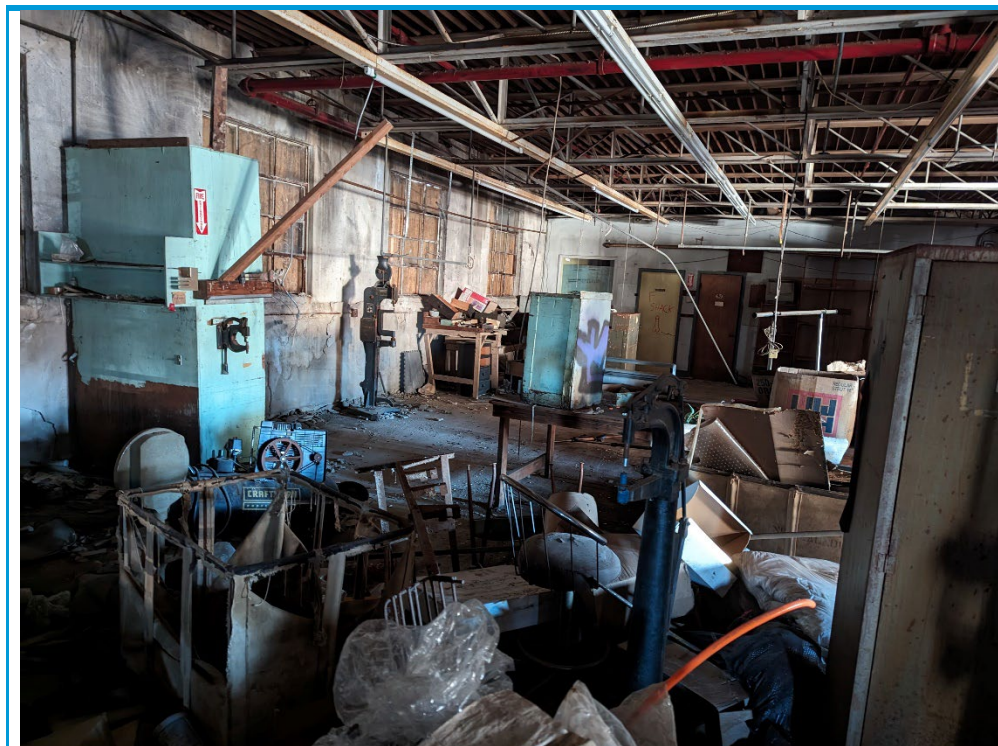
Photo No. 6

Description:
Interior of the building
with a cleared area for
GPR work.

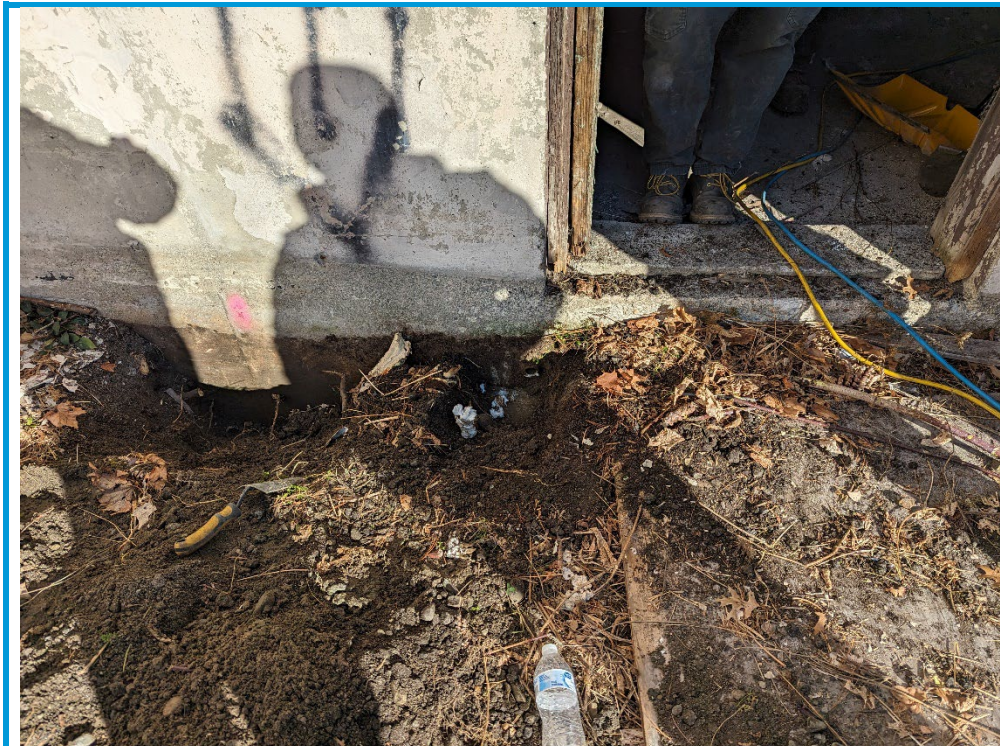
Photo No. 7

Beacon excavated soil on the exterior of the building where the PCE UST had been located and found the pipe where it entered the building. Water was poured into the interior pipe and it appeared in the excavation. A second excavation was completed to the south of the side entrance door and the end of another pipe was found. Utilizing the electronic sonde, ProMark discerned that this pipe was the end of the vent pipe observed to the north of the structure.

Description:
Location of former
product pipe on the
exterior of the site
building.

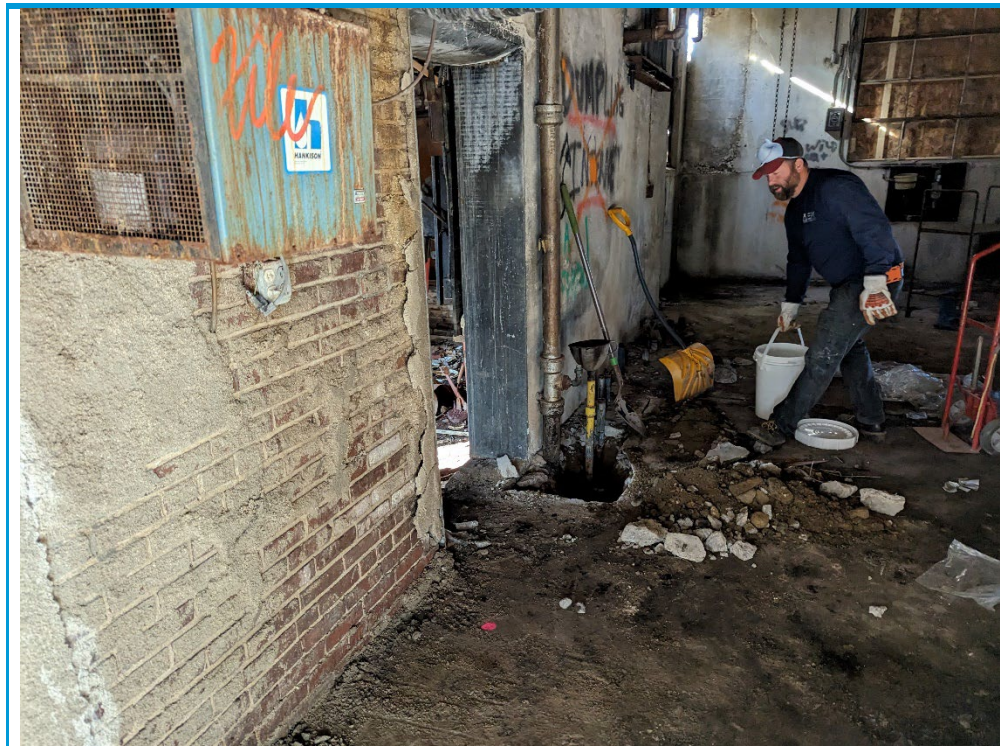
Photo No. 8

Description:
Preparing to pour water
down the interior pipe
(former product line).

- An ACM survey be completed prior to demolition;
- If the structure is demolished, sampling of the concrete slab should be completed to determine whether concrete exceeds hazardous waste guidelines;
- If the building is demolished, piping previously connected to the perchloroethylene UST should be assessed per the MEDEP rules;
- Soils beneath the slab should be sampled to document whether impacts above the MEDEP guidelines exist;
- RCRA Closure will be needed to be completed once the structure has been removed or a final investigation has determined that impacts are not present.
