June 3, 2024

**Re: Toddy Pond Dam | Orland, Maine**

AIM DEVELOPMENT USA, LLC  
TODDY POND DAM

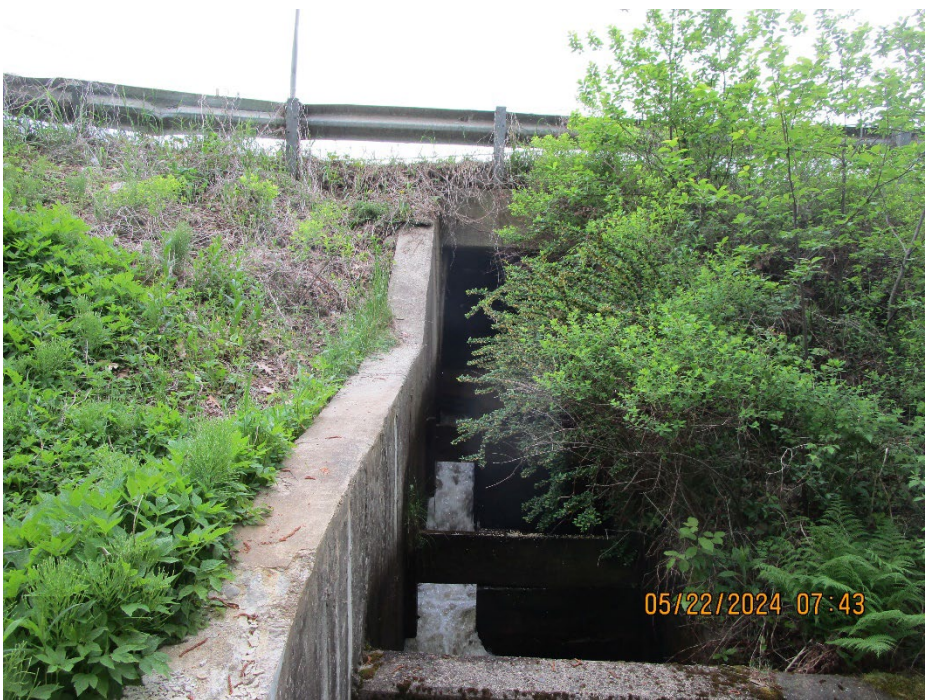
| <b>Photo No. 1</b> | |

| <b>Description:</b><br>Fishway Retaining<br>Wall | |

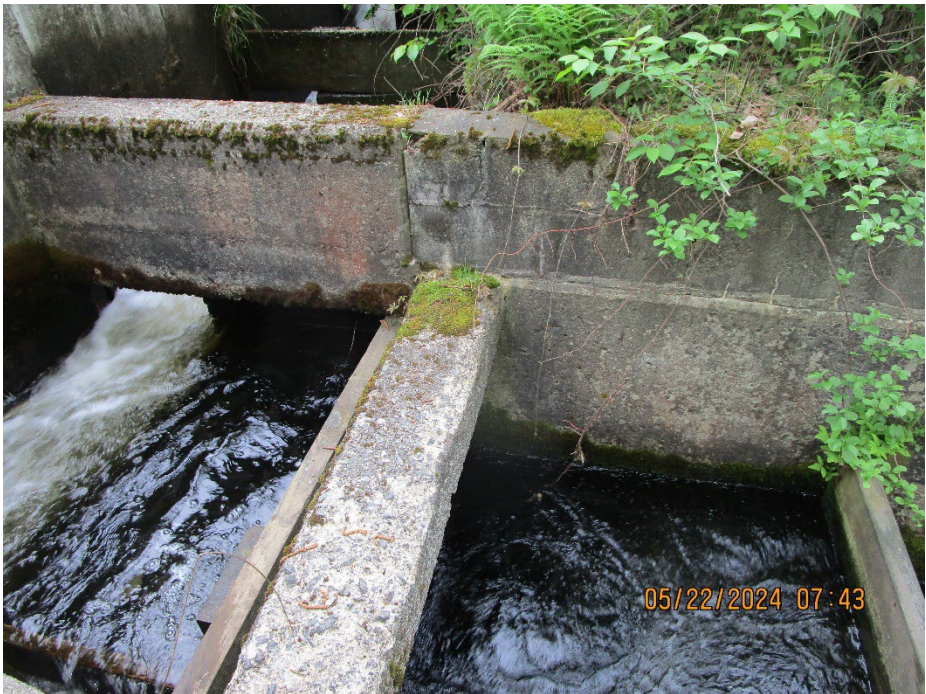
| <b>Photo No. 2</b> | |

| <b>Description:</b><br>Fishway Concrete<br>Structure | |

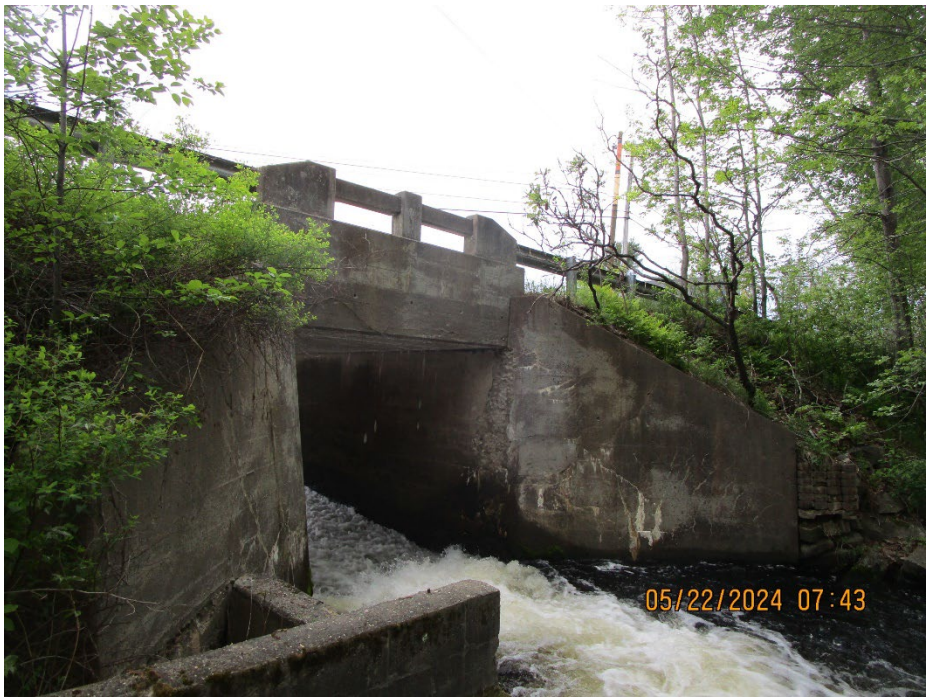
| <b>Photo No. 3</b> | <p>05/22/2024 07:43</p> |

| <b>Description:</b><br>Concrete Bridge<br>With Abutments and<br>Wing Walls | |

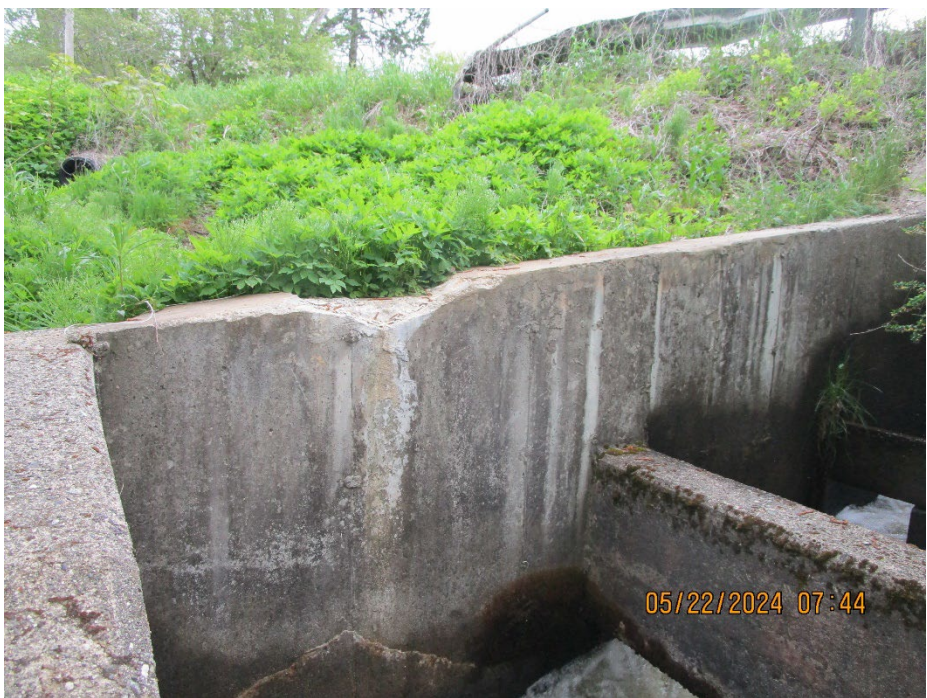
| <b>Photo No. 4</b> | <p>05/22/2024 07:44</p> |

| <b>Description:</b><br>Spalled Section of<br>Fishway Retaining<br>Wall | |

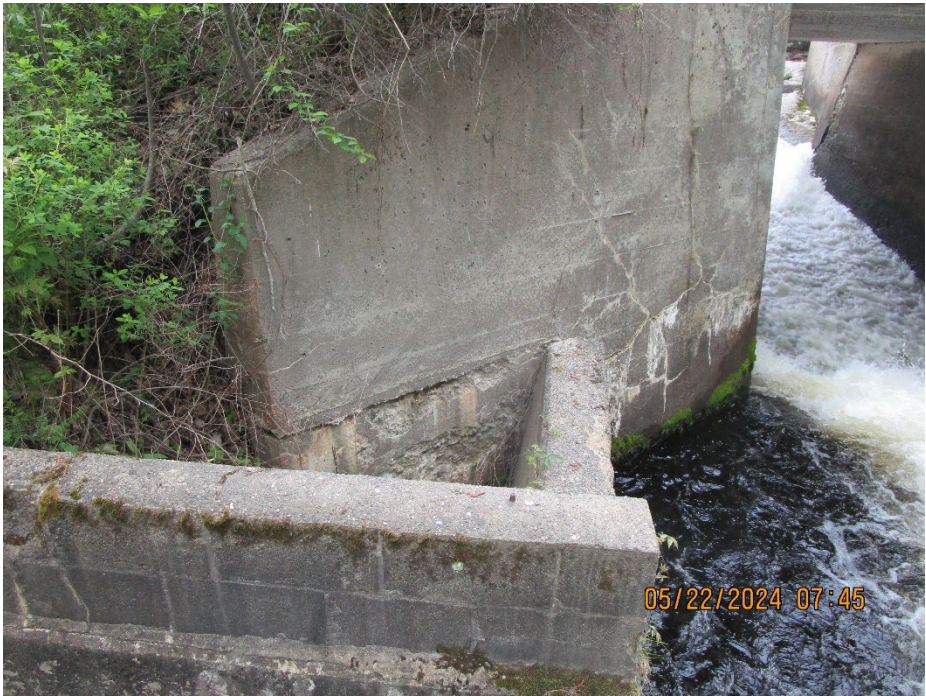
| <b>Photo No.</b> 5 | <p>05/22/2024 07:45</p> |

| <b>Description:</b><br>Concrete Fishway<br>and Concrete Wing<br>Wall Showing Signs<br>of Deterioration | |

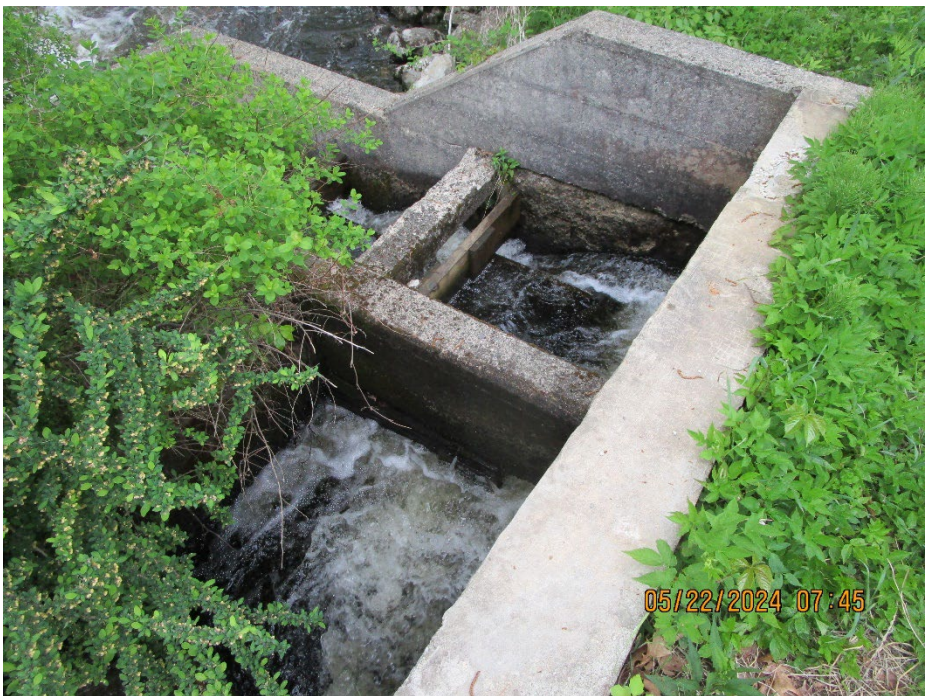
| <b>Photo No.</b> 6 | <p>05/22/2024 07:45</p> |

| <b>Description:</b><br>Concrete Fishway<br>Showing Some<br>Deterioration | |

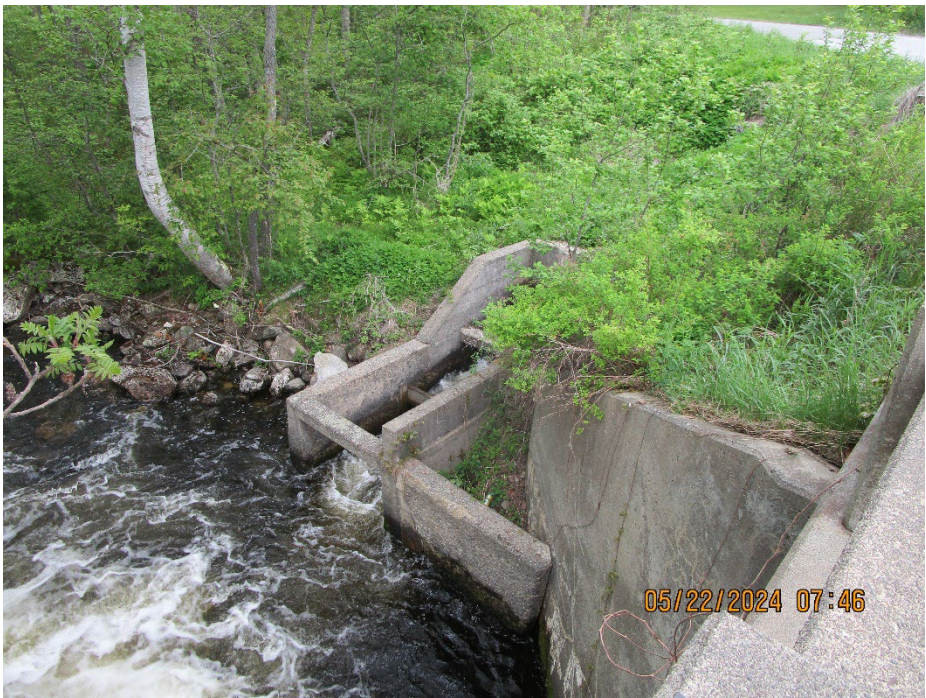
| <b>Description:</b><br>Concrete Fishway at<br>Entrance to the<br>Stream | |

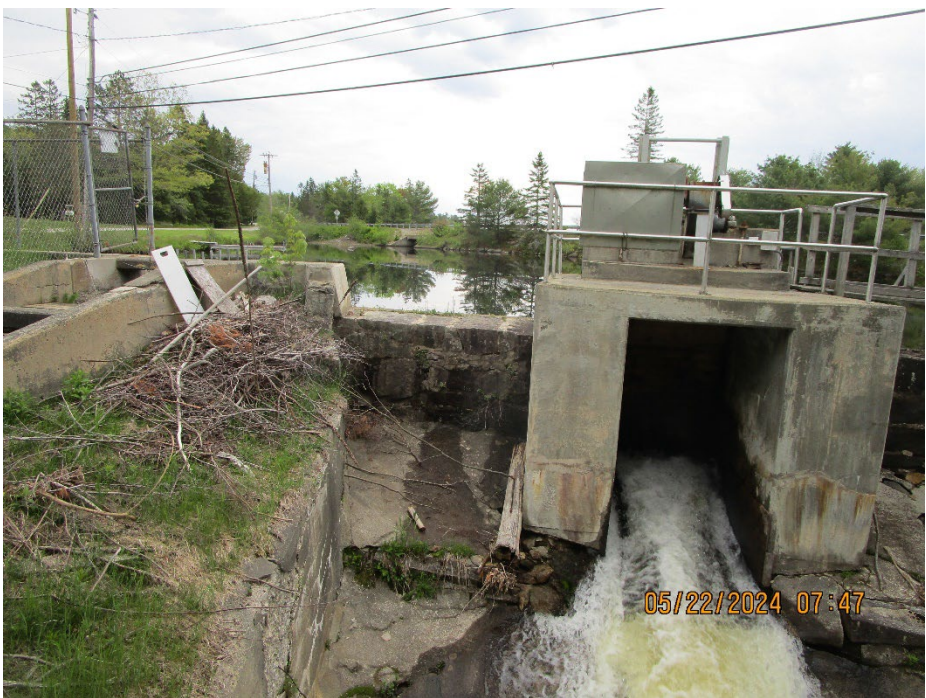
| <b>Description:</b><br>Concrete Spillway,<br>Apron, Retaining<br>Wall, and Head<br>Gate with Elevated<br>Deterioration | |

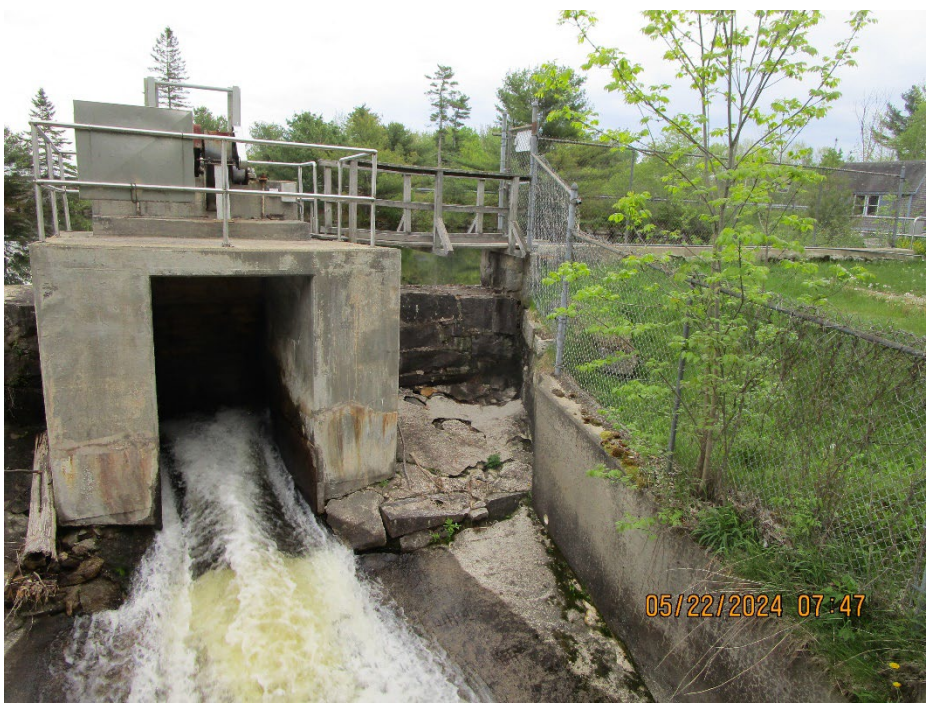
| <b>Photo No.</b> 9 | |

| <b>Description:</b><br>Concrete Spillway,<br>Apron and Retaining<br>Wall With Elevated<br>Deterioration | |

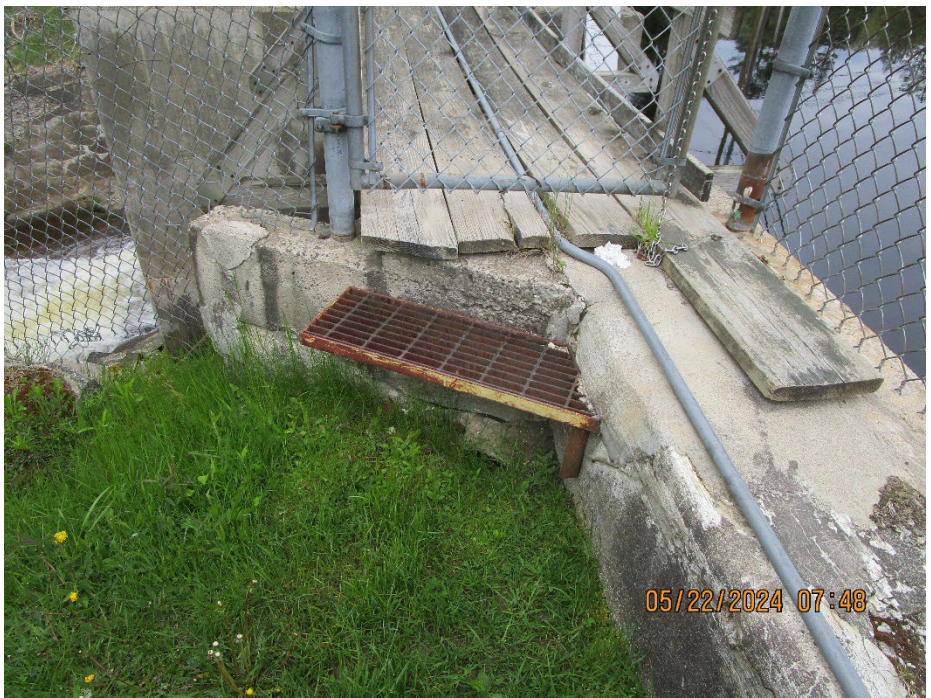
| <b>Photo No.</b> 10 | |

| <b>Description:</b><br>Concrete Dam<br>Section with<br>Deterioration | |

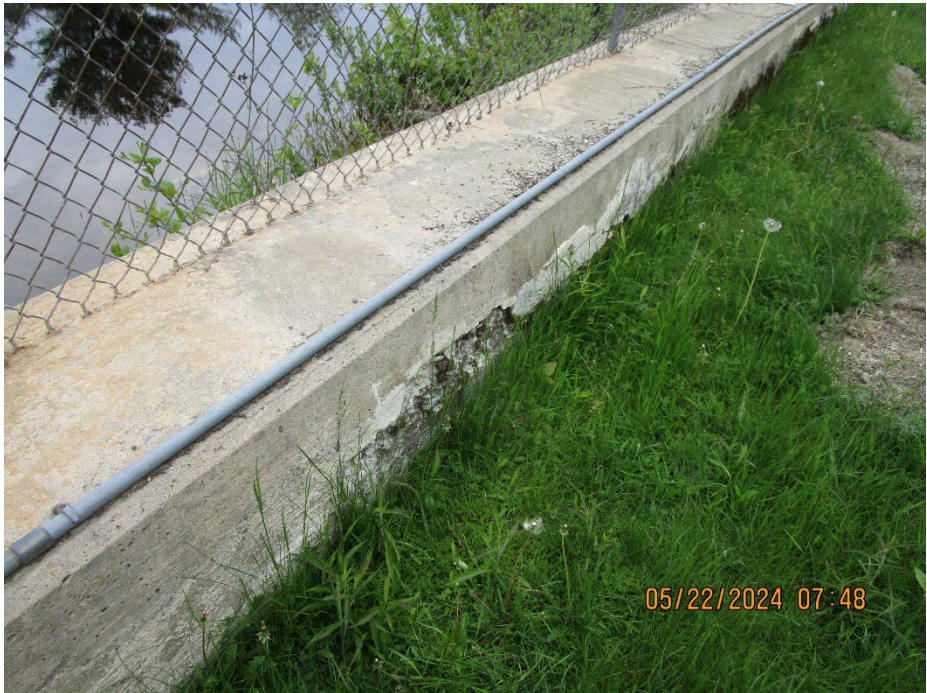
| <b>Photo No.</b> 11 | <p>05/22/2024 07:48</p> |

| <b>Description:</b><br>Concrete Cutoff<br>Wall with<br>Deterioration | |

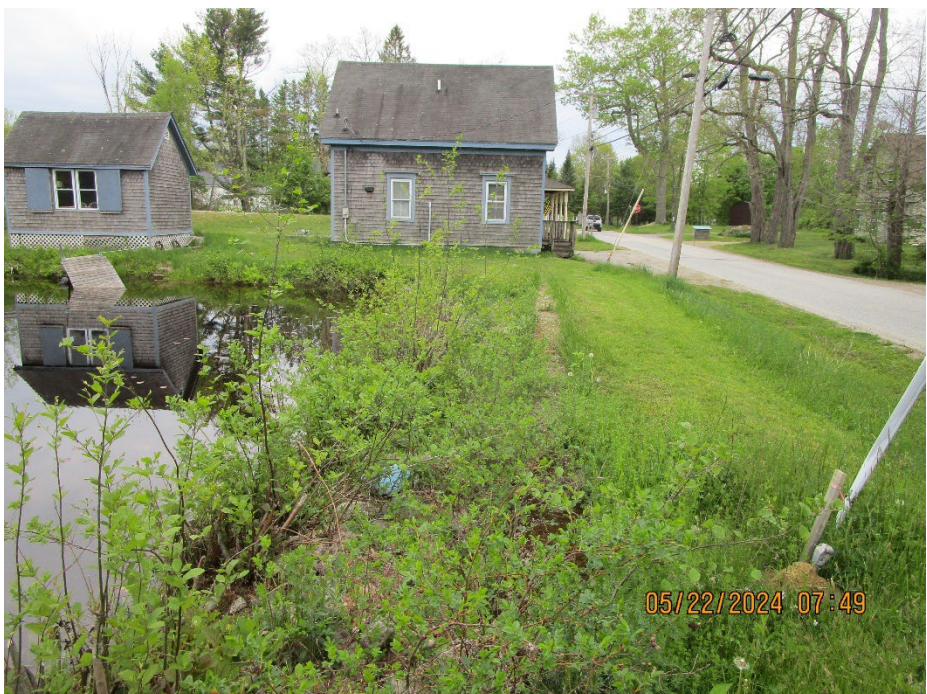
| <b>Photo No.</b> 12 | <p>05/22/2024 07:49</p> |

| <b>Description:</b><br>Vegetation on<br>Upstream Side of<br>Impoundment | |

1. Retain the services of a commercial diver to complete an underwater inspection of the dam structures and head gate, especially around the known leaking areas.
2. Complete coring of various concrete elements and test for ASR deterioration
3. Develop a design to repair deteriorated concrete elements and address the leakage around the head gate.
4. Remove vegetation and debris on the upstream face of the Dam and stabilize with stone riprap.

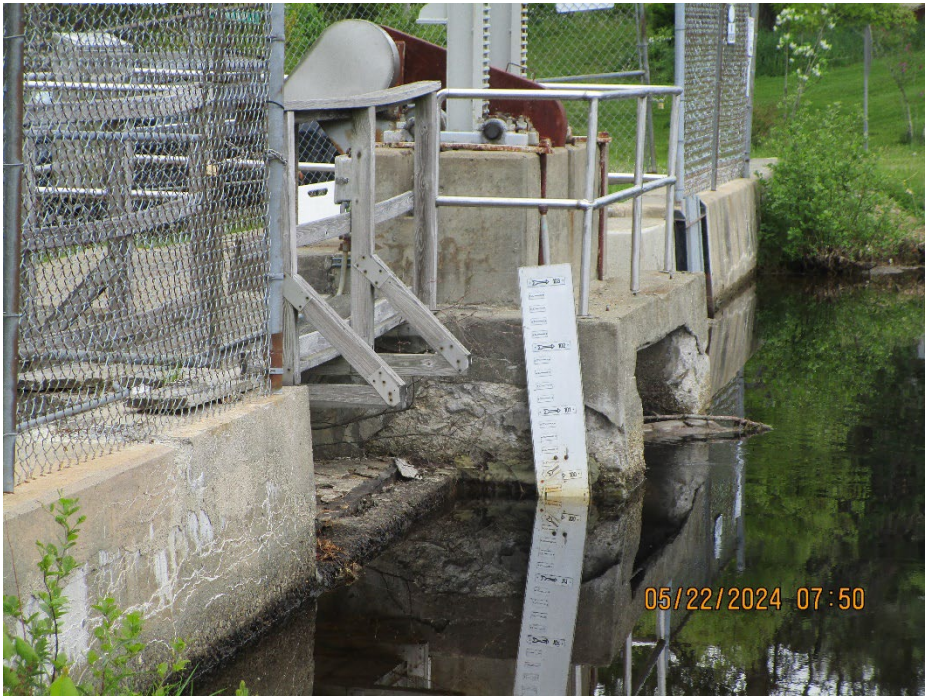
| <b>Photo No.</b> 13 | |

| <b>Description:</b><br>Elevated<br>Deterioration of<br>Head Gate and<br>Structure | |
