Re: DEP Consolidated Petition for Release from Dam Ownership related to Silver Lake, Alamoosook Lake, and Toddy Pond, 38 M.R.S. §§ 901, et seq (the “Petition”).

June 3, 2024

Re: Toddy Pond Dam | Orland, Maine

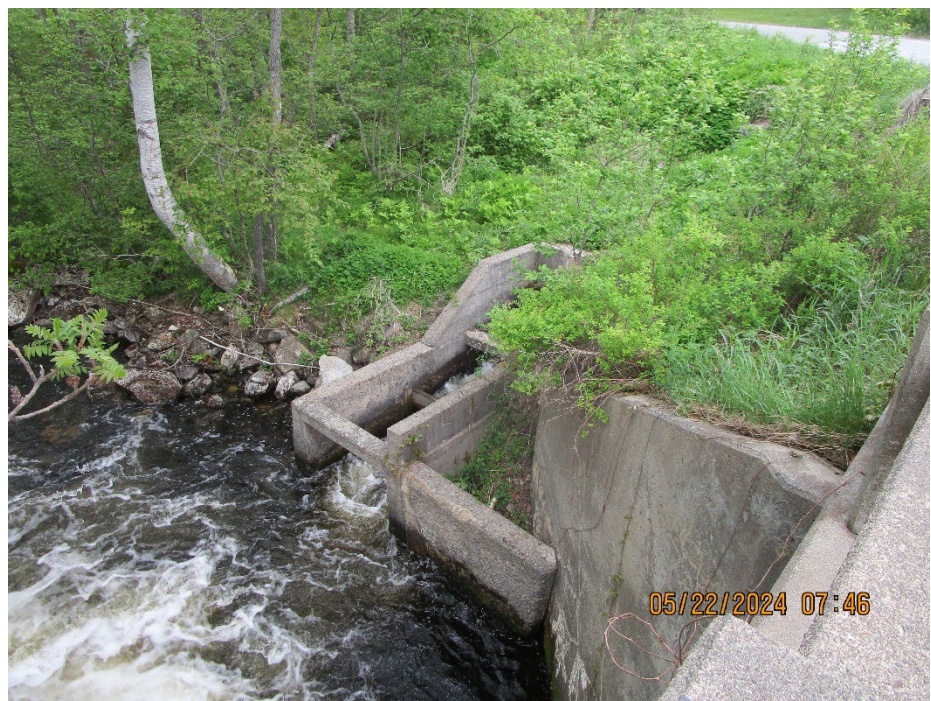
Photo No. 7

Description:
Concrete Fishway at
Entrance to the
Stream

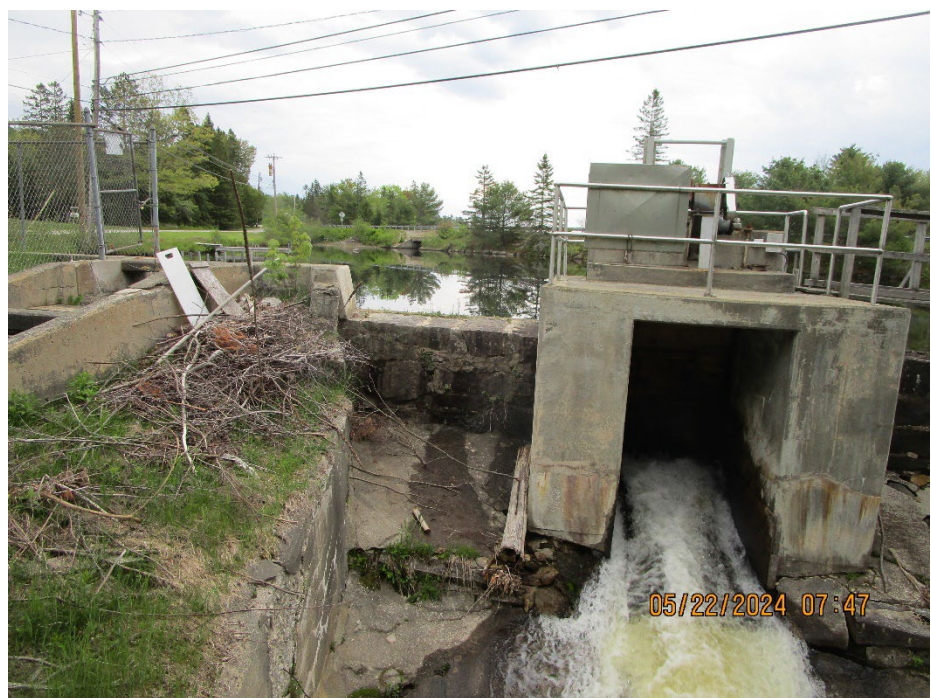
Photo No. 8

Description:
Concrete Spillway,
Apron, Retaining
Wall, and Head
Gate with Elevated
Deterioration

1. Retain the services of a commercial diver to complete an underwater inspection of the dam structures and head gate, especially around the known leaking areas.
2. Complete coring of various concrete elements and test for ASR deterioration
3. Develop a design to repair deteriorated concrete elements and address the leakage around the head gate.
4. Remove vegetation and debris on the upstream face of the Dam and stabilize with stone riprap.

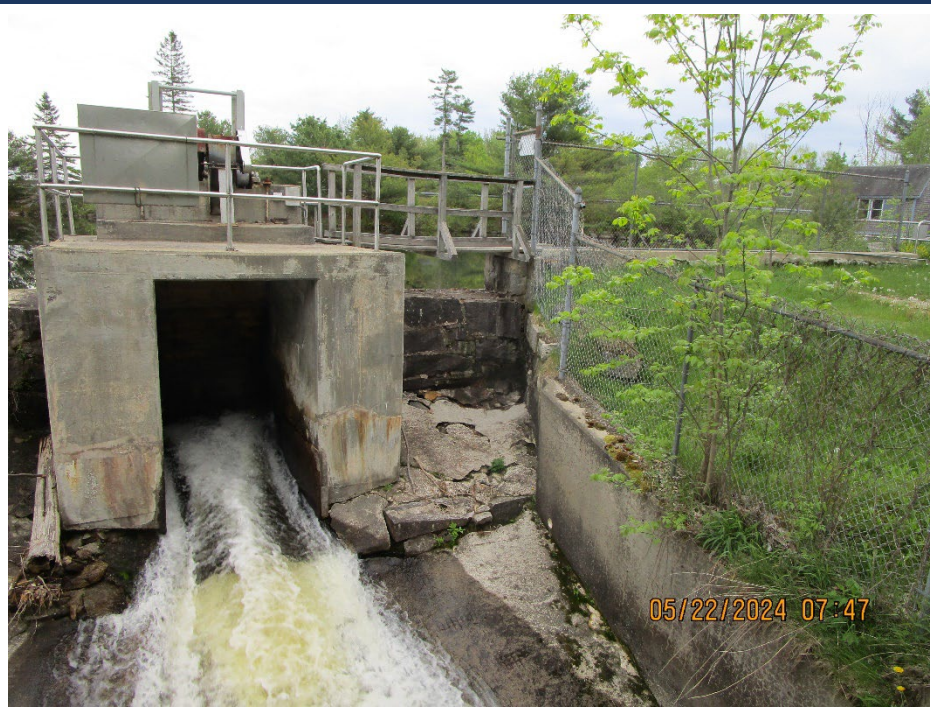
Photo No. 9

Description:
Concrete Spillway,
Apron and Retaining
Wall With Elevated
Deterioration

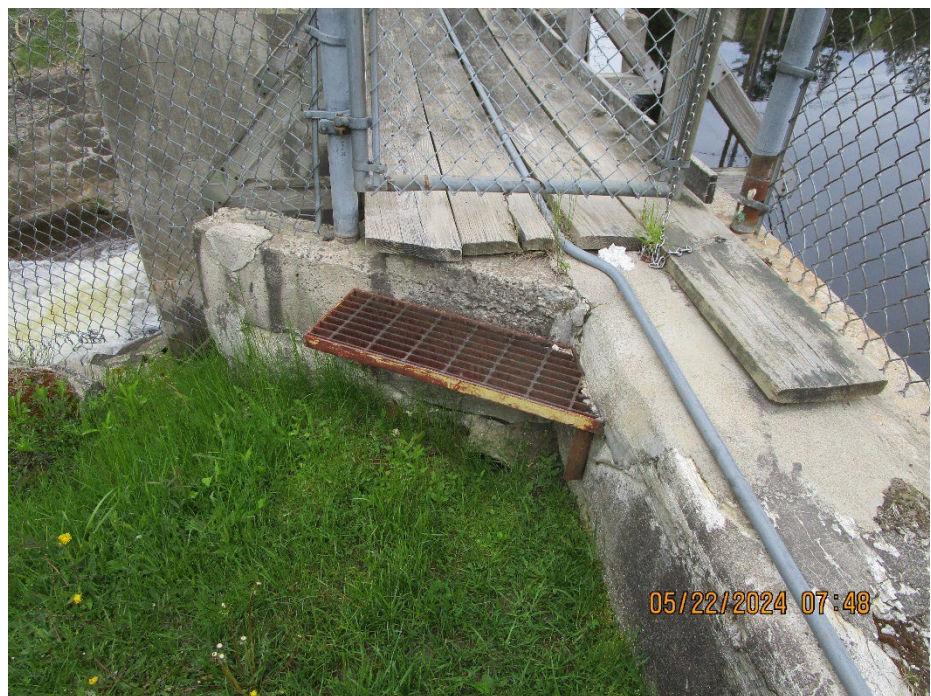
Photo No. 10

Description:
Concrete Dam
Section with
Deterioration

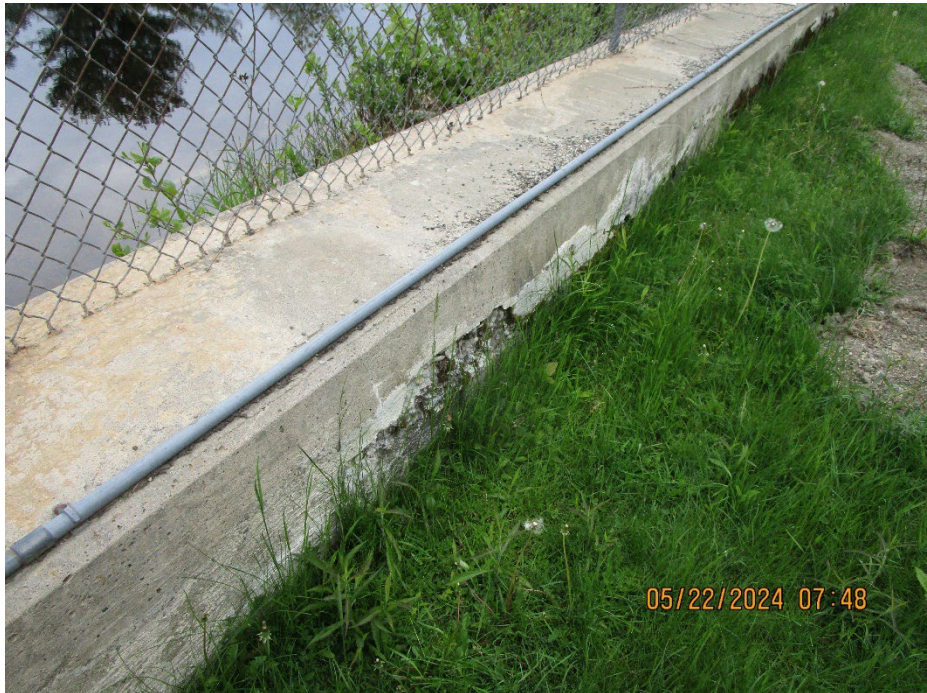
Photo No. 11

<p>05/22/2024 07:48</p>
Photo Date: May 22, 2024	
Site Location: Toddy Pond Dam, Orland, Maine	
Description: Concrete Cutoff Wall with Deterioration	
Photo By: PJT

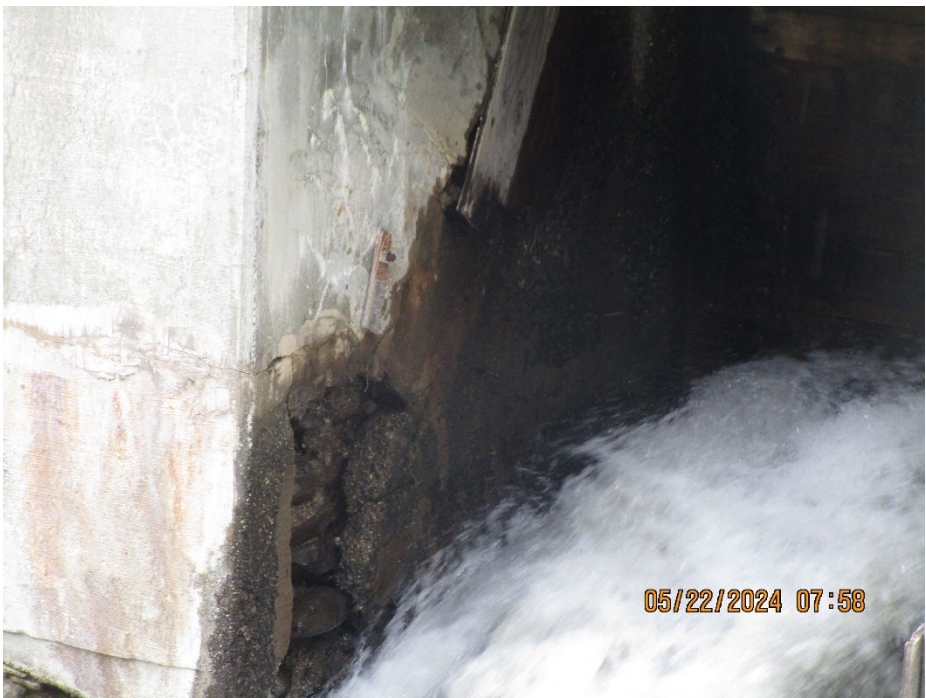
Photo No. 14

Photo Date: May 22, 2024	
Site Location: Toddy Pond Dam, Orland, Maine	
Description: Elevated Deterioration of Head Gate Structure at Base	
Photo By: PJT
