# **Maine Emergency Management Agency**

## **Dam Safety After Action Review Form**

1.1 The purpose of this report is to provide an engineering assessment of the general condition of the Bucksport Mill's Water System. The following maps show an overview of the entire water intake system. This report will evaluate from Silver Lake to the Bucksport Mill. The report also includes: Design capacity, life expectancy, spare parts, and operational / maintenance budgets.

## 2.0 Silver Lake Dam

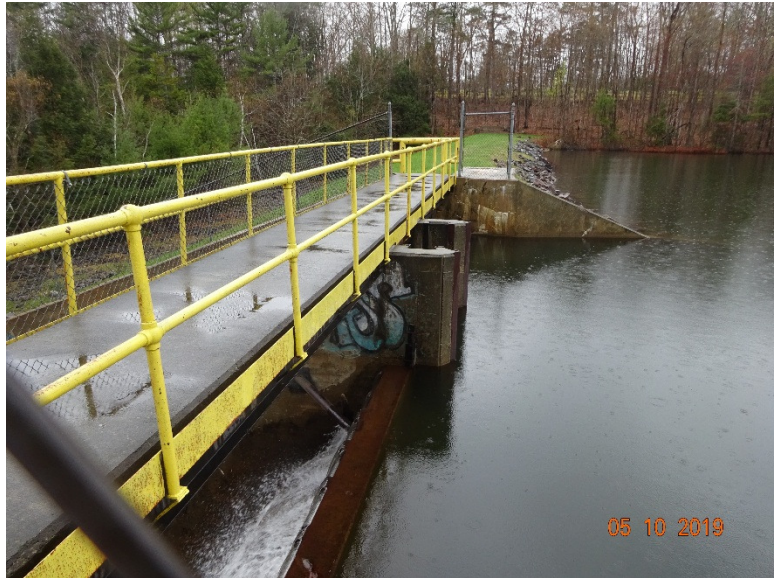
2.2 The concrete and earthen dam had no spalling or earth movement and is in good condition.

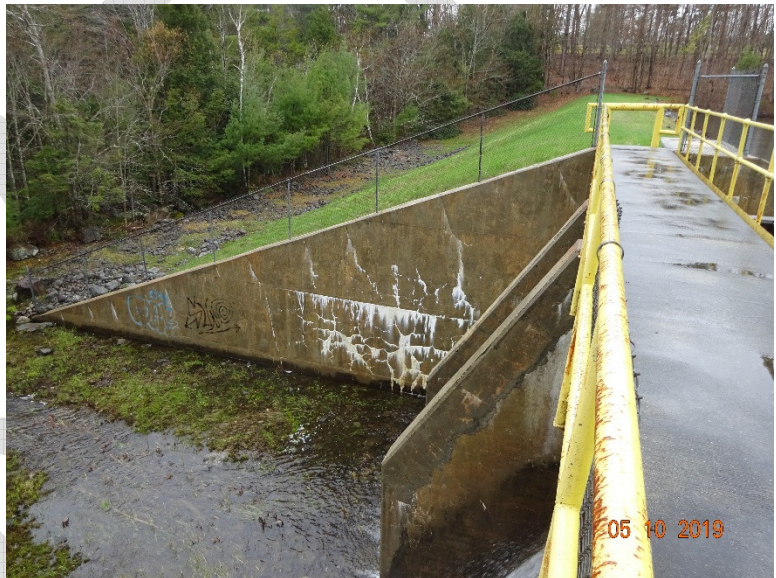
2.3 The concrete wing walls shows water leaks thru the concrete cracks. To protect the rebar in the concrete, these cracks should be pressure injected.

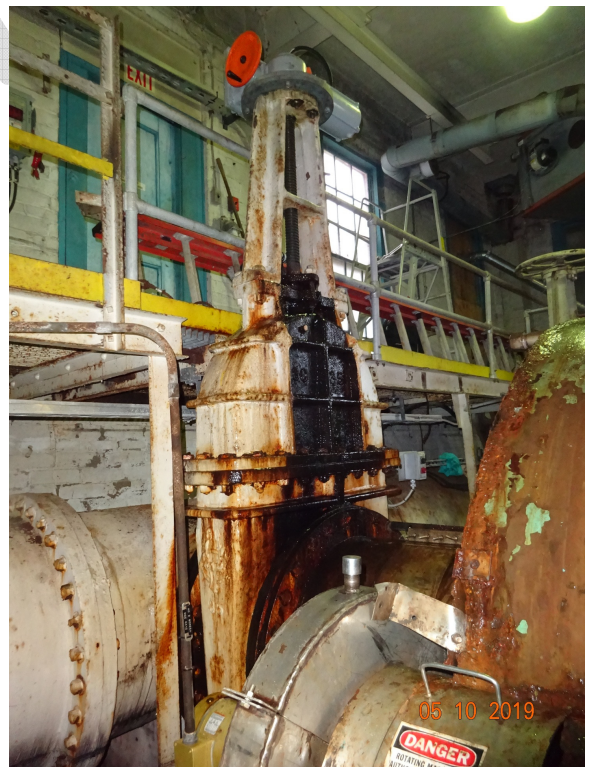
4.5 The inlet water to filter #2 needs its stem packing replaced. See photo.

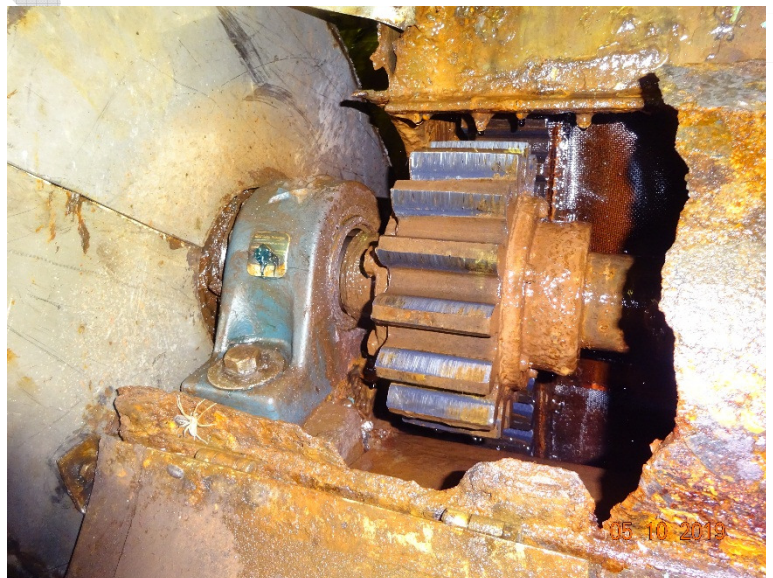
4.8 The shaft is support by bearing on both ends. The shaft turns the two small plastic pinion gears which rotates the two cast iron bull gears. The pinion gears and bearings need to be replaced.

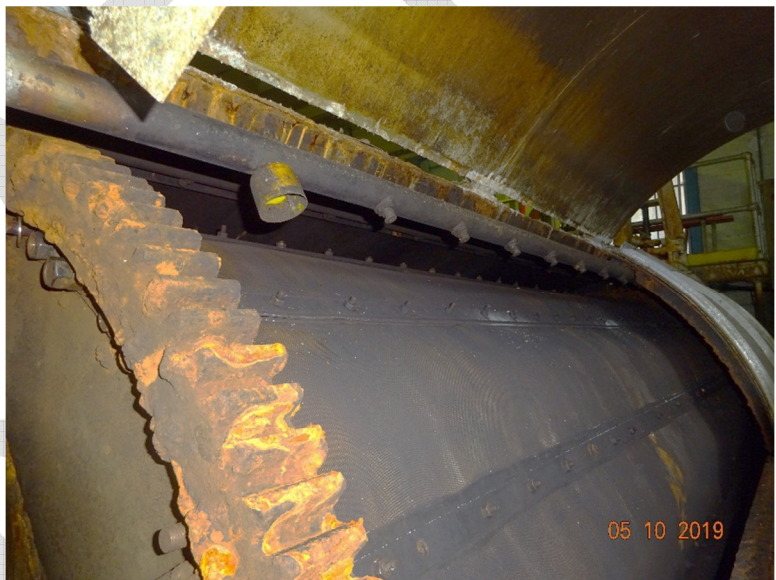
4.10 This picture shows the built up of rust on the bull gears. This can be cleaned up. The shower spray bar is visible in this picture.

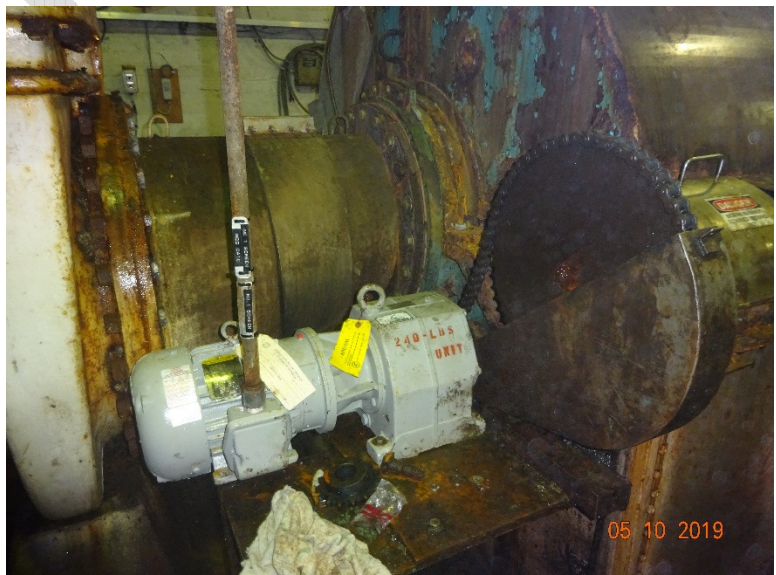
4.11 This motor and gearbox is quite new. The chain guard is missing.

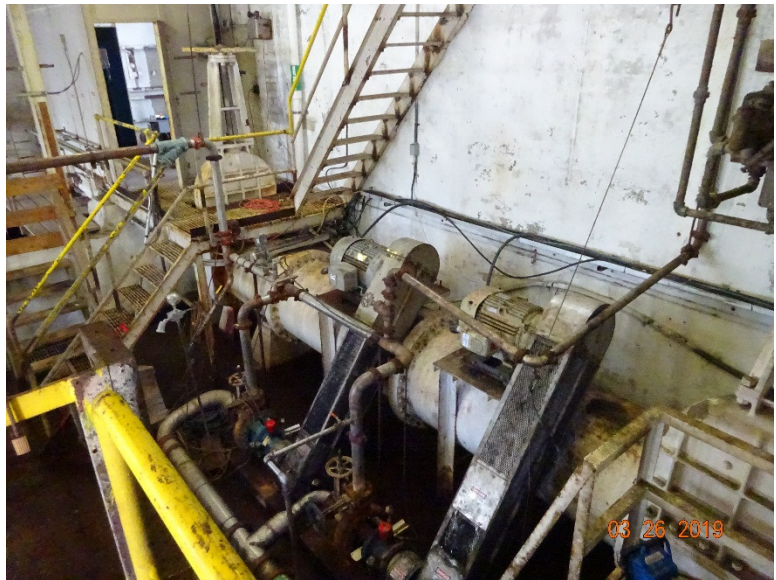
4.12 The shower water is provided by a Goulds 3196 3x4-13 pump with a 40HP motor. The system has an inline spare. A pump can supply 230 gpm @ 90 psi. Each filter needs 94 gpm. The motor are above the floor in case the room floods. One pump base is so corroded that it needs to be replaced.

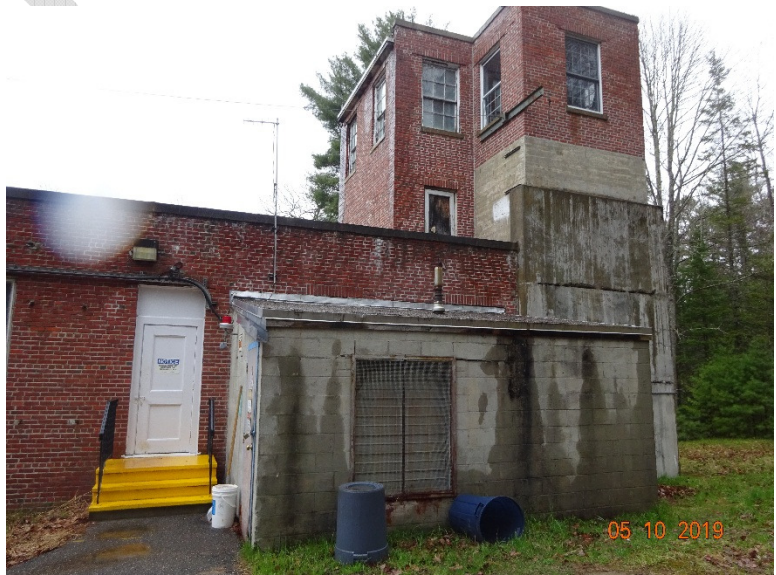
4.14 It was raining the day of our inspection. The original 1930s brick building has a leaking roof system. Also the dark stain on the CMU wall is an area that the masonry needs to be repointed.

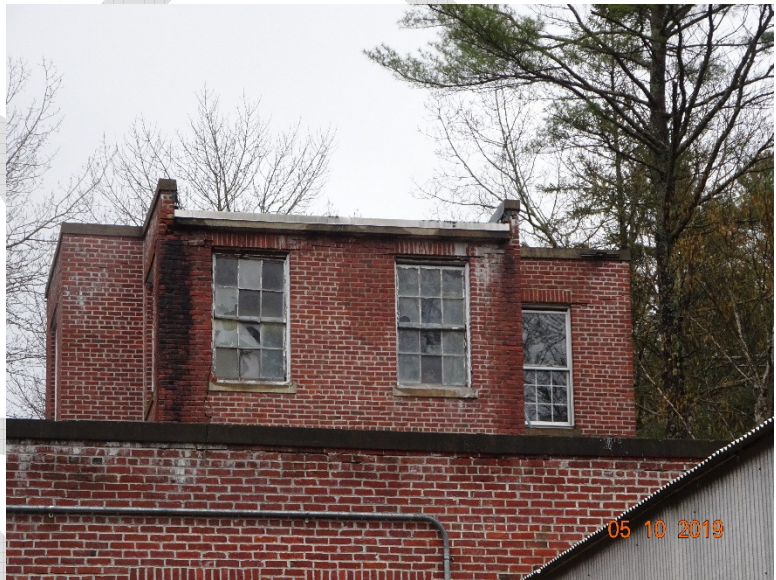
4.16 The brick with the dark stain needs to be repointed.

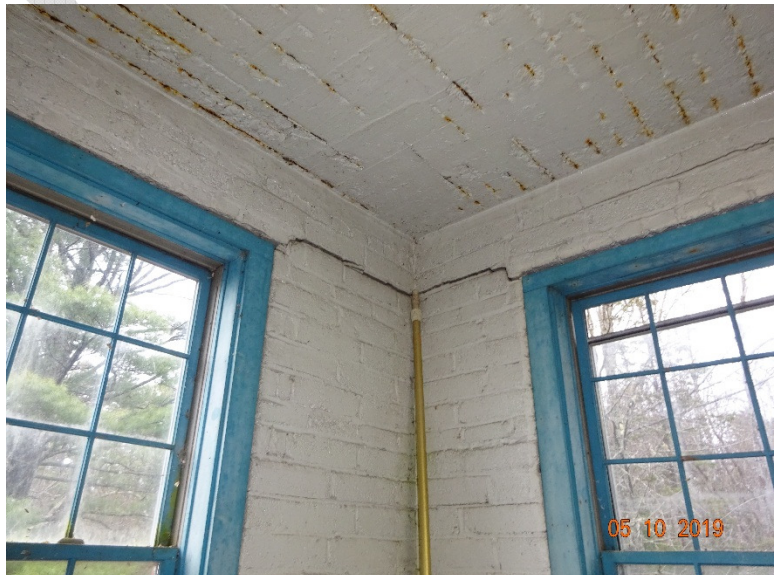
4.17 The second story shown in the previous pictures has several cracks in the walls. This photo shows the cracks in corner. About six windows are so damaged that it is better to replace them.

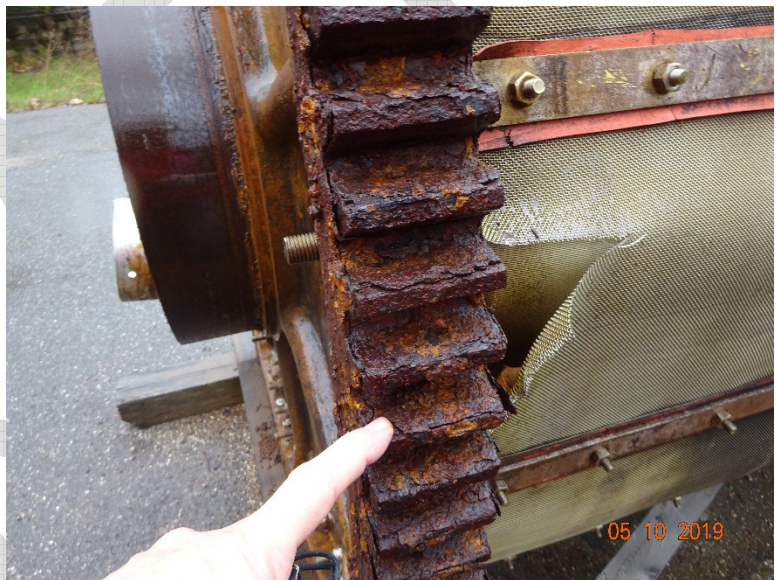
6.2 This picture is a close up of the bull gear. Each filter has one bull gear on each end. Of the three screen drums, this one is in the worst condition. The rust flaking is typically 5 times greater than the actual corrosion. Due to the very slow turning rate, the drum still has life, but needs to be cleaned up and stored inside the 2006 addition.

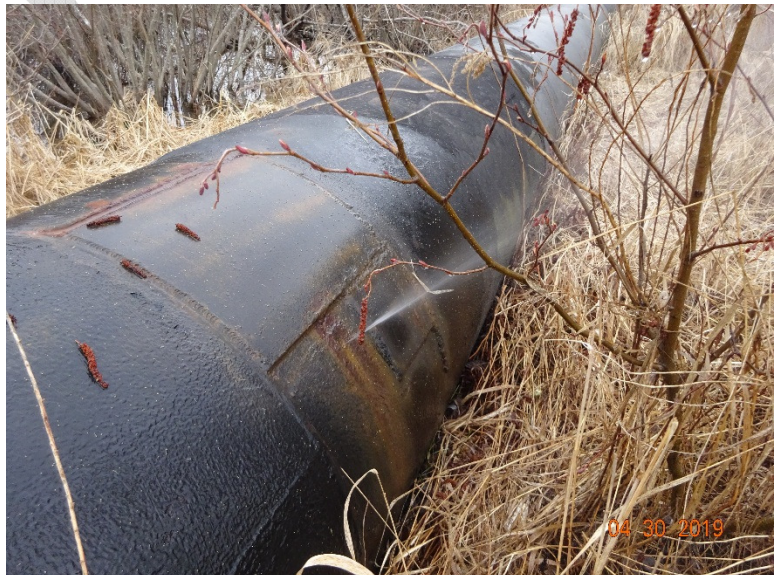
3.2 During the pump tests, we found several pipe leaks as seen in the photo. A close look shows the pipe has been patched in the past.

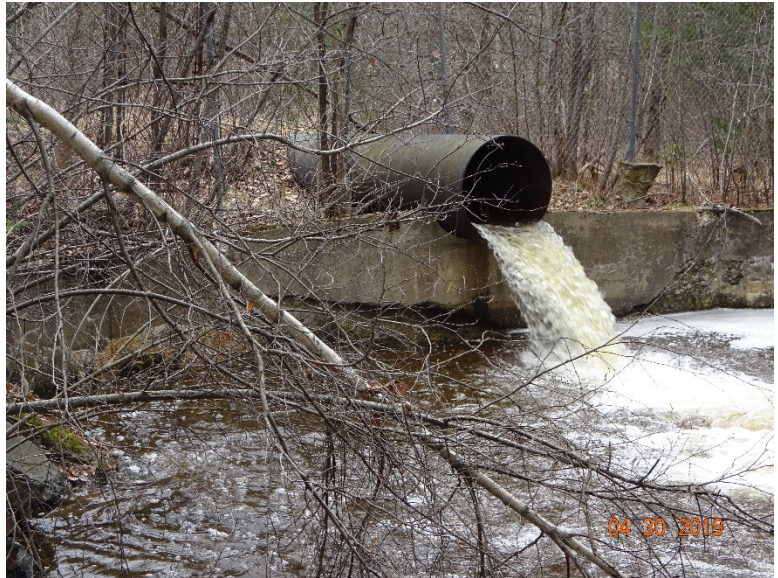
3.5 The concrete under the end of the pipe is undermining and will eventually need a repair.

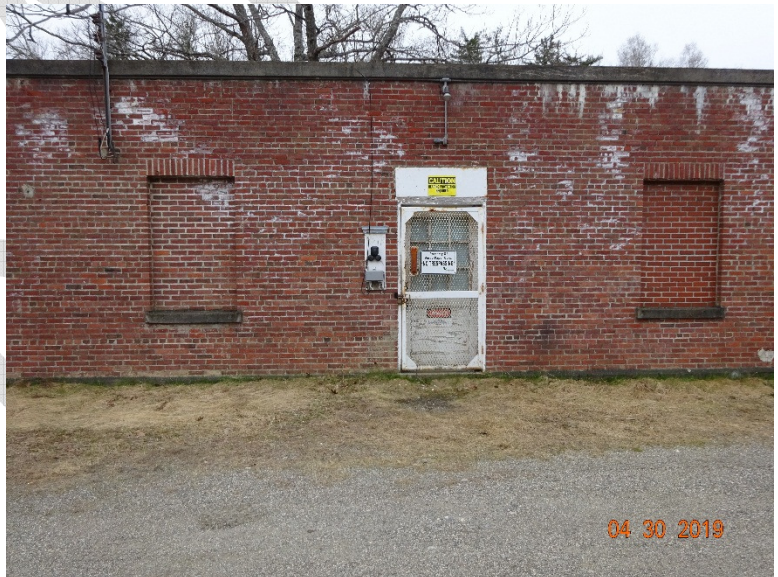
4.1 The 1930s pump house is a typical brick mill building. The structure shows no cracked bricks. The wall does show efflorescent which means water is leaking thru the wall.

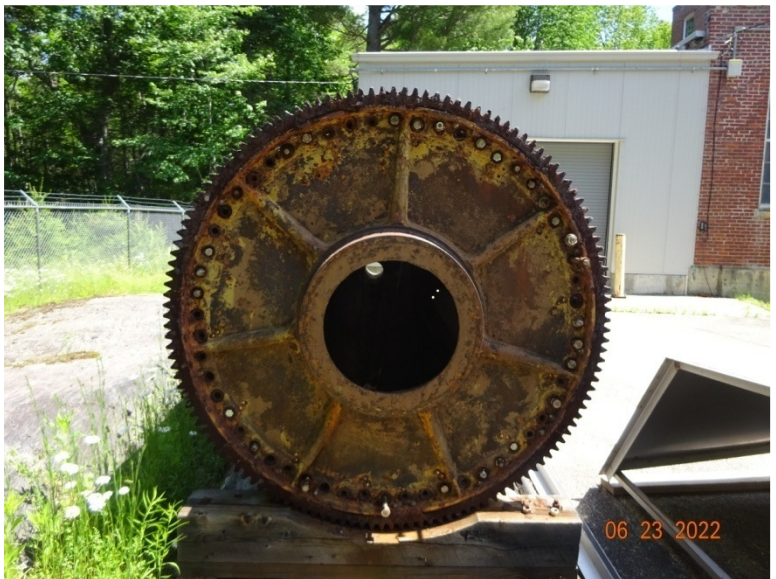
6.2 This picture is a close up of the bull gear. Each filter has one bull gear on each end. Of the three screen drums, this one is in the worst condition. The rust flaking is typically 5 times greater than the actual corrosion. Due to the very slow turning rate, the drum still has life, but needs to be cleaned up and stored inside the 2006 addition.

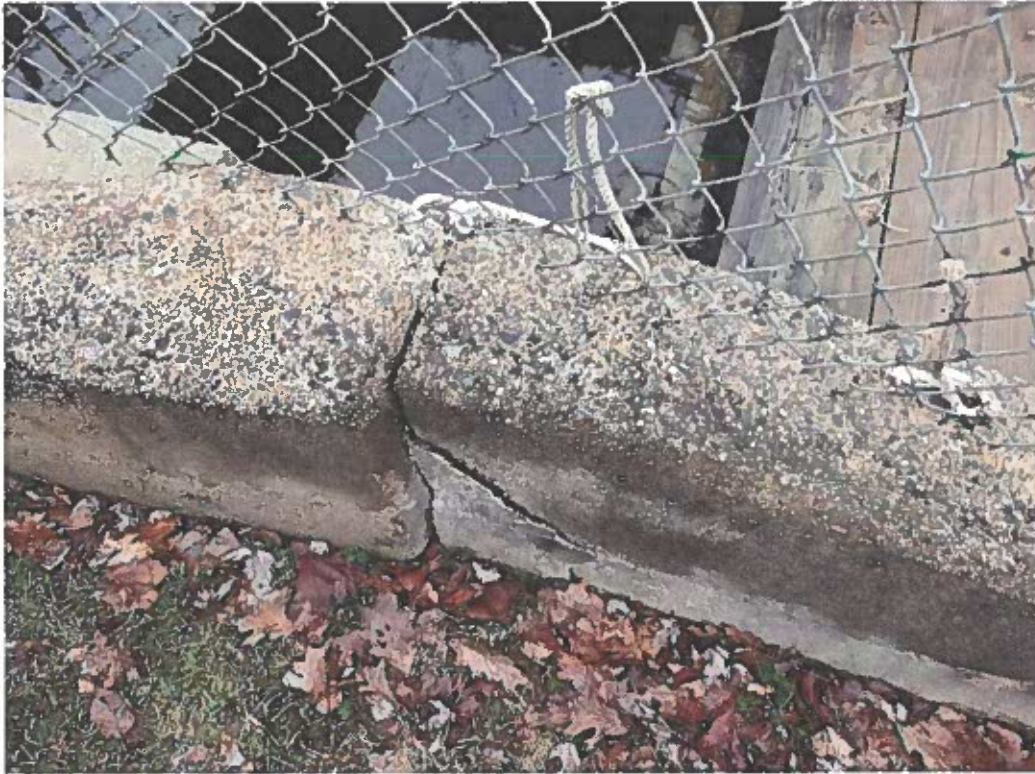
1. The right fishway retaining wall is displaced at concrete joint.

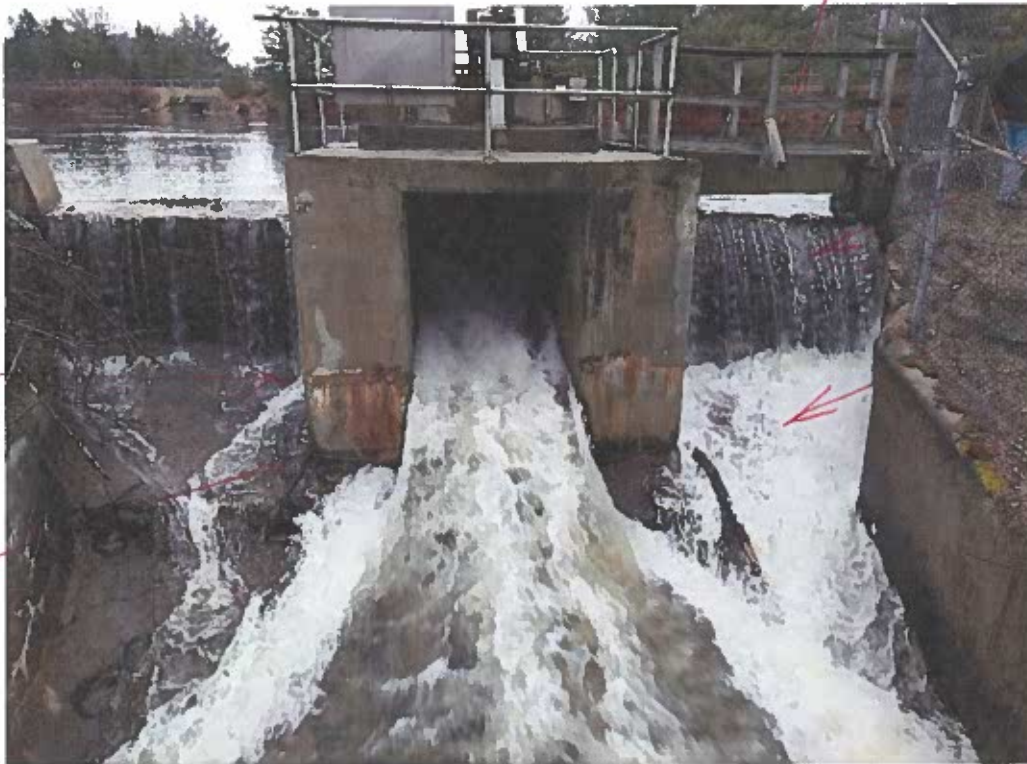
2. The left spillway flows more than right spillway despite originally being level.
