Foresight Engineering P.C.

Upstream Engineering Assessment of Bucksport Mill Water System Alamoosook Pump House to Silver Lake (Project # 19023Ra)

5-12-2019

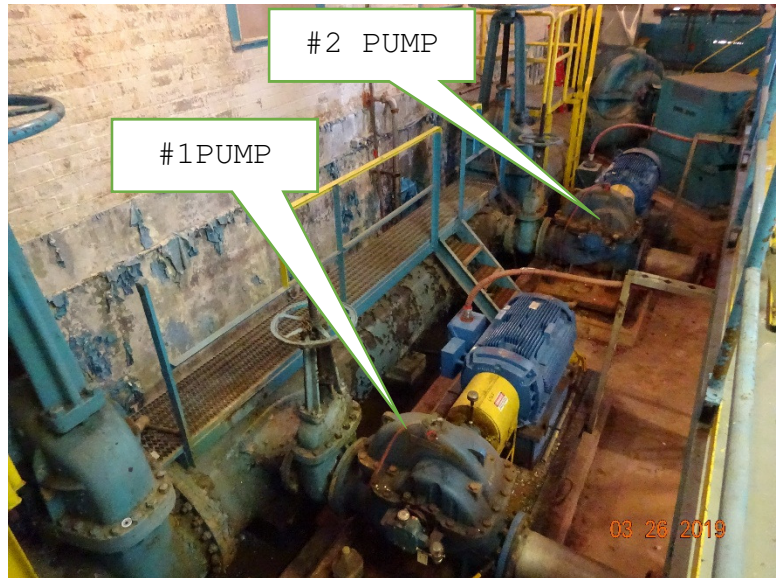
2.1 The following picture shows the 3 pumps in the pump house. The #3 pump is not usable. The #1 & #2 pumps are operational.

2.3 The equipment file shows that pumps #1 & #2 are Goulds 3410 Size 10x12x17L with a 14.5" bronze impellor. The pumps are a premium brand which was installed in mid-2001.

2.4 Per the original pump curve (see atch 2), one pump could pump 4,200 gpm. Using the amp meters on the MCC, we back calculated that one existing pump is pumping around 4,055 gpm or 5.8 MGD. By using both pump #1 & #2, the flow rate will be around 8,000 gpm or 11.5 MGD. The flow rate is nearly double due to most of the head is caused by the static head component.

2.5 We did witness both pumps running. They ran with no excessive vibration and typical packing leakage.

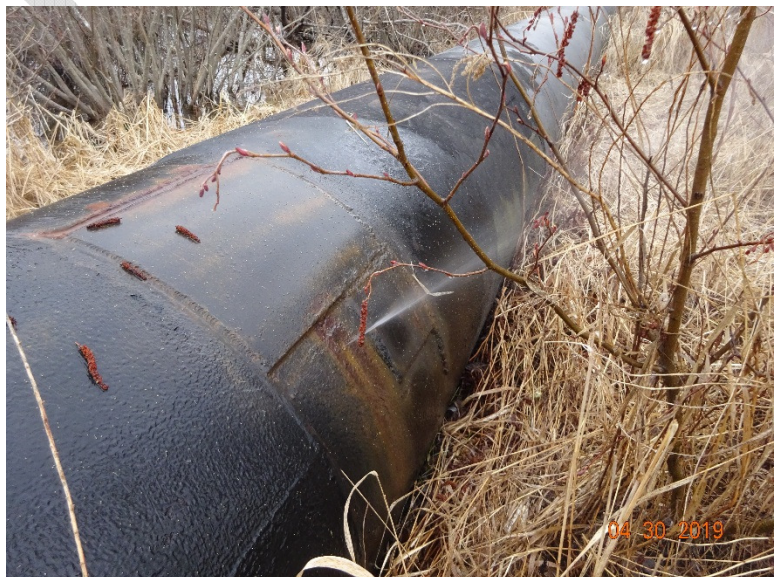
3.2 During the pump tests, we found several pipe leaks as seen in the photo. A close look shows the pipe has been patched in the past.

3.4 The original pipe thickness is 0.375". Therefore the pipe has only lost XX % due to corrosion. Most of the leaks are occurring that the welds which is typical and will continue.

5.3 As for the 12,200 feet of carbon steel 36" diameter piping, you should expect annual leak patching.

6.2 Since the pipeline has routine leaks, a couple sheet of A36 rolled steel plate should be on site.

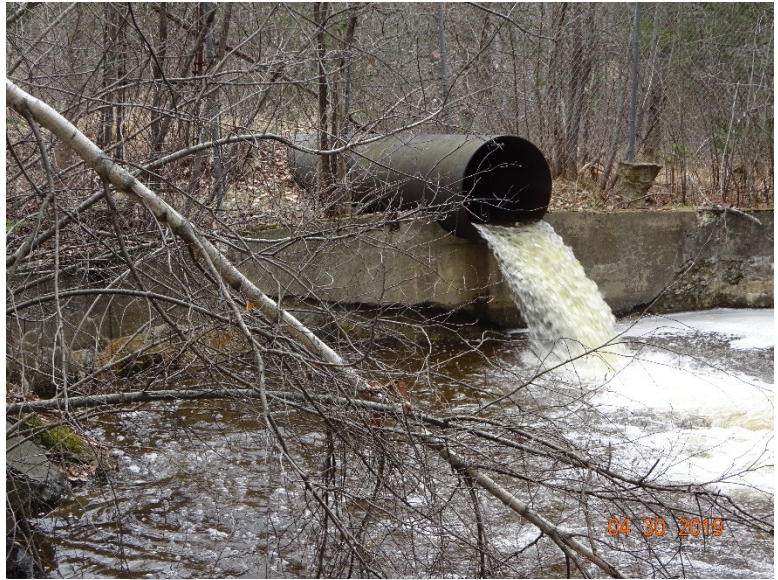
3.3 This next picture shows outlet which flows to Silver Lake. We measured the wall thickness of this pipe to be:

3.5 The concrete under the end of the pipe is undermining and will eventually need a repair.

8.3 Another capital job will be reface the concrete outfall of the piping system. The budget price for this project is \$30,000. This is expected within 5 years.

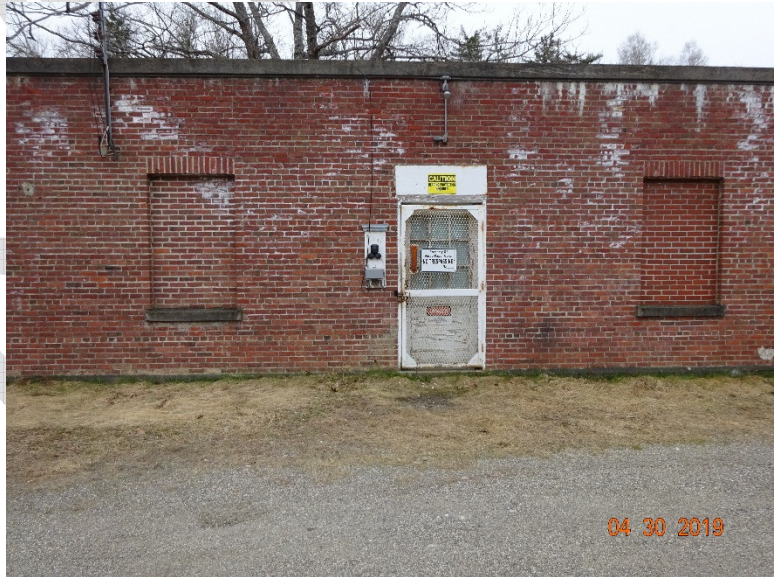
4.1 The 1930s pump house is a typical brick mill building. The structure shows no cracked bricks. The wall does show efflorescent which means water is leaking thru the wall.
