CANDERS DIVING SERVICES

INSPECTION REPORT

CONSUMERS MAINE WATER CO.
855 ROCKLAND ST.
ROCKPORT, MAINE 04856

INITIAL INSPECTION AND
AFTER CLEANING PHOTOGRAPHS
OF THE INTAKE SCREEN
AT SILVER LAKE
BUCKSPORT, MAINE
NOVEMBER 22, 2003.

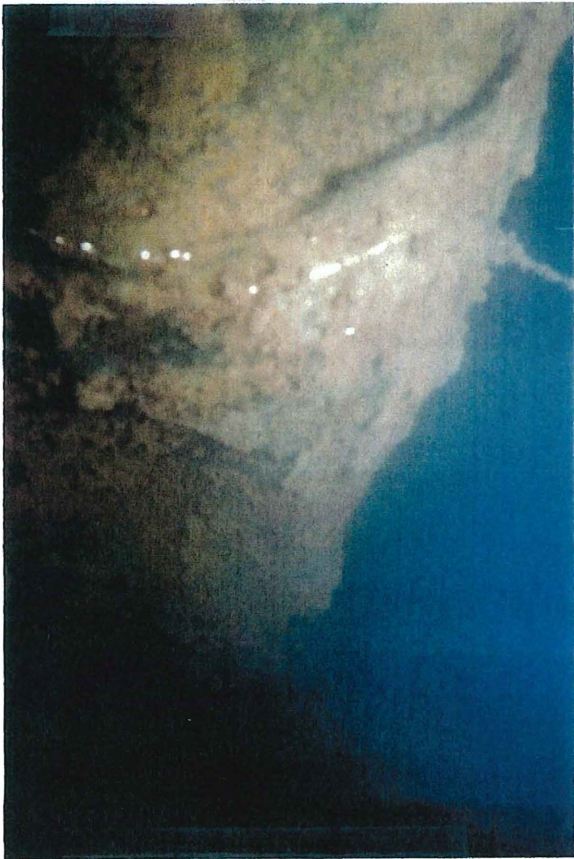
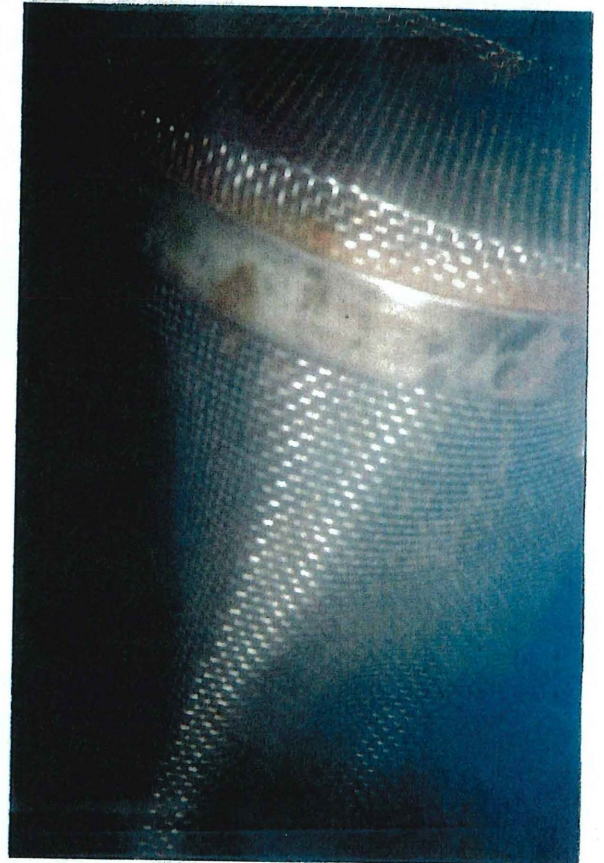
TOP OF SCREEN

THE INITIAL INSPECTION OF THE INTAKE SCREEN WAS INCONCLUSIVE DUE TO THE TREMENDOUS AMOUNT OF ALGAE AND DEBRIS ON THE SCREEN (SEE ATTACHED PHOTOS). WE DECIDED TO CLEAN THE SCREEN AND RE-INSPECT / RE-PHOTOGRAPH.

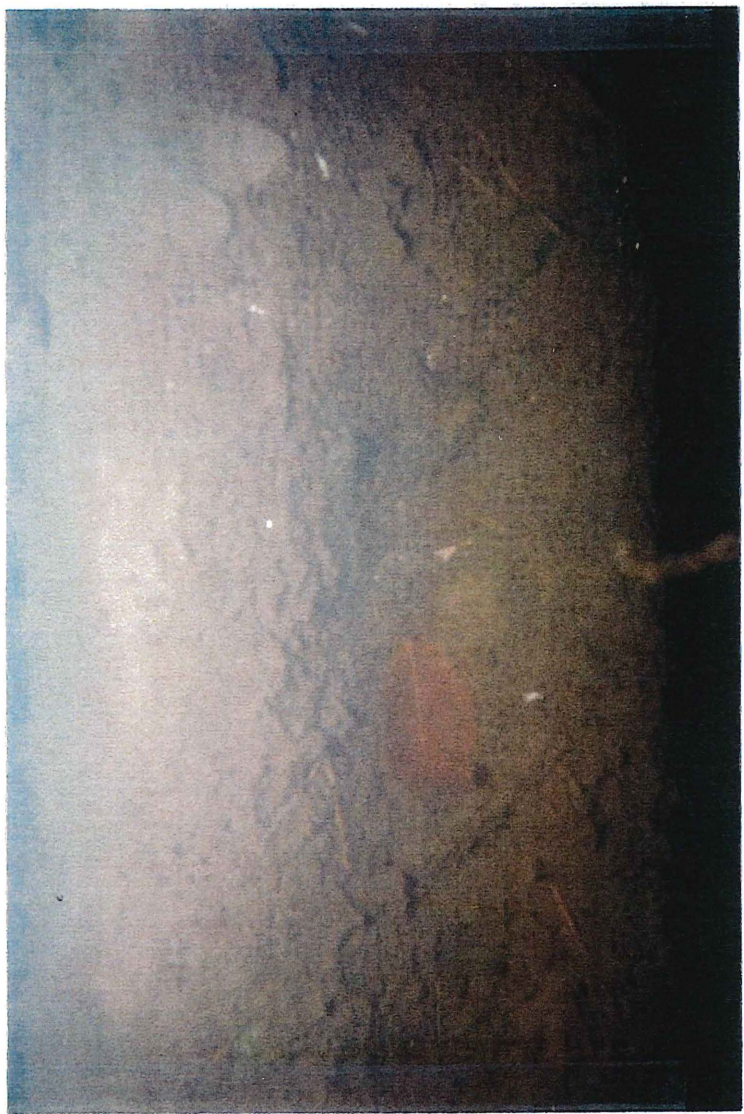
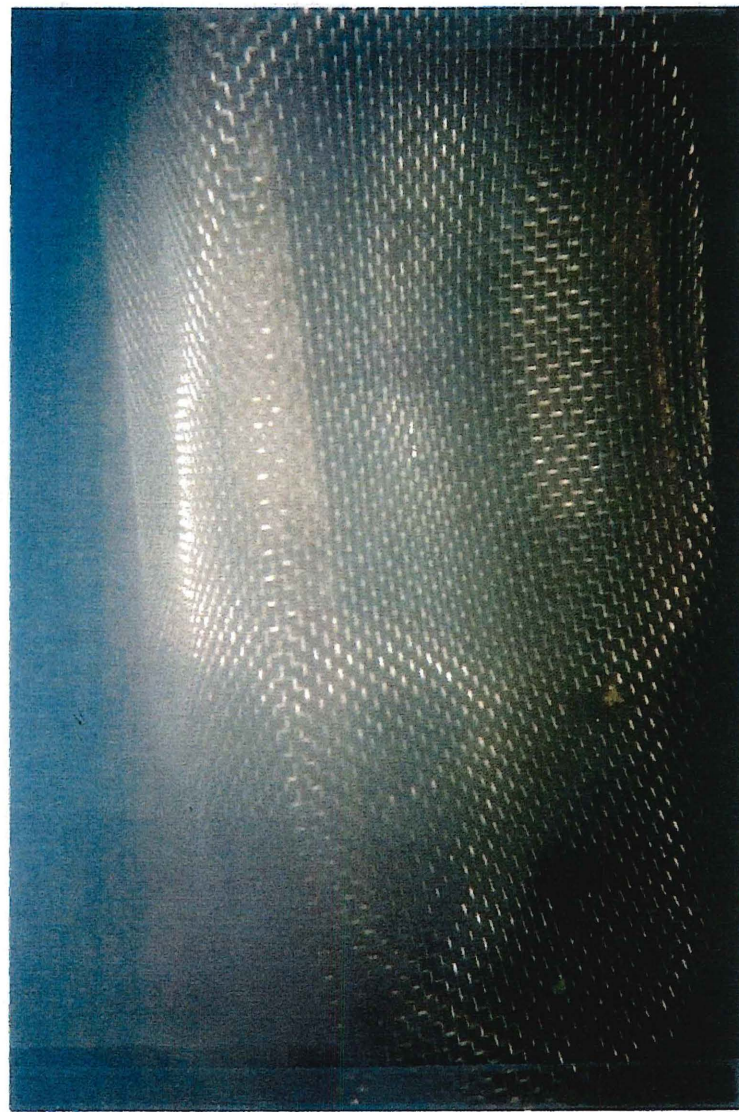
I AM CONCERNED ABOUT THE OBVIOUS DISTORTION IN THE SCREEN AND WOULD LIKE TO COMPARE THESE PHOTOGRAPHS WITH THE ONES TAKEN IN 1991 (LAST INSPECTION) CAUSES OF THE DISTORTION NEED TO BE DISCUSSED/ INVESTIGATED FURTHER.

NOTE DISTORTION IN SCREEN

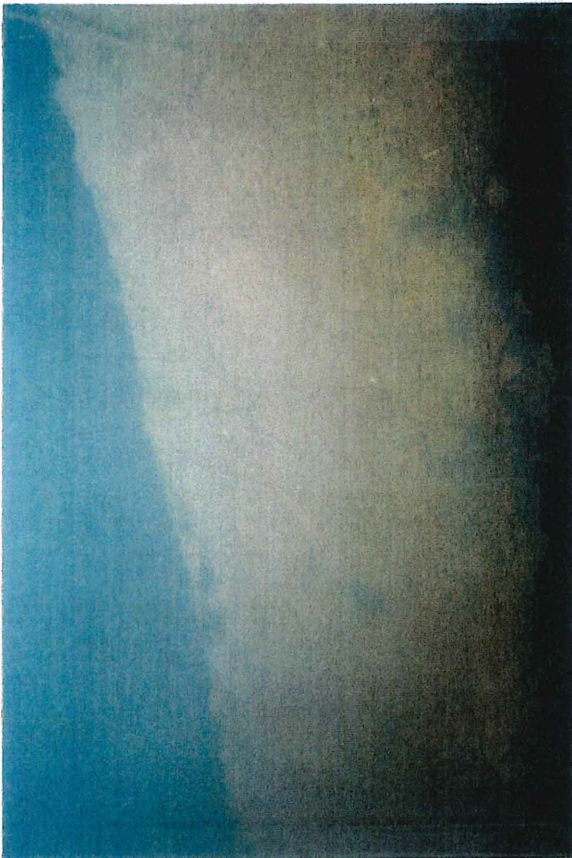
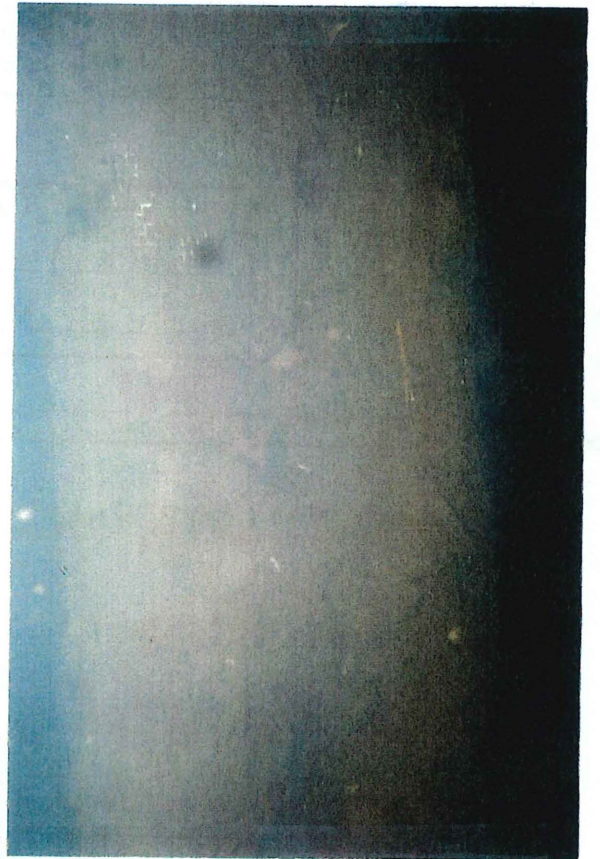
TOP OF SCREEN

AFTER CLEANING THE SCREEN WE INSPECTED IT AGAIN AND FOUND IT TO BE STRUCTURALLY SOUND, VOID OF HOLES. ALL FLANGES ARE SOUND AS ARE ALL SEAMS ALONG THE SCREEN. WE INSPECTED THE SEALING JOINT WHERE THE NEW (1985) STAINLESS STEEL PIPING MEETS THE OLD CAST IRON BELL HOUSING INTAKE PIPE AND THERE WERE NO GAPS OR INDICATIONS OF PIPE SHIFTING.

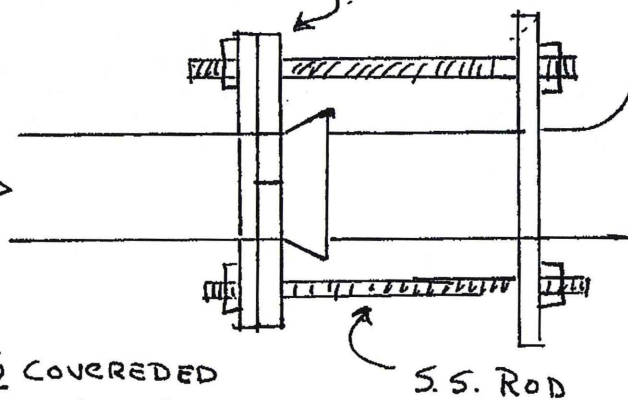
DETAIL
OF OLD PIPE
TO SCREEN ELBOW
INSTALLED 1985

WE INSPECTED THE SCREEN, ELBOW AND MATING JOINT (OLD CAST IRON PIPE TO STAINLESS STEEL PIPE) AGAIN AND FOUND NO GAPS IN THE MATING SURFACES.

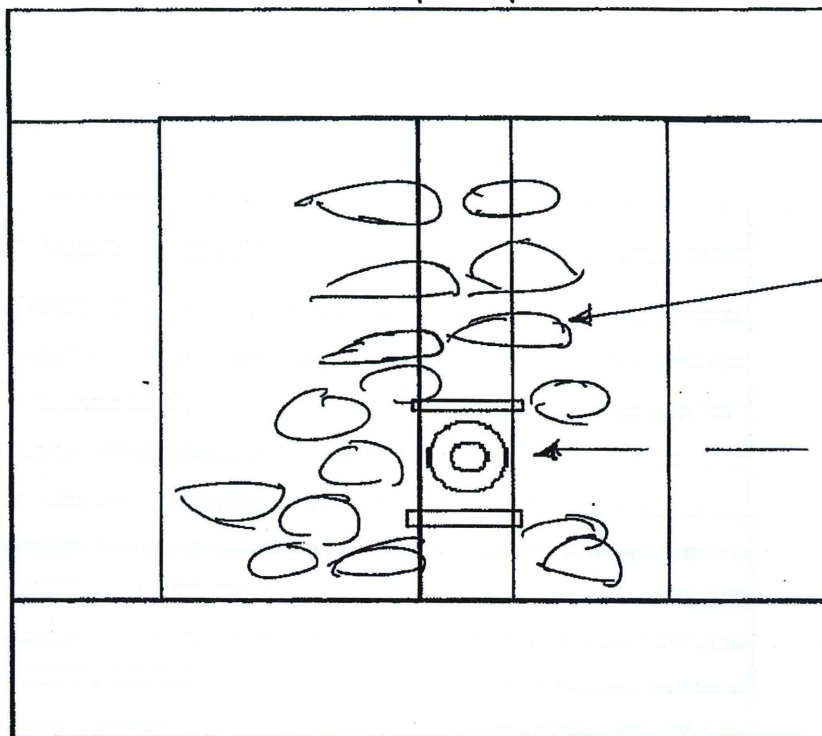
FOLLOWING THE CRIBWORK INTERNAL INSPECTION I DID AN EXTERNAL INSPECTION WITH THE IDEA THAT PERHAPS SOMETHING HAD PENETRATED THE PIPE NEAR WHERE IT EXITS THE CRIBWORK BETWEEN THE SOUTH FACE AND THE DAM. I FOUND THAT THE PIPELINE IS NOT EXPOSED WHEN IT LEAVES THE CRIBWORK, IT IS COVERED WITH MUD.

PIPELINE IS NOT EXPOSED ON THIS SIDE

ROCKS AND DEBRIS
INSIDE CRIBWORK
COVERING OLD
PIPELINE

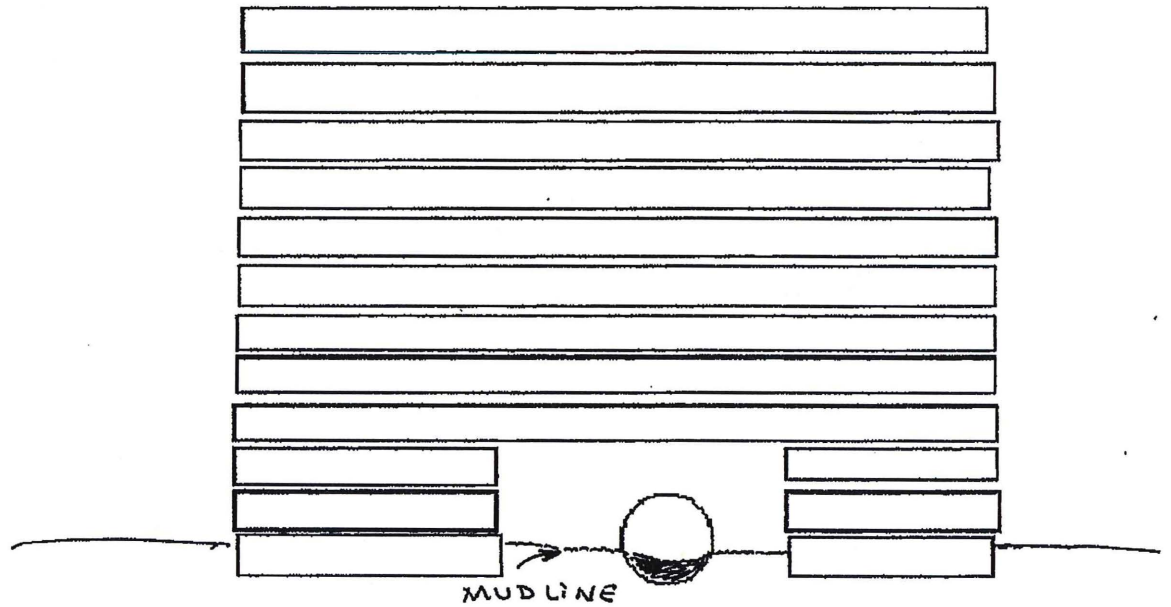
drawing 1174-5

END OF INTAKE PIPELINE INSIDE CRIBWORK AS IT EXISTED IN 1985.
THIS FACE OF CRIBWORK IS TOWARD CENTER OF LAKE.
