SILVER LAKE DAM (No. 105)

**October 2024 – Revision 1
JN: 11299.023**

REVISION SHEET
OPERATION AND MAINTENANCE MANUAL

FOR
SILVER LAKE DAM NO. 105

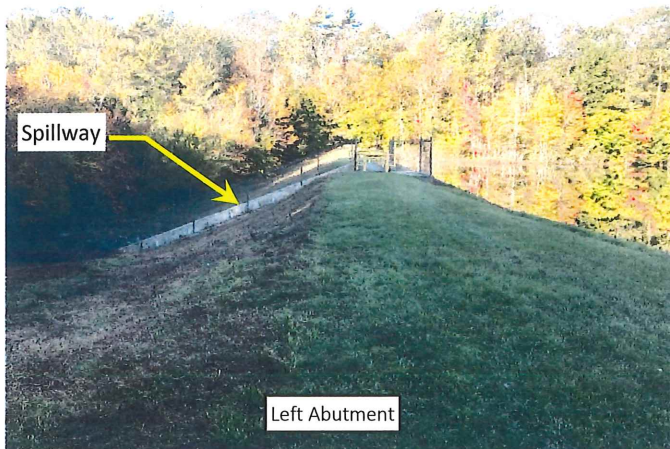
1. Left abutment from top of dam (TOD). Brush recently cut, bank well grassed. Some settlement along TOD. Downstream slope has significant settlement in place.

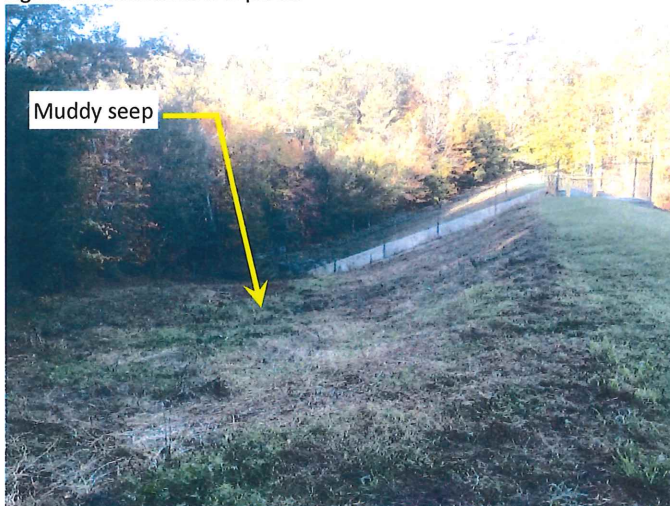
3. Left embankment downstream recently cleared of brush. Both the inclined & level surfaces show unevenness indicating embankment or local slippage.

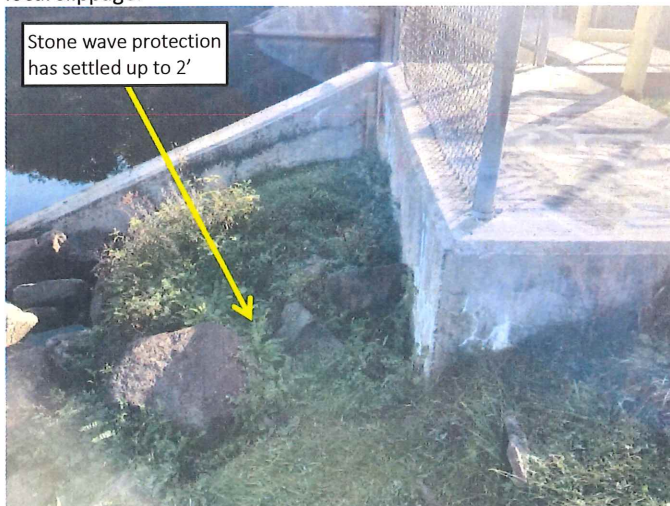
5. Settlement, random boulders & uneven earthwork surface. Concrete cracked but surfaces are plain. This concrete block is connected to the reinforced concrete cutoff wall.

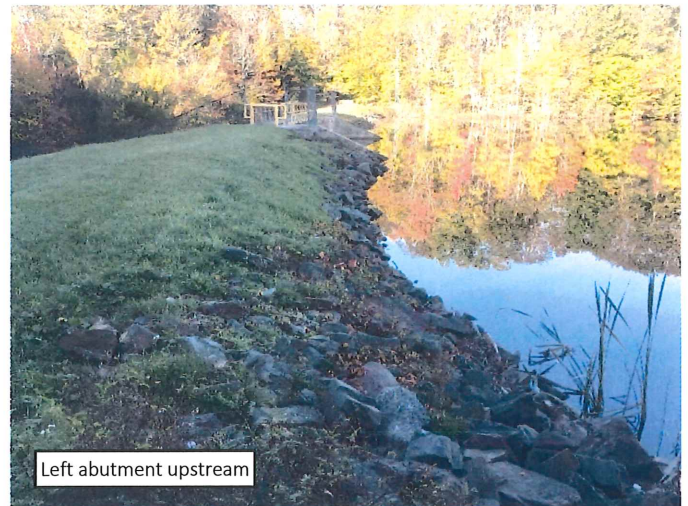
2. Uneven TOD & stone wave protection. Waters edge not straight indicating settlement and/or riprap slippage. No new shoreline development upstream of dam.

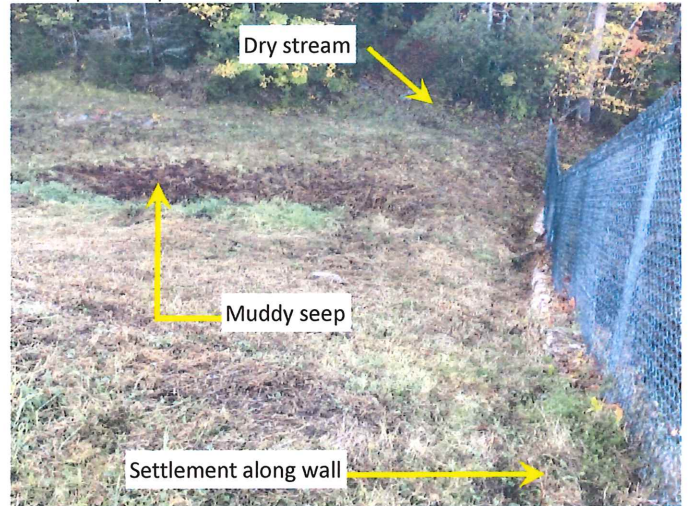
4. Left embankment looking downstream. The brown area is a muddy seep which must be inspected after spring runoff & around labor day & monitored for flow & reservoir stage.

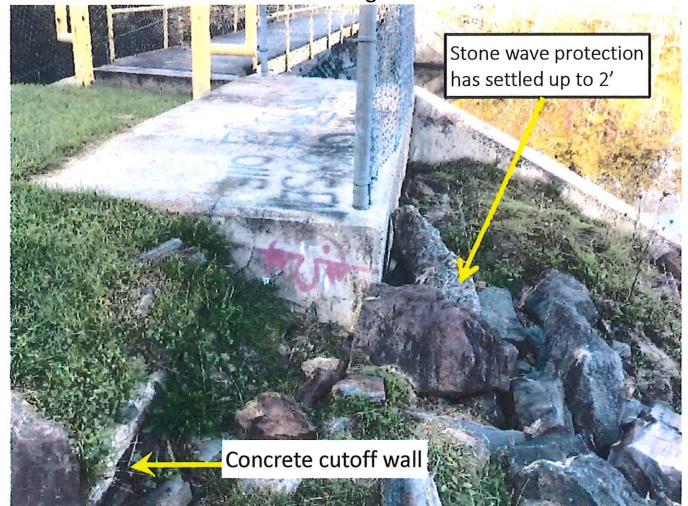
6. Stone wave protection (rip-rap) settled by up to 2 feet at the concrete connecting block - arrow. No visible distress in concrete.

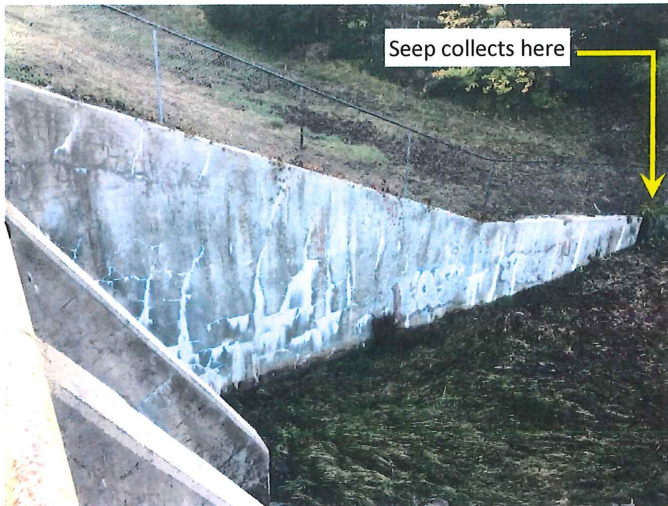
7. Left downstream mass gravity channel. Built 1930, re-faced 1984, with Gunitite. Photos show similar cracks & efflorescence reported by the Army Corps of Engineers (COE) in 1978, A3&A6. Efflorescence shows calcium carbonate developed by evaporation.

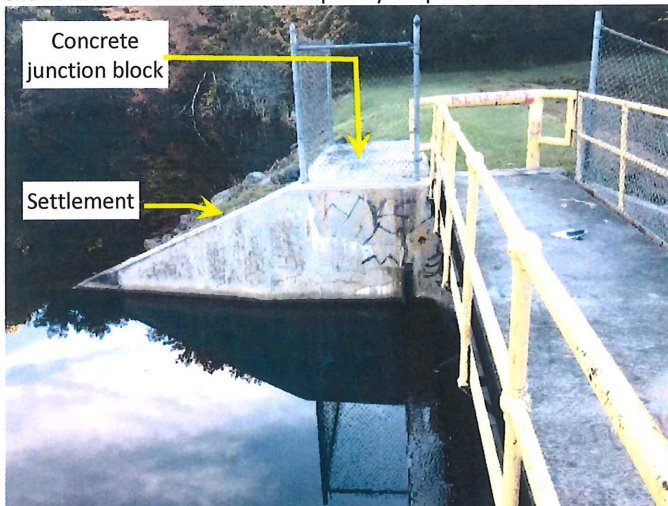
9. Upstream, left mass-gravity retaining wing wall & footbridge. Minor cracking & efflorescence at junction with block. Note graffiti.

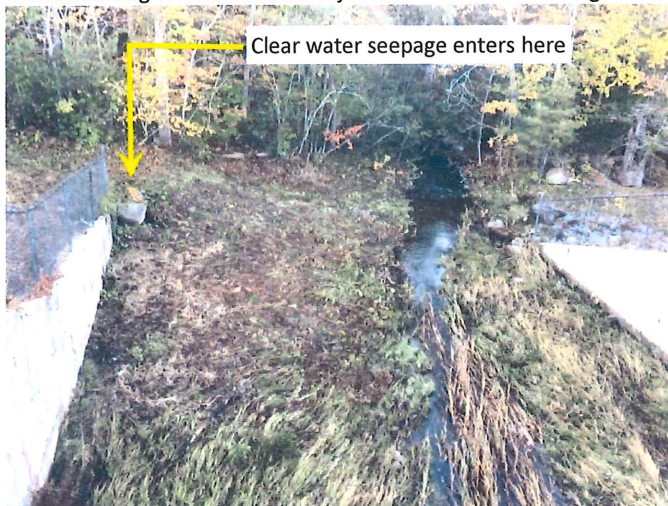
11. Spillway downstream channel between left & right wingwalls silted. Note flattened grass from recent storm.

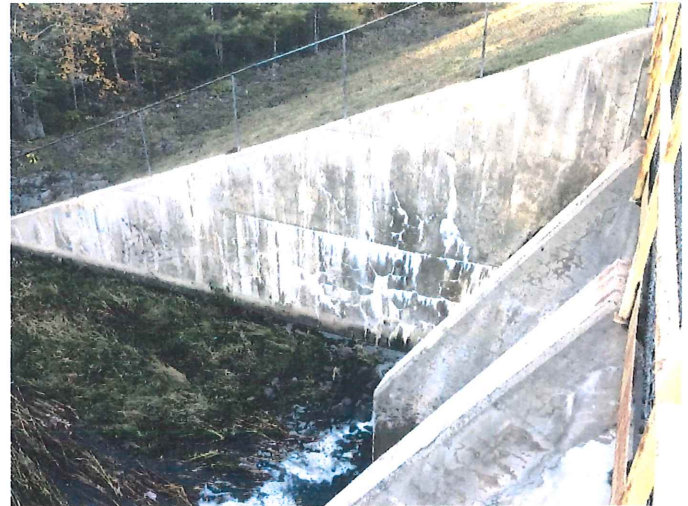
8. Same as A7. Craze cracks & a lift joint can be seen. Efflorescence caused by dissolved free lime in the leak dissolved within the mass gravity concrete wall. No inward deflection or iron oxide from rebar seen along the wall - A18.

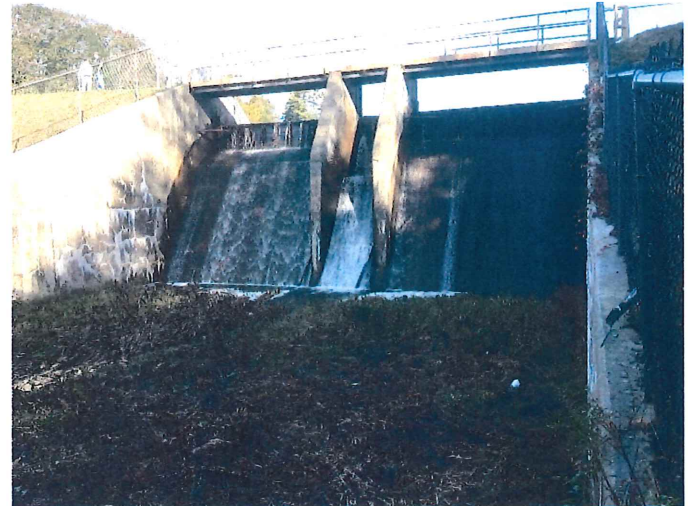
12. Spillway & stoplog weirs. Note the right bulkhead overtopping considerably more than the left & right stoplogs. Note difficult access to stoplogs.

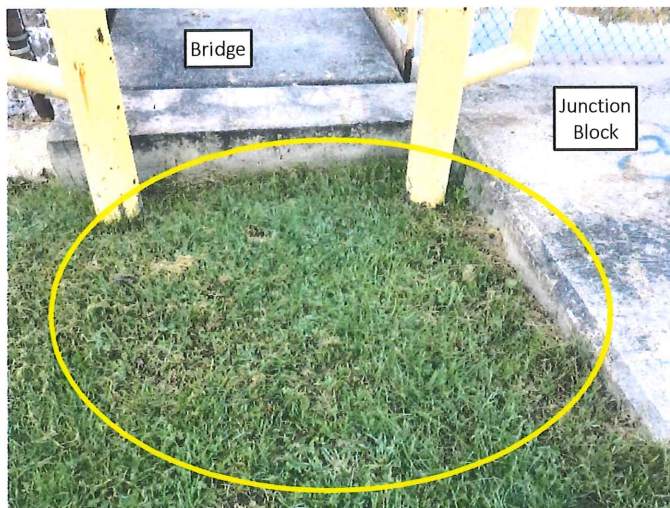
15. Settlement of left embankment at walkway. No defects seen on the concrete junction.

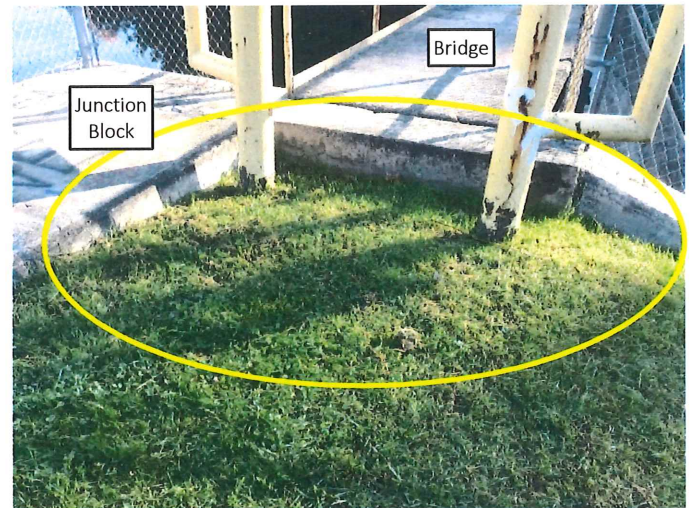
16. Settlement of right embankment at walkway. No movement seen on the concrete junction block.

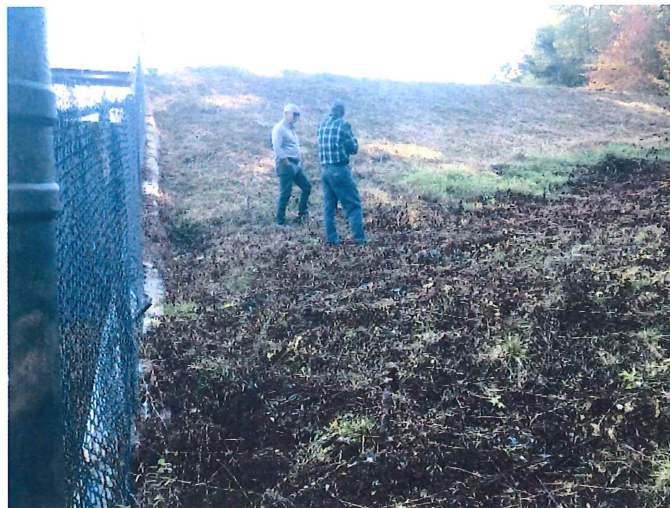
17. Left embankment/wing-wall abutment. Swamp from seepage in the area where the brush has been cut.

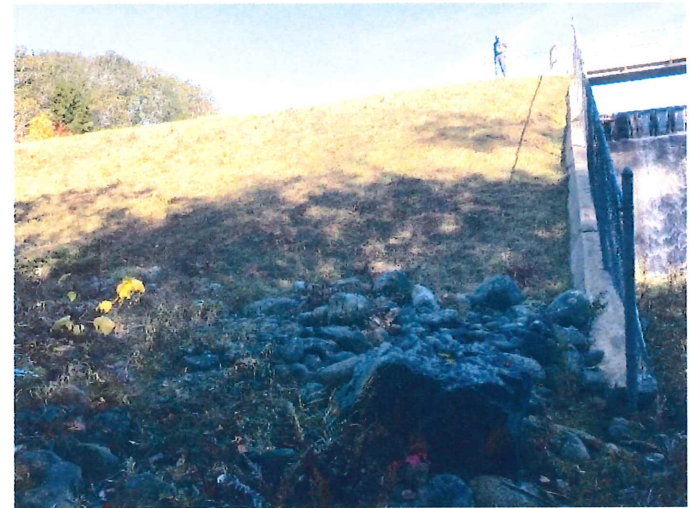
18. Right embankment/wing-wall abutment. Note either settlement or erosion along wall

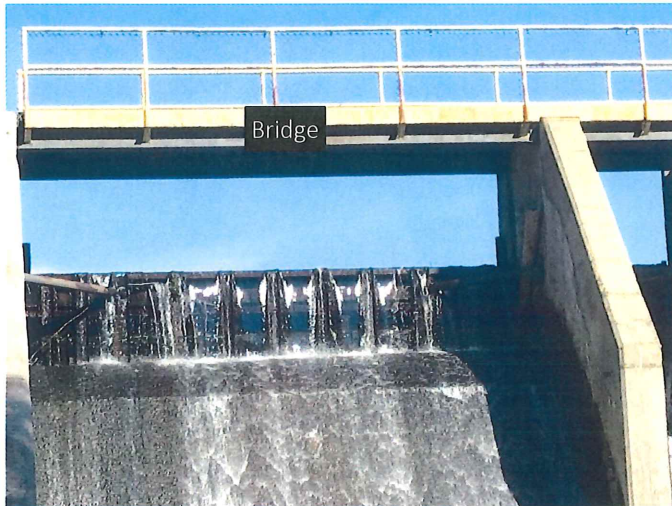
19. Right Spillway. The reason for overflow is that the top of the bulkhead is lower than the left bulkhead.

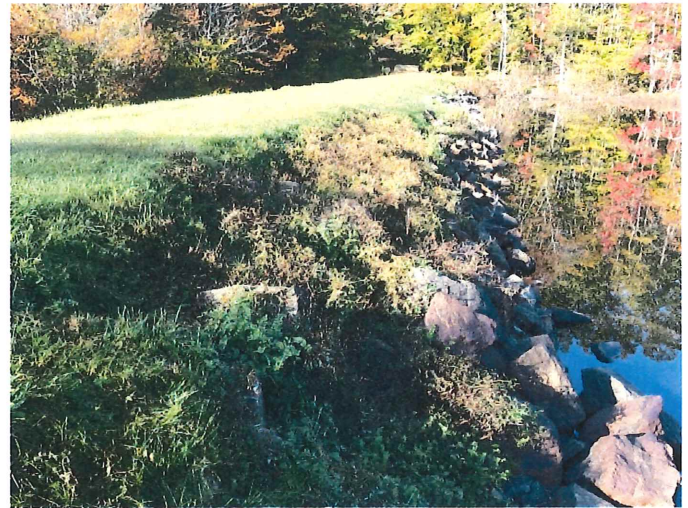
22. Right embankment stone wave protection (rip-rap). Remove brush & rearrange riprap to correct slope. Place new riprap where embankment is exposed.

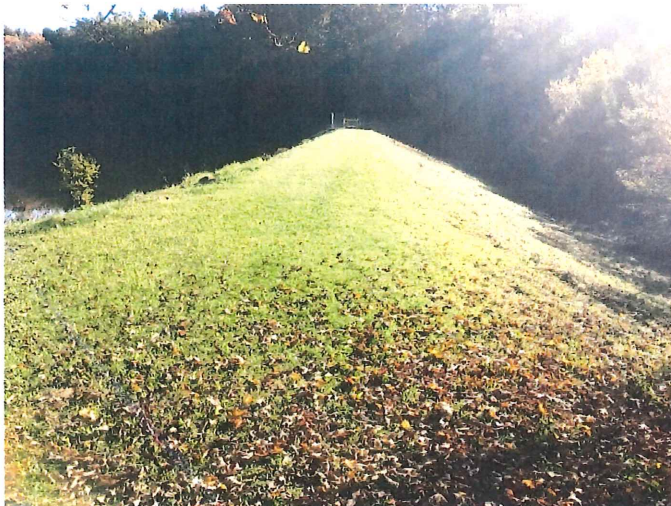
23. Top of Right embankment & downstream face — mostly covered by grass. Downstream face of dam uneven due to local settlement and/or small slips.

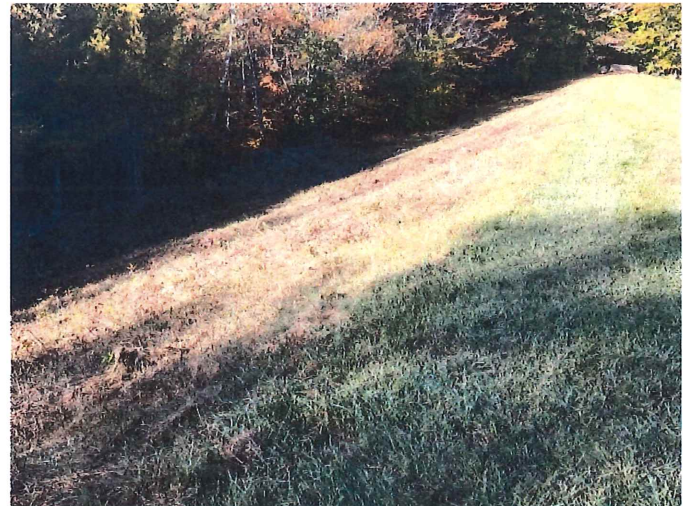
24. Right embankment plane recently cut & uneven. Soil surface could not be seen, however, sporadic settlement, erosion & cracks seen.

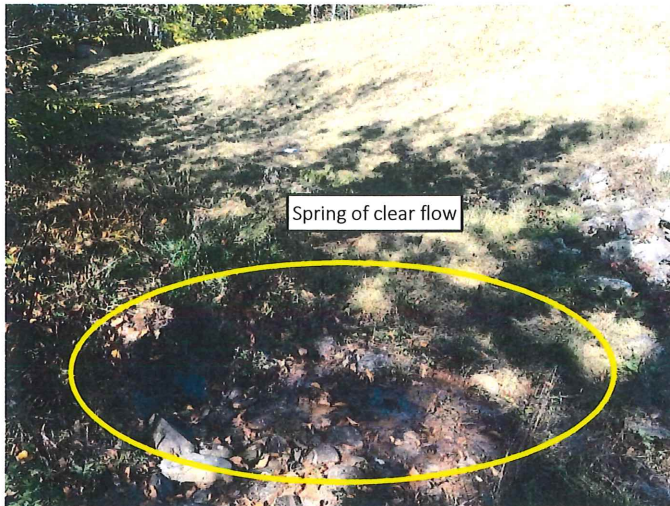
25. Right embankment seepage clear, possibly a toe drain outlet.

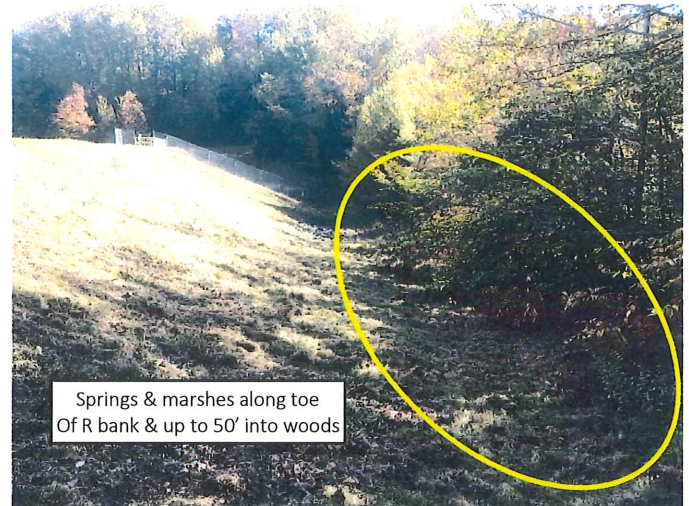
26. View down right embankment toe. Yellow ellipse is area where at least 6 separate marshes have formed. No seepage carried silt or was discoloured.

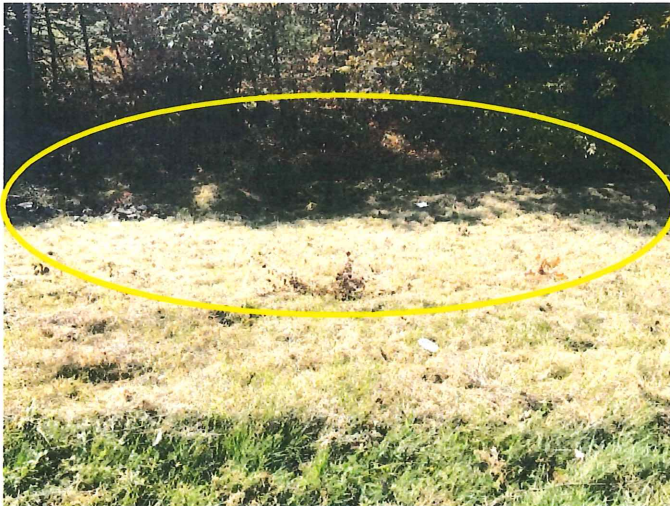
27. View down embankment toward seepage. A28 is in the middle of the photo.

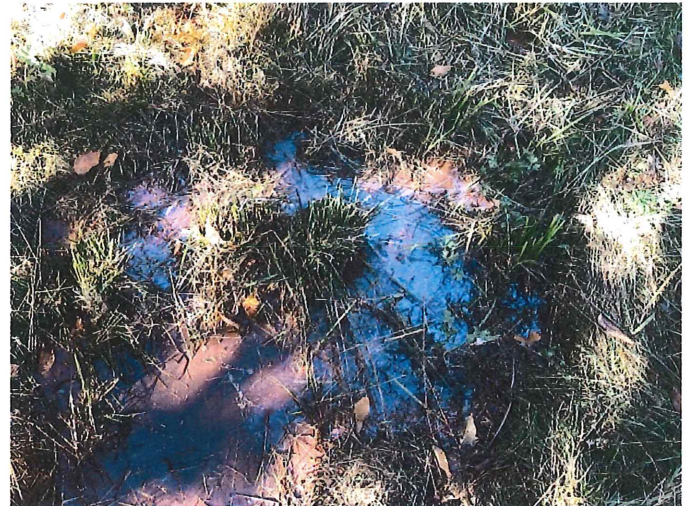
28. Typical low flow marsh showing seepage. This spot is located about 150 feet from the left spillway wall.

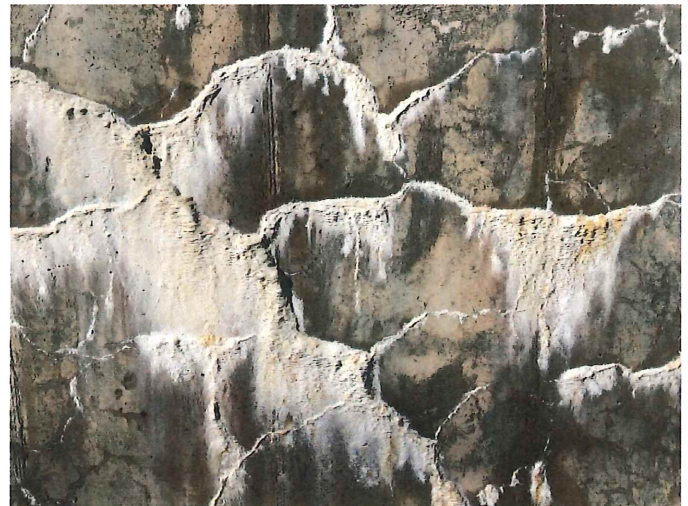
30. Efflorescence (calcium carbonate) caused by evaporation of water seeping through cracks in the channel wall.
