TODDY POND DAM (#111)

**October 2024 – Revision 1
JN: 11299.023**

**REVISION SHEET
OPERATION AND MAINTENANCE MANUAL**

**FOR
TODDY POND DAM NO. 111**

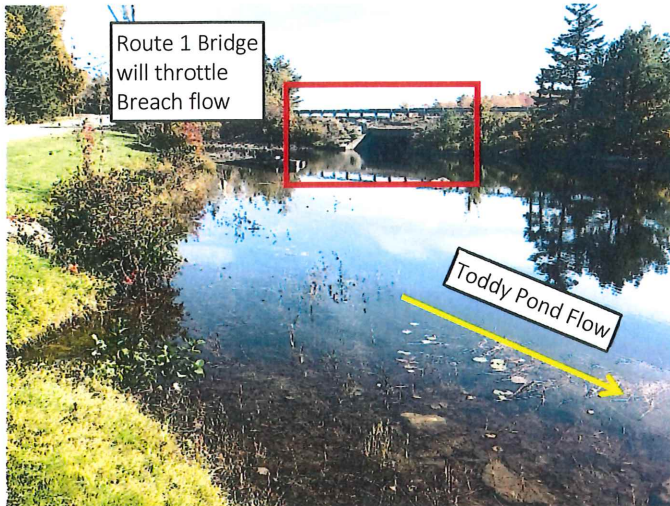
1. Toddy pond head pond drawn down about 12". No new development was seen in the basin that would increase runoff. No new development seen along Pond shoreline.

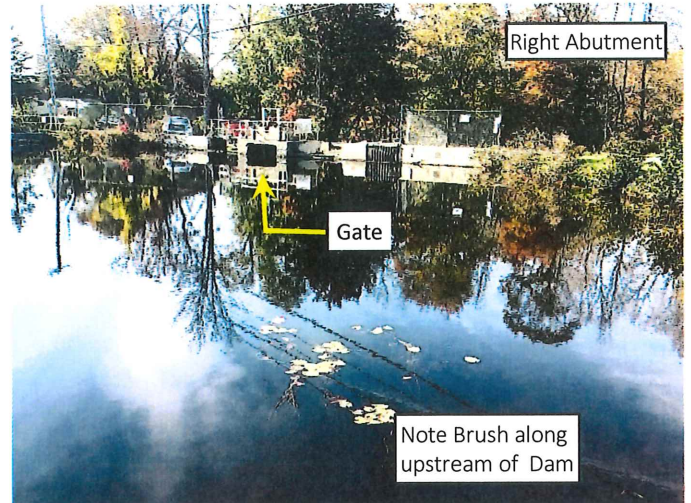
2. Dam headpond. No debris on screen. Concrete deteriorated throughout dam. Gate leaking. Fishway flowing & functional. Brush upstream on embankments left & right of concrete wall.

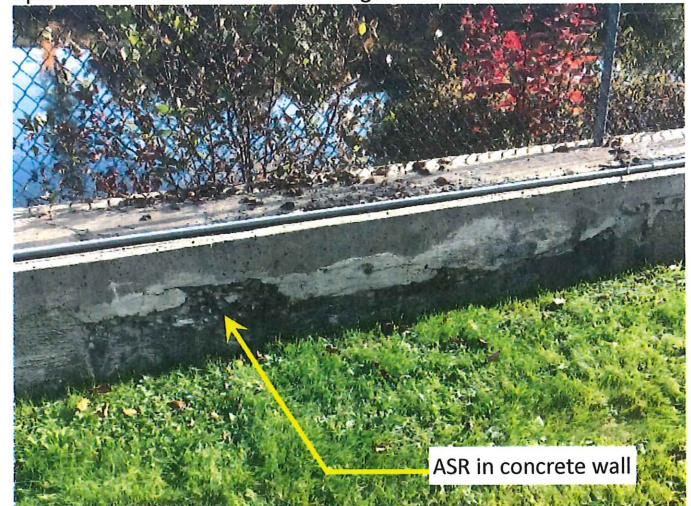
4. Concrete wall between left abutment & bridge.

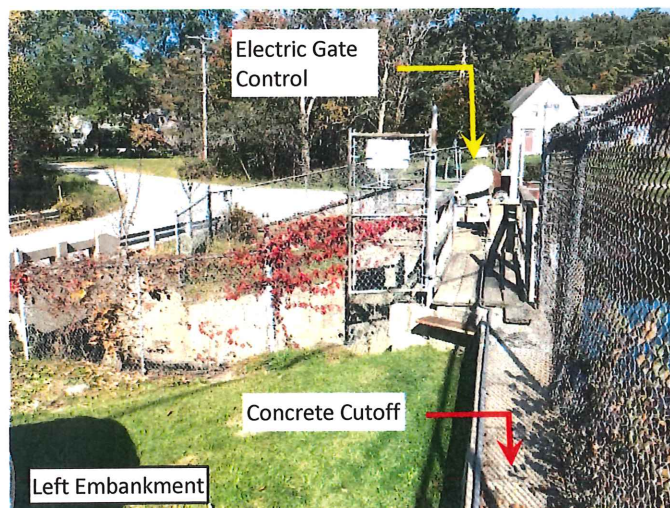
5. Gate opened for inspection. Concrete cutoff wall leads to bridge & gate control. Note fenced channel from spillway to bridge. The lawn is the left embankment.

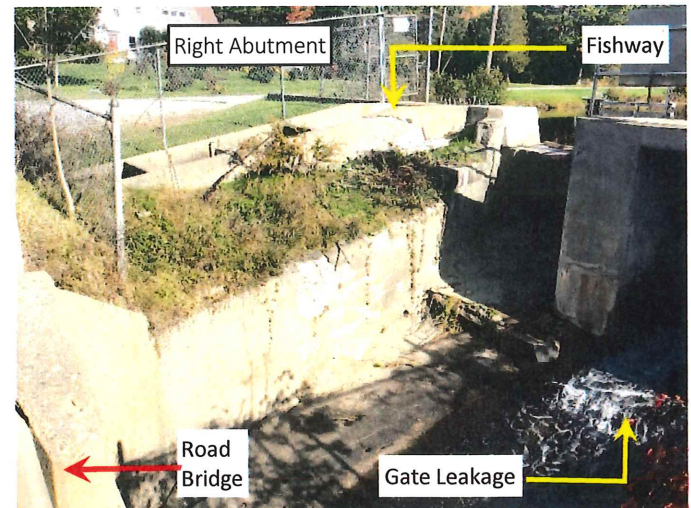
6. Concrete outlet channel. Note close proximity of dam to Hatchery Road & bridge. All concrete serviceable but deteriorated.

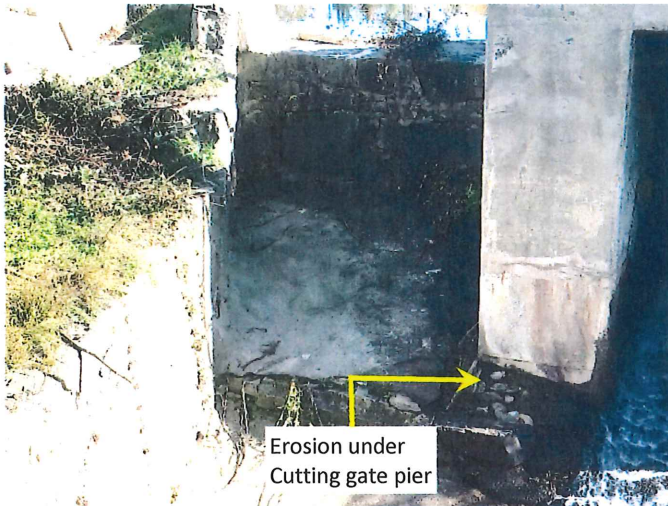
7. Right uncontrolled spillway. Concrete cracks show seepage but little movement

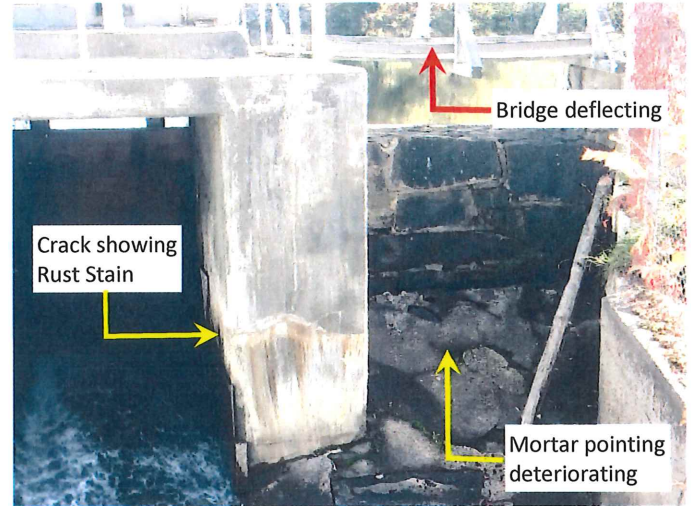
8. Gate & Left uncontrolled spillway. Concrete mortar at gate breaking up. Bridge deflecting. Gate operational.

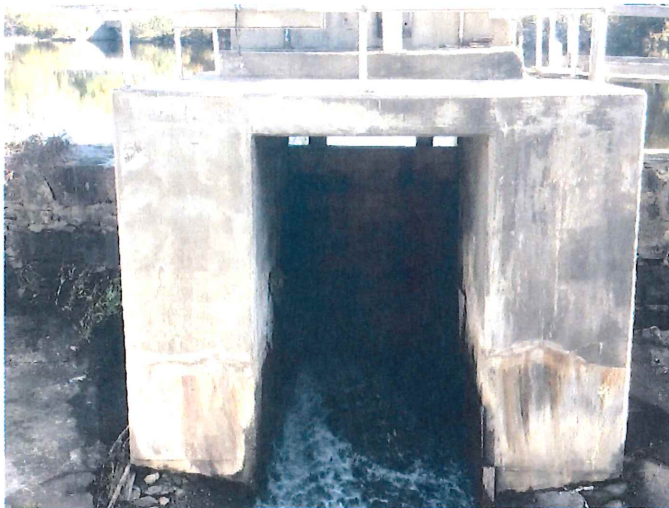
9. Concrete piers & slab housing sluice gate & electric hoist. Rust streaks are likely at construction joints.

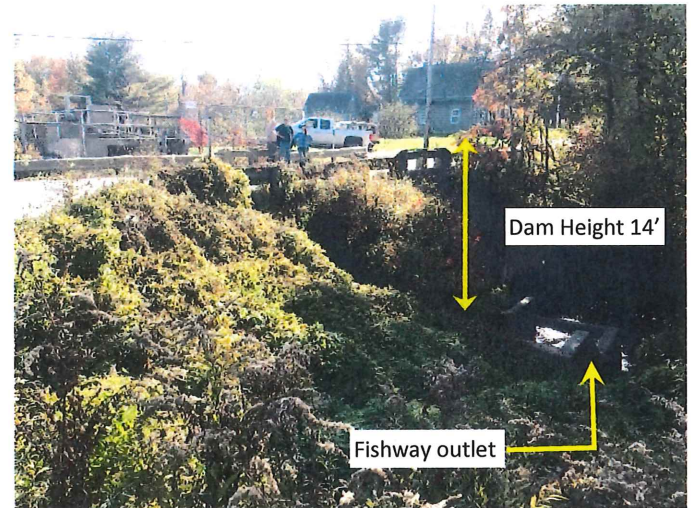
10. Downstream road embankment which merges with the road embankment. Fishway outlet lower right. Toe of dam assumed at channel outlet to bridge.

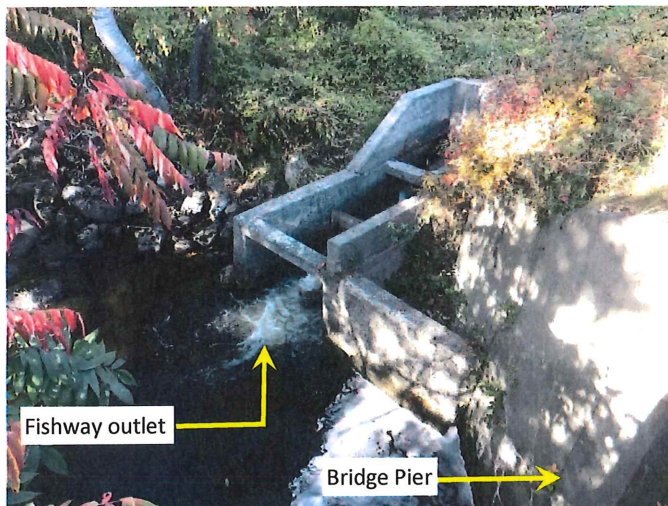
11. Fishway outlet.
