ALAMOOSOOK LAKE DAM (#110)

**October 2024 – Revision 1
JN: 11299.023**

REVISION SHEET
OPERATION AND MAINTENANCE MANUAL

FOR
ALAMOOSOOK LAKE DAM NO. 110

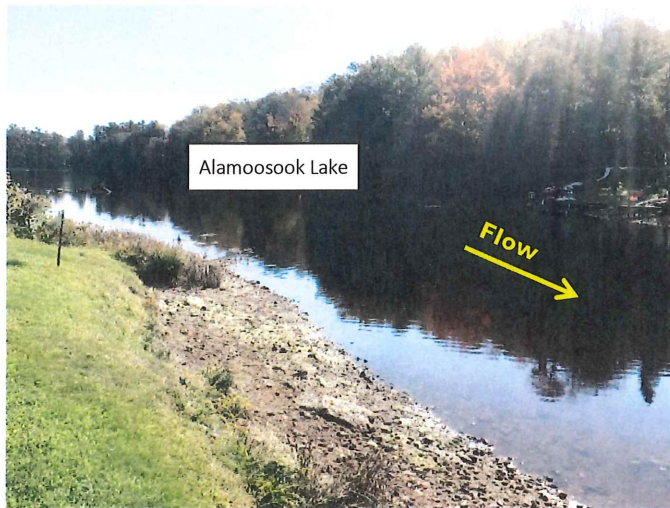
1. Alamoosook Lake drawn down about 30". Little new development seen in the basin or along the lake shore. Convention, "left" means left looking downstream.

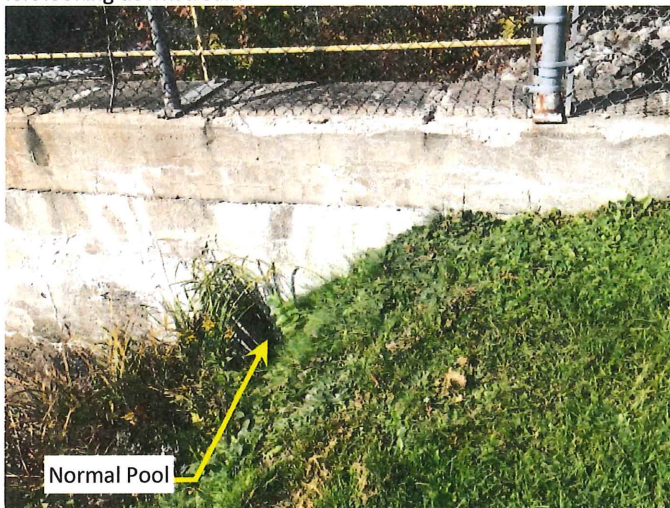
3. Right abutment. Typical surface concrete deterioration. Main body of concrete shows no movement. Fence & poles corroding. Gate locked. Warning signs posted

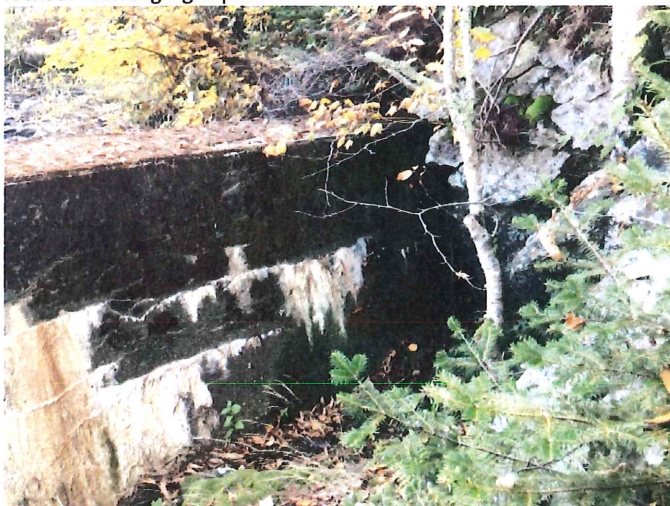
5. Left non-overflow section taken from left downstream. Crack matches horizontal crack in 4. Above. Clear trees & brush to allow for regular easy inspection of abutment. Note ledge.

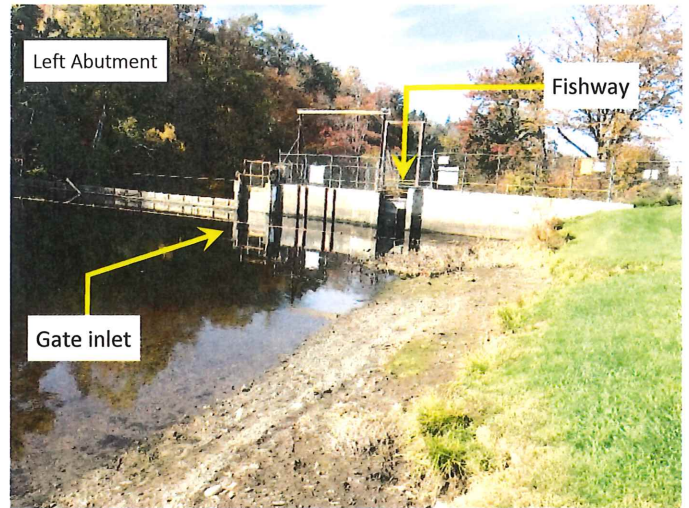
2. View from right upstream shoreline. No debris seen on screen. General Concrete deterioration. Security fence, Gate & Fishway functional but rusted in places.

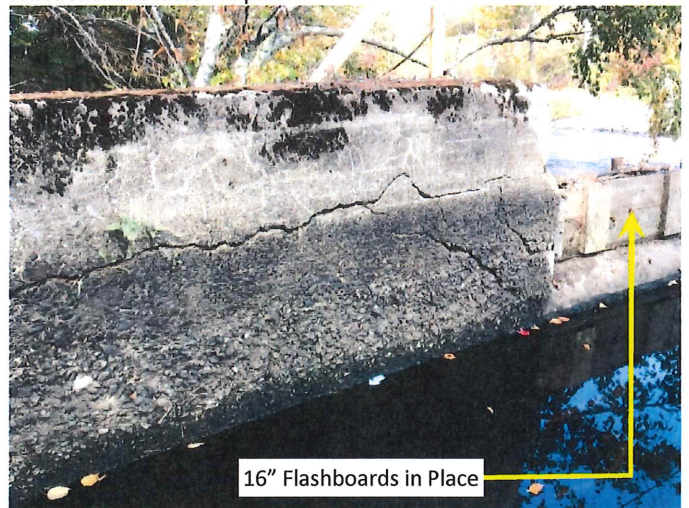
4. Left abutment. Horizontal & diagonal crack through the structure. See photo 5 taken from opposite face. Concrete aggregate exposed possibly due to surface corrosion by tannin in the water.

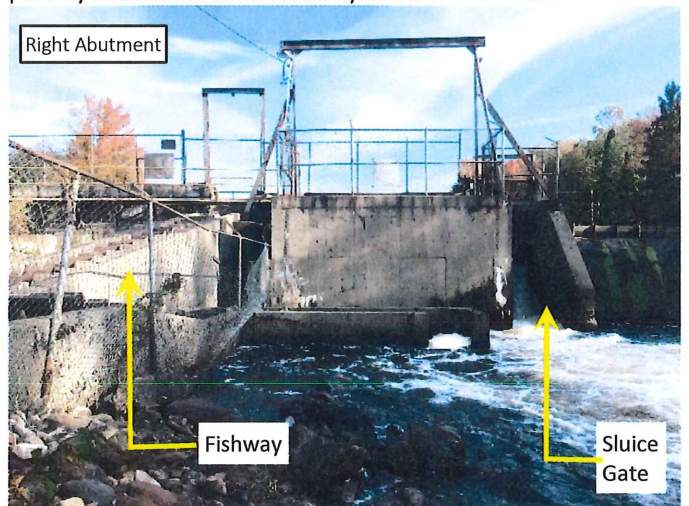
6. View of gate & fishway structure. No movement seen. Concrete spalling & flaking on ogee spillway. Green trace on spillway is either algae or moss. No instability seen.

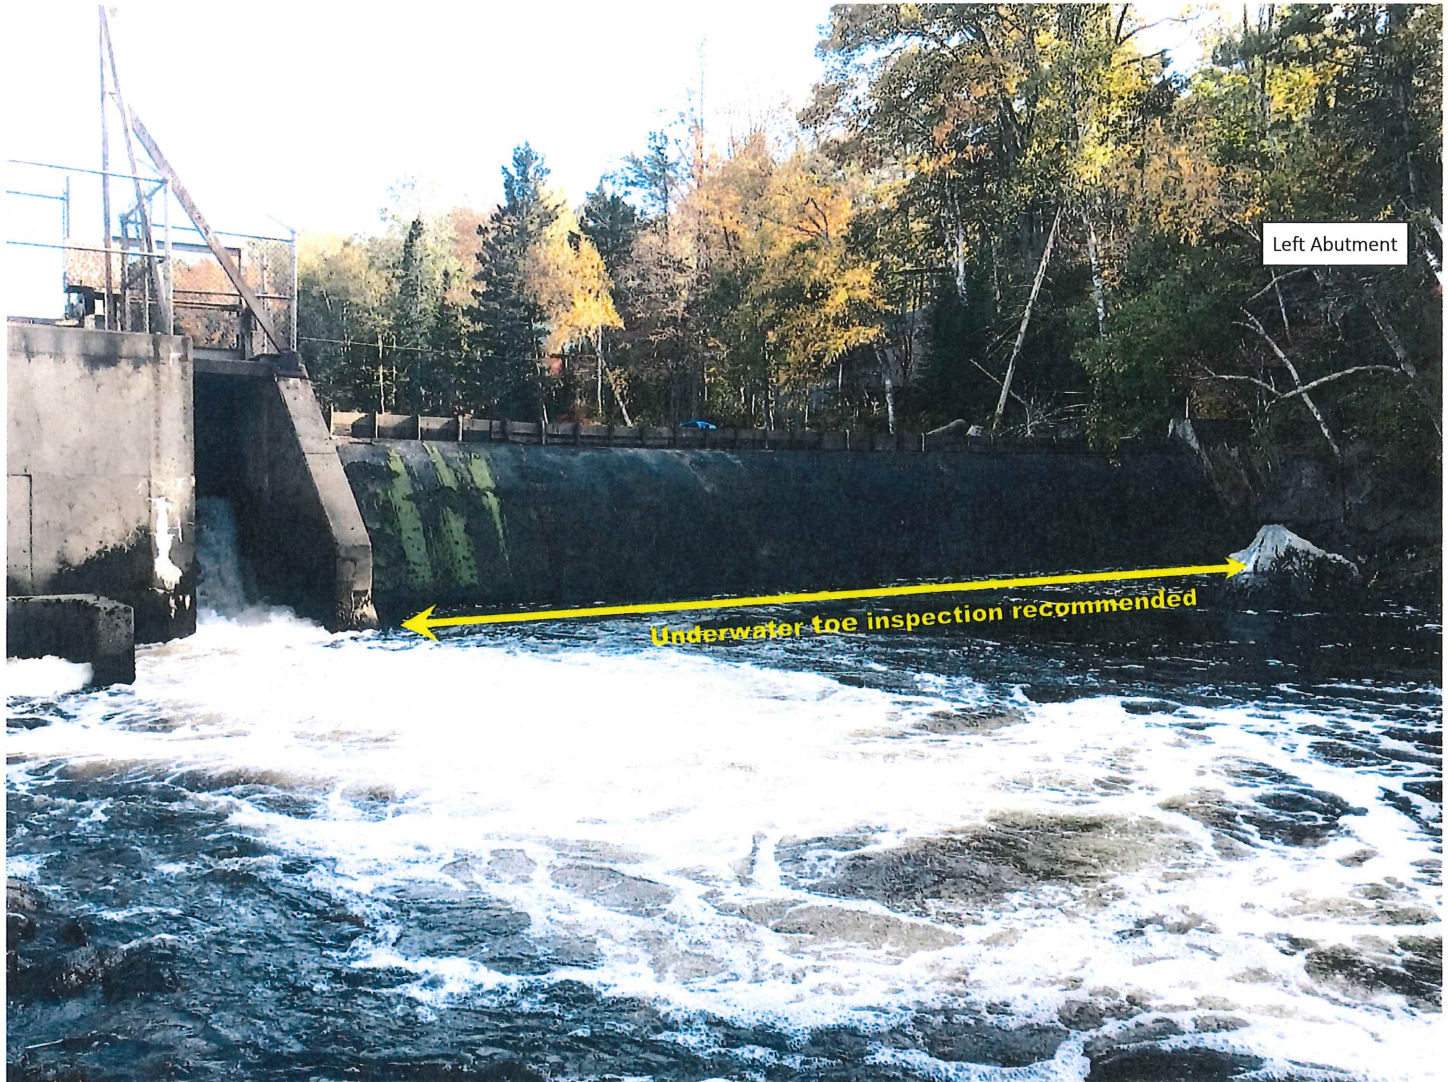
7. Sluce gate & Left concrete ogee weir spillway. Photograph modified to accentuate concrete surface deterioration. Owner requested to have the underwater toe area probed for undercutting by water currents in tail-pond.

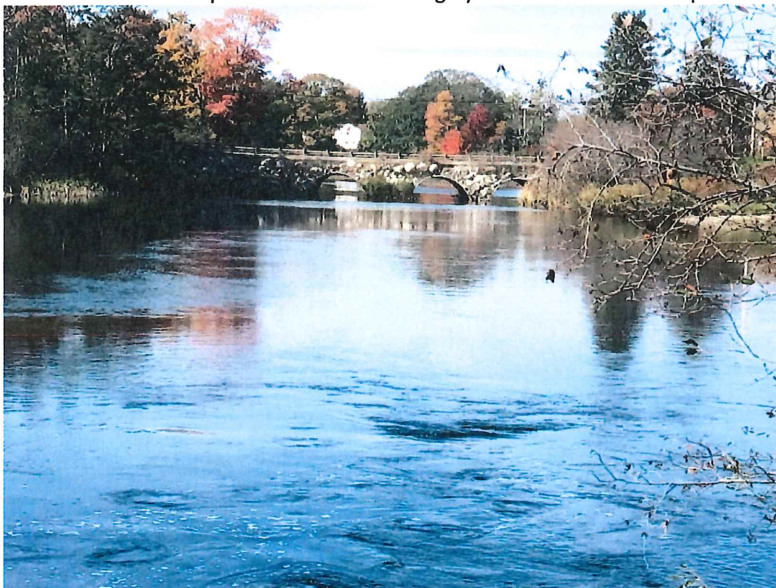
8. Breach of Alamoosook Dam likely to wash out Upper Falls Road CMP Bridge.
