SUBJECT: Dam Inspection Report for MEMA #110 – Alamoosook Lake Dam

#110 Alamoosook Lake Dam
Town of Orland, Hancock County, ME

Hazard & Condition Report
Date of Inspection – 10/12/2021

RE: Condition Assessment of #110 Alamoosook Lake Dam, Town of Orland, Hancock County, ME

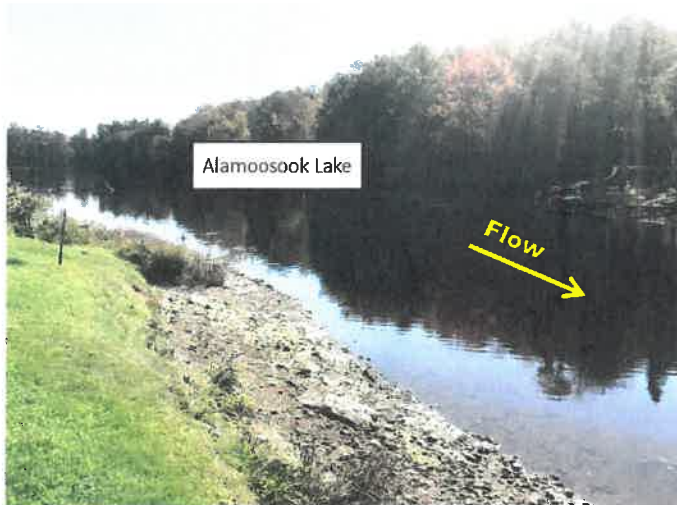
1. Alamoosook Lake drawn down about 30". Little new development seen in the basin or along the lake shore. Convention, "left" means left looking downstream.

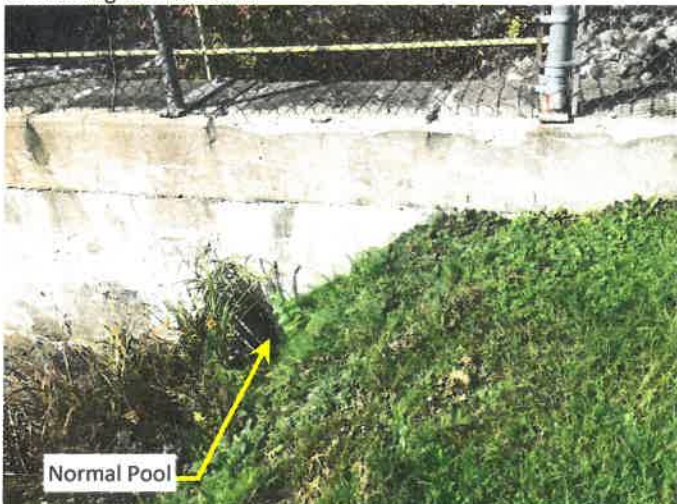
3. Right abutment. Typical surface concrete deterioration. Main body of concrete shows no movement. Fence & poles corroding. Gate locked. Warning signs posted

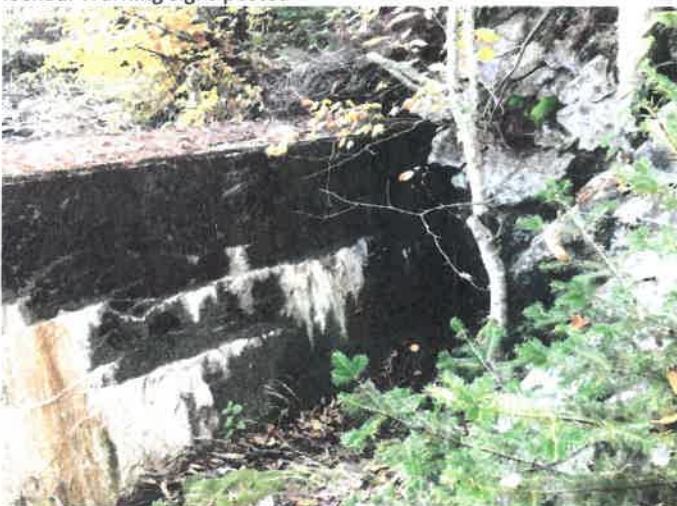
Large horizontal cracks have formed in the left non-overflow concrete section of the dam (4,5).

Although no movement or misalignment of the monolith was seen, it appears horizontal sliding or overturning of the left (looking downstream) non-overflow section is imminent. Other concerns are the loss of significant areas of surface concrete on the ogee section of the spillway, exposed only because the spillway was not overflowing. Standard operating procedures (SOP's) are recommended to establish inspection & operating regimen for this dam, as well as keep a record of events.

5. Left non-overflow section taken from left downstream. Crack matches horizontal crack in 4. Above. Clear trees & brush to allow for regular easy inspection of abutment. Note ledge.

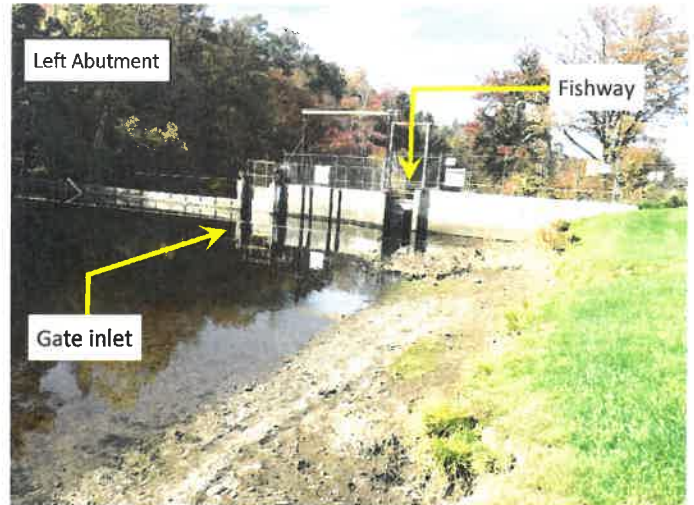
2. View from right upstream shoreline. No debris seen on screen. General concrete deterioration. Security fence, Gate & Fishway functional but rusted in places.

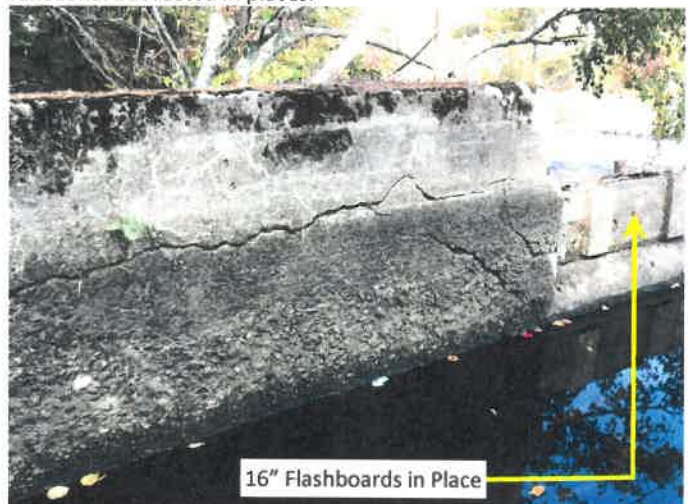
4. Left abutment. Horizontal & diagonal crack through the structure. See photo 5 taken from opposite face. Concrete aggregate exposed possibly due to surface corrosion by tannin in the water.

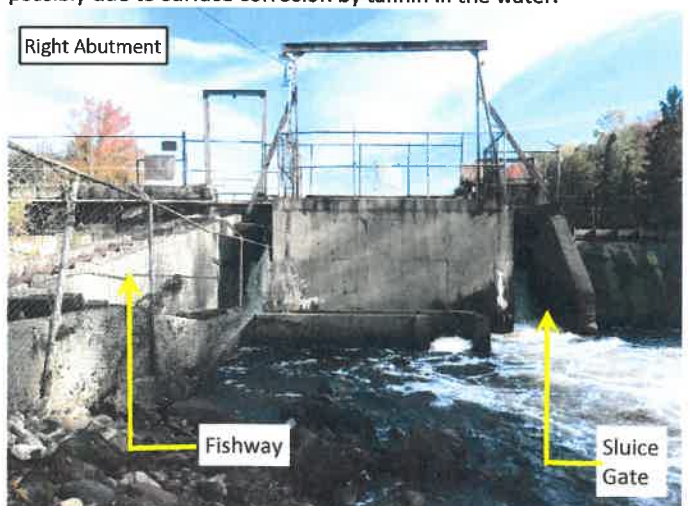
6. View of gate & fishway structure. No movement seen. Concrete spalling & flaking on ogee spillway. Green trace on spillway is either algae or moss. No instability seen.

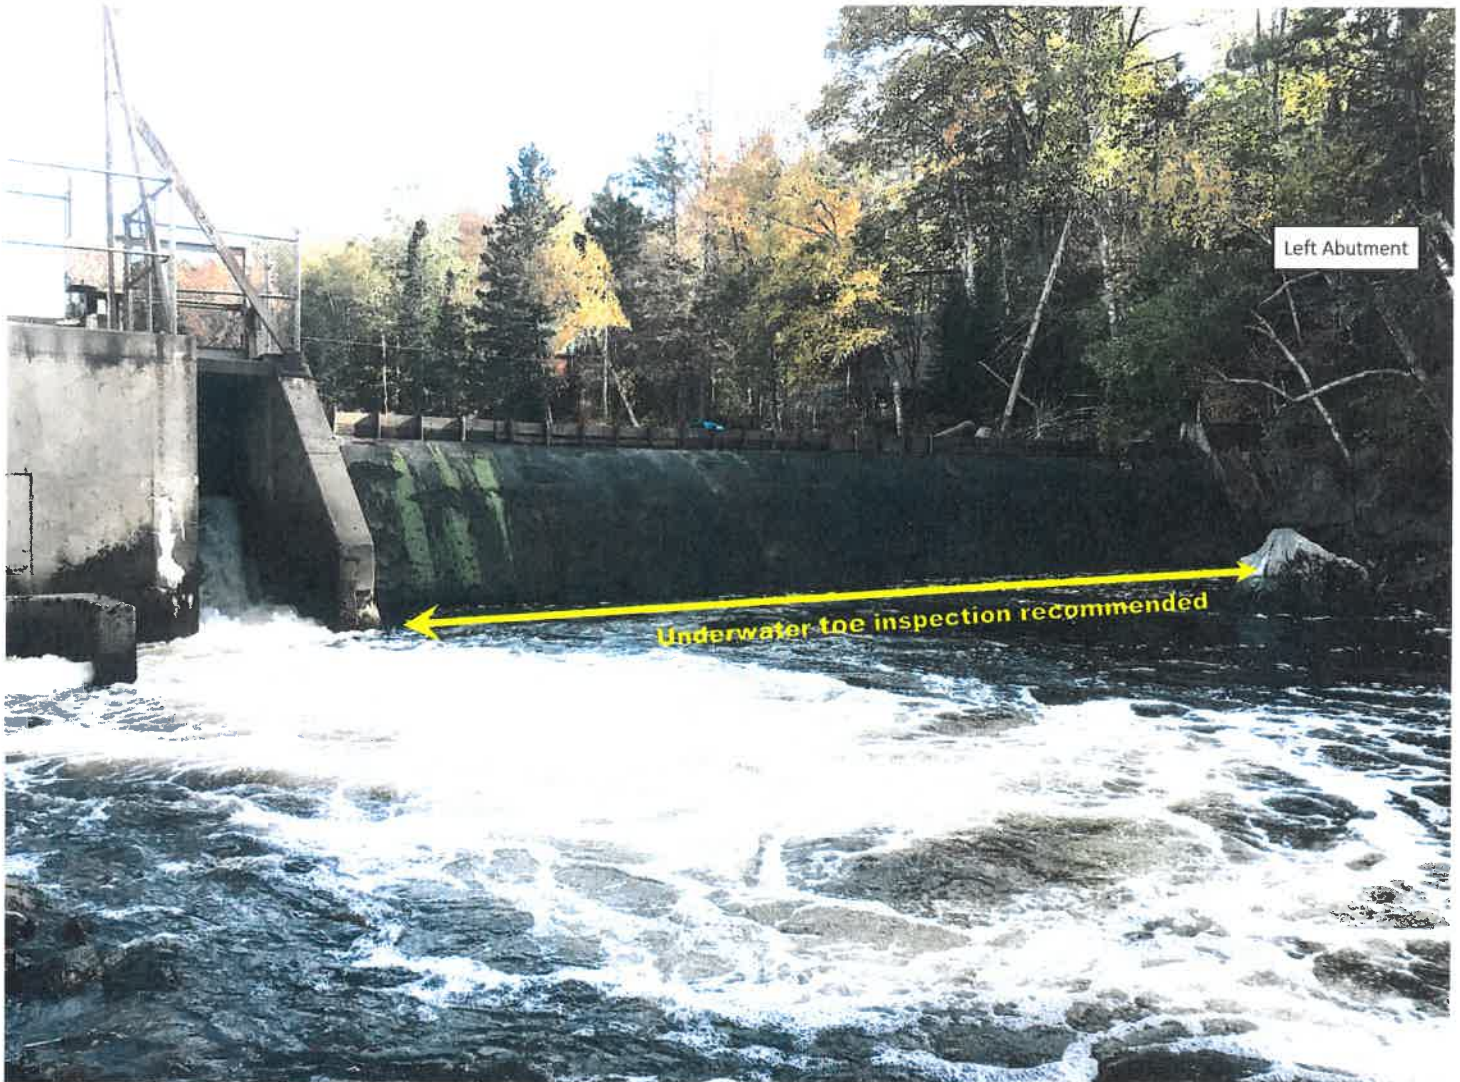
7. Sluice gate & Left concrete ogee weir spillway. Photograph modified to accentuate concrete surface deterioration. Owner requested to have the underwater toe area probed for undercutting by water currents in tail-pond.

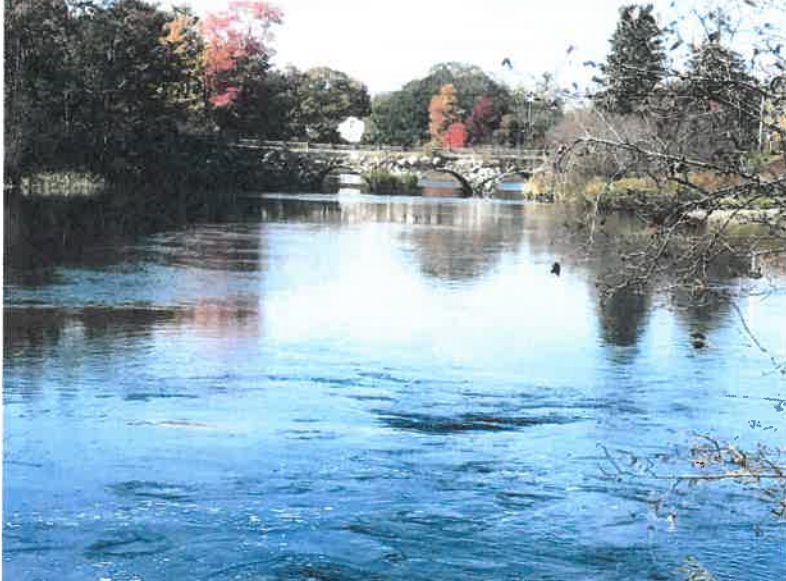
8. Breach of Alamoosook Dam likely to wash out Upper Falls Road CMP Bridge.

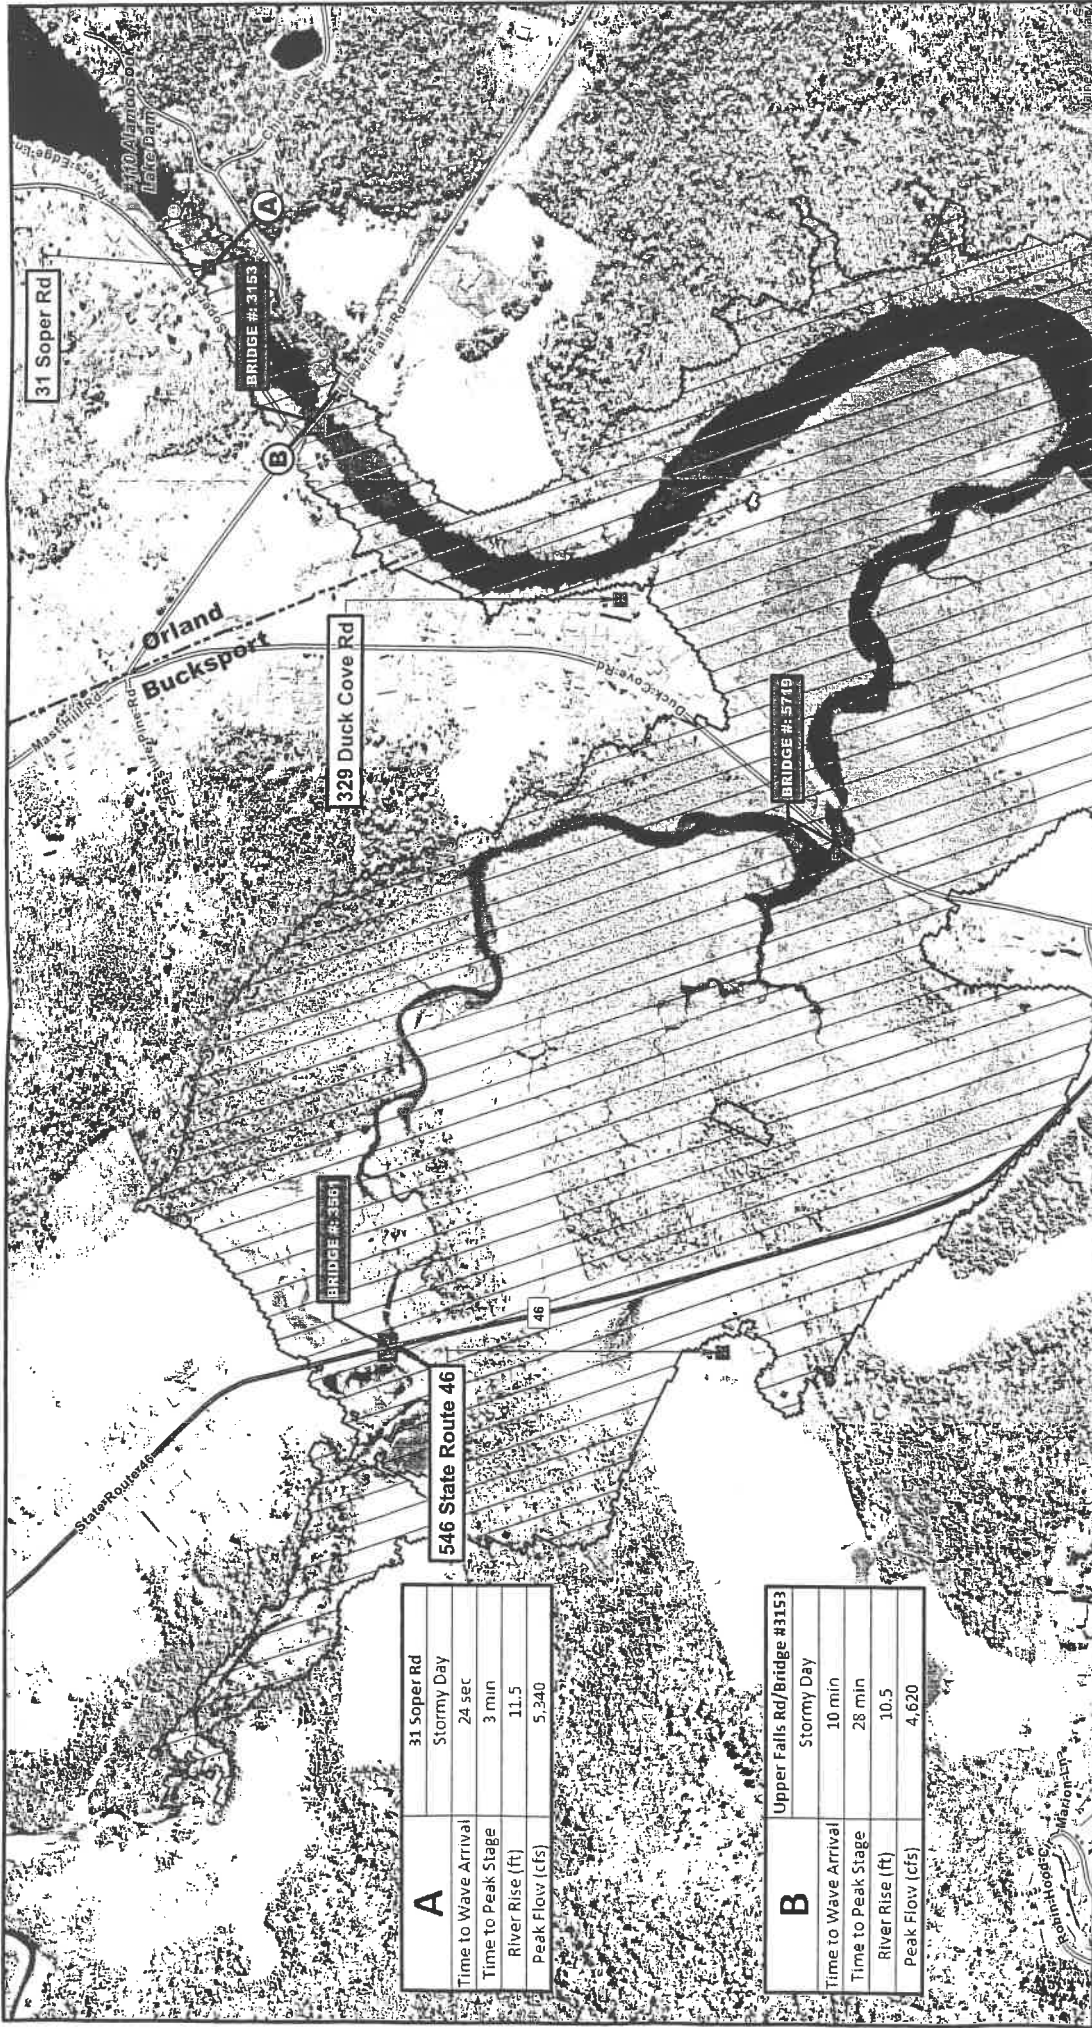
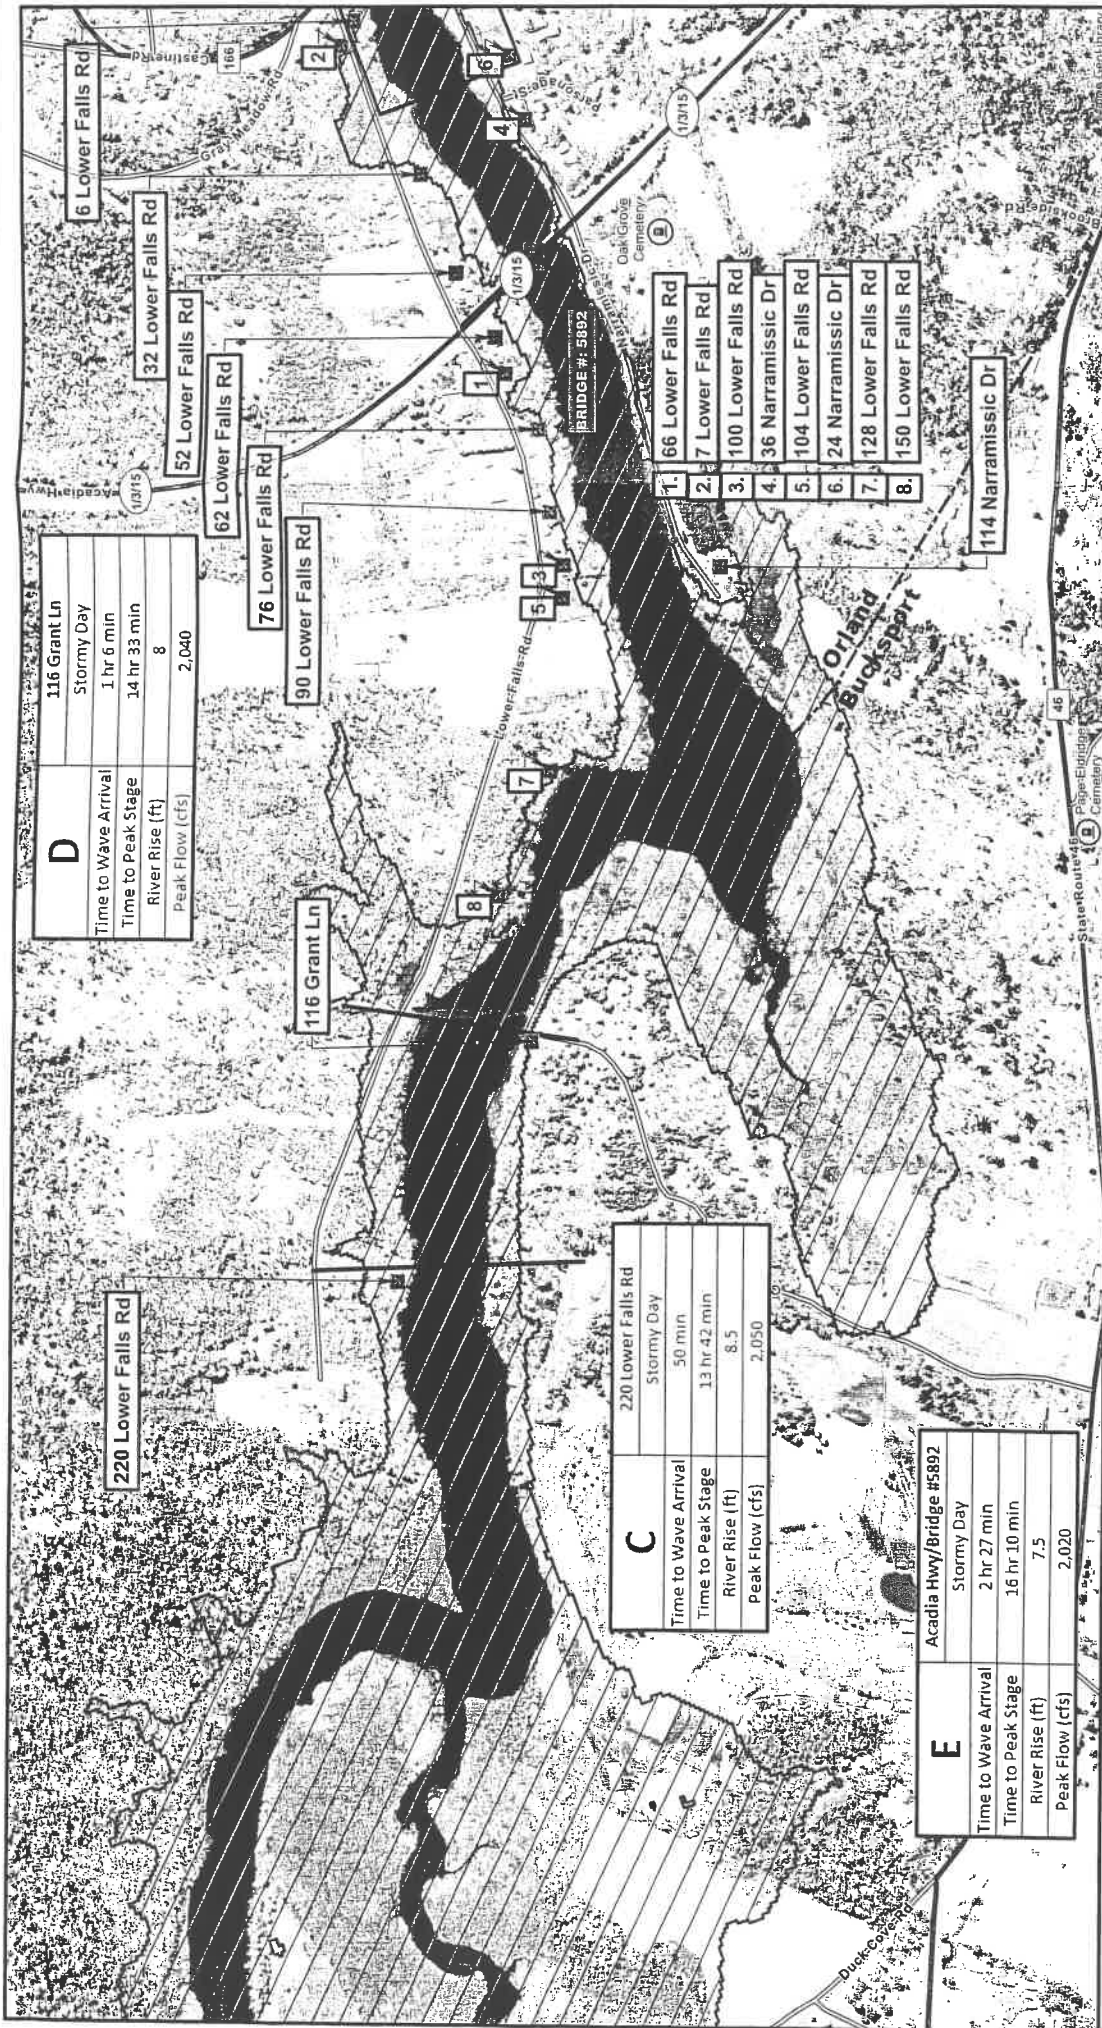
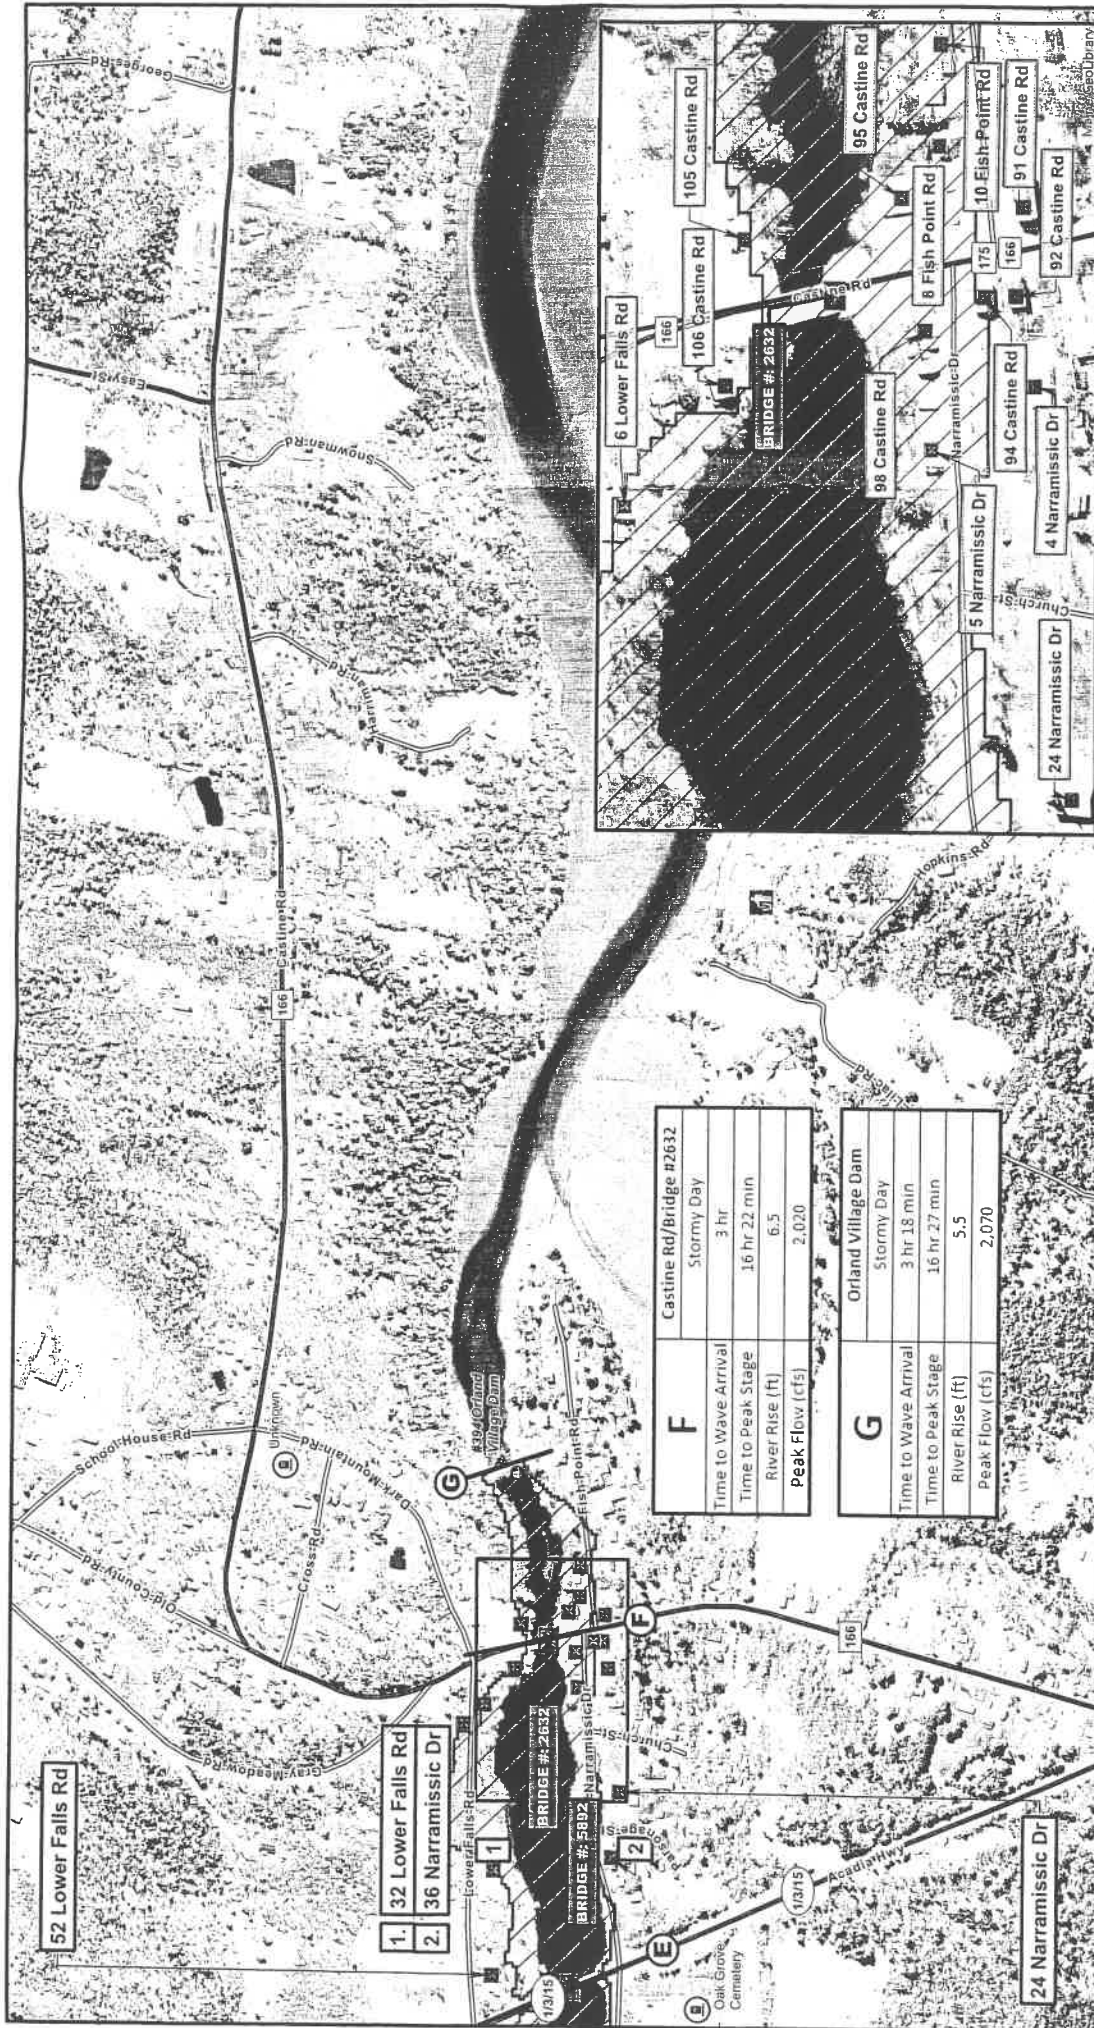
Attachments F1, F2, F3, are "dam breach inundation maps" (DBIM's) copied from the draft MEMA "Alamoosook Lake Dam Breach Study" dated 2/7/20, by MEMA. The flood line on this map was derived from a 8,000 cfs breach of Alamoosook dam. The breach was routed down the Narramissic River valley for 2.5 miles to the Orland Village Dam. The time of arrival & flood water depth are shown at 7 downstream sections A-G. Infrastructure impacted by this flood; the pump station, 6 bridges, several miles of road & the Orland Village Dam. It is recommended that the dam owner produce a similar DBIM for inclusion into the dam EAP.

By comparison, the breach flow of the MEMA study was 7,960 cfs reducing to 5,340 cfs at section A, about 6 times the breach flow used in the existing EAP. The breach flow caused by the overturning of the 70' ogee spillway section, head pond at spillway crest (elevation 20.00') is 12,000 cfs (9.4 times the capacity of the dams outlets or 2.7 time the 100-year flood). Using the MEMA DBIM, about 9 houses fall inside the dam breach flood zone. Accordingly, Alamoosook Lake Dam is a "high potential hazard dam" & must be reclassified by MEMA

- 1) Make replacement dam breach flood maps (DBIM's - example F1,F2,F3) using a 1 hour, 70 wide, TOD overturning breach.
- 2) Agree new flood maps with MEMA & replace current EAP DBIM's. Copy map to MEMA in a PDF format.
- 3) List all house & downstream infrastructure flooded by the breach & include; address, # occupants, contact & telephone #.
- 4) Re-test new EAP & DBIM before the 2022 spring runoff.

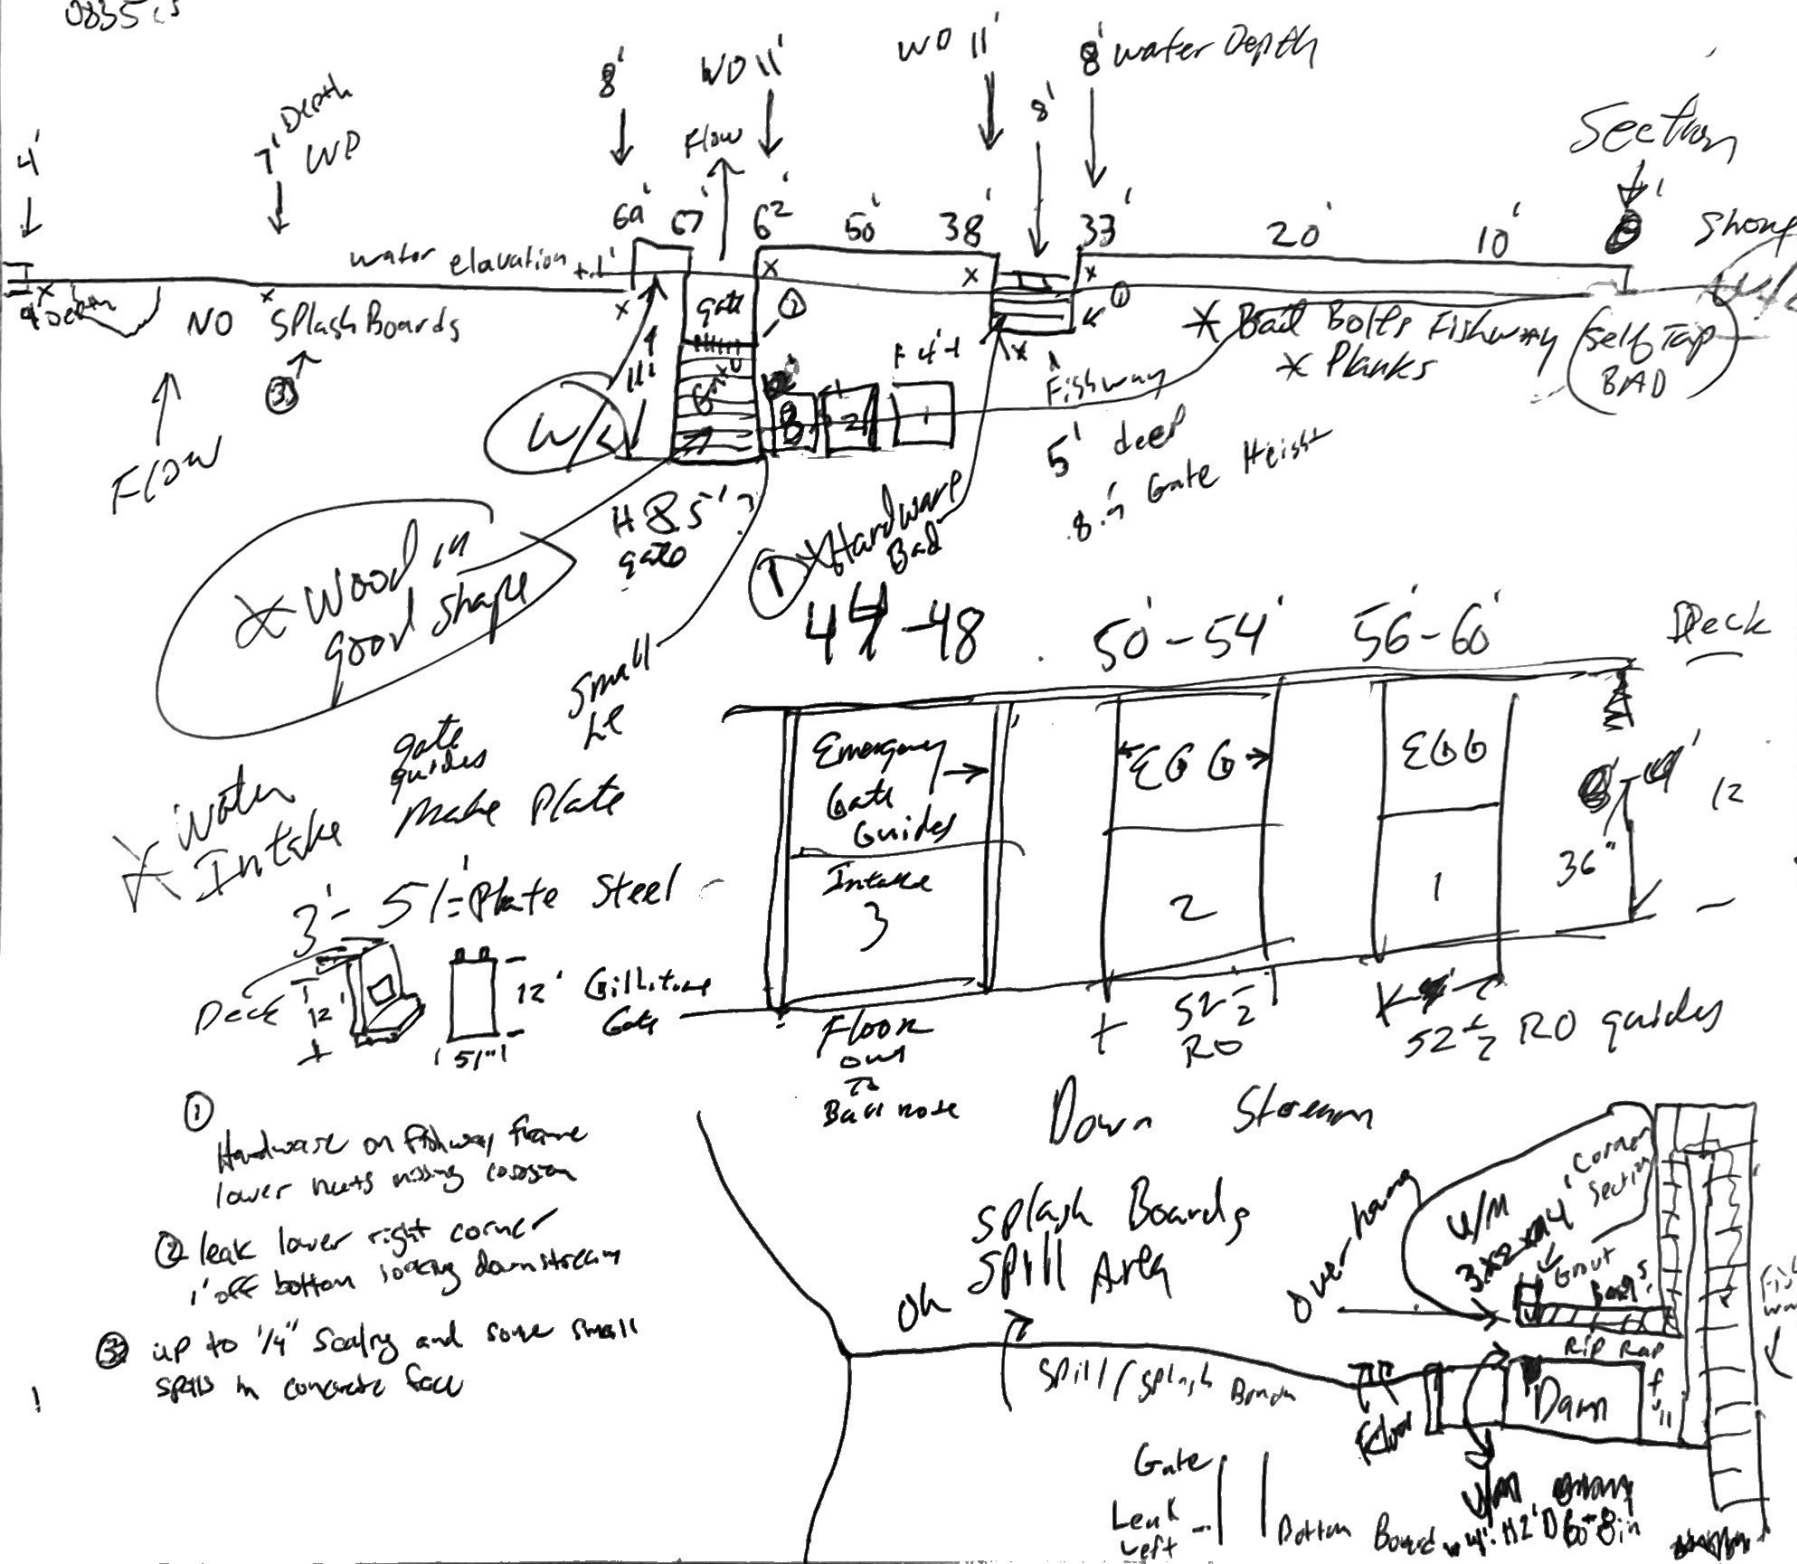
- 1 - Check wood on gates (Good) Done
- 2 - Clean Screens (3) (Good) Done
- 3 - Fish-Way Boards Anchors (Bad self taper) Hardware Bad
- 4 - Fence Bad Falling in water. *see video
- 5 - No splash Boards
- 6 - Clean out Debris in splash Boards Holes
- 7 - *Undermine at Tank footing 4X
- 8 - Down stream 2 Bad Trees 4/5
Can Fall on Power Lines / Fences.

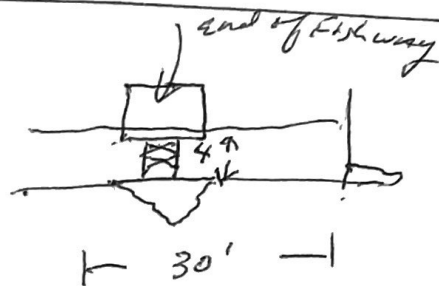
- ① Fishway Rip-Rap + Grout Bags
Cavity under screen Building Underneath

- ② cracks upstream Holes In concrete

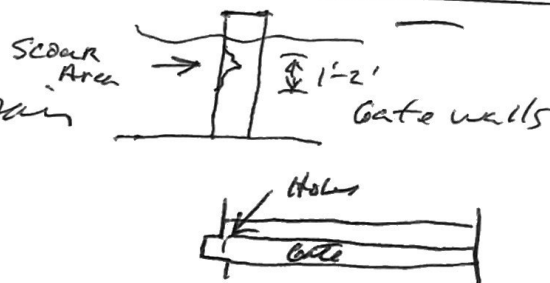
- ① Gate walls need concrete Repair
- ② Split in Pier of concrete
- ③ Holes in corner large gate

- ① Clean Racks 3' + Debris Find Floor?, Racks Not Down
- ② Repair + Replace Gate + shaft/bears?, Pad gate Broken
- ③ Clean out 6' opening + 36" P/L * Remove Debris sand/brush
- ④ Repair concrete on Intake

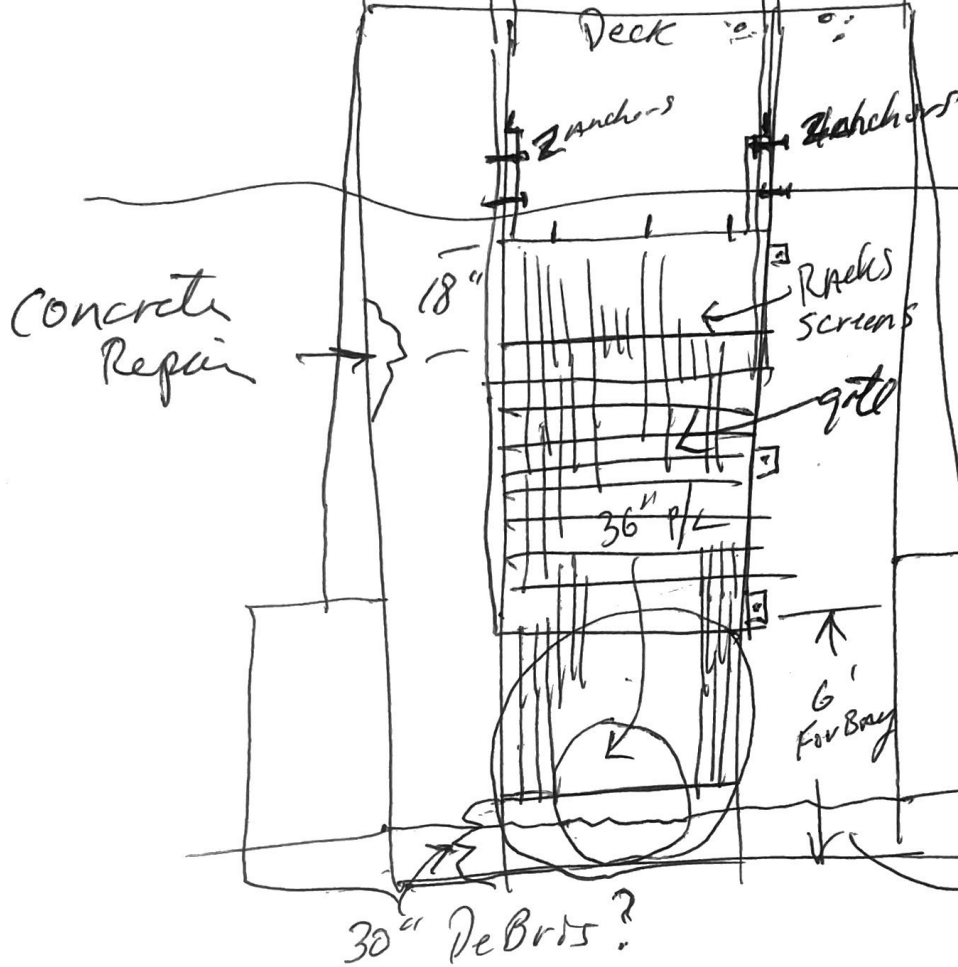
Silver Lake Intake

30+ "
Debris
Rocks

- ① clean Racks
- ② Repair Concrete
- ③ Anchor Bolts Racks
- ④ Clean Floor
Inside 30"
outside Racks
- ⑤ gate Dog in
- ⑥ Pad gate Broken

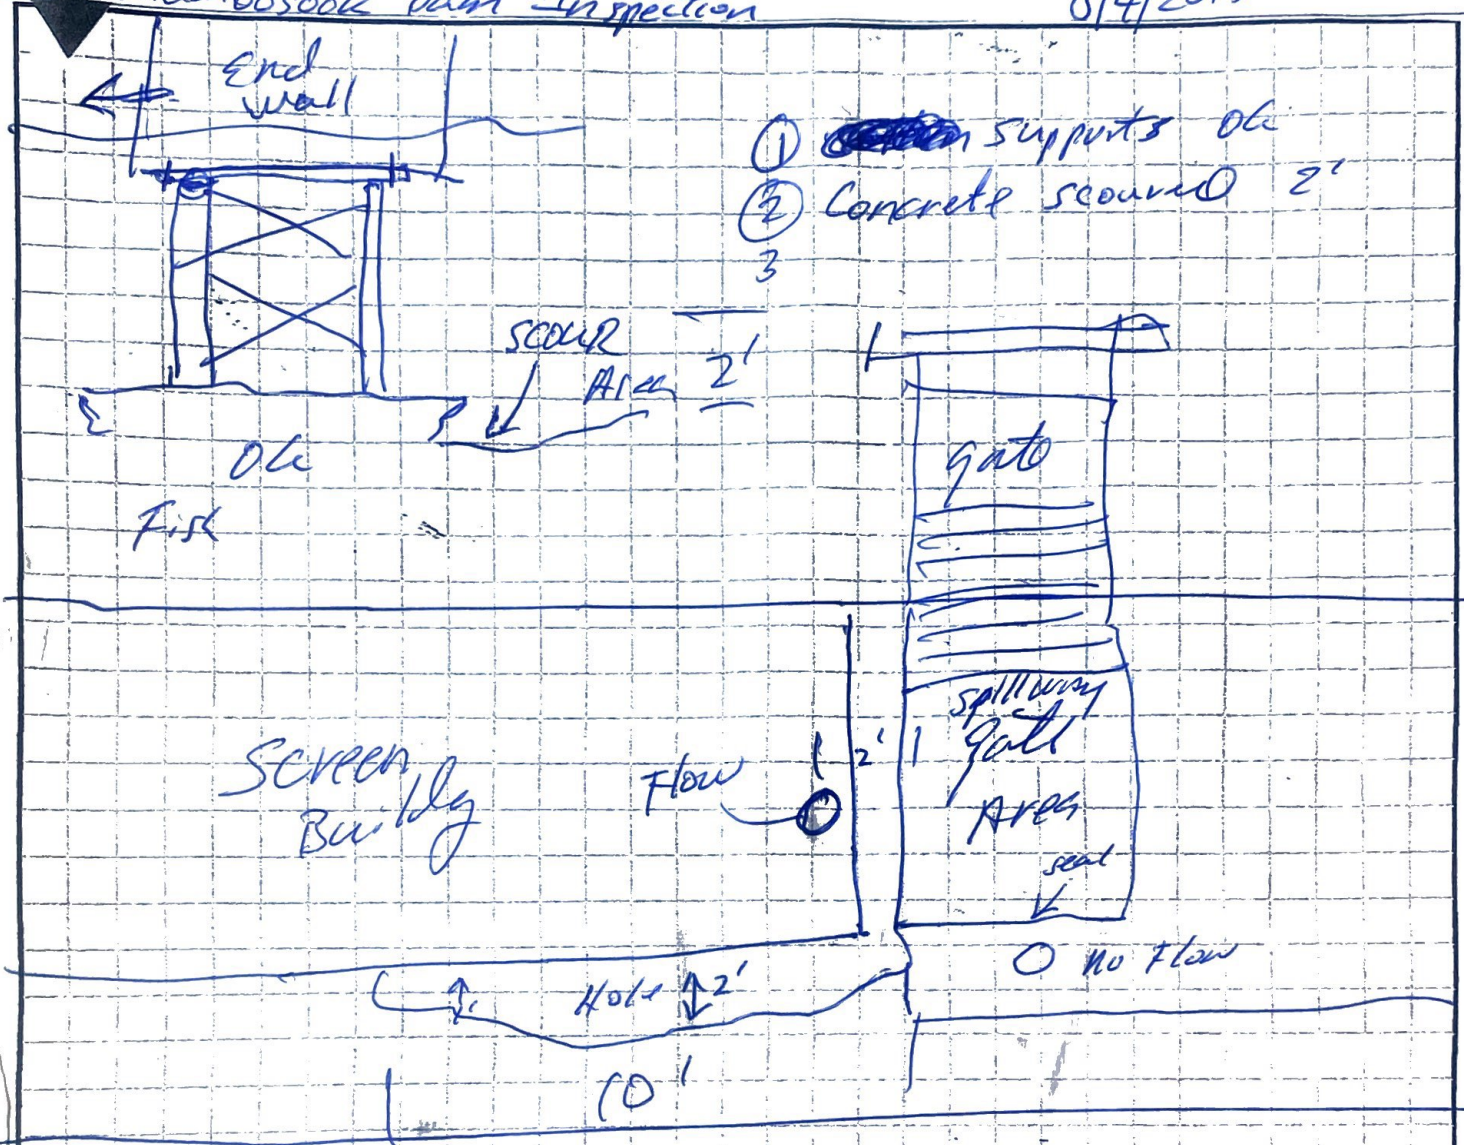
Up stream Dam

- ① screens bad need clearing
- ② Floor has 2"-3" debris
- ③ Gate seal leaks a little (Flow gate)
