SUBJECT: Dam Inspection Report for MEMA #105 Silver Lake Dam

#105 Silver Lake Dam
Town of Buckport, Hancock County, ME

Hazard & Condition Report
Date of Inspection – 10/12/2021

#105 Silver Lake Dam – Hazard & Condition Inspection Report

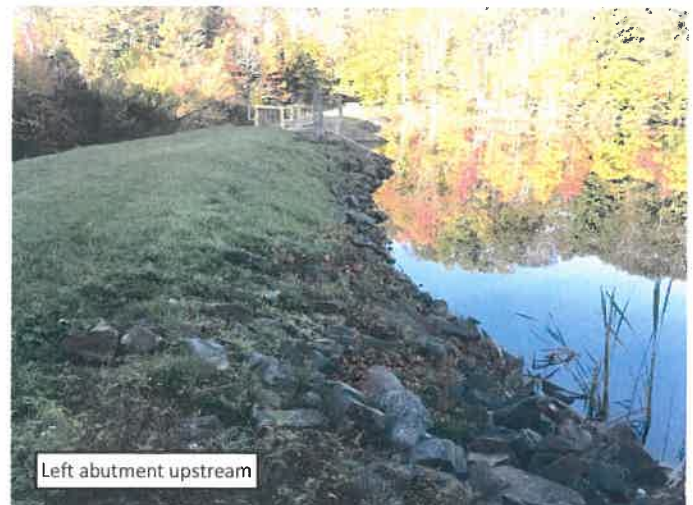
1. Left abutment from top of dam (TOD). Brush recently cut, bank well grassed. Some settlement along TOD. Downstream slope has significant settlement in place.

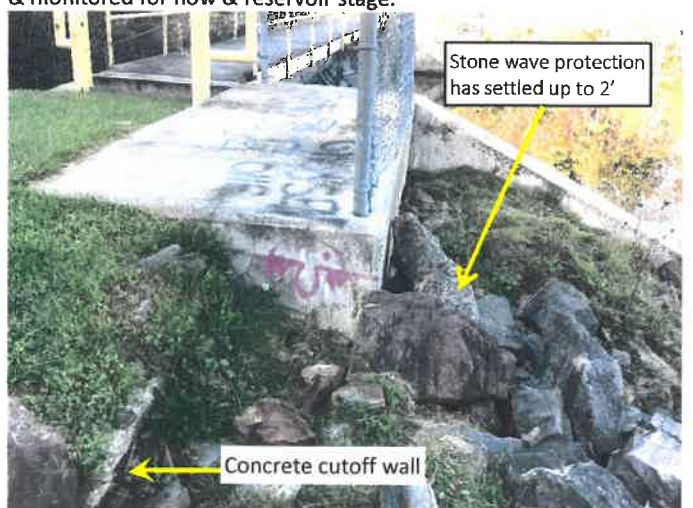
5. Settlement, random boulders & uneven earthwork surface. Concrete cracked but surfaces are plain. This concrete block is connected to the reinforced concrete cutoff wall.

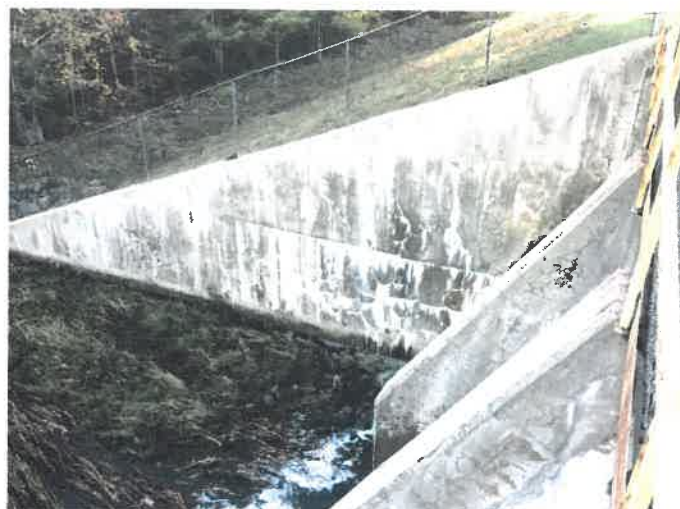
7. Left downstream mass gravity channel. Built 1930, re-faced 1984, with Gunitite. Photos show similar cracks & efflorescence reported by the Army Corps of Engineers (COE) in 1978, A3&A6. Efflorescence shows calcium carbonate developed by evaporation.

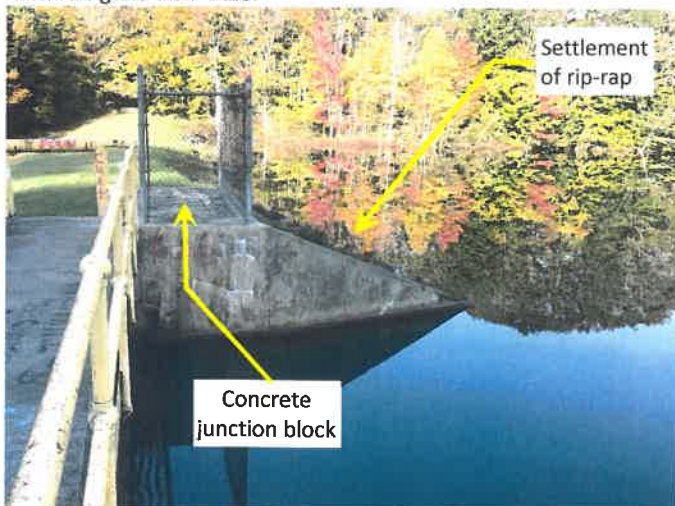
9. Upstream, left mass-gravity retaining wing wall & footbridge. Minor cracking & efflorescence at junction with block. Note graffiti.

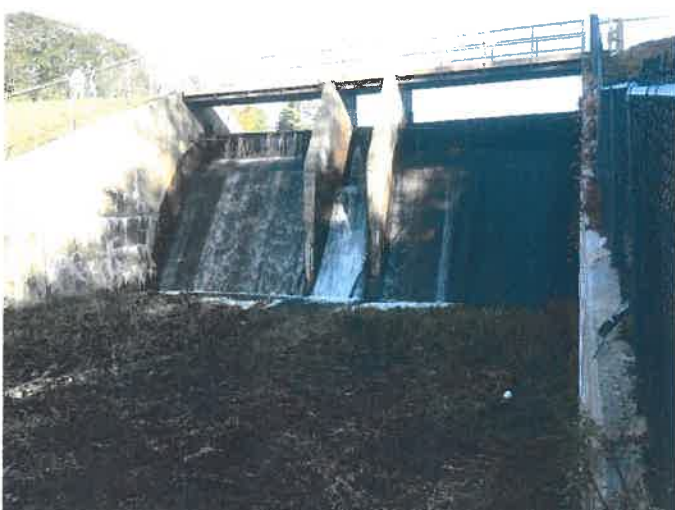
A11, A12, shows the results of a recent storm which caused the dam's spillway to flow. Significantly the channel has silted, see D6 supporting thick vegetation. D6 also shows the components of the channel bed covered by silt. On the day of the inspection, Silver Lake was at NP elevation.

11. Spillway downstream channel between left & right wingwalls silted. Note flattened grass from recent storm.

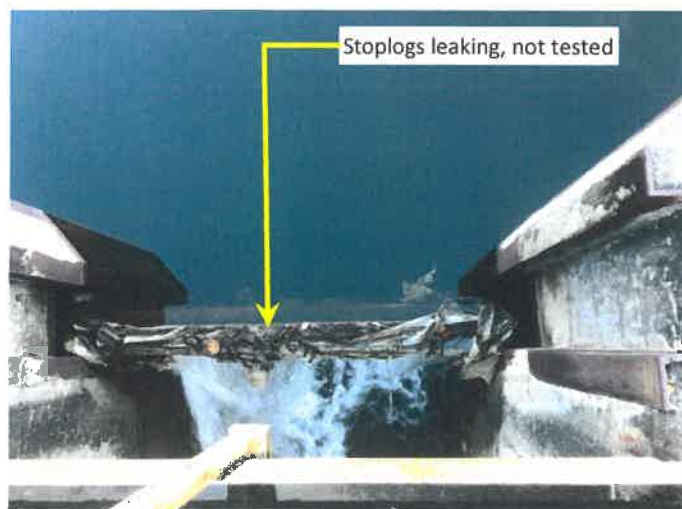
12. Spillway & stoplog weirs. Note the right bulkhead overtopping considerably more than the left & leaking stoplogs leaking. Note difficult access to stoplogs.

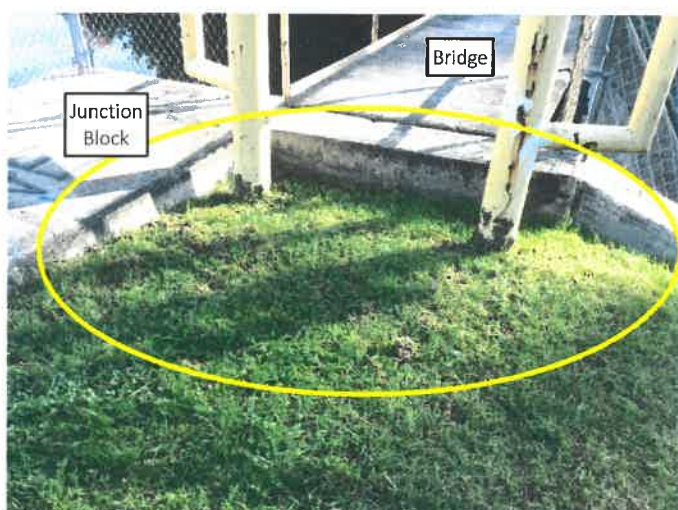
15. Settlement of left embankment at walkway. No defects seen on the concrete junction.

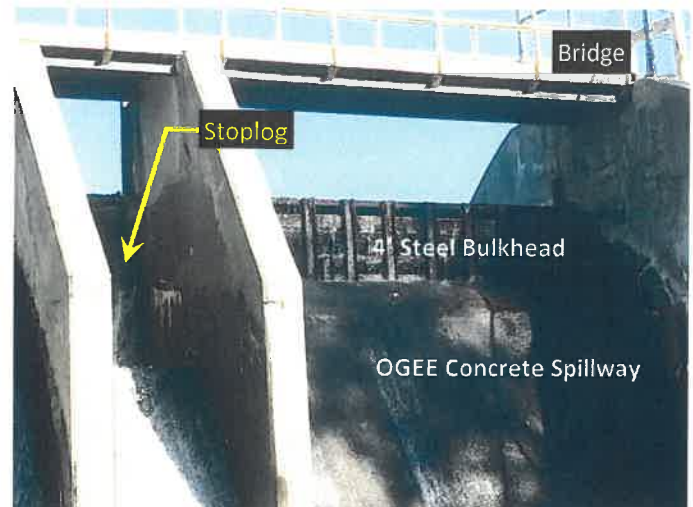
19. Right Spillway. The reason for overflow is that the top of the bulkhead is lower than the left bulkhead.

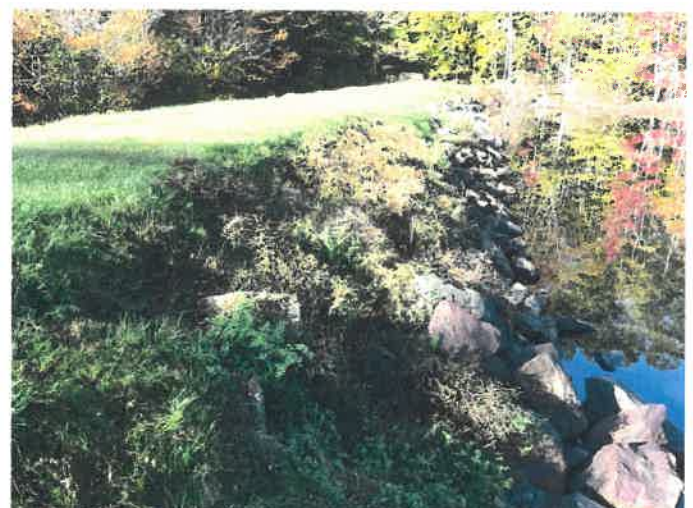
21. Spillway Bridge from left embankment.

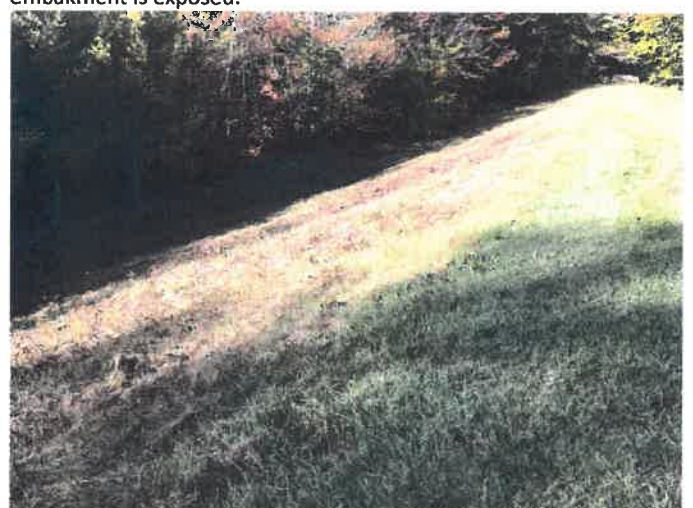
23. Top of Right embankment & downstream face — mostly covered by grass. Downstream face of dam uneven due to local settlement and/or small slips.

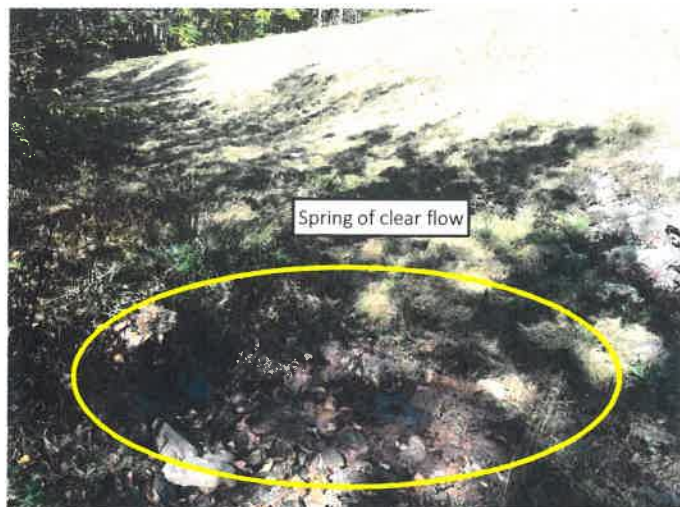
24. Right embankment plane recently cut & uneven. Soil surface could not be seen, however, sporadic settlement, erosion & cracks seen.

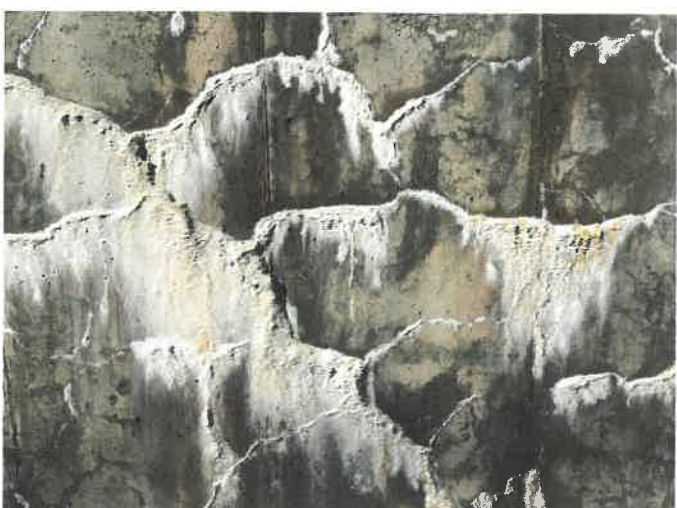
30. Efflorescence (calcium carbonate) caused by evaporation of water seeping through cracks in the channel wall.

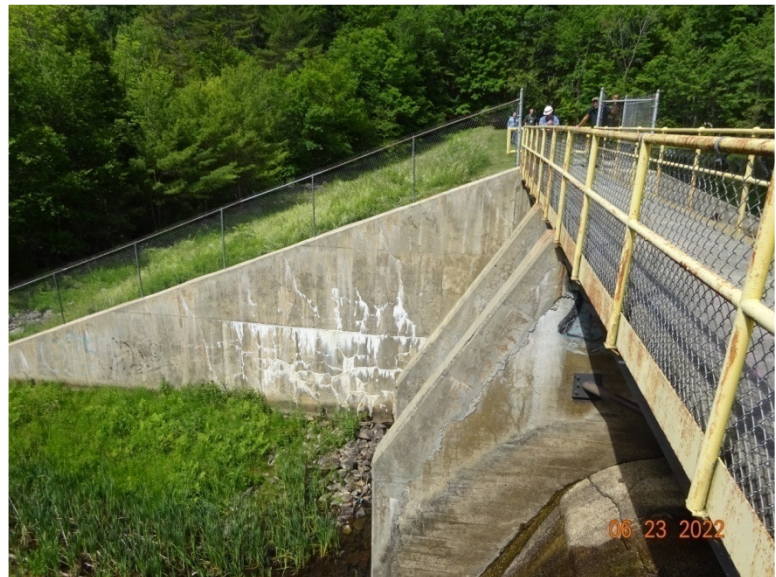
2.3 The concrete wing walls show water leaks thru the concrete cracks. To protect the rebar in the concrete, these cracks should be pressure injected if water leakage occurs.

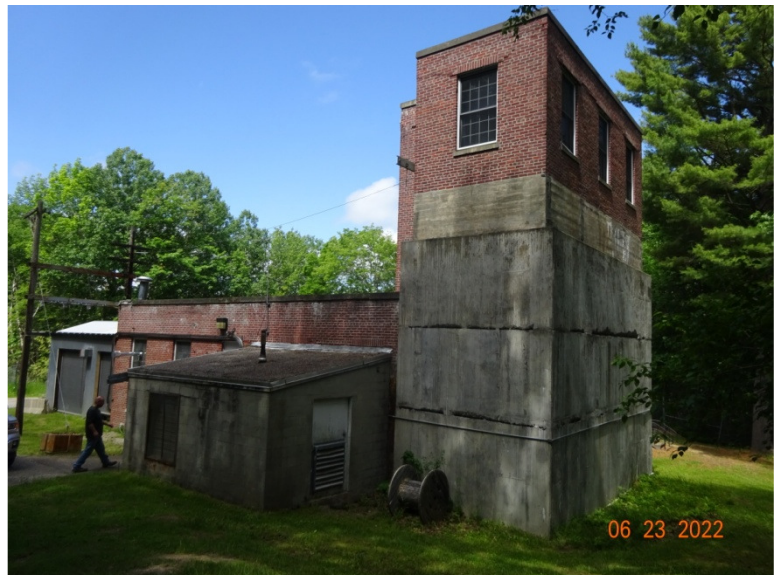
4.10 The original 1930s brick building has a leaking roof system. Also the dark stain on the CMU wall is an area that the masonry needs to be repointed.

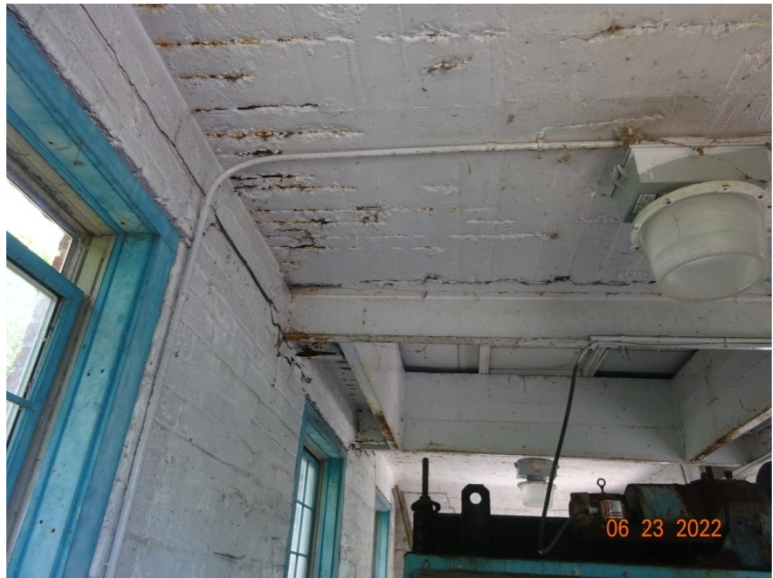
4.12 The second story shown has several cracks in the walls. This photo shows the cracks in corner. About six windows are so damaged that it is better to replace them.

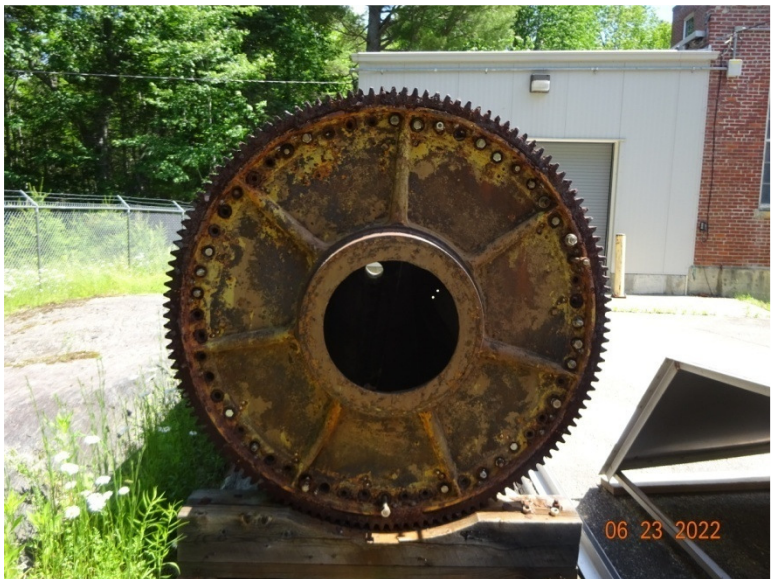
6.2 This picture is a close up of the bull gear. Each filter has one bull gear on each end. Of the three screen drums, this one is in the worst condition. The rust flaking is typically 5 times greater than the actual corrosion. Due to the very slow turning rate, the drum still has life, but needs to be cleaned up and stored inside the 2006 addition.

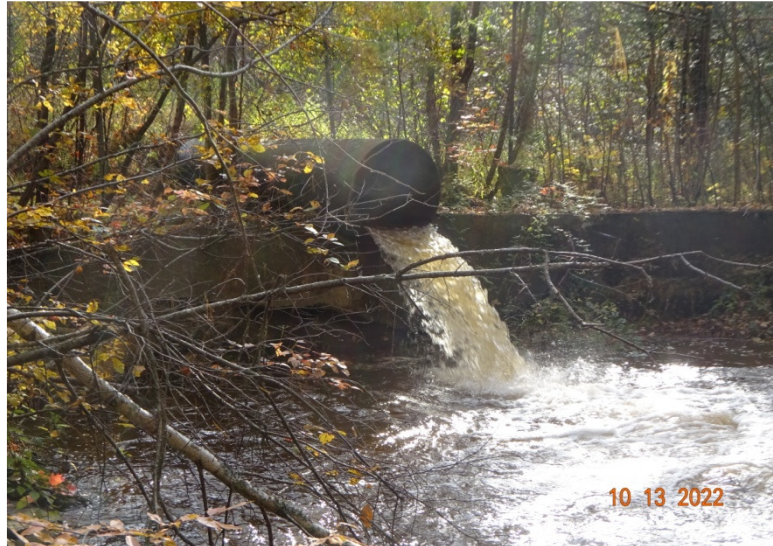
3.3 This next picture shows outlet which flows to Silver Lake after the leak was fixed. We measured the wall thickness of this pipe to be:

- At 12:00 0.480 Inches
- At 3:00 0.448 Inches
- At 6:00 0.269 Inches
- At 9:00 0.469 Inches

3.4 The original pipe thickness is 0.5". Therefore the pipe has lost 47 % due to corrosion. Most of the leaks are occurring that the welds which is typical and will continue. The pipe is pitted on the bottom half.
