# Technical Memorandum

**Via Email:** [ginabushong@gmail.com](mailto:ginabushong@gmail.com)  
**To:** Gina Bushong, Orland Select Board  
**From:** Gillian Williams, P.E. and Charles Grant, P.E., S.E. (MA)  
**cc:** Narramissic Watershed Coalition  
**Date:** August 18, 2025  
**Re:** Phase I – Site Visit and Due Diligence Assistance  
 Alamoosook (ME00144) and Toddy Pond (ME00146) Dams  
 Orland, Maine  
**Project No.** 2502852

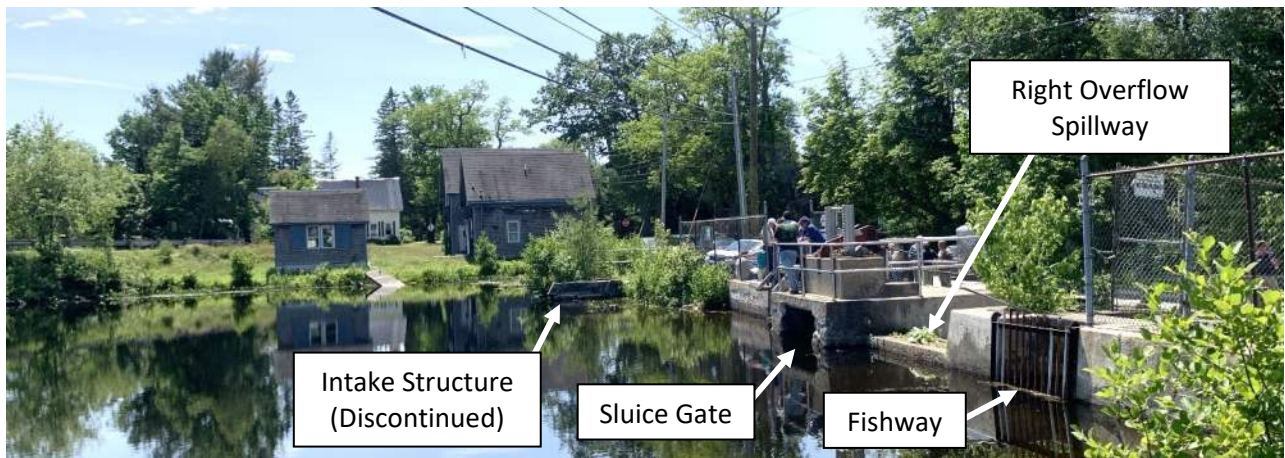
Gina Bushong reported that the old intake pipe is speculated to have been once connected to a power generation plant, though a plant no longer exists. There is significant vegetation growth on top of the old intake structure and along the embankments on either side (Photos 1 and 12). An outlet for the intake pipe was not found during the inspection.

The fishway was in fair condition. At least four of the bars of the trash rack in front of the fishway intake appeared to have been replaced with stainless steel bars (Photos 1 and 18). The other bars show signs of rust, but no obvious section loss was observed. Debris was observed at the top of the fishway but was blocked from traveling farther downstream by the first fishway baffle. A prior concrete repair was evident on the top of the left wall of the fishway, near the inlet (Photo 16). The new concrete appeared to be separating from the original concrete. Cracking was observed on the inner face of the right wall near the inlet (Photo 22). The grassy area to the right of the fishway appeared to be recently mowed, but vegetation was observed in the area between the fishway and the right spillway and along the section of

Photo No. 1 – View of dam from right upstream shore, looking left/downstream.

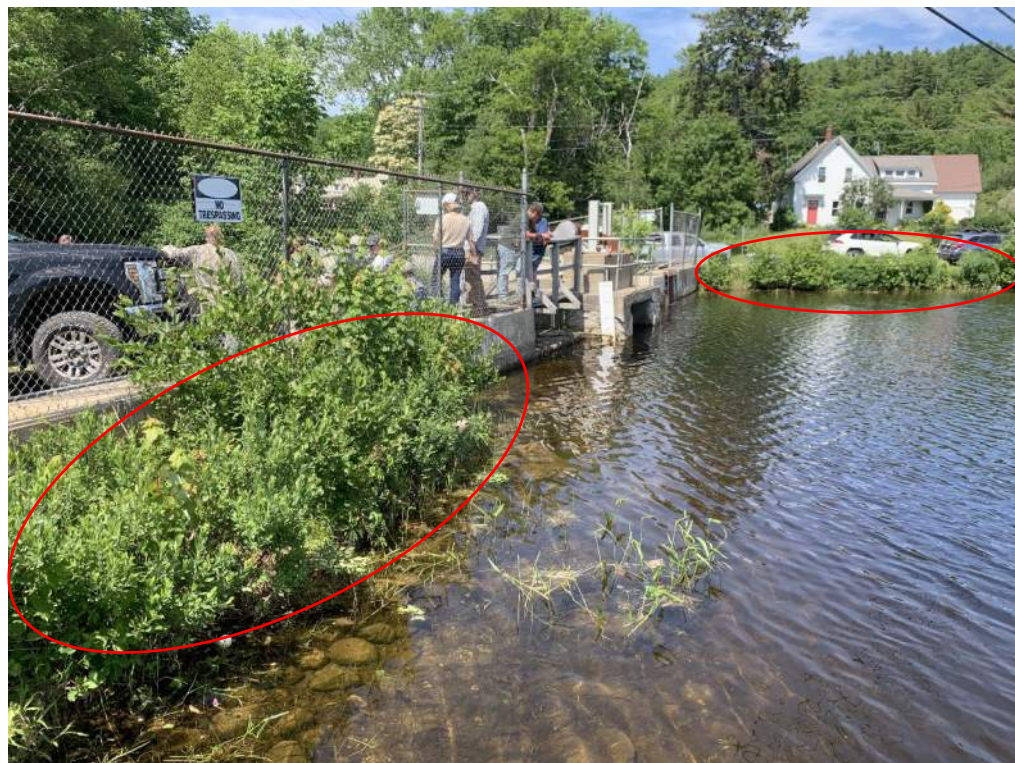
Photo No. 2 – View from discontinued intake structure, looking right. Note vegetation.

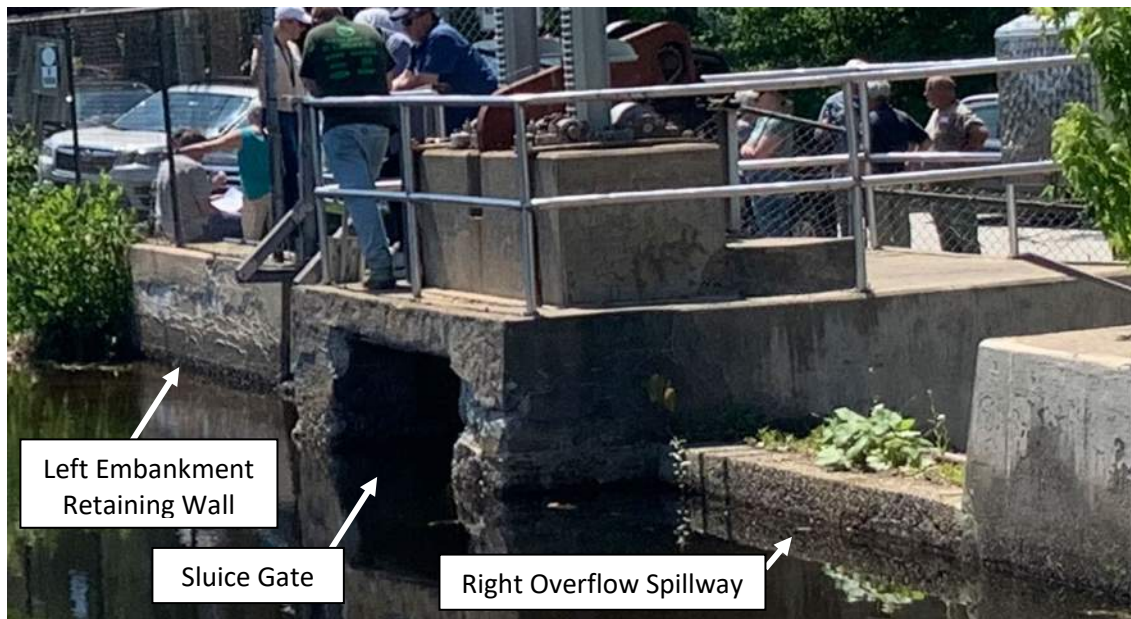
The embankment between the left concrete retaining wall and Hatchery Road was partially mowed (Photo 5). The embankment downstream of Hatchery Road was estimated to be approximately 2V:1H. Heavy vegetation, including mature trees, was observed on the embankment downstream of Hatchery Road (Photo 6). Vegetation was also observed upstream of the left retaining wall (Photo 2). Spalling and efflorescence were observed on the left retaining wall (Photos 3, 4, and 5).

The gate structure was in poor condition. Section loss was evident on the concrete piers of the gate structure at the interface of the piers and the apron. Concrete was also observed to be missing from the inner face of the right pier. Plywood appeared to have been placed over an area of concrete loss on the inner face of the right pier, as well as at the inner face of the left pier where it meets the apron (Photos 7, 9, and 10). Horizontal cracking was observed on the piers of the gate structure approximately 1 to 2 feet above the apron. Concrete loss was observed on the approximately 1 to 1.5 feet of concrete above

the headwater elevation on the upstream walls of the gate structure (Photos 3 and 4). The railing around the operator platform on top of the gate structure is stainless steel and appears to be in good condition.

The concrete apron downstream of the spillways and gate structure was in poor condition (Photo 7). Significant cracking and section loss was observed. Exposed steel mesh reinforcing was observed. Branches and vegetation were observed on the apron. The concrete was patched in the past but appeared to be separating from the original concrete. When the gate was opened, water was observed to flow under portions of the concrete. Epoxy grout was reported to have been applied to the upstream faces of the dam by divers in 2012 or 2013. While Figure 1 indicates that the sills of the left and right overflow spillways are both at El. 165, observations during the field visit indicate that the sill at the right spillway is approximately 2 inches higher than the left spillway (Photos 3 and 4).

Photo No. 3 – Close up view from right upstream shore, looking left/downstream. Note concrete loss on gate structure and left embankment upstream retaining wall. Note the difference in the height of the spillway crest above the headwater of the right overflow spillway (pictured here) and the left overflow spillway (pictured in the following photo).

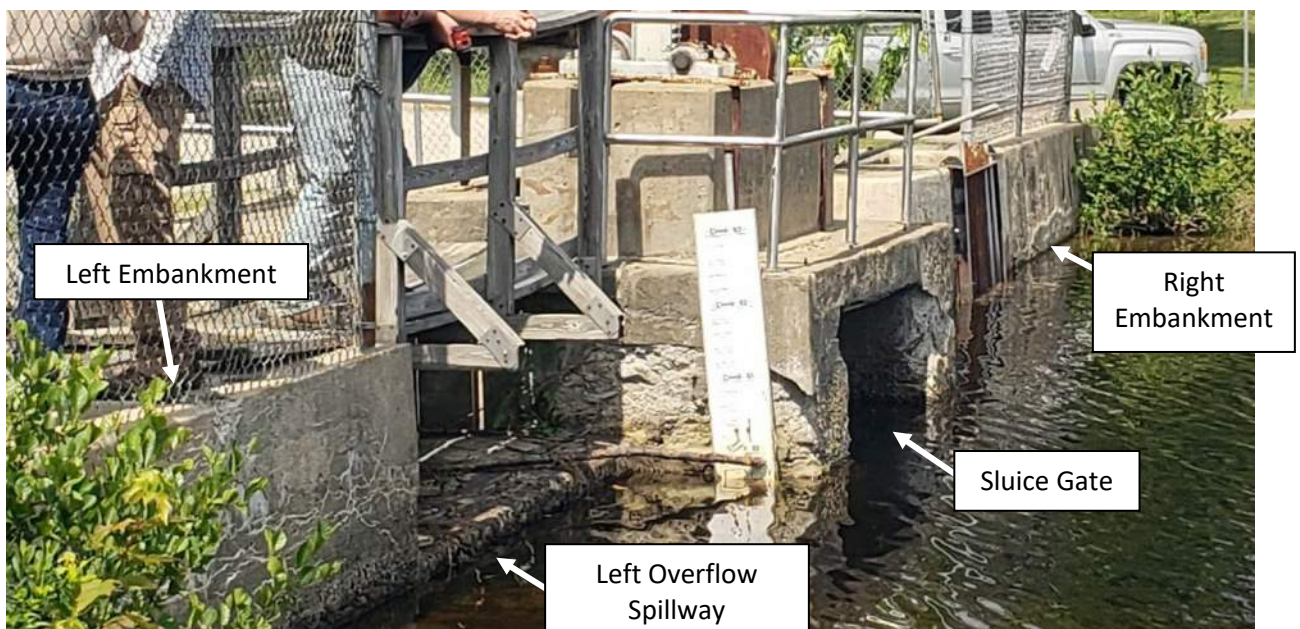
Photo No. 4 – Close up view from discontinued intake structure, looking right. Note concrete loss on the gate structure. Note the difference in the height of the spillway crest above the headwater of the right overflow spillway (pictured in the previous photo) and the left overflow spillway (pictured here).

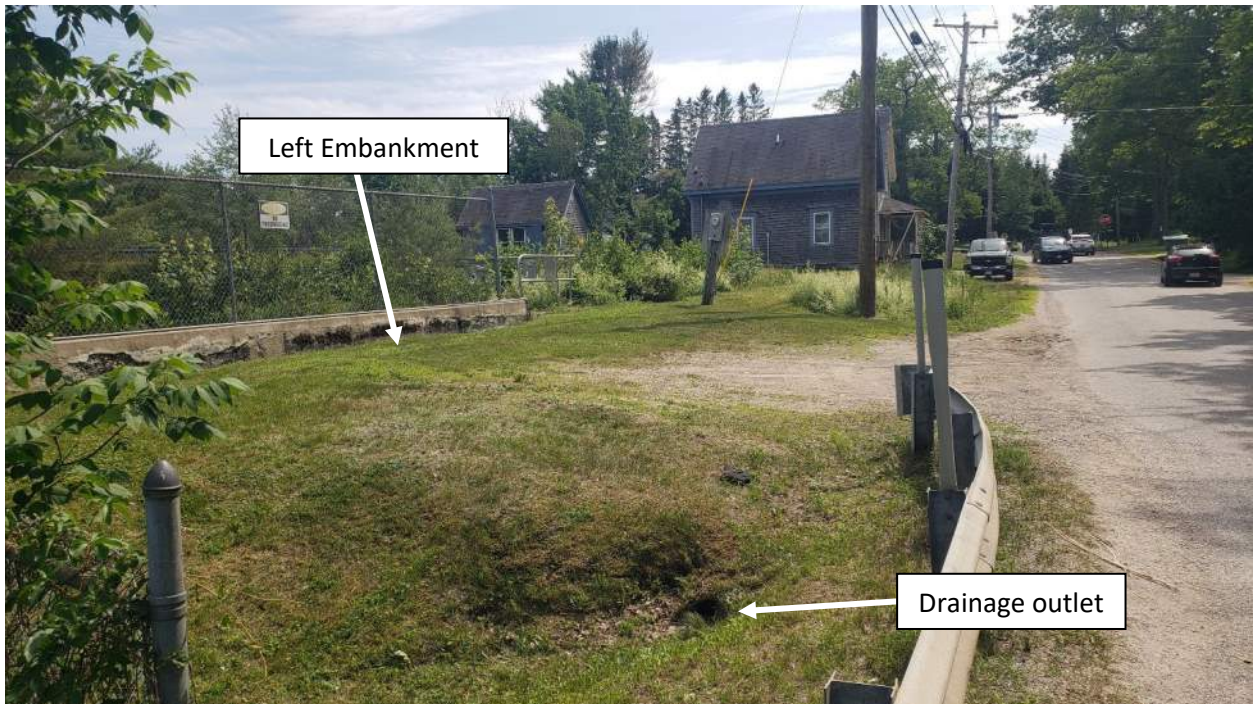
Photo No. 5 – View of left embankment and abutment from Hatchery Road bridge, looking left/upstream.

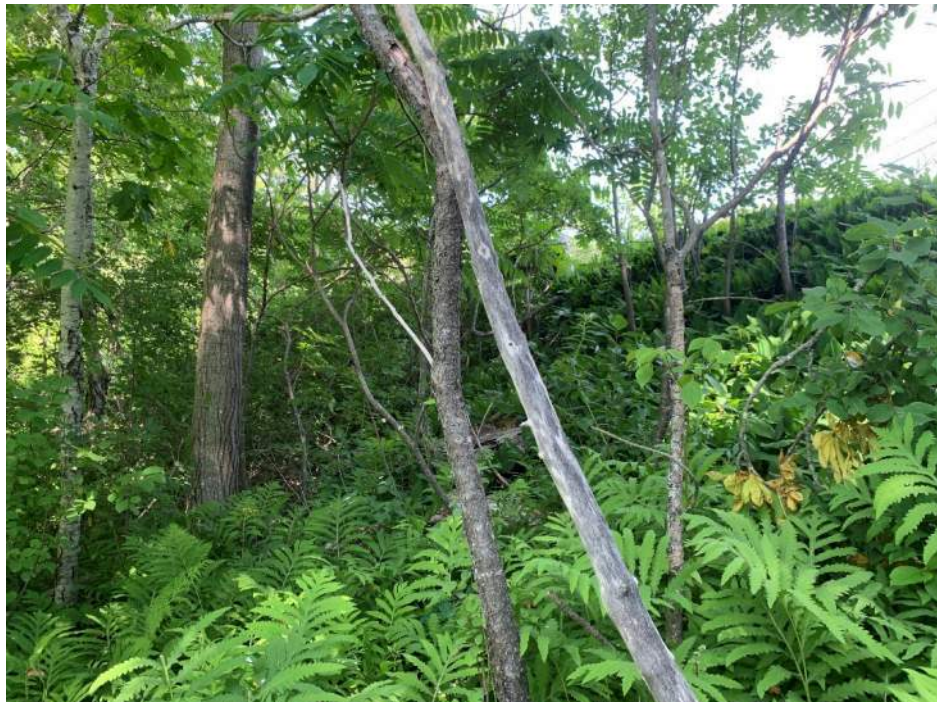
Photo No. 6 – Downstream side of left embankment (downstream of roadway), looking right. Note vegetation and large trees.

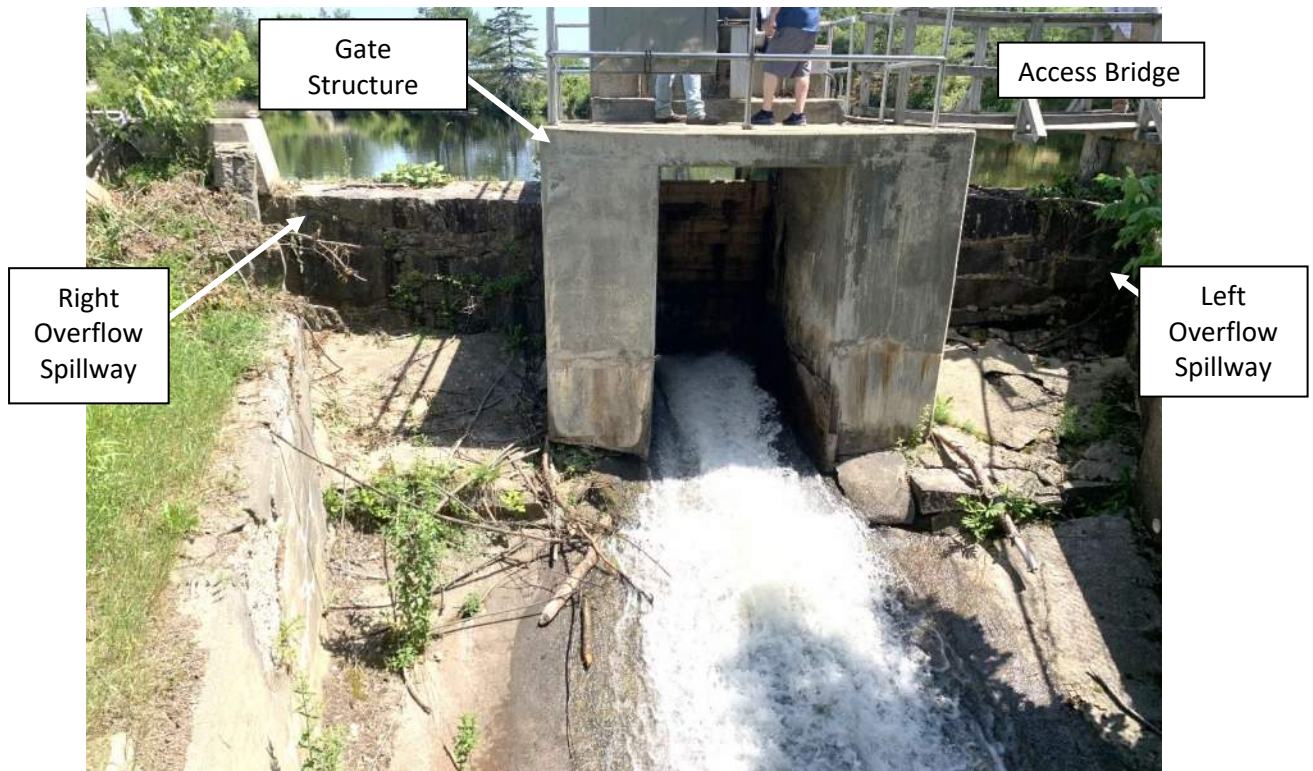
The condition of the granite block overflow spillways was consistent with previous inspection reports. Young vegetation was observed growing on the crest and the downstream face of the right overflow spillway (Photos 3 and 7). Branches were observed on both spillway crests. Voids between granite blocks were observed on the downstream faces of the spillways. Seepage was observed coming from the bottom of the spillway walls. The rate of the seepage was estimated to be approximately 1 to 2 gallons per minute for each of the spillways (Photo 23).

Photo No. 7 – View of dam from Hatchery Road bridge, looking upstream while the gate was opened. Note the debris and vegetation on the spillway aprons.

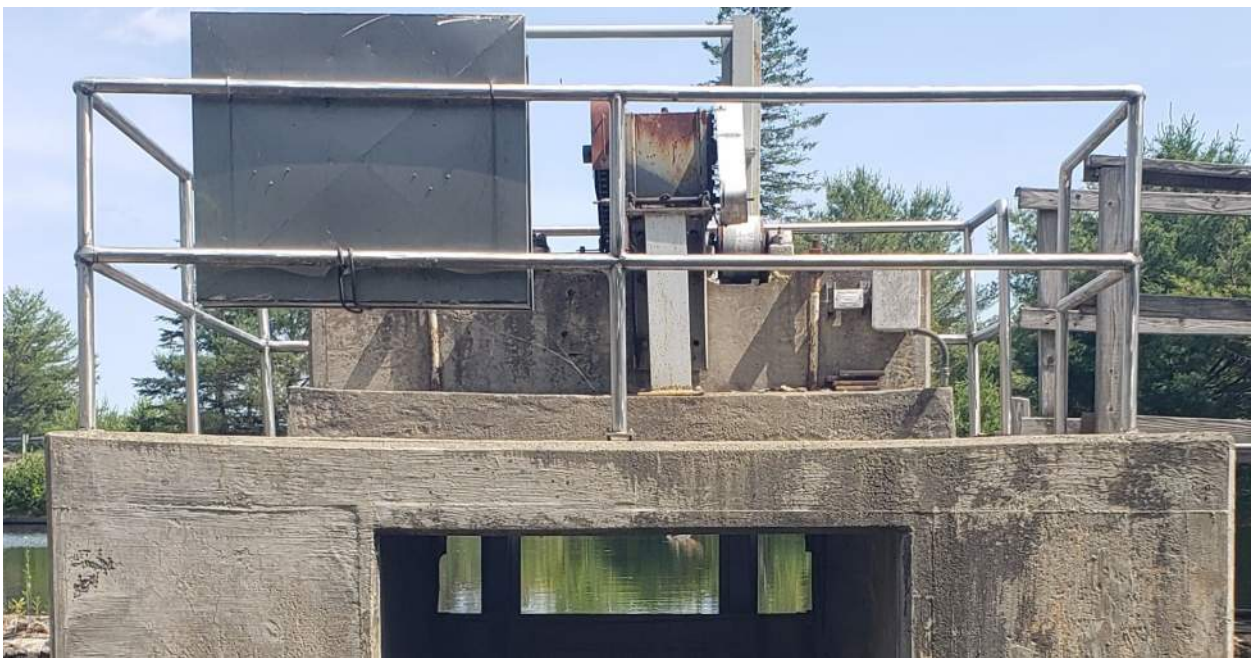
The deck of the gate structure appears to be deflected. This is evidenced by the connection of the stainless-steel railing to the concrete slab (Photo 8). The bottoms of the two outer downstream-most railing posts are flush with the concrete slab of the gatehouse, but the bottom of the center downstream-most railing is approximately  $\frac{1}{4}$  to  $\frac{1}{2}$  inch above the concrete slab. This suggests that the center of the concrete slab sags below the edges of the slab. The gate was reported to have been replaced in 2015. Beavers are reported to periodically block the gate and fishway intakes with mud. The gate intake is cleared by opening the gate. The gate is operated with a handheld battery-operated drill. Rust was observed on the gate mechanism on the operator platform (Photo 25). The gate was opened several inches during the inspection using a battery powered hand drill. No issues with gate operation were noted during the inspection. The gate components and gears were reported to have been recently greased.

Photo No. 8 – View of the gate structure/operator platform from Hatchery Road bridge, looking upstream. Note the deflection of the concrete slab.

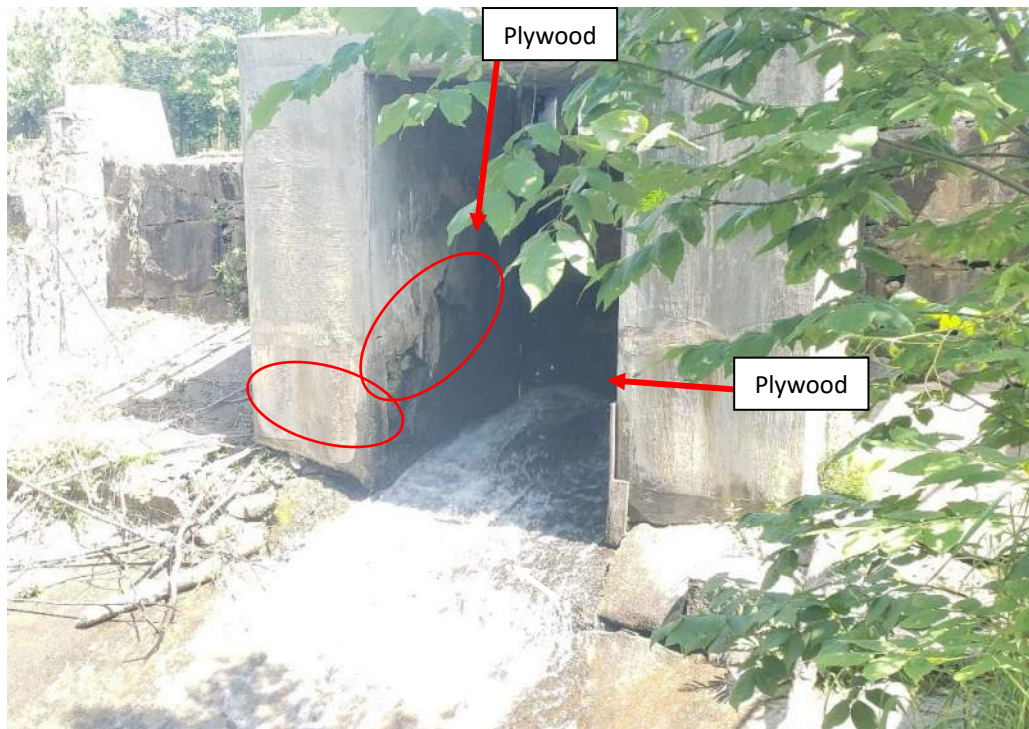
Photo No. 9 – View of dam from Hatchery Road bridge, looking upstream while the gate was opened. Note concrete loss. Plywood has been installed on the inside walls of the gate structure.

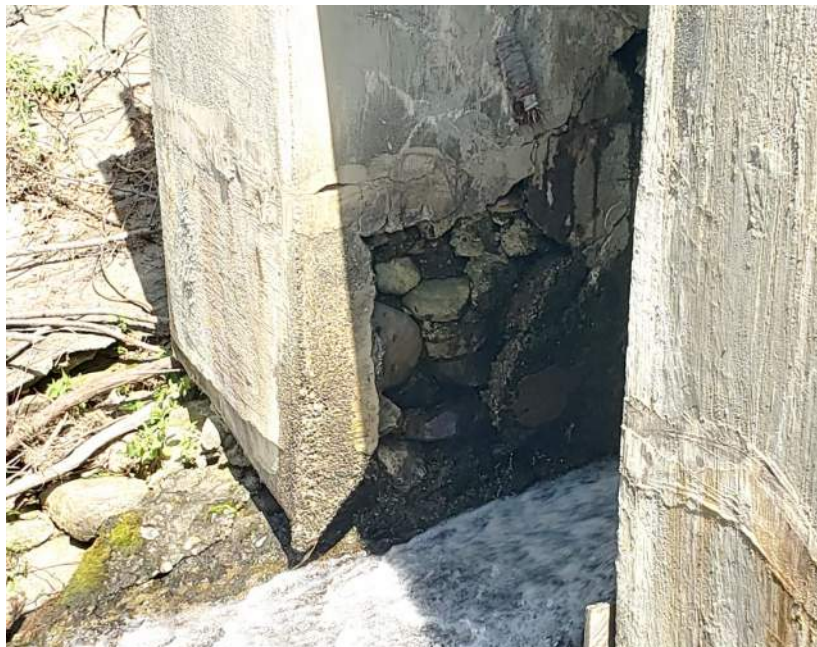
Photo No. 10 – Close up view of gate structure from the left embankment, looking right/upstream while the gate was opened. Note concrete loss.

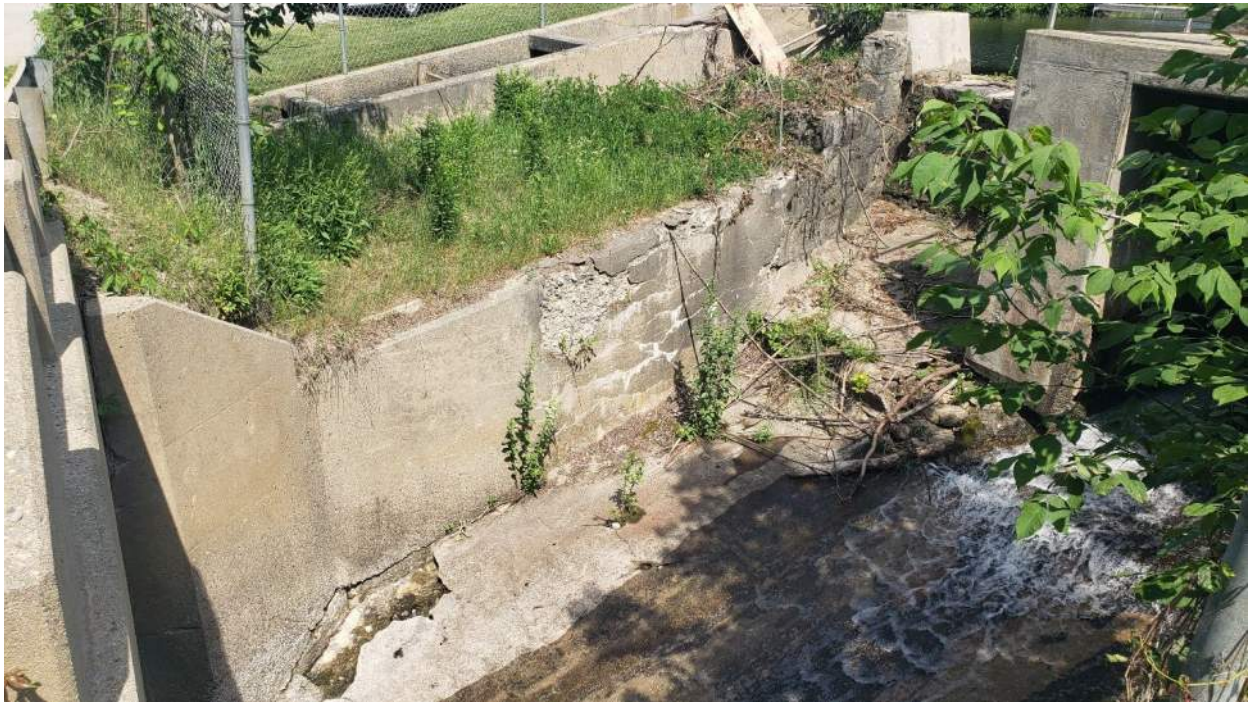
Spalling and efflorescence were observed on the right retaining wall adjacent to the spillway channel. (Photo 11). The wall is granite masonry immediately downstream of the spillway. It transitions to concrete after approximately 5 feet.

Photo No. 11 – View of dam from Hatchery Road bridge, looking upstream while the gate was opened. Note concrete loss on the right training wall and apron.

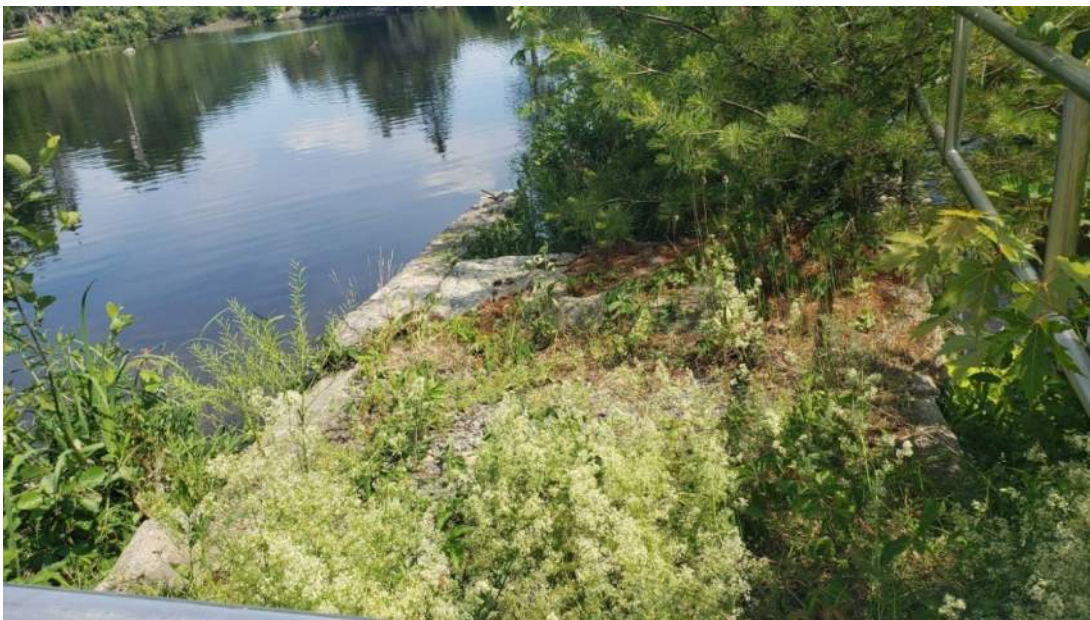
Photo No. 12 – View of discontinued intake structure, looking upstream. Note vegetation.

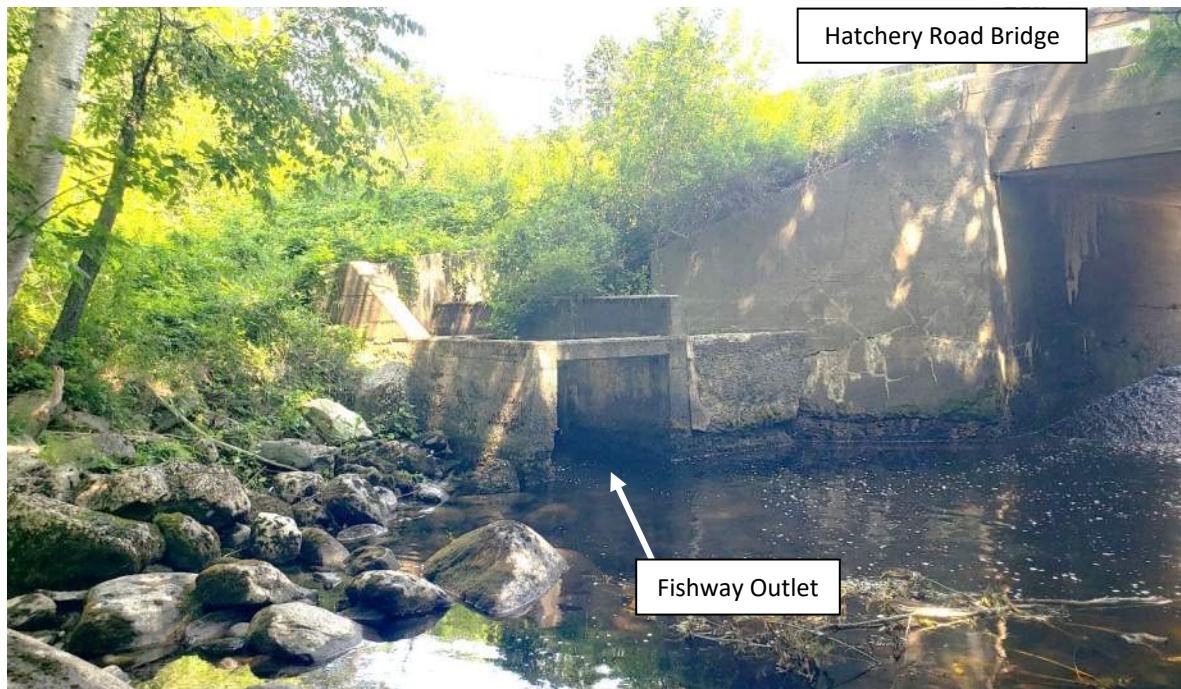
The embankment between the right upstream concrete retaining wall and Hatchery Road was mowed (Photo 21). The embankment downstream of Hatchery Road was estimated to be approximately 2V:1H. Heavy vegetation was observed on the embankment downstream of Hatchery Road (Photo 13).

Photo No. 13 – View from left downstream shore, looking upstream toward the fishway outlet and Hatchery Road bridge. Note concrete loss and vegetation on the embankment.

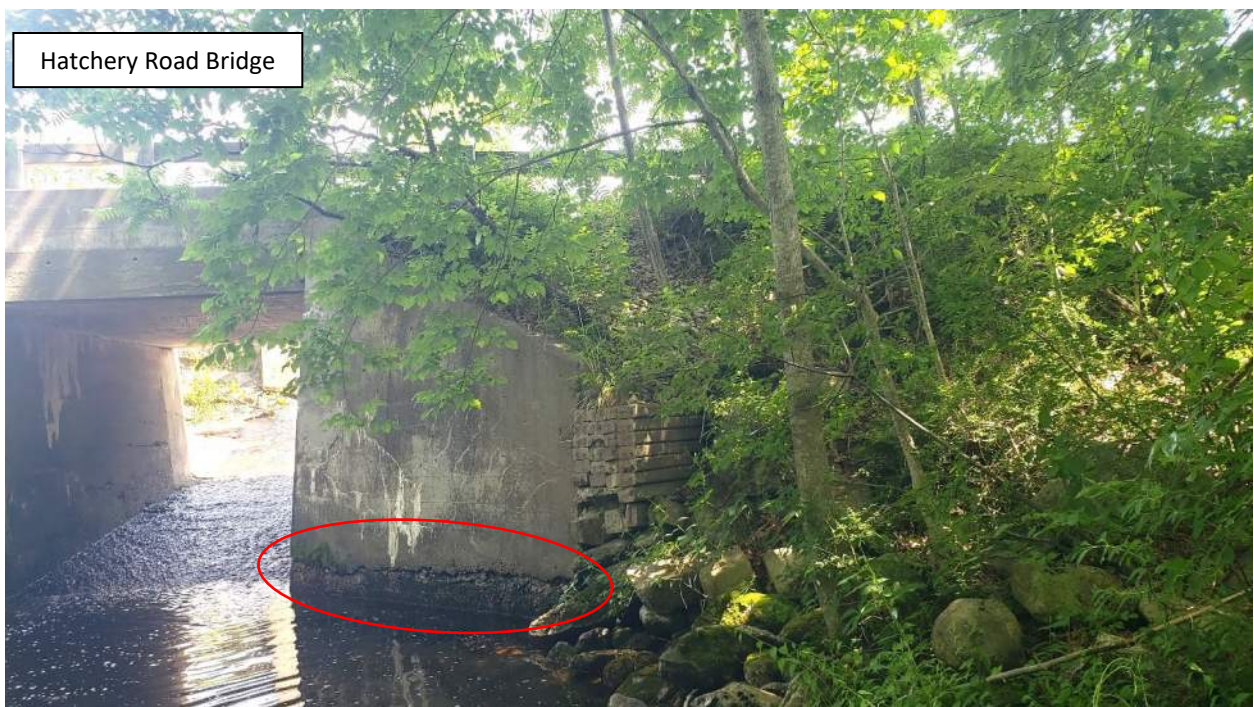
Photo No. 14 – View from left downstream shore, looking upstream toward the Hatchery Road bridge. Note concrete cracking and vegetation on the embankment.

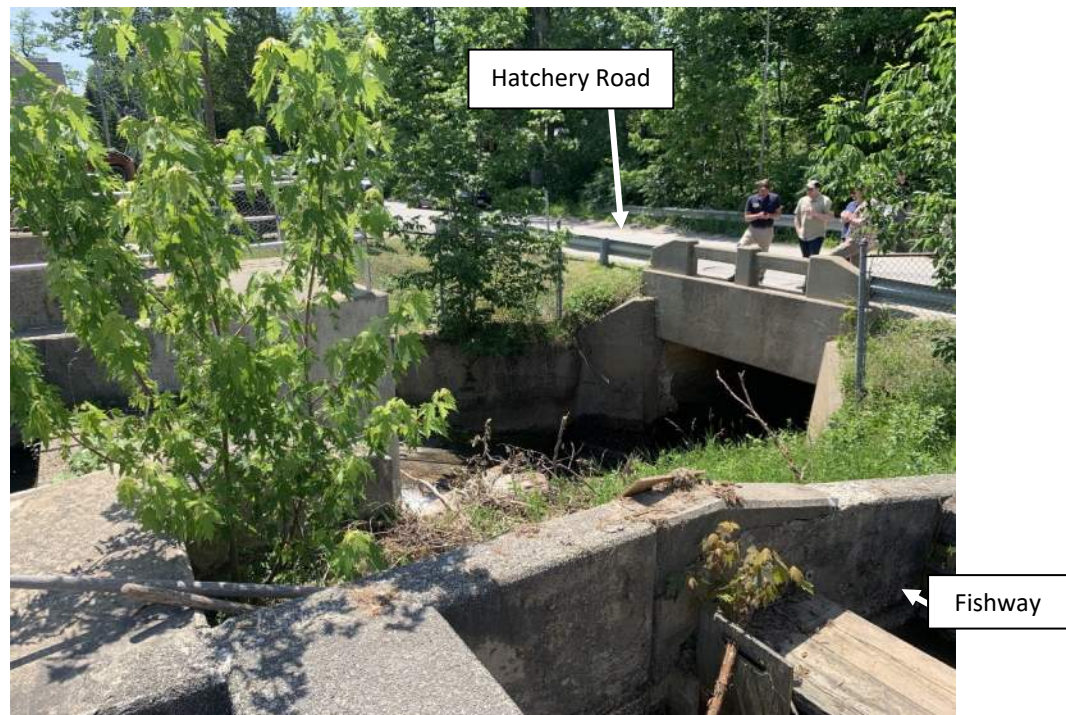
Photo No. 15 – View from right upstream shore, looking downstream toward Hatchery Road bridge. Note tree growth.

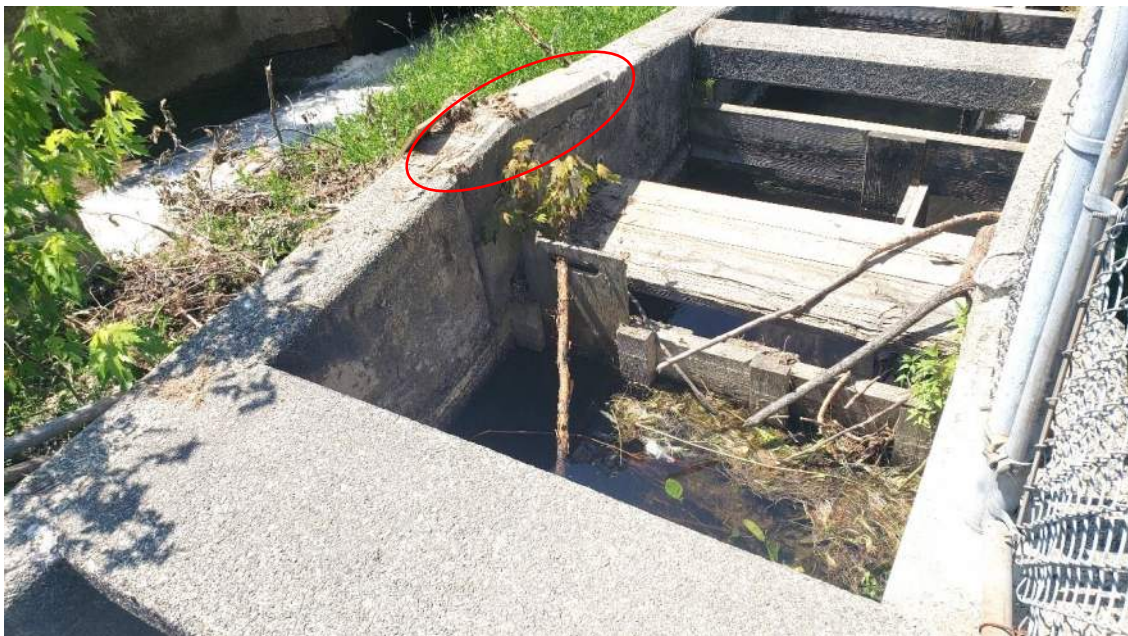
Photo No. 16 – View of top of fishway, looking downstream. Note debris and evidence of concrete repair.

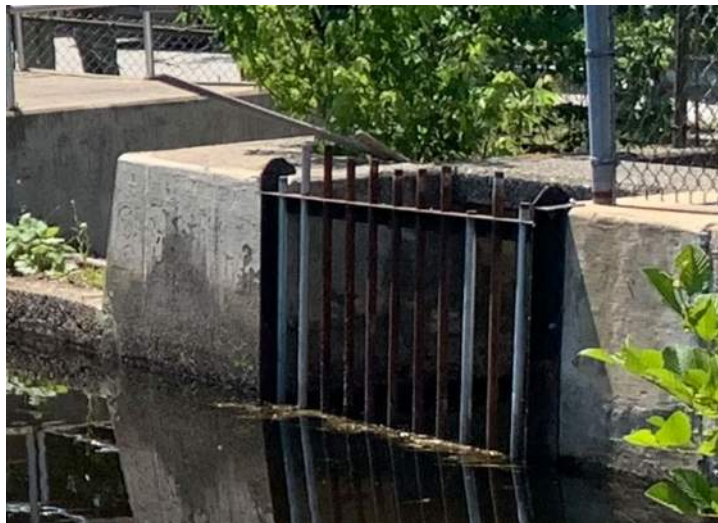
Photo No. 18 – Close up view of top of fishway, looking left/downstream.

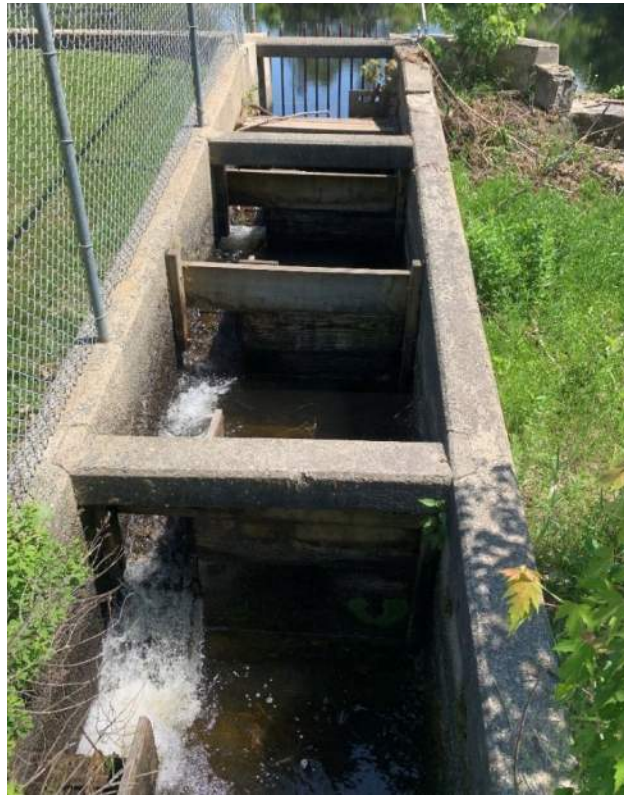
chain link fence parallel with Hatchery Road. Significant vegetation growth was observed on the embankment downstream of Hatchery Road. At the fishway outlet, the fishway walls exhibited concrete loss approximately 6 to 12 inches above the tailwater elevation (Photo 13). The wall between the fishway outlet and the right downstream wingwall of the Hatchery Road bridge also exhibited section loss at approximately 6 to 12 inches above the tailwater elevation. The upper part of the wall showed signs of spalling and wear. The part of the wall immediately adjacent to the fishway appeared to have been repaired. The fishway is reported to be heavily used by alewives. The fishway baffles are reported to have been replaced in 2012 (Photo 19).

Photo No. 19 – View of top of fishway, looking upstream.

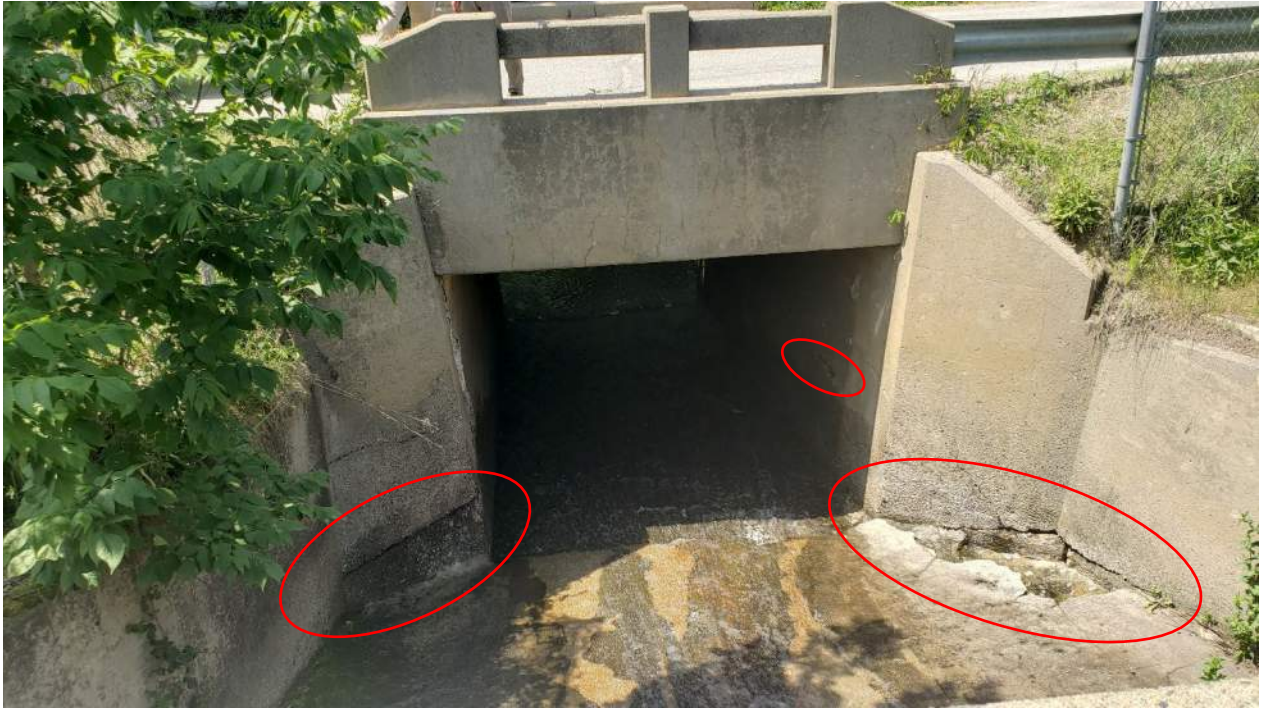
Photo No. 20 – View from top of gate looking downstream toward Hatchery Road bridge. Note cracking and concrete loss.

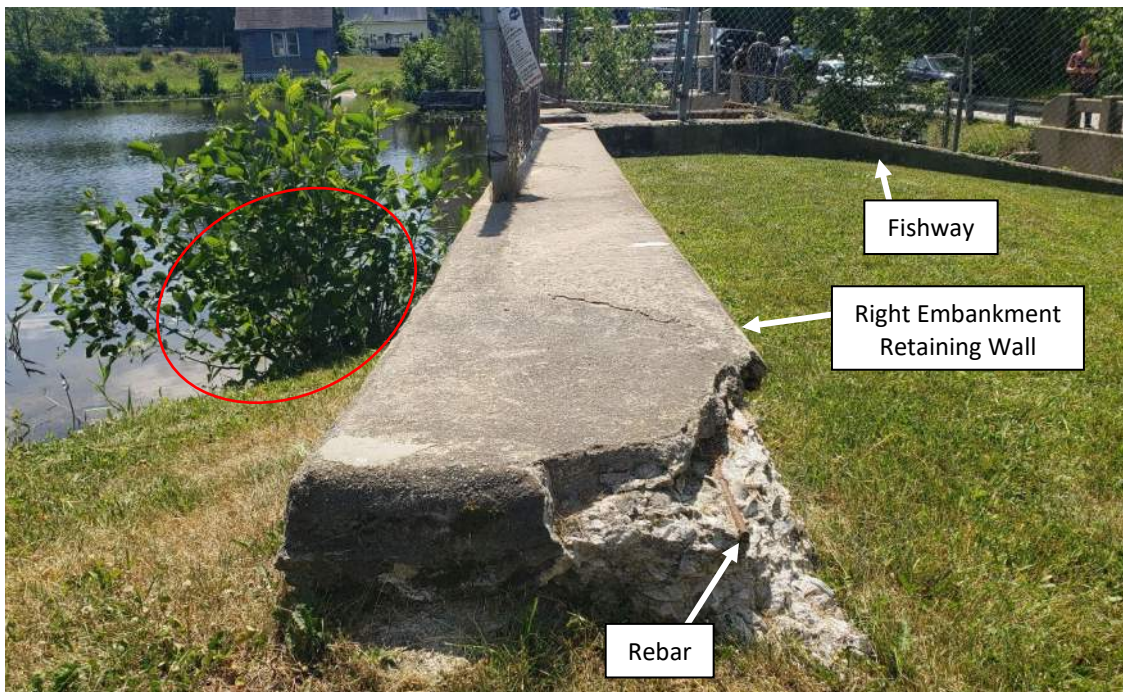
Photo No. 21 – View from right abutment, looking left. Note upstream vegetation and concrete loss.

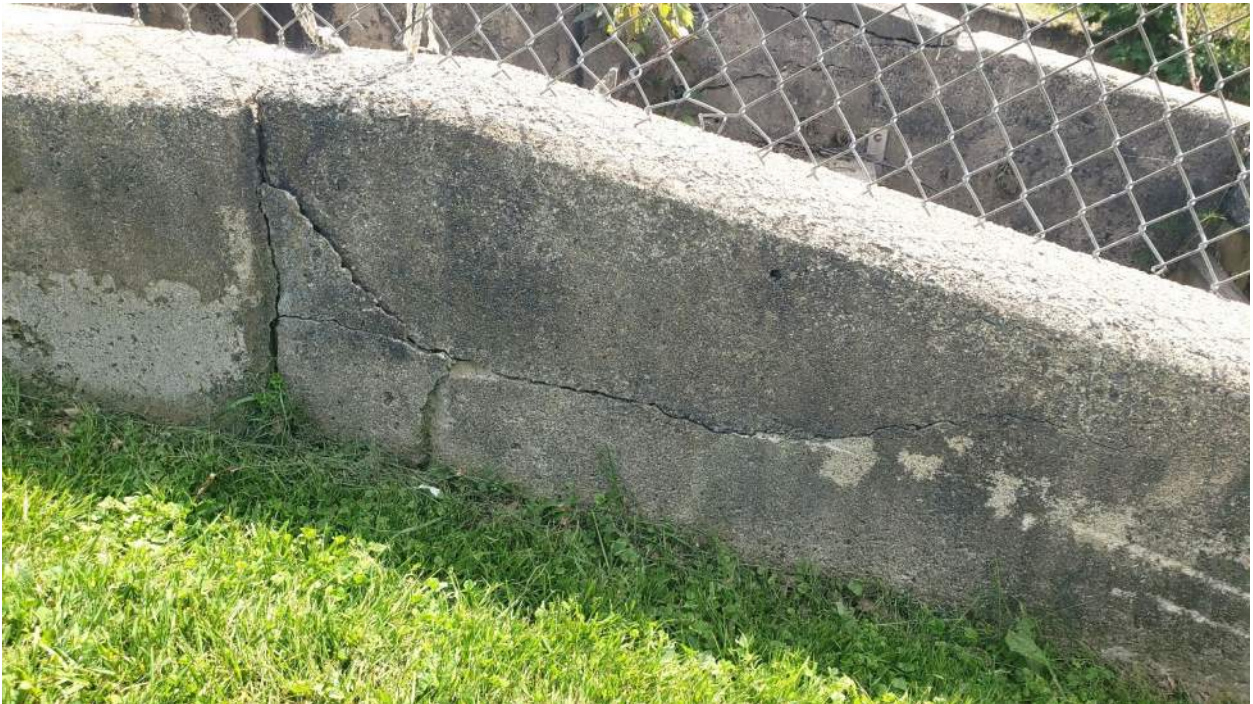
Photo No. 22 – View of right wall of fishway from right embankment, looking left. Note cracking.

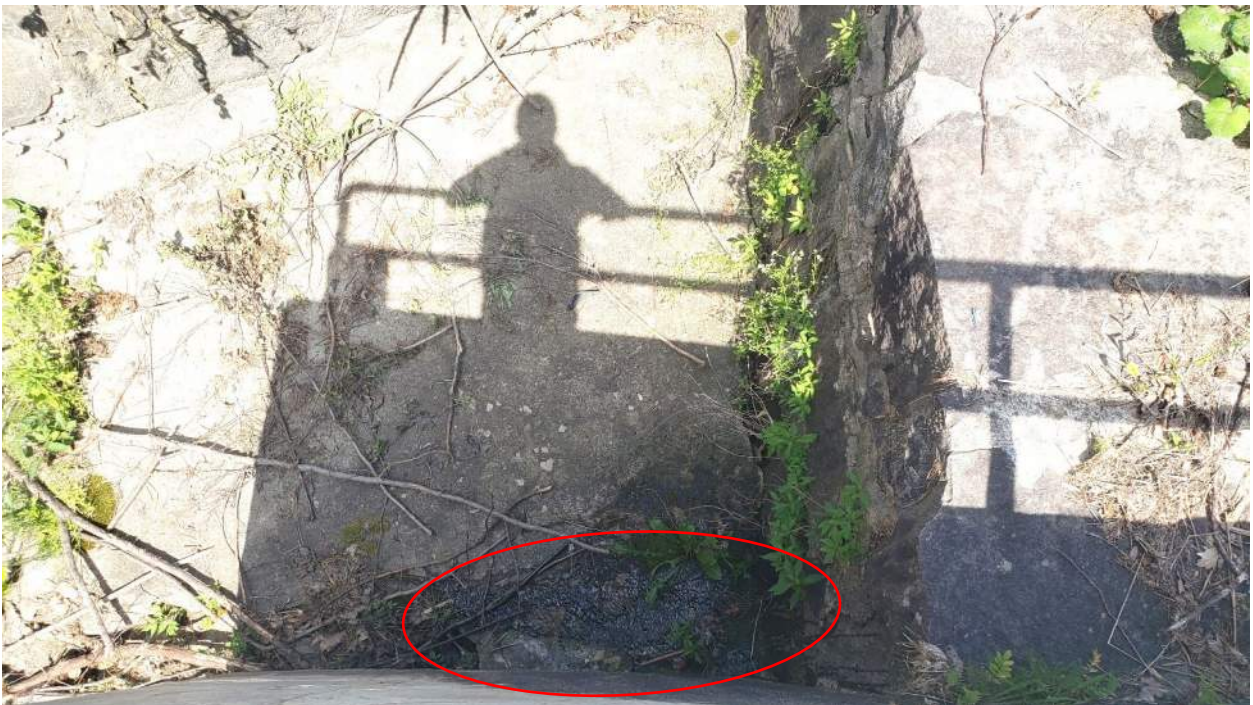
Photo No. 23 – View of right spillway and apron from top of gate, looking down. Note seepage.

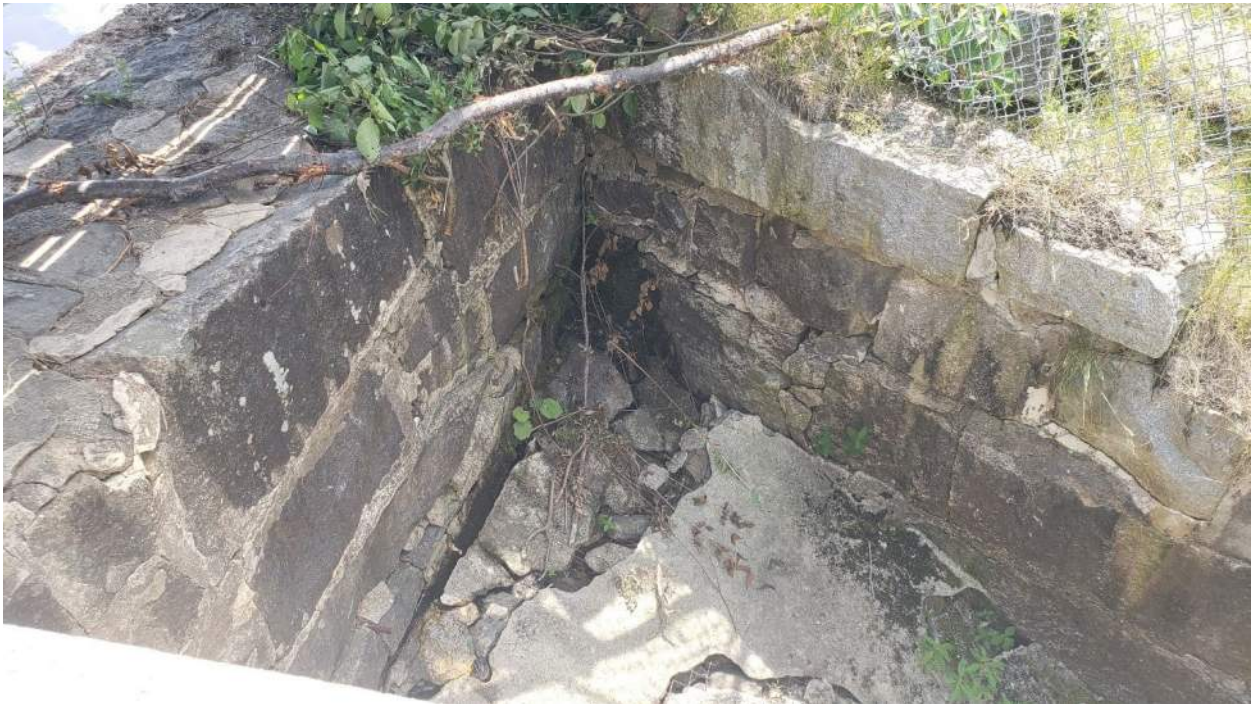
The left retaining wall is granite masonry immediately downstream of the spillway (Photo 24). It transitions to concrete after approximately 5 feet. The concrete appeared to be in fair condition. Small trees were observed growing on top of the concrete wall.

Photo No. 24 – View of left spillway and apron from top of gate, looking left/down.

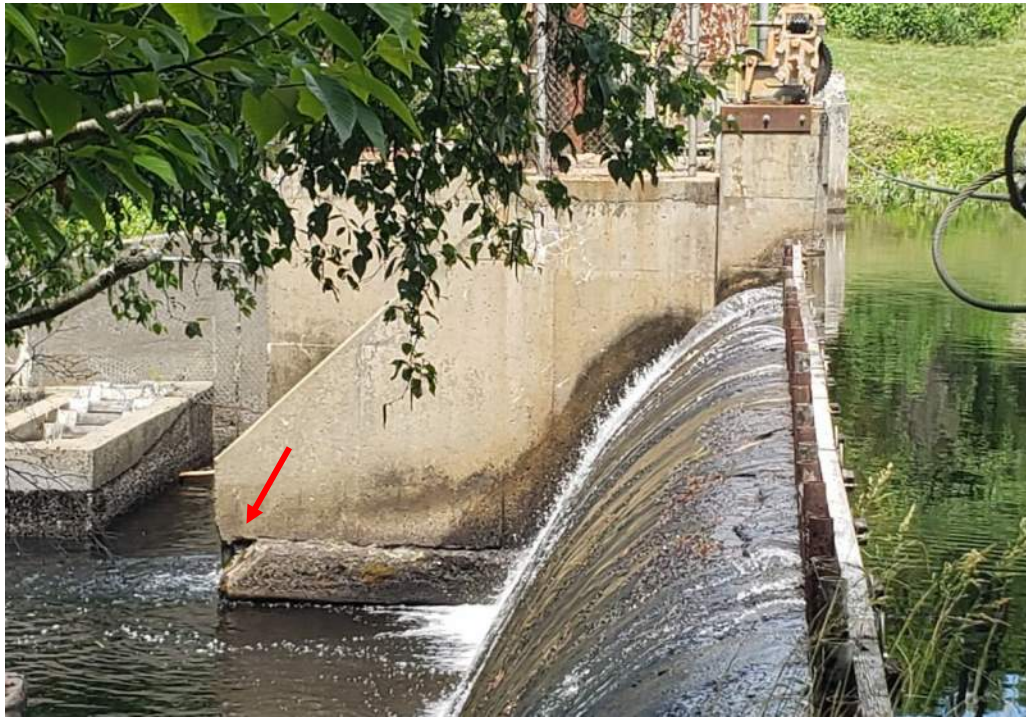
Photo No. 4 – View from left upstream shore, looking right. Note cracking and concrete loss on gate pier.

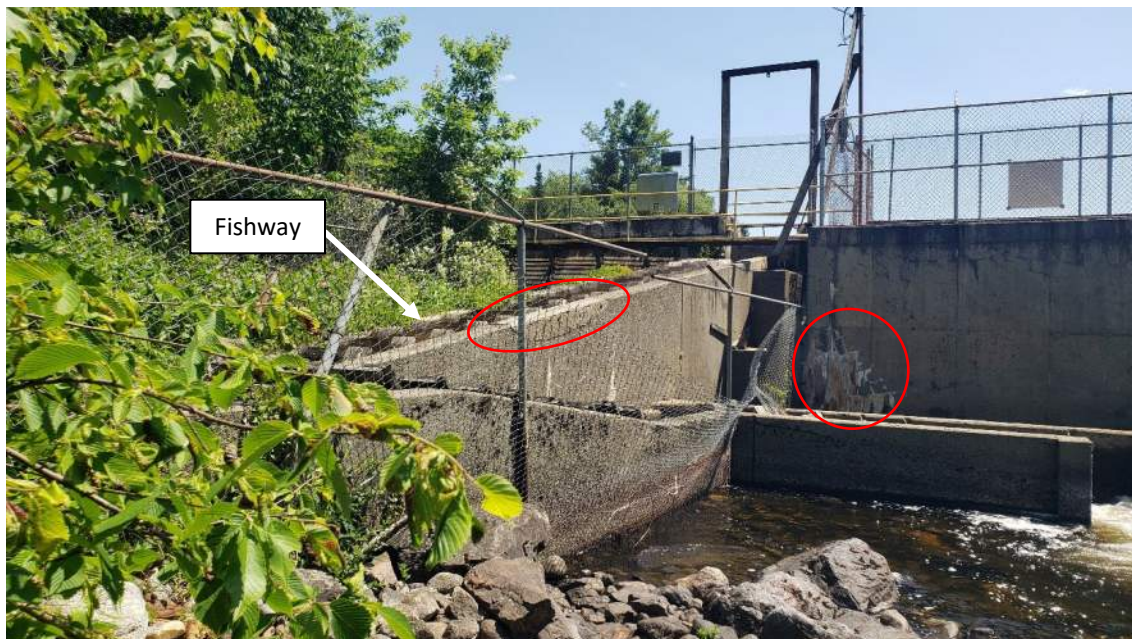
Photo No. 7 – View of fishway and intake structure from right downstream shore, looking upstream. Note efflorescence on the intake structure, repaired concrete on the fishway, and the broken chain link fence.

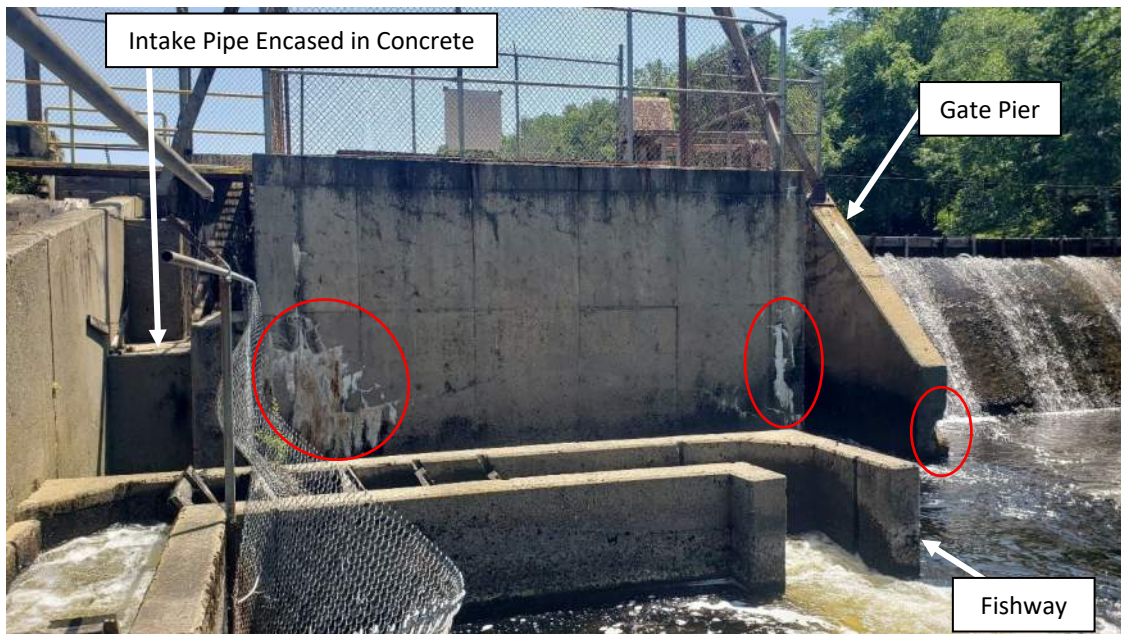
Photo No. 8 – View of fishway, intake structure, gate outlet, and spillway from right downstream shore, looking upstream. Note efflorescence on the intake structure, concrete loss on the gate pier, and the broken chain link fence.
