# Technical Memorandum

**Via Email:** [ginabushong@gmail.com](mailto:ginabushong@gmail.com)  
**To:** Gina Bushong, Orland Select Board  
**From:** Gillian Williams, P.E. and Charles Grant, P.E., S.E. (MA)  
**cc:** Narramissic Watershed Coalition  
**Date:** August 18, 2025  
**Re:** Phase I – Site Visit and Due Diligence Assistance  
 Alamoosook (ME00144) and Toddy Pond (ME00146) Dams  
 Orland, Maine  
**Project No.** 2502852

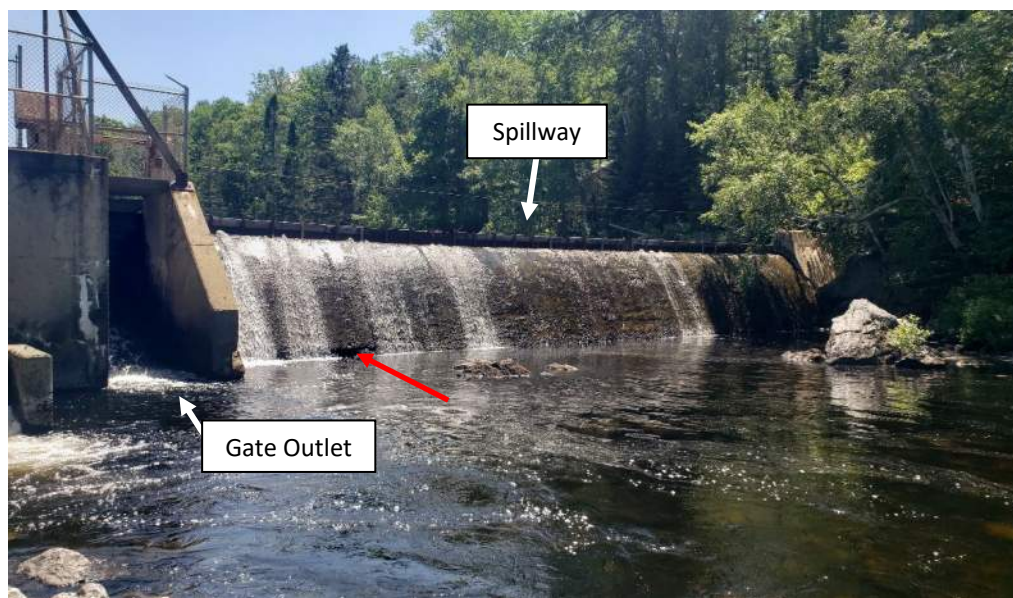
Photo No. 9 – View of gate outlet and spillway from right downstream shore, looking upstream. Note deterioration at concrete lift joint (red arrow).

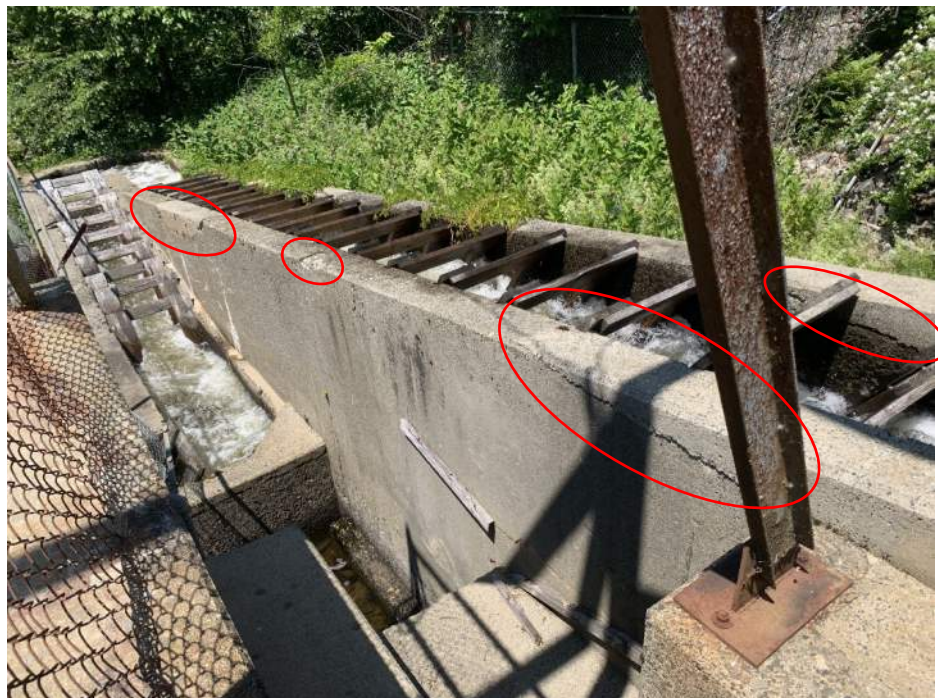
Photo No. 11 – View of fishway from operator platform. Evidence of prior concrete repairs visible. Some concrete spalling.

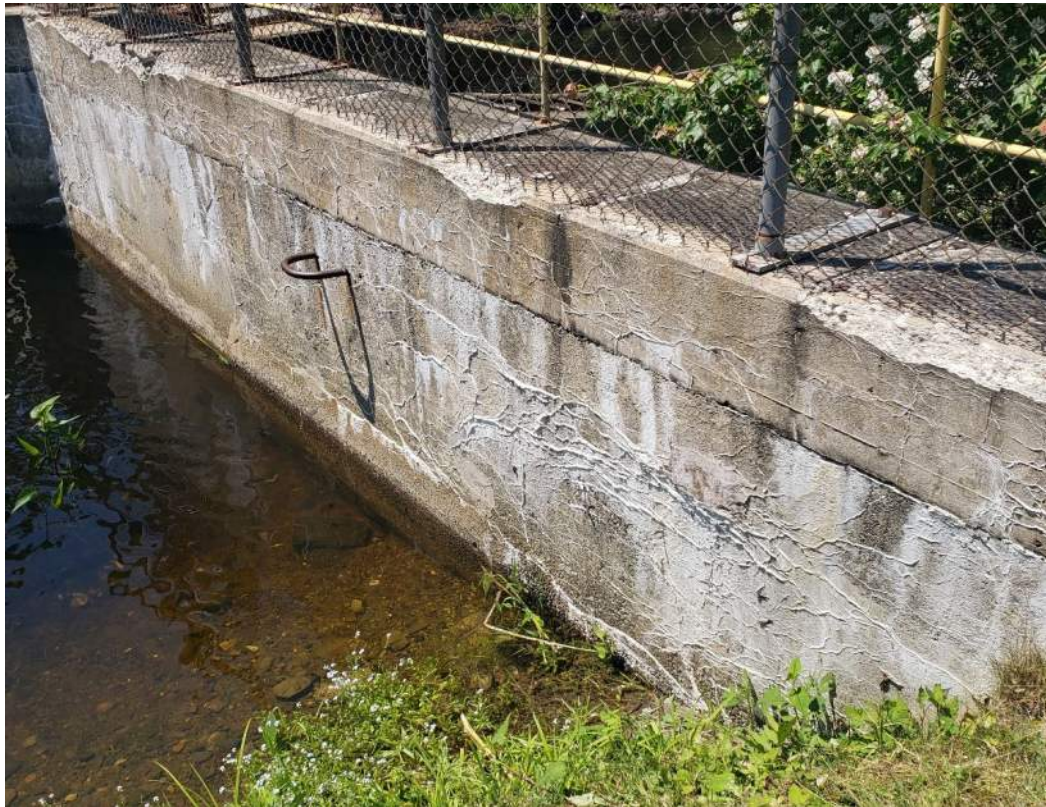
Photo No. 12 – View of right abutment from upstream right bank. Note efflorescence and spalling.

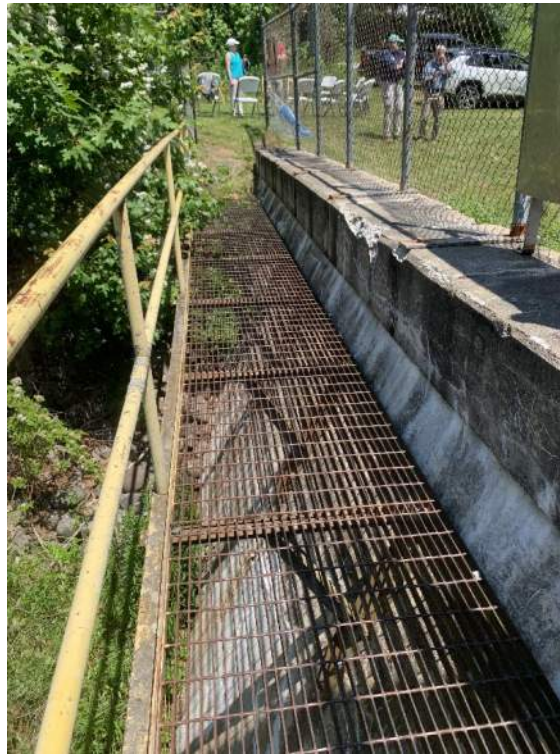
Photo No. 13 – View of access walkway, railing, and right abutment from the top of the intake structure, looking right. Note efflorescence and spalling.

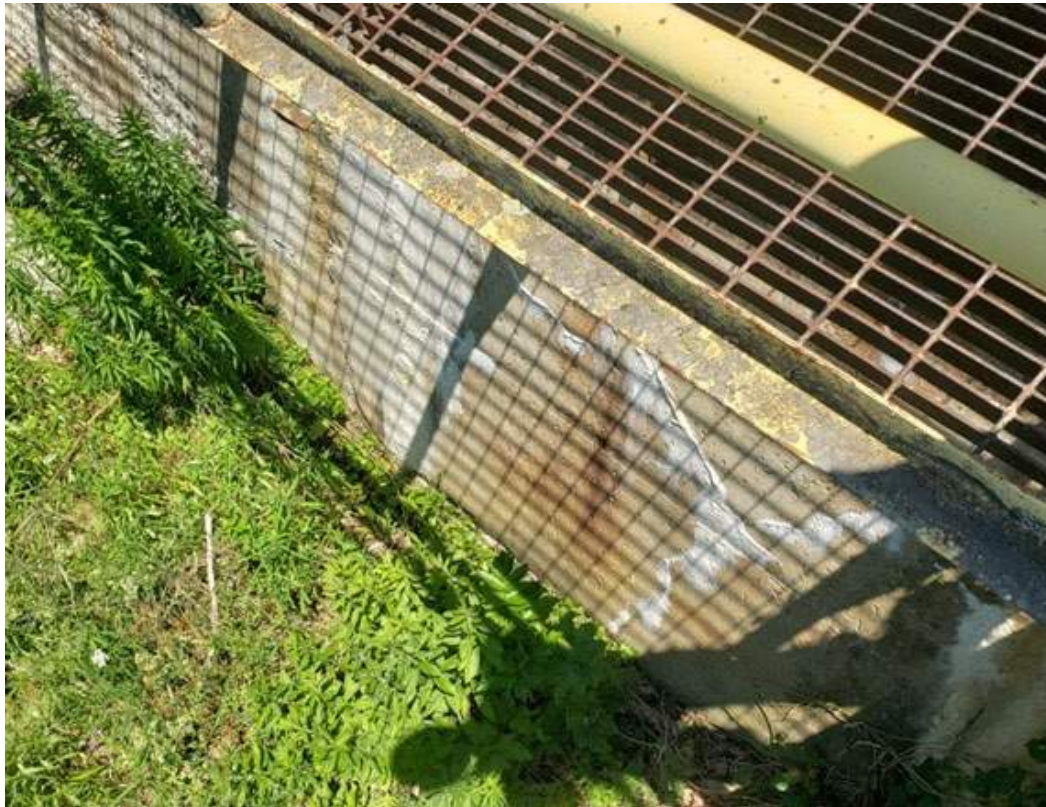
Photo No. 14 – View of the right abutment, looking down over the railing of the access walkway. Note efflorescence.

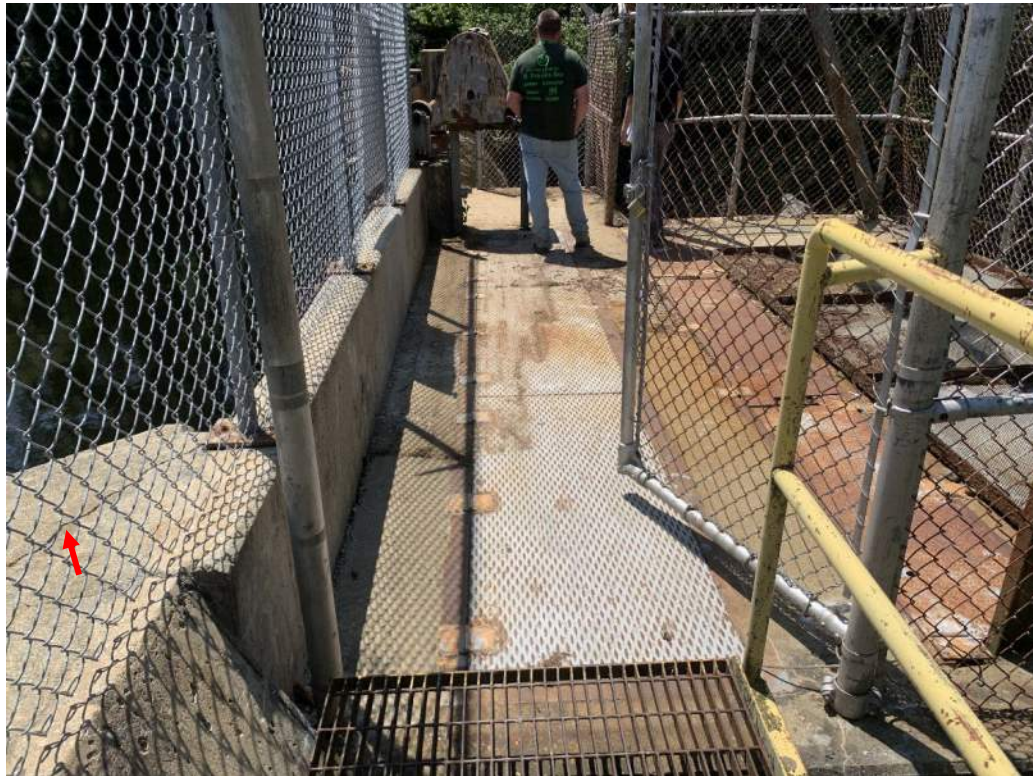
Photo No. 15 – View of operator platform/top of intake structure from access walkway, looking left. Note cracking.

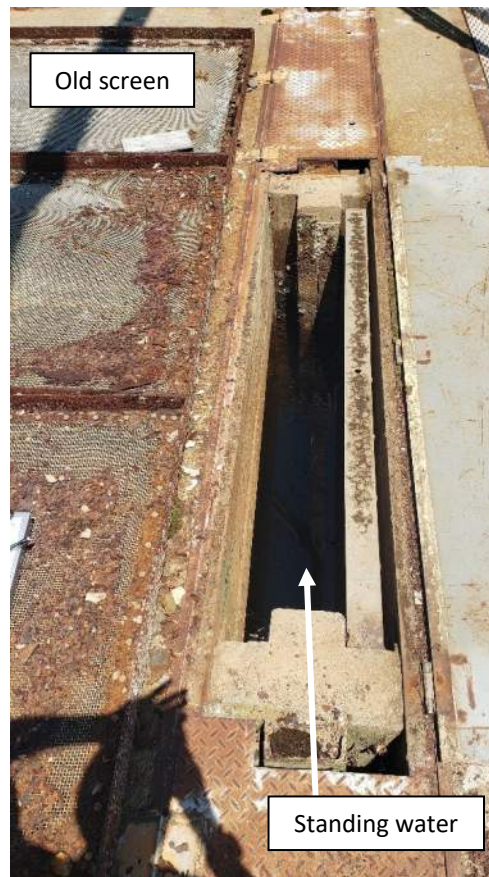
Photo No. 16 – View of open center hatch on top of intake structure, looking right. Old unused screen visible downstream of open hatch. Standing water was visible beneath the hatch.

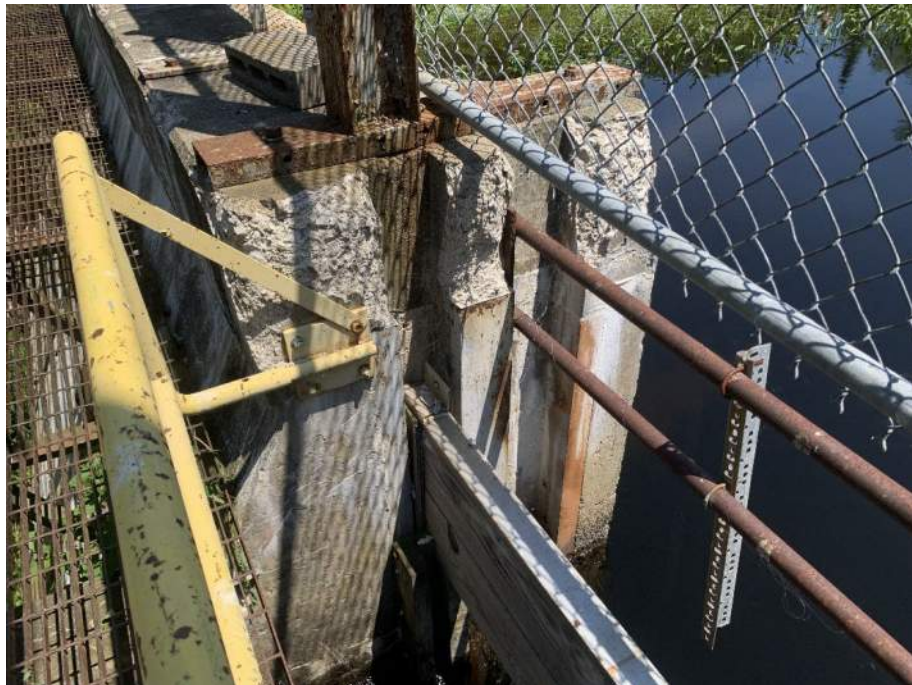
Photo No. 18 – View of right side of fishway intake. Note concrete loss.

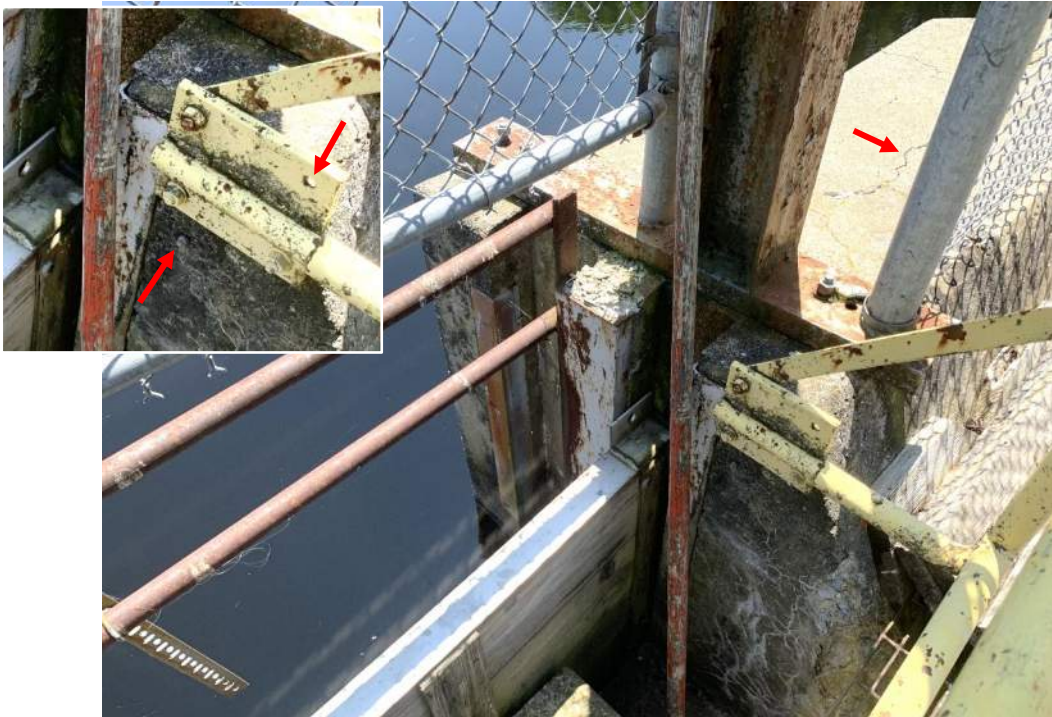
Photo No. 19 – View of left side of fishway intake. Note connection with walkway railing. Two screws appear to have a minimal distance to the edge of the concrete. Note cracking to the left of the fishway intake.

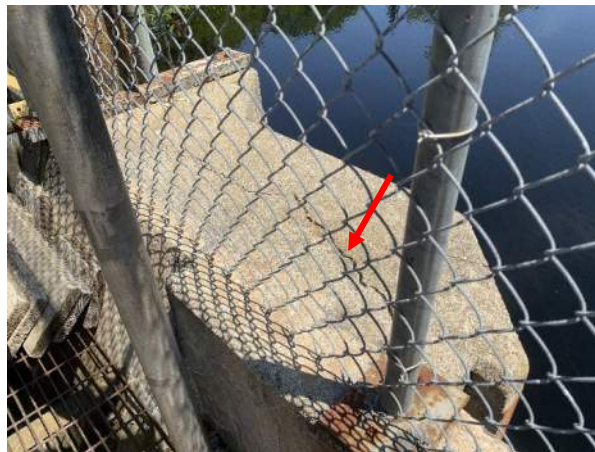
Photo No. 20 – View of concrete between fishway and intake structure from the top of the intake structure, looking upstream. Note cracking.
