M e m o r a n d u m

Date: 22 April 2020

Subject: Summary of 2019 Site Wide Stability Monitoring
WMDSM – Crossroads Landfill
Norridgewock, Maine

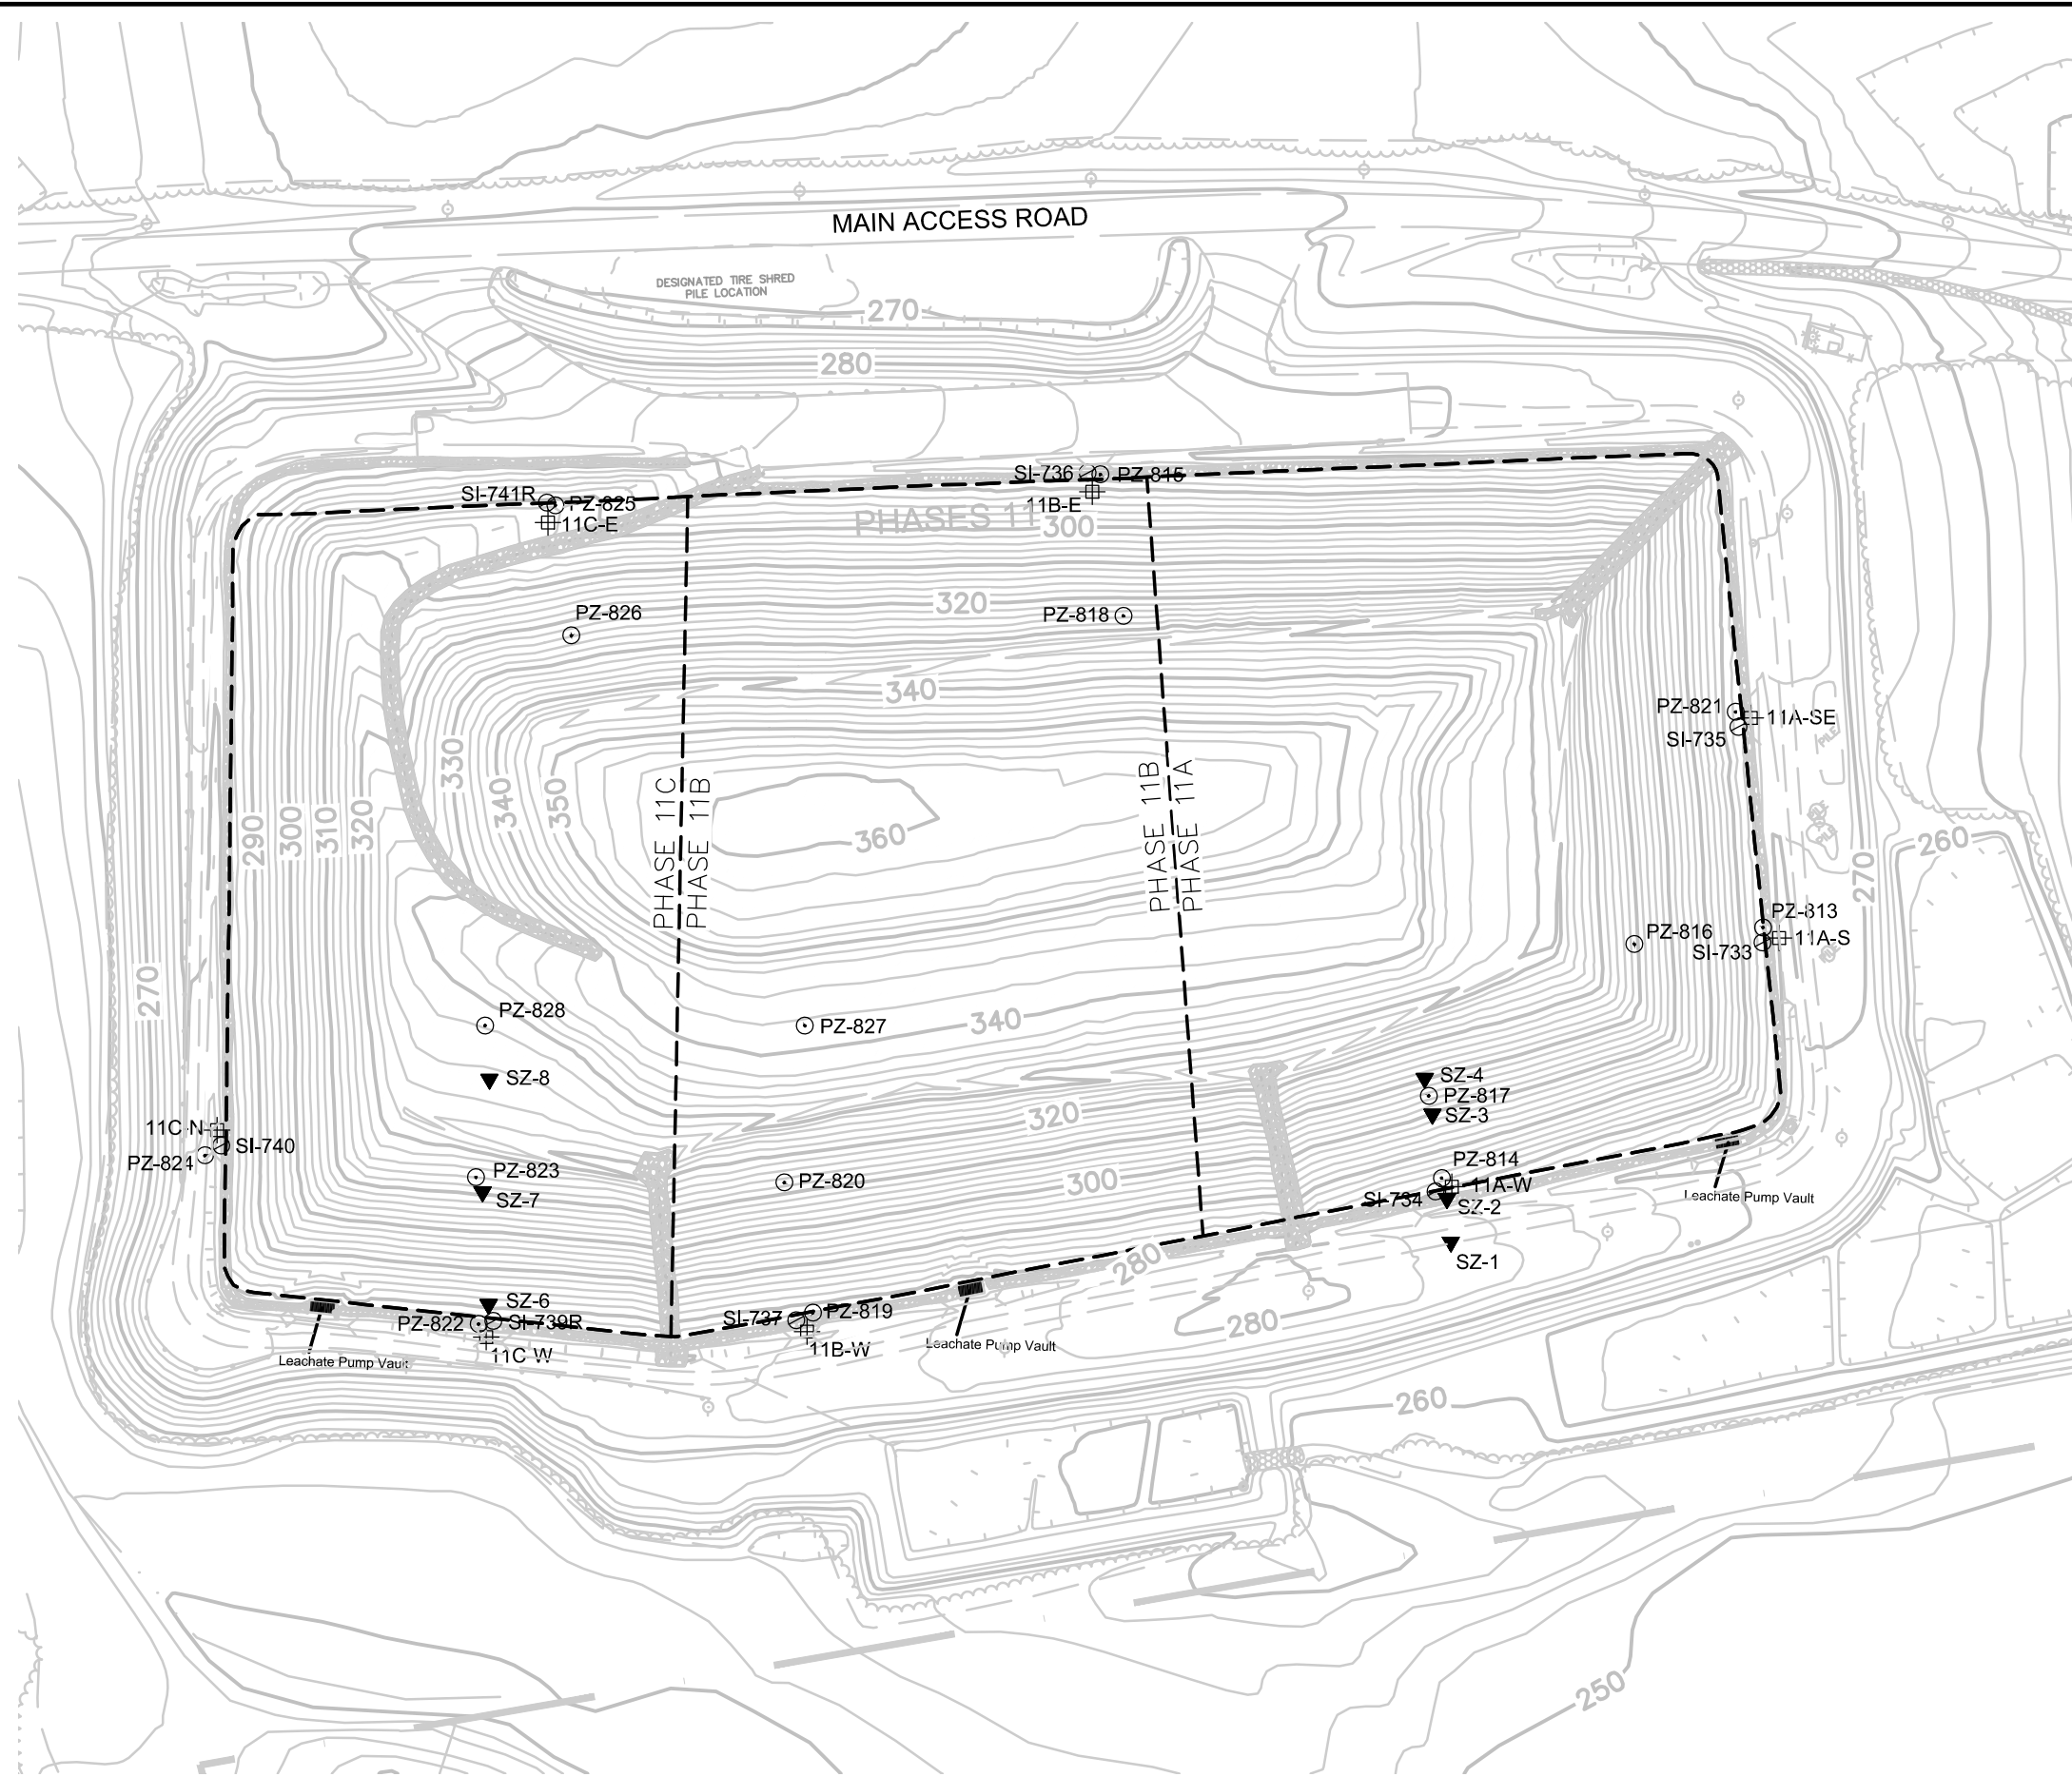
INSTRUMENT LOCATION PLAN	
PHASE 11 CROSSROADS LANDFILL NORRIDGEWOCK, MAINE	
	FIGURE 2
Acton, MA	APRIL 2020

Phase 11B – west: A yellow alert exceedance was observed in SI-737 during the 20 March 2019 readings at a depth of 27 ft. A negative displacement (i.e. towards the landfill) of similar magnitude was recorded at the same depth during the subsequent measurement on 19 June 2019. Pore pressure measurements in the nearby piezometer, PZ-819, were typical for this time of the year and not indicative of shear induced pore pressures. The exceedances were therefore attributed to measurement fluctuation and are not considered indicative of slope instability.

Phase 11C – west: Significant measurement fluctuation was observed in SI-739R during the 20 March 2019 readings, including exceedances of the yellow alert criteria at depths of 39 ft, 43 ft, and 51 ft. Subsequent readings measured on 18 April 2019 did not show any yellow alert exceedances. Pore pressure measurements in the nearby piezometer, PZ-822, were typical for this time of the year and not indicative of shear induced pore pressures. The exceedances were therefore attributed to measurement fluctuation and are not considered indicative of slope instability.

Phase 11 – multiple locations: Measurement fluctuation was observed during the 16 December 2019 measurement round at several locations including SI-733, SI-736, SI-737, SI-739R, SI-740, SI-741R. Pore pressure measurements in the nearby piezometers were typical for this time of the year and not indicative of shear induced pore pressures. The slope inclinometers will be reread and evaluated in 2020.

No additional exceedances of the yellow or red alert criteria or spikes in excess pore water pressure associated with undrained shearing in the clay were observed with the Phase 11 inclinometers and piezometers in 2019.

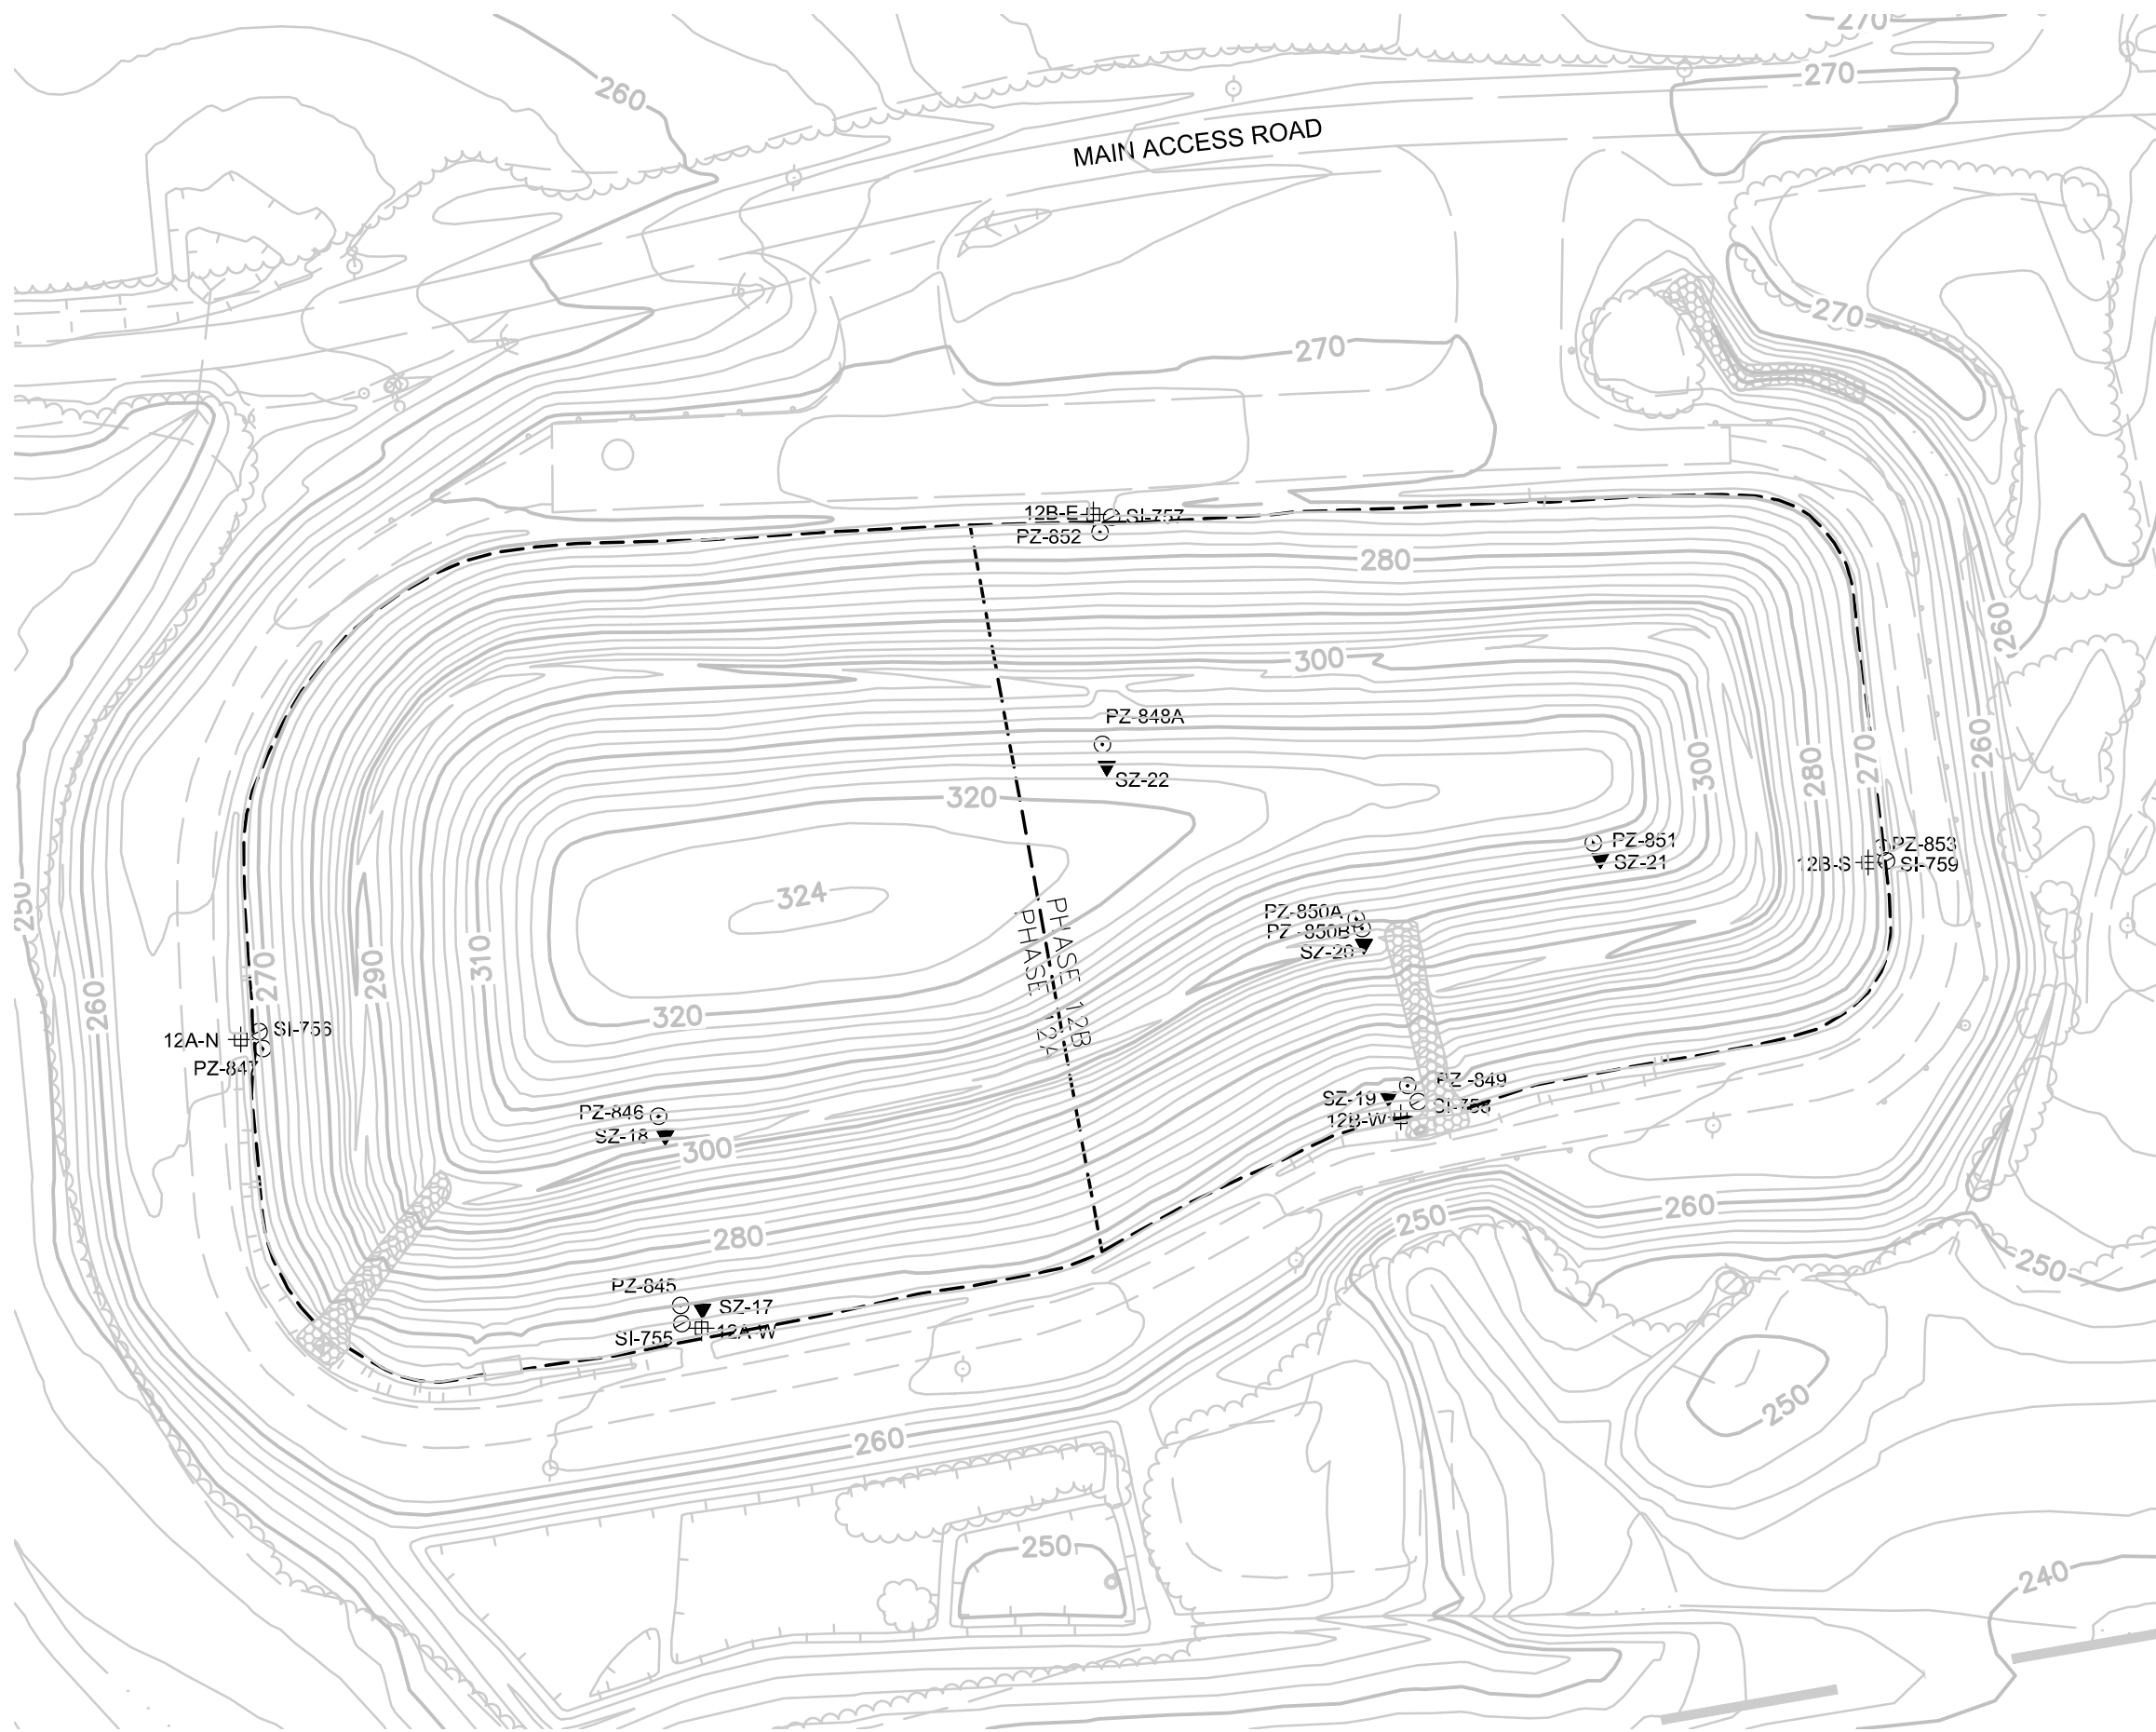
INSTRUMENT LOCATION PLAN

Phase 12 was permanently closed in 2016, and therefore WMDSM did not place waste in Phase 12 during 2019. The instrumentation was monitored on 23 May and 29 November 2019.

No exceedances of the yellow or red alert criteria or spikes in excess pore water pressure associated with undrained shearing in the clay were observed with the Phase 12 inclinometers and piezometers in 2019.
