RE: RFP#202008127 Grant Application for Thomaston, Maine Stream Crossing Replacement

Beechwood Street Culvert Replacement Project

Attachment 1
Town of Thomaston
Application for 2020 Stream Crossing Public Infrastructure Grant

TOWN OF THOMASTON, MAINE
 BEECHWOOD STREET
 CULVERT REPLACEMENT PROJECT

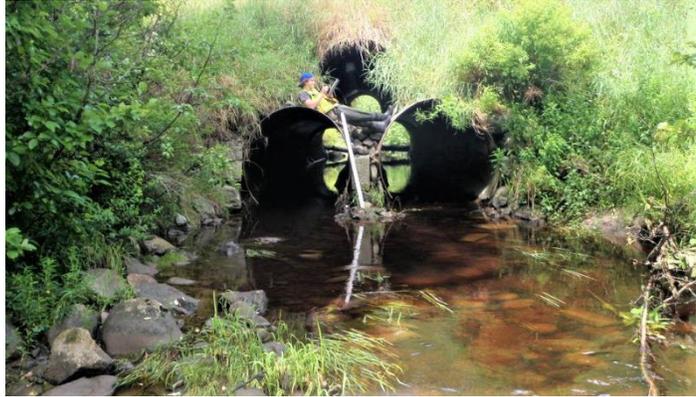
Figure 1 Existing culverts viewed from downstream

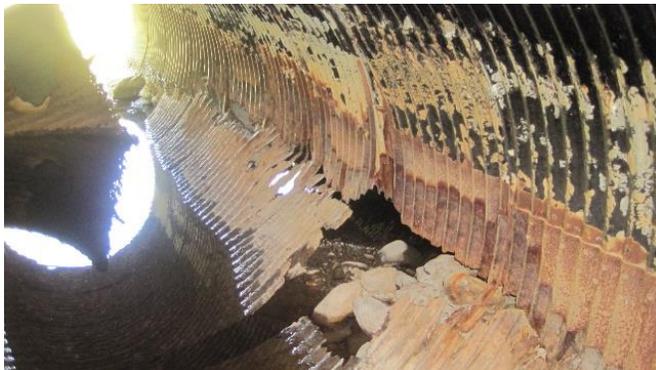
Figure 2 Showing holes allowing rocks to enter culvert

corrosion and that the fill material is ending up inside the culverts from holes rusted away in the sides of the culverts. This has also led to voids in the material around and between the culverts. In addition, the bottoms of the culverts have corroded away and the inlet end of one culvert has bent up blocking the flow. In June 2020 the Town contacted Dirigo Engineering to review the situation and provide advice on how

to proceed. After inspecting the site, they recommended that Thomaston completely replace the culverts as soon as possible. They have given Thomaston a proposal for engineering services that includes preliminary design, permit and grant applications, final design, bidding and construction services. The estimated cost of all engineering services is \$31,000 to \$34,000.

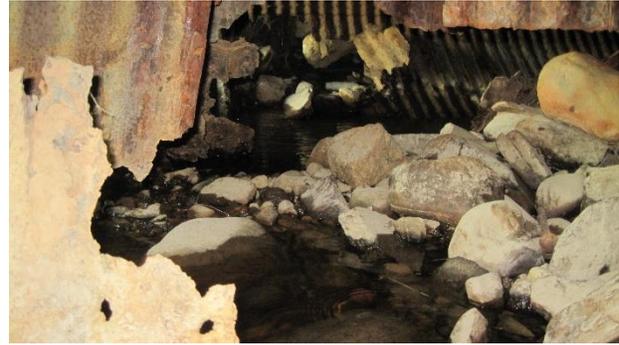
Figure 4 Void between the culverts

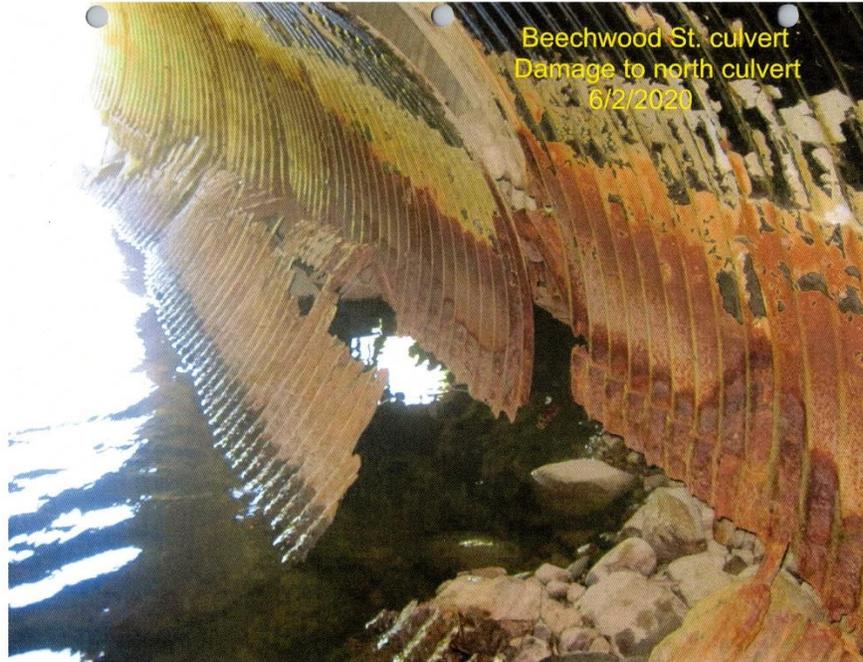
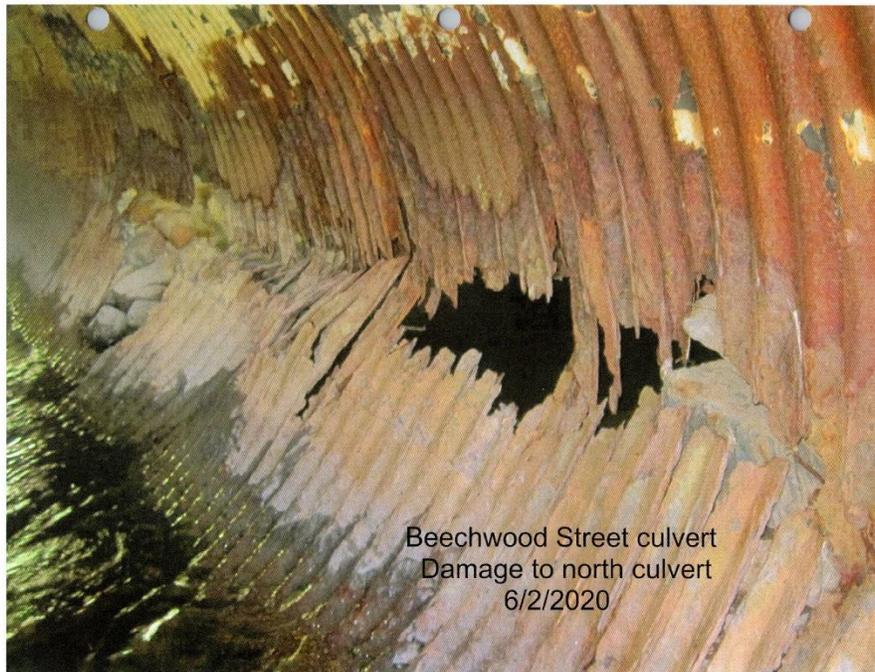
EXISTING CULVERT DAMAGE

8. Describe any issues with the current condition of the crossing						Much of the bottom and some of the sides of the culverts have corroded away, allowing material to wash into the culverts and creating voids around the culverts. This has created sinkholes and will ultimately result in collapse of the roadway.

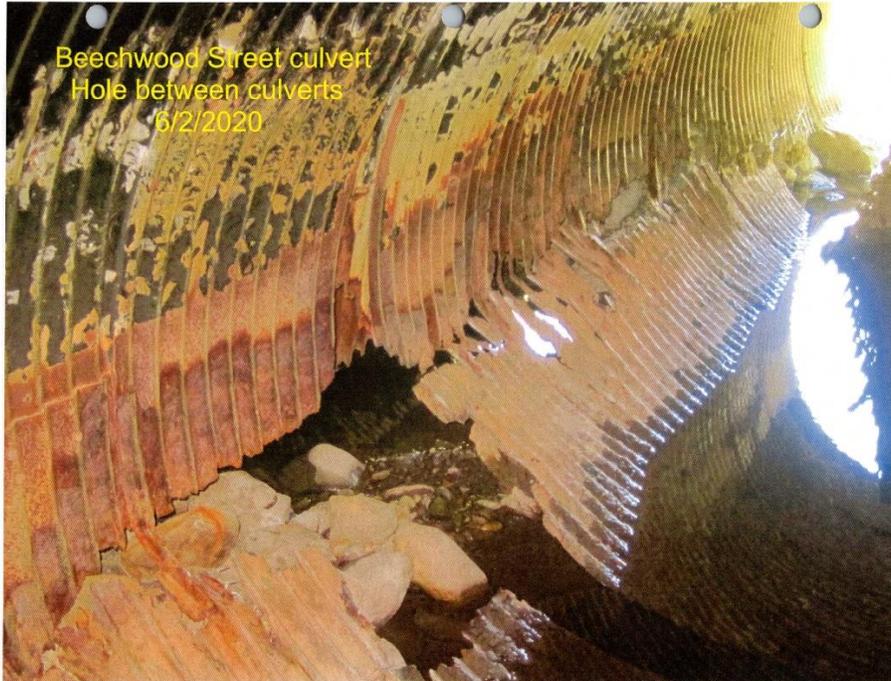
Beechwood Street culvert
Hole between culverts
6/2/2020

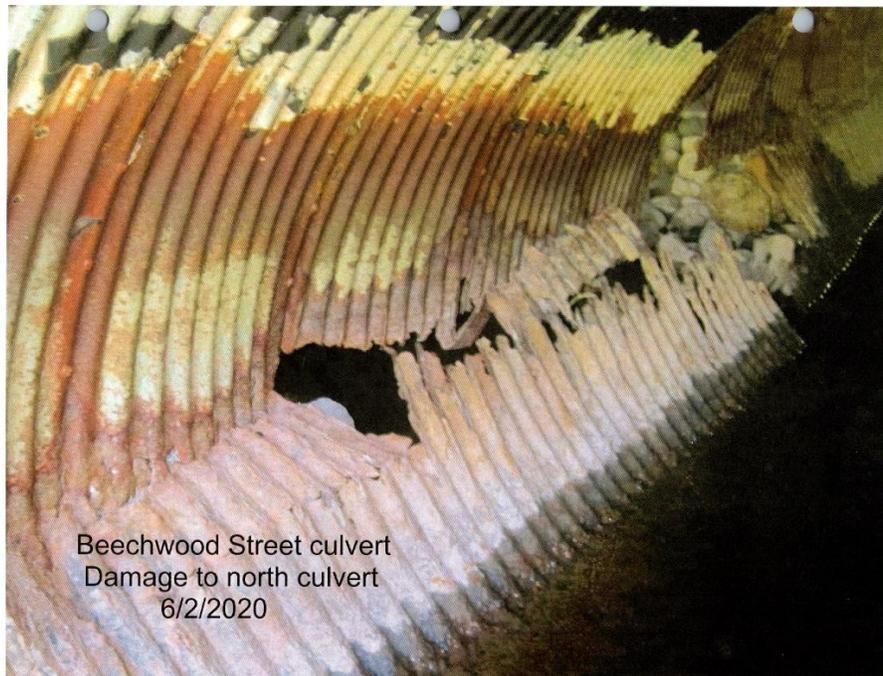
Beechwood Street culvert
Damage to north culvert
6/2/2020

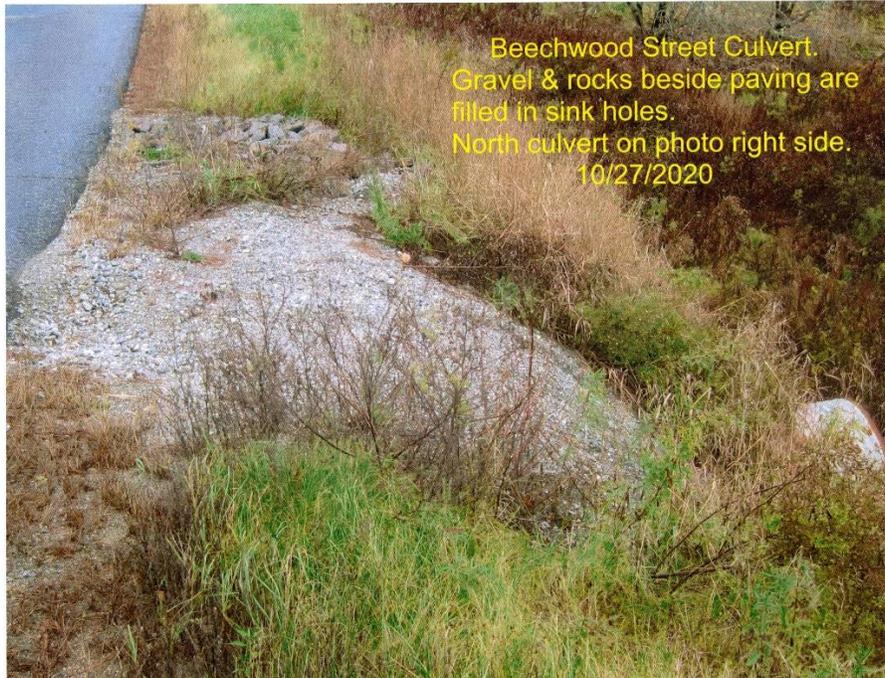
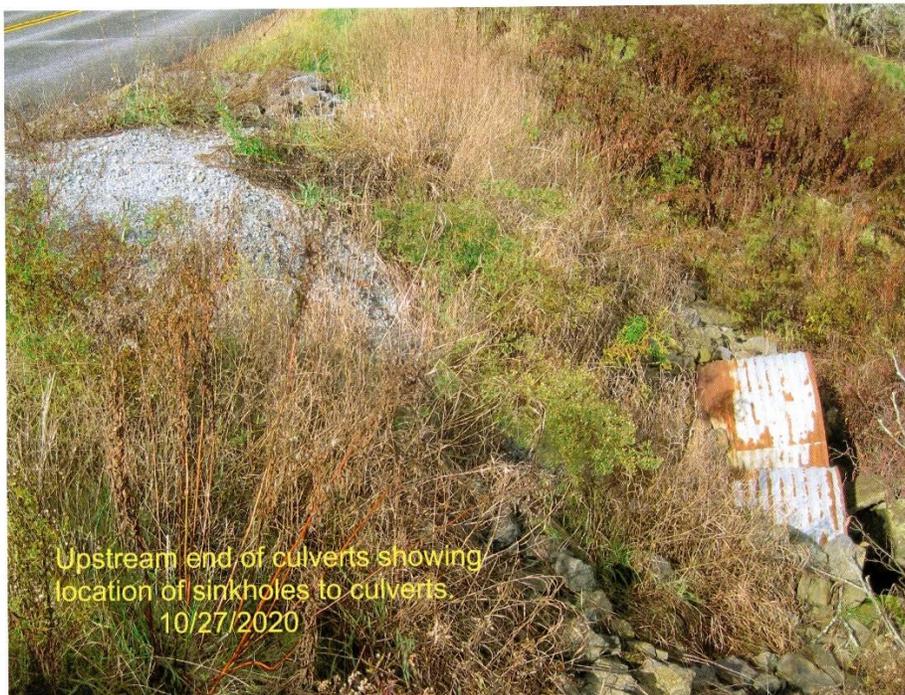
SINKHOLE LOCATIONS

Problem: Several sinkholes have appeared in the shoulder of the road next to the paving. These have been filled but investigation in June 2020 found that the culverts have significant
